The Road Inventory of Muir Woods National Monument

Road Inventory Program

Prepared by: Federal Highway Administration Eastern Federal Lands Highway Division March 1999

Muir Woods National Monument in California

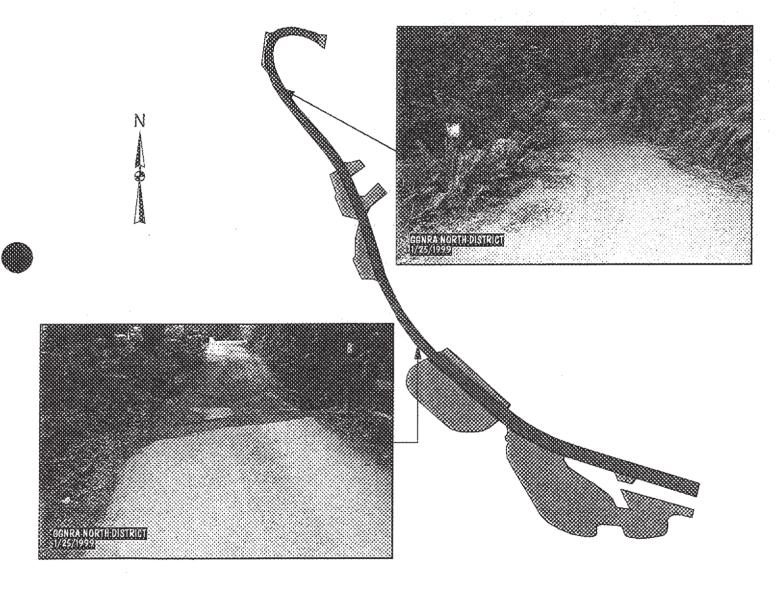
Photo # 02 Alligator cracking upper area section 2.

Route	Date	Length (mi)	Width (ft)	Area (sq ft)		Condition	Surface
203	990125	0.25	18	23,700	0.41	Fair	Asphalt

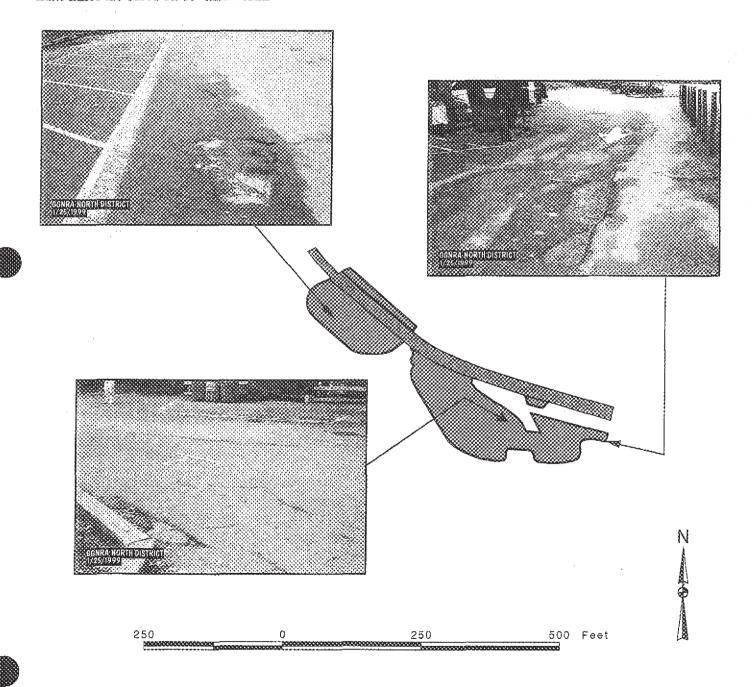
Route P900 MUIR WOODS PARKING

Route	Date	Length (mi)	Width (ft)	Area (sq ft)	Lane Miles	Condition	Surface
900	990125	-	-	43,497	0.75	Good	Asphalt

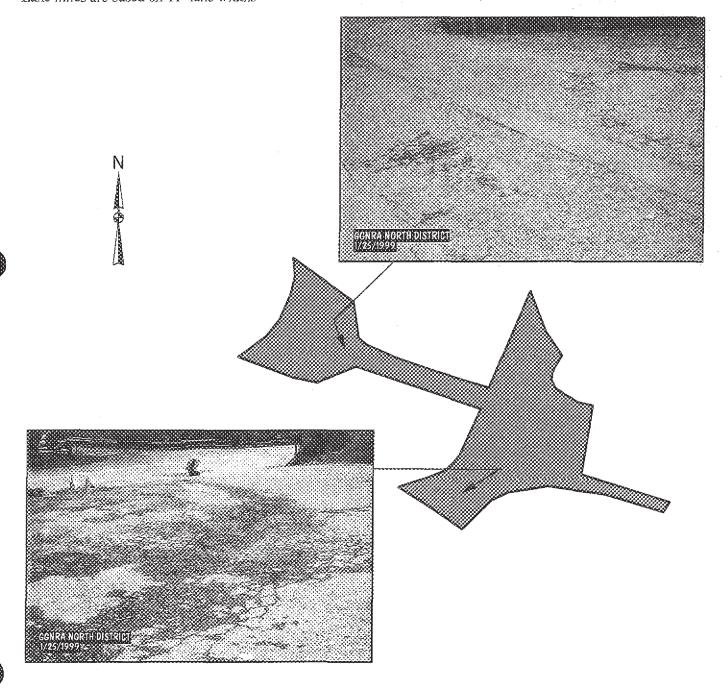
Route P901

MUIR WOODS OLD INN PARKING LOT

Route	Date	Length (mi)	Width (ft)	Area (sq ft)	Lane Miles	Condition	Surface
901	990125	-	-	12,523	0.22	Good	Asphalt

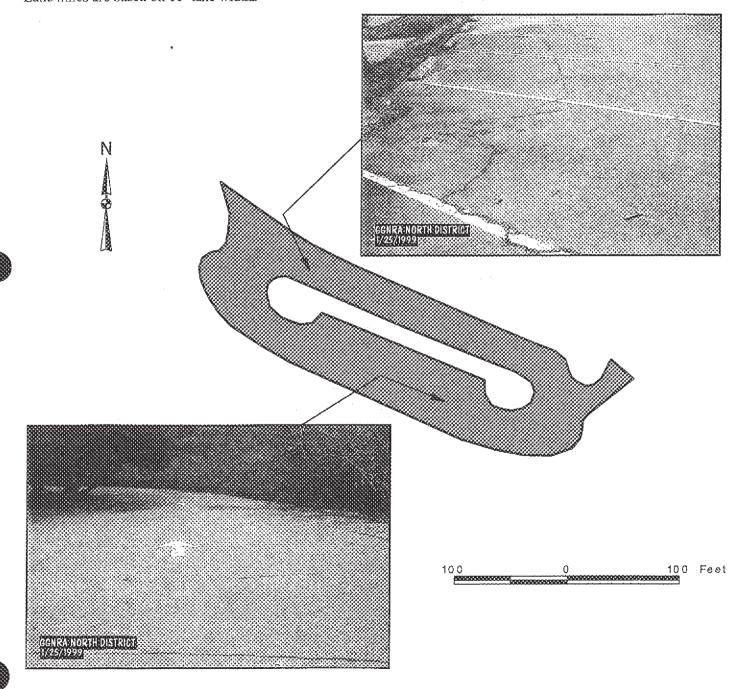
Route	Date	Length (mi)	Width (ft)	Area (sq ft)	Lane Miles	Condition	Surface
902	990125	ı	•	30,429	0.52	Good	Asphalt

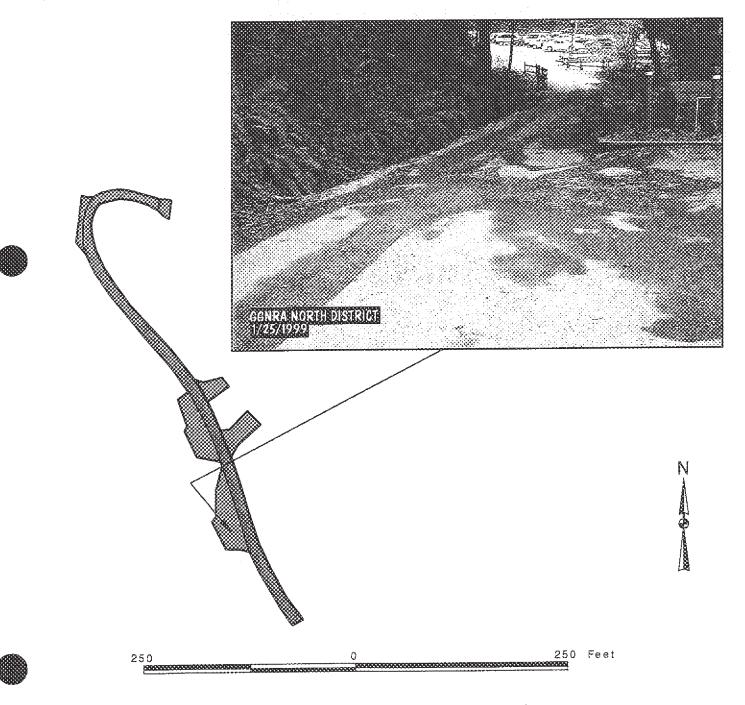
Route P903

ARAMARK-NPS ADMIN PARKING

Route	Date	Length (mi)	Width (ft)	Area (sq ft)	Lane Miles	Condition	Surface
903	990125	J		7,307	0.13	Good	Asphalt

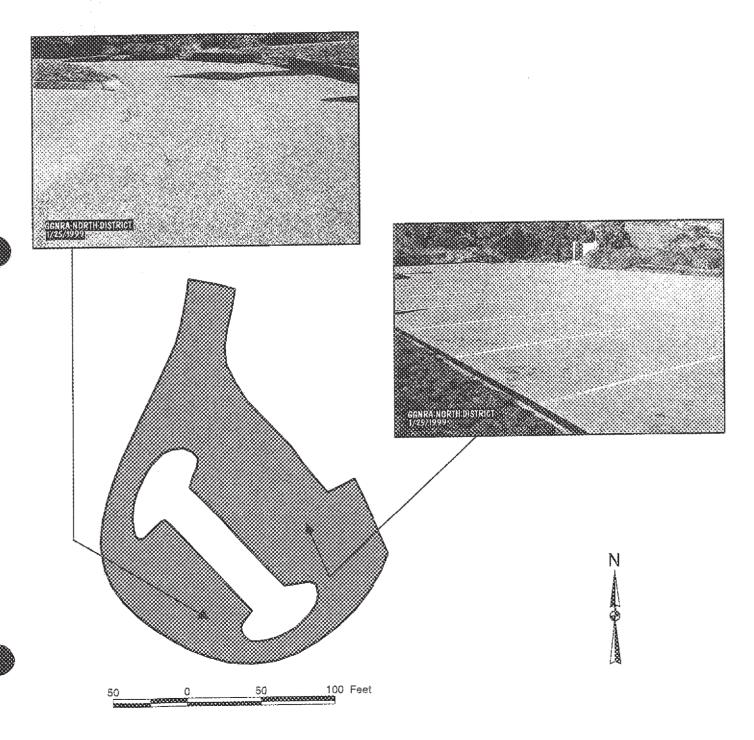
Route P922

MUIR BEACH OVERLOOK PARKING

Route Date Length (mi) Width (ft) A	Area (sq ft)	Lane Miles	Condition	Surface	
922 990125 -	14,438	0.25	Excellent	Asphalt
