# TRAFFIC SAFETY STUDY

# **ROCK CREEK PARK**

# Traffic Safety Study Rock Creek Park, Washington, D.C.

### United States Department of the Interior National Park Service Denver Service Center

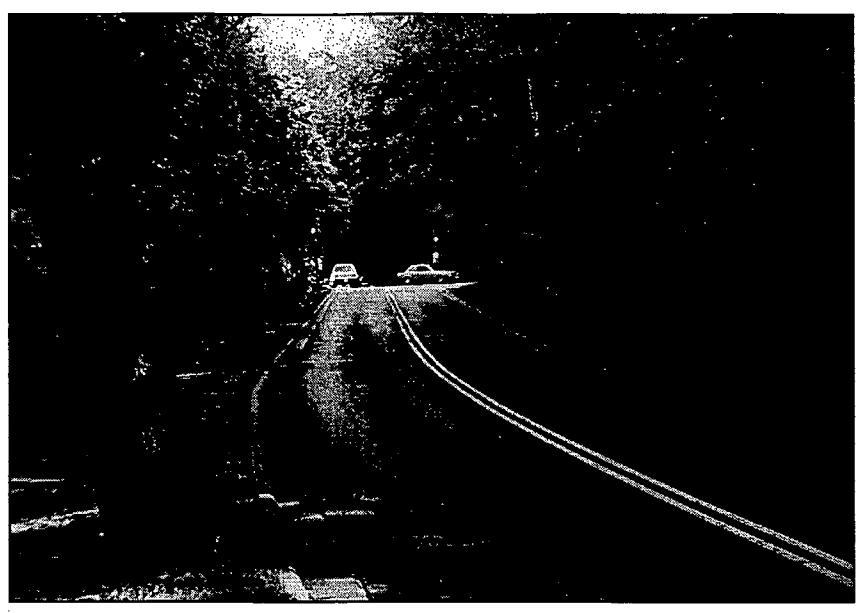
These two trees on the west side of Beach Drive south of Tilden are located immediately behind the curb line. Both trees show evidence of vehicle impacts.

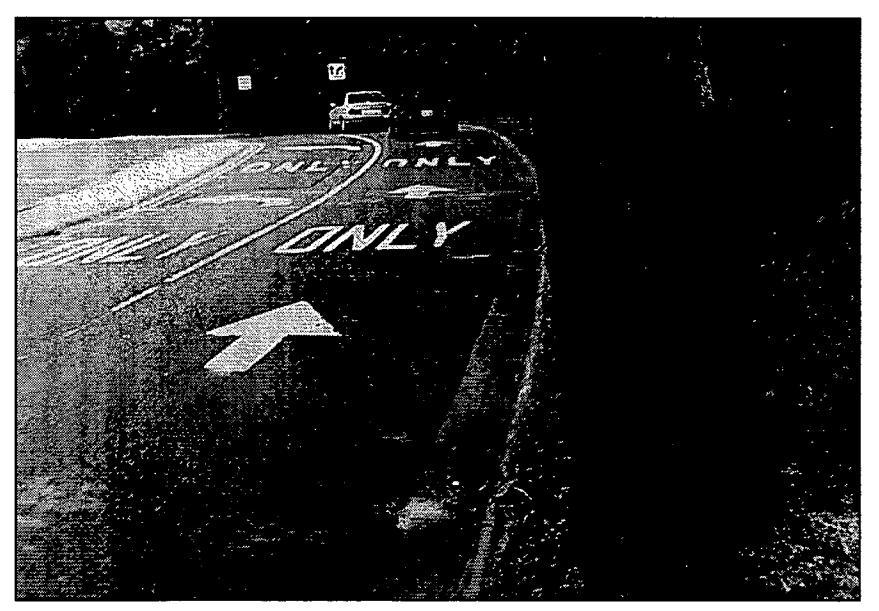
The large tree on the right is located within a foot of the curb line on the south approach to the Klingle Road intersection.

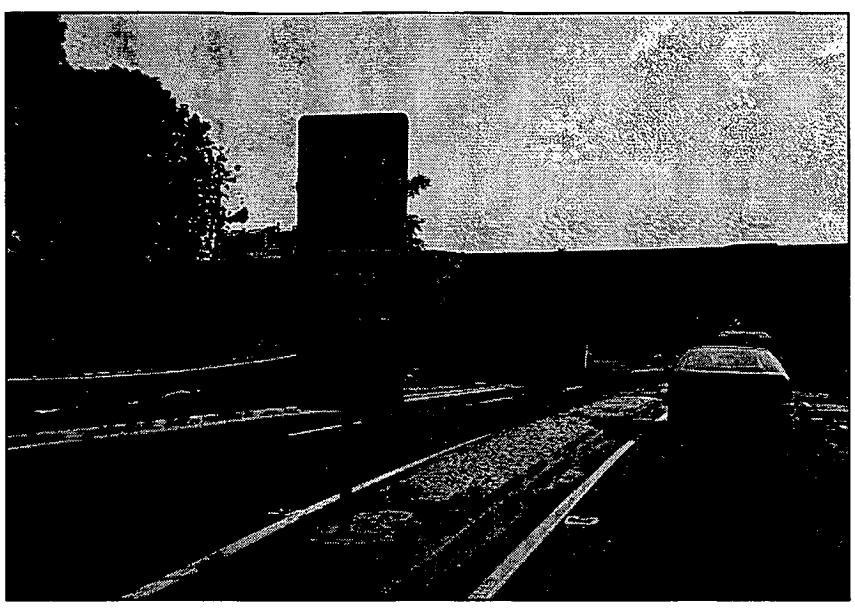
This keep right sign on the RCP is displayed twice. This is non-standard. In this case the lower sign is folded up to cover the upper sign during one-way operations in afternoons. It would be more appropriate if the lower sign was blocked out or left blank.

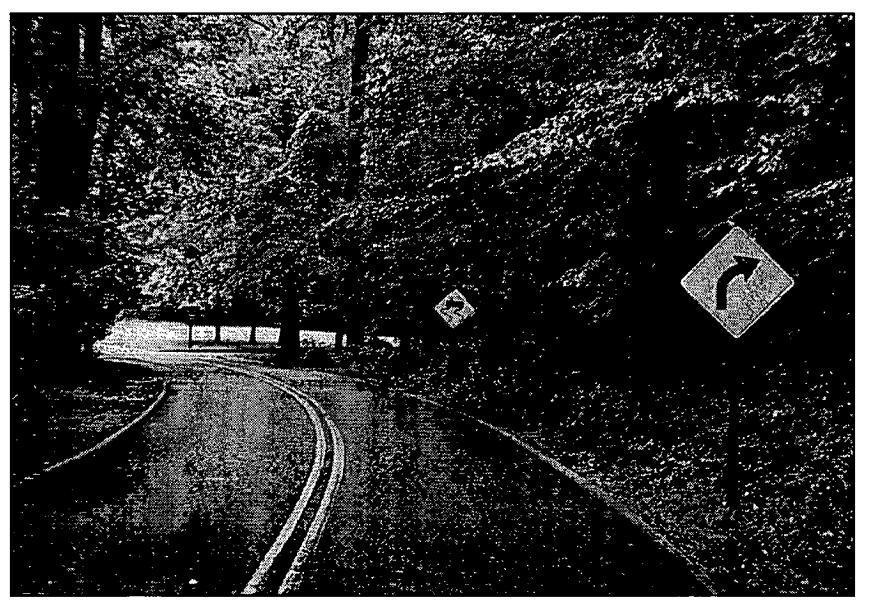
The curve warning sign on Glover Road indicates a curve to the right when the roadway is clearly turning to the left. It would be more appropriate if the location of this sign was switched with the slippery when wet warning sign farther along the road.

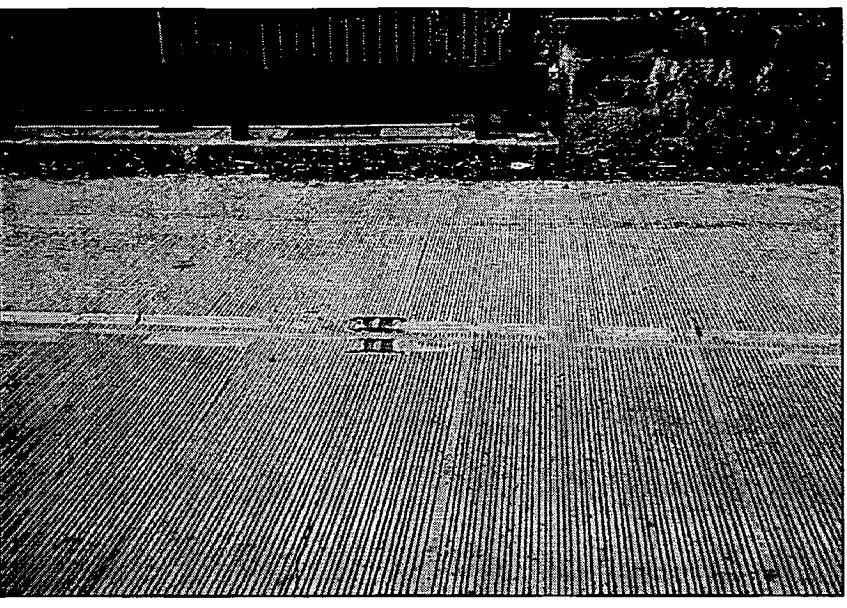
This photo shows how the concrete bridge deck on Tilden Street has been grooved to increase skid resistance. The reflectors on the centerline are plowable. Both applications are appropriate and effective. This bridge is under the jurisdiction of the DC DPW.

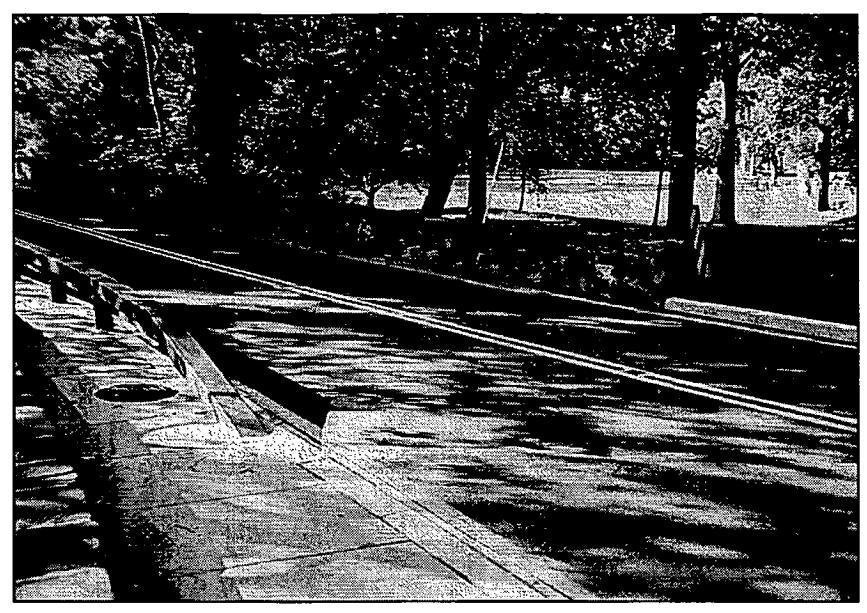
This photo of the west end of the bridge on Tilden Street shows two bridge end treatments used in the Park. The stone guidewall on the far side of the street is vertical and appropriately accompanied by a black and yellow object marker. The steel guardrail on the near side of this street is rolled down. Tilden Street and this bridge are under the jurisdiction of the DC DPW.

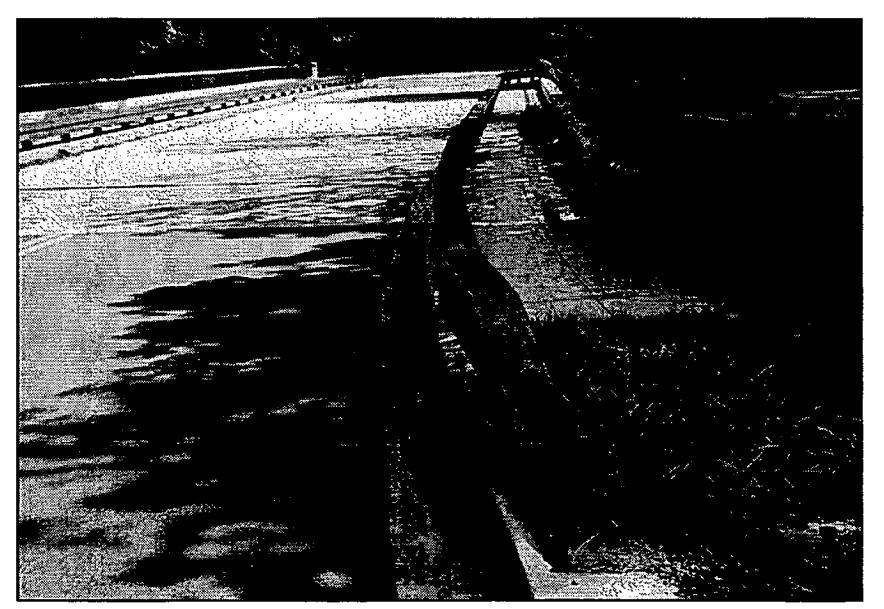
The steel guardrail on the Klingle Road bridge is located directly over the inside edge of the curb. The rail shows evidence of vehicle scrapes. Silver reflectors mounted on the face of this rail would help identify it for drivers at night. This bridge is under the jurisdiction of the DC DPW.

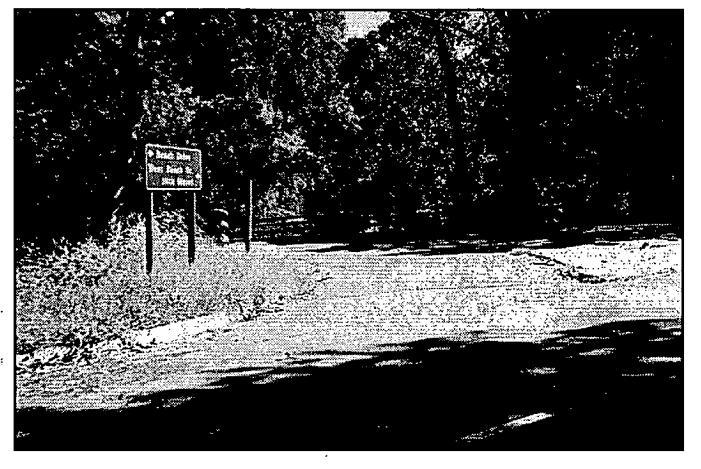
This photo shows the south approach to the intersection. The raised channelization delineates the right turn lane. Orange cones are used to divert traffic to the right during times when Beach Drive is closed north of the intersection.

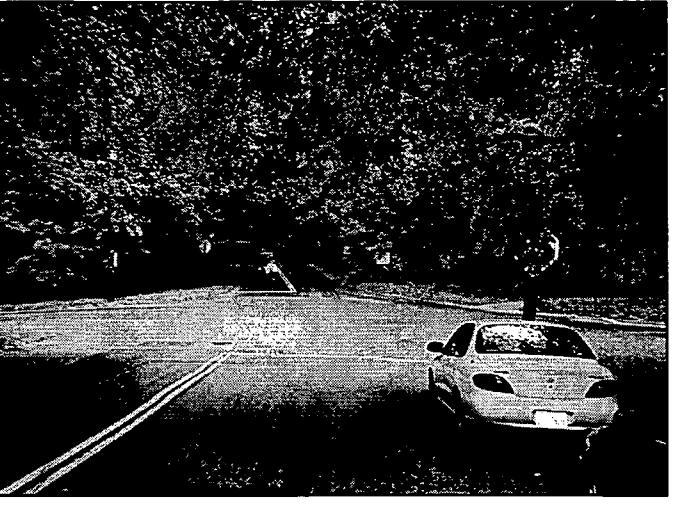
Low tree branches block the driver's view of the stop sign on the west approach to the intersection of Wise and Oregon. Vegetation blocks the view of other signs on the east approach.

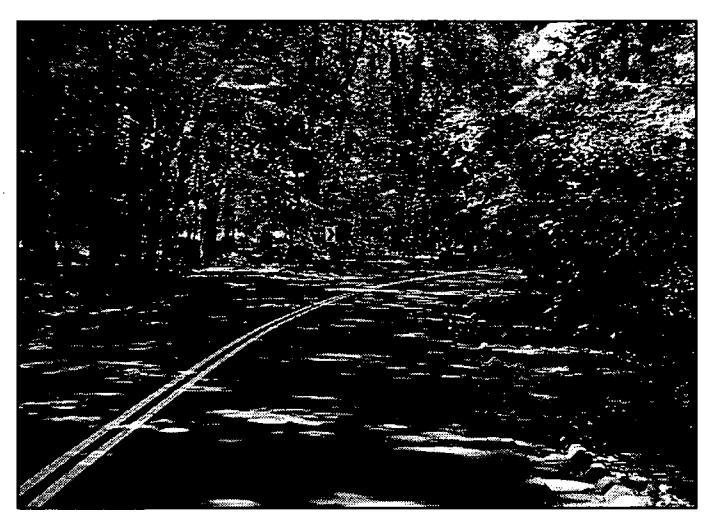
A horse trail crossing is located on the east side of the curve on Wise Road. The lack of adequate sight distance created by the curve makes the location of this crossing undesirable. The crossing should be relocated farther to the east along the tangent section of Wise Road.

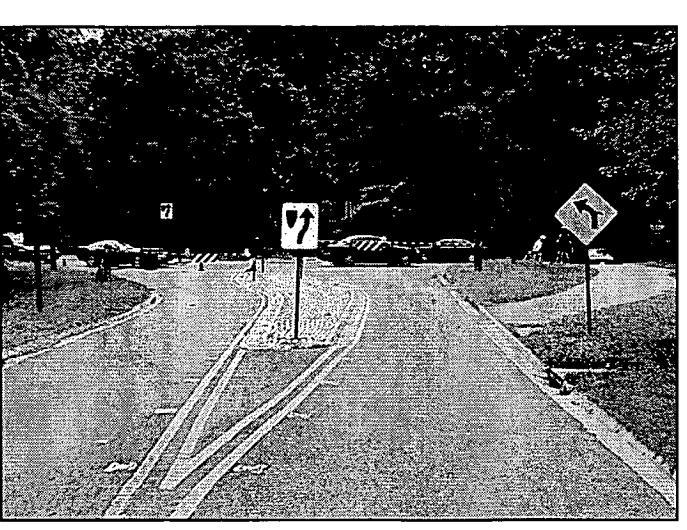
This is a view of the intersection from the north approach. Beach Drive north of the intersection was closed to traffic when this photo was taken as evidenced by the barricade gates. The intersection has raised channelization and plowable raised pavement markers that help guide the driver.

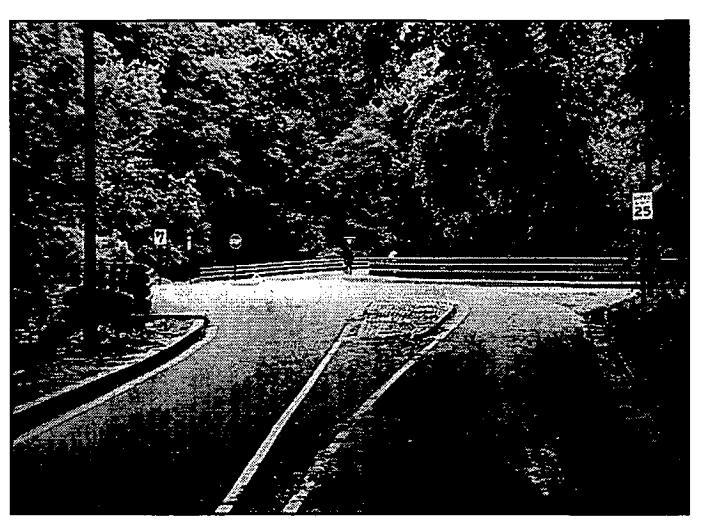
This photo shows the west approach to the intersection. Notice the entrance to the picnic parking area on the right. The driver has a clear view of the Beach Drive intersection when approaching on Broad Branch.

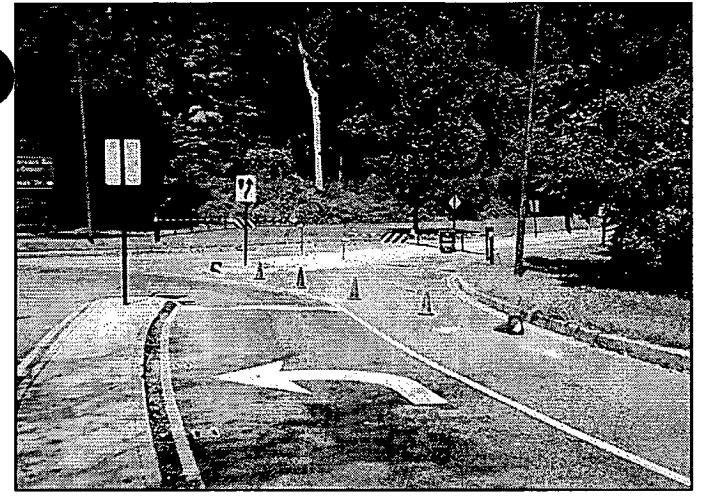
The south approach to the intersection has a designated left turn lane and a through lane. Drivers tend to straddle the center lane line when making left turns which pushes through vehicles into the far right curb.

- On the median on the west approach, rotate the existing "Keep Right" sign to face the opposite direction and install another "Keep Right" sign on the other end of the median. Estimated Cost: \$ 300
- Install candlestick delineators between the through and left turn lanes on the south approach to help maintain the necessary vehicle separation on this approach to the intersection. Estimated Cost: \$ 600
- Modify the gate as shown in **FIGURE 2-7**.

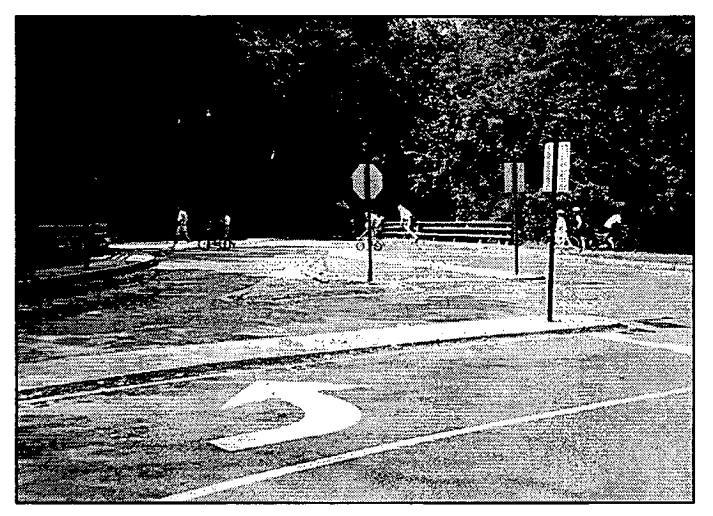
There is a high use pedestrian crossing located adjacent to the intersection on the west approach. Vehicles stopping for pedestrians or bicyclists back traffic up into the intersection.

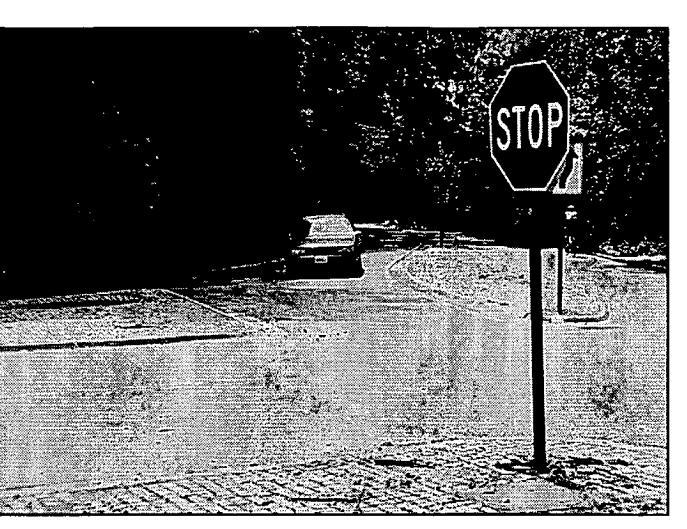
It is difficult to predict whether traffic approaching the intersection from the south is turning right or proceeding straight through the intersection until the last minute. Drivers waiting at the stop sign often misread the situation and pull out in front of through traffic causing angle accidents.

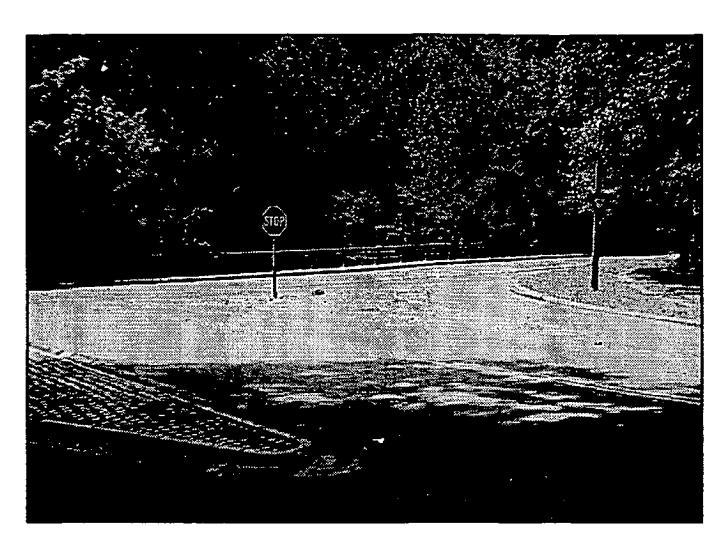
This photo shows the intersection from the east approach. The intersection has raised channelization. The east approach is controlled by a stop sign for left turning traffic and a yield sign for traffic turning right.

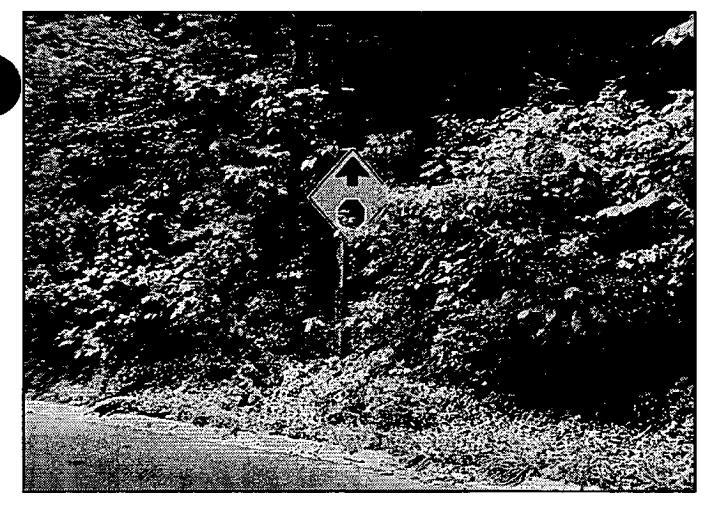
The driver's view of the stop ahead sign on the east approach is blocked by vegetation.

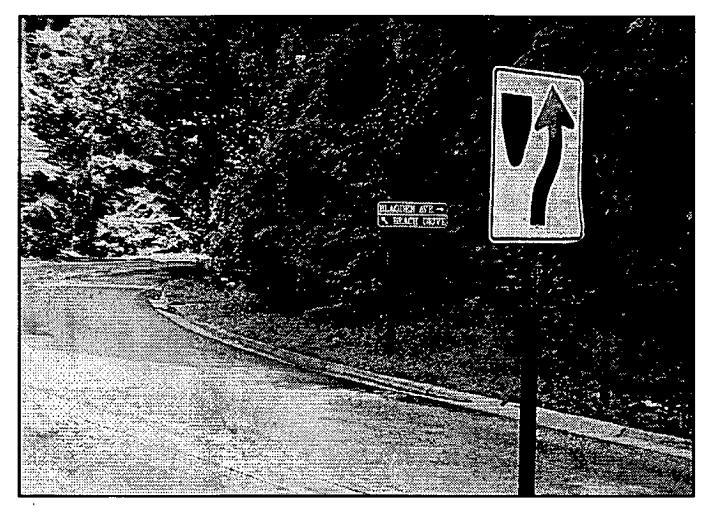
The guidance sign on the south approach is too small and located too close to the intersection to be effective.

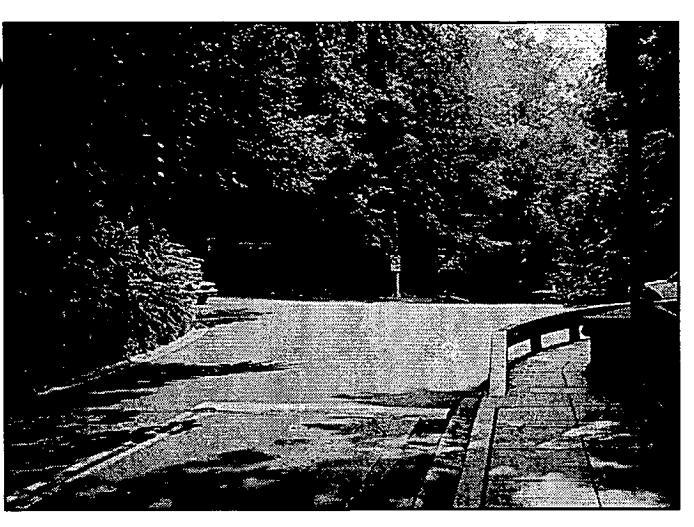
The guardrail on the northwest corner of the intersection is located directly above the curbline and shows evidence of repeated vehicle sideswipes. There is a concern that the turned down end of the guardrail could vault a vehicle if struck from the north.

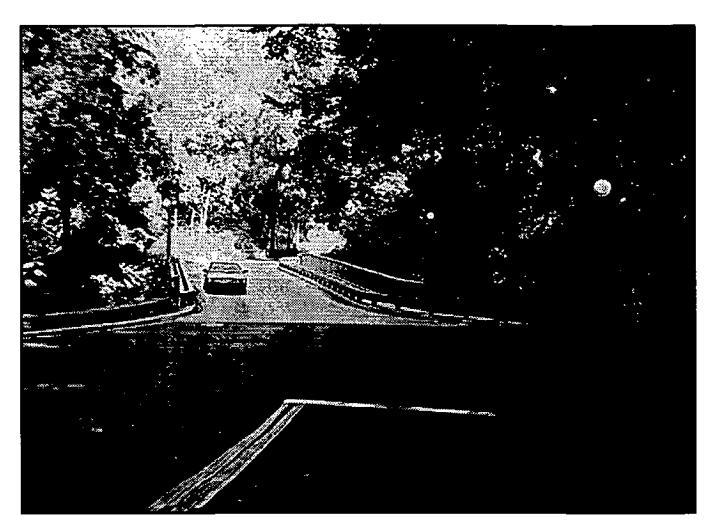
This photo shows the east approach on the west side of Beach Drive and the Tilden Street bridge on the west approach. The vegetation on the northeast corner encroaches into the driving lane and should be pruned back.

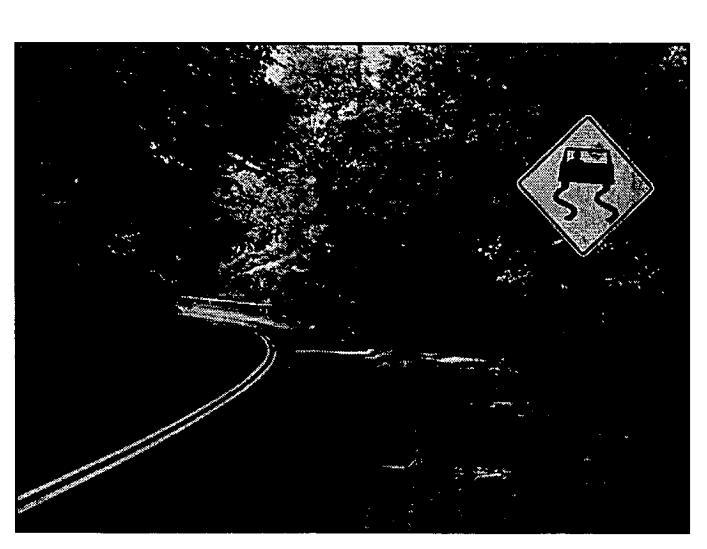
This "Slippery When Wet" warning sign is the only warning provided prior to the curve when approaching from the north. Notice how the vegetation on the inside of the curve limits the sight distance.

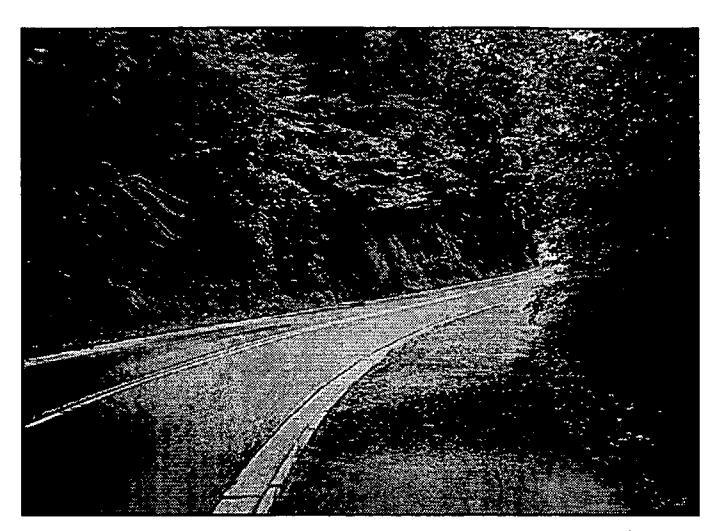
The paved pedestrian path is located immediately adjacent to the road through the curve. This places the pedestrian and bicycle traffic very close to passing vehicles. It would be desirable to separate these traffic flows with a white candlestick delineators.

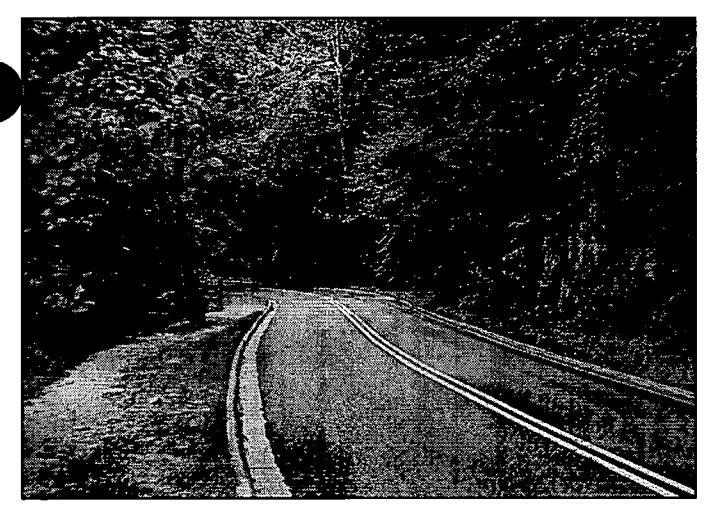
This photo shows a view of the curve from the south approach. There is no advance warning of this curve or any delineation through the curve section. Notice the dirt path that extends south from the Bluff Bridge on the west side of the road.

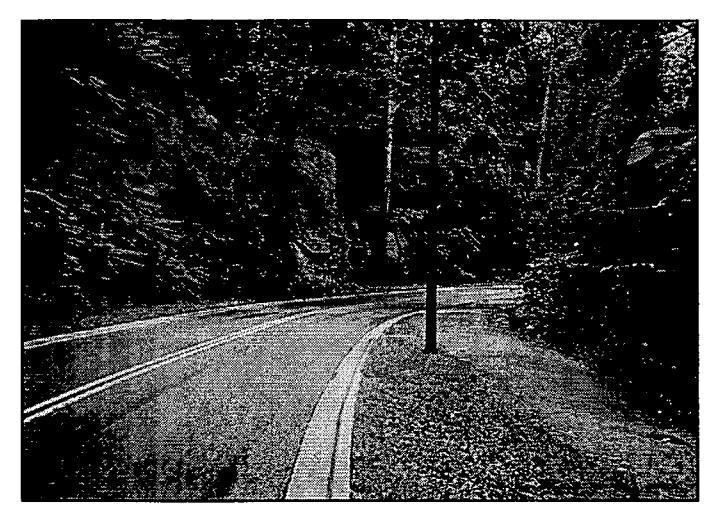
A large rock outcropping is located on the outside of the curve. These rock formations are often impacted when vehicles leave the roadway at this site.

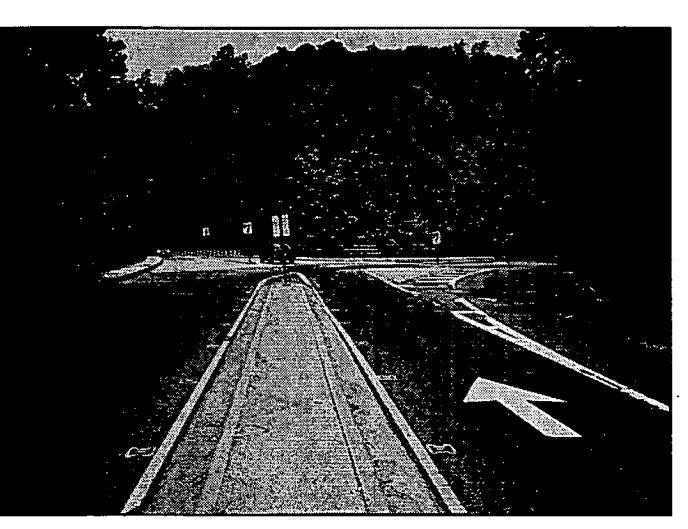
This photo of the south approach to the intersection shows the raised median and raised pavement markers. Portions of the pavement striping have pulled up in the gore area separating the thru and right turn lanes. Notice how the vegetation on the right blocks the view of the right ramp.

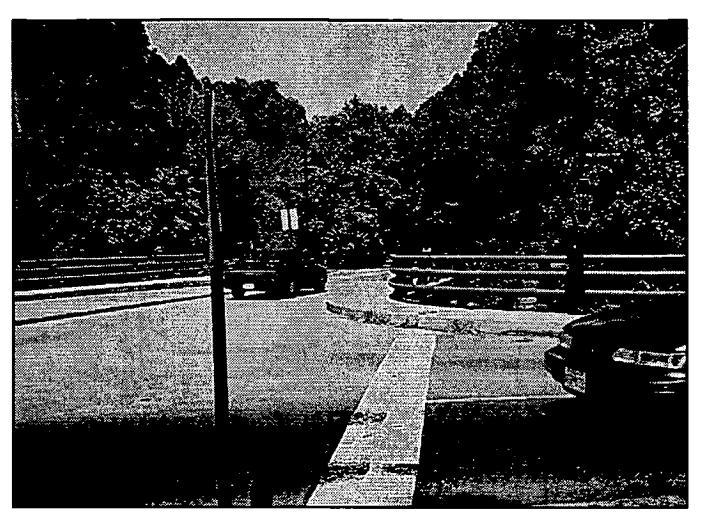
The bridge railing on the northeast corner blocks the driver's view of the north approach. Stop signs are used on the right and on the center median to control traffic approaching from the east.

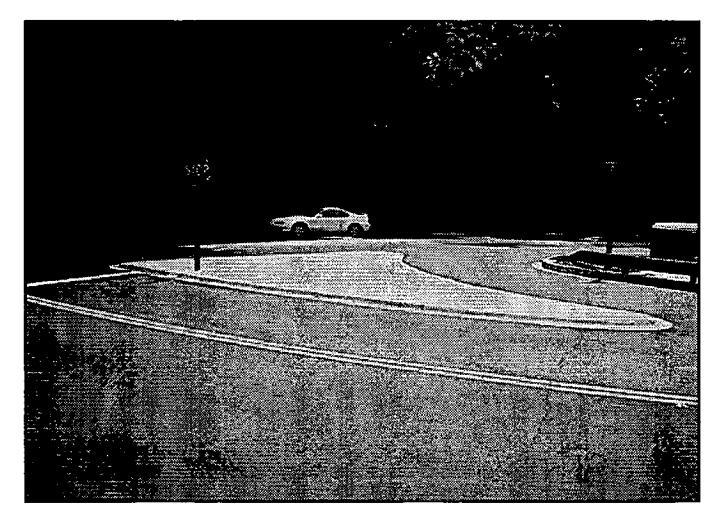
This photo shows the median island that separates the through and right turn lanes on the west approach. When a vehicle is waiting at the stop sign, vehicles on the right ramp can not see the north approach to the intersection.

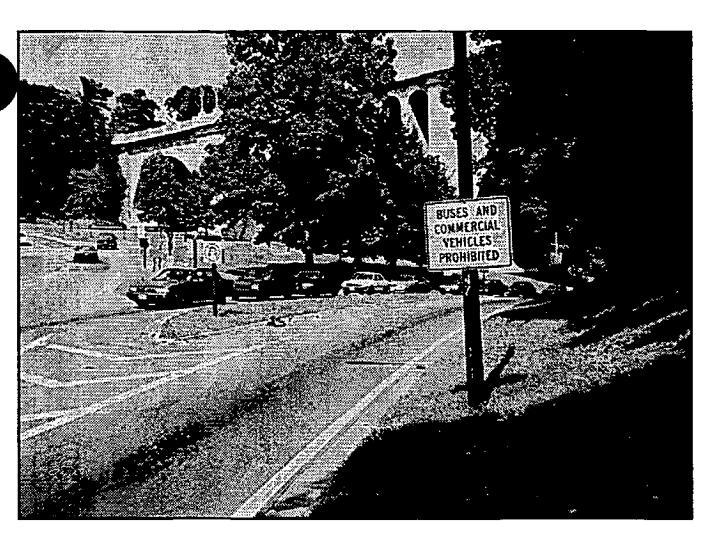
Traffic often backs up on the north approach to the intersection on Beach Drive.

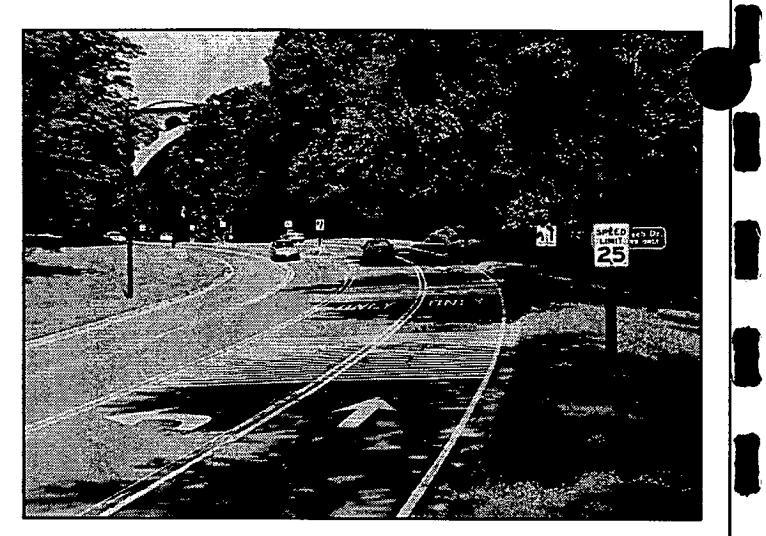
This photo shows the lane-use sign and pavement markings on the south approach to the intersection. Notice the rumble strips on this approach. They are constructed of Thermoplastic pavement lines across the roadway. They are not considered severe enough to adequately slow traffic.

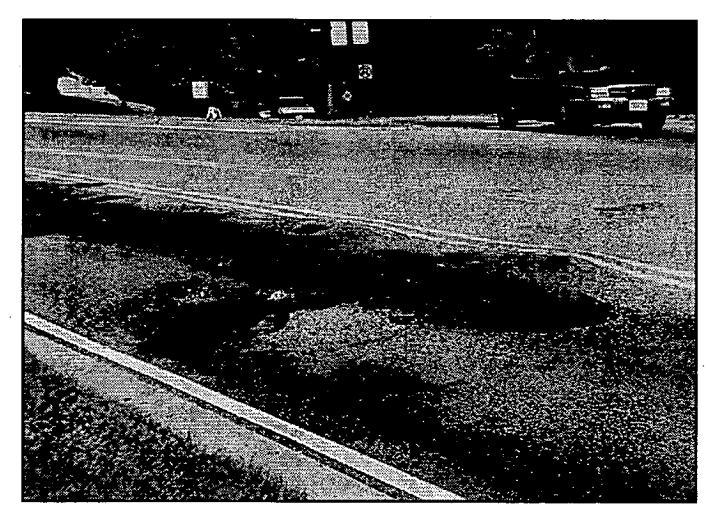
Rough pavement exists in the southbound lane of the Parkway across from the Beach Drive intersection.

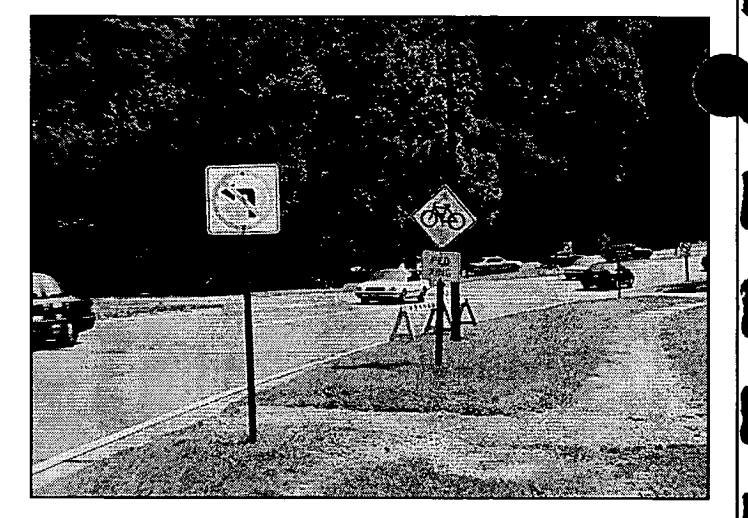
An old paved pedestrian path exists on the west side of the Parkway. This path leads to an unmarked crossing near the Cathedral intersection.

Extend the trail on the west side of the Parkway up to the intersection at Calvert Street. Eliminate all indications of a crossing north of the Cathedral Street Intersection. If necessary install a fence along the west side of the Parkway on the hill to enforce the no crossing zone. Estimated Cost: \$ 5,000

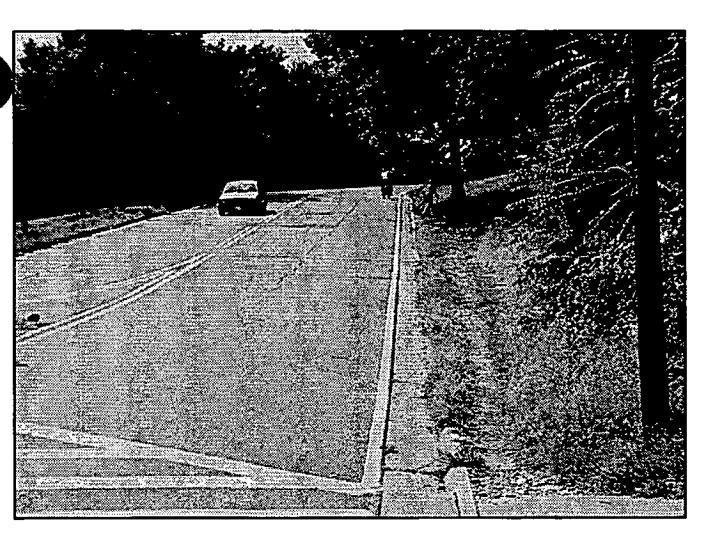
The dirt path on the north side of the access road demonstrates the need for a paved path at this location.

Install a paved trail up the access road to P Street. Locate the new trail on the north side of the access ramp.

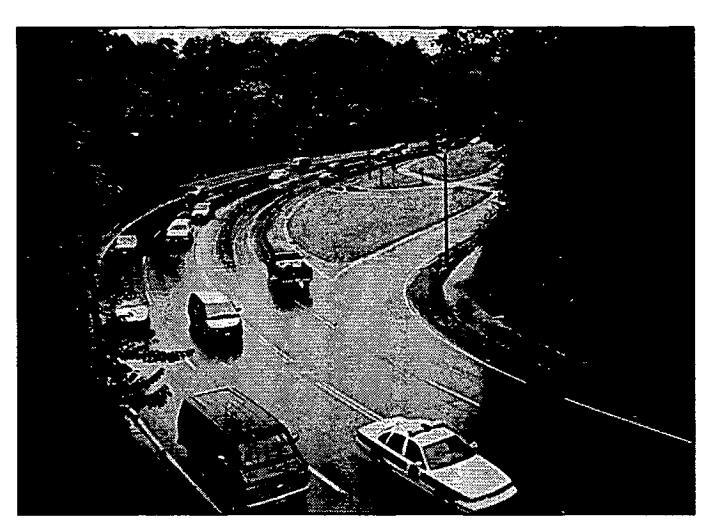
This view from the P Street Bridge shows the alignment of the exit ramp. This ramp has a maximum safe speed of 15 mph. Traffic approaches this ramp at speeds in excess of 50 mph.

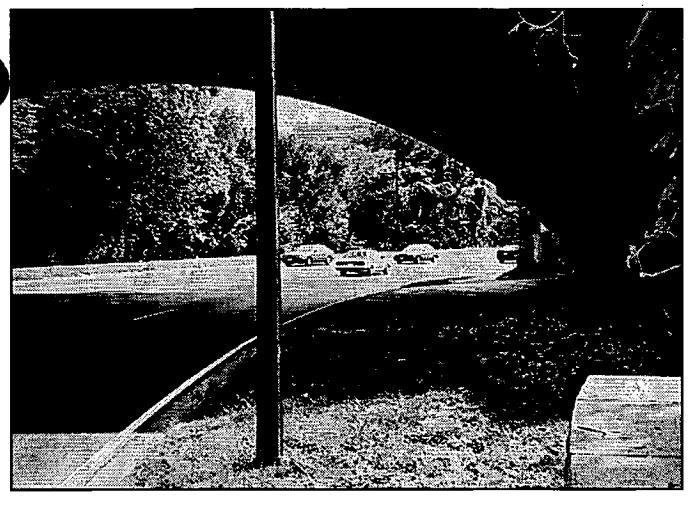
The driver can not see the exit ramp due to the bridge when approaching from the north.

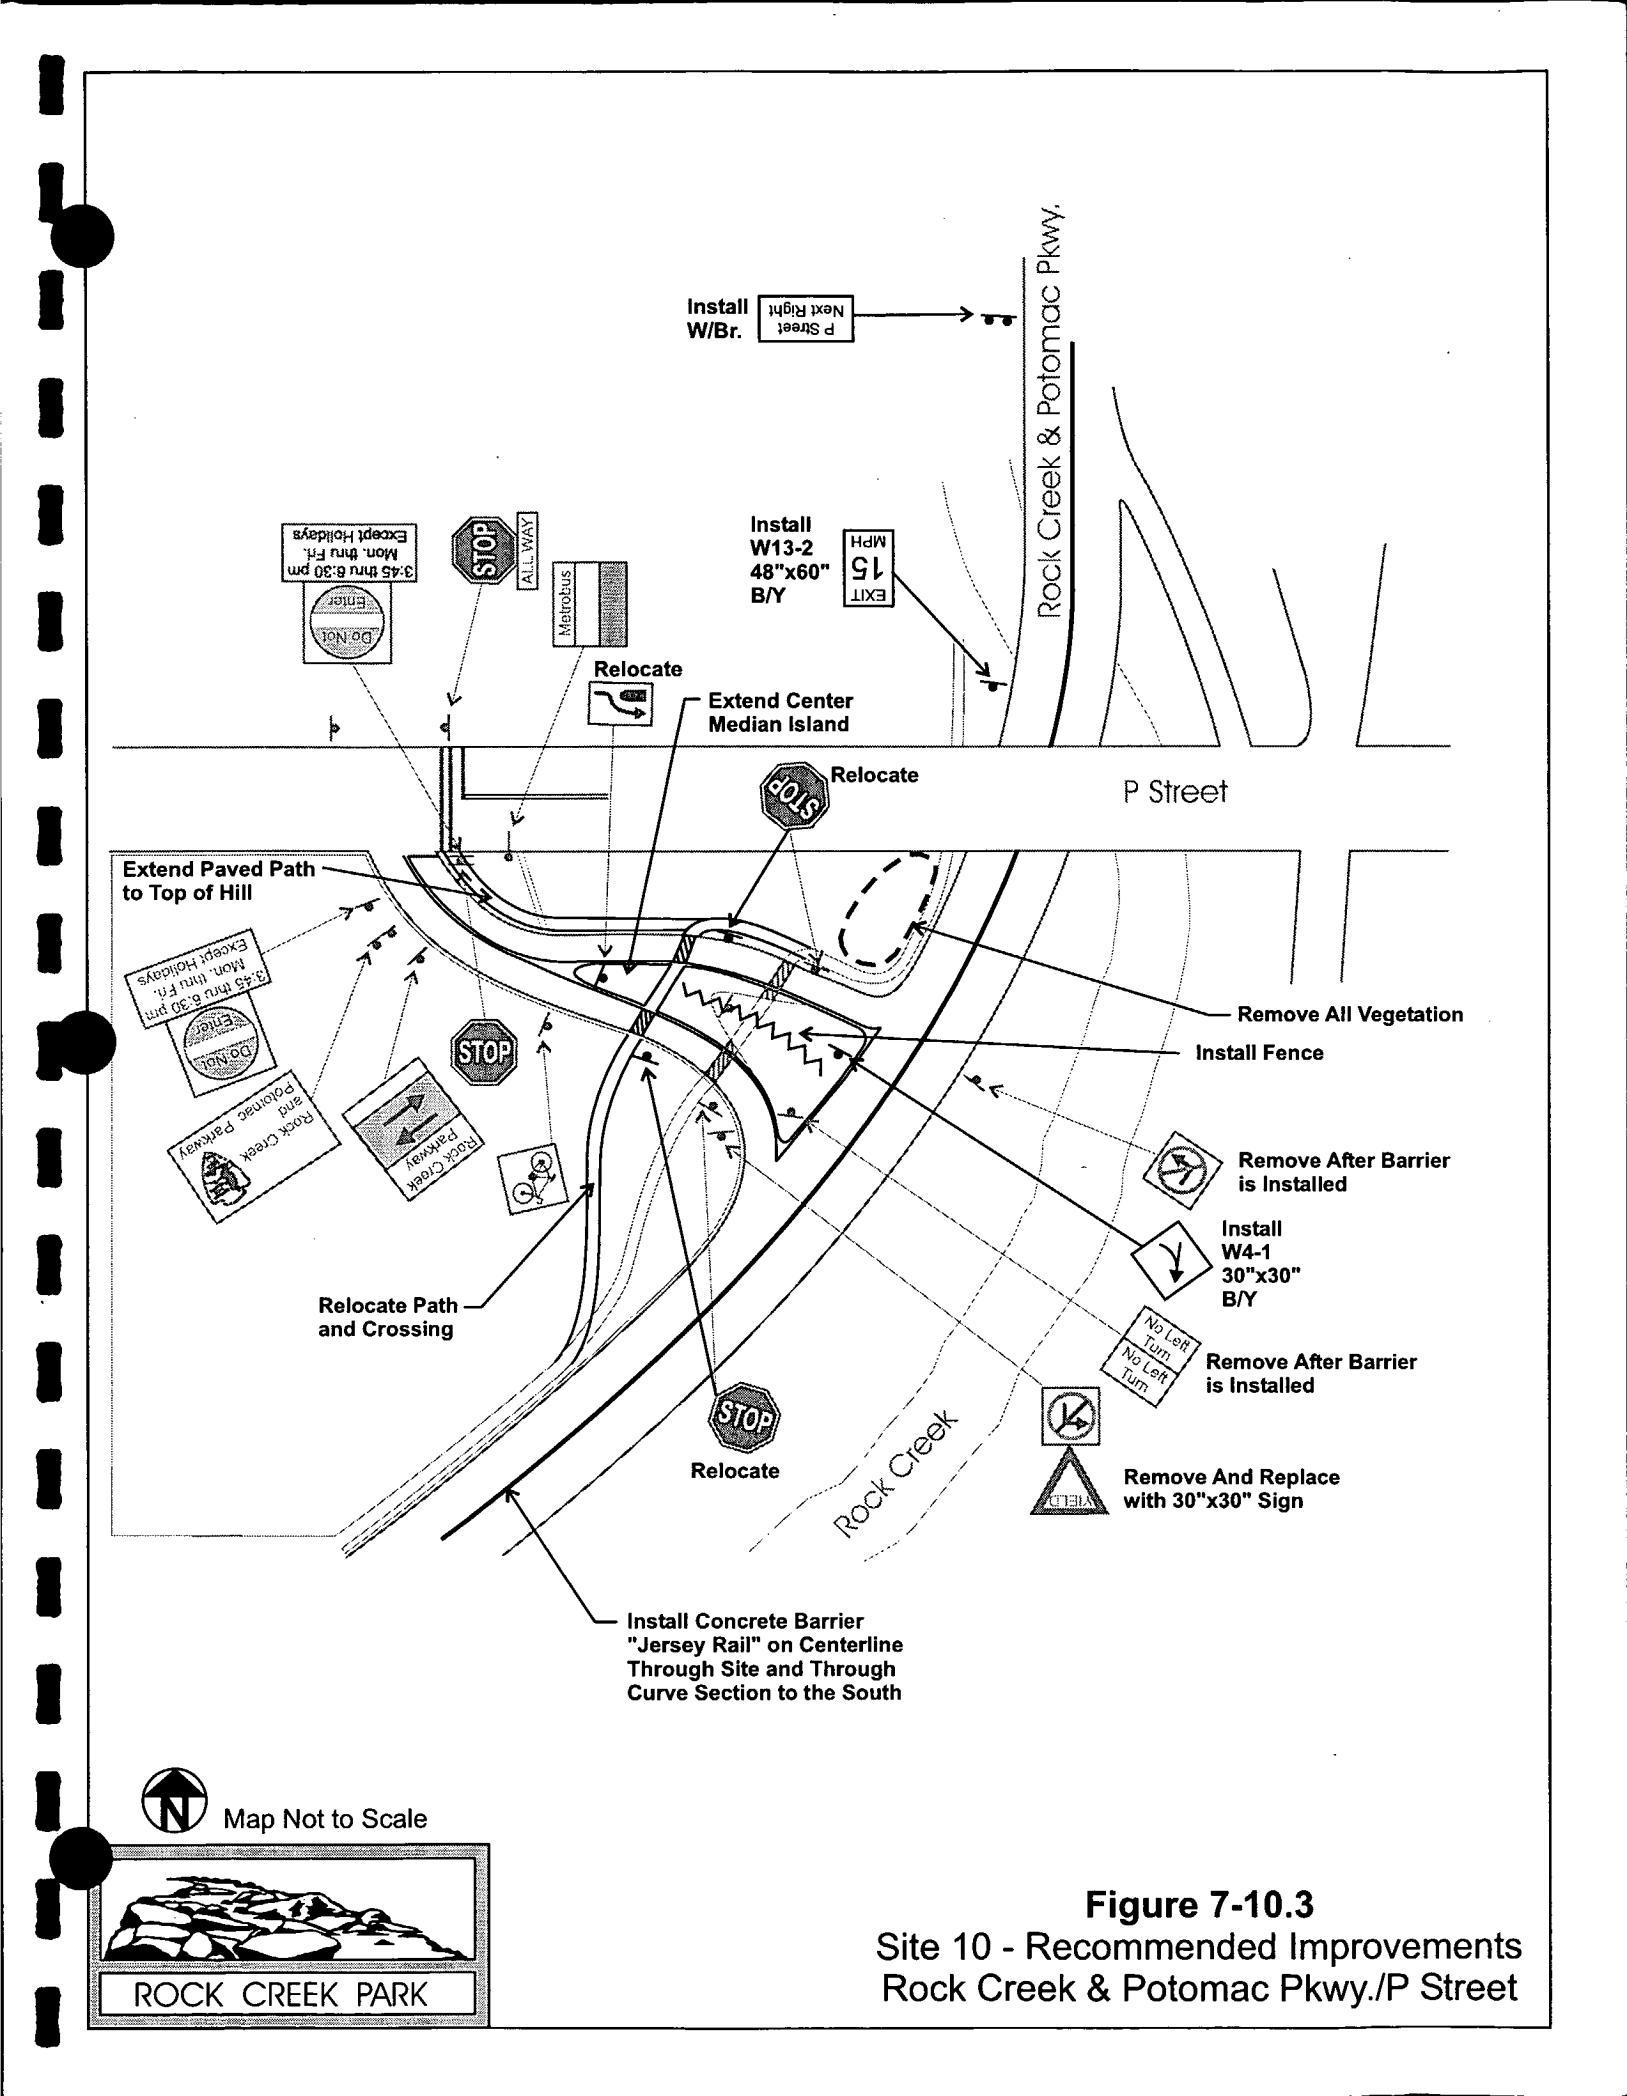
- The pedestrian/bicycle path conflicts with traffic entering and exiting the Parkway.
- The curve in the Parkway south of P Street is the location of many of the head-on collisions and sideswipes caused by vehicles not staying in their designated lanes.
- Northbound left turns on to the P Street exit ramp are prohibited but not at all uncommon, particularly among taxi drivers. The sight distance for this maneuver is very poor.
- Vegetation on the inside of the curve on the north approach limits the sight distance at this location.
- The southbound exit ramp has a maximum safe speed of 15 mph, while the average speed on the Parkway in this area is approximately 50 mph. There is no room available on the Parkway under the P Street bridge for a deceleration lane.

Remove all of the vegetation on the inside of the curve between the P Street Bridge and the site. This will benefit the visitors using the path and improve sight distance for the vehicles entering and exiting the Parkway.

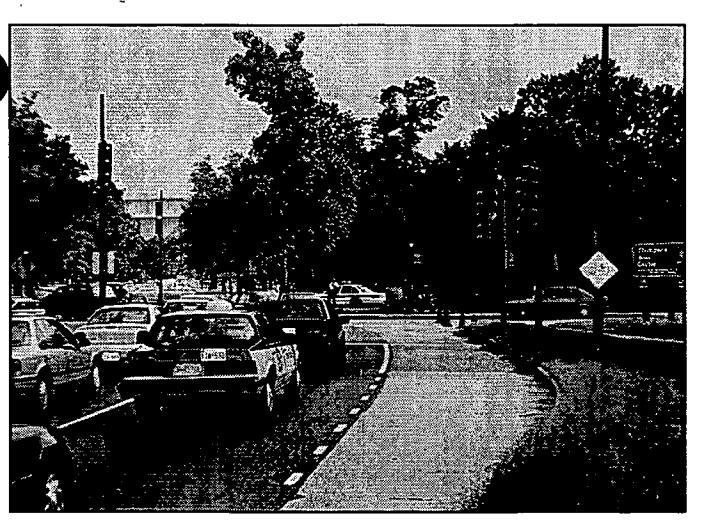
A deceleration/right turn lane is provided for southbound traffic turning into the Thompson Boat House parking area.

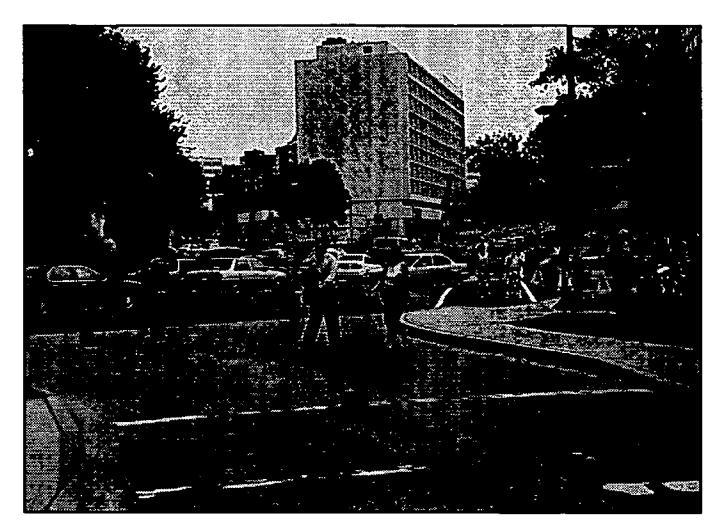
High volumes of pedestrians and bicyclists cross the south and west approaches at this intersection.

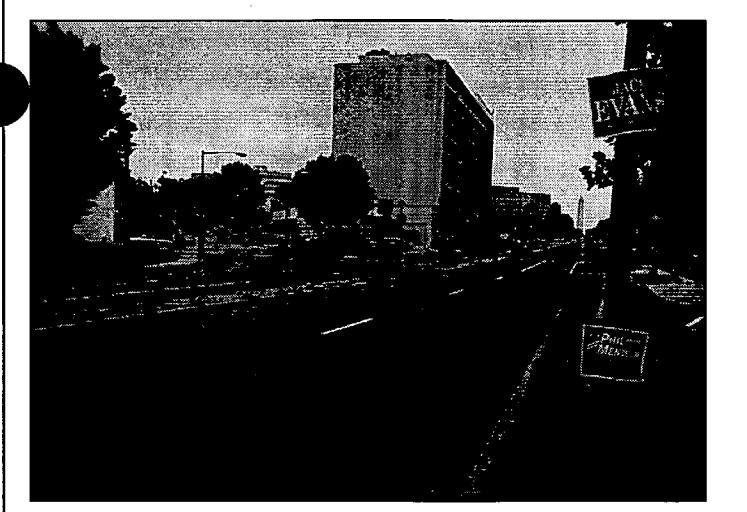
The gap in the center median island on the east approach to the intersection is heavily used by traffic heading onto E. Street and the Theodore Roosevelt Bridge.

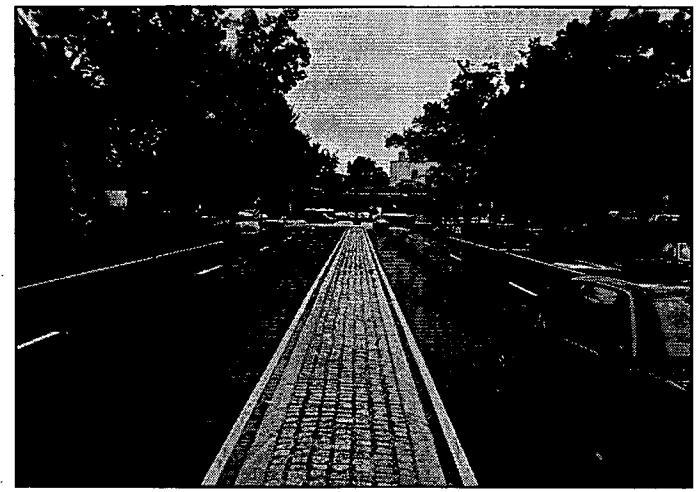
The intersection is clearly visible on the south approach. The four traffic lanes are separated by a raised center median island.
