# TRAFFIC SAFETY STUDY

# **ROCK CREEK PARK**

# Traffic Safety Study Rock Creek Park, Washington, D.C.

### United States Department of the Interior National Park Service Denver Service Center

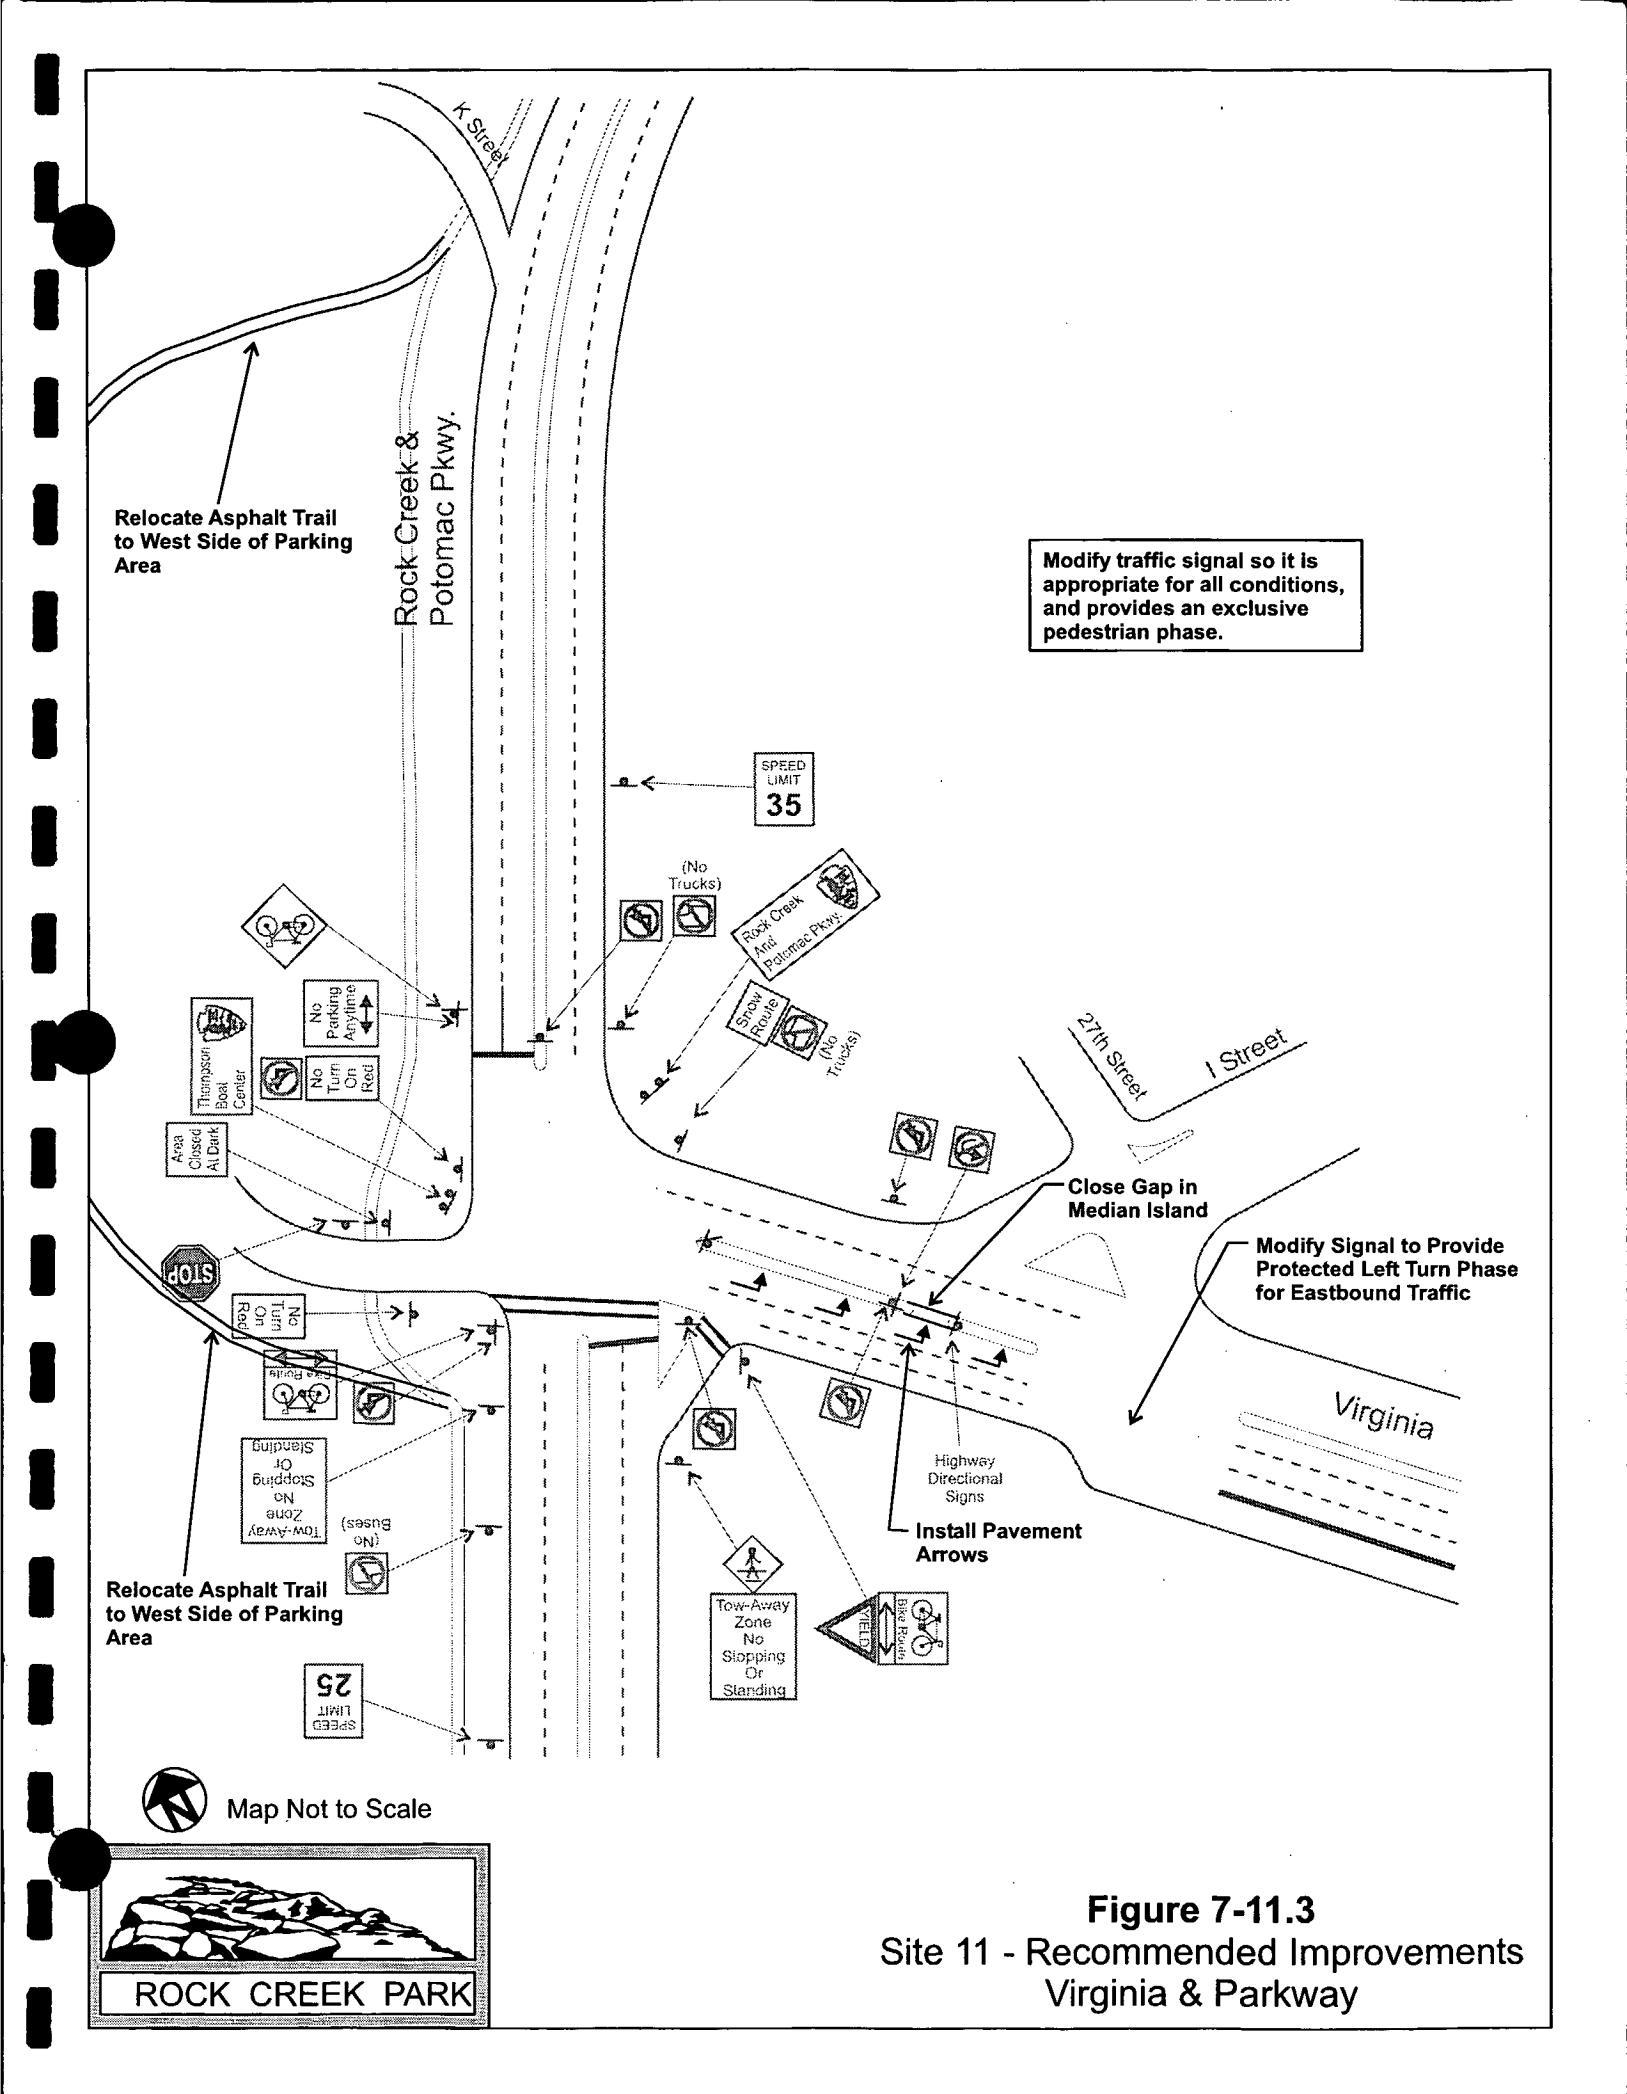
- The signal operation during the AM and PM peaks is disregarded by drivers because it is not appropriate for the current traffic condition.
- Northbound drivers occasionally turn left into the Boat House parking lot although this movement is prohibited.
- Pedestrian safety is a major concern at this site. Several pedestrians have been injured or killed at this location in the last decade.
- Access into the Thompson Boat House parking area is difficult and dangerous at various times of the day due to the congested traffic.

The recommended improvements for this site are shown in FIGURE 7.11.3.
