HISTORIC STRUCTURES REPORT

SAGAMORE HILL

Restoration of Porch, Stabilization of  
Staircase, Masonry Pointing and Painting

Prepared by  
Norman M. Souder  
Architect  
August 1964

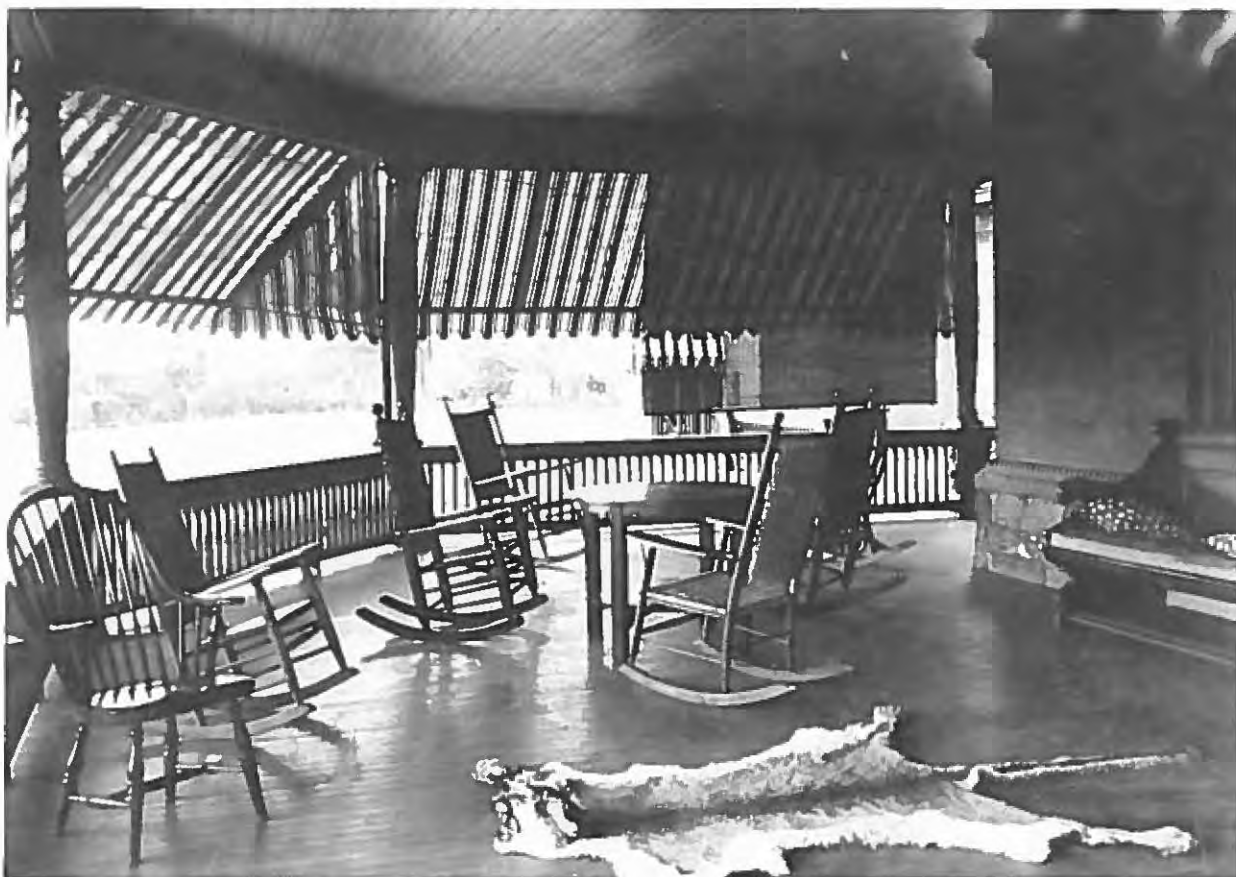
Copy Neg. No. EODC 4860

Interior of the large west porch taken in 1905 when Roosevelt was president. The skin on the floor is a mountain lion. This portion of the porch remains the same as when the photograph was taken except for deterioration.

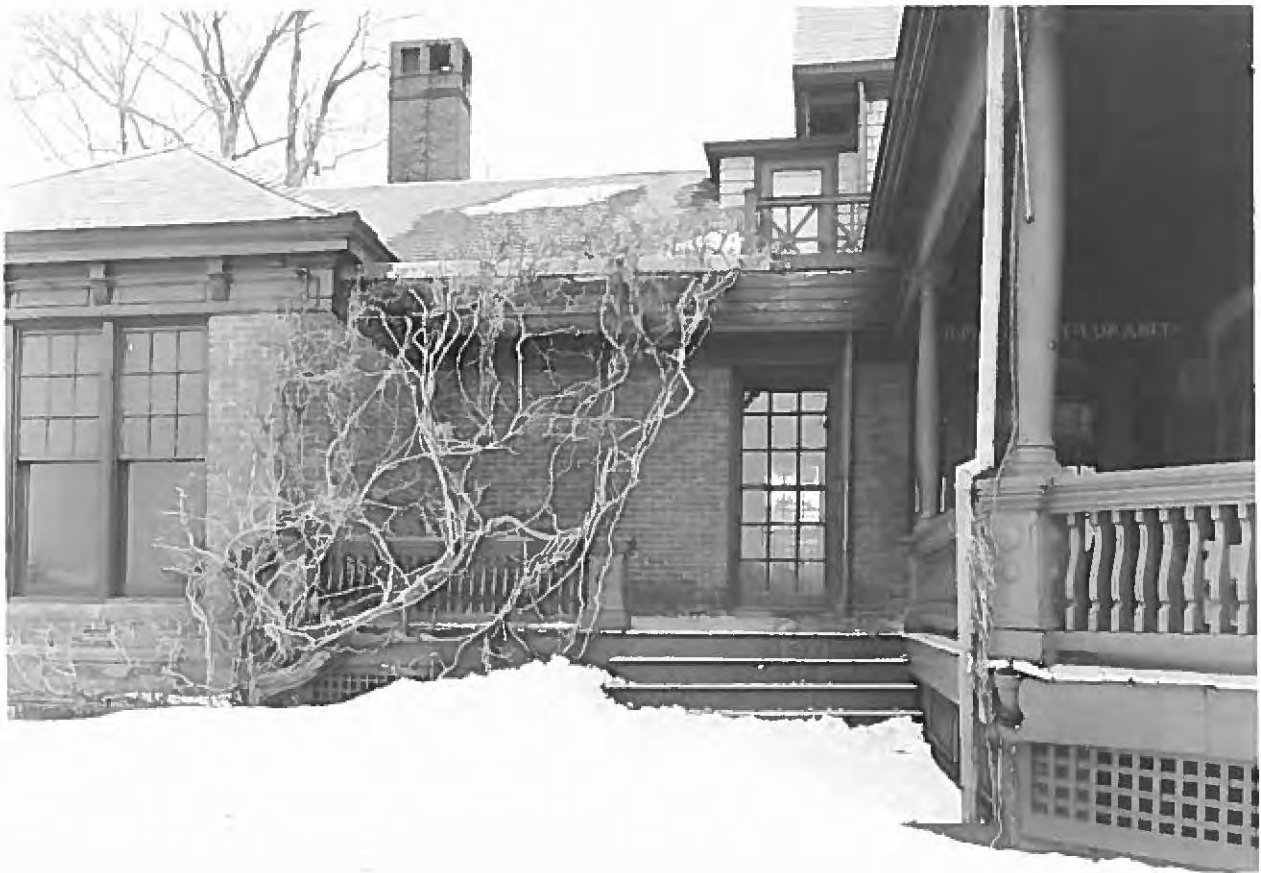
EODC Neg. No. 4837

The northwest corner of the porch, showing the partially collapsed pedestal next to the Trophy Room bay on the left. The railing on the roof, near the center of the photograph is the deck opening from Mr. Roosevelt's bath room. To the right of this point, the porch roof is sloping in toward the house wall, causing water damage to the interior. At the right of the second floor railing there are large holes in the metal flashing.

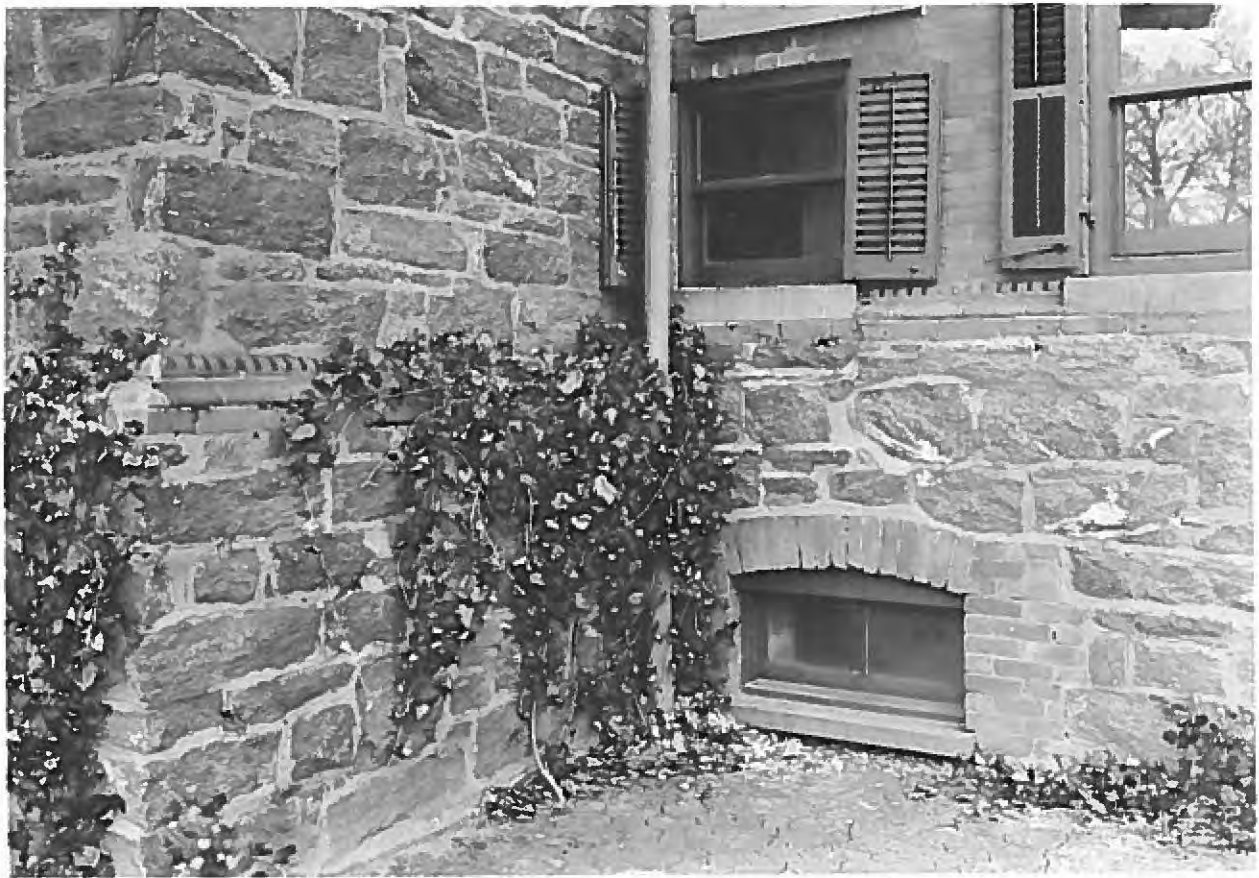
EODC Neg. No. 4840

Photograph showing the condition of the  
stone and brick joints on the south side of the  
house, near the library chimney.

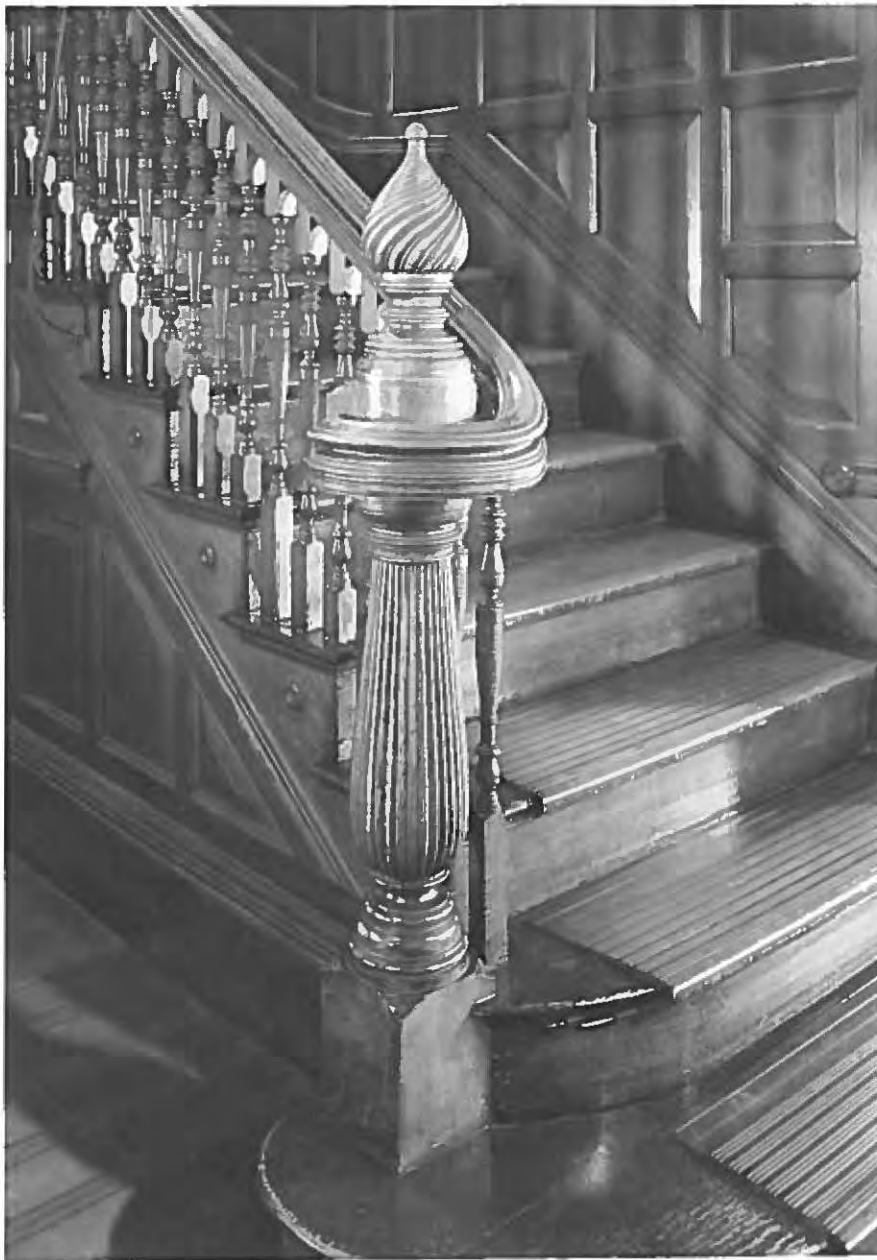
EODC Neg. No. 4839

Detail photograph of the newel on the main staircase. Note the wear on the lower tread and broken nose mould on the second riser.

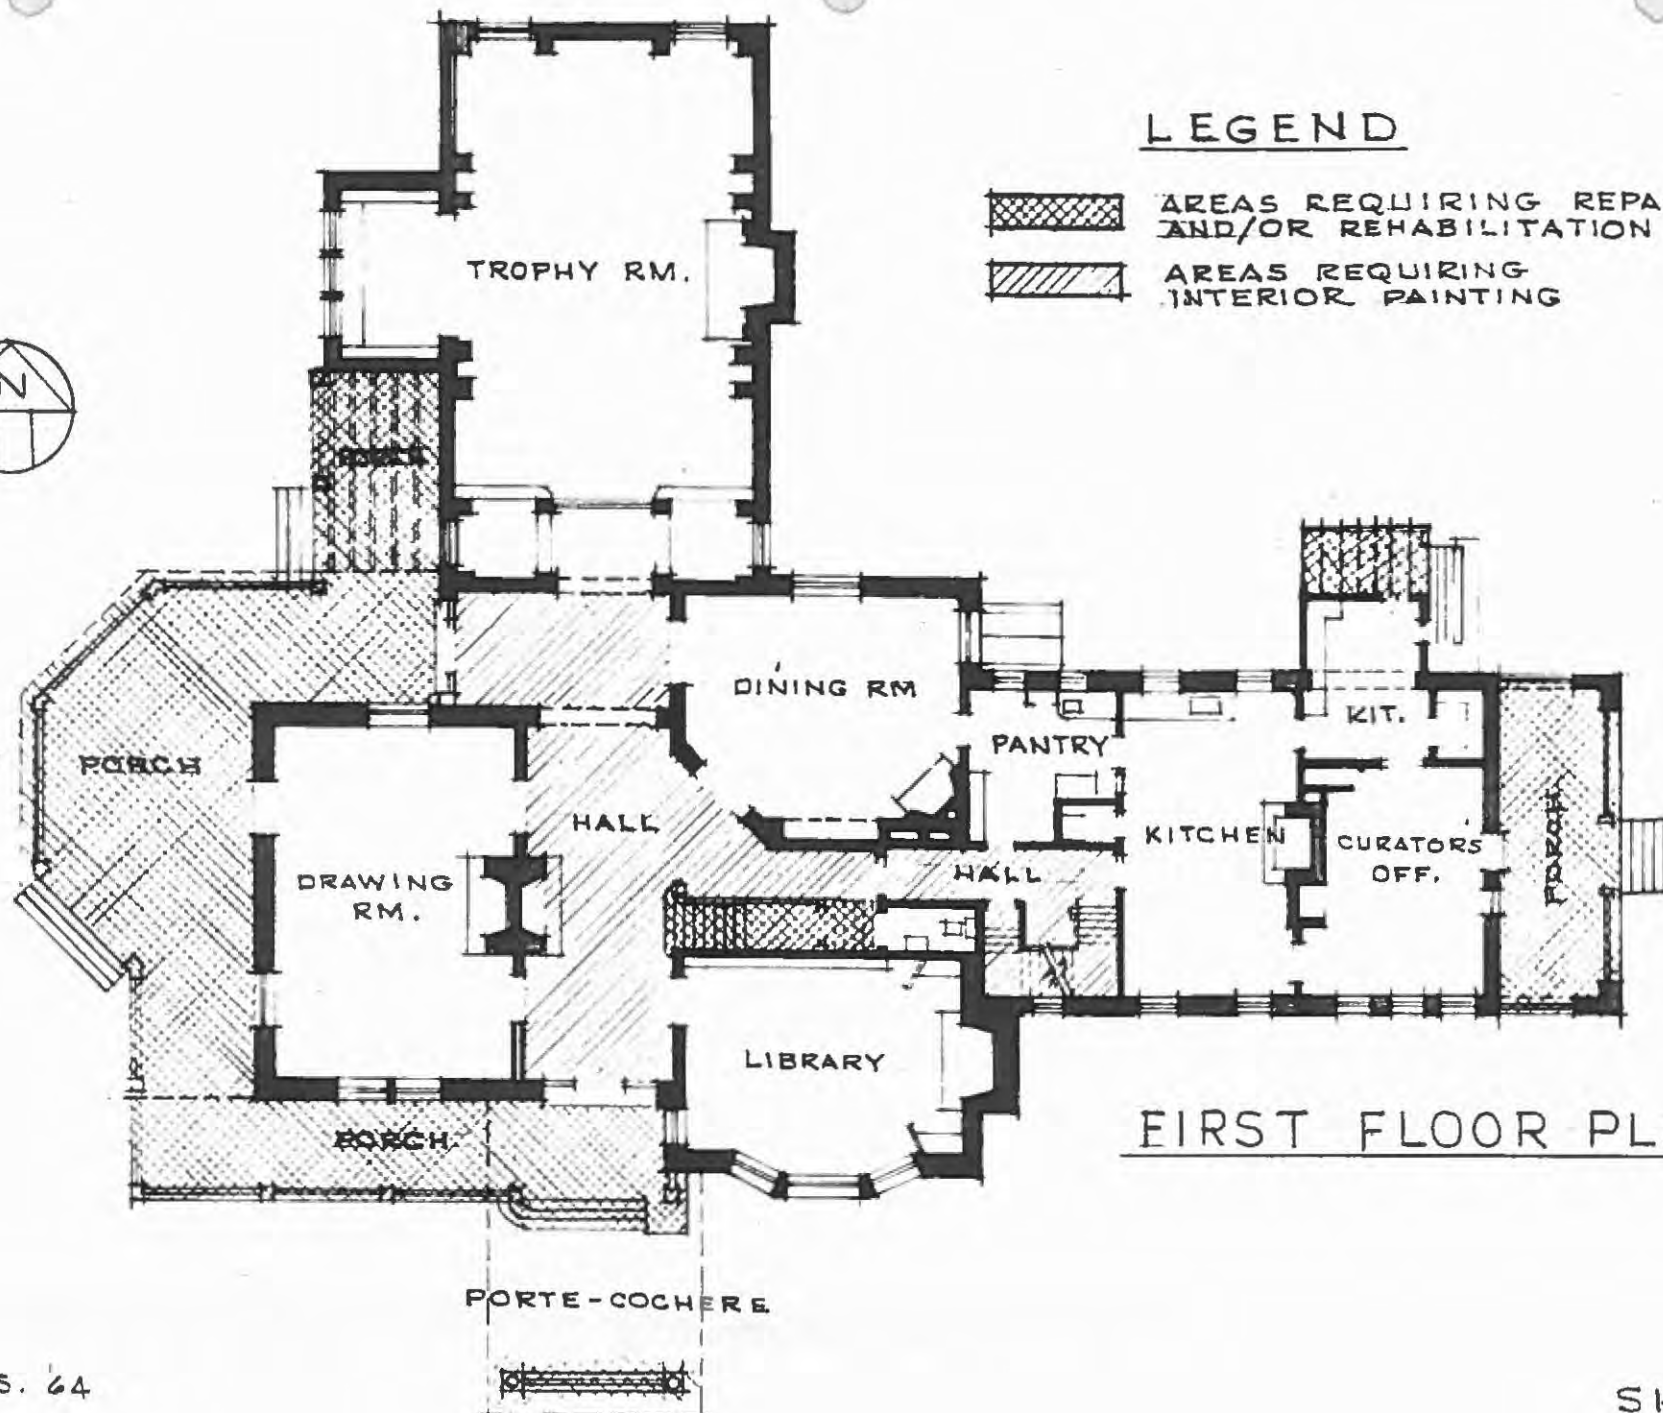
FIRST FLOOR PLAN

AREAS REQUIRING REPAIRS AND/OR REHABILITATION
-
