INVESTIGATION OF THE OLD MILL AND TAVERN IN
SHENANDOAH NATIONAL PARK 134/133244

By: Thor Borresen

Shenandoah NP

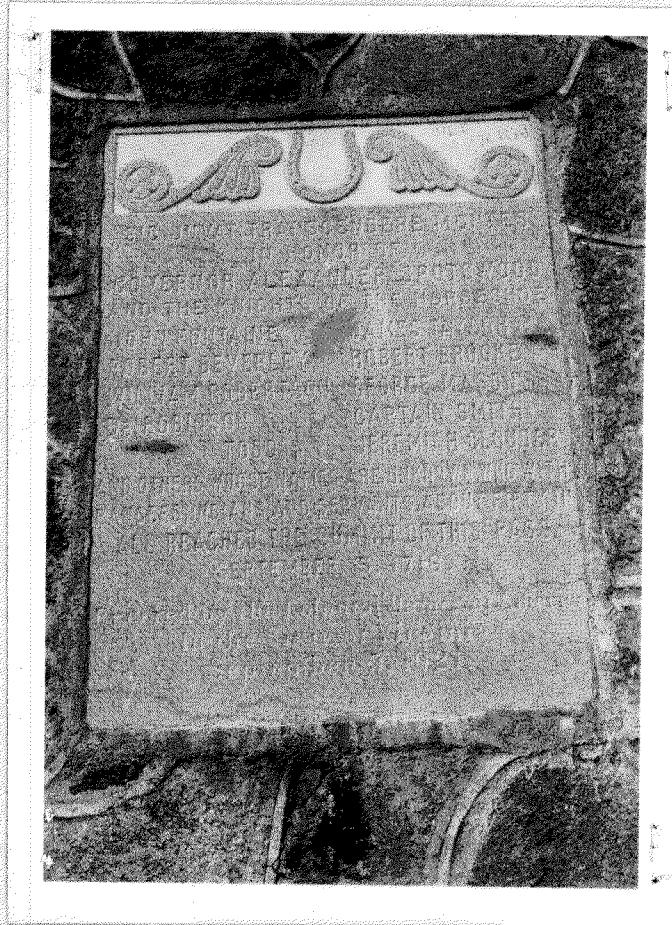
Motley of the Spottedwood Trail as told on a stone tablet. Part of a stone pyramid monument placed at the intersection of the Skyline Drive, and Route # 31.
