historic structures report

mechanical/electrical rehabilitation

main building

STATUE OF LIBERTY ELLIS ISLAND

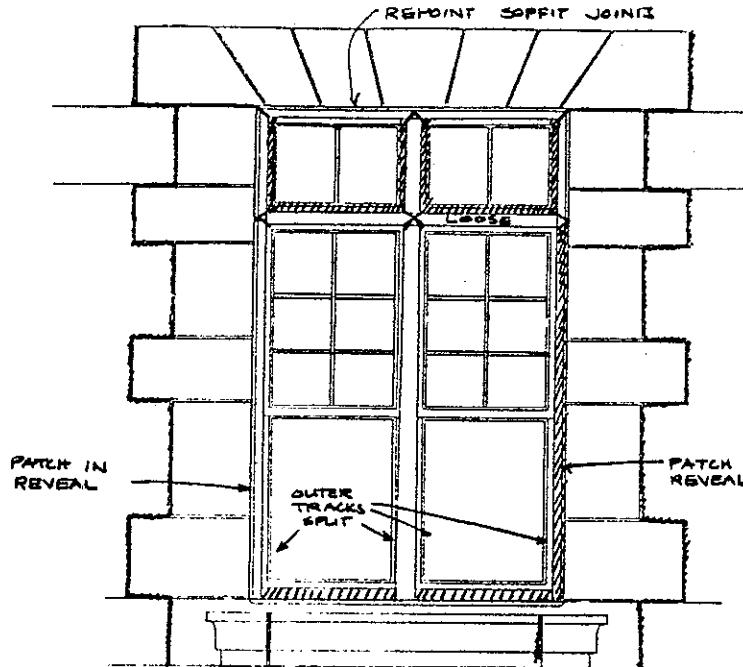
Figure 1.

Repair: Windows requiring any of the above work which also contained elements so seriously split, warped or decayed as to require replacement, were designated for Repair. The amount of work to be replaced could range from 1 to 50% of the total window parts, and varied from a single sash stop, needed in many of the basement windows, to several feet of ovolo moulding, two sills, two transom rails, four transom stiles and four outer sash tracks, needed in window E209 (Figure 1).

Existing conditions in
window E209, designated
for "Repair."

INTERIOR: - REPLACE BOTH STOOLS
- SASH WILL NOT OPEN

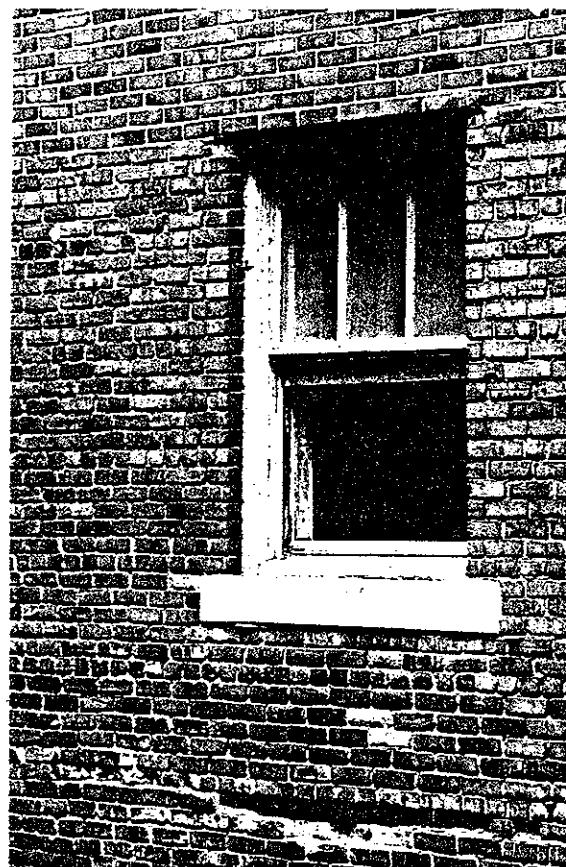
Figure 2.

- All windows appear to have steel lintels between the exterior stonework and interior wood framing or plaster surround. Where the head framing has rotted through or the plaster has deteriorated, as in the third floor central windows (Type X), the lintels are exposed and have corroded. Windows on the second floor of the light courts (Type P) have no stone lintels, only the steel lintels covered with copper flashing. In all cases, this flashing has come loose and the lintels are corroded, splitting and sagging. The resulting pressure on the bricks below has caused some of the masonry framing the windows to crack and spall and will eventually cause damage to the

windows themselves (Figure 2).

Spalled brick caused by
corroding lintel on SEL
209.

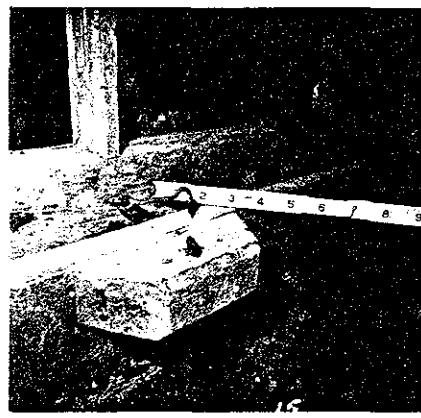
Figure 3.

Type A, Basement Window Hook.

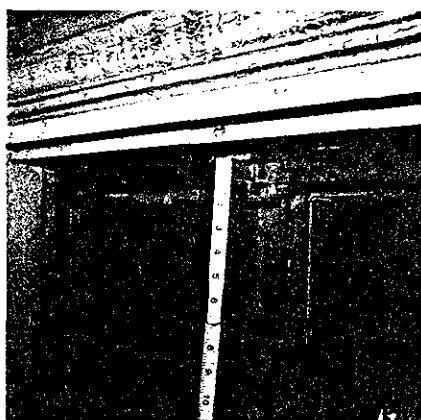
Figure 5.

Type C1, First Floor Casement Detail of Top of Latch Mechanism.

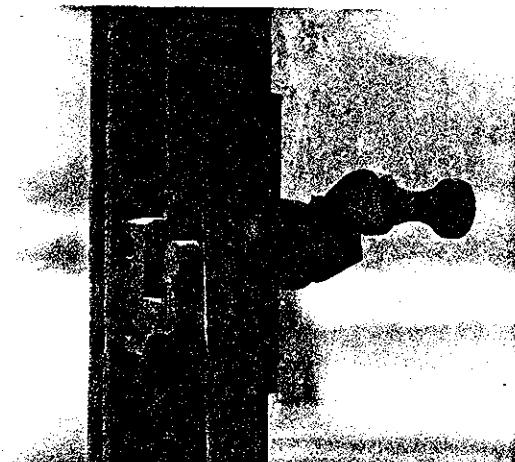
Figure 6.

Type C1, First Floor Casement Detail of Center of Latch Mechanism.

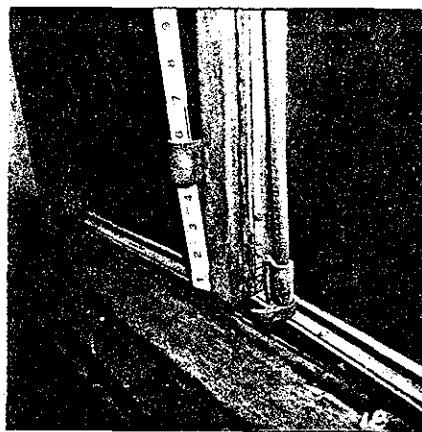
Figure 7.

Type Cl, First Floor
Casement Detail of
Bottom of Latch
Mechanism.

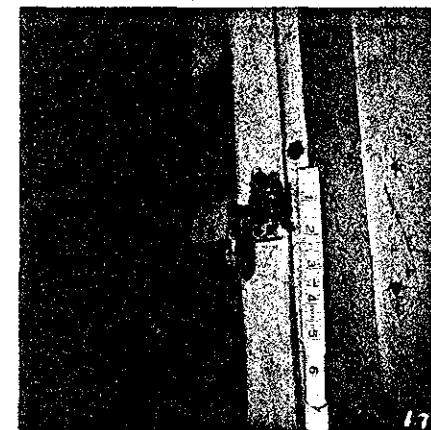
Figure 8.

Type Cl, First Floor
Casement Screen
Hardware.

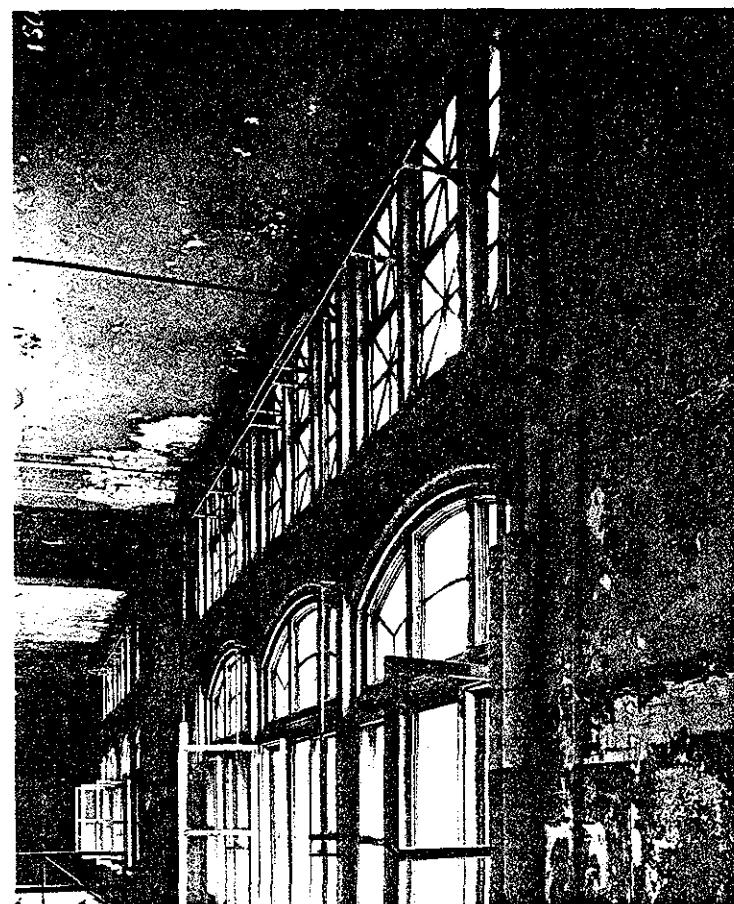
Figure 9.

Type Cl, Main Arches
Transom Operating
Mechanism.

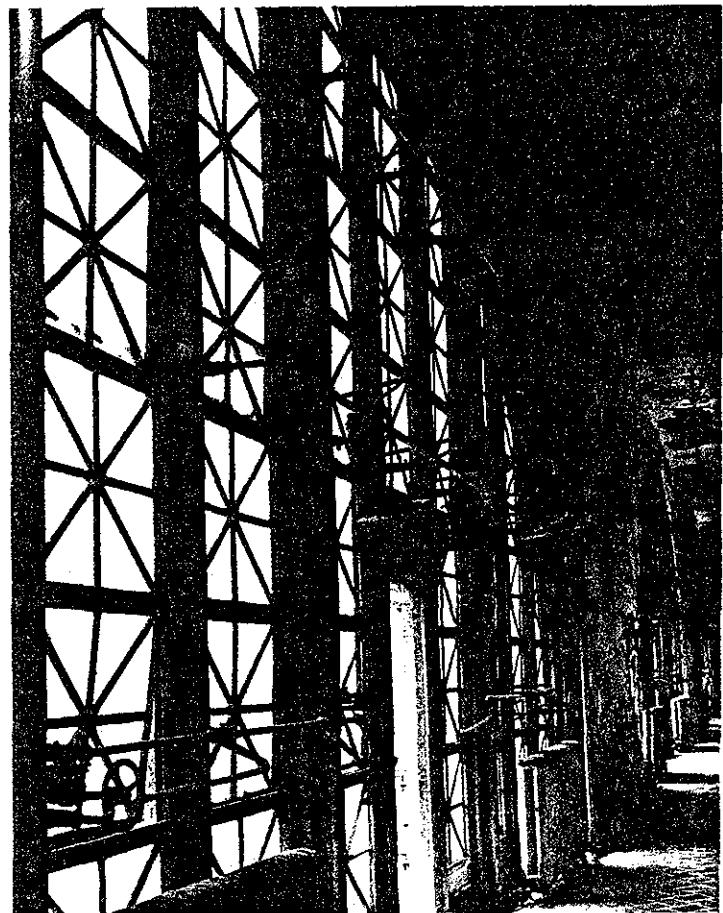
Figure 10.

*Type C2, Main Arches
Transom Operating
Mechanism.*

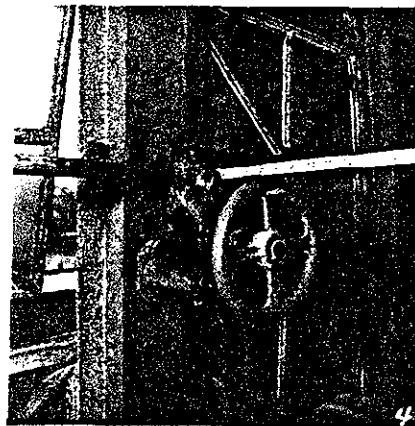
Figure 11.

*Type C2, Main Arches
Detail of Transom
Operating Mechanism.*

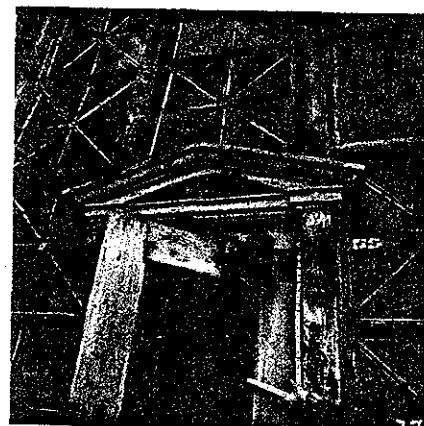
Figure 12.

*Type C2, Main Arches
Exterior Door Hardware.*

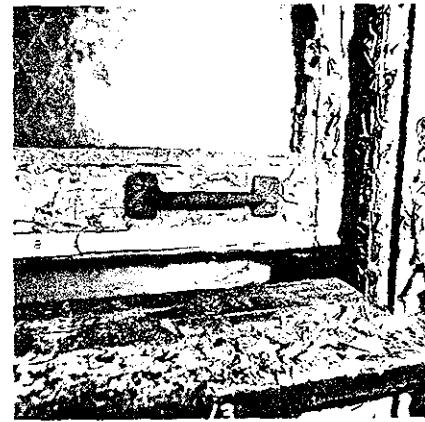
Figure 18.

Type F Ticket Office
Sash Pull.

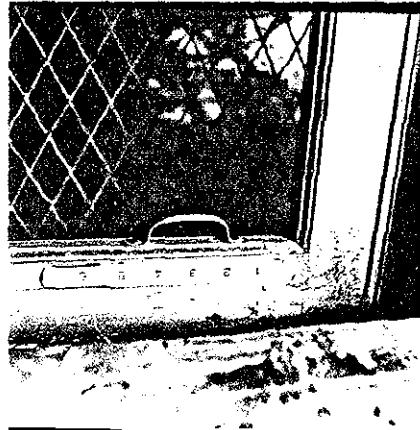
Figure 19.

Type F Ticket Office
Screen Hardware.

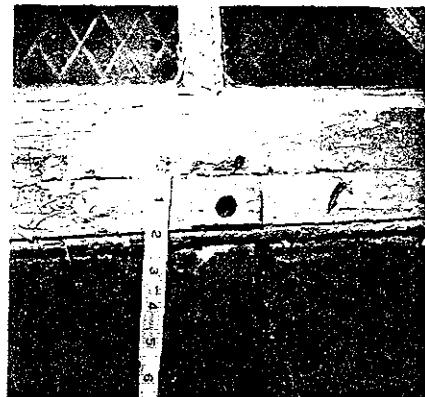
Figure 20.

Type F Ticket Office
Transom Hardware.

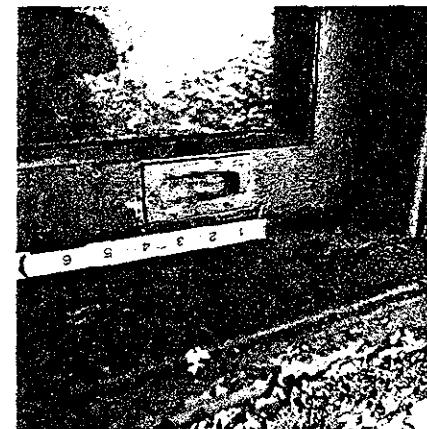
Figure 22.

Type S Third Floor
Window Sash Handles.

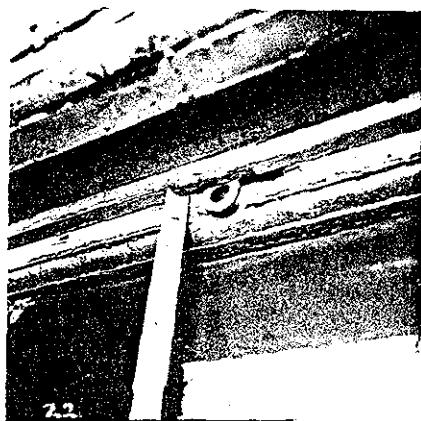
Figure 25.

Type S Third Floor
Transom Lock.

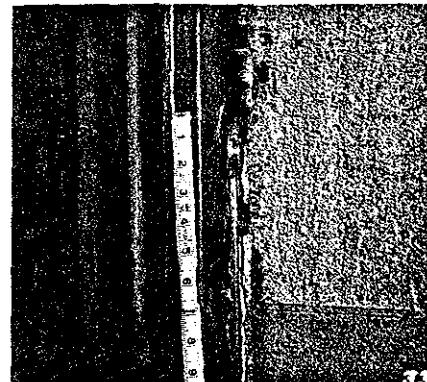
Figure 26.

Type S Third Floor
Window Awning
Hardware.

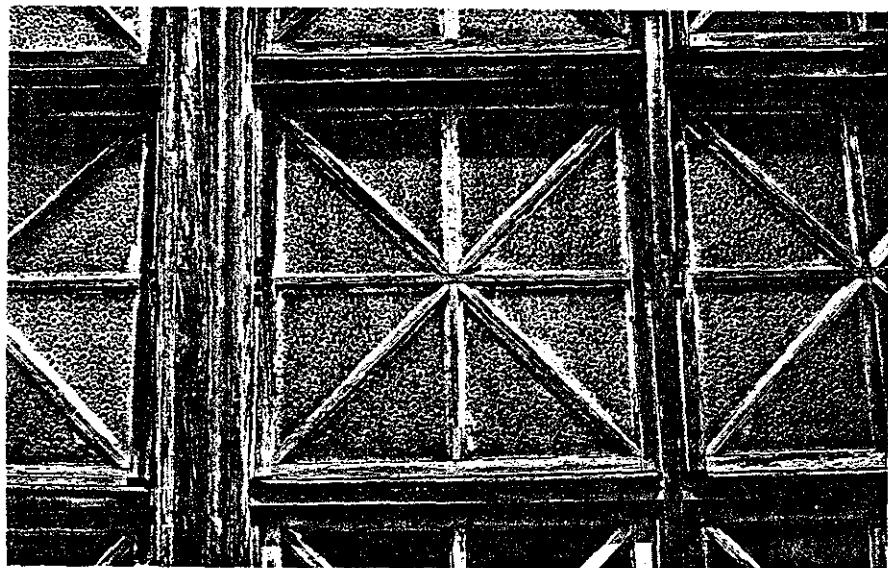
Figure 30.

Split and rotted panels and missing decorative detail
in Door E106.

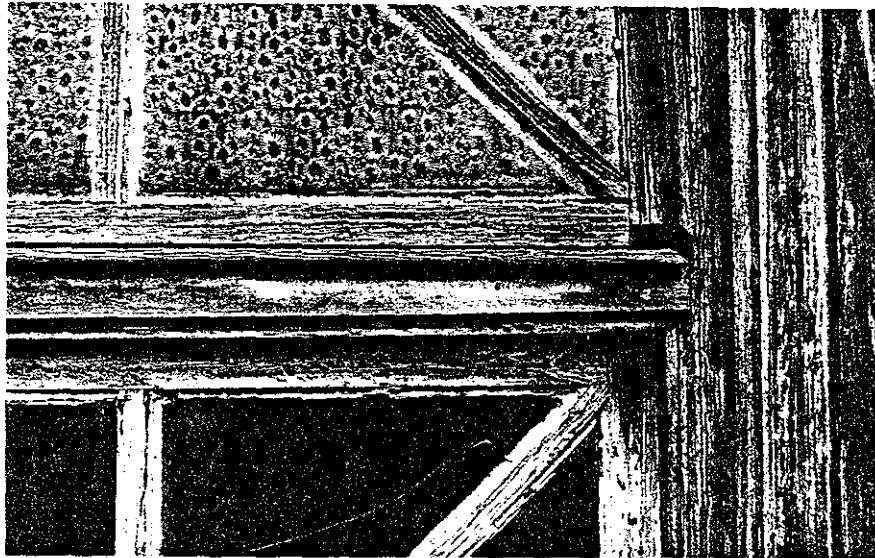
Figure 31.

The clerestory windows are constructed of multiple 8-part wooden sash units set into an arched wooden framework. They have been exposed to the most extreme weather conditions, and consequently are severely deteriorated (Figures 31 and 32). Mouldings, stiles, muntins and rails are checked and almost all joints are open. Approximately 95% of the sash members require replacement. The mechanism for opening the sash, similar to that found on the C1 and C2 windows, does not appear to be functional.

Typical Clerestory (Type C3 and C4) Window Sash.

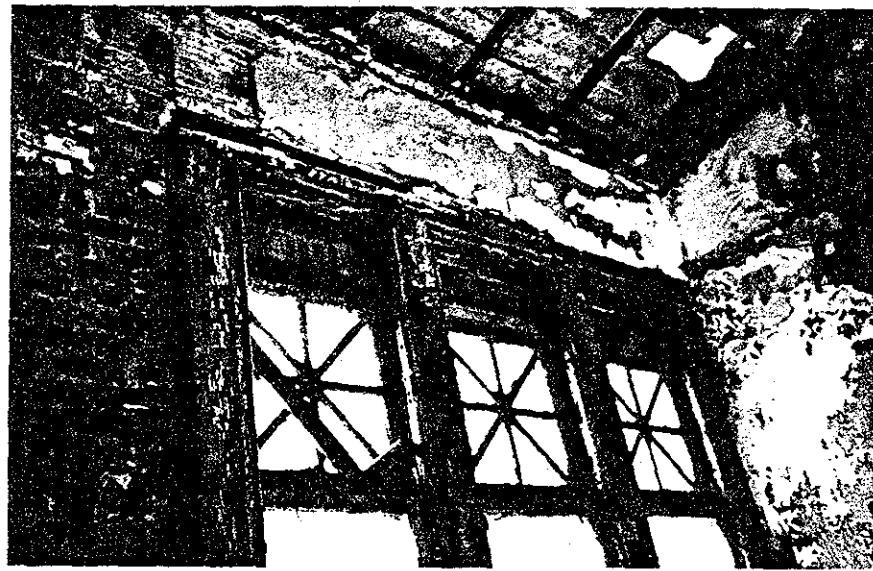
Figure 32.

Detail of Clerestory Sash showing open joints and decayed wood.

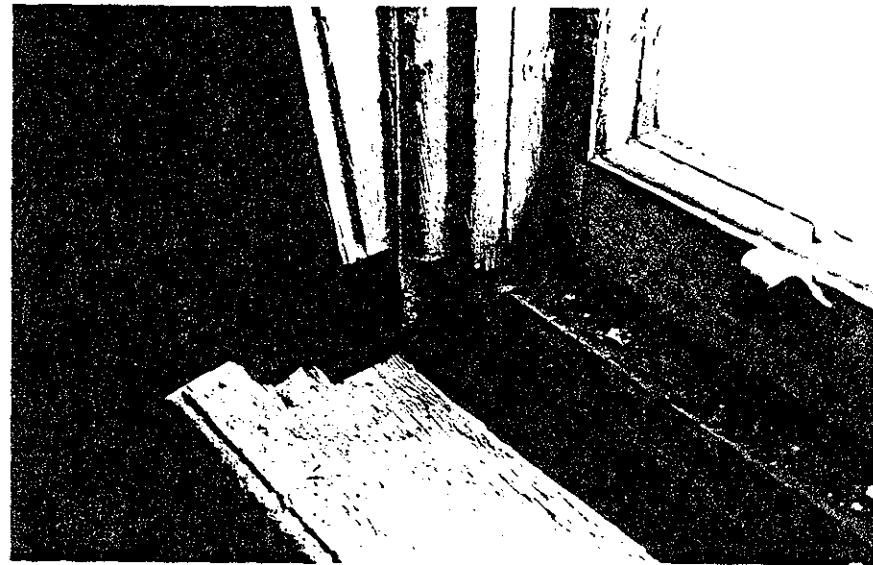
Figure 33.

The wood sash and interior framing, by contrast, are in very poor condition. 40% of the sills and/or lower rails are split. Joints in the 8-part transom windows are generally open. Mouldings along the iron frame are usually loose. On the interior, water running down the walls has detached large quantities of plaster and caused warping and rotting in the frames. The secondary members have bent in turn, and in many instances, the entire window frame has pulled away from the metal casing (Figure 33).

Interior elevation of Ticket Office (Type F) window E115 showing warped and rotted head and jamb members.

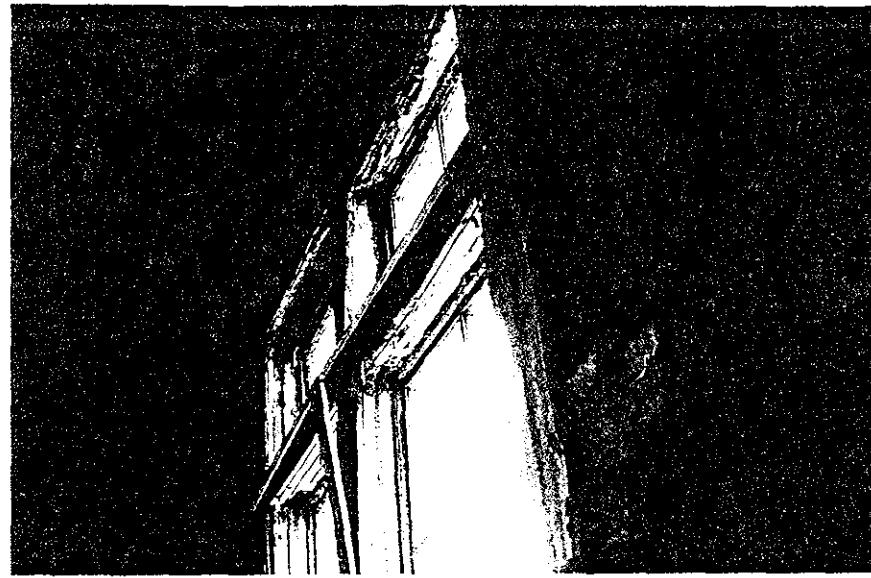
Figure 34.

Rotten interior jamb and stool on second floor (Type J) window N203.

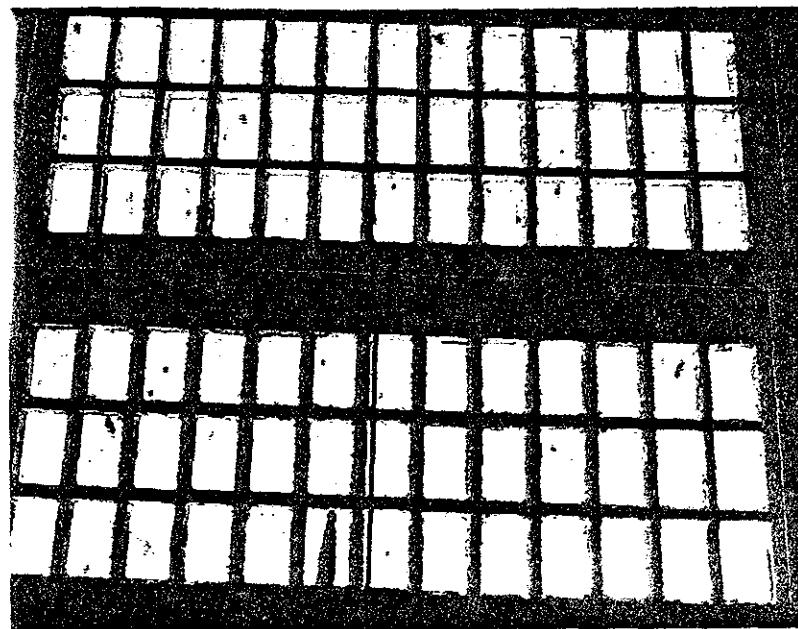
Figure 35.

Rotted and broken head, transom and jamb framing
on interior of window N203.

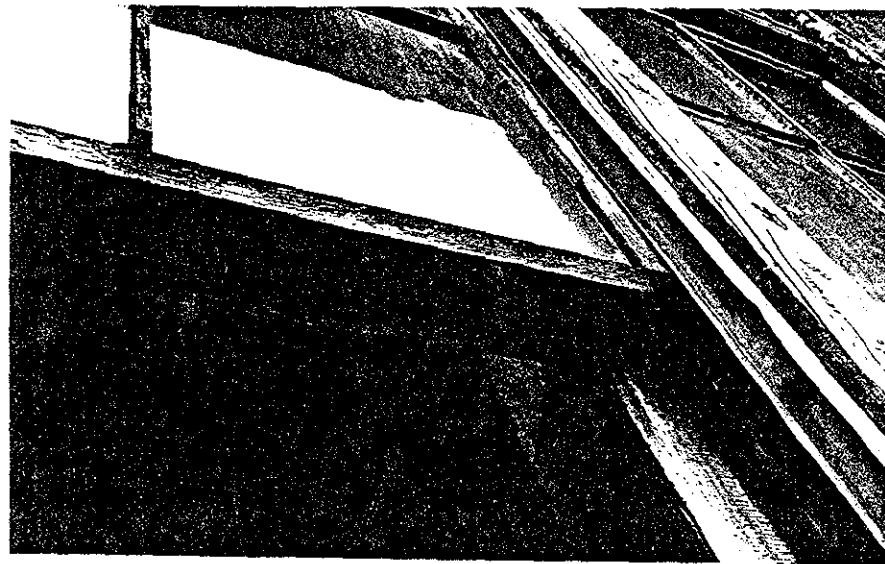
Figure 37.

Detail from window W308, showing conditions typical of second floor (Type J) and third floor (Type S) windows. Shown here is the sill, with open sash joints, loose trim, and cracks in the lower sash rail.

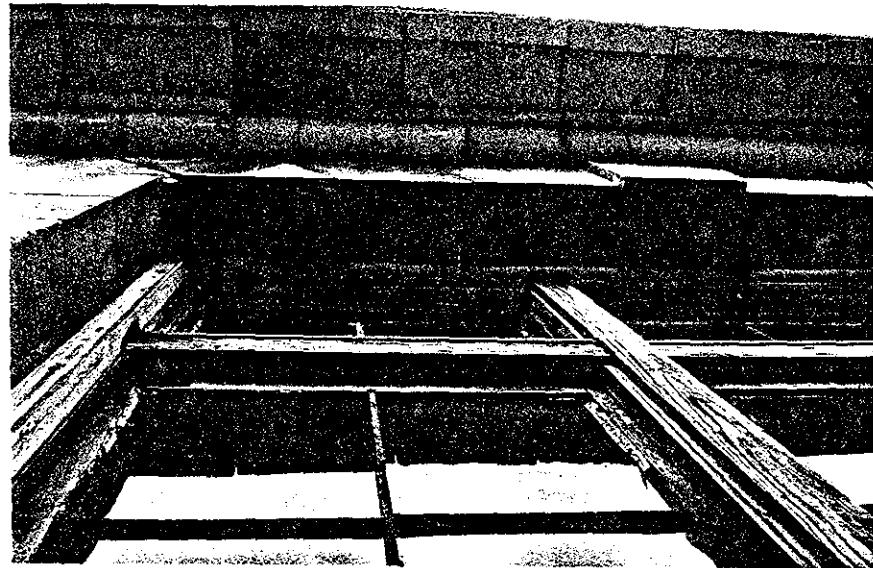
Figure 38.

Upper half of sash, showing open joints at muntin and corner of stile and rail.

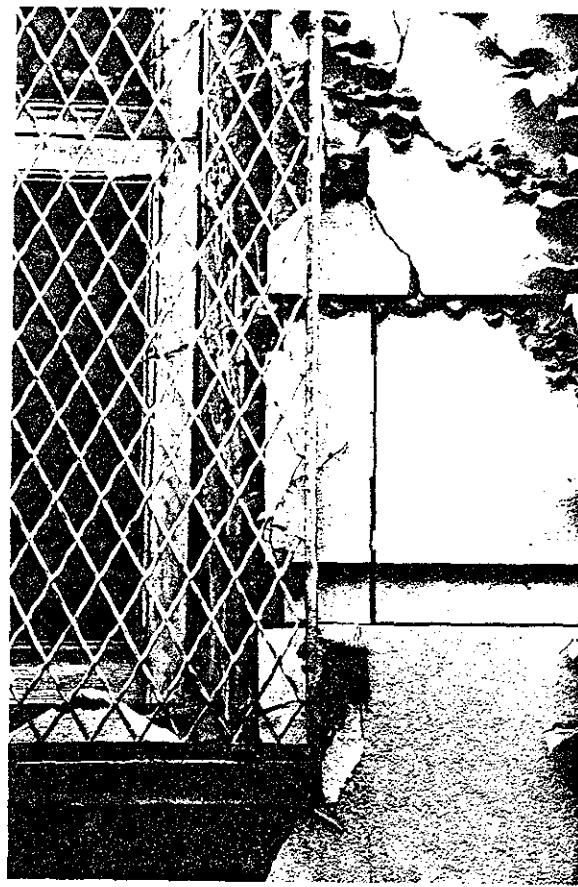
Figure 40.

Interior of window N325, where head mouldings are missing and transom and joints are rotted.

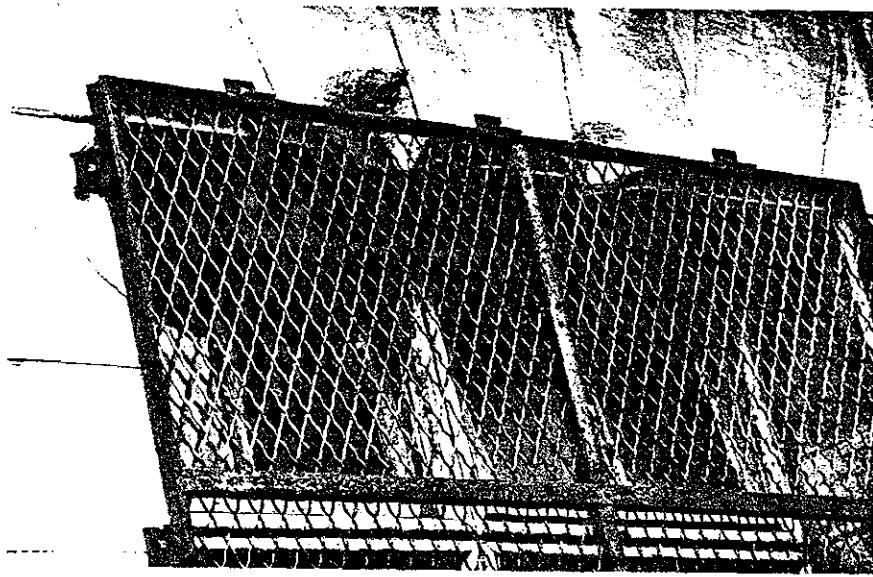
Figure 41.

In all three cases, as the metal has corroded, it has expanded in volume, shattering the adjacent stonework (Figure 41). Extensive damage has occurred in the northwest corner, where as many as half the masonry units containing cramps have spalled (Figure 42), and along the south side of the first floor, where grills were inserted into the stone reveal and the entire reveal area has subsequently spalled (Figure 43). This damage has been covered with concrete parging, which is visually incompatible and has already begun to crack itself. Where grills were installed on the face of the surrounds and remain in place, the paint on the metal appears to have protected the anchors from moisture. Where the grills were removed, most of the anchors were simply left in place. Some were covered with lead, but many have been exposed, rusted, and damaged the stone (Figure 44).

Cracked and spalling stone caused by corroding grill anchors.

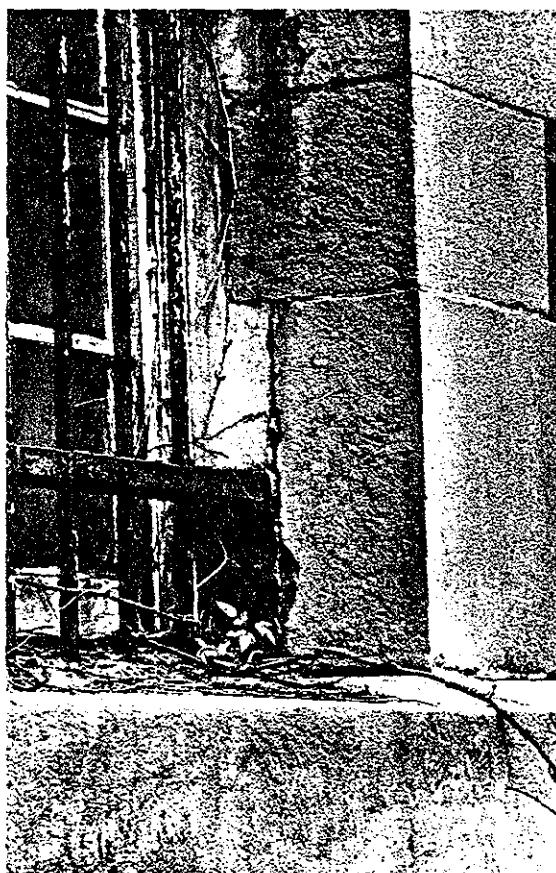
Figure 42.

Head of window N211, where stone spalling has been caused both by cramps inserted in window reveal (along the tops) and by grill anchors (cracking in the side).

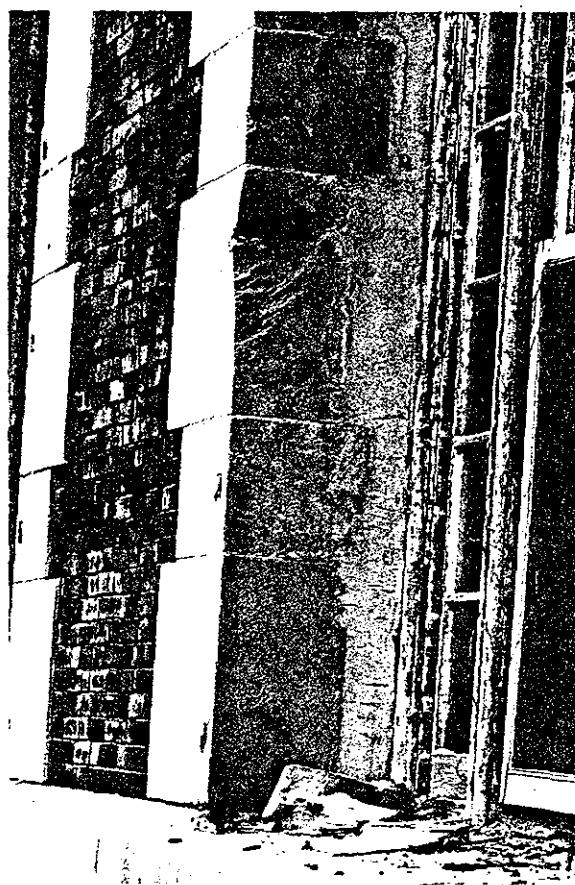
Figure 43.

Grill drilled into stone reveal of window E107.
Note parging at inner edge of reveal.

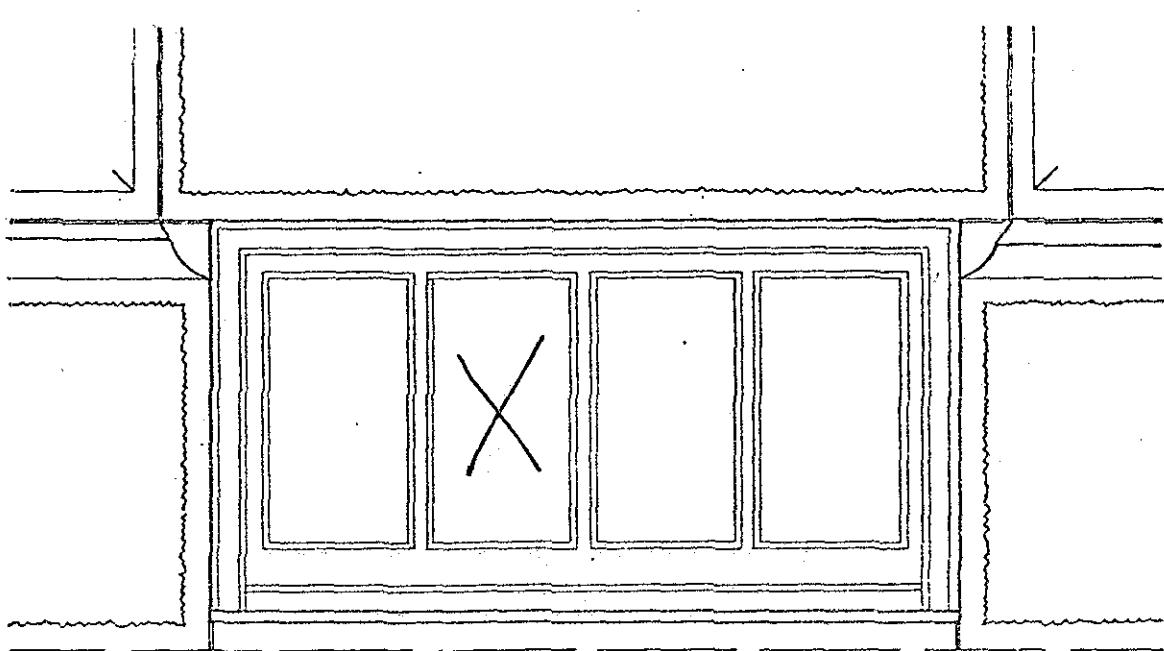
TYPE	NUMBER	CLASS
A- BASEMENT WINDOW	N 002	1/2
MECHANICAL AND ELECTRICAL REHABILITATION MAIN BUILDING ELLIS ISLAND	BUILDING CONSERVATION TECHNOLOGY THE DEDENKANTZ GROUP	
Statue of Liberty National Monument, New York	19 West 44th Street, New York NY 10036

UNABLE TO REACH SASH THRU BARS - ALL
TRIM COVERED WITH IVY-VERIFY CONDITION
WHEN GRILL OR BACKING REMOVED.

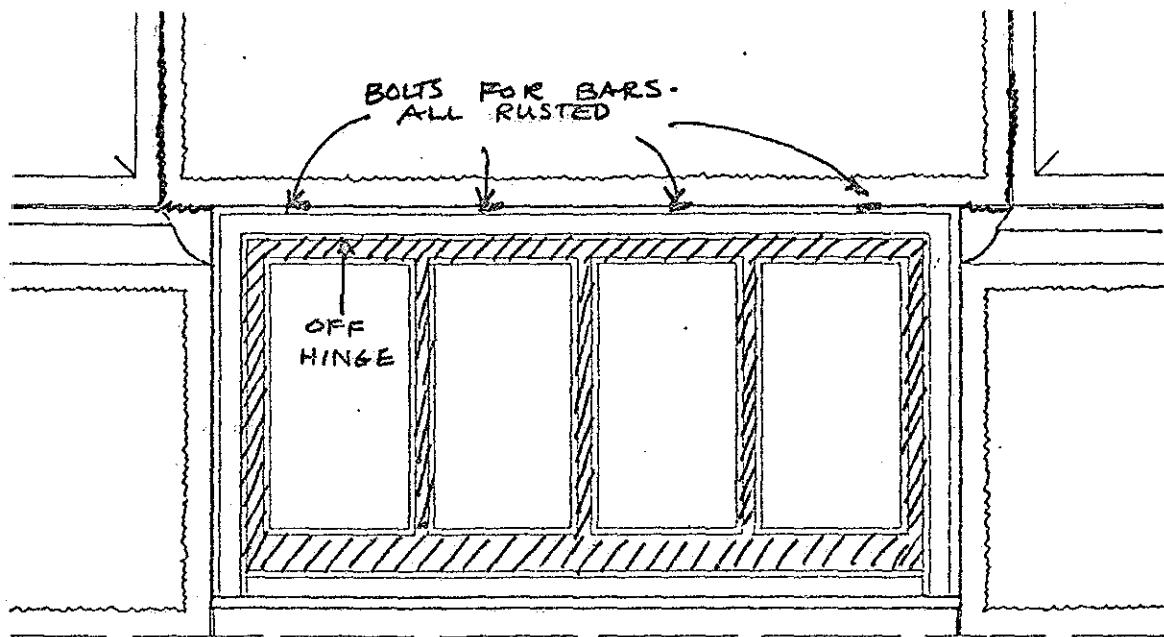
TYPE	NUMBER	CLASS
A- BASEMENT WINDOW	N 003	1/2
MECHANICAL AND ELECTRICAL REHABILITATION MAIN BUILDING ELLIS ISLAND	BUILDING CONSERVATION TECHNOLOGY THE EBERKANTZ GROUP	
Statue of Liberty National Monument, New York	19 West 41st Street, New York NY 10036

UNABLE TO REACH SASH THRU BARS; TRIM
COVERED WITH VEGETATION & IVY - WEEDS
GROWING BEHIND WINDOW - VERIFY CONDITION
WHEN GRILL OR BACKING REMOVED

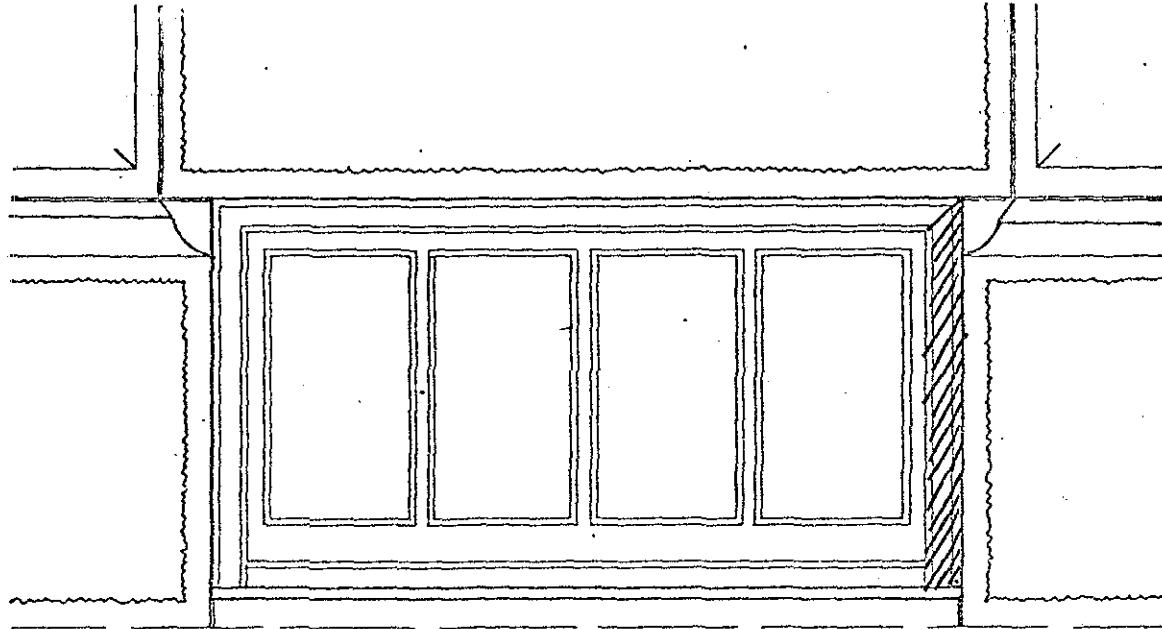
TYPE	NUMBER	CLASS
A- BASEMENT WINDOW	N 007	2
MECHANICAL AND ELECTRICAL REHABILITATION MAIN BUILDING ELLIS ISLAND Statue of Liberty National Monument, New York	BUILDING CONSERVATION TECHNOLOGY THE DROMSTON GROUP 19 West 44th Street, New York NY 10036

EXTERIOR NOT ACCESSIBLE

INTERIOR: - REPLACE WEST (RIGHT) JAMB
'REPLACE ROTTED STOPS ON SILL

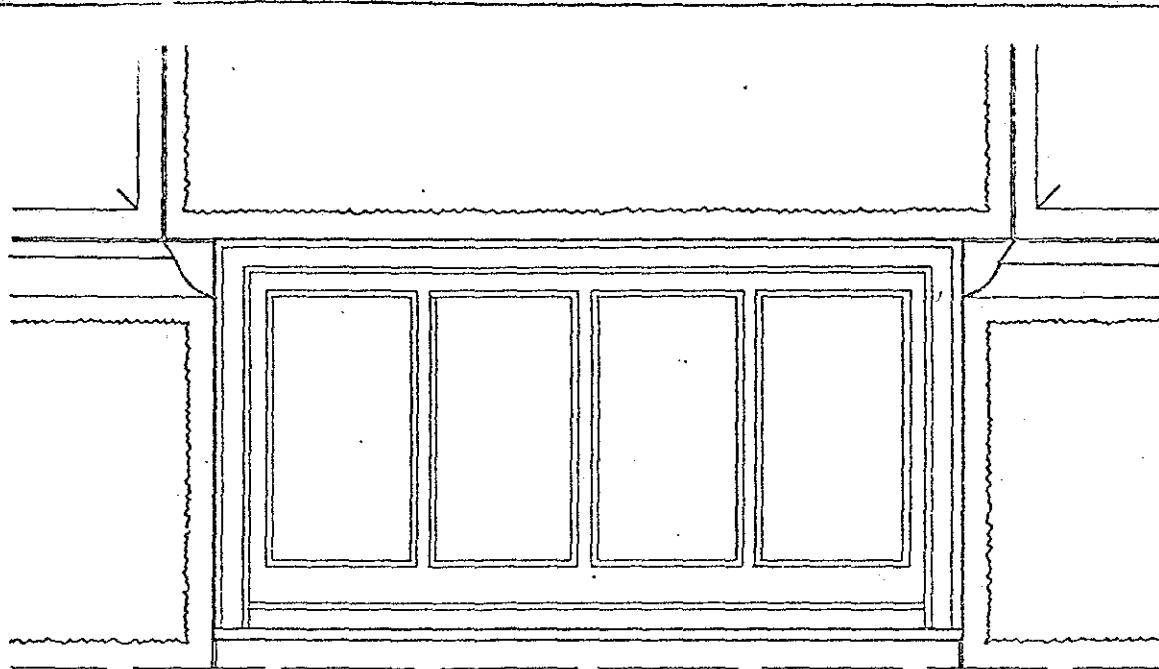
TYPE	NUMBER	CLASS
A- BASEMENT WINDOW	N 008	I
MECHANICAL AND ELECTRICAL REHABILITATION MAIN BUILDING ELLIS ISLAND	BUILDING CONSERVATION TECHNOLOGY THE EBENKANTZ GROUP	
Statue of Liberty National Monument, New York		19 West 44th Street, New York NY 10036

NOT ACCESSIBLE FROM EXTERIOR
CLOSED SHUT
APPEARS O.K.

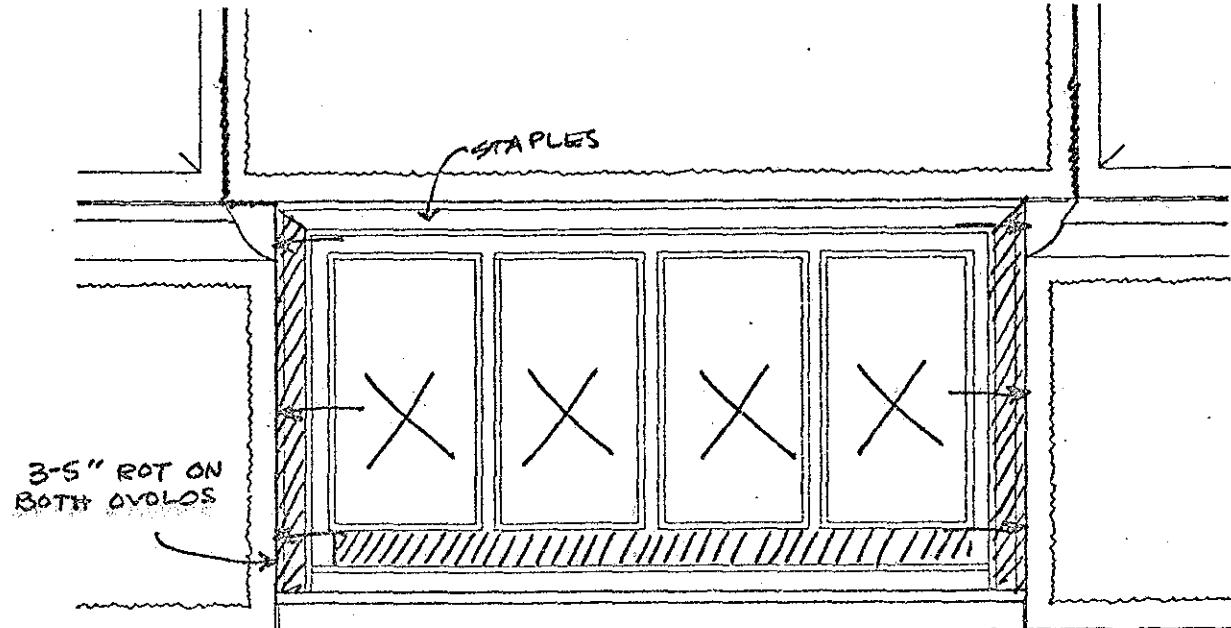
TYPE	NUMBER	CLASS
A- BASEMENT WINDOW	E 004	2
MECHANICAL AND ELECTRICAL REHABILITATION MAIN BUILDING ELLIS ISLAND	BUILDING CONSERVATION TECHNOLOGY THE ENTHORN GROUP	
Statue of Liberty National Monument, New York		19 West 44th Street, New York NY 10036

GRILL REMOVED

INTERIOR: REPLACE STOP ON GILL

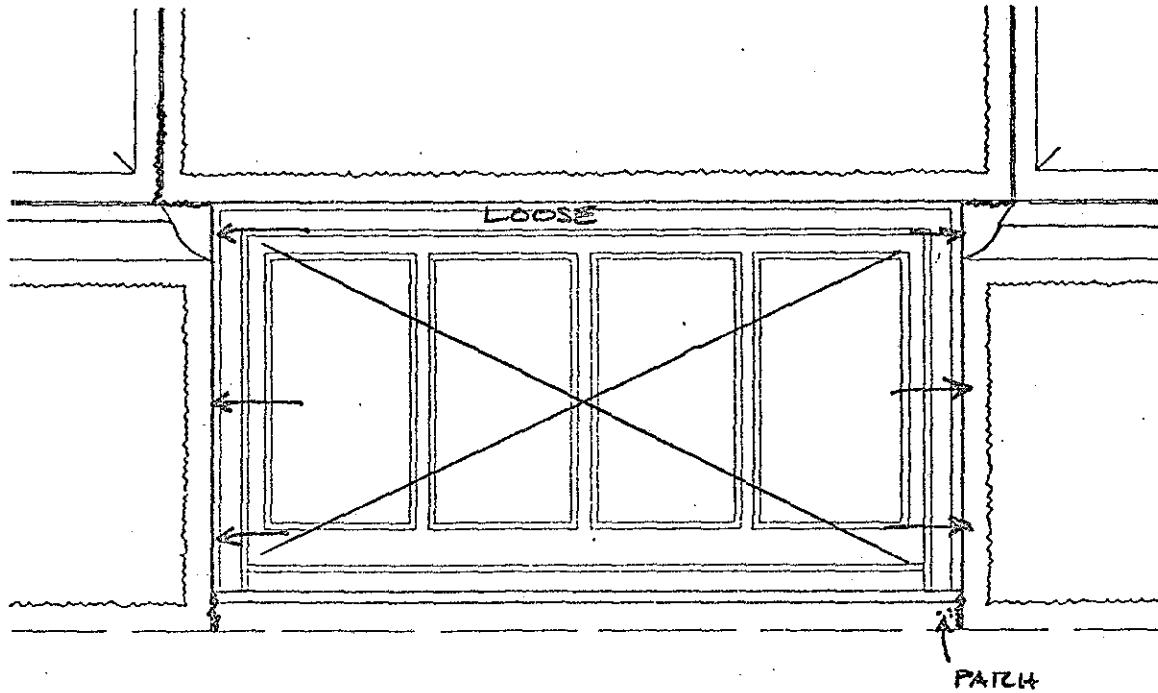
TYPE	NUMBER	CLASS
A- BASEMENT WINDOW	E 007	3
MECHANICAL AND ELECTRICAL REHABILITATION MAIN BUILDING ELLIS ISLAND	BUILDING CONSERVATION TECHNOLOGY THE DENGRAANTZ GROUP	
Statue of Liberty National Monument, New York		19 West 44th Street, New York NY 10036

CASEMENT SASH INSTALLED - REPLACE

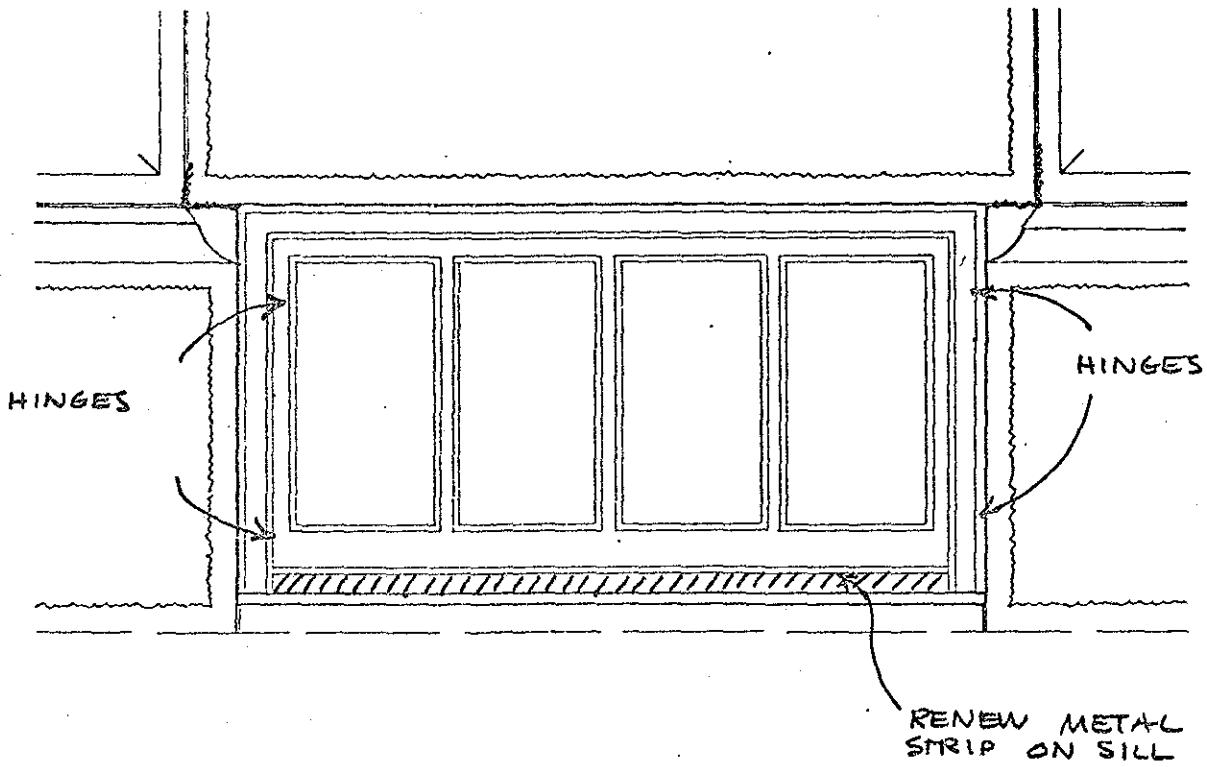
TYPE	NUMBER	CLASS
A- BASEMENT WINDOW	5002	3
MECHANICAL AND ELECTRICAL REHABILITATION MAIN BUILDING ELLIS ISLAND	BUILDING CONSERVATION TECHNOLOGY THE EHRENGRANTZ GROUP	
Statue of Liberty National Monument, New York	19 West 44th Street, New York NY 10036

CASEMENT SASH - REPLACE

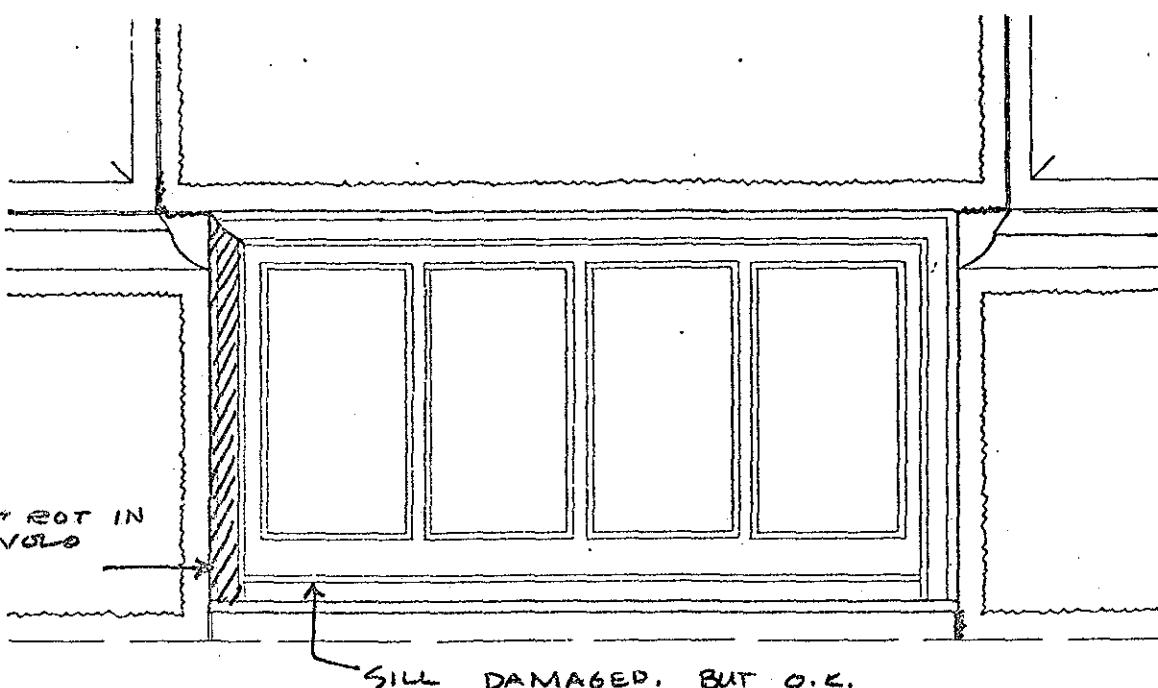
TYPE	NUMBER	CLASS
A- BASEMENT WINDOW	5004	2
MECHANICAL AND ELECTRICAL REHABILITATION MAIN BUILDING ELLIS ISLAND	BUILDING CONSERVATION TECHNOLOGY THE EHRENKRANTZ GROUP	
Statue of Liberty National Monument, New York	19 West 44th Street, New York NY 10036

3" ROT IN
OVER

SILL DAMAGED, BUT O.K.

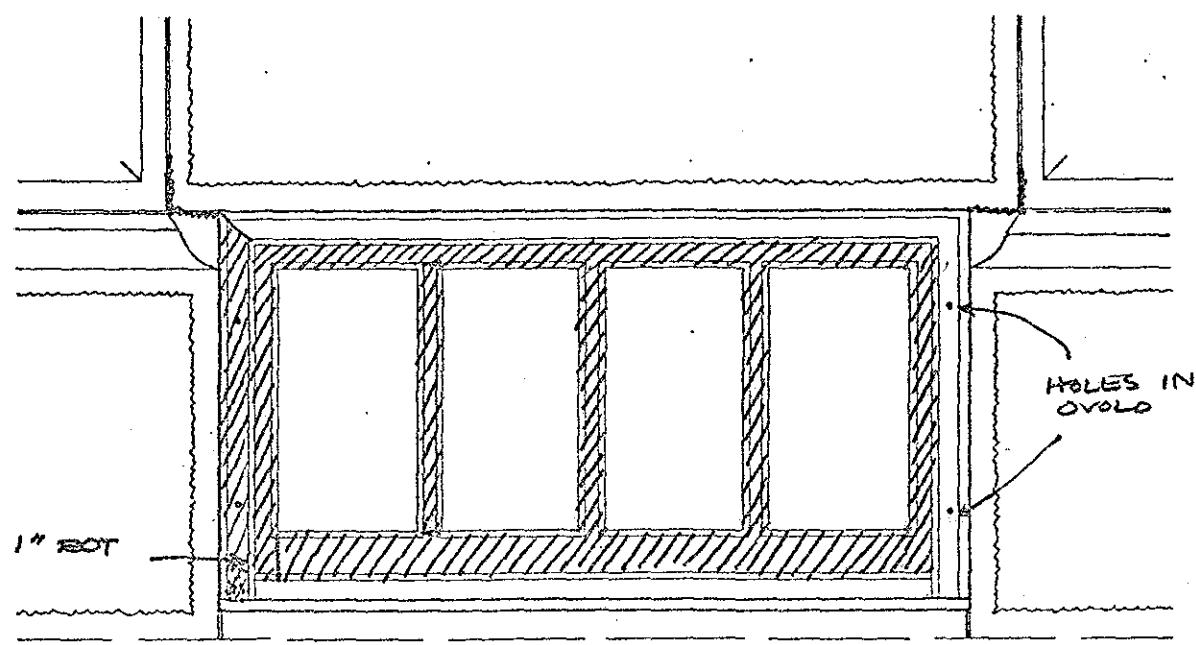
TYPE	NUMBER	CLASS
A- BASEMENT WINDOW	S 007	3
MECHANICAL AND ELECTRICAL REHABILITATION MAIN BUILDING ELLIS ISLAND	BUILDING OBSERVATION TECHNOLOGY THE EBENKANTZ GROUP	
Statue of Liberty National Monument, New York		19 West 44th Street, New York NY 10036

KICK
 LOWER & UPPER SASH SPONGY, WET
 NO GRILL

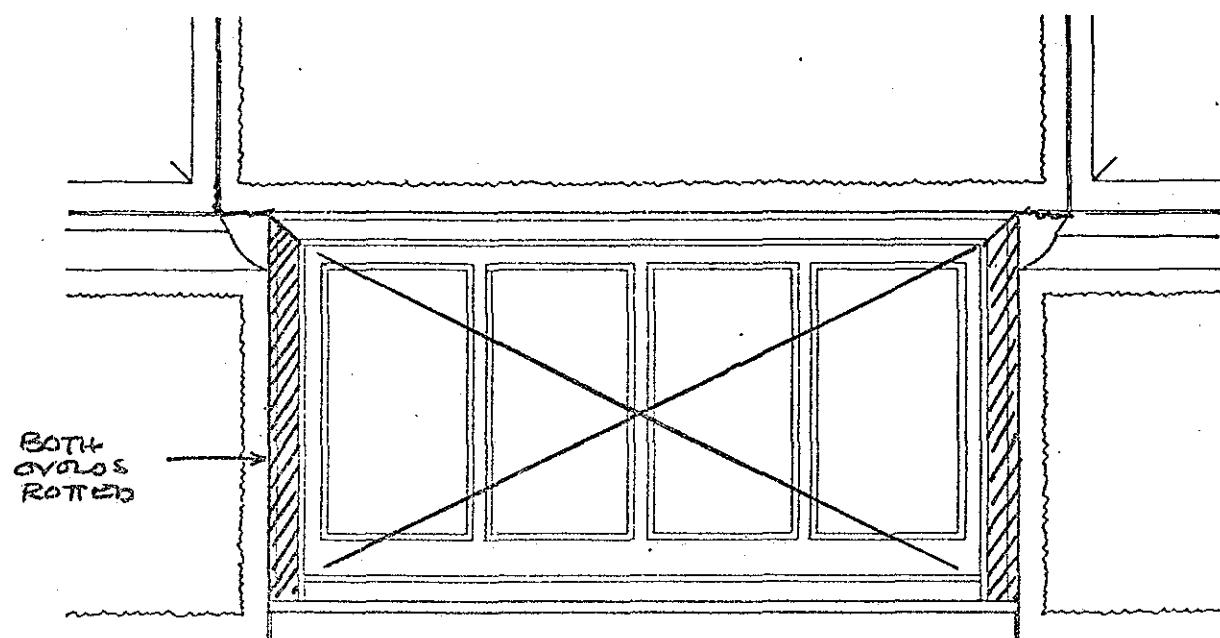
TYPE	NUMBER	CLASS
A- BASEMENT WINDOW	S DO8	3
MECHANICAL AND ELECTRICAL REHABILITATION MAIN BUILDING ELLIS ISLAND	BUILDING CONSERVATION TECHNOLOGY THE EHRENGRANTZ GROUP	
Statue of Liberty National Monument, New York	19 West 44th Street, New York NY 10036

CASEMENT - CENTRAL BAR MISSING - REPLACE

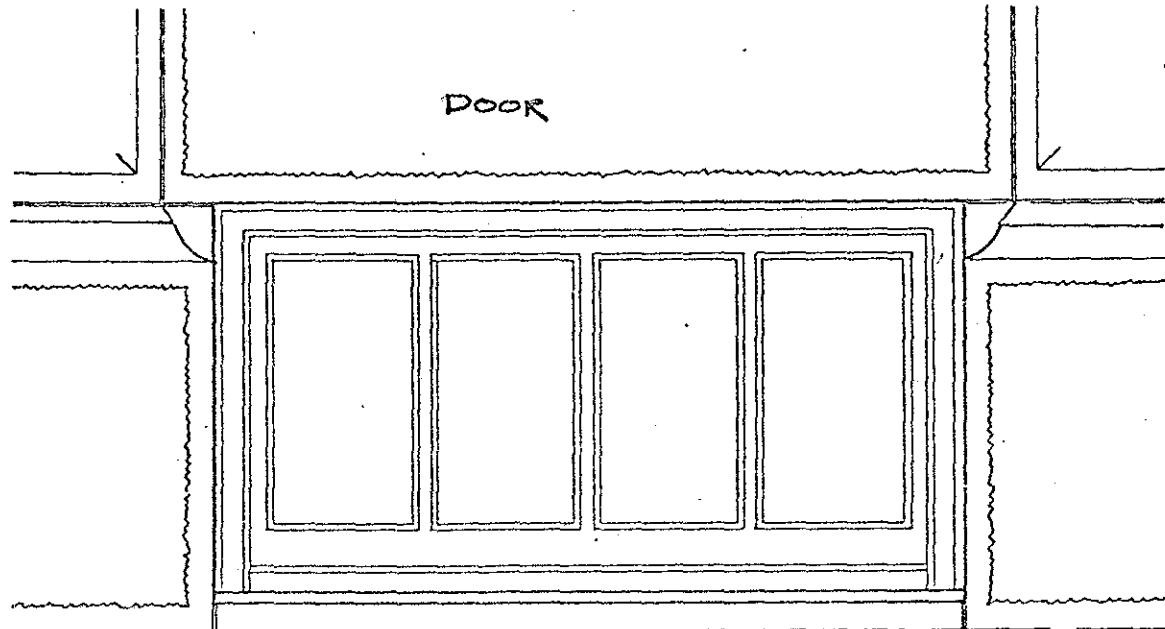
TYPE	NUMBER	CLASS
A- BASEMENT WINDOW	W 001	—
MECHANICAL AND ELECTRICAL REHABILITATION MAIN BUILDING ELLIS ISLAND	BUILDING CONSERVATION TECHNOLOGY THE DROMGARZ GROUP	
Statue of Liberty National Monument, New York	19 West 44th Street, New York NY 10036

BRICKED UP

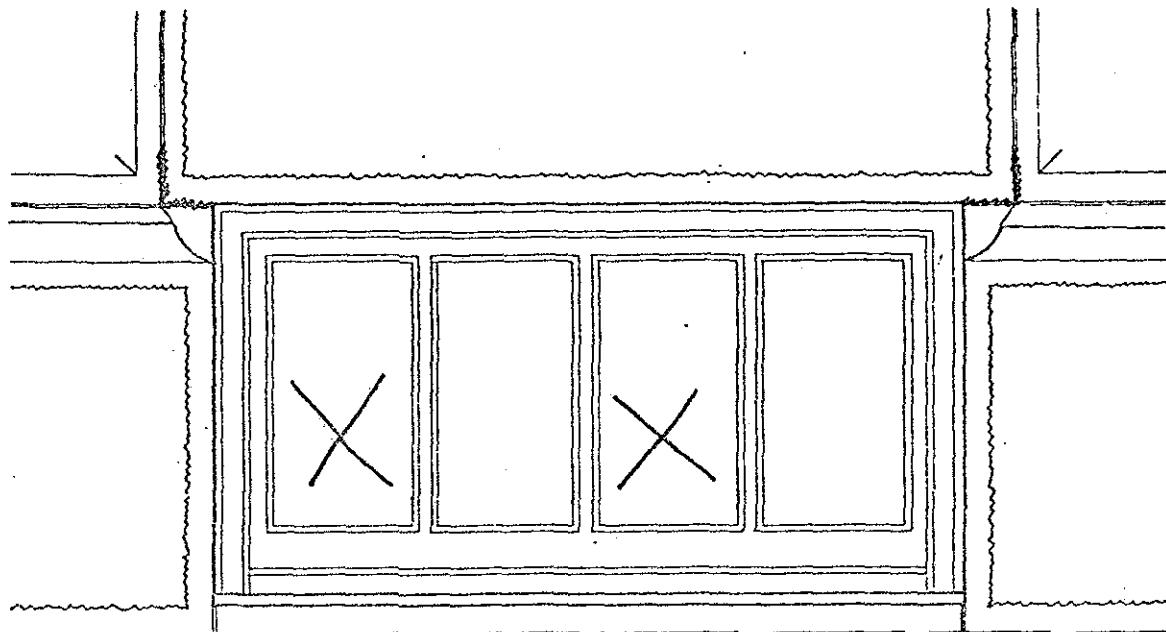
TYPE	NUMBER	CLASS
A- BASEMENT WINDOW	W 004	2
MECHANICAL AND ELECTRICAL REHABILITATION MAIN BUILDING ELLIS ISLAND	BUILDING CONSERVATION TECHNOLOGY THE DZENKANTZ GROUP	
Statue of Liberty National Monument, New York	19 West 44th Street, New York NY 10036

GRILL - PARTIALLY CUT OFF
