historic structures report

mechanical/electrical rehabilitation

main building

STATUE OF LIBERTY ELLIS ISLAND

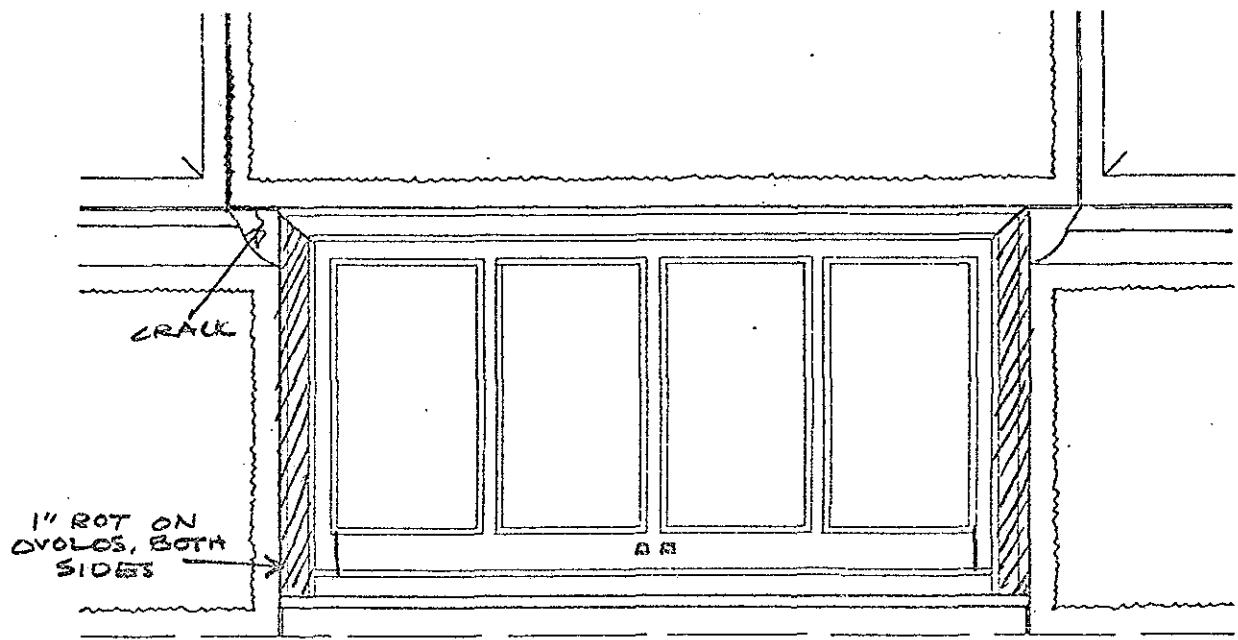
TYPE	NUMBER	CLASS
A- BASEMENT WINDOW	W 007	2
MECHANICAL AND ELECTRICAL REHABILITATION MAIN BUILDING ELLIS ISLAND	BUILDING CONSERVATION TECHNOLOGY THE ENRICOANTZ GROUP	
Statue of Liberty National Monument, New York	29 West 44th Street, New York NY 10036

INTERIOR - STOP ON SILL ROTTED - REPLACE

MESH GRATING INSIDE WINDOW
ROD HOLDING SASH OPEN.

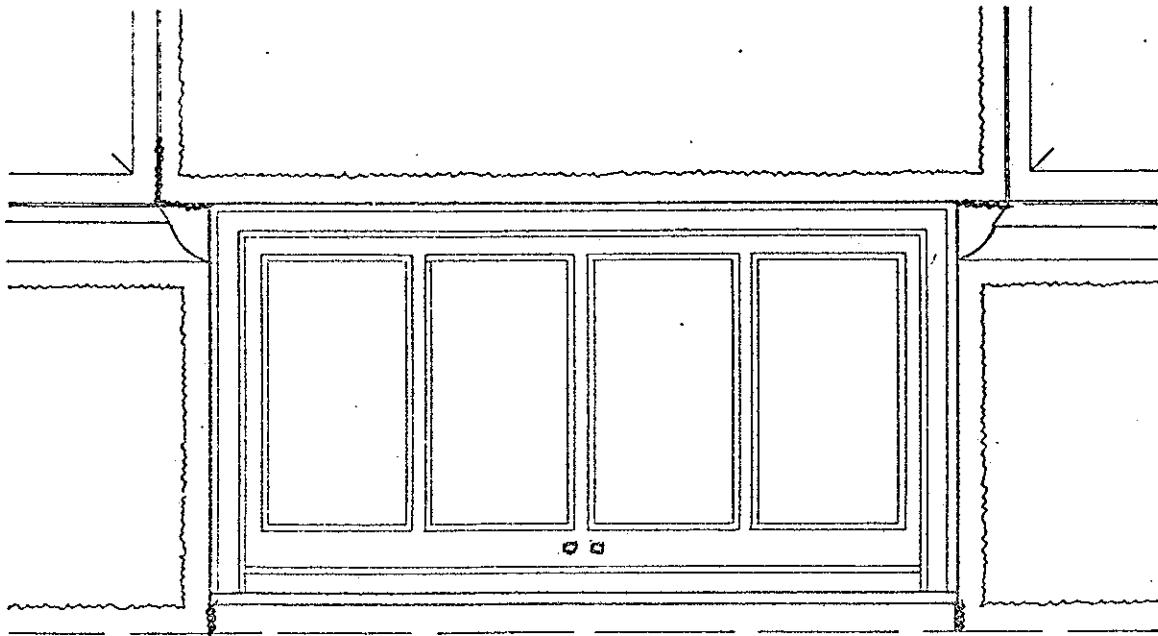
TYPE	NUMBER	CLASS
A- BASEMENT WINDOW	W 008	2
MECHANICAL AND ELECTRICAL REHABILITATION MAIN BUILDING ELLIS ISLAND	BUILDING CONSERVATION TECHNOLOGY THE BRENGARTZ GROUP	
Statue of Liberty National Monument, New York	19 West 44th Street, New York NY 10036

INTERIOR: STOP ON SILL LOOSE - REPLACE

BAR HOLDING BOTTOM UP.

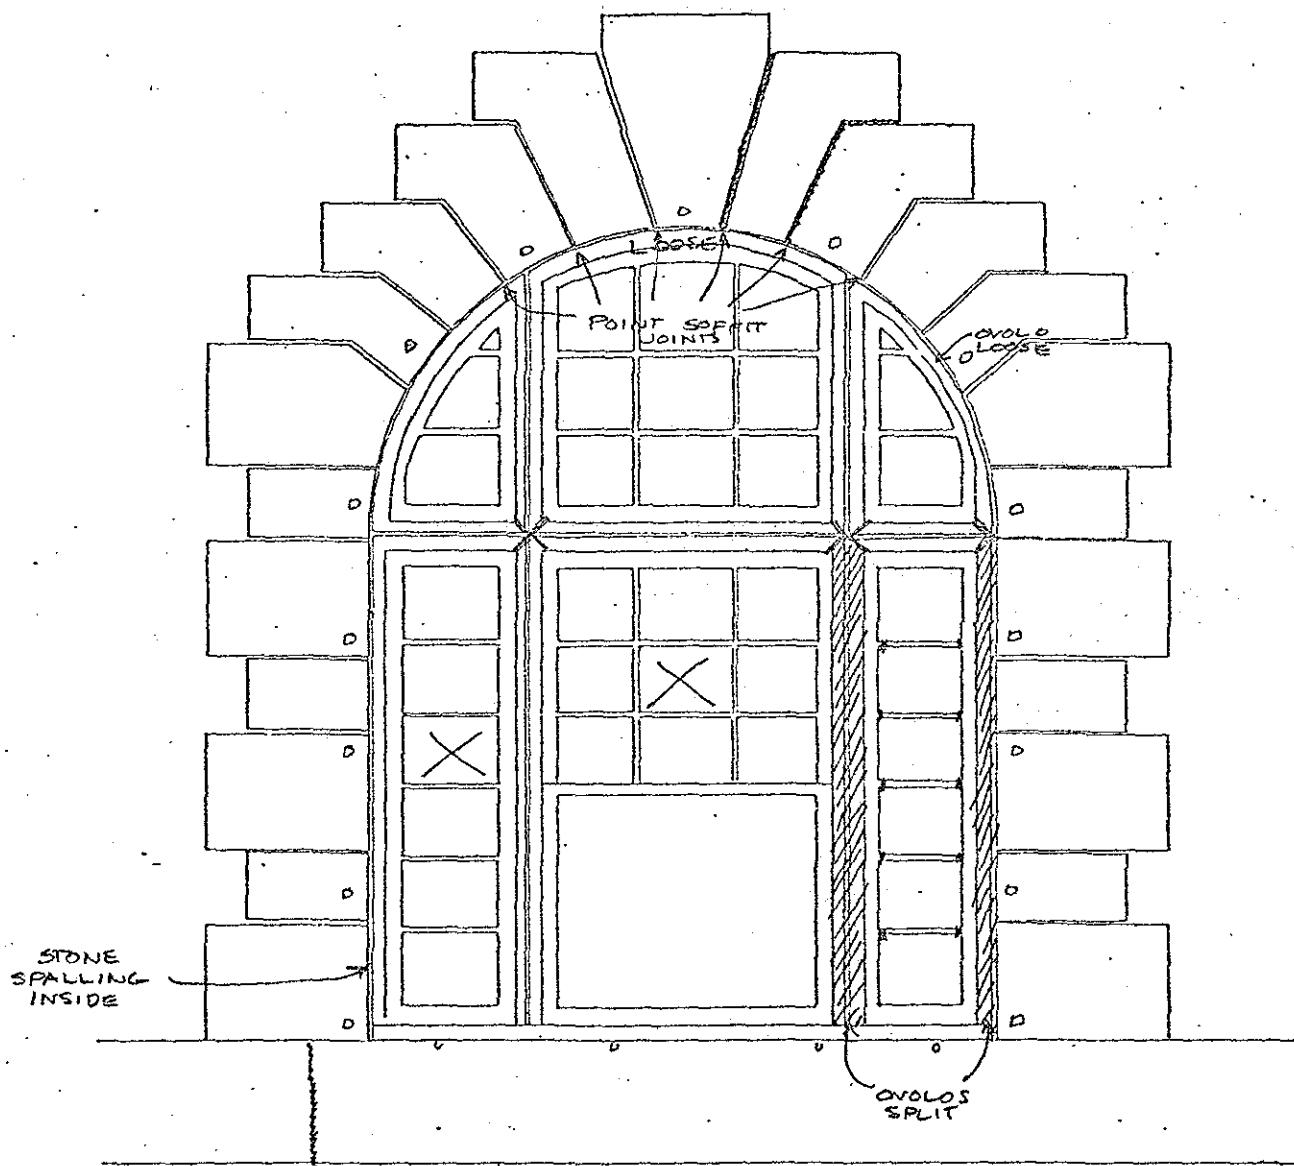
B1 FIRST FLOOR	NUMBER N 105	CLASS 2 / 3 wood
MECHANICAL AND ELECTRICAL REHABILITATION MAIN BUILDING ELLIS ISLAND Statue of Liberty National Monument, New York	BUILDING CONSERVATION TECHNOLOGY THE DRENNANZ GROUP	2 stone

SCREENS - WOOD CHECKED, MESH TORN, POOR CONDITION

INTERIOR:
 -STOPs MISSING, ROTTED, LOOSE
 -STOOLS ROTTEN

SCREEN OVER LOWER SASH - POOR CONDITION

INTERIOR: SASH STOPS ROTTED, LOOSE

SCREEN OVER LOWER SASH - FAIR CONDITION - SOME CHECKING

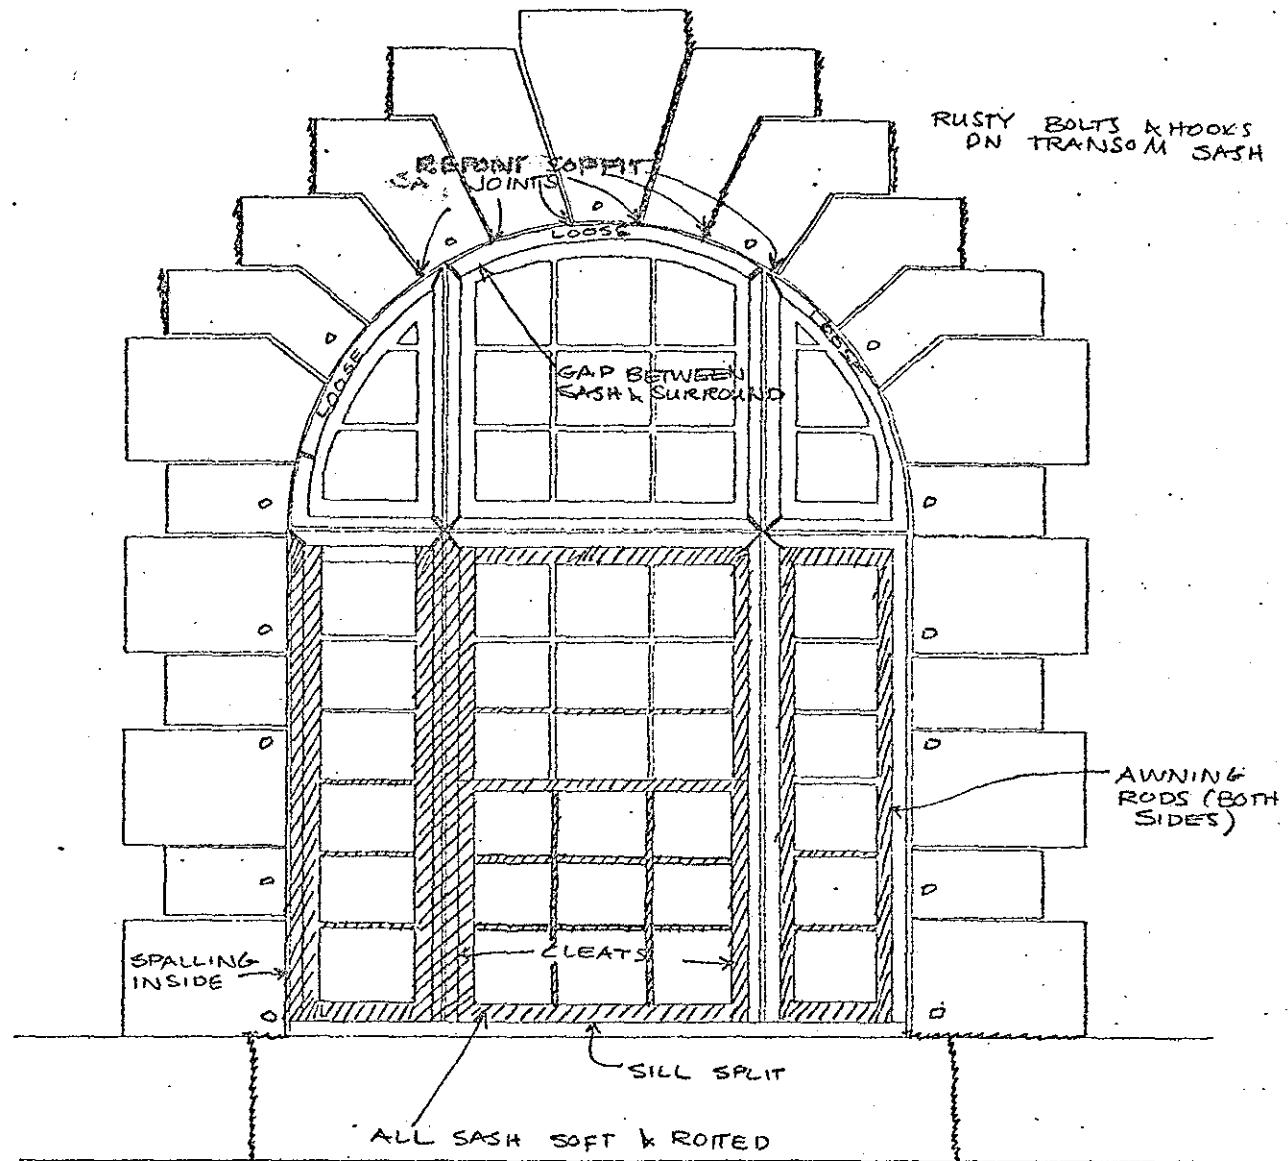
B1 FIRST FLOOR	NUMBER	CLASS
MECHANICAL AND ELECTRICAL REHABILITATION MAIN BUILDING ELLIS ISLAND Statue of Liberty National Monument, New York	NJ 106 BUILDING PRESERVATION TECHNOLOGY THE DEDDANTS GROUP	3

SCREEN MISSING (METAL TRACK ON FRAME)

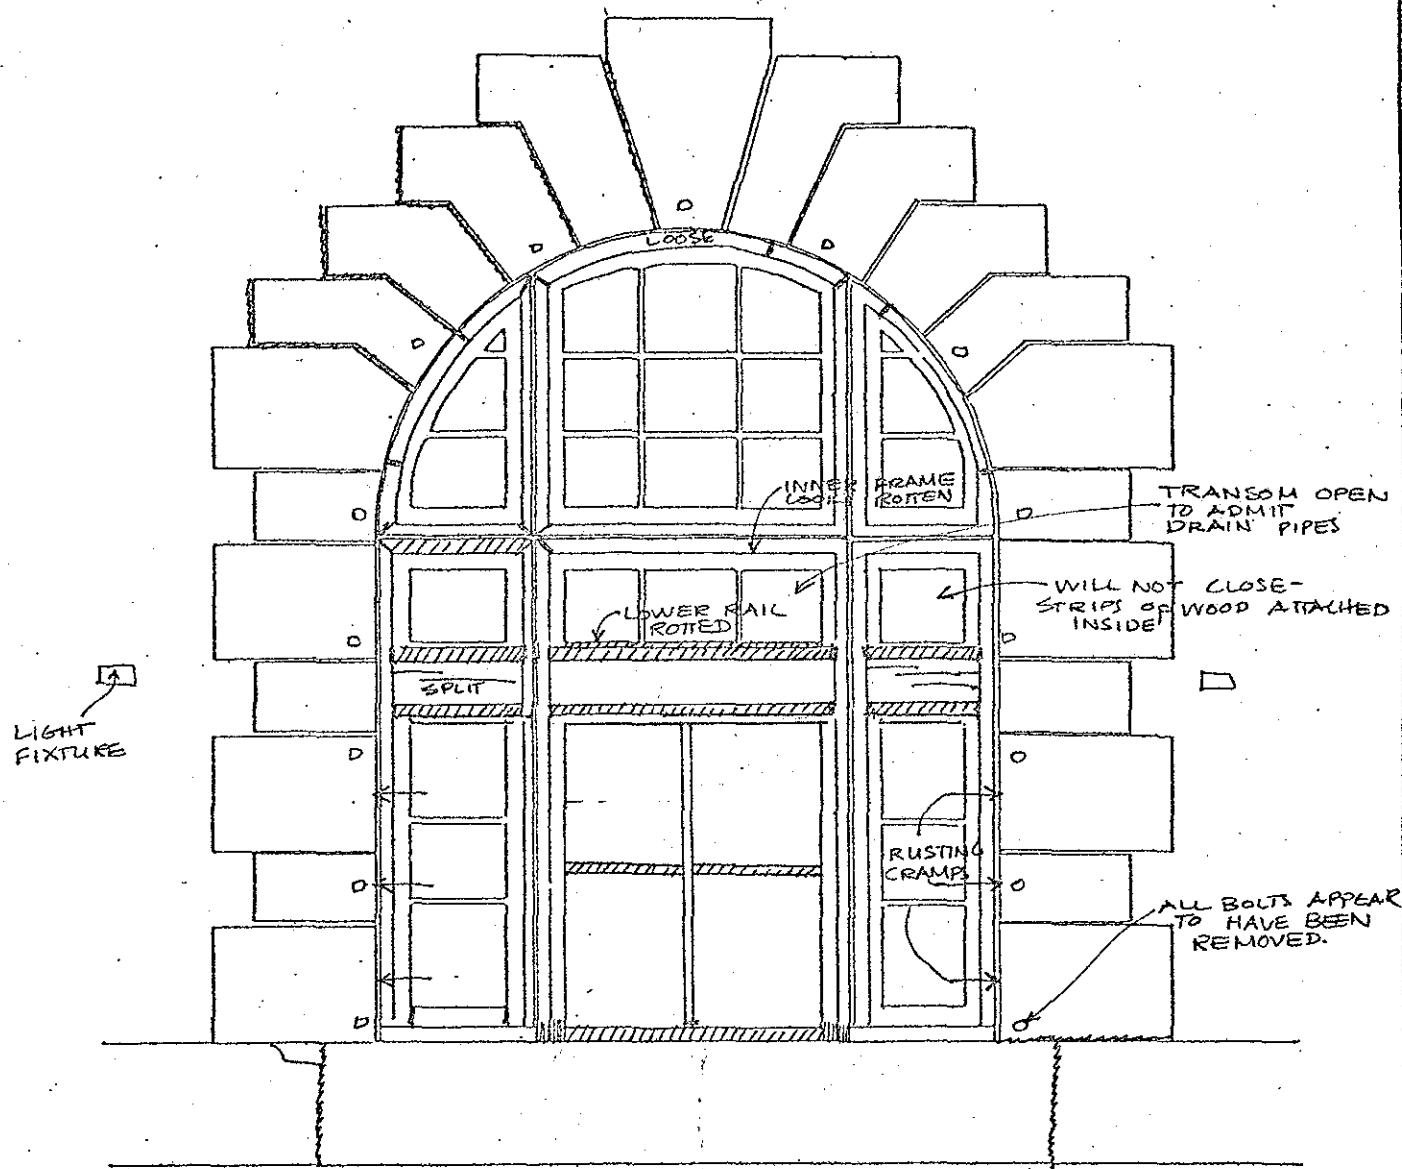
B3 FIRST FLOOR NORTH ELEVATION	NUMBER	CLASS
MECHANICAL AND ELECTRICAL REHABILITATION MAIN BUILDING ELLIS ISLAND Statue of Liberty National Monument, New York	N121 BUILDING CONSERVATION TECHNOLOGY THE BREKANTZ GROUP 19 West 44th Street, New York NY 10036	2 -

ALL JOINTS WHERE OVOLOS MEET POORLY CONSTRUCTED -
ENDS OF HORIZONTAL MLDGS SPLIT, LARGE GAPS FOR
WATER PENETRATION.

GRILL OVER ARCHED PORTION ONLY.

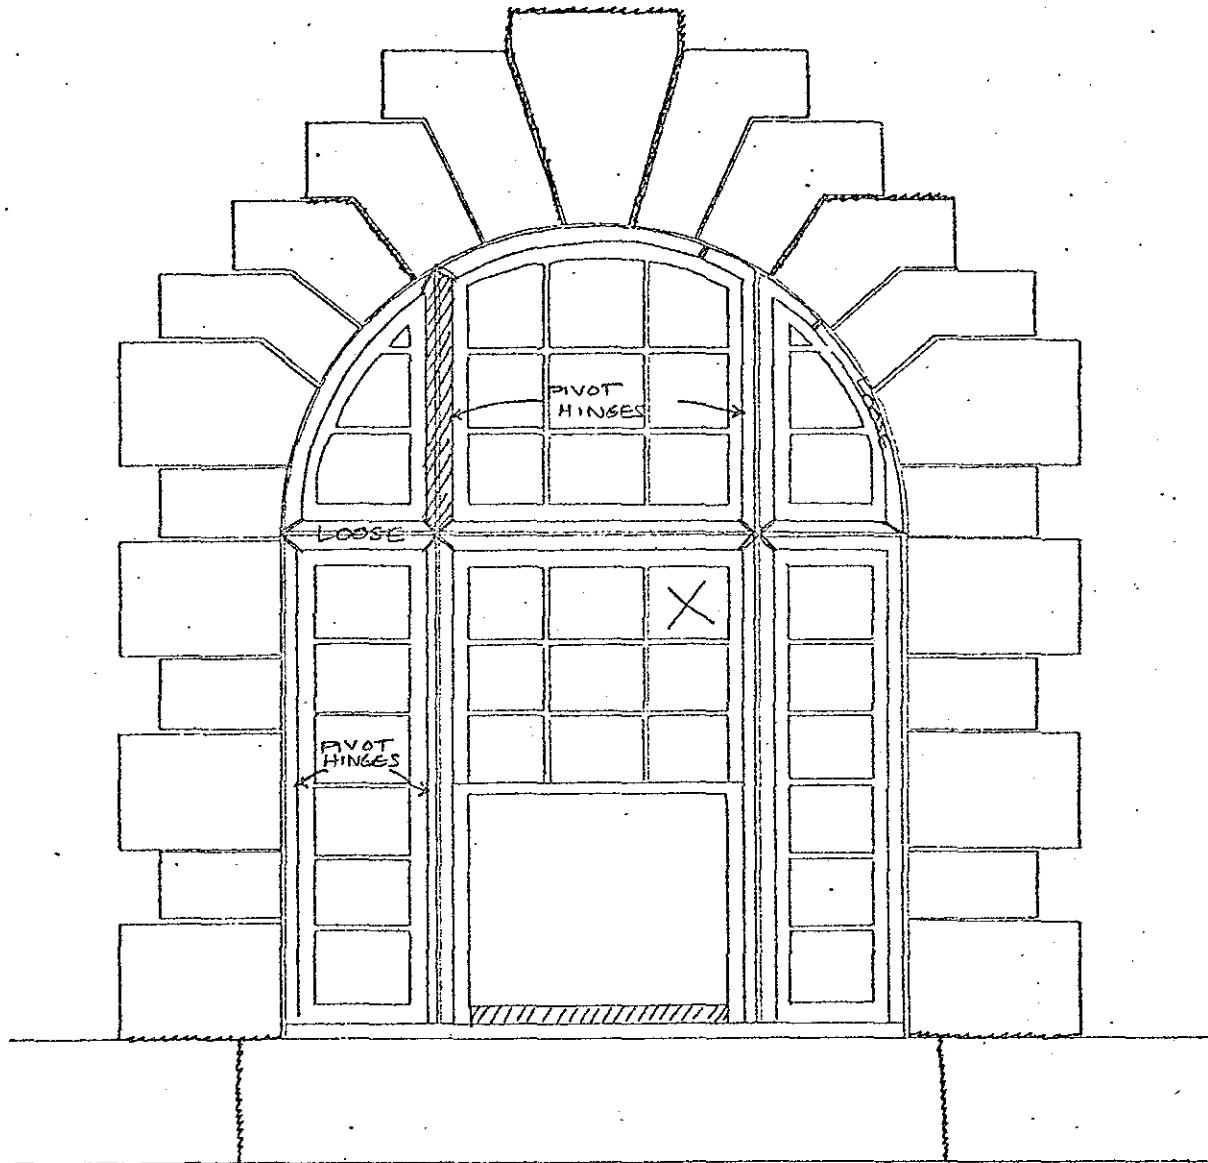
B1 FIRST FLOOR	NUMBER	CLASS
MECHANICAL AND ELECTRICAL REHABILITATION MAIN BUILDING ELLIS ISLAND Statue of Liberty National Monument, New York	N 122 BUILDING OBSERVATION TECHNOLOGY THE DEDDAROFF GROUP	2 -

INTERIOR: TRANSMON HARDWARE NOT OPERABLE

GRILL IN PLACE

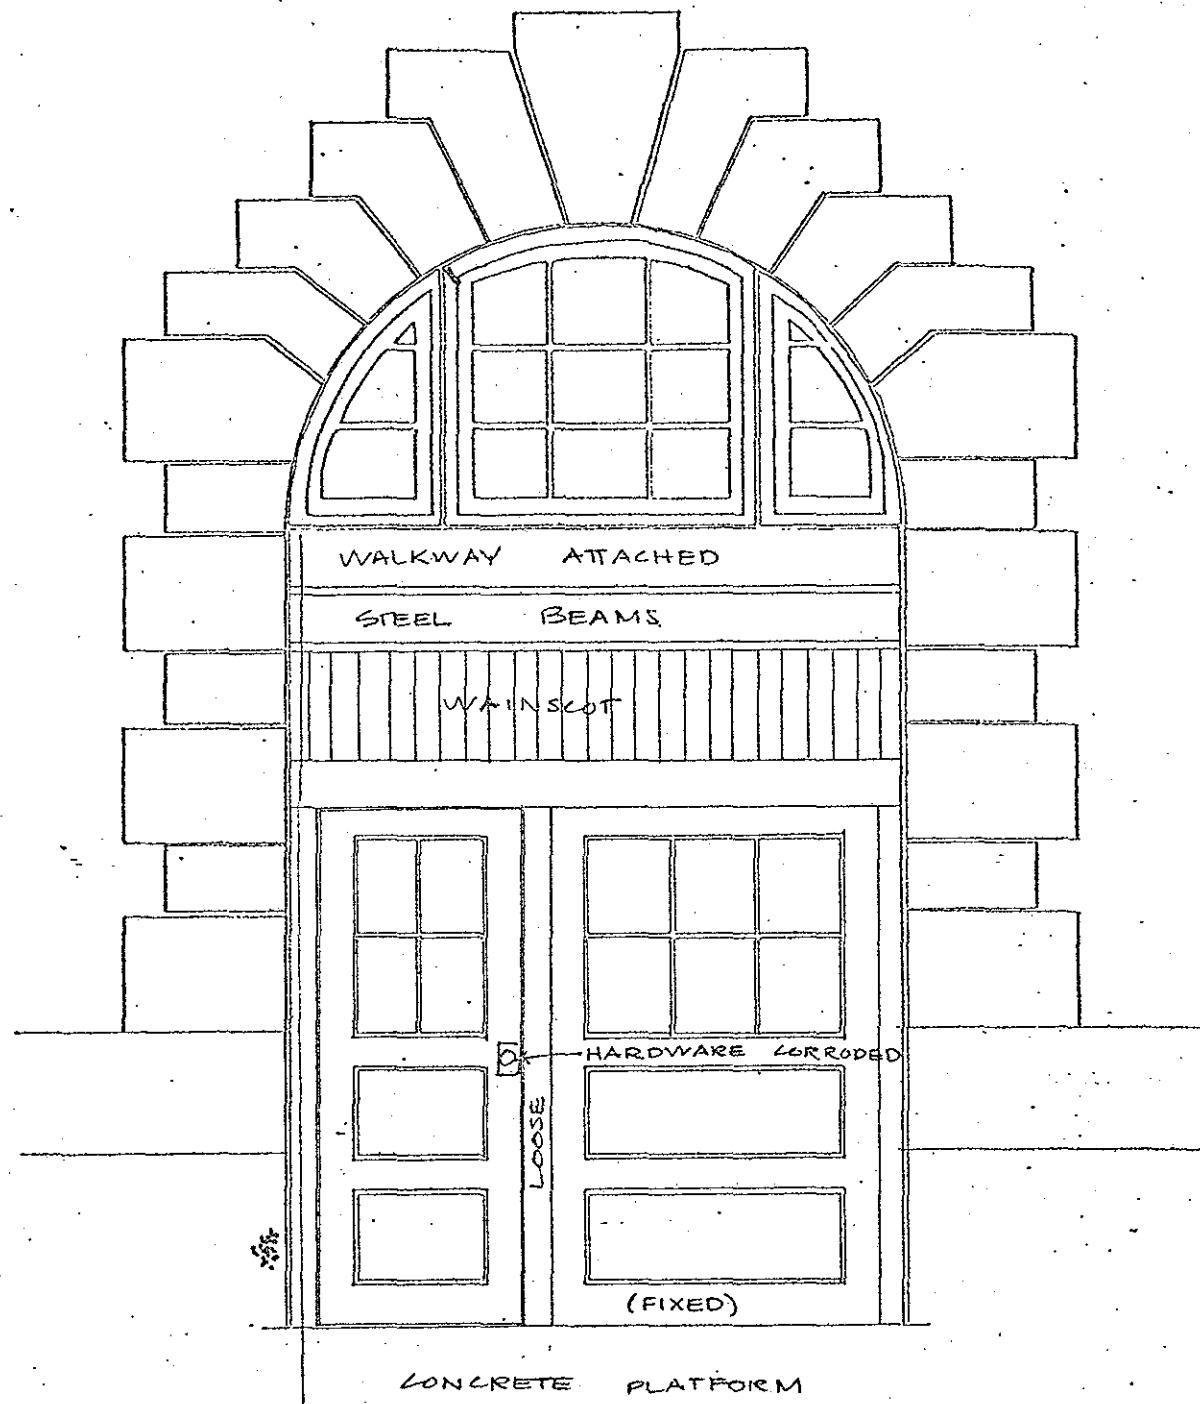
NUMBER N 123	CLASS I
MECHANICAL AND ELECTRICAL REHABILITATION MAIN BUILDING ELLIS ISLAND Statue of Liberty National Monument, New York	BUILDING CONSERVATION TECHNOLOGY THE EBENKANTZ GROUP 19 West 44th Street, New York NY 10036;

GRILL OVER TRANSMON.

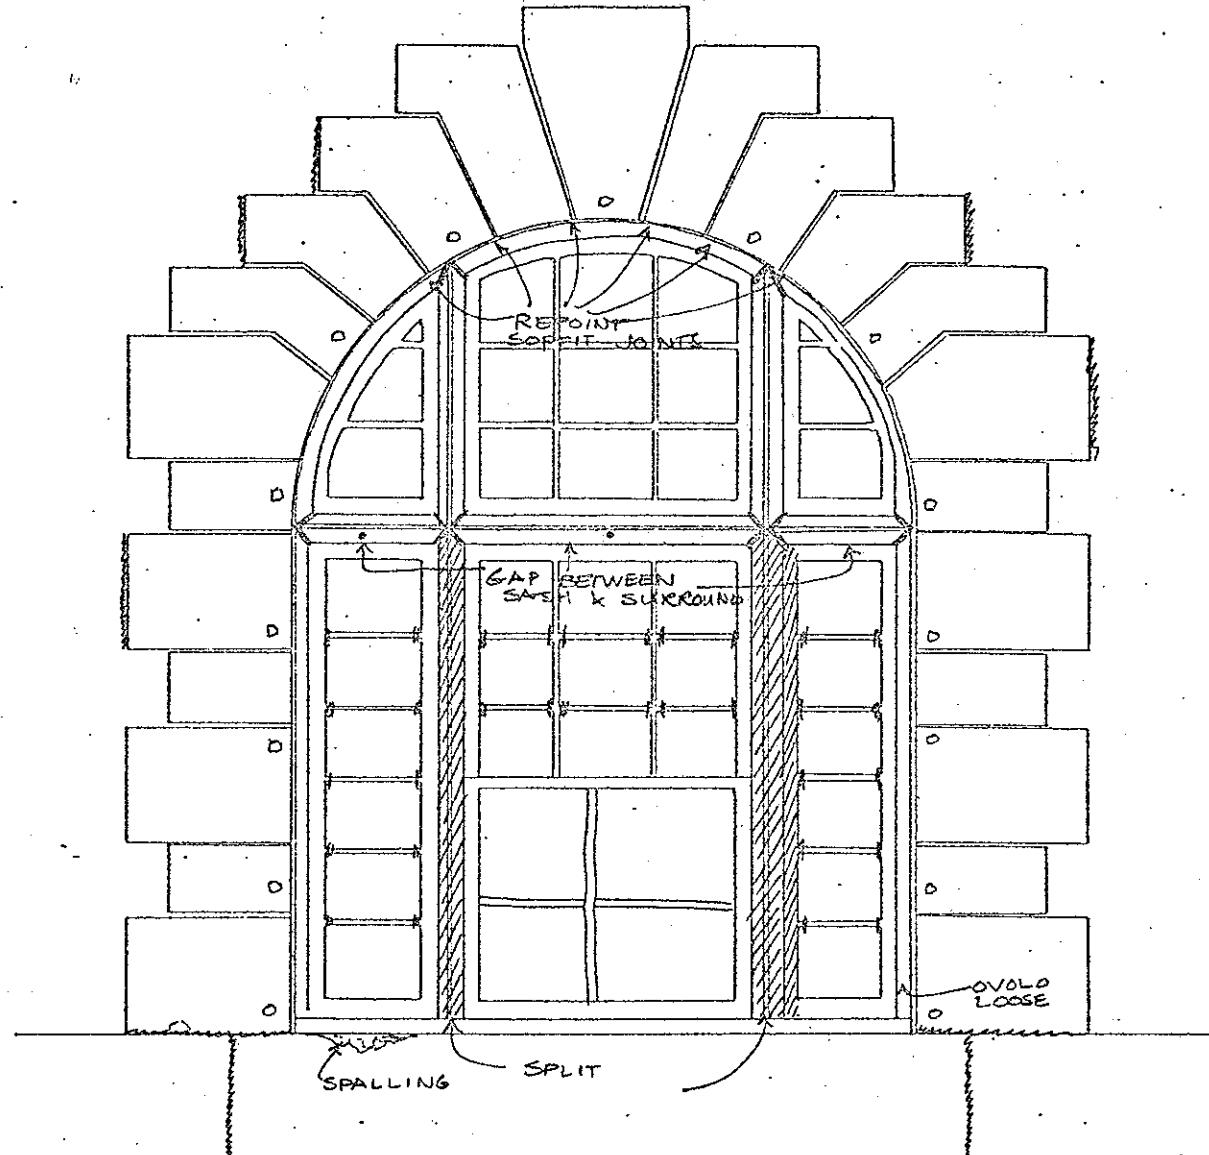
B1 FIRST FLOOR	NUMBER E 103	CLASS 2 wood
MECHANICAL AND ELECTRICAL REHABILITATION MAIN BUILDING ELLIS ISLAND Statue of Liberty National Monument, New York	BUILDING CONSERVATION TECHNOLOGY THE DECORATORS GROUP 19 West 44th Street, New York NY 10036	2 stone

INACCESSIBLE ON INSIDE

GRILL REMOVED

SCREEN ON LOWER HALF OF WINDOW - BOTTOM RAIL ROTTEN,
MOLDS WARPED

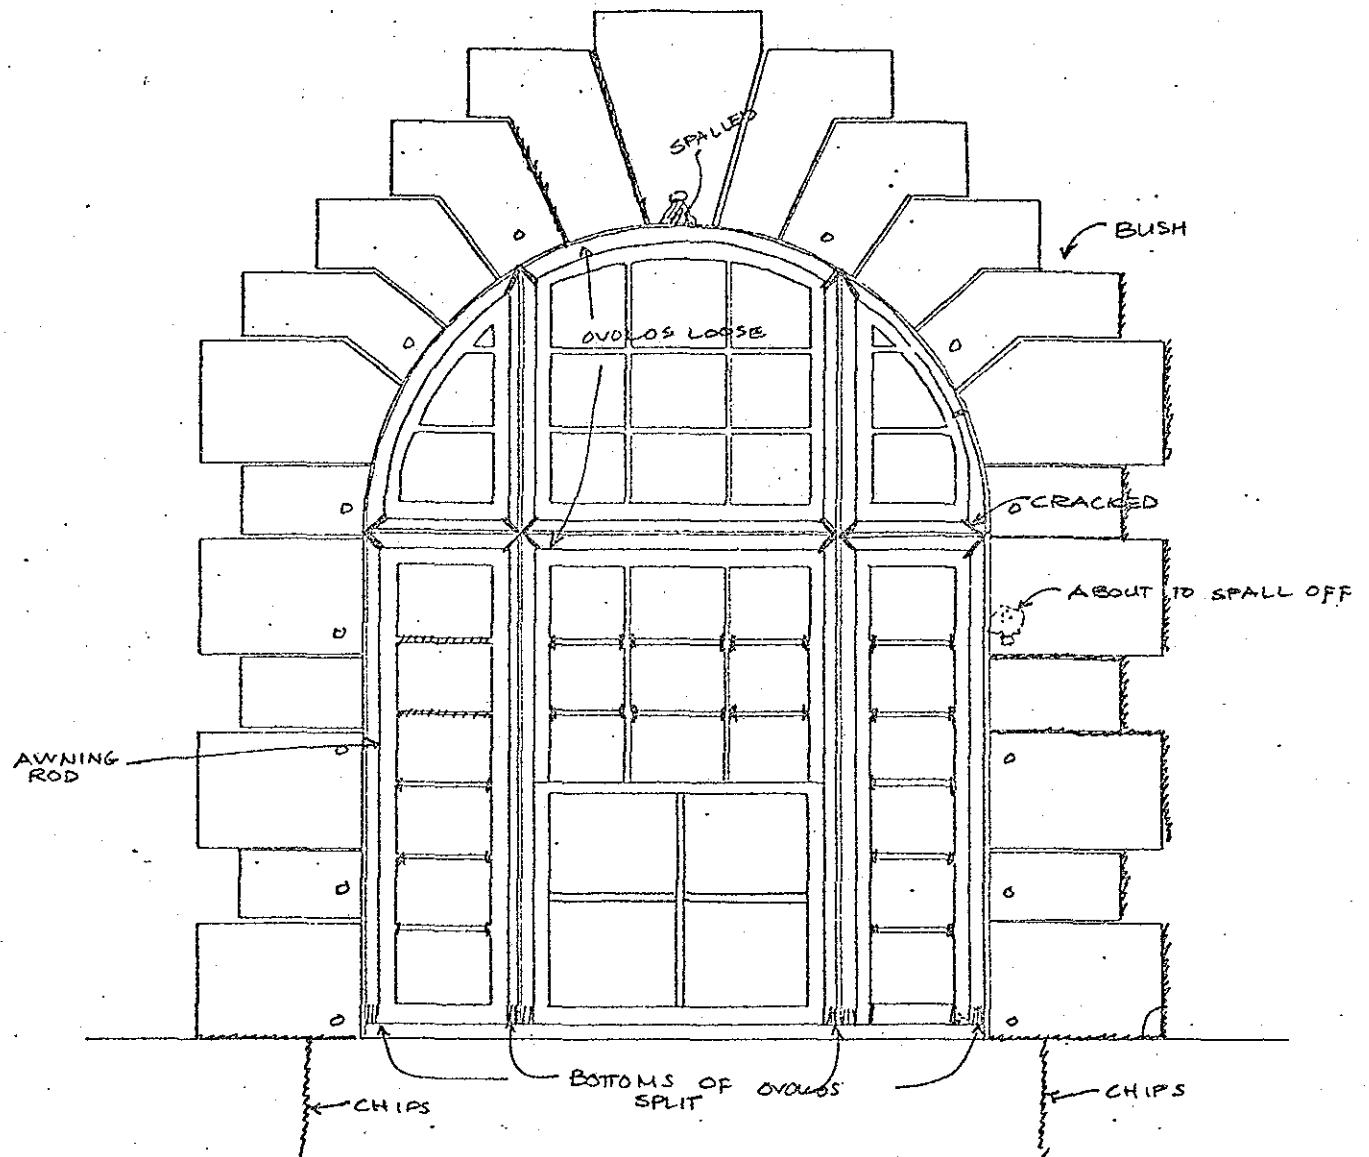
B1 FIRST FLOOR	NUMBER E 104	CLASS 2
MECHANICAL AND ELECTRICAL REHABILITATION MAIN BUILDING ELLIS ISLAND Statue of Liberty National Monument, New York	BUILDING CONSERVATION TECHNOLOGY DE BRENNANZ GROUP 19 West 46th Street, New York NY 10036

ALL JOINTS OPEN

GRILL REMOVED

SCREEN ON LOWER HALF - BOTTOM RAIL ROTTED, MLDGS LOOSE

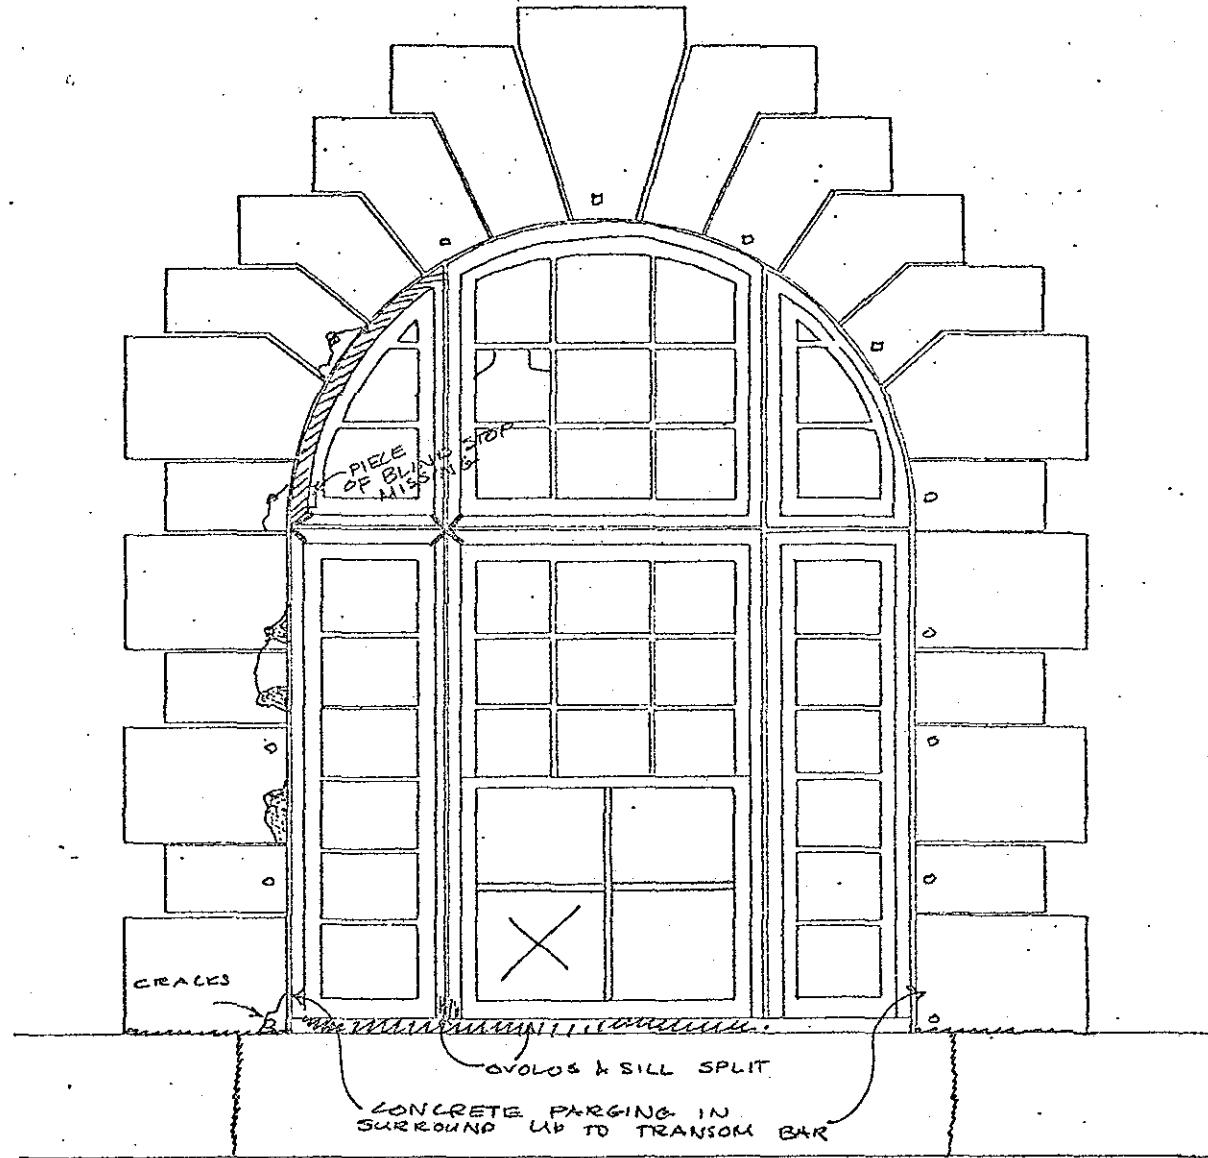
GRILL REMOVED

SCREEN ON LOWER HALF - TOP RAIL SPLIT; MLDG WARPED &
LOOSE; MESH RIPPED

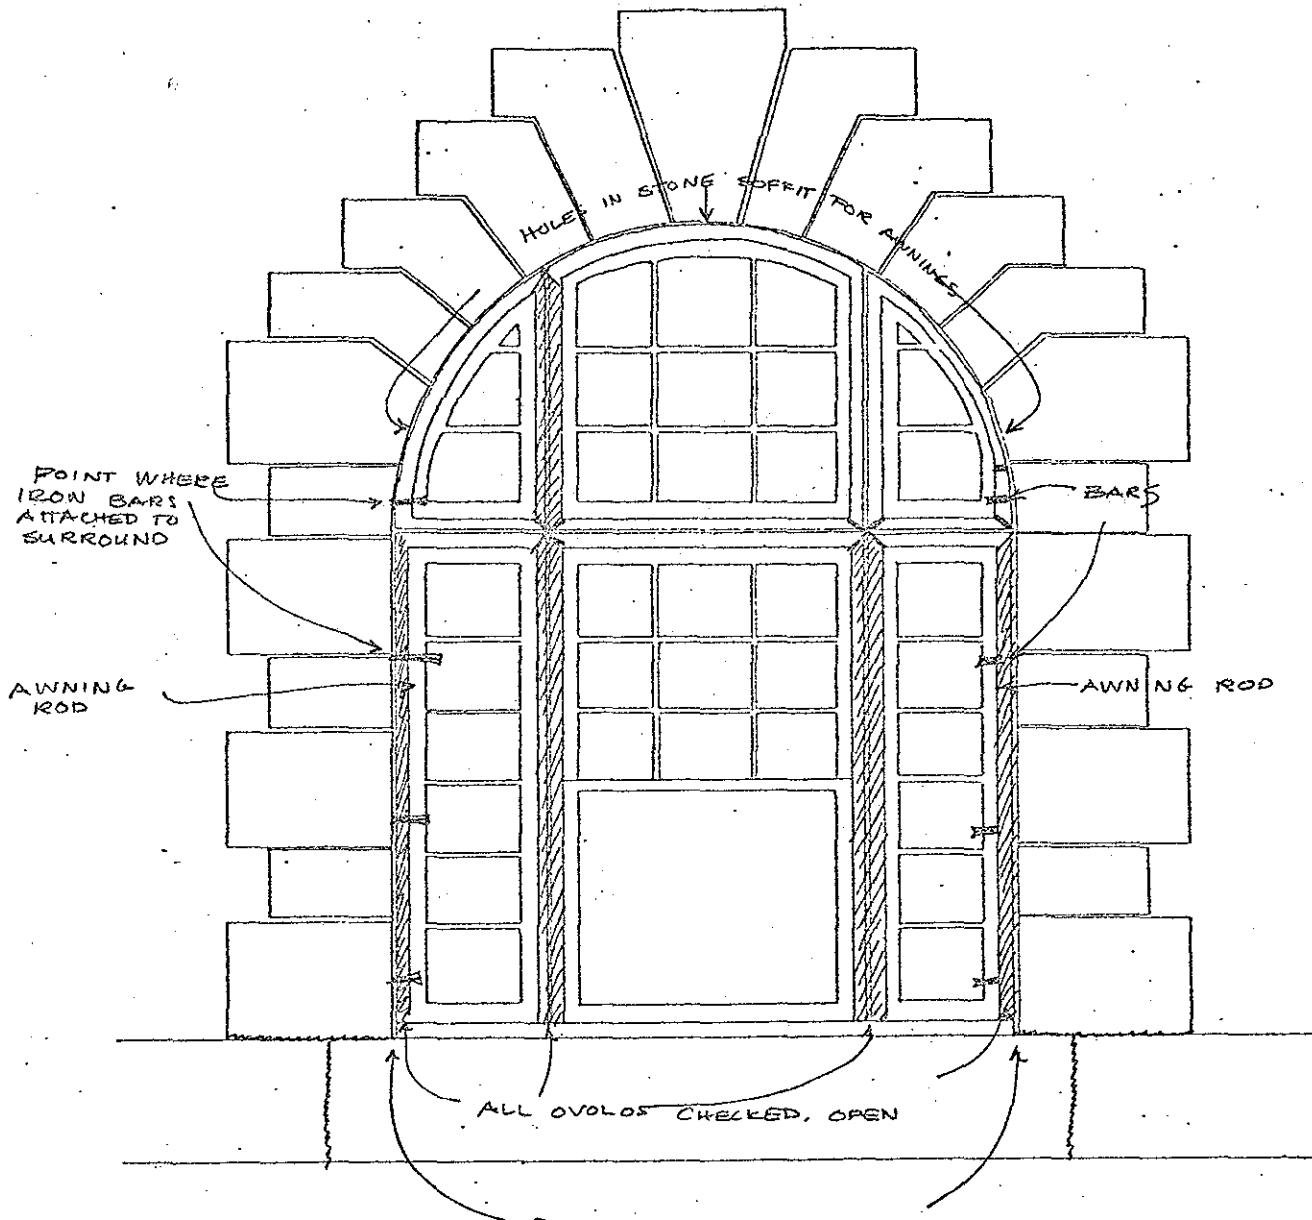
NOT ACCESSIBLE INSIDE

SCREEN LOWER HALF MAIN SASH.

IRON BARS INSTEAD OF GRILL - CORRODED; STONE HAS SPALLED
INSIDE

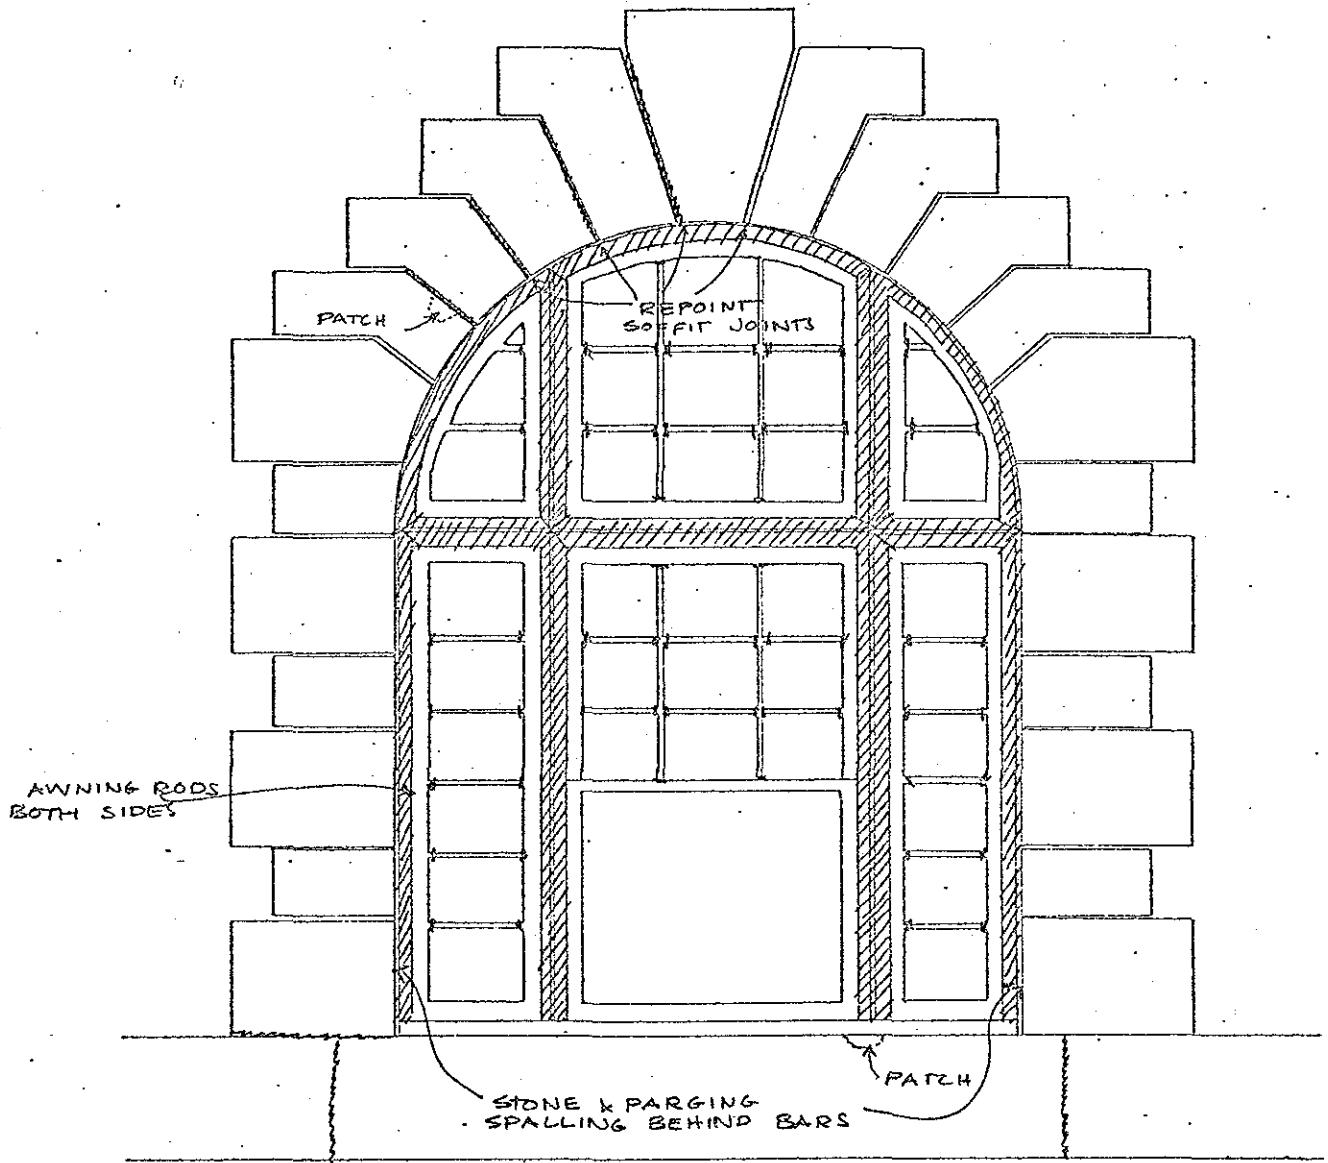
B1 FIRST FLOOR	NUMBER E 109	CLASS 2/3
MECHANICAL AND ELECTRICAL REHABILITATION MAIN BUILDING ELLIS ISLAND Statue of Liberty National Monument, New York	BUILDING CONSERVATION TECHNOLOGY THE EBRICKART GROUP	
	19 West 44th Street, New York NY 10036

NOT ACCESSIBLE ON INTERIOR

ALL OVOLOS SPLIT, CRACKED
ALL JOINTS OPEN

SCREEN ON LOWER HALF - WOOD SPLIT, MESH TORN

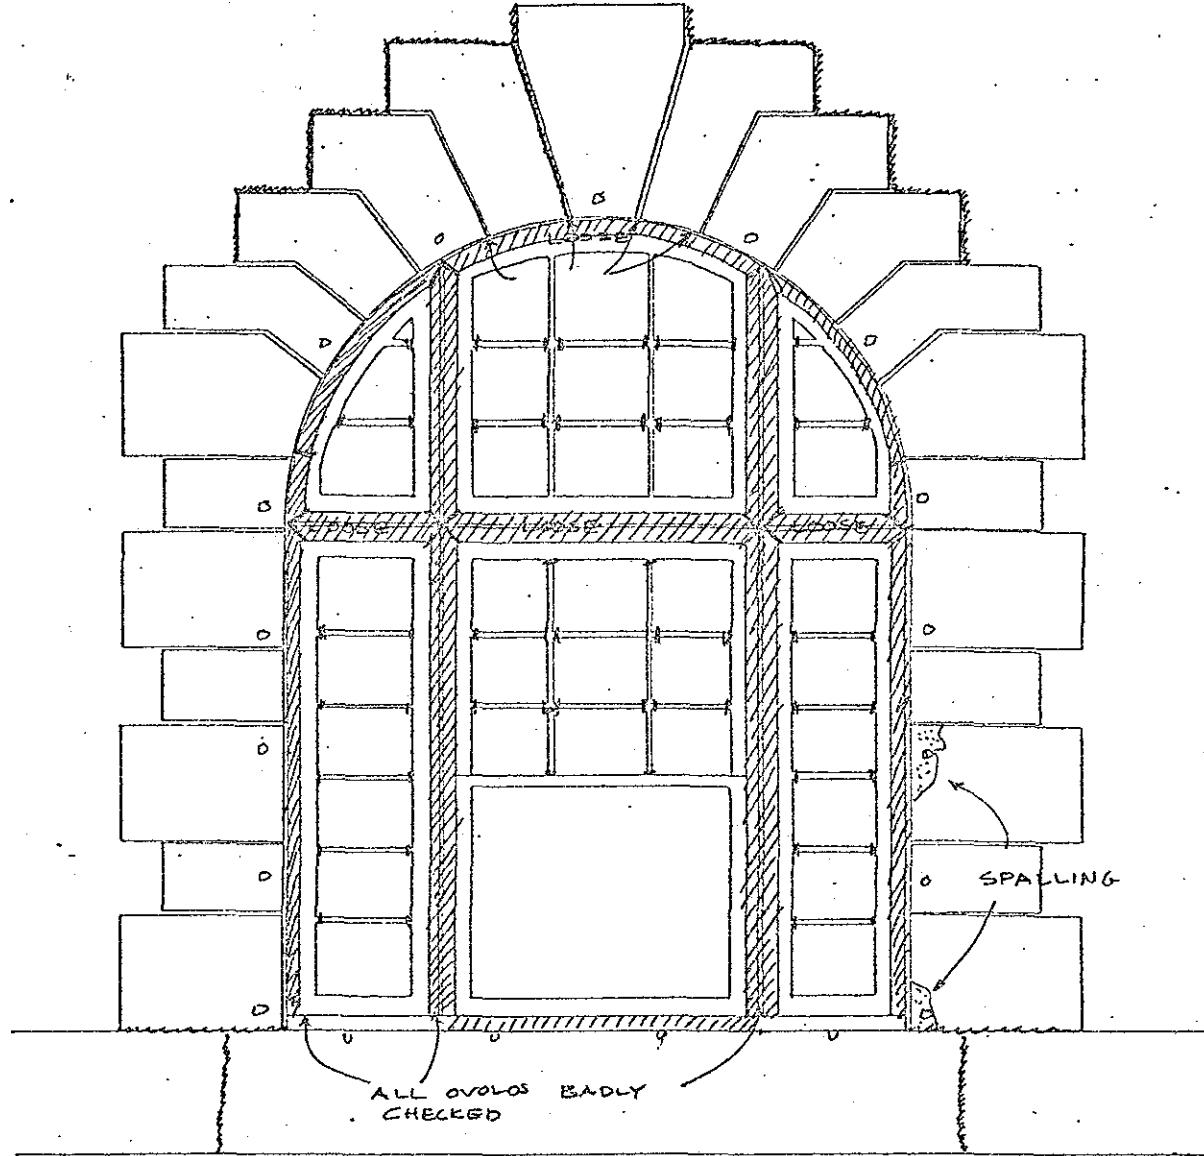
B1 FIRST FLOOR	NUMBER E 110	CLASS 3 wood
MECHANICAL AND ELECTRICAL REHABILITATION MAIN BUILDING ELLIS ISLAND Statue of Liberty National Monument, New York	BUILDING OBSERVATION TECHNOLOGY THE BRECHERANTZ GROUP 19 West 46th Street, New York NY 10036	2 stone

ALL JOINTS OPEN

GRILL REMOVED

SCREEN ON LOWER SASH - POOR CDFN

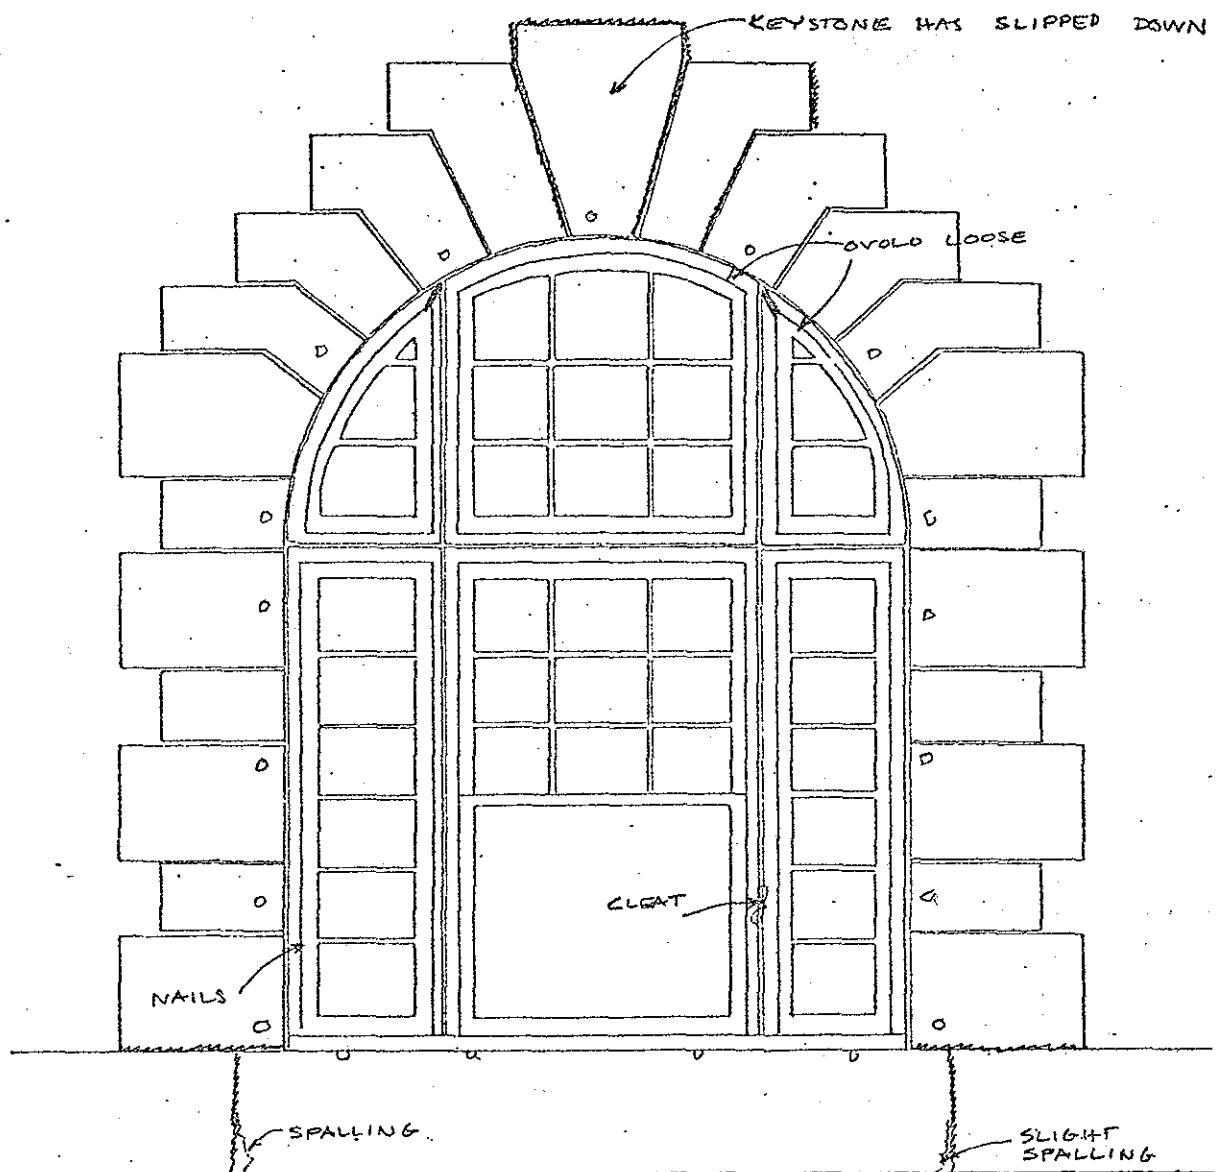
B1 FIRST FLOOR	NUMBER S101	CLASS 2
MECHANICAL AND ELECTRICAL REHABILITATION MAIN BUILDING ELLIS ISLAND Statue of Liberty National Monument, New York	BUILDING CONSERVATION TECHNOLOGY THE DIBBLENZERZ GROUP 39 West 44th Street, New York NY 10036

INTERIOR:

- SASH STOPS LOOSE & MISSING
- SASH OPERABLE
- TOP RAIL OF LOWER SASH DAMAGED
- SASH LOCK INOPERABLE - TRANSOM

GRILL REMOVED

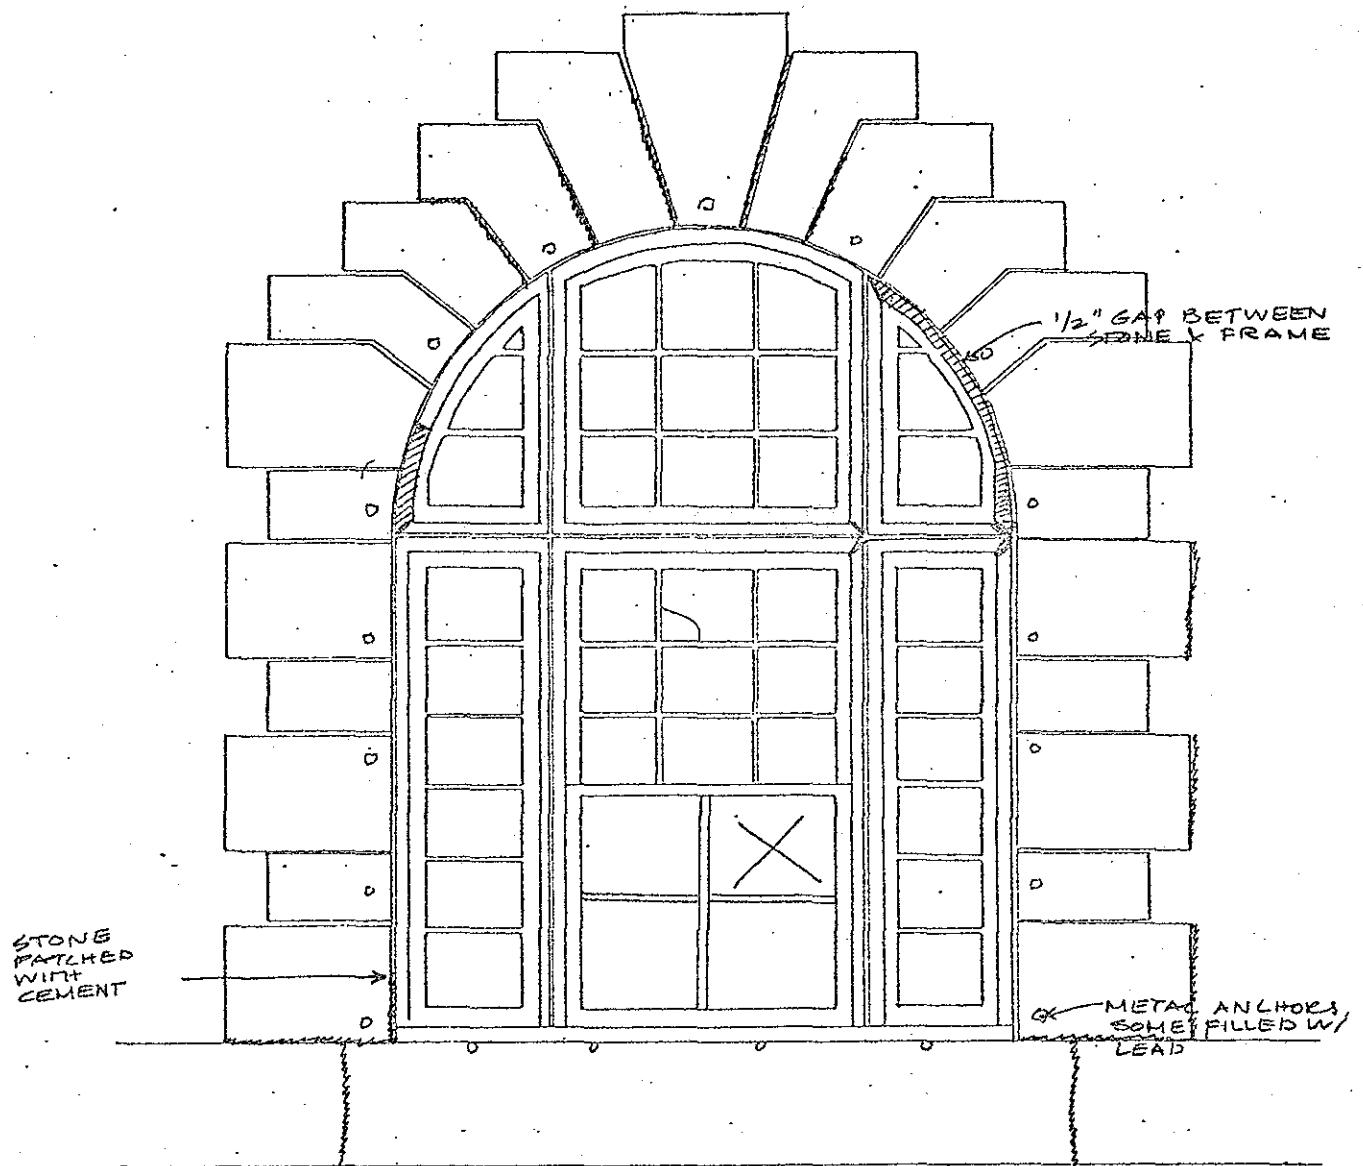
B1 FIRST FLOOR	NUMBER S102	CLASS 2
MECHANICAL AND ELECTRICAL REHABILITATION MAIN BUILDING ELLIS ISLAND Statue of Liberty National Monument, New York	BUILDING CONSERVATION TECHNOLOGY THE DEDDINGTON GROUP 19 West 44th Street, New York NY 10036

INTERIOR:

- WEST SIDE JAMB, SURROUND & STOOL ROTTEN
- HARDWARE INOPERABLE

GRILL REMOVED
