historic structures report

mechanical/electrical rehabilitation

main building

STATUE OF LIBERTY ELLIS ISLAND

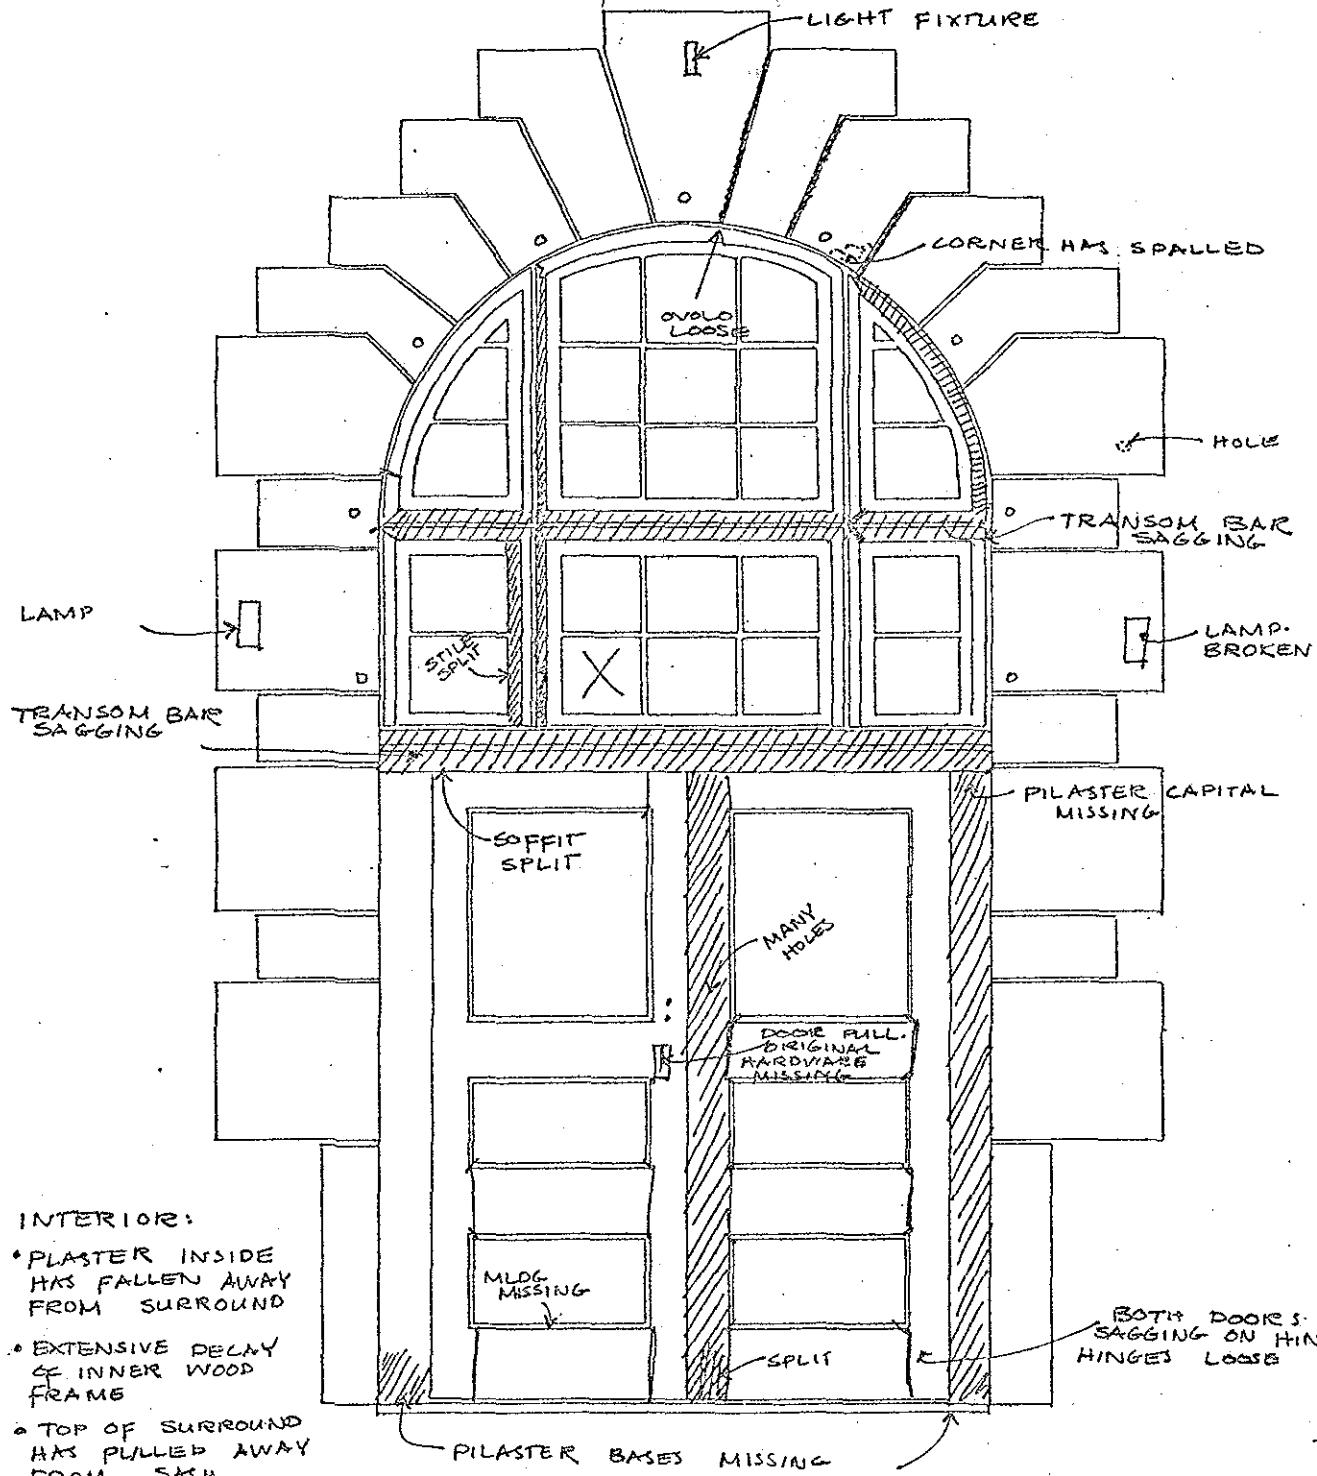
B2 FIRST FLOOR DOOR	NUMBER S103	CLASS 2
MECHANICAL AND ELECTRICAL REHABILITATION MAIN BUILDING ELLIS ISLAND Statue of Liberty National Monument, New York	BUILDING CONSERVATION TECHNOLOGY THE EHRENKRANTZ GROUP 19 West 44th Street, New York NY 10036

GRILL REMOVED

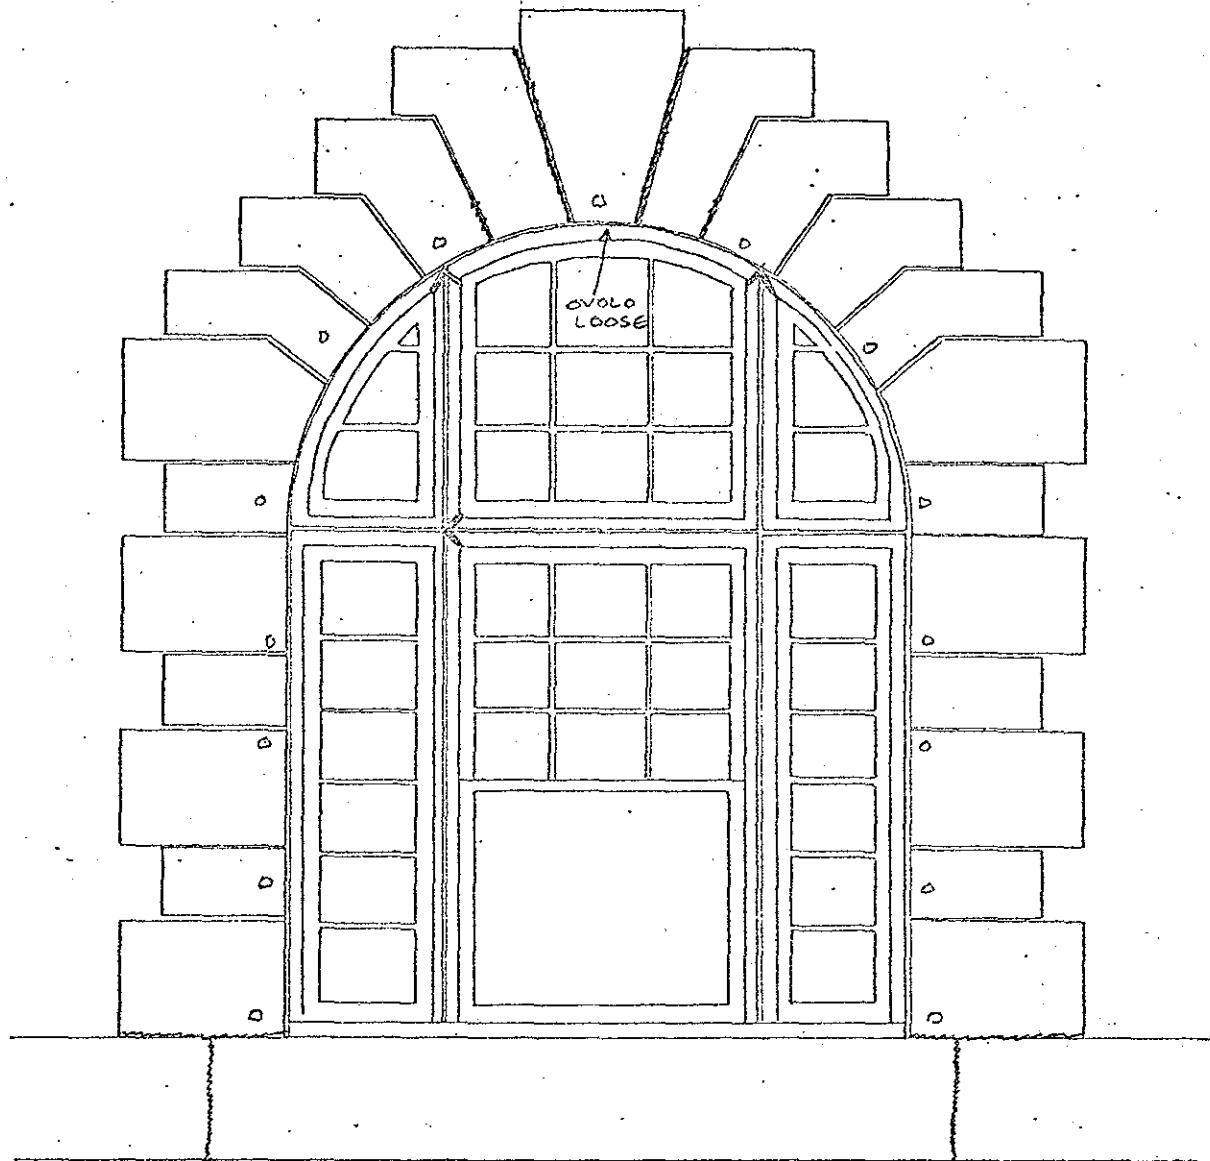
INTERIOR:

- SASH STOPS MISSING, ROTTEN, LOOSE
- SASH OPERABLE

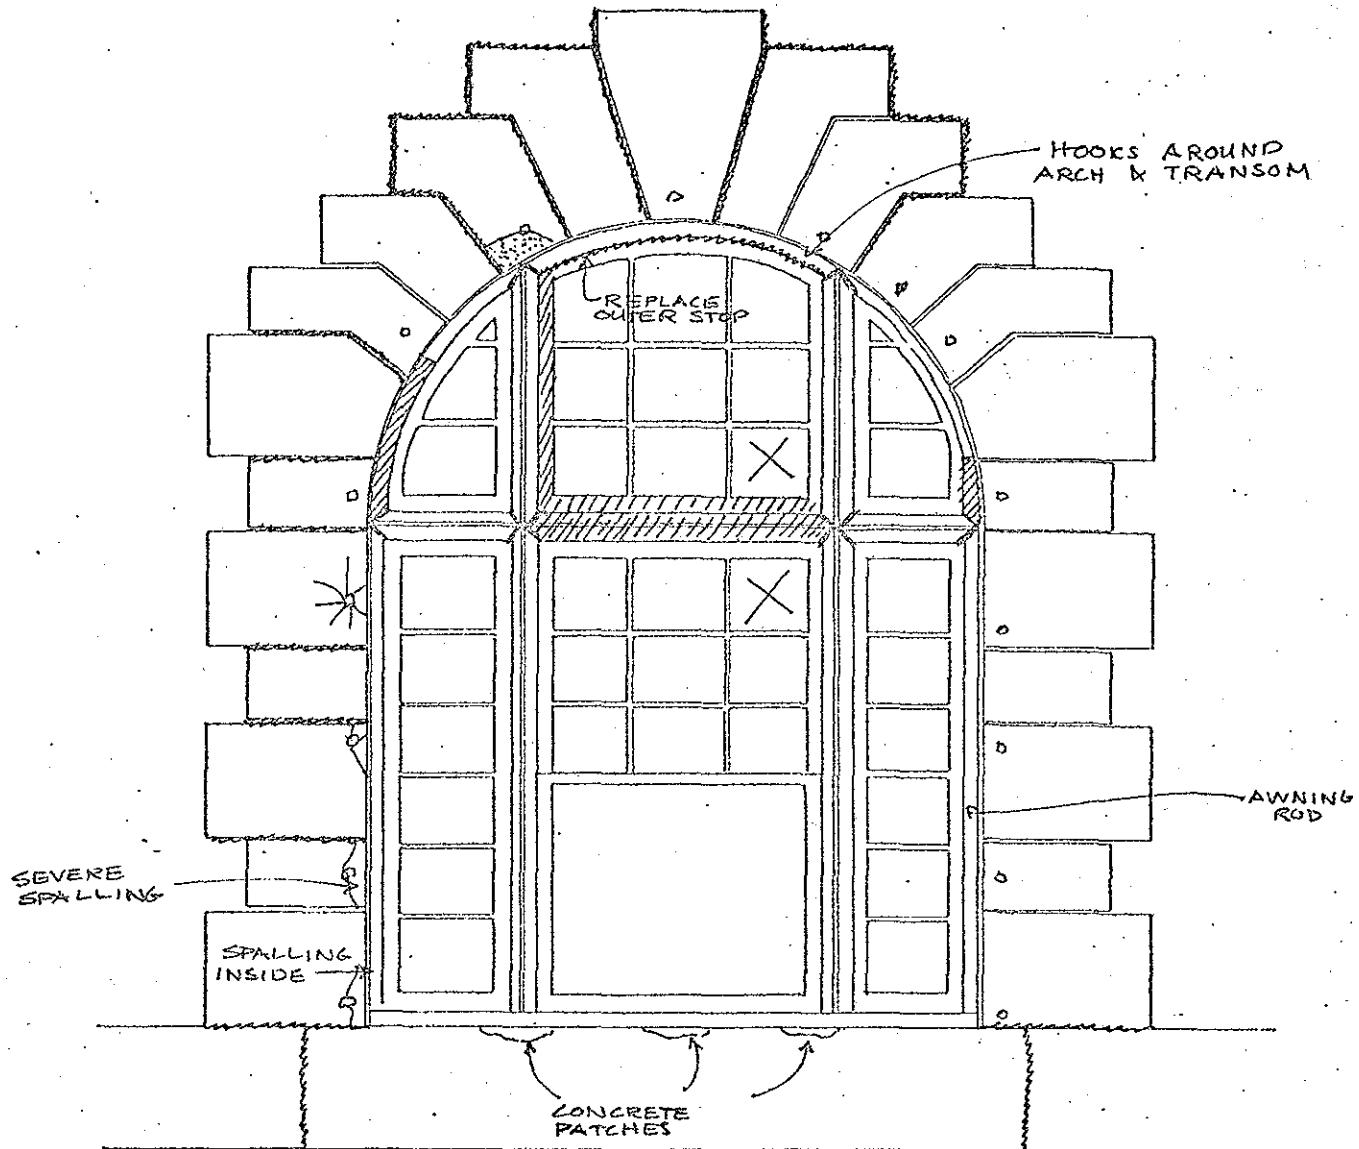
B1 FIRST FLOOR	NUMBER S118	CLASS 2
MECHANICAL AND ELECTRICAL REHABILITATION MAIN BUILDING ELLIS ISLAND Statue of Liberty National Monument, New York	BUILDING CONSERVATION TECHNOLOGY THE BREWSTER GROUP 19 West 44th Street, New York NY 10036

INTERIOR:

- SASH STOPS MISSING, ROTTED, LOOSE
- SASH & HARDWARE NOT OPERABLE

SCREEN ON LOWER SASH - POOR CONDITION

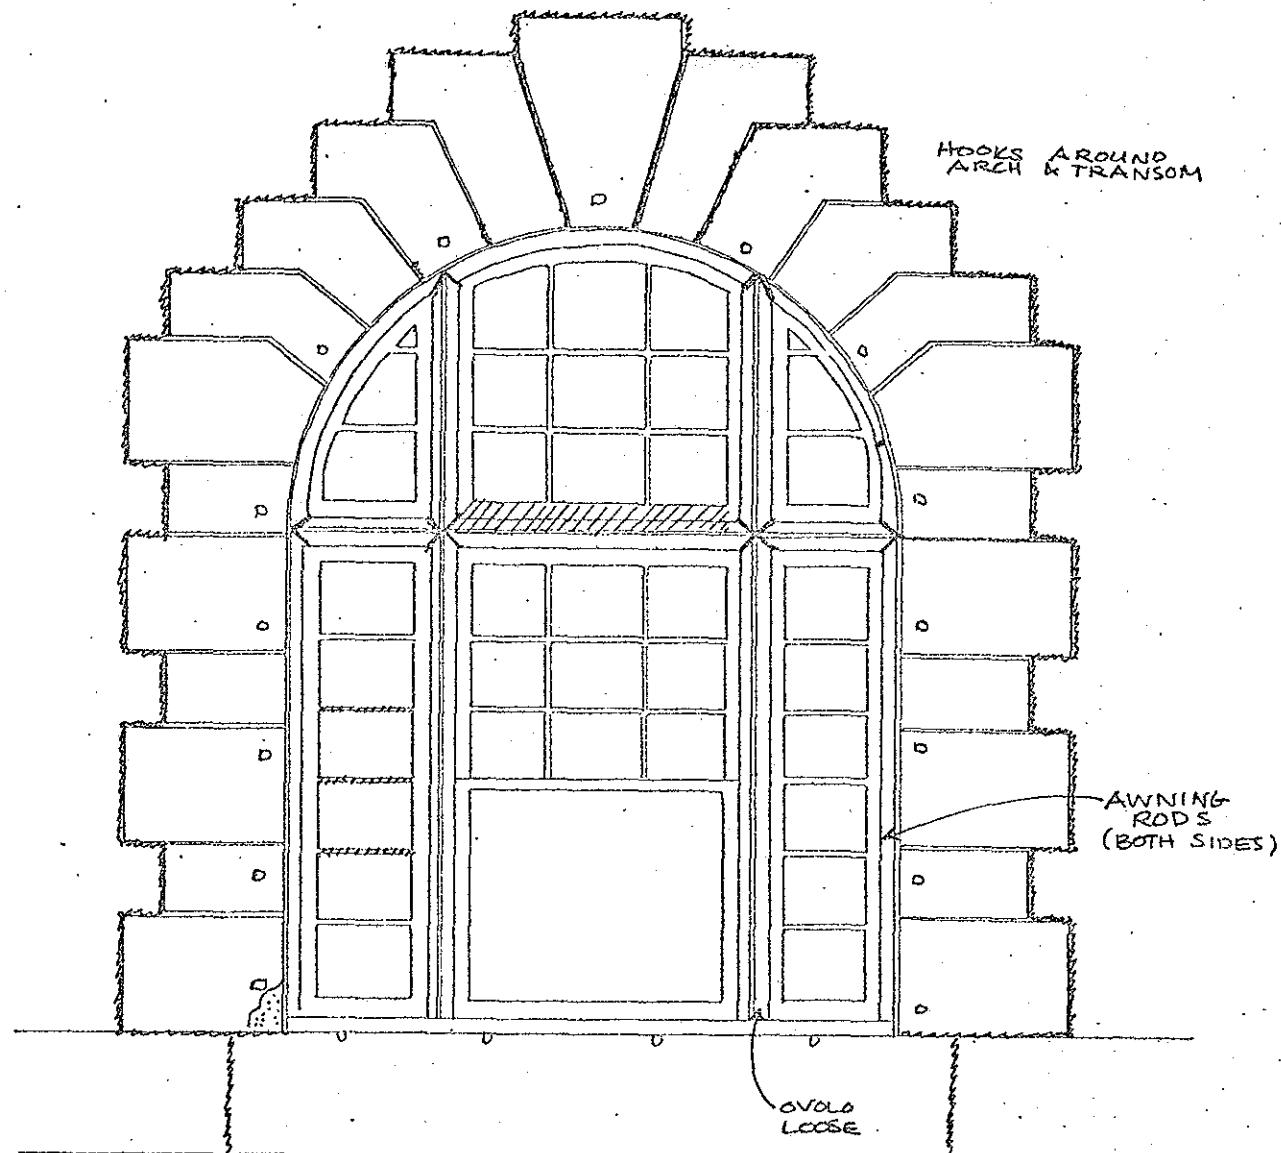
INTERIOR:

- SASH STOPS MISSING, ROTTEN, LOOSE
- STOOLS DAMAGED

SCREEN OVER LOWER SASH - POOR CONDITION

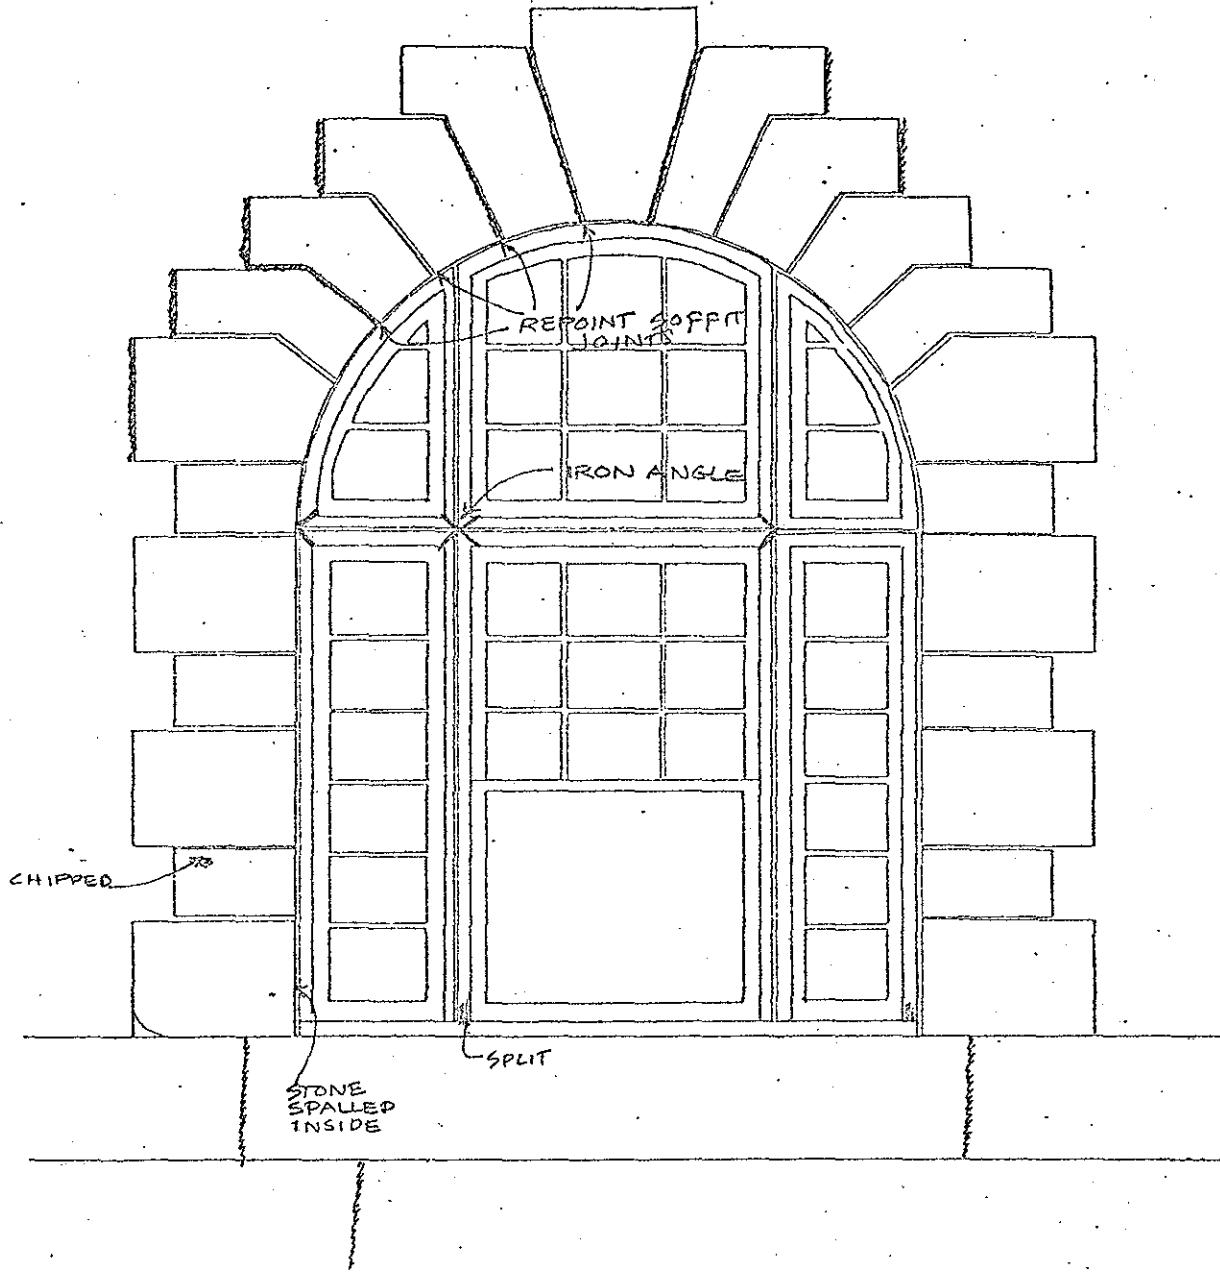
B1 FIRST FLOOR	NUMBER W.103	CLASS I
MECHANICAL AND ELECTRICAL REHABILITATION MAIN BUILDING ELLIS ISLAND Statue of Liberty National Monument, New York	BUILDING CONSERVATION TECHNOLOGY THE DERNERAYZ GROUP	19 West 45th Street, New York NY 10036

WINDOW STUCK SHUT - UNABLE TO EXAMINE EXTERIOR CLOSELY

GRILL IN PLACE - RUSTED AT BOTTOM

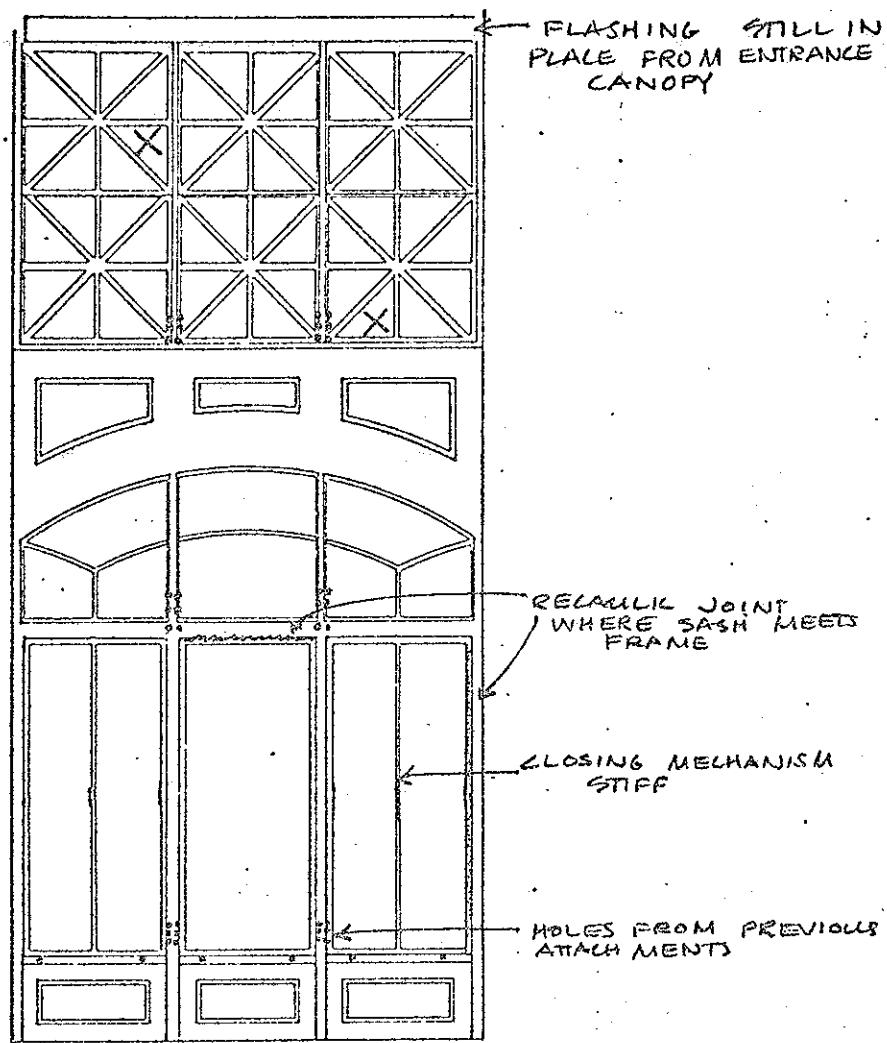
C1 MAIN ARCH, BOTTOM UNIT (4)	NUMBER S 108	CLASS I
MECHANICAL AND ELECTRICAL REHABILITATION MAIN BUILDING ELLIS ISLAND Statue of Liberty National Monument, New York	BUILDING OPERATIONS TECHNOLOGY THE BIRNBOIM GROUP 19 West 44th Street, New York NY 10036

CASEMENT WINDOWS WILL NOT CLOSE FULLY - CLEAN OUT TRACKS, CHECK HINGES

SCREENS [REDACTED], SIDE WINDOWS - GOOD CONDITION - SOME LOOSE & RUSTY HARDWARE; MESH TORN

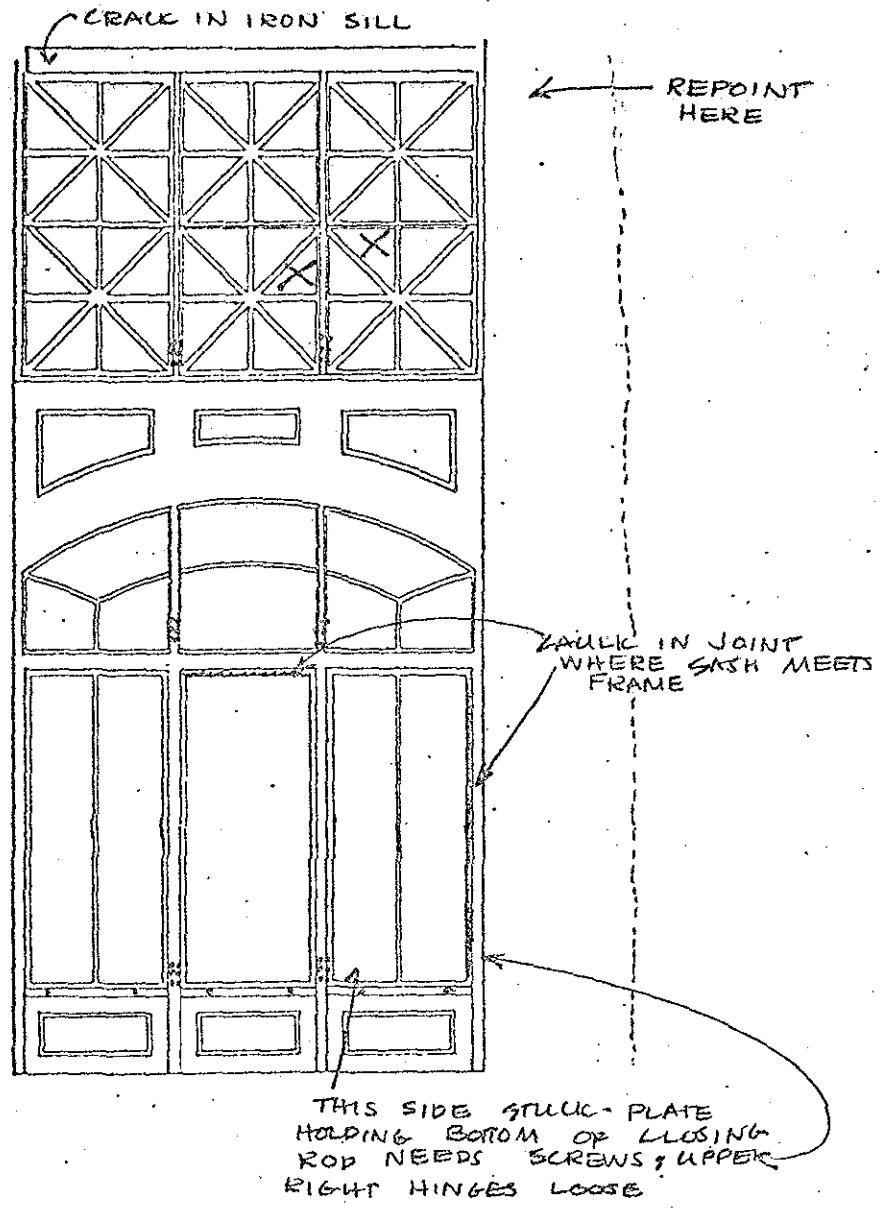
C1 MAIN ARCH, BOTTOM UNIT (4)	NUMBER S109	CLASS
MECHANICAL AND ELECTRICAL REHABILITATION MAIN BUILDING ELLIS ISLAND Statue of Liberty National Monument, New York	BUDGET ORGANIZATION TECHNOLOGY THE FIREBIRD GROUP 19 West 44th Street, New York NY 10036

SCREENS ON INTERIOR OF CASEMENT WINDOWS - PAIR CONDITION.
SOME HARDWARE LOOSE OR MISSING, MESH TORN.

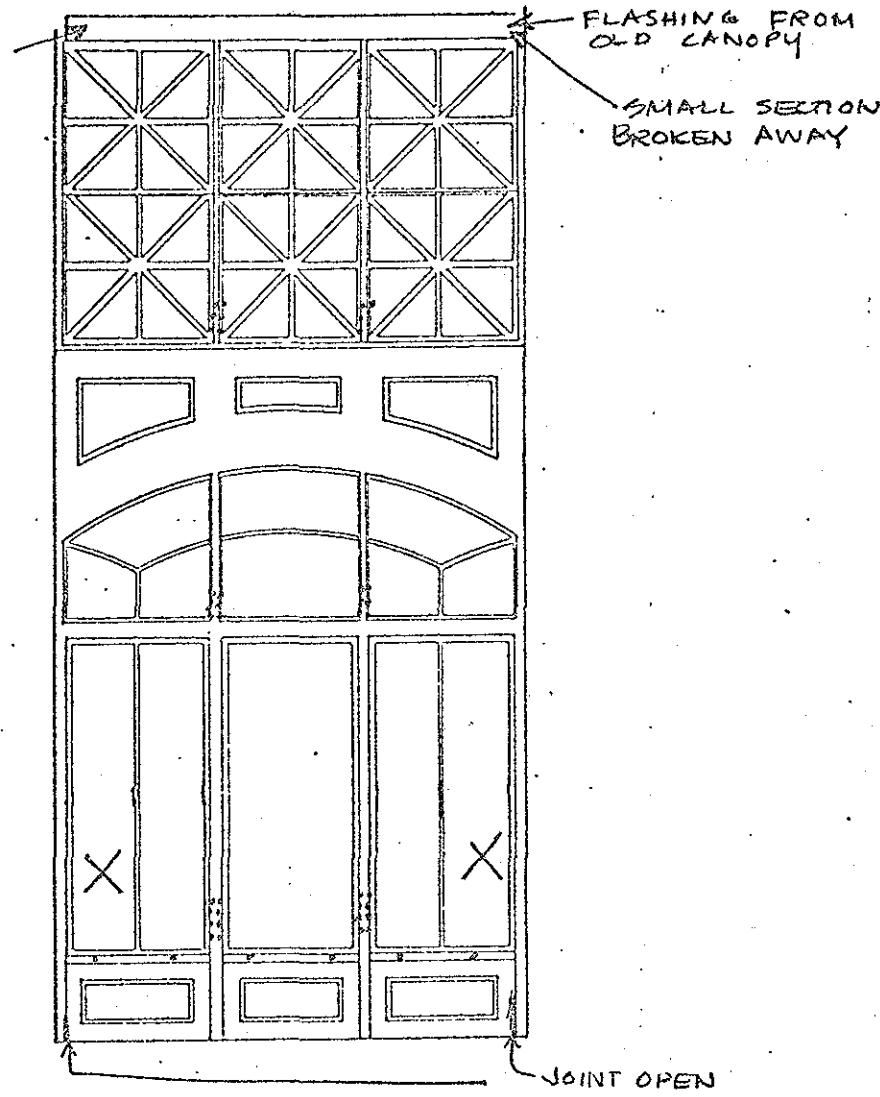
C1 MAIN ARCH, BOTTOM UNIT (4)	NUMBER S11	CLASS I
MECHANICAL AND ELECTRICAL REHABILITATION MAIN BUILDING ELLIS ISLAND Statue of Liberty National Monument, New York	BUDING OPERATION TECHNOLOGY THE DRESSERWITZ GROUP 19 West 44th Street, New York NY 10036

CASEMENTS OPERABLE - SOME INTERIOR HARDWARE LOOSE
OR STUCK

WOODEN SCREENS ON INTERIOR OF CASEMENT SASH - SCREEN
POOR

INTERIOR METAL IN GOOD CONDITION - SOME LIGHT SCALE -
EXTERIOR SAME

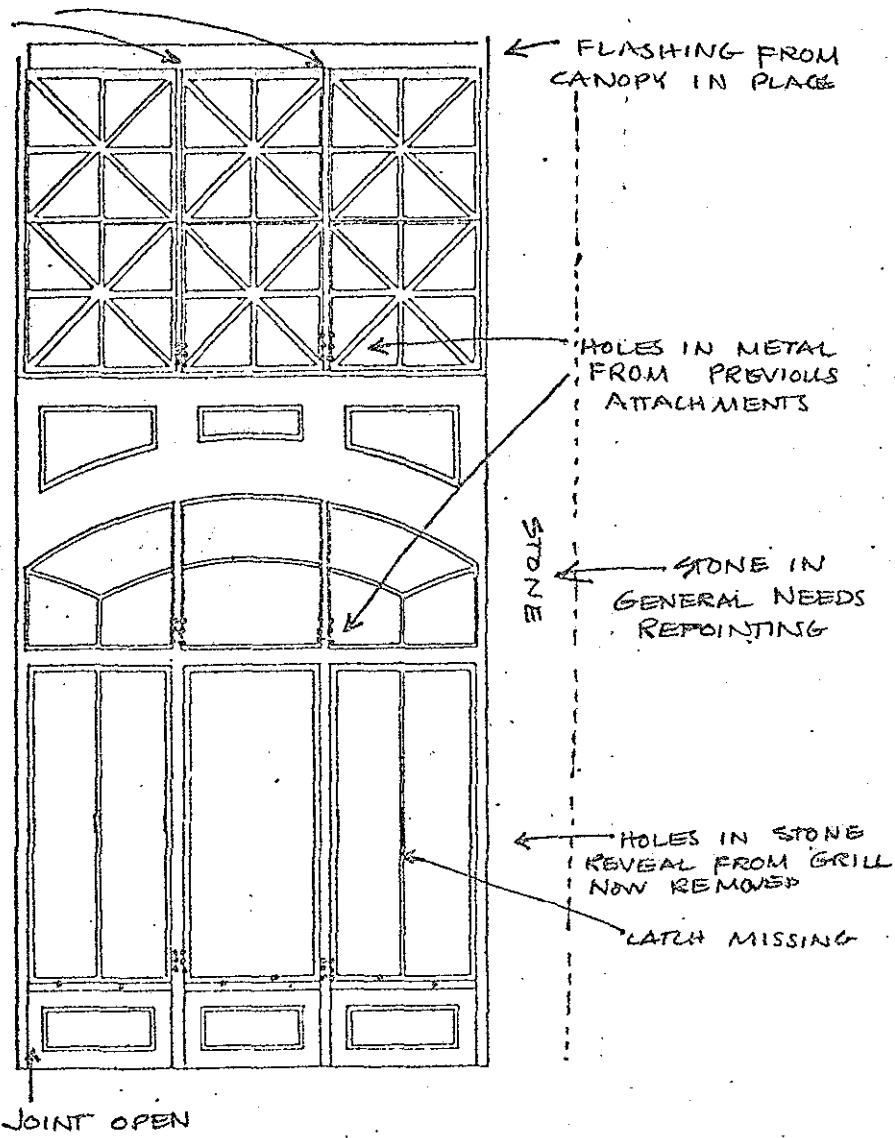
C1 MAIN ARCH, BOTTOM UNIT (4)	NUMBER S112	CLASS I
MECHANICAL AND ELECTRICAL REHABILITATION MAIN BUILDING ELLIS ISLAND Statue of Liberty National Monument, New York	BUILDING OPERATION TECHNOLOGY THE DRAZENOVIC GROUP 19 West 44th Street, New York NY 10036

JOINT OPEN

INTERIOR TRANSOM HARDWARE MISSING 2 ARMS - OTHERWISE
ALL IN PLACE BUT PRESENTLY INOPERABLE

WOOD SCREENS ON INTERIOR OF CASEMENT SASH - GOOD CONDITION

METAL IN GOOD CONDITION - SOME SCALE

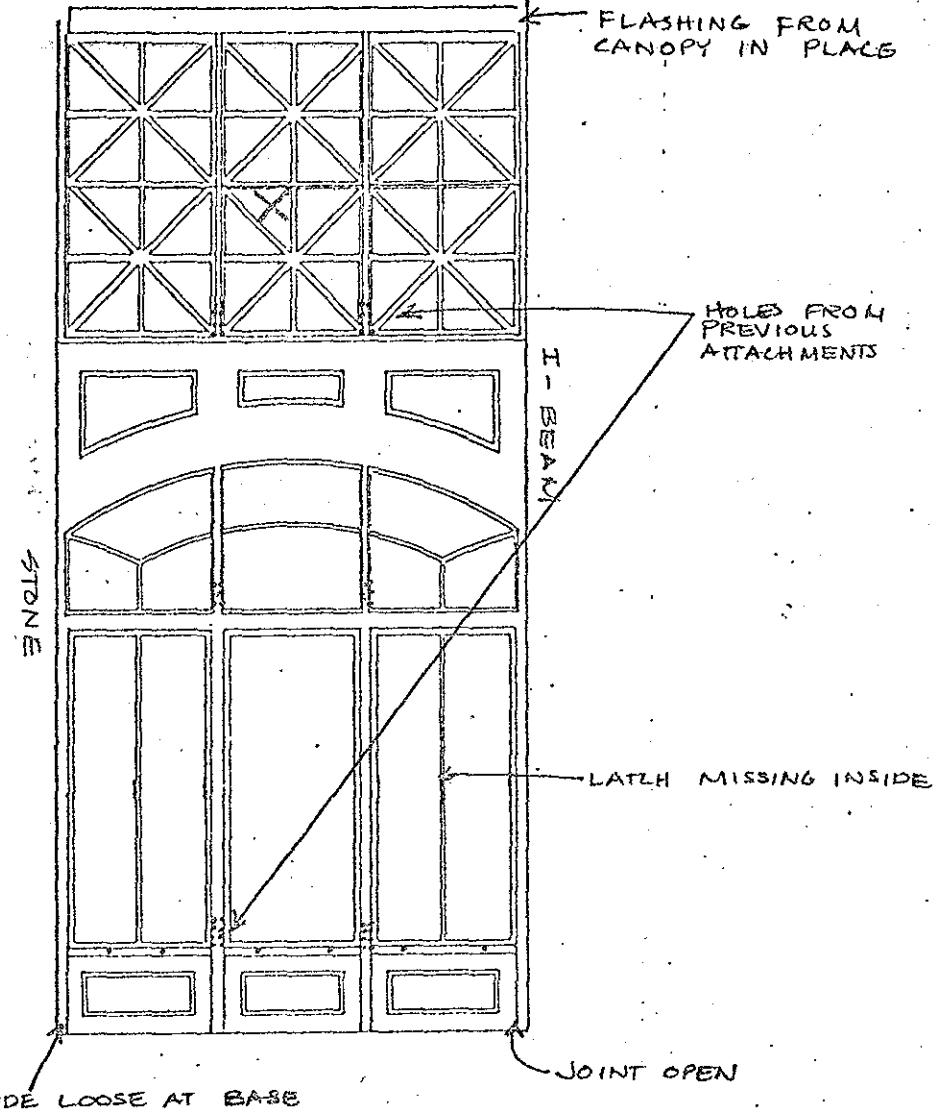
INTERIOR TRANSOM HARDWARE ALL IN PLACE - STIFF
CASEMENT HARDWARE STIFF

WOOD SCREENS ON INTERIOR OF CASEMENTS - GOOD CONDITION

METAL IN GOOD CONDITION - SOME SCALE

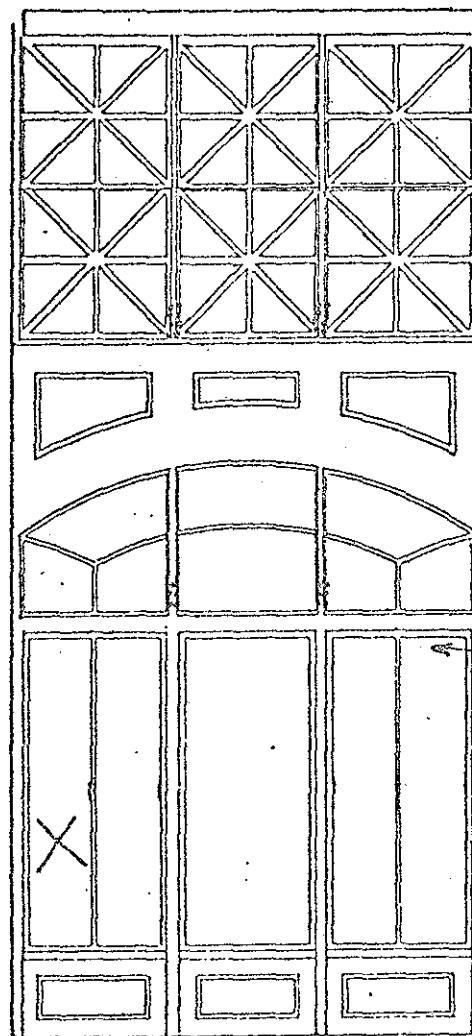
CASEMENTS - STIFF, CLOSING HARDWARE LOOSE

SCREENS ON INTERIOR OF CASEMENT SASA - GOOD CONDITION

INTERIOR TRANSOM HARDWARE ALL IN PLACE - PAINTED,
CORRODED, UNOPERABLE

METAL IN GOOD CONDITION, SOME LIGHT SCALE

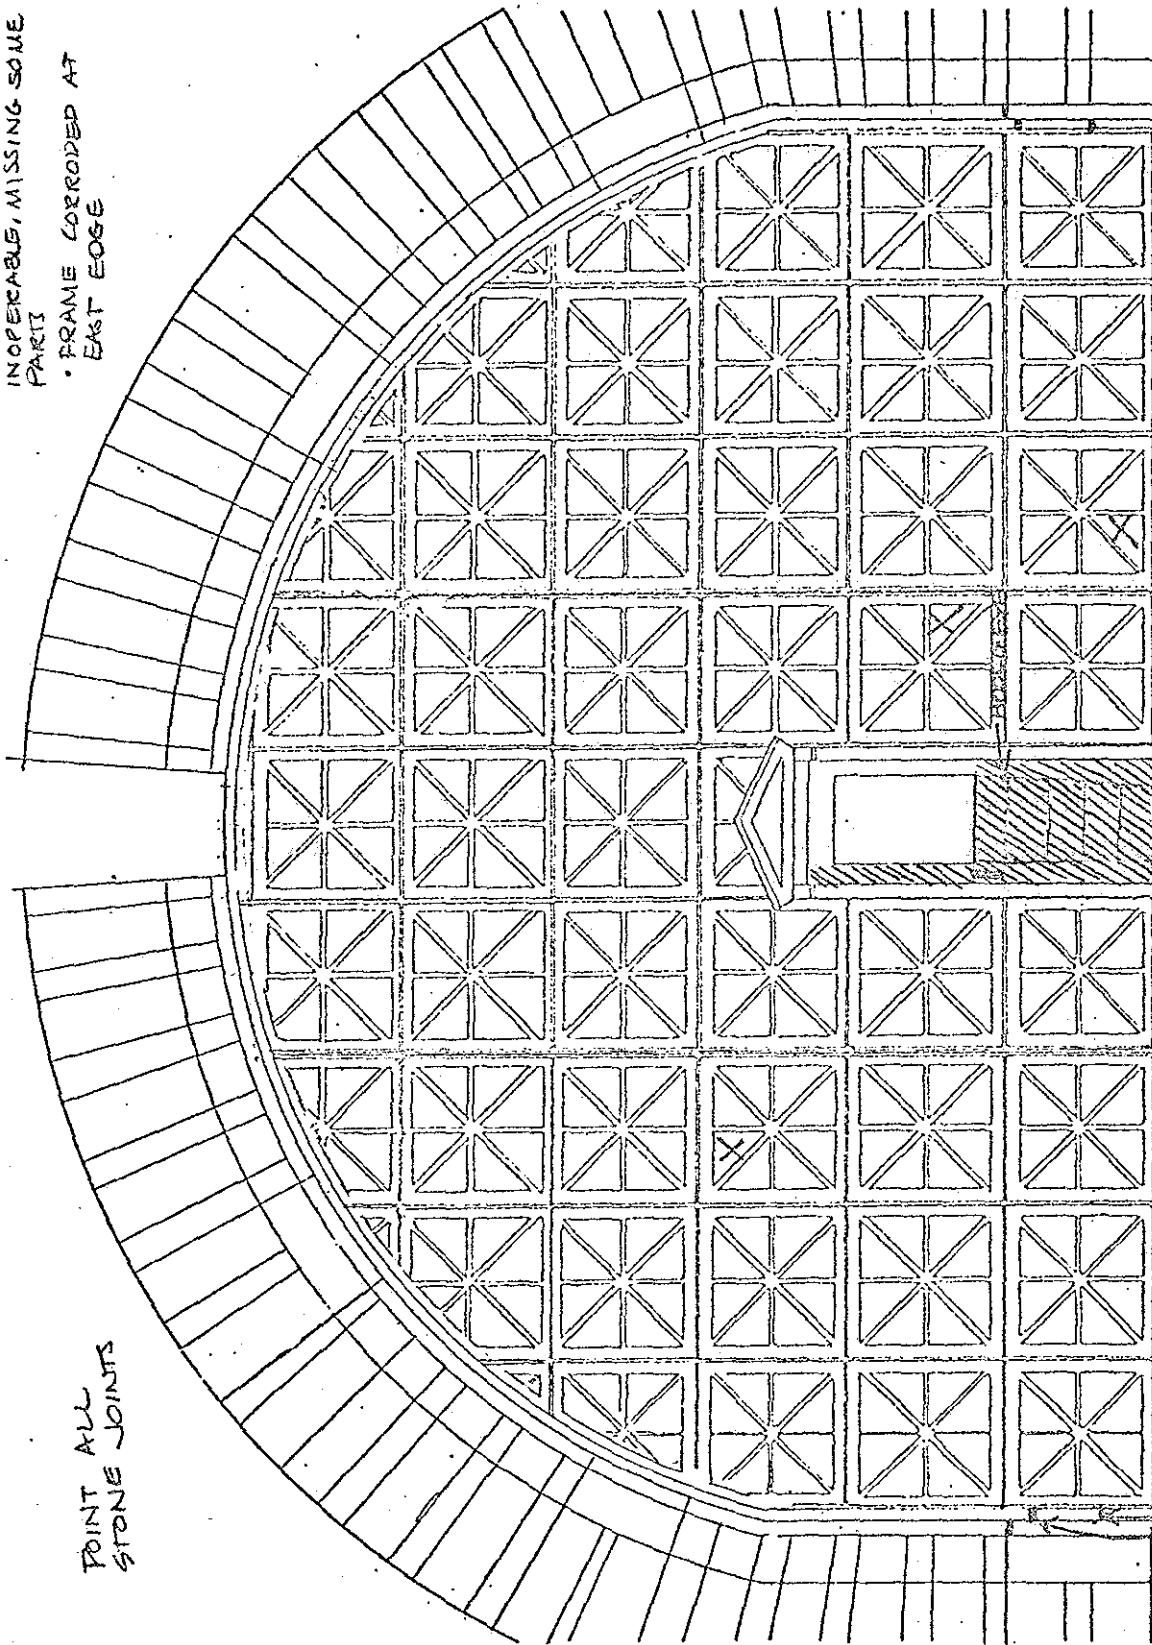
C2 MAIN ARCH, 2nd FLOOR UNIT (6)

INTERIOR: METAL CORRODED BUT
O.K.
• 10% OF OPERATING
MECHANISM IN PLACE
STIFF & CORRODED

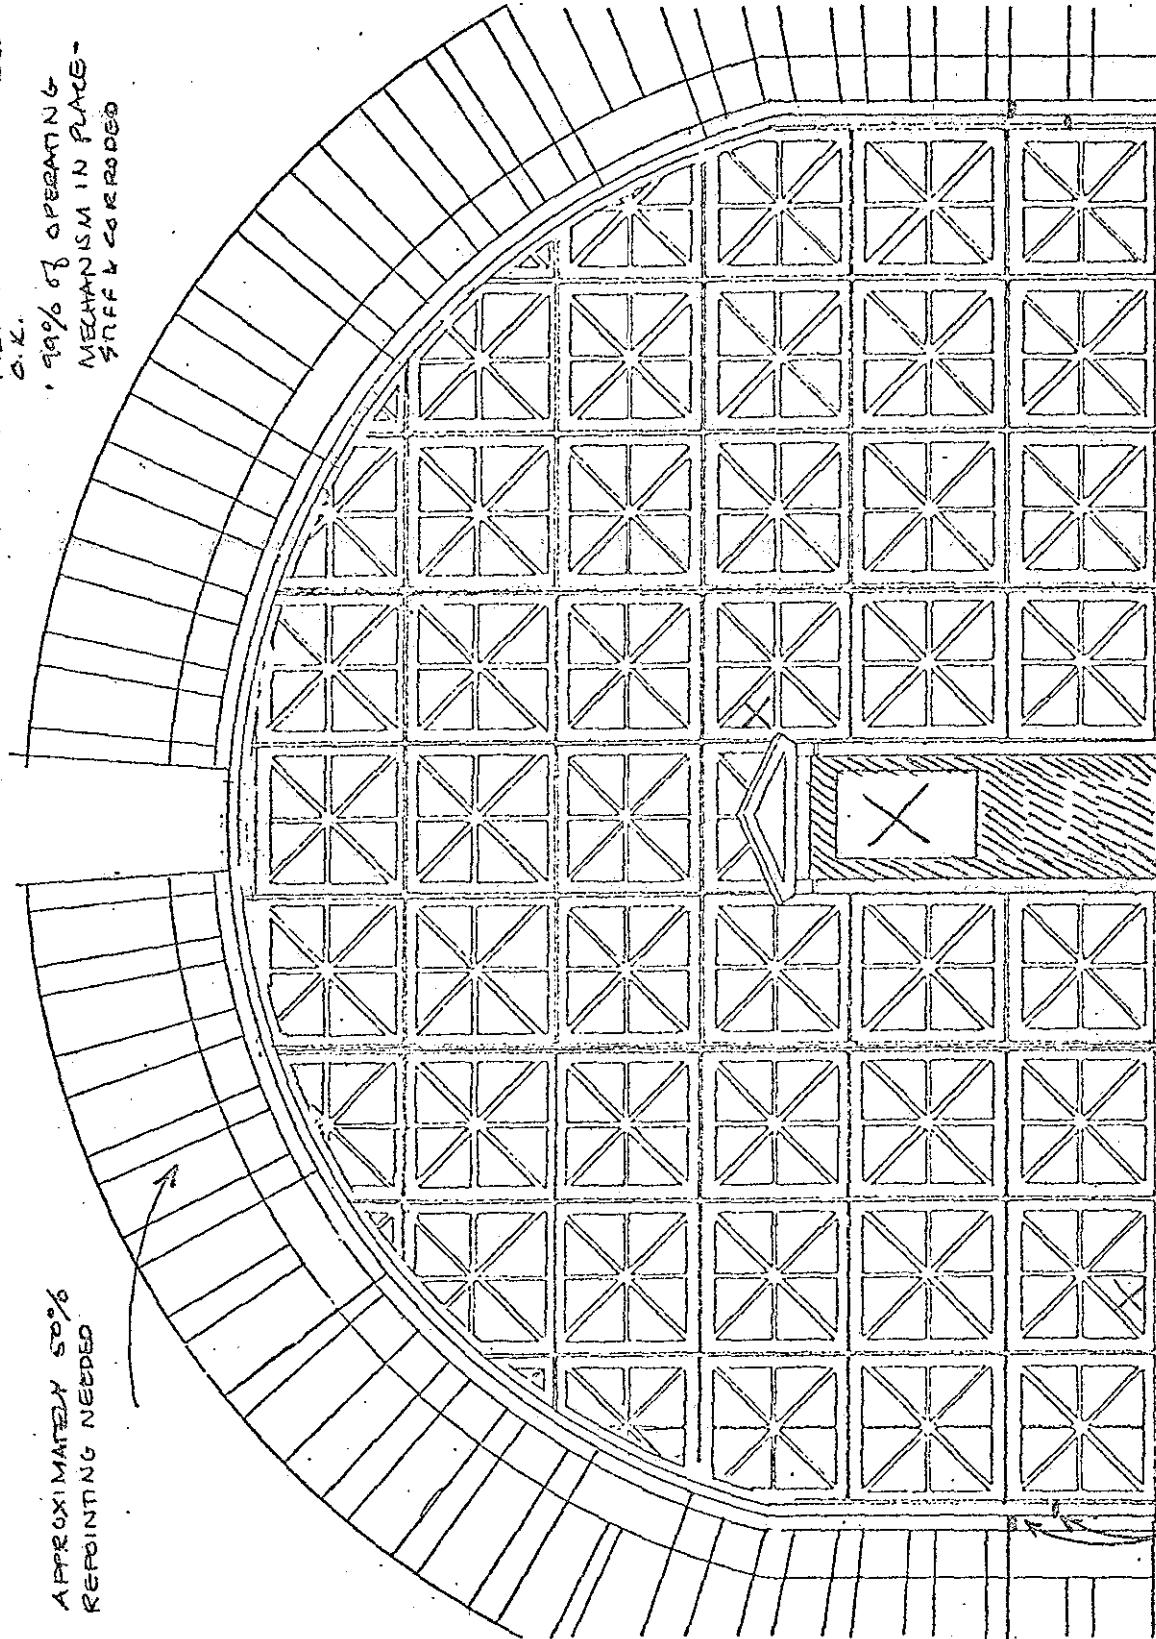
C2 MAIN ARCH, 2nd FLOOR UNIT

INTERIOR: PART OF OPERATING MECHANISM MISSING

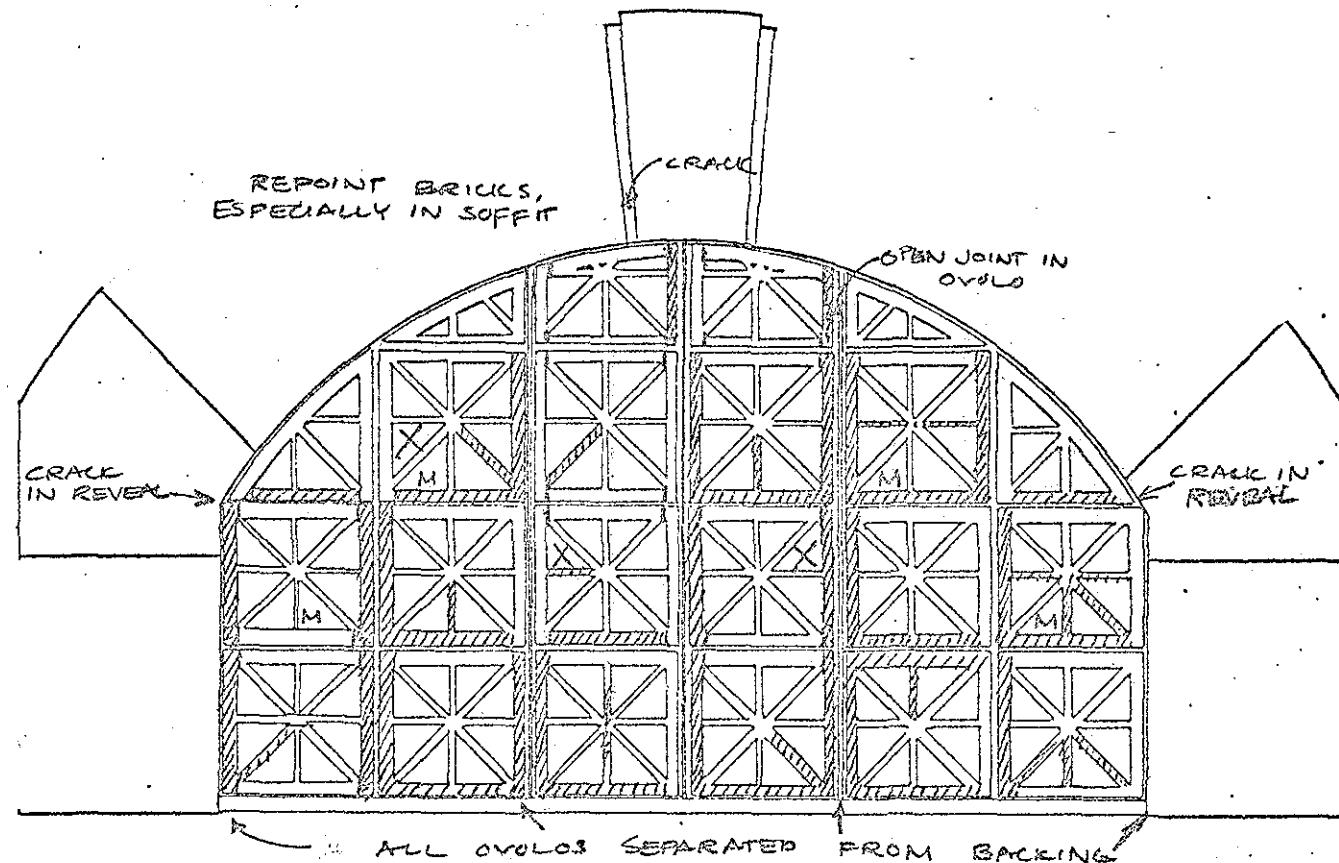
C3 ROOF LEVEL, SOUTH & NORTHERN ELEVATIONS (C)	NUMBER N 402	CLASS 3
MECHANICAL AND ELECTRICAL REHABILITATION MAIN BUILDING ELLIS ISLAND	BUDDE CONSTRUCTION INCORPORATED THE FRIEDMAN GROUP	19 West 44th Street, New York NY 10036

"M" INDICATES SASH WITH EXTERIOR MOULDINGS FOR GLAZING - ALL
ARE LOOSE

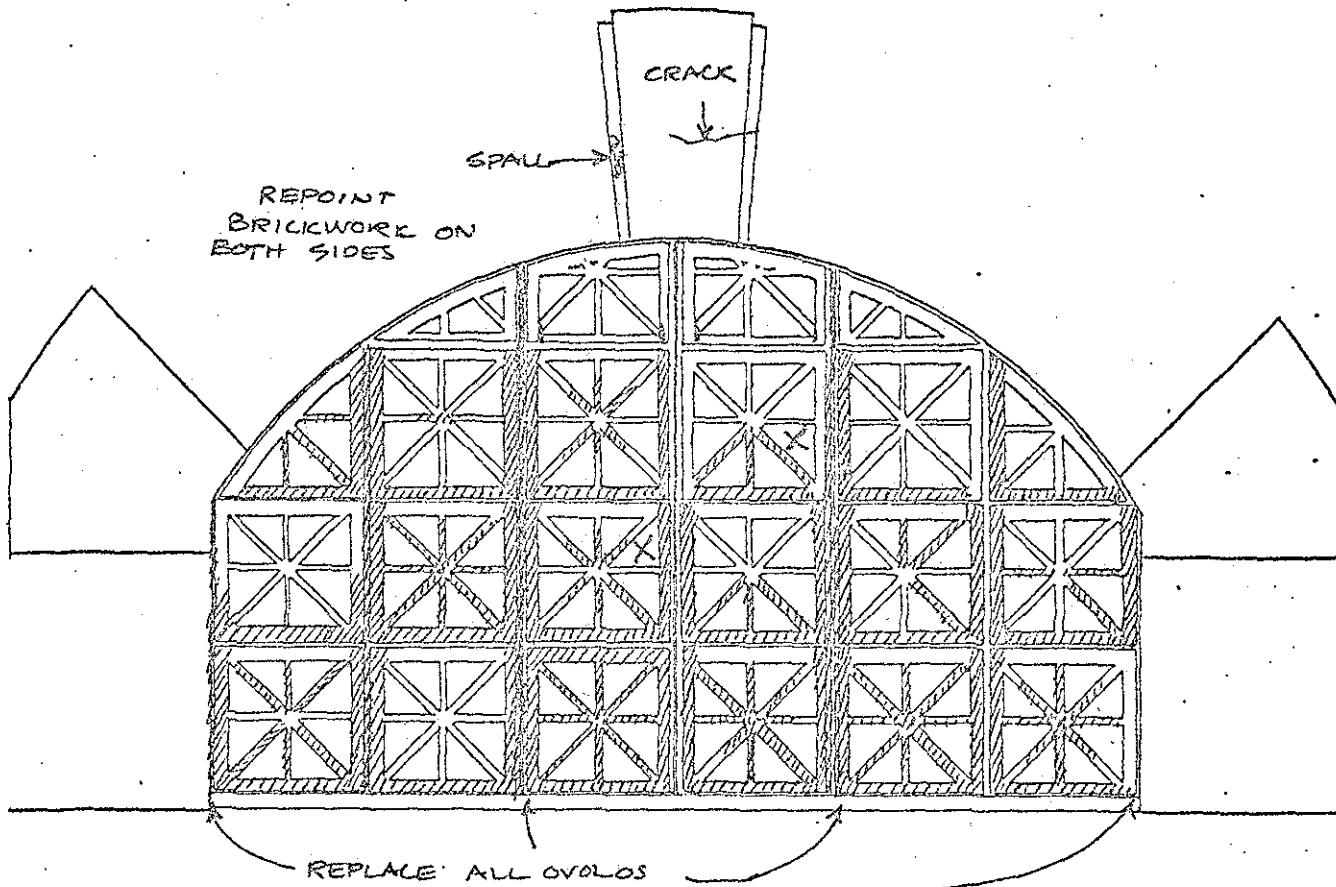
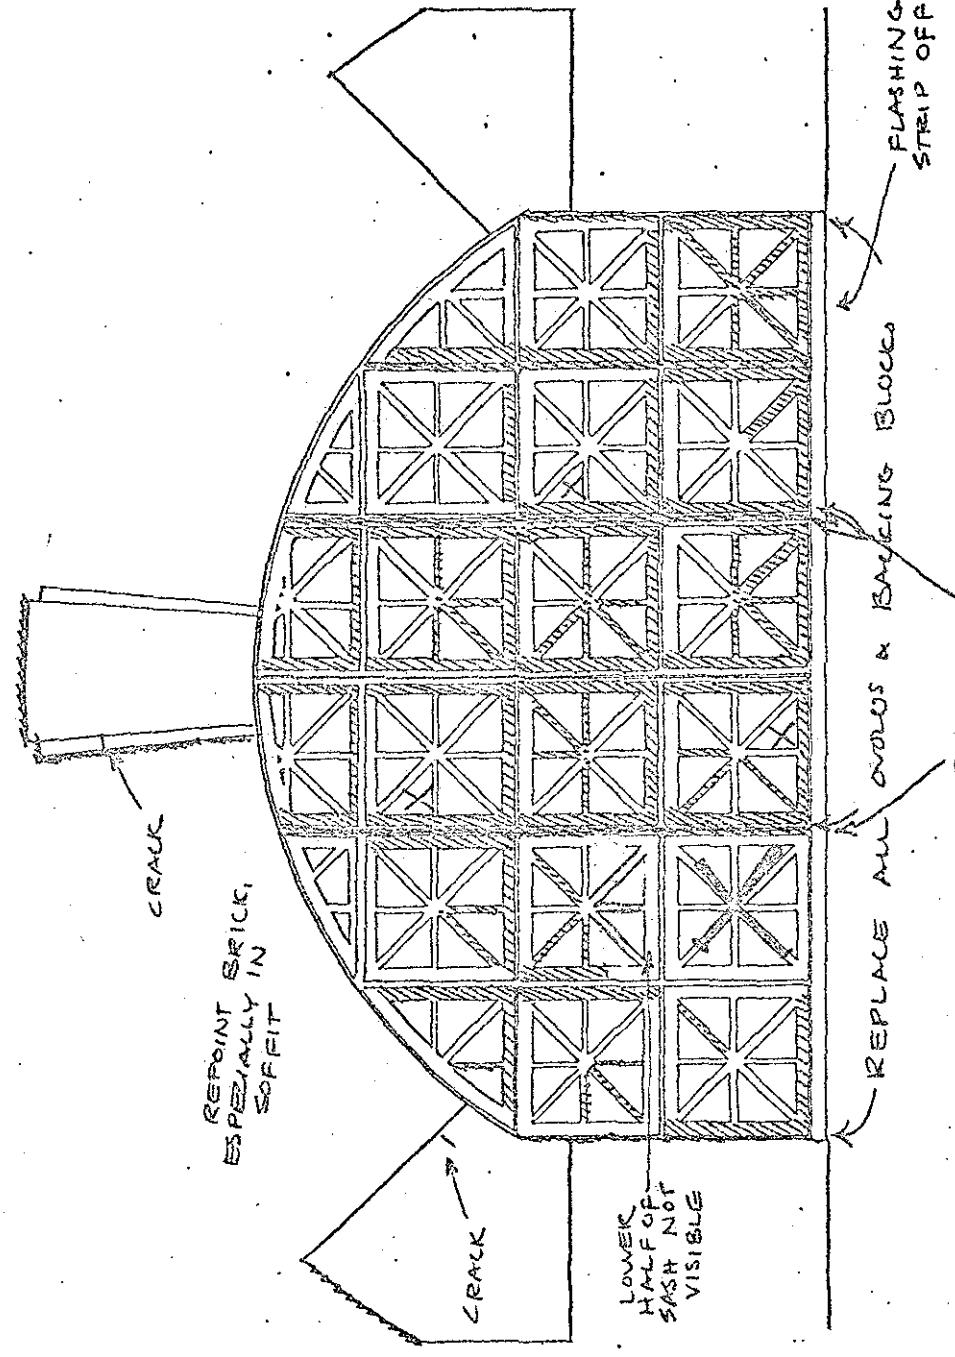
C3 ROOF LEVEL, SOUTH & NORTH ELEVATIONS (C)

ALL MUNIN JOINTS OPEN
FLASHING DENTED, NAILS ATTRACTING IT TO WINDOW FRAMES HAVE PULLED
