historic structures report

mechanical/electrical rehabilitation

main building

STATUE OF LIBERTY ELLIS ISLAND

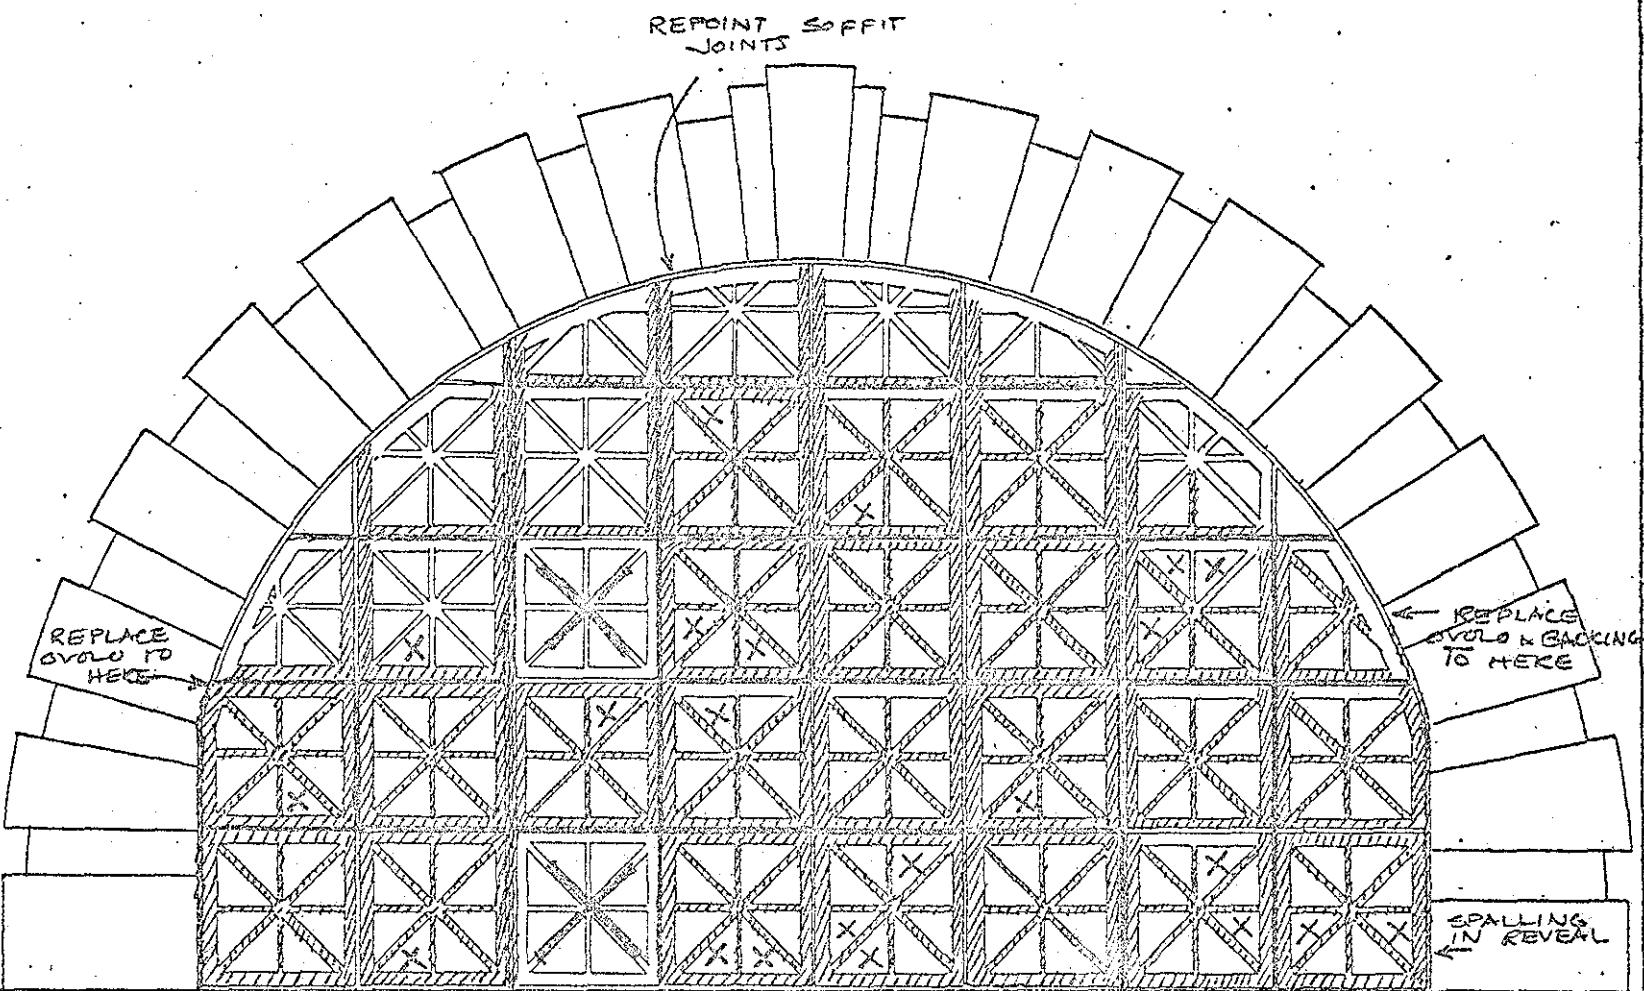
Joints in wood generally open

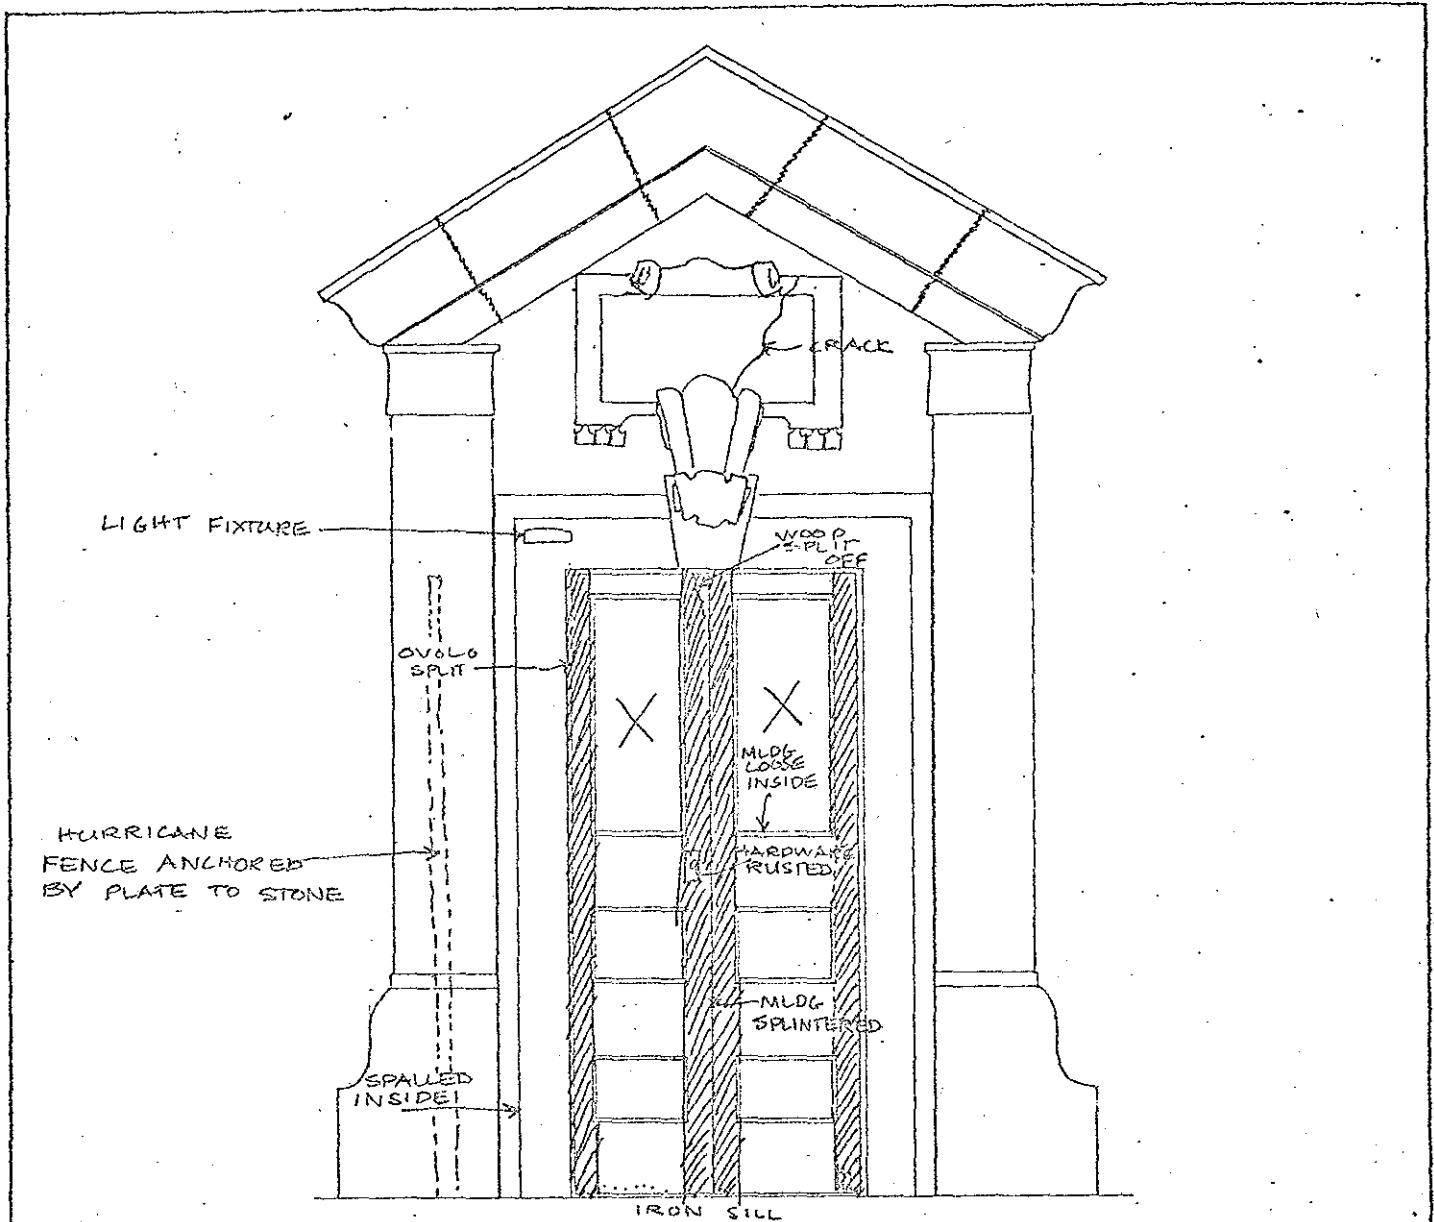
► TOWER ENTRANCE	NUMBER NET-101	CLASS 2
MECHANICAL AND ELECTRICAL REHABILITATION MAIN BUILDING ELLIS ISLAND Statue of Liberty National Monument, New York	BUILDING CONSERVATION THOLOGY THE DIBBLETT GROUP

INTERIOR:

- "A" MISSING IN UPPER CORNER, EAST SIDE, WHERE SURROUND CUT AWAY FOR ELECTRICAL CONDUIT
- RUSTY IRON CLOSER, EAST SIDE
- BOTTOM 1" OF ALL FRAME ROTTED
- SURROUND MLDG EAST SIDE LOOSE.

WILL NOT CLOSE BECAUSE PIN THRU LEFT DOOR FROZEN IN PLACE & IRON STRIP INSIDE RIGHT DOOR PREVENTS FROM CLOSING.

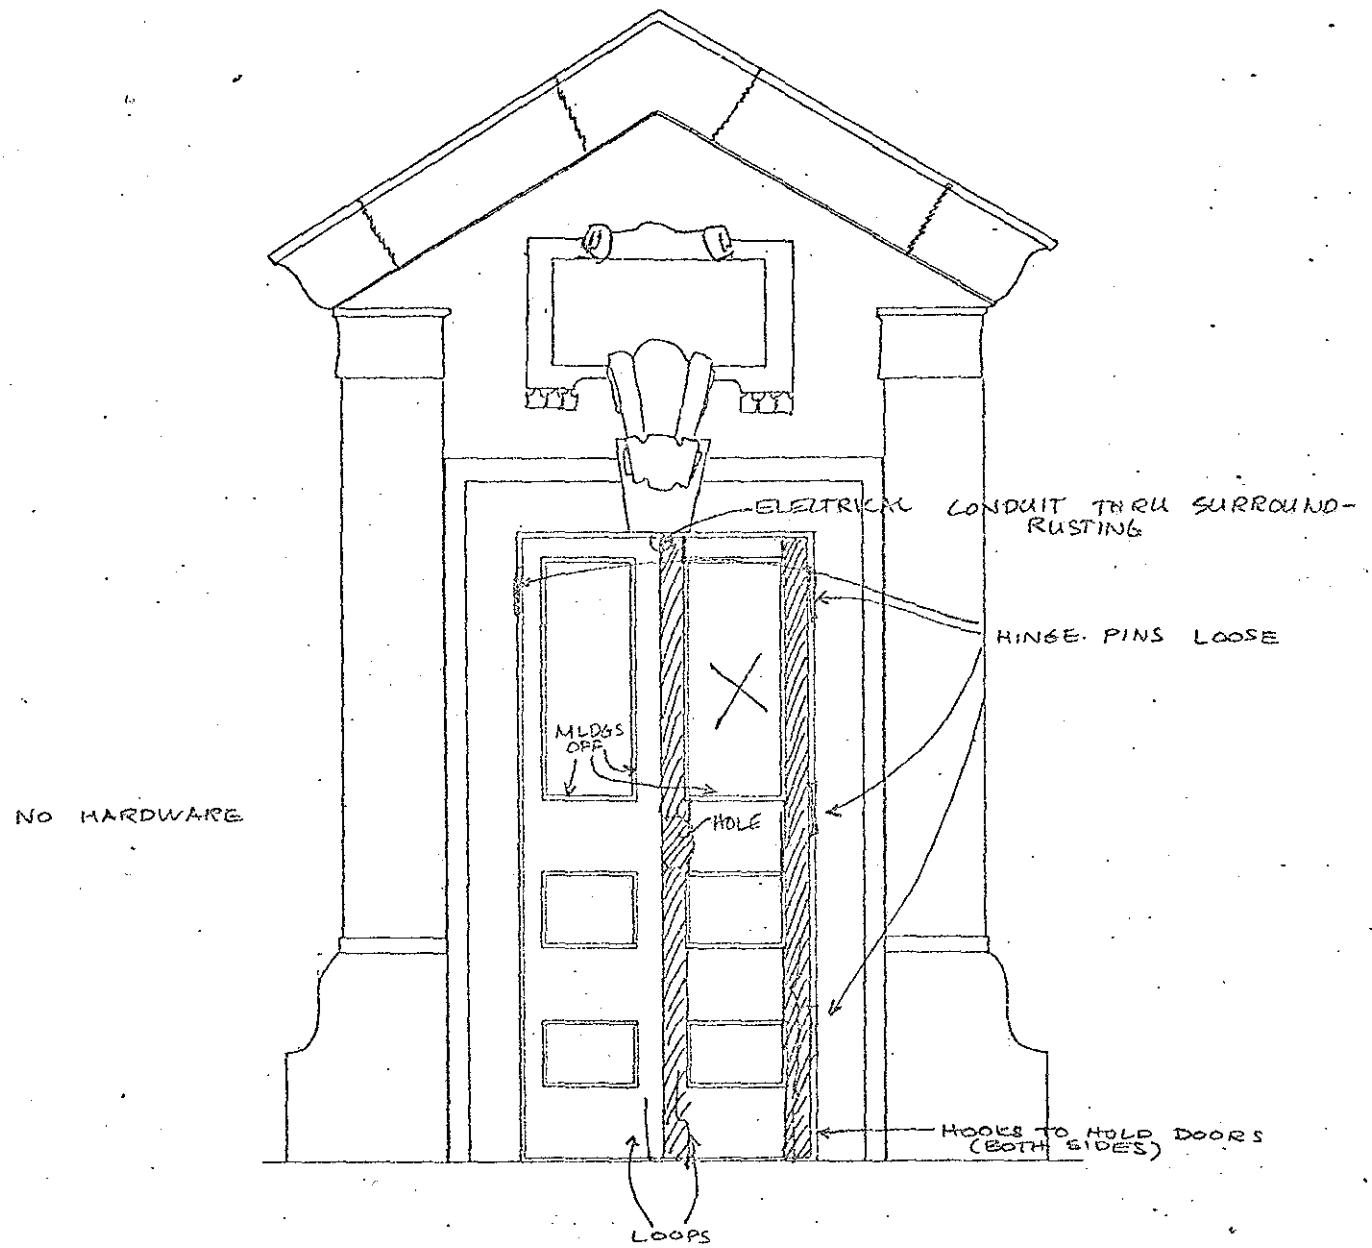
B TOWER ENTRANCE	NUMBER SWT-101	CLASS 2
MECHANICAL AND ELECTRICAL REHABILITATION MAIN BUILDING ELLIS ISLAND Statue of Liberty National Monument, New York	BRIDGE OBSERVATION TOWER THE FIRENZE GROUP

INTERIOR - NOT ACCESSIBLE - DOOR NAILED SHUT

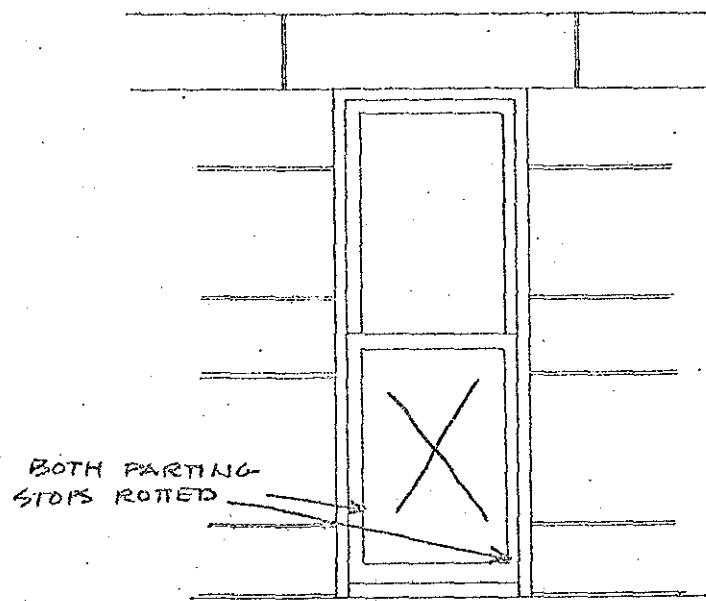
INTERIOR " 1" WORN SPOT ON BOTTOM RAIL
TOP OF FRAME NOT VISIBLE

GRILL BOLTED INTO FRAME
SCREEN- POOR CONDITION.

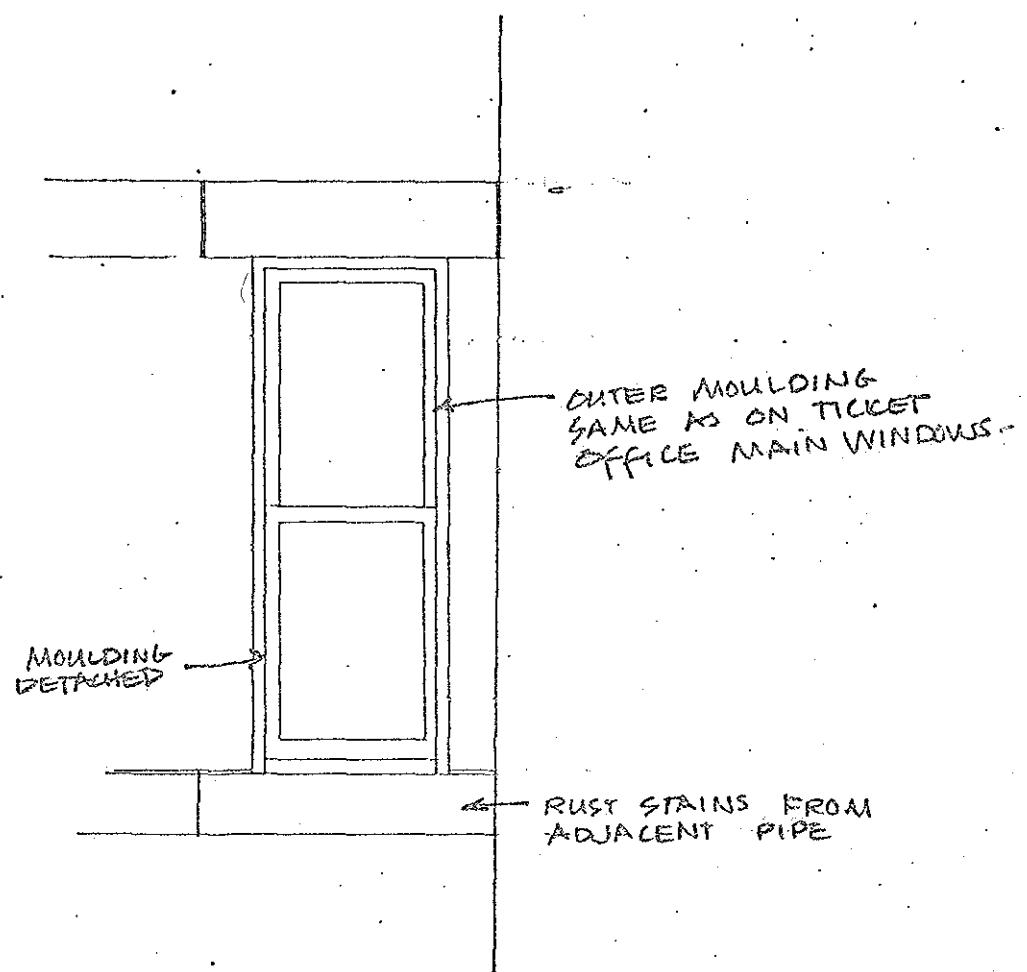
EXTERIOR INACCESSIBLE- WINDOW NAILED SHUT

GRILL- GOOD CONDITION

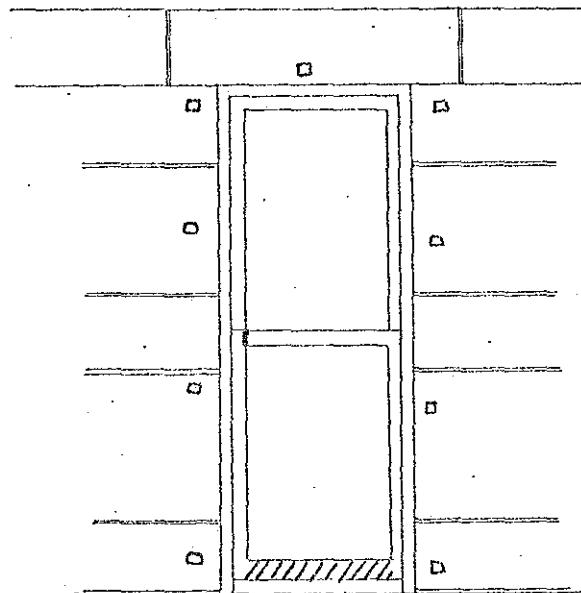
METAL GRATING - RUSTED

INTERIOR: REPLACE SILL STRIP THAT SASH
RESTS ON

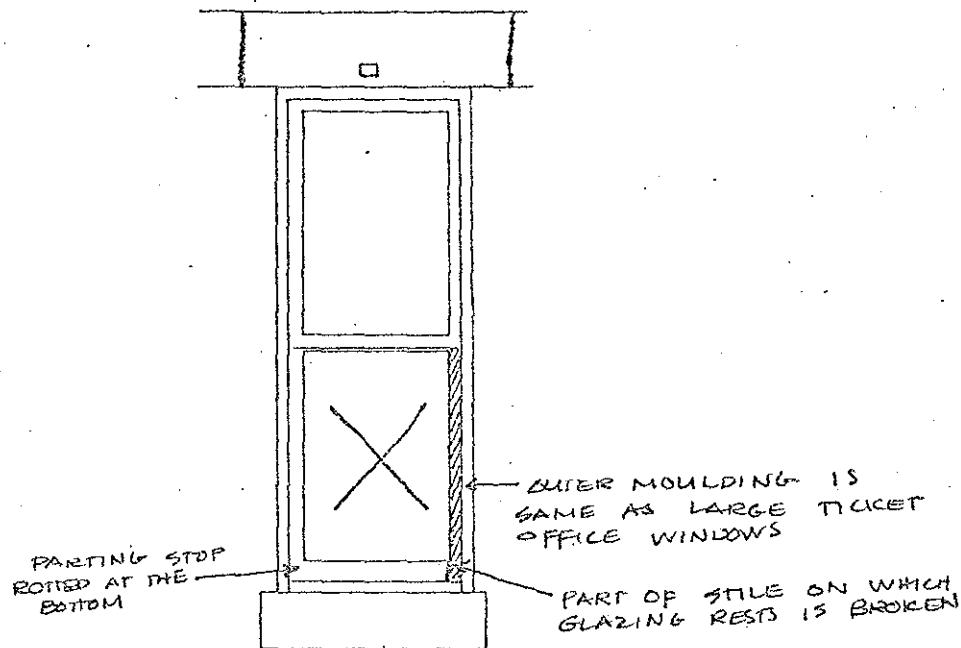
INTERIOR: HOLES IN INNER EDGE OF STOOL

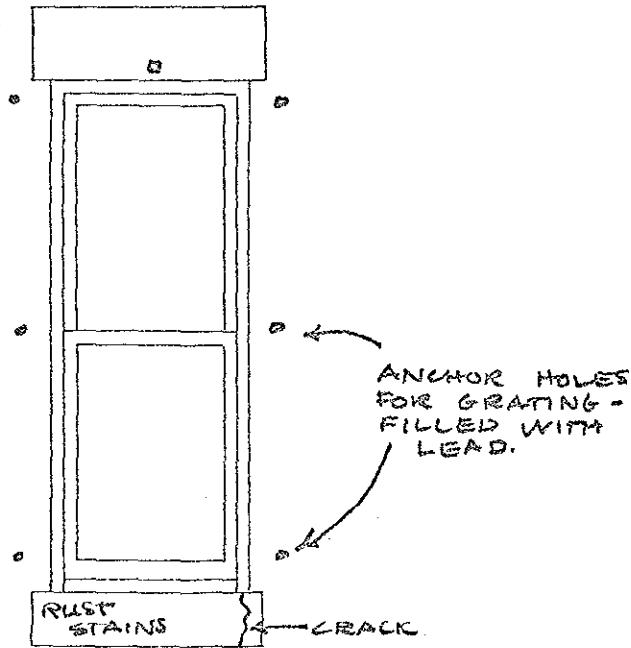
SCREEN ON LOWER SASH

GRATING REMOVED

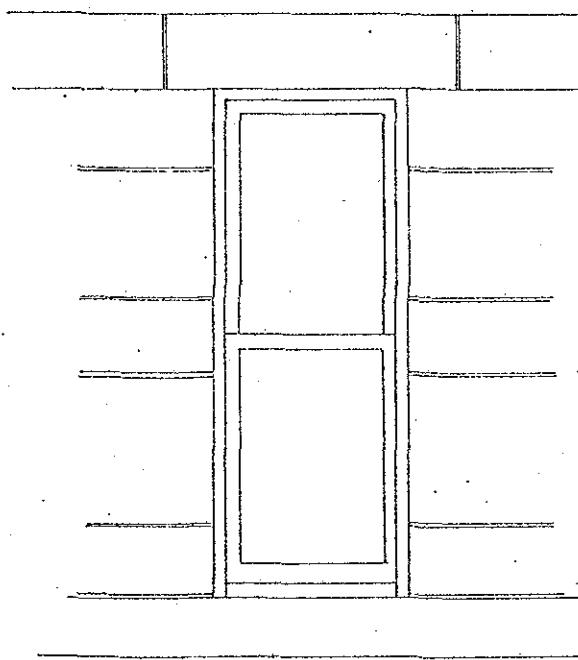
INTERIOR: MLDGS ON HEAD OF WINDOW DAMAGED
BUT O.K.

IRON GRATING RUSTY

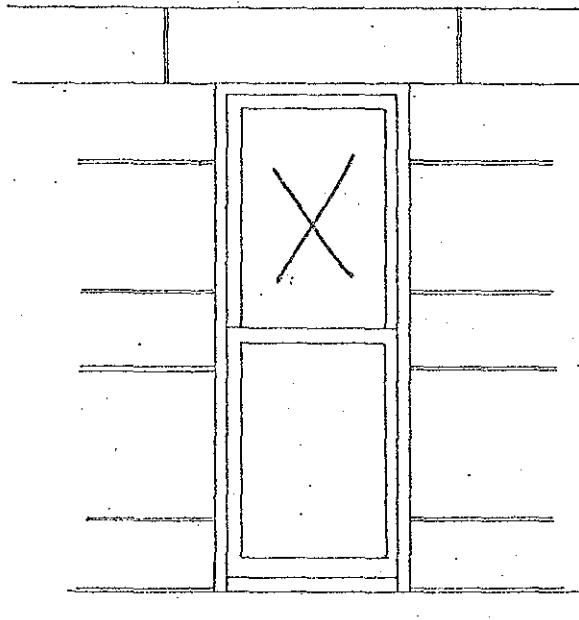
LOWER SASH STUCK OPEN

SCREENS ON LOWER HALF - FAIR CONDITION

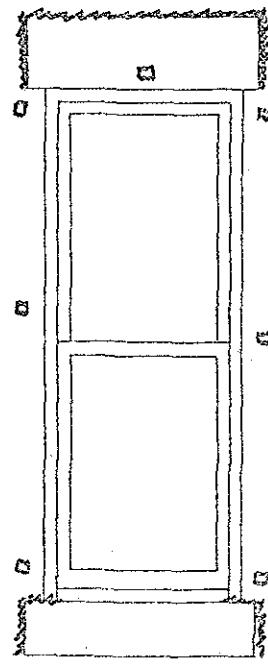
GRATING REMOVED
SCREEN OVER LOWER SASH - POOR CONDITION

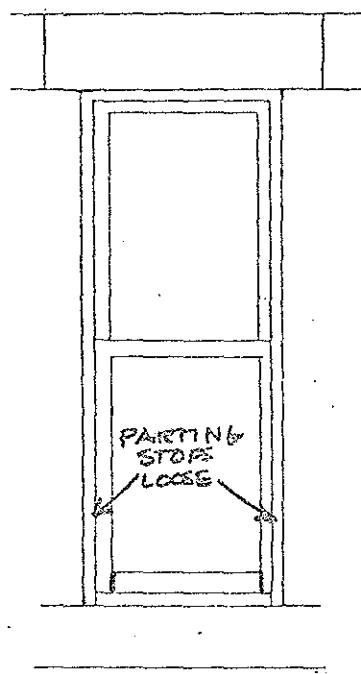
INTERIOR, IR STEEL LINTEL EXPOSED & RUSTY

NO GRILL.

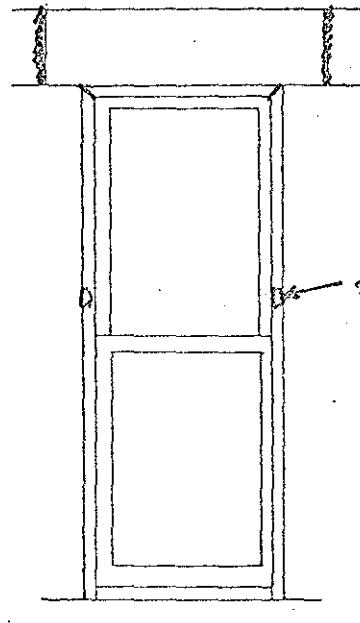
INTERIOR NOT ACCESSIBLE

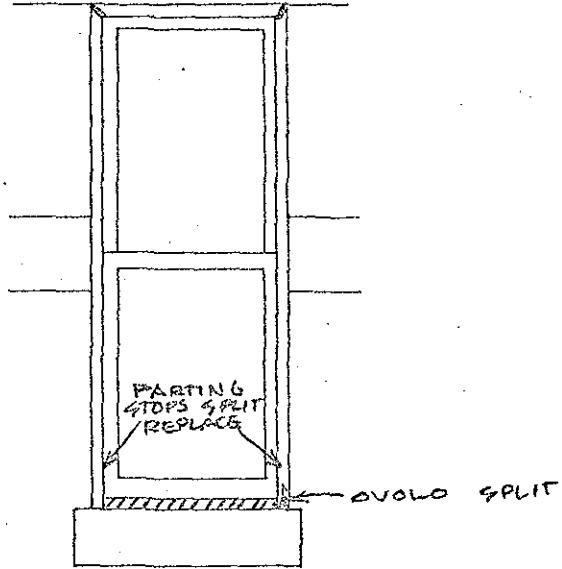
SASH WILL NOT OPEN

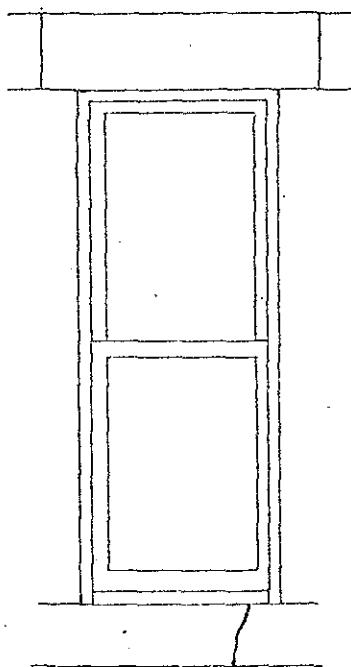
WILL NOT OPEN

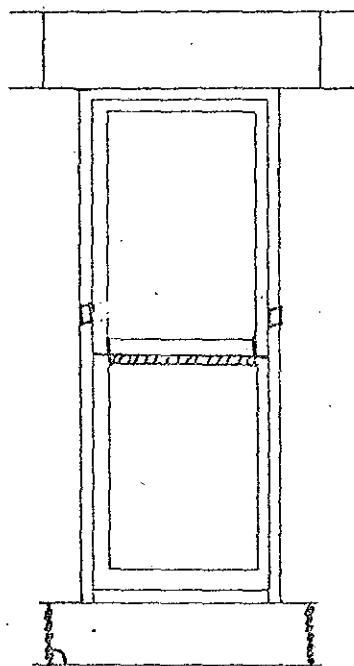
WILL NOT OPEN

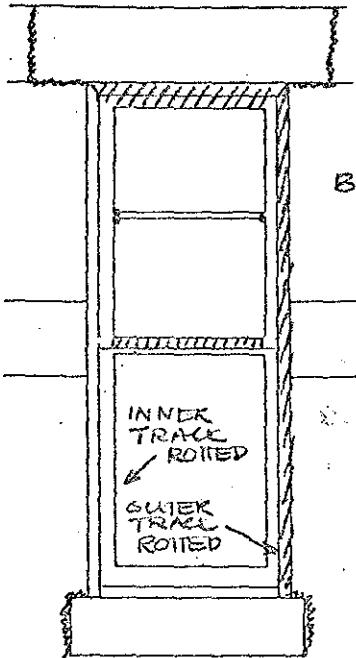
- ALL MOULDINGS LOOSE, JOINTS OPEN
- SOFFIT OF HEAD & TOP RAIL ROTTED

SCREEN OVER LOWER SASH - FAIR CONDITION

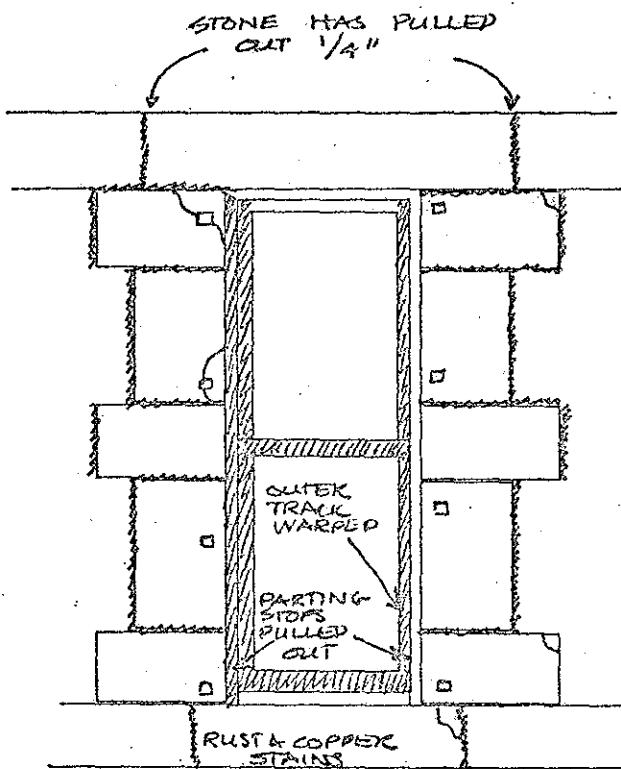
GRILL
HAS METAL TRACKS BUT NO SCREENS

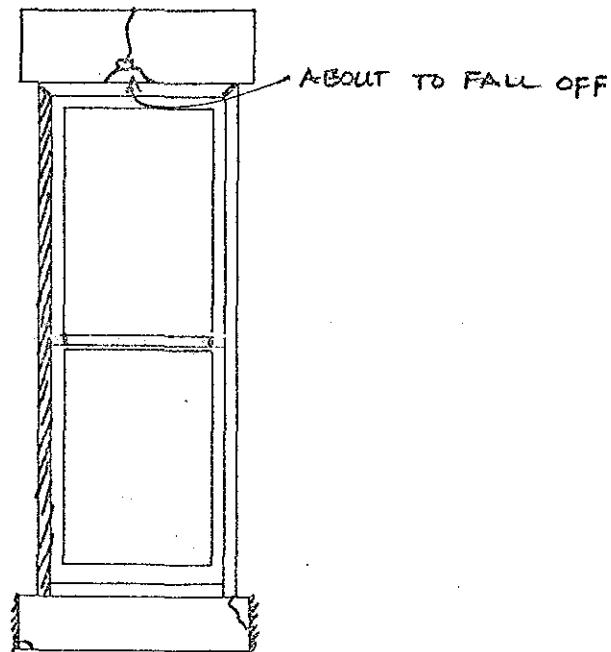
SCREEN OVER LOWER SASH - POOR CONDITION

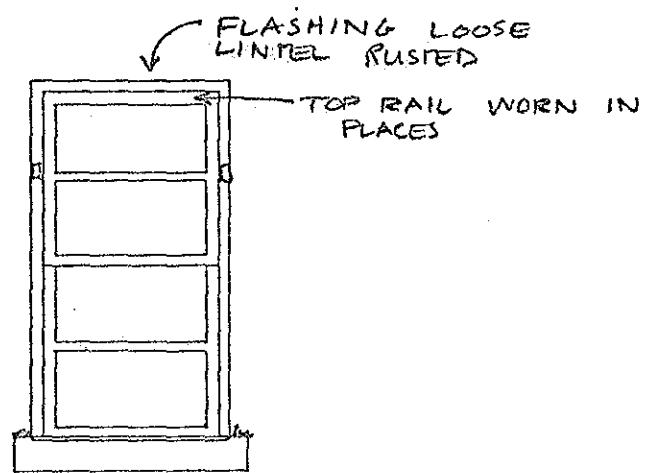
WILL NOT OPEN - UNABLE TO EXAMINE SILL OR
EXTERIOR TRIM

NO GRILL

NO SCREENS

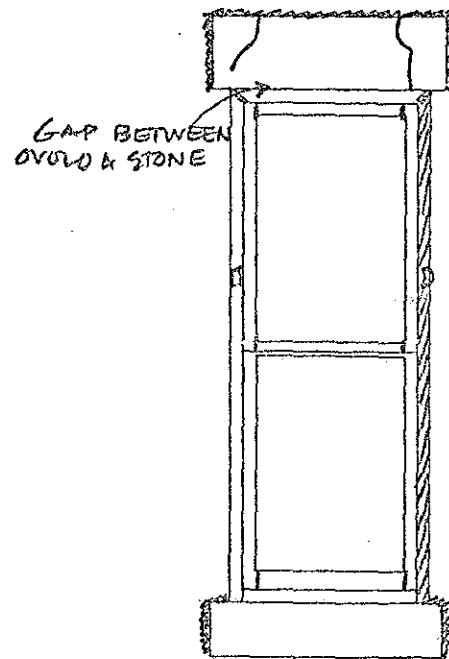
INTERIOR: MARBLE STOOL CRACKED

SCREEN ON LOWER SASH - POOR CONDITION

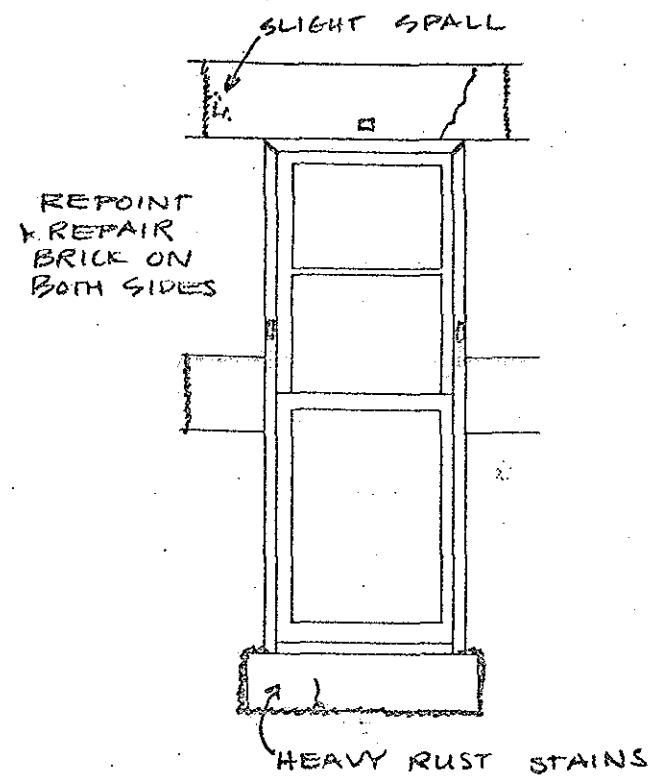
SASH WILL NOT OPEN - UNABLE TO EXAMINE EXTERIOR

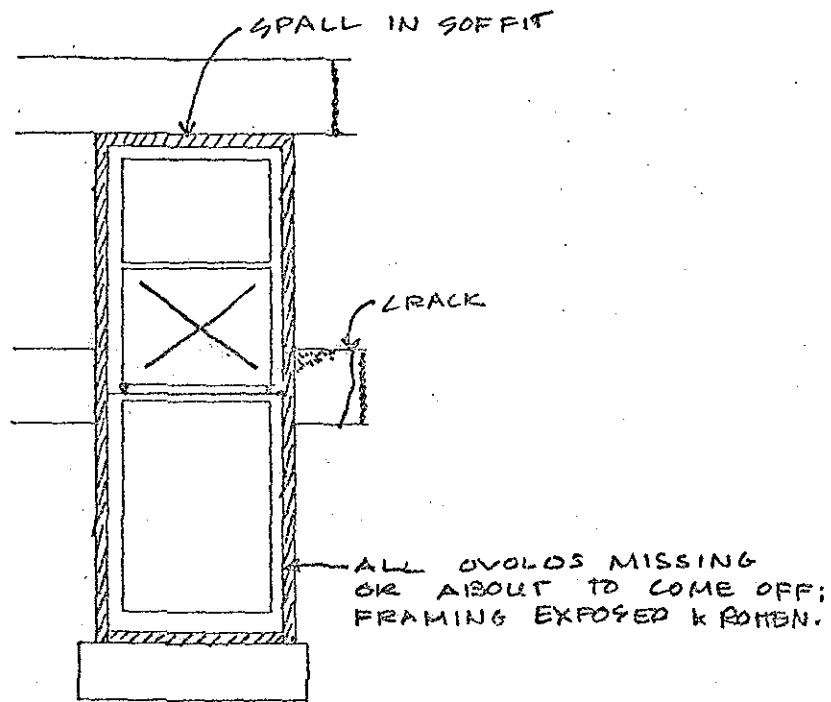
INTERIOR: LINTEL RUSTED

GRILL REMOVED, SLEEVES STILL IN PLACE, BRICK SPALLING AROUND THEM.

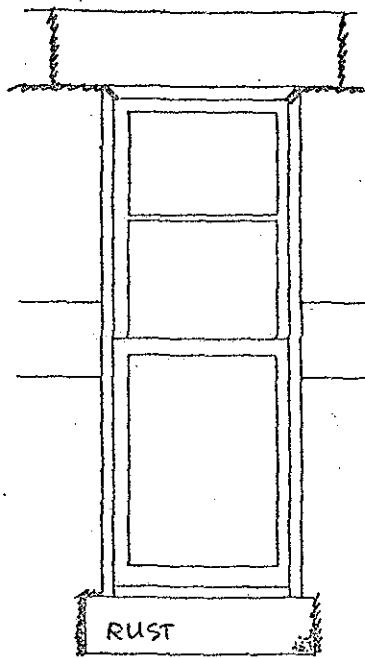
INTERIOR: UPPER STOOL MOULDING LOOSE.

NOT ACCESSIBLE ON OUTSIDE

SCREEN ON LOWER SASH - POOR CONDITION

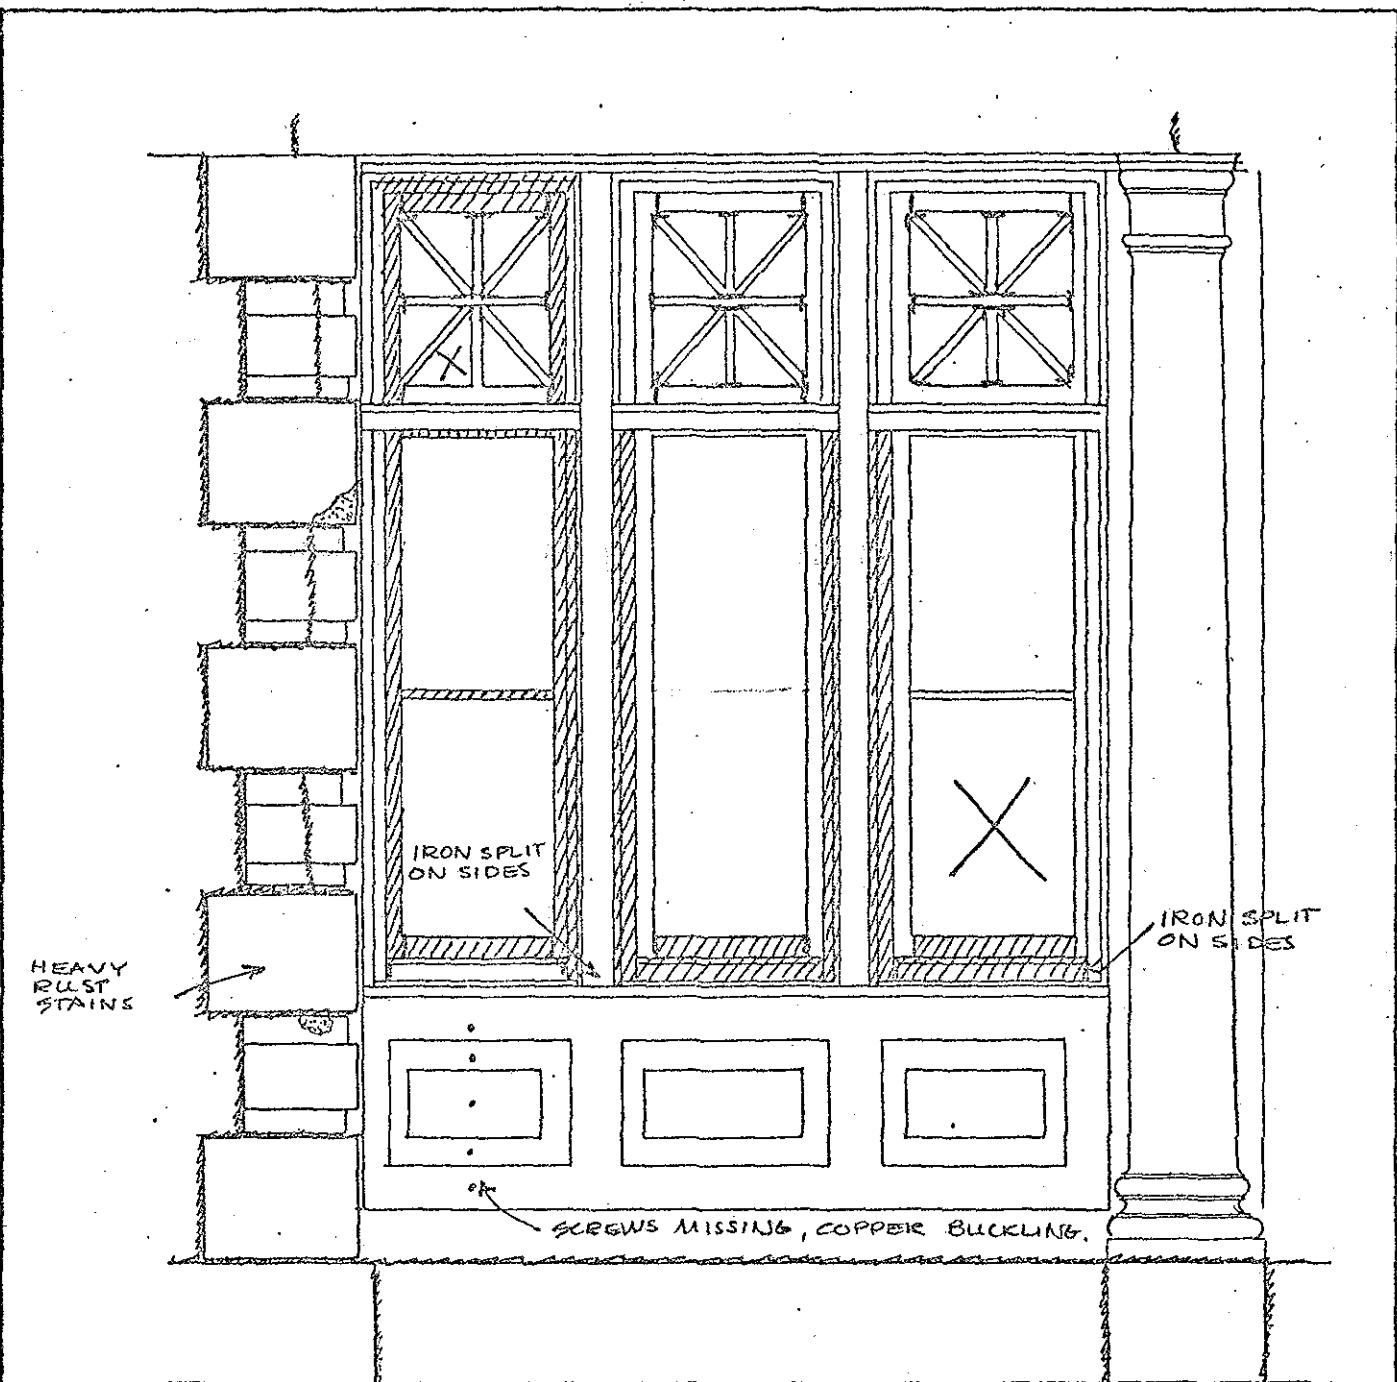
- SASH STOPS ROTTEN
- JAMB & UPPER FRAME ROTTEN

GRILLS OVER TRANSOM & LOWER SASH
SCREENS OVER LOWER SASH

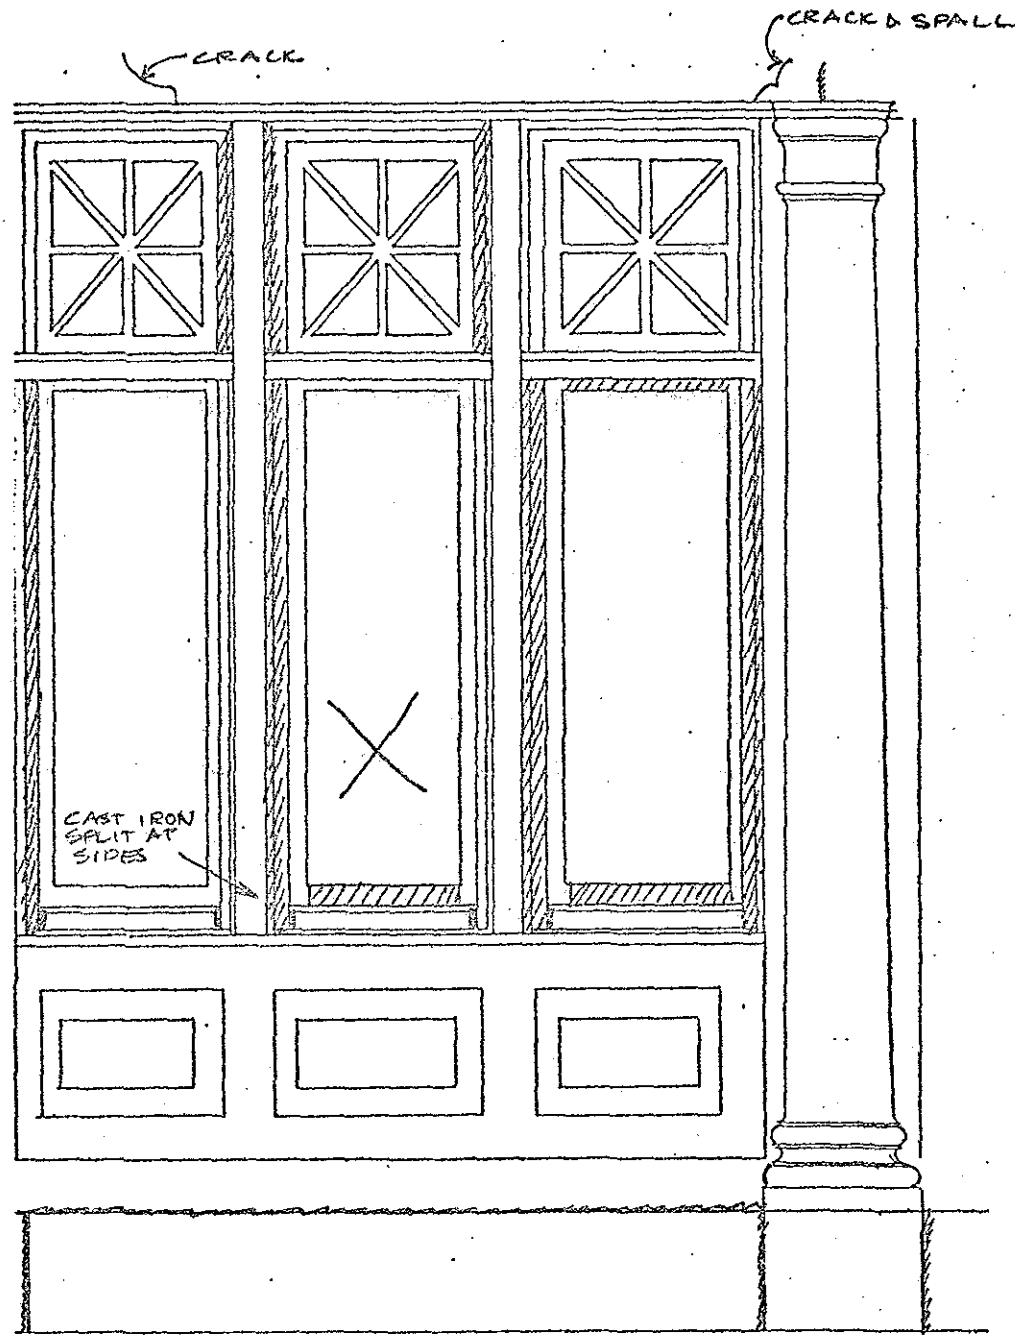
INTERIOR: SASH STOPS ROTTED & LOOSE

GRILLS OVER TRANSOM & LOWER SASH - CORRODED
SCREENS OVER TWO SIDE SASH - FAIR CONDITION

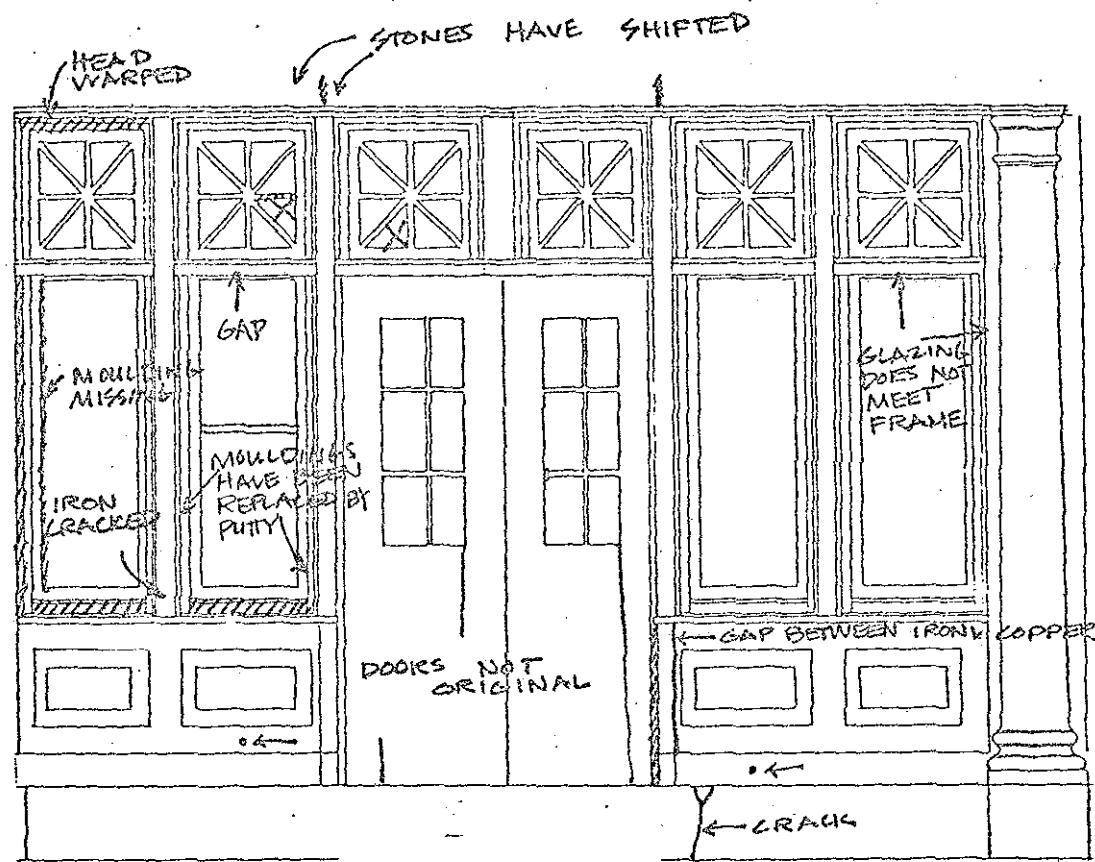
INTERIOR: • ALL MEMBERS LOOSE
 • SASH STUCK
 • ALL TRANSOMS BUT CENTER TWO NAILED SHUT

GRILLS OVER TRANSOMS, LOWER SASH & DOOR WINDOWS.
 LOWER BAR ON LEFT SASH CORRODED THRU

SCREENS OVER LOWER SASH & IN FRONT OF DOORS -
 FAIR CONDITION

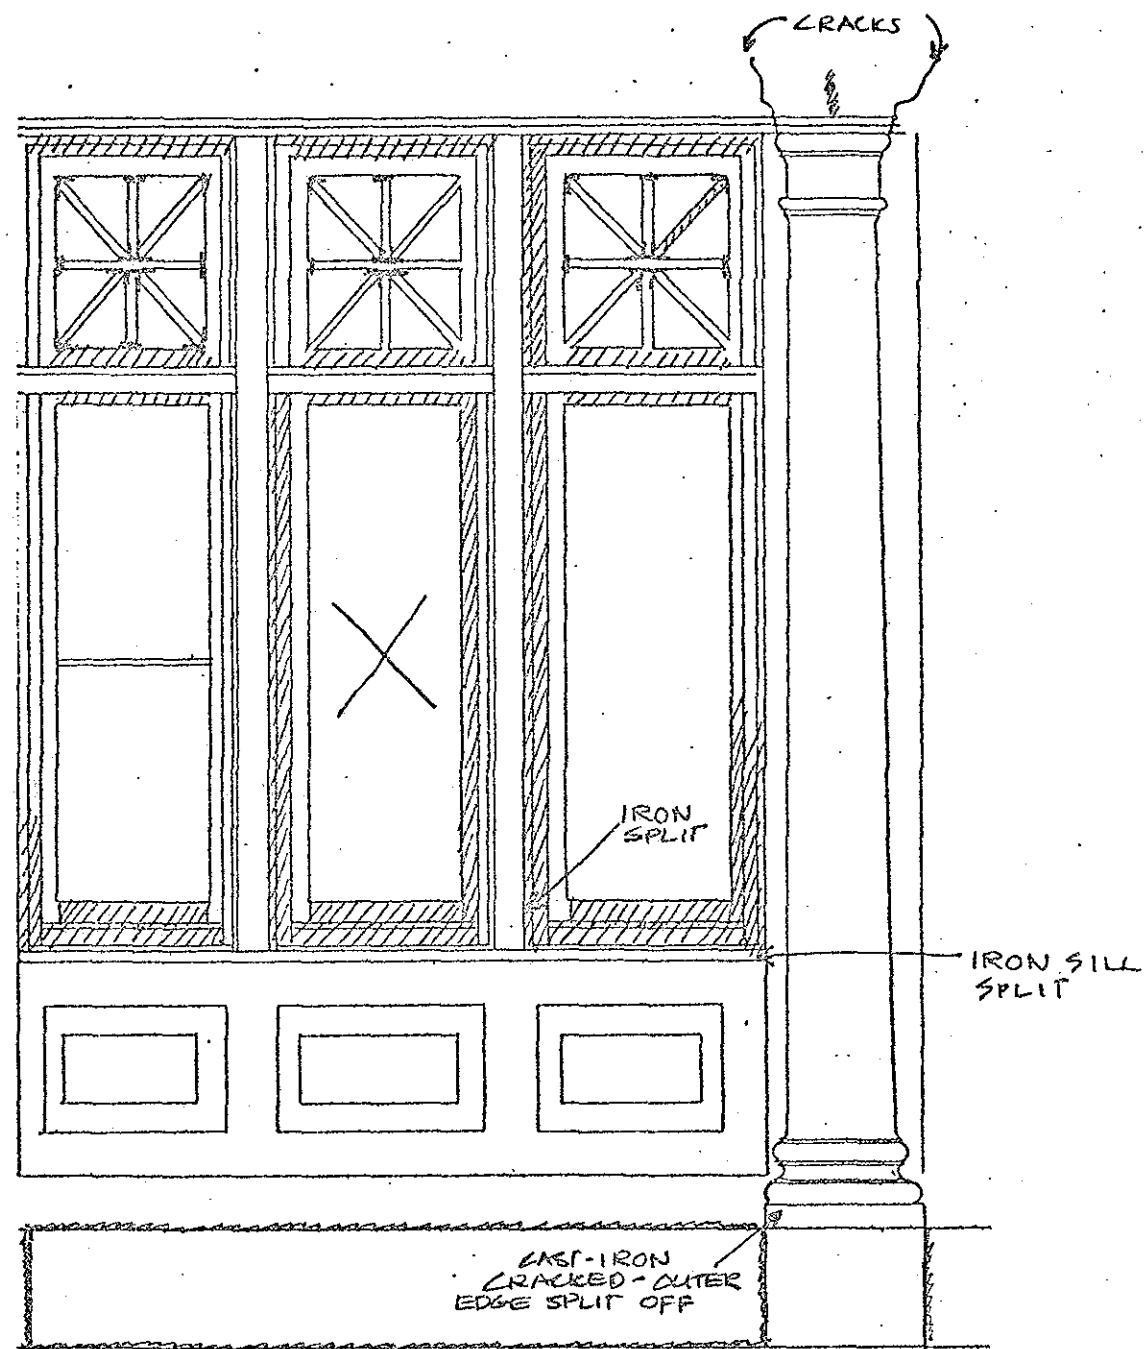
GRILLS OVER TRANSOM & LOWER SASH

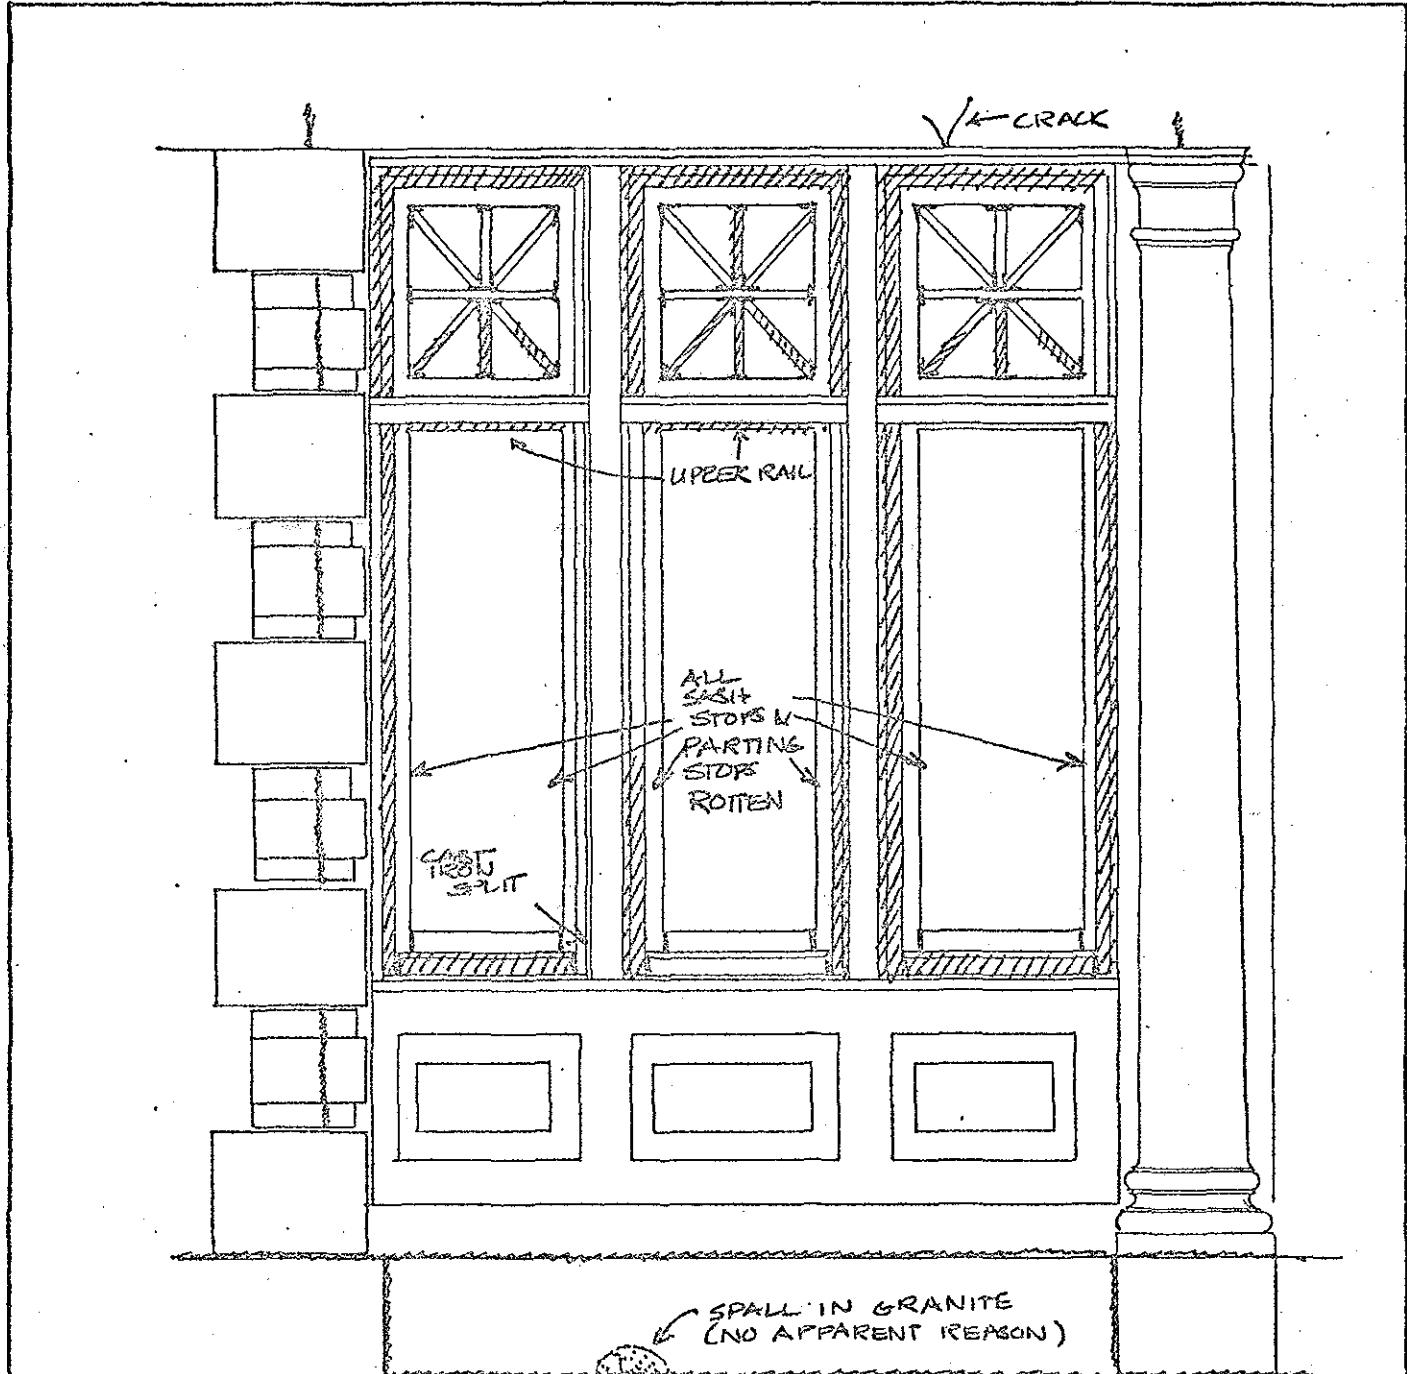
SASH INOPERABLE

- GRILL OVER TRANSOM & LOWER SASH
- SCREENS REMOVED
- AWNING HARDWARE

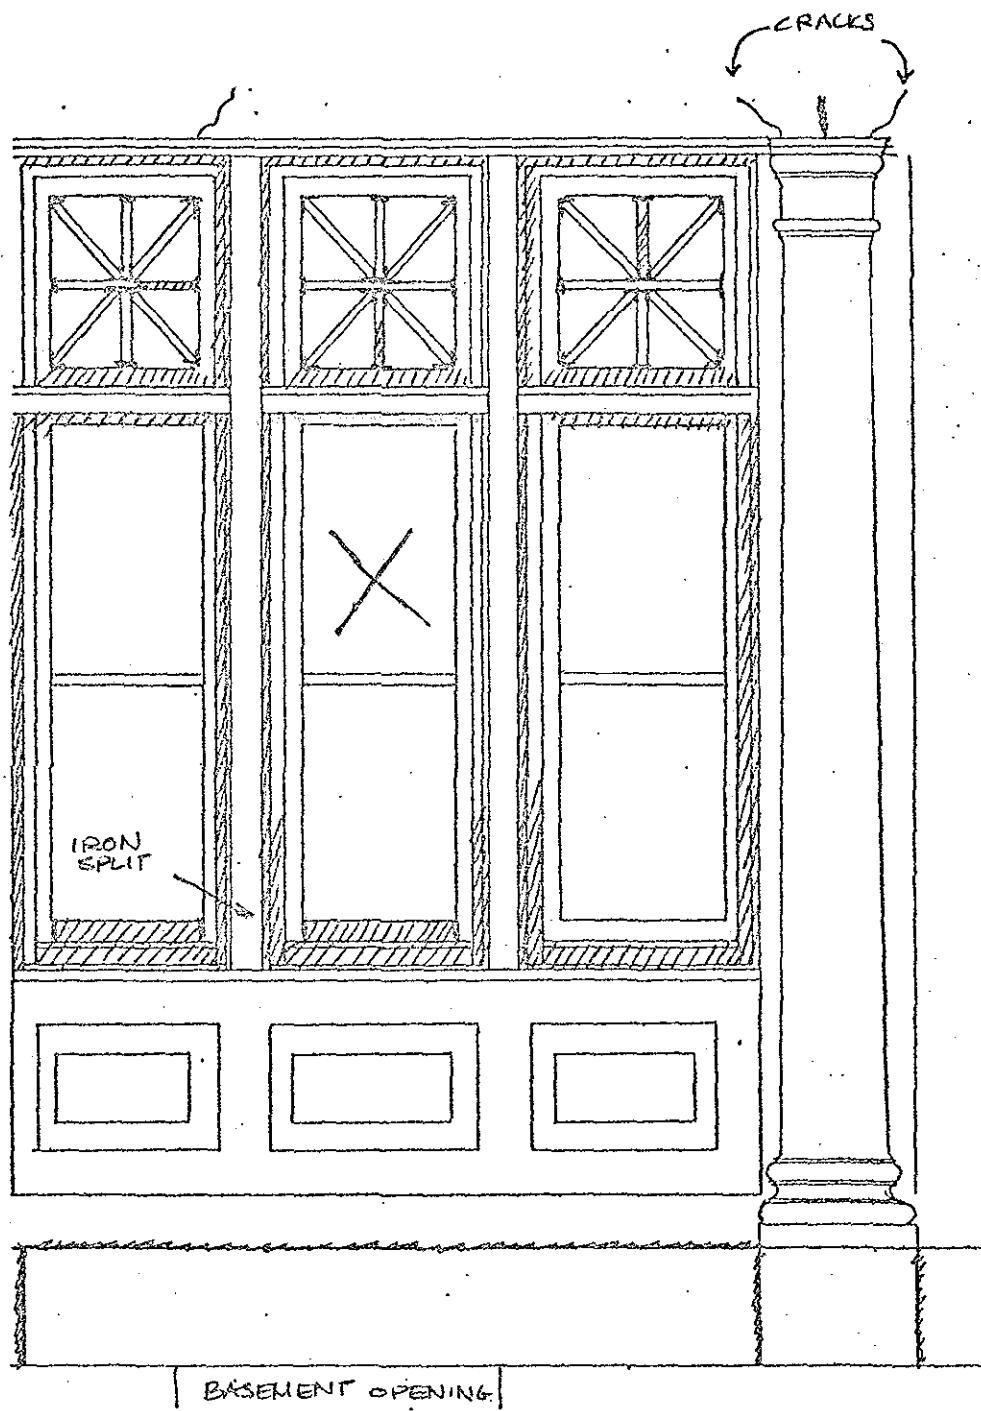
GRILL OVER TRANSOM & LOWER SASH - CORRODED
AWNING HARDWARE
