historic structures report

mechanical/electrical rehabilitation

main building

STATUE OF LIBERTY ELLIS ISLAND

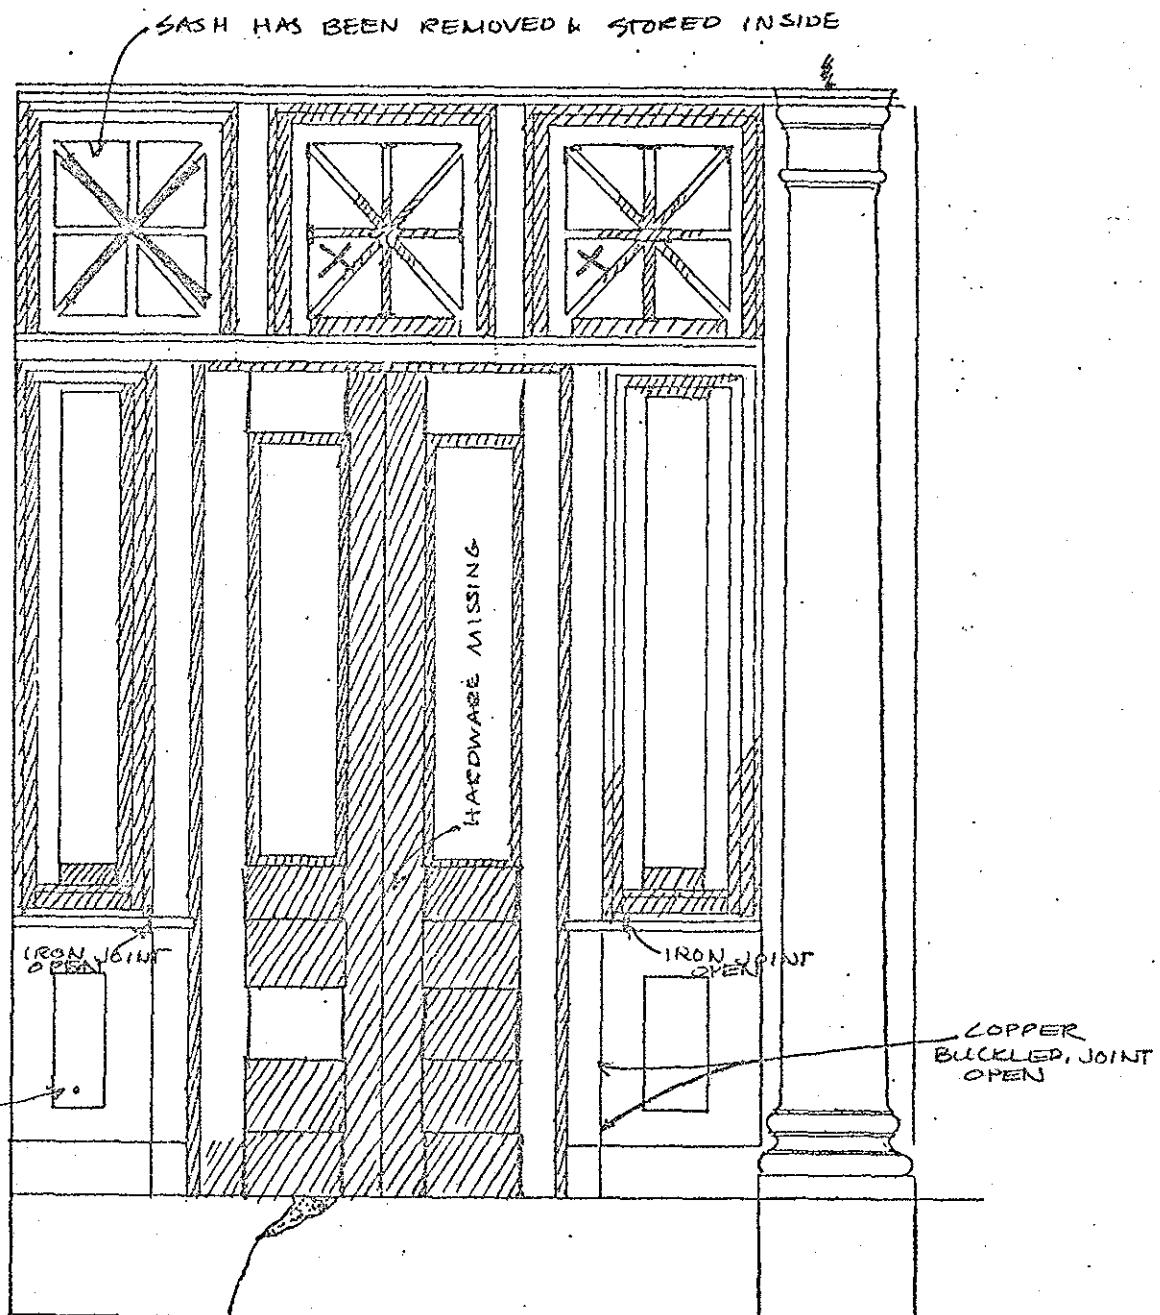
GRILLS IN PLACE OVER SIDELIGHTS, TRANSOMS, & DOOR GLASS

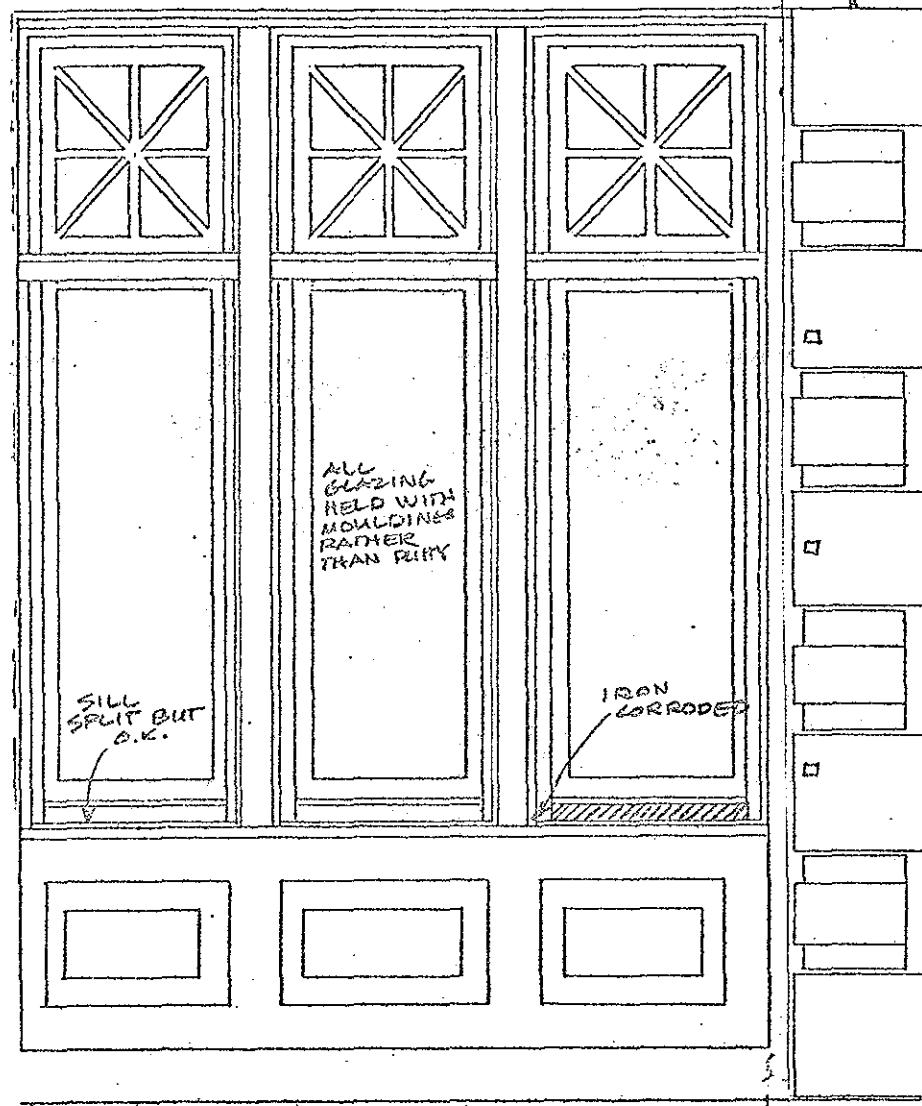
- LINTEL RUSTED
- PANELS & HEAD MOULDINGS LOOSE & WARPED
- SASH NAILED SHUT
- NORTH JAMB EXPOSED, ROTED, CHECKED
- STOOL & APRON ROTED AT NORTH END
- MOULDINGS ON TOP OF STOOLS ALL LOOSE

EXTERIOR INACCESSIBLE

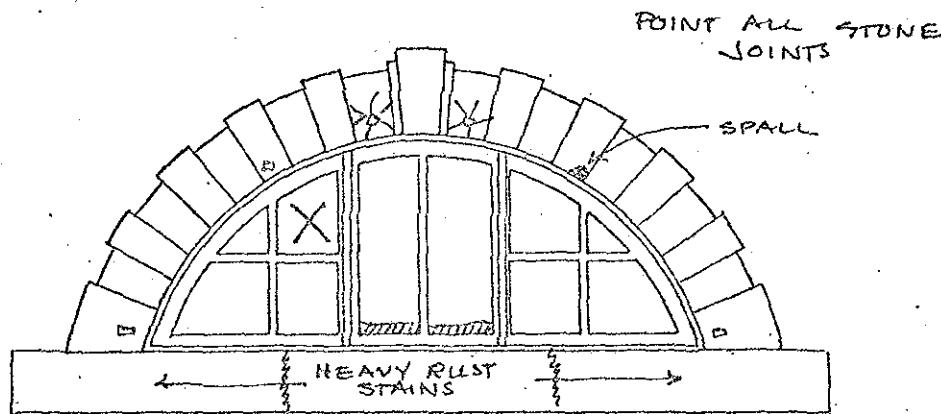
INTERIOR: SURROUND LOOSE

GRILL REMOVED (RECENTLY)

CASH IRON BAR SCREEN OVER SASH - CORRODED

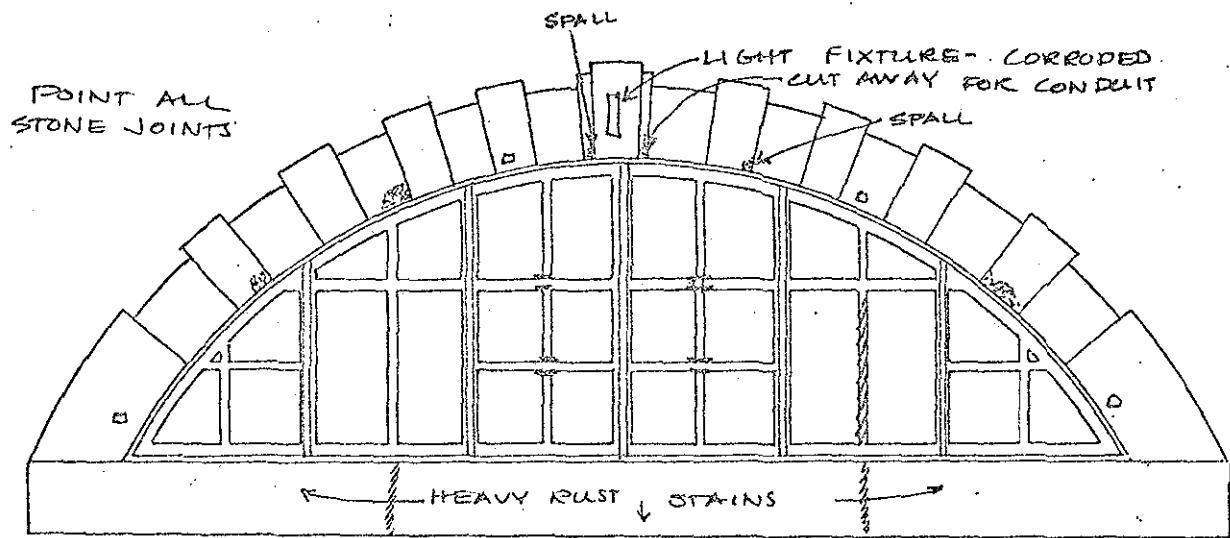
GRILL REMOVED (RECENTLY)

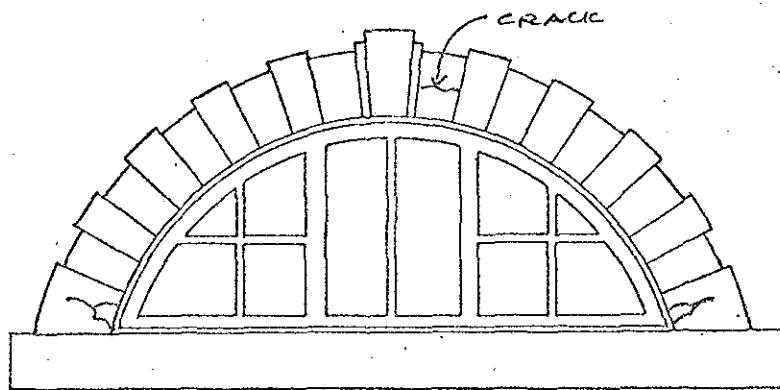
WOOD SASH & FRAME INACCESSIBLE

GRILL OVER OPENING - CORRODED
CAST IRON BAR SCREEN BEHIND GRILL - CORRODED

REPAIR &
REPOINT BRICK
ON BOTH SIDES

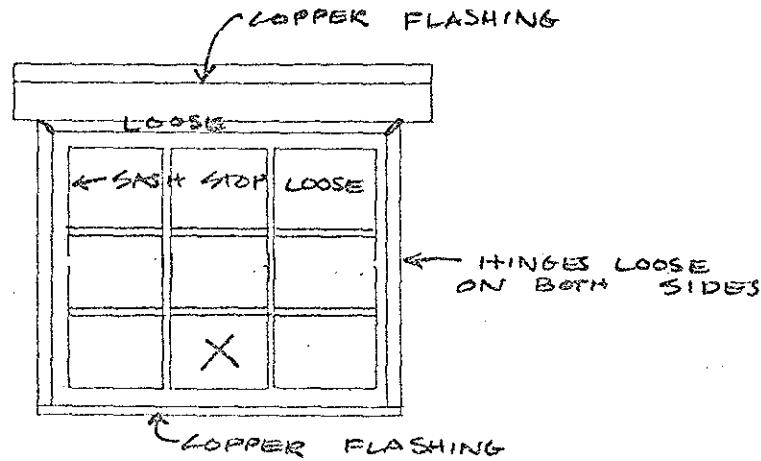
INTERIOR: MOULDINGS VERY LOOSE

NO GRILL

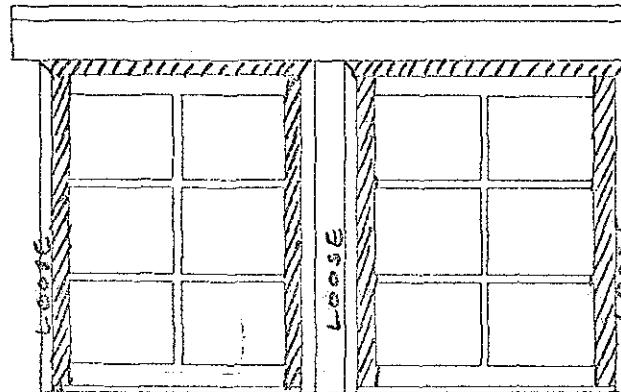
ALL SIDE RAILS SPLIT

SCREENS ON UPPER HALF, GOOD CONDITION (INSIDE),
LOWER HALF (OUTSIDE) FAIR CONDITION

BRICKS
MISSING

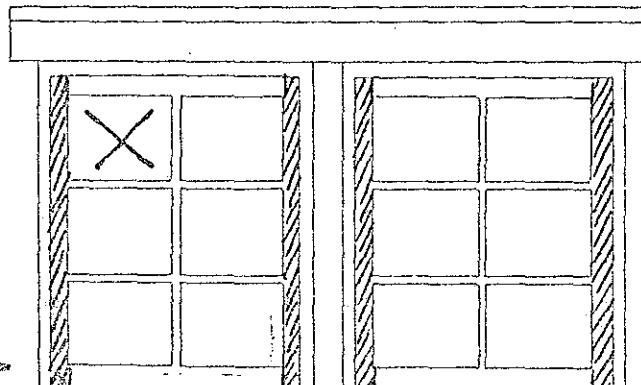
ALL SIDE RAILS SPLIT

UPPER & LOWER SCREENS - POOR CONDITION

NO GRILL

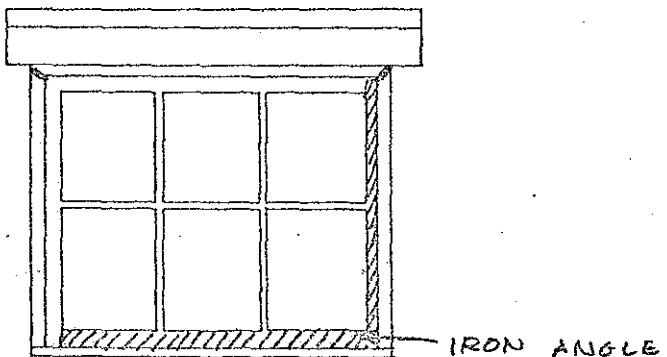
IRON ANGLE

NOT ACCESSIBLE

SCREENS OVER UPPER & LOWER PARTS OF SASH
- POOR CONDITION

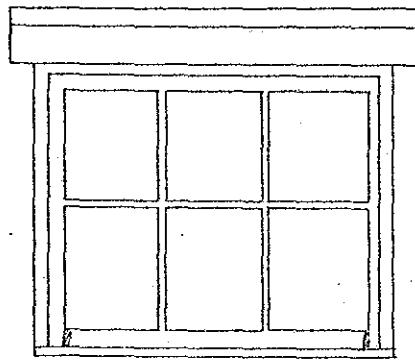
H1 EAST LIGHT COURTS	NUMBER SEL-104	CLASS I
MECHANICAL AND ELECTRICAL REHABILITATION MAIN BUILDING ELLIS ISLAND Statue of Liberty National Monument, New York	BUILDING CONSERVATION TECHNOLOGY THE FRENKELANTZ GROUP	19 West 44th Street, New York NY 10036

NOT ACCESSIBLE

GRILL OVER TOP HALF ONLY

SCREENS ON TOP - FAIR CONDITION

BRICKS
SPALLED

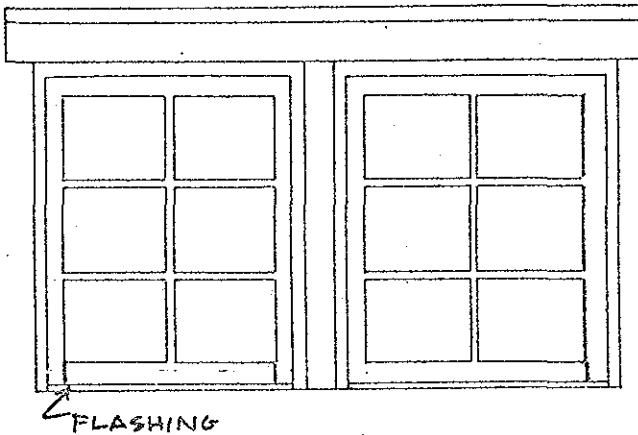
H2 EAST LIGHT COURTS (2)	NUMBER SEL-102	CLASS I.
MECHANICAL AND ELECTRICAL REHABILITATION MAIN BUILDING ELLIS ISLAND Statue of Liberty National Monument, New York	BUILDING CONSERVATION TECHNOLOGY, THE EHRENKRANZ GROUP

NOT ACCESSIBLE

GRILL REMOVED

SCREEN OVER UPPER & LOWER PARTS OF SASH -
FAIR CONDITION

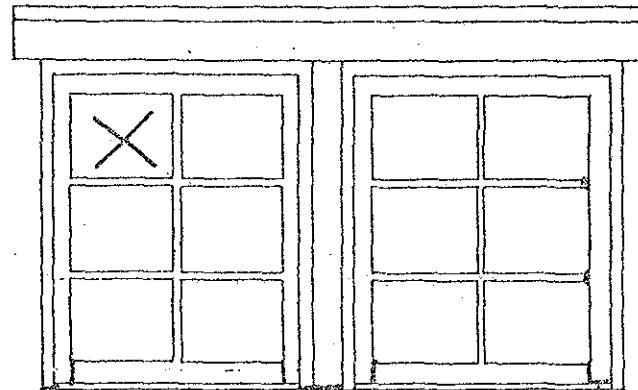
H2 EAST LIGHT COURTS (2)	NUMBER	CLASS
MECHANICAL AND ELECTRICAL REHABILITATION MAIN BUILDING ELLIS ISLAND Statue of Liberty National Monument, New York	SEL-103	I.
	BUILDING PRESERVATION TECHNOLOGY THE EINENKONZ GROUP 19 West 44th Street, New York NY 10036

SPACE BETWEEN
ALL OVOLOS & FLASHING

NOT ACCESSIBLE

ASPHALT COATING • BRICK SPALLING UNDERNEATH

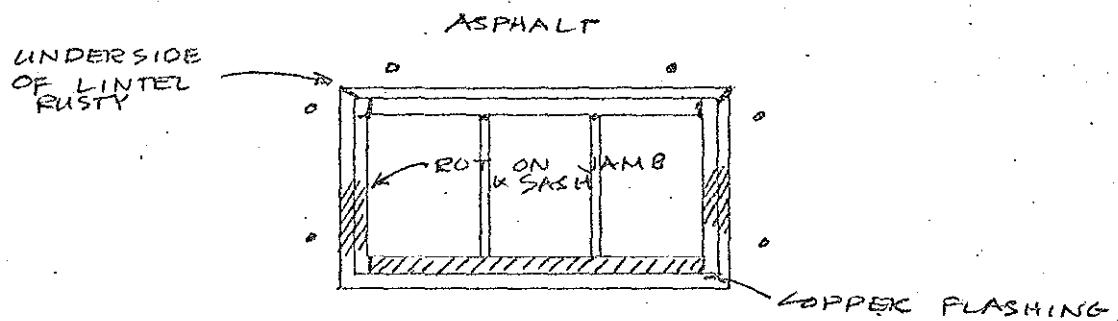
I WEST LIGHT COURTS	NUMBER NWL- 210	CLASS 3
MECHANICAL AND ELECTRICAL REHABILITATION MAIN BUILDING ELLIS ISLAND Statue of Liberty National Monument, New York	BUILDING CONSERVATION TECHNOLOGY THE FINEKRAUT GROUP	19 West 44th Street, New York NY 10036

- INTERIOR:
- CONDENSATION ON GLASS
 - LINTEL EXPOSED
 - HEAD MOULDINGS SAGGING
 - GAPS IN TRIM JOINTS

GRILL

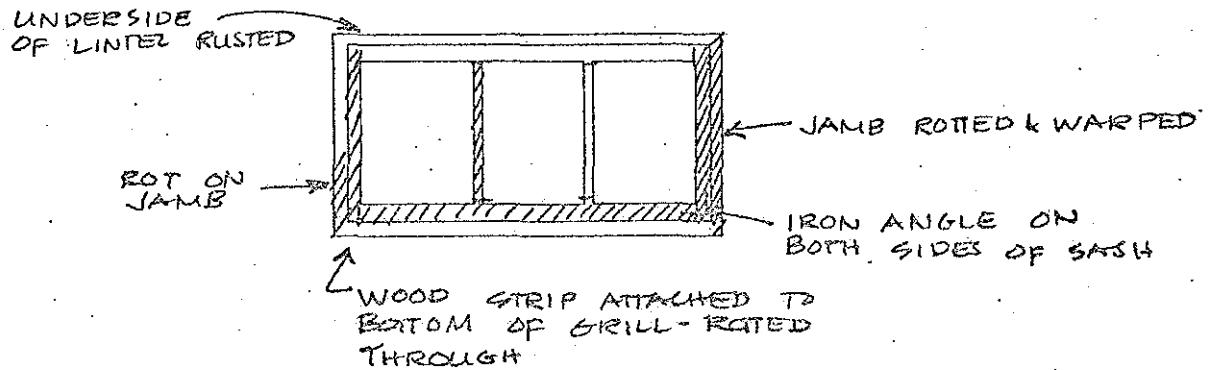
INTERIOR:

- CONDENSATION ON GLASS
- JOINTS OPEN
- LINTER EXPOSED

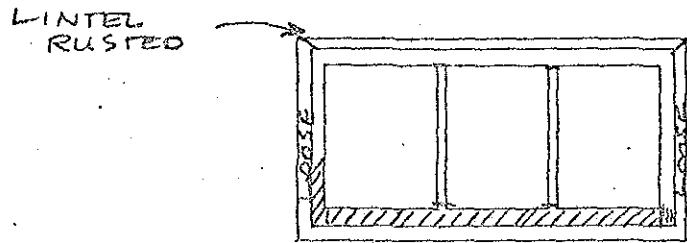
I WEST LIGHT COURTS	NUMBER NWL-214	CLASS 2
MECHANICAL AND ELECTRICAL REHABILITATION MAIN BUILDING ELLIS ISLAND Statue of Liberty National Monument, New York	BUILDING OBSERVATION TECHNOLOGY THE EHRENKRANTZ GROUP 19 West 45th Street, New York NY 10036

INTERIOR:

- LINTEL EXPOSED
- JOINTS OPEN
- WATER APPEARS TO BE RUNNING DOWN HEAD

GRILL

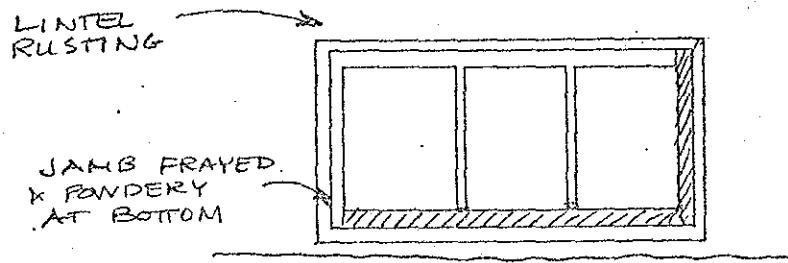
I WEST LIGHT COURTS	NUMBER NWL-215	CLASS 2
MECHANICAL AND ELECTRICAL REHABILITATION MAIN BUILDING ELLIS ISLAND Statue of Liberty National Monument, New York	BUILDING CONSERVATION TECHNOLOGY THE EBENKRAUTZ GROUP 19 West 44th Street, New York NY 10036

NOT ACCESSIBLE INSIDE

GRILL

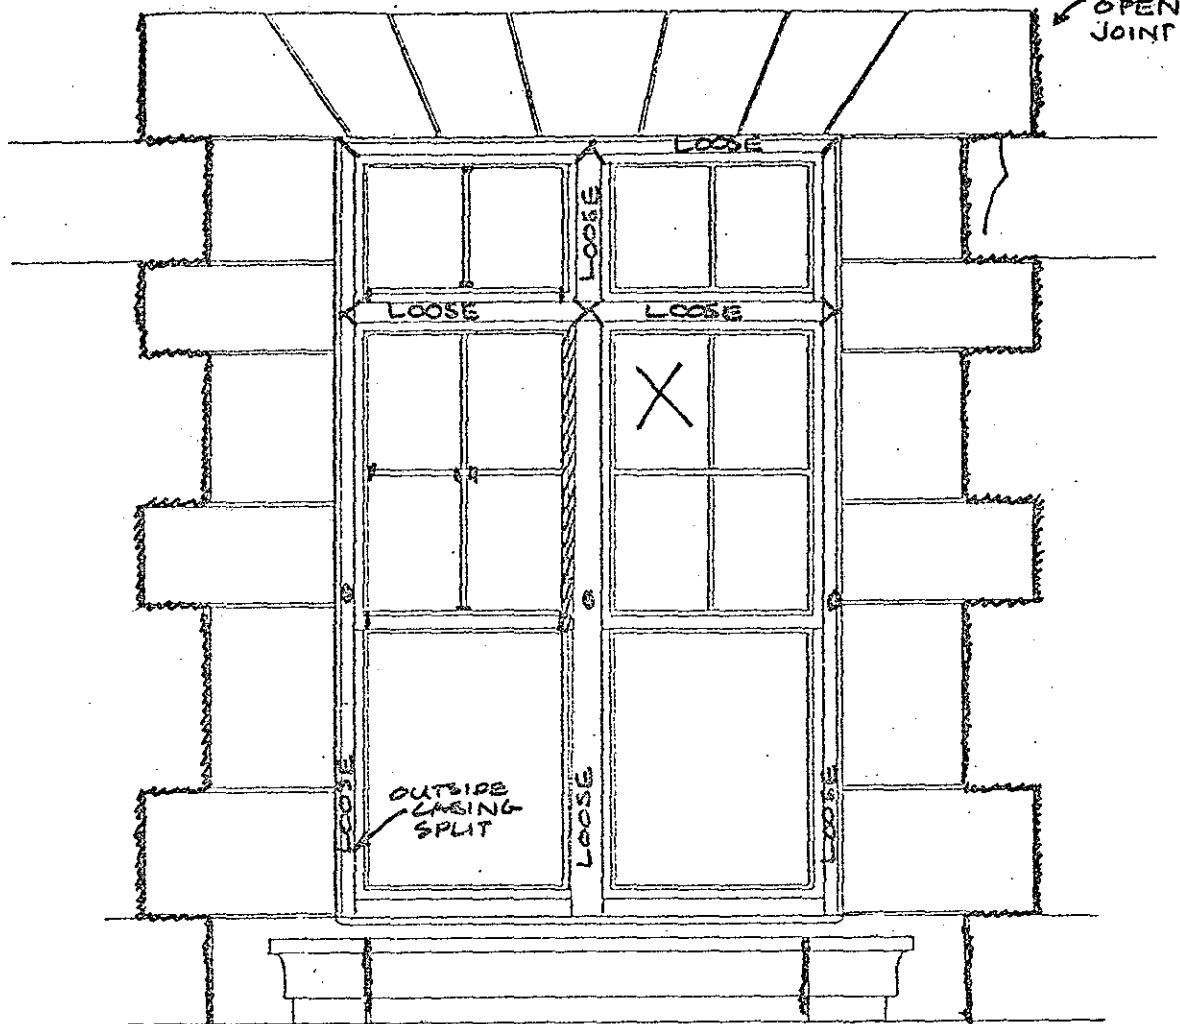
INTERIOR FRAME ROTTED & SPLIT ON WEST SIDE &
BOTTOM

NO GRILL

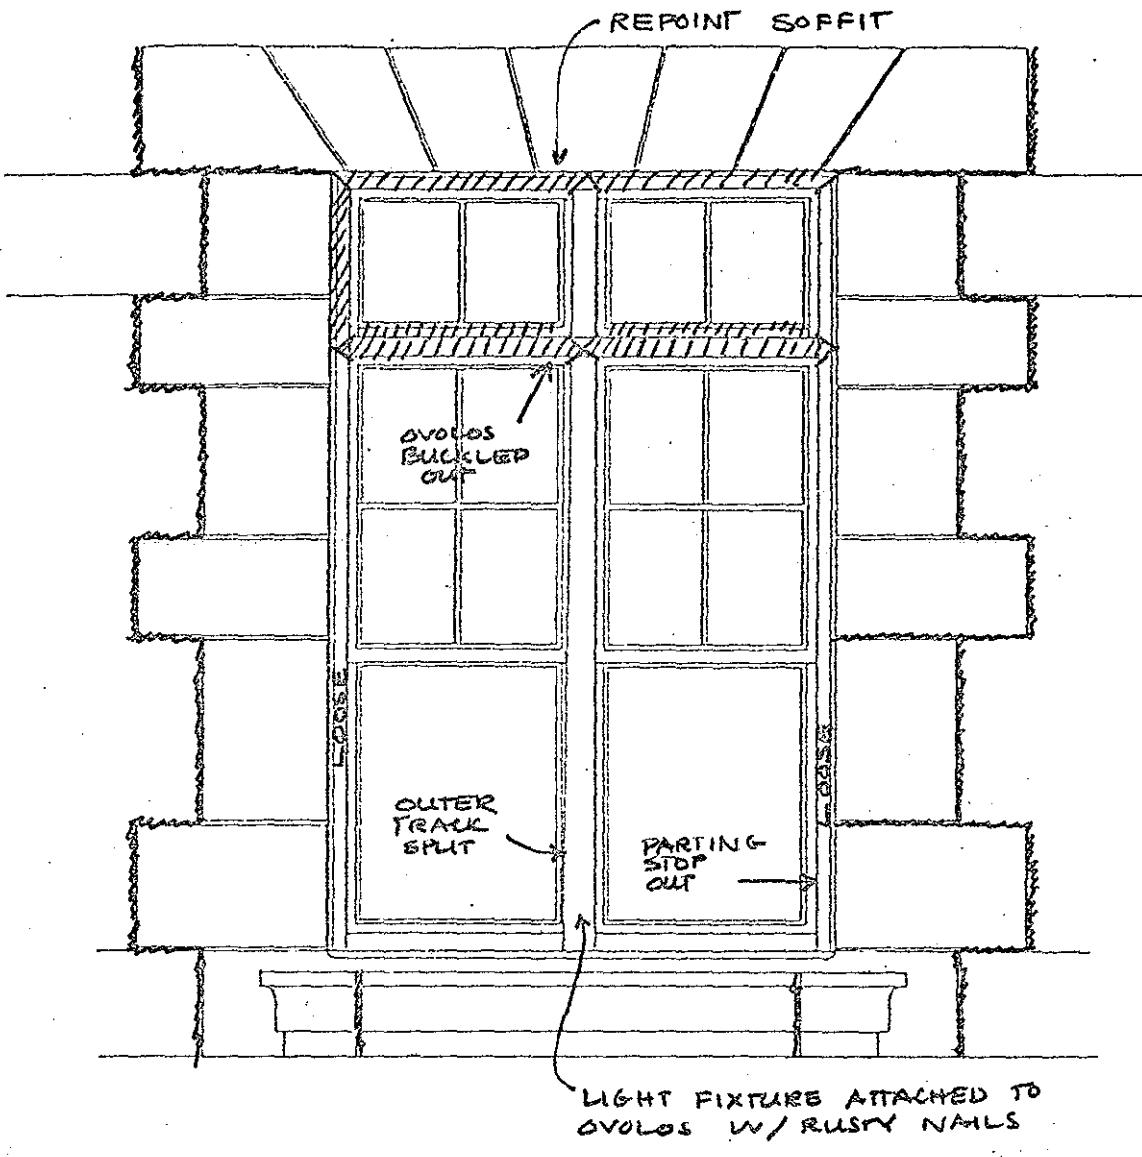
J SECOND FLOOR EXTERIOR ELEVATIONS	NUMBER N 204	CLASS 3
MECHANICAL AND ELECTRICAL REHABILITATION MAIN BUILDING ELLIS ISLAND Statue of Liberty National Monument, New York	BUILDING CONSERVATION TECHNOLOGY THE DEDMONTEC GROUP 19 West 45th Street, New York NY 10036

INTERIOR:

- EAST (LEFT) STOOL ROTTED
- " " JAMB ROTTED
- HEAD MOULDINGS LOOSE

NO GRILL

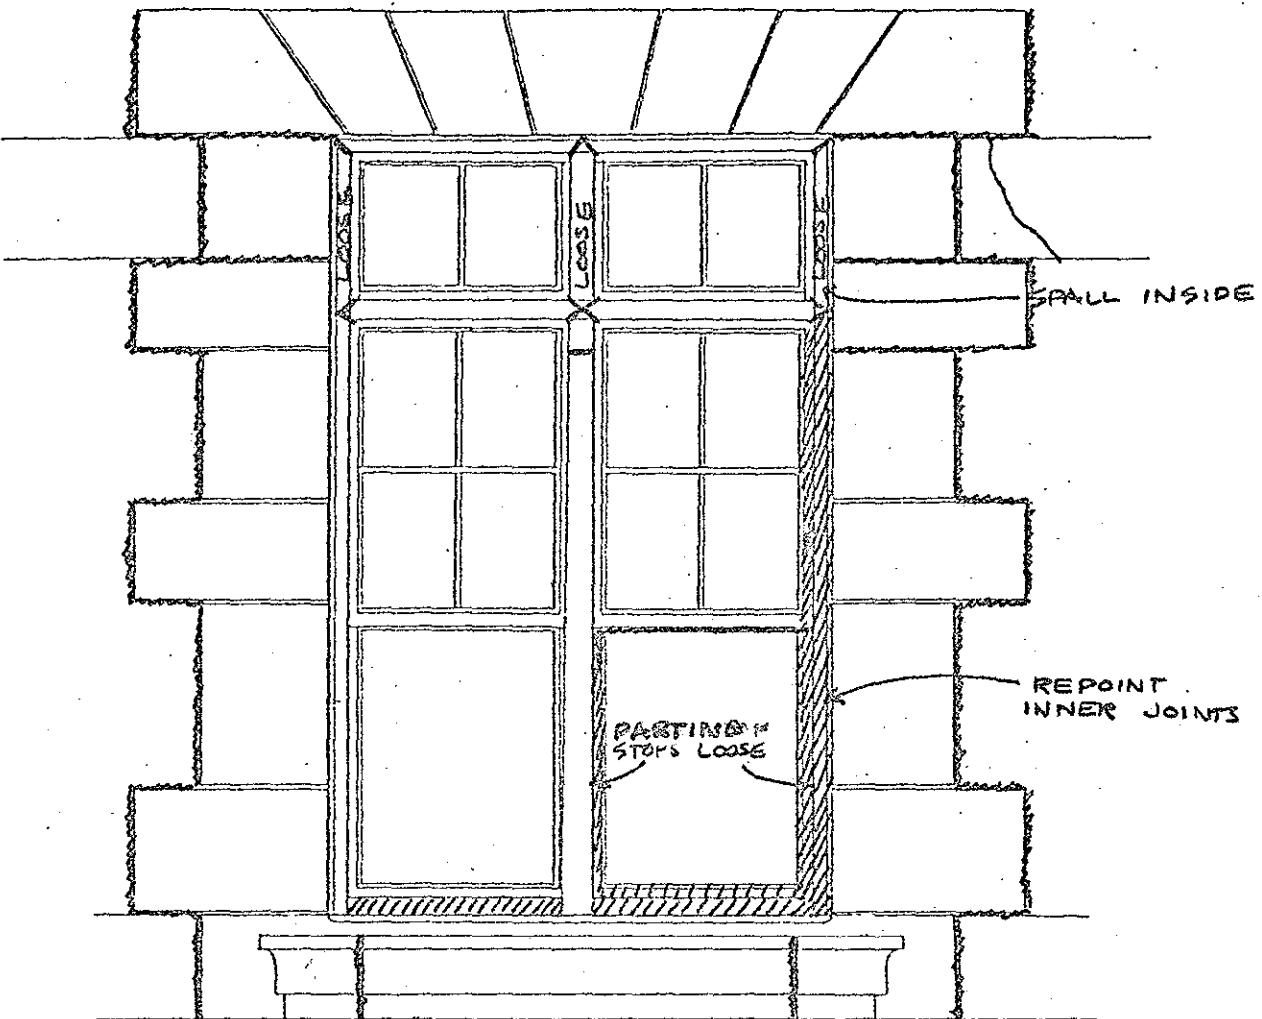
J. SECOND FLOOR EXTERIOR ELEVATIONS	NUMBER N 205	CLASS 3
MECHANICAL AND ELECTRICAL REHABILITATION MAIN BUILDING ELLIS ISLAND Statue of Liberty National Monument, New York	BUILDING CONSERVATION TECHNOLOGY THE DREGENGARTZ GROUP

INTERIOR:

- BOTH STOOLS ROTTED
- WEST JAMS & DIVIDING PANEL ROTTED
- MLEDGS FRAMING RIGHT (WEST) OPENING MISSING

GRILL REMOVED

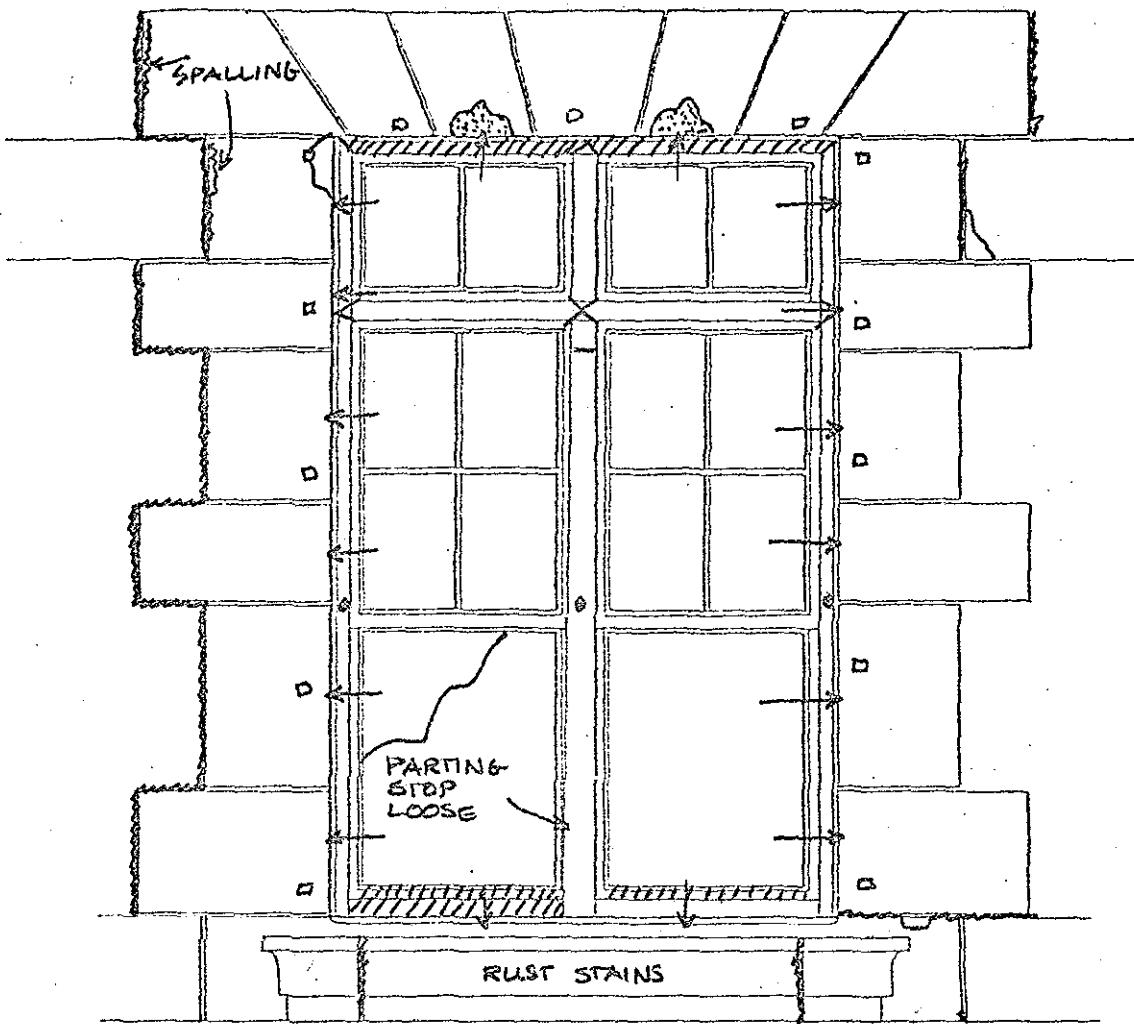
J SECOND FLOOR EXTERIOR ELEVATIONS	NUMBER N 211	CLASS 4/3
MECHANICAL AND ELECTRICAL REHABILITATION MAIN BUILDING ELLIS ISLAND Statue of Liberty National Monument, New York	BUILDING CONSERVATION TECHNOLOGY THE DPERKOWITZ GROUP

INTERIOR:

- ALL MLDGS WET, ALL JOINTS OPEN
- HEAP BULGES - REPLACE IT & TOP OF TRANSMOM
- WINDOWS WILL NOT OPEN
- EAST (LEFT) SIDE WET & ROTTED

GRILL

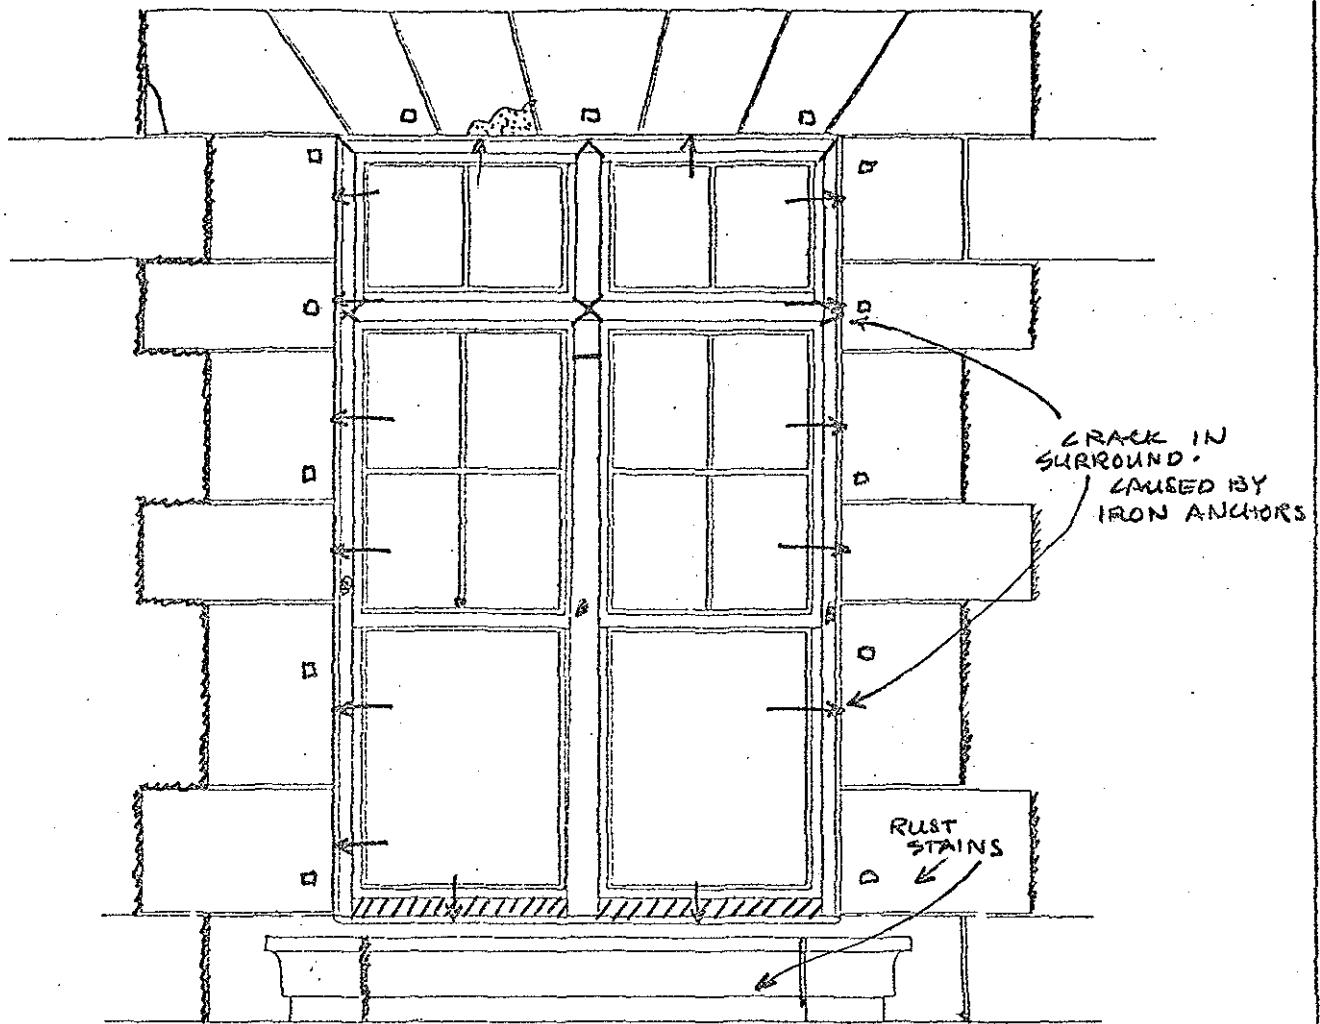
J. SECOND FLOOR EXTERIOR ELEVATIONS	NUMBER N212	CLASS 2
MECHANICAL AND ELECTRICAL REHABILITATION MAIN BUILDING ELLIS ISLAND Statue of Liberty National Monument, New York	WINDING CONSERVATION TECHNOLOGY THE DRENNANZ GROUP	19 West 44th Street, New York NY 10036

INTERIOR:

- ALL WOOD WET BUT APPEARS SOUND.
- MLDGS FRAMING TRANSOM OPENINGS ON BOTH SIDES WARPED & LOOSE
- SASH NAILED SHUT
- TRANSOM MECHANISM RUSTY

GRILL

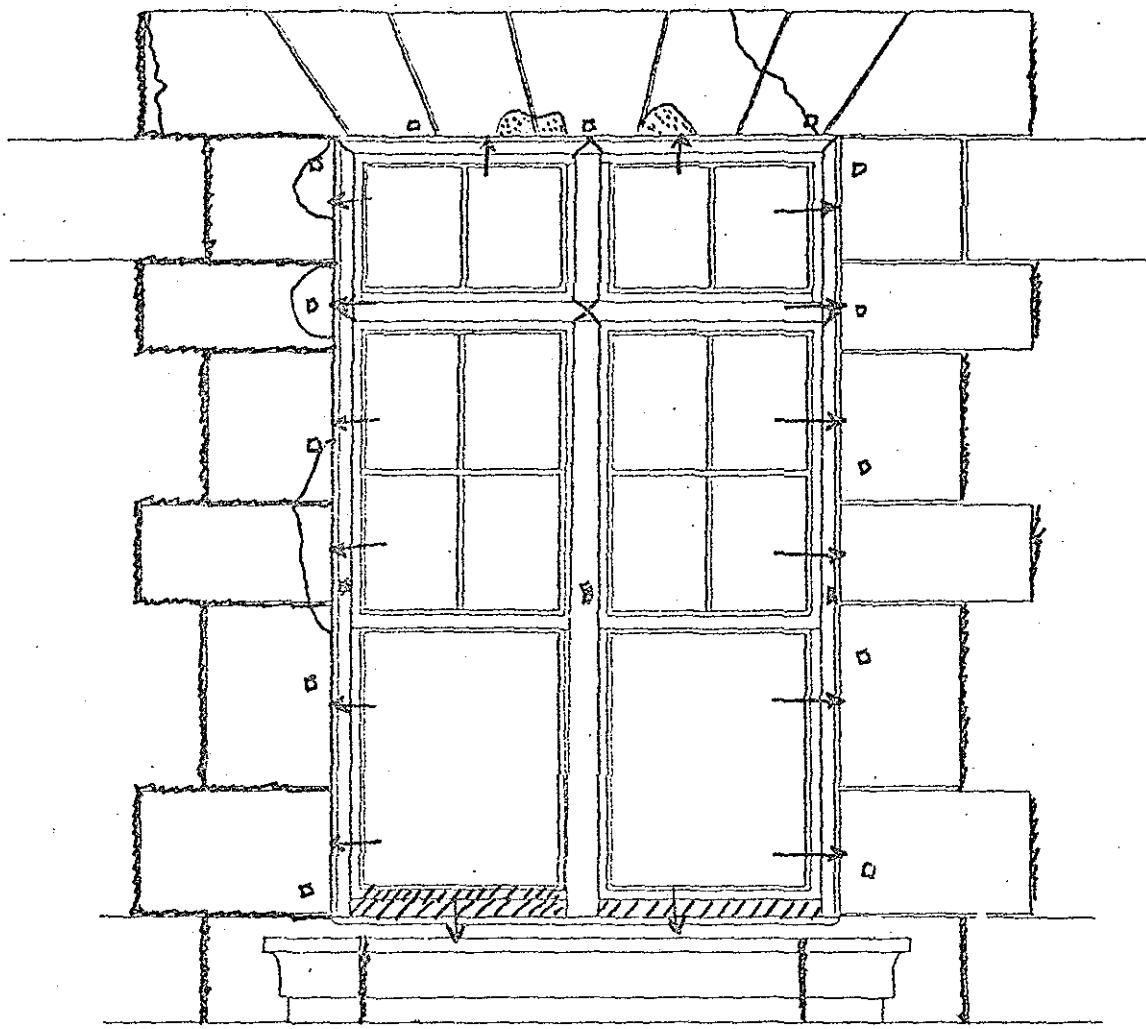
J SECOND FLOOR EXTERIOR ELEVATIONS	NUMBER N 213	CLASS 3
MECHANICAL AND ELECTRICAL REHABILITATION MAIN BUILDING ELLIS ISLAND Statue of Liberty National Monument, New York	BUILDING CONSERVATION TECHNOLOGY THE DERNANTZ GROUP

INTERIOR: • UPPER PART OF FRAME COMPLETELY
TORN OFF.

GRILL

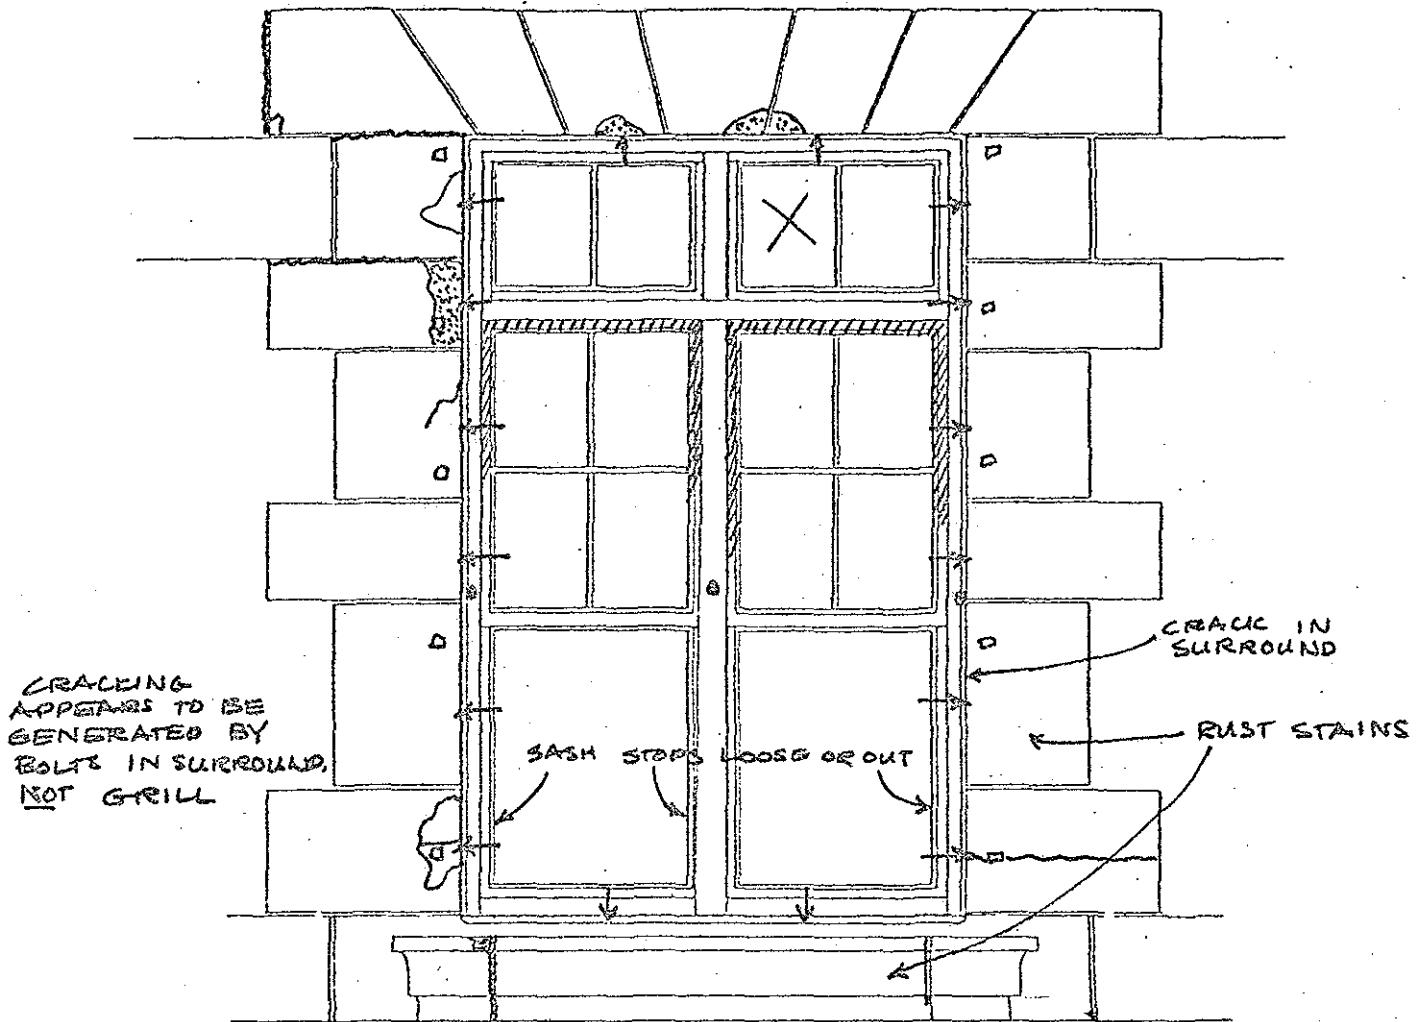
HEAD & TRANSOM ROTED INSIDE

TRANSOM MECHANISM RUSTED

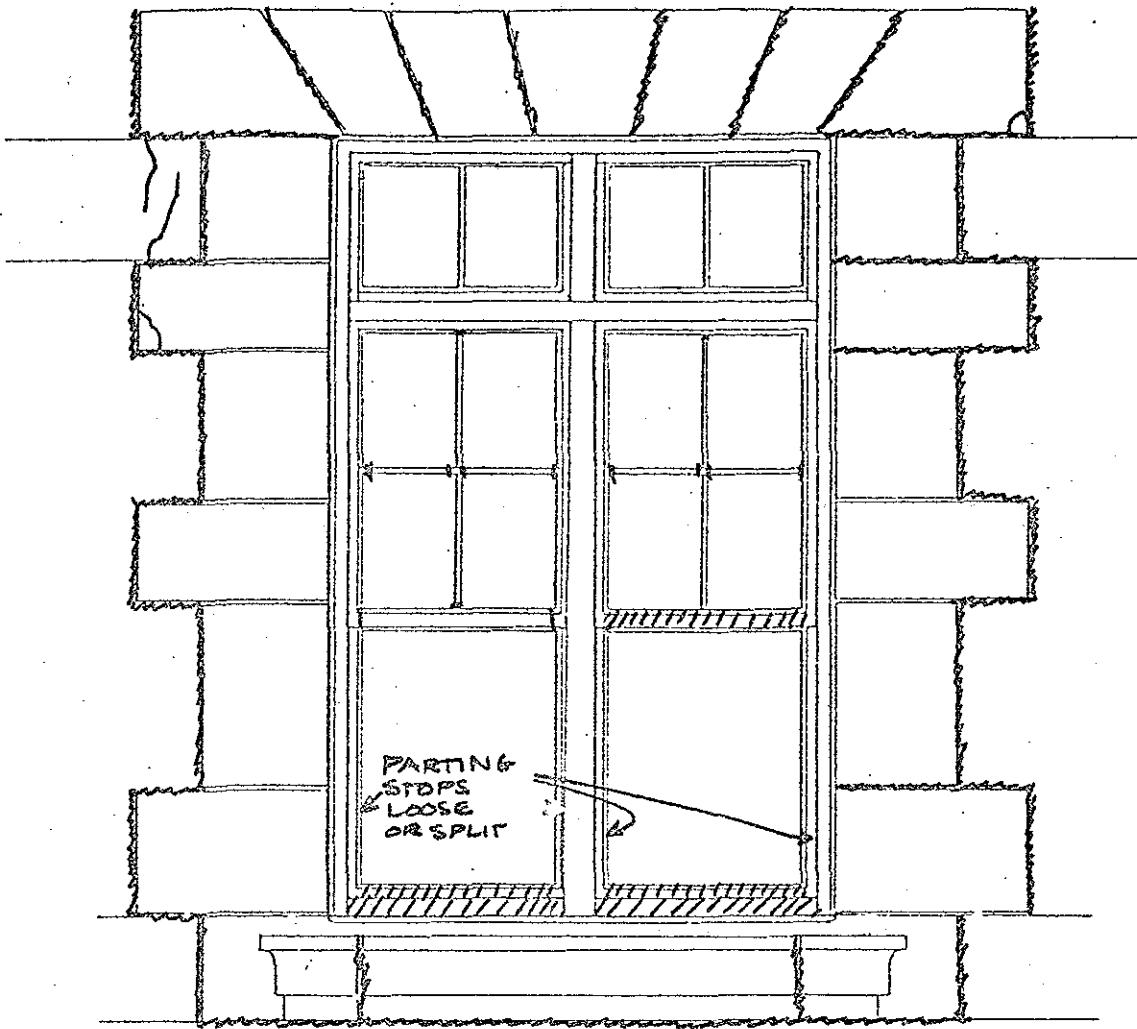
J. SECOND FLOOR EXTERIOR ELEVATIONS	NUMBER E 201	CLASS 2
MECHANICAL AND ELECTRICAL REHABILITATION MAIN BUILDING ELLIS ISLAND Statue of Liberty National Monument, New York	BUILDING CONSERVATION TECHNOLOGY THE DEDICATED GROUP 19 West 44th Street, New York NY 10036

FRAME BUILT ON TOP OF OVOLOS - REMOVE

NO GRILL

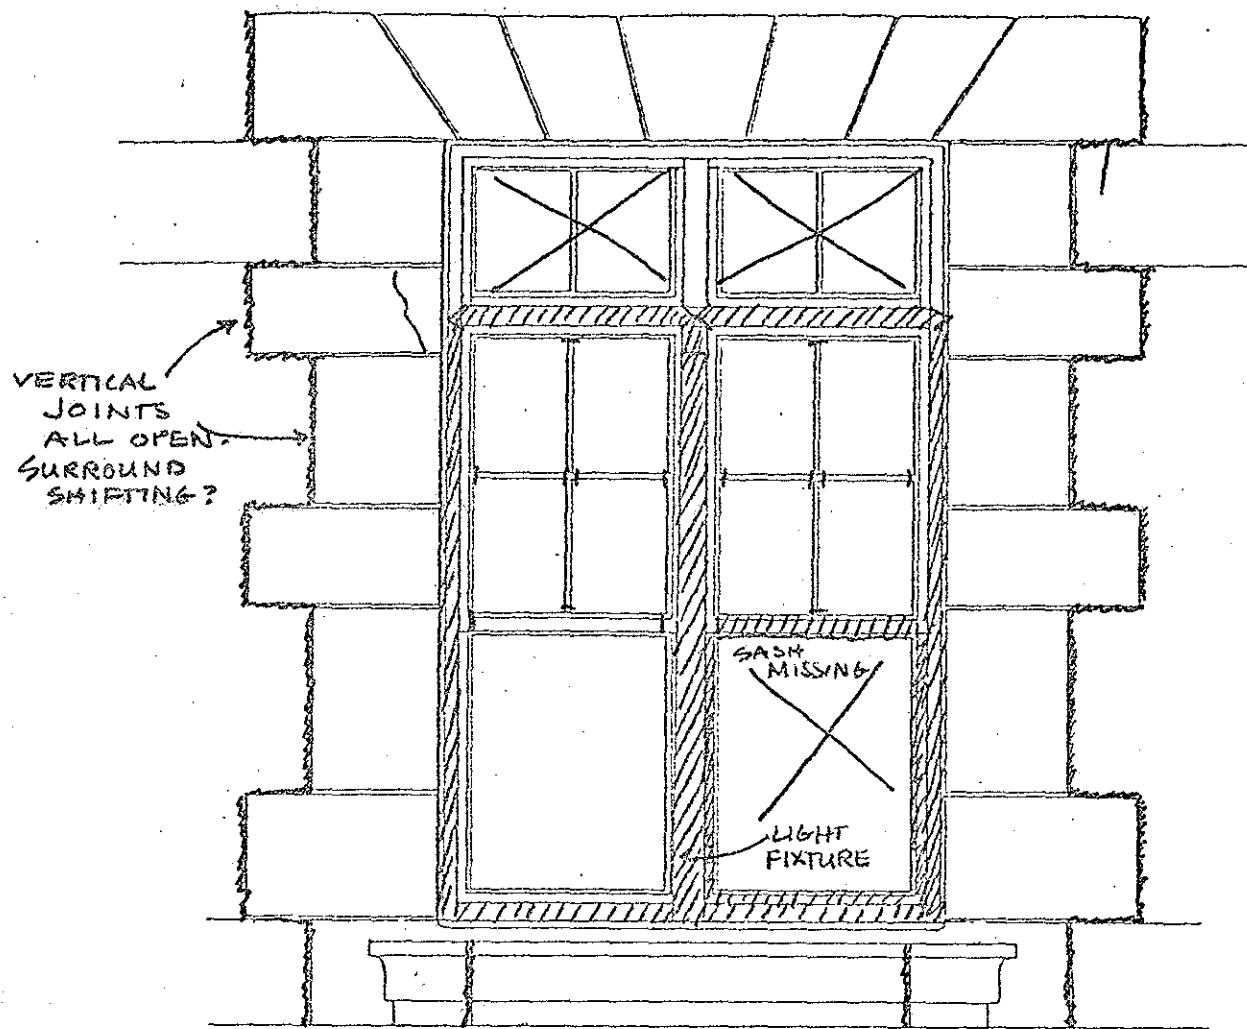
J. SECOND FLOOR EXTERIOR ELEVATIONS	NUMBER E 203	CLASS 3
MECHANICAL AND ELECTRICAL REHABILITATION MAIN BUILDING ELLIS ISLAND Statue of Liberty National Monument, New York	BUILDING CONSERVATION TECHNOLOGY THE DEGENGHEZ GROUP 19 West 44th Street, New York NY 10036

INTERIOR:

- REPLACE HEAD & TRANSOM
- REPLACE NORTH (RIGHT) STOOL
- SOUTH JAMB PULLING APART
- NORTH JAMB SPLIT, WINDOW FALLING IN

NO GRILL

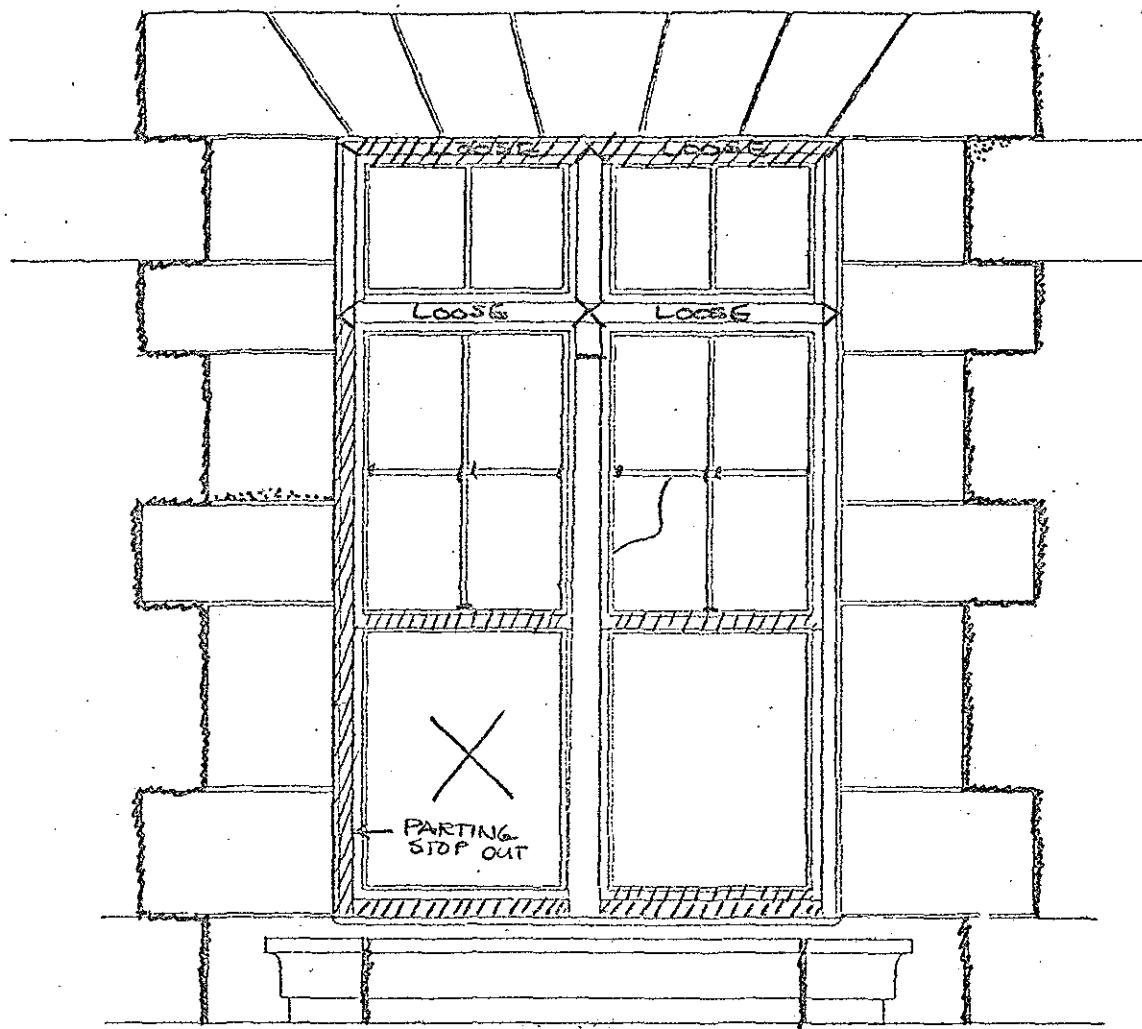
J. SECOND FLOOR EXTERIOR ELEVATIONS	NUMBER E 204	CLASS 3
MECHANICAL AND ELECTRICAL REHABILITATION MAIN BUILDING ELLIS ISLAND Statue of Liberty National Monument, New York	BUILDING CONSERVATION TECHNOLOGY THE DIAZONI GROUP

- INTERIOR:
- NORTH (RIGHT) JAMB & ROTTING, FRAME FALLING IN
 - REPLACE STOOL, SOUTH (LEFT) WINDOW
 - REPLACE HEAD & TRANSOM

NO GRILL

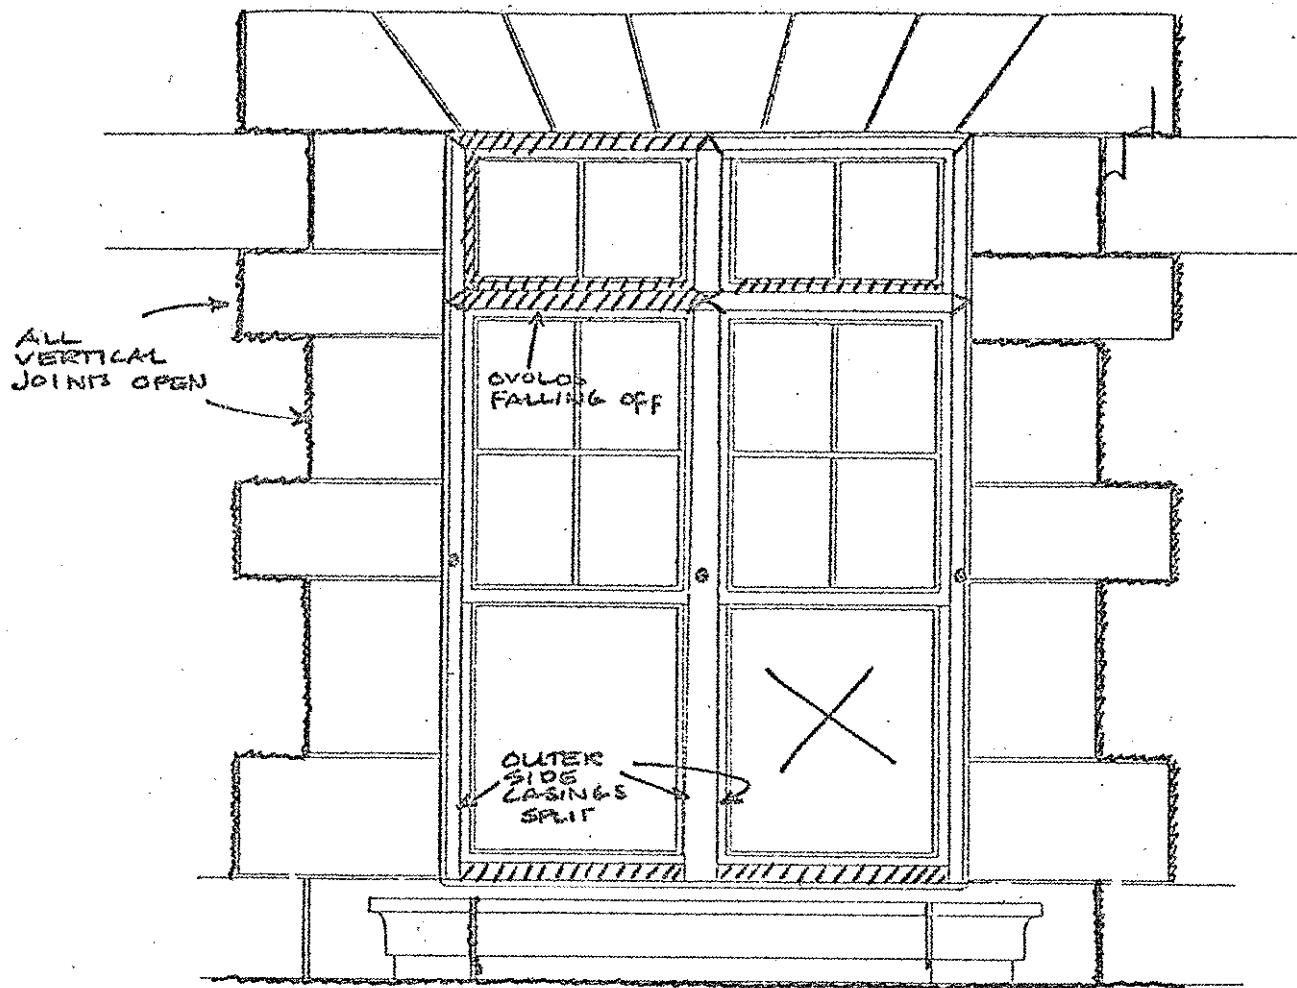
J SECOND FLOOR EXTERIOR ELEVATIONS	NUMBER E 205	CLASS 2
MECHANICAL AND ELECTRICAL REHABILITATION MAIN BUILDING ELLIS ISLAND Statue of Liberty National Monument, New York	KILDING CONSERVATION TECHNOLOGY THE DEGRANZ GROUP	19 West 44th Street, New York NY 10036

INTERIOR:

- SASH WILL NOT OPEN.
- FRAMING ON SOUTH (LEFT) SIDE SPLIT)
- HEAD FASCIA WARPED- REPLACE

NO GRILL
