historic structures report

mechanical/electrical rehabilitation

main building

STATUE OF LIBERTY ELLIS ISLAND

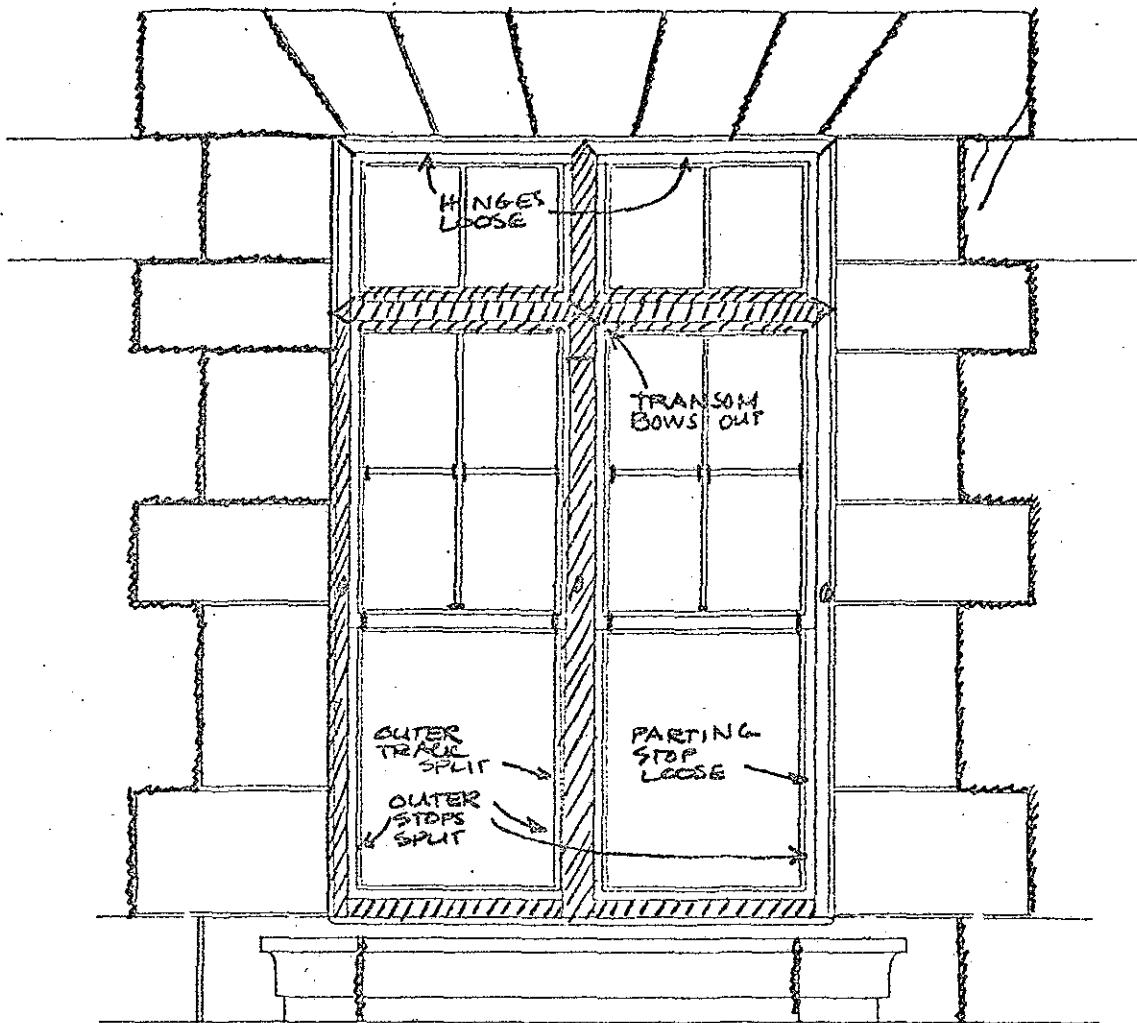
MECHANICAL AND ELECTRICAL REHABILITATION MAIN BUILDING ELLIS ISLAND Statue of Liberty National Monument, New York	NUMBER E 206 BUILDING CONSERVATION TECHNOLOGY THE DEDARANTZ GROUP 19 West 46th Street, New York NY 10036	CLASS 3
--	--	------------

INTERIOR: REPLACE BOTH STOOLS

NO GRILL

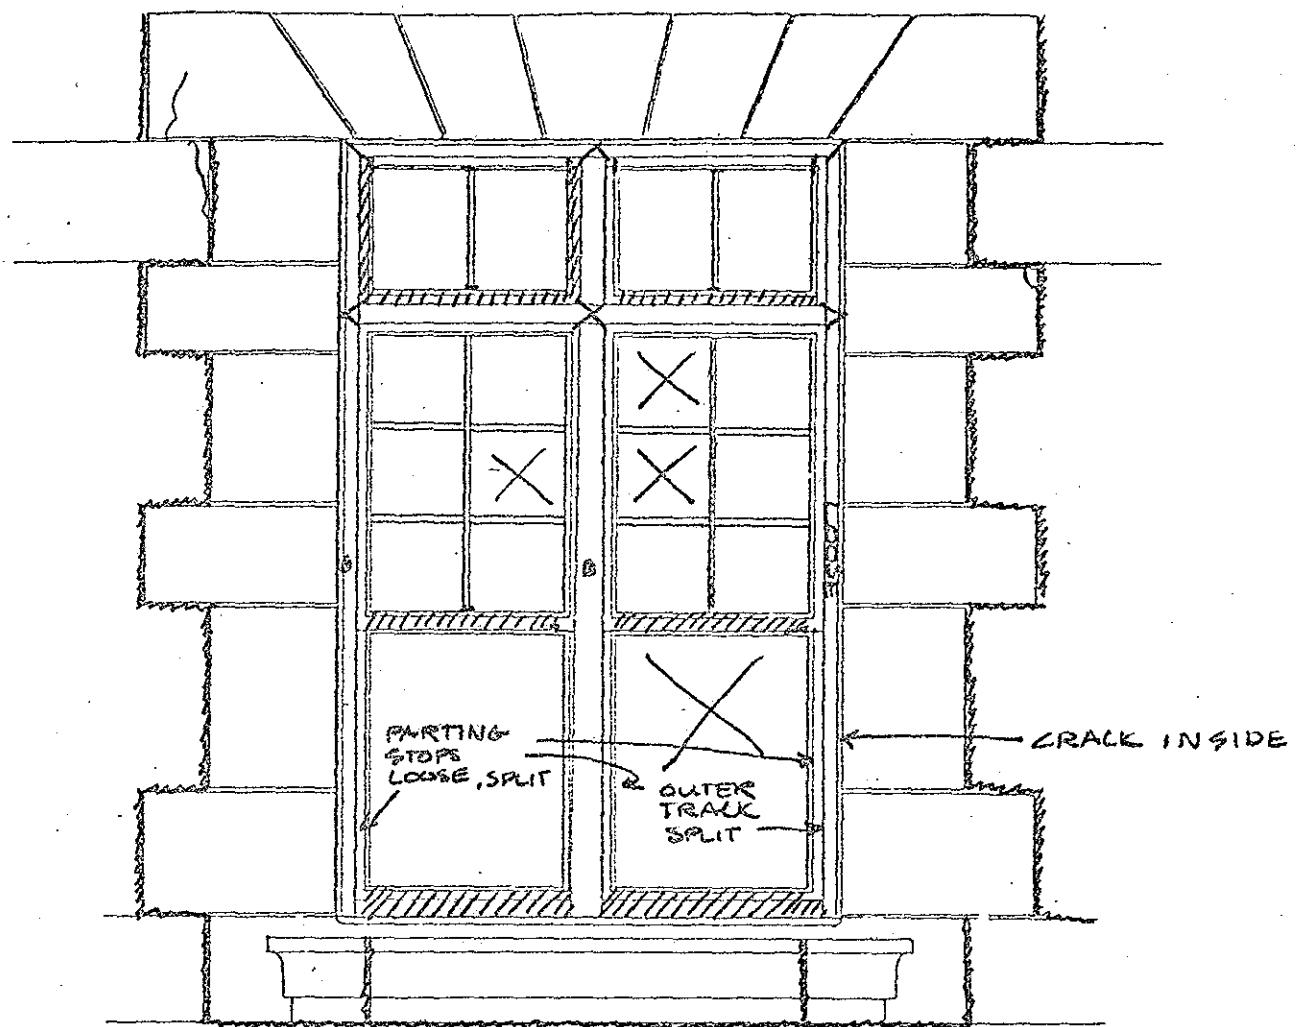
INTERIOR: -HEAD & TRANSOM SPLIT, ROTTED!

NO GRILL

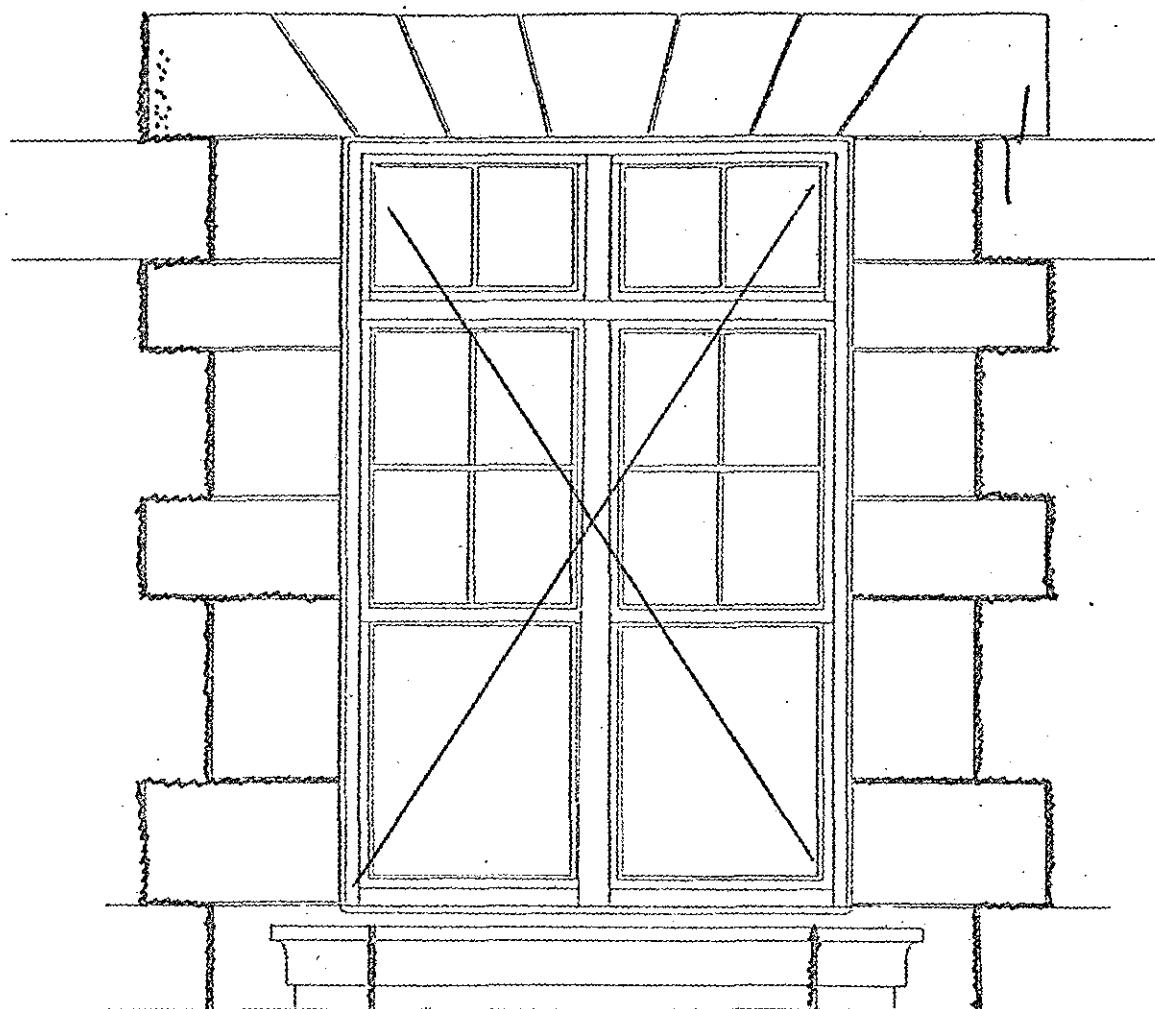
J. SECOND FLOOR EXTERIOR ELEVATIONS	NUMBER E208	CLASS 3
MECHANICAL AND ELECTRICAL REHABILITATION MAIN BUILDING ELLIS ISLAND Statue of Liberty National Monument, New York	WILLING CONSERVATION TECHNOLOGY THE DEDMANZ GROUP	19 West 44th Street, New York NY 10036

INTERIOR: IRON LINTEL EXPOSED & RUSTY

NO GRILL

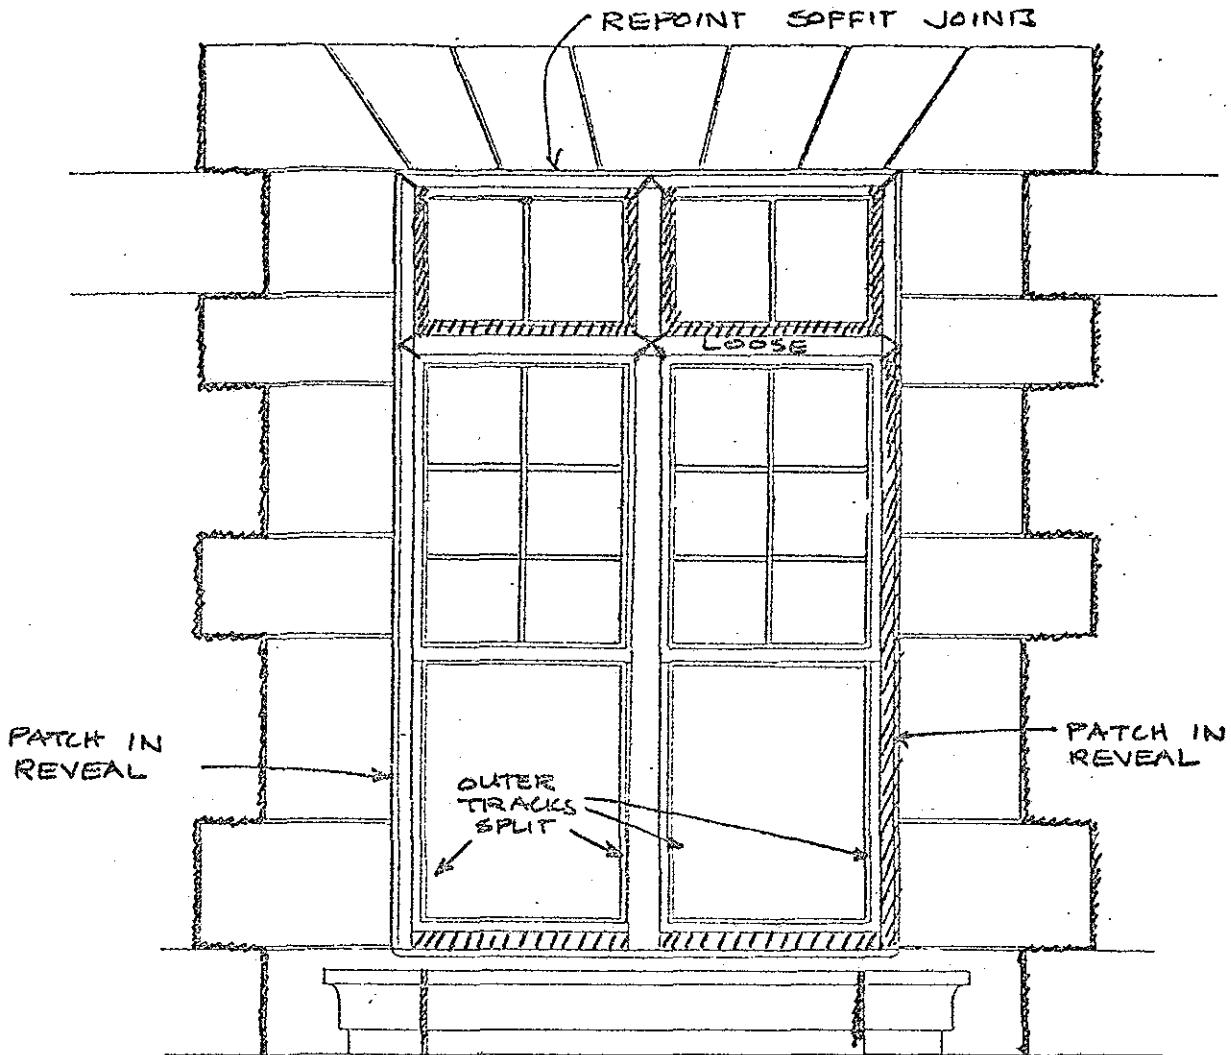
INTERIOR:

- REPLACE BOTH STOOLS
- SASH WILL NOT OPEN

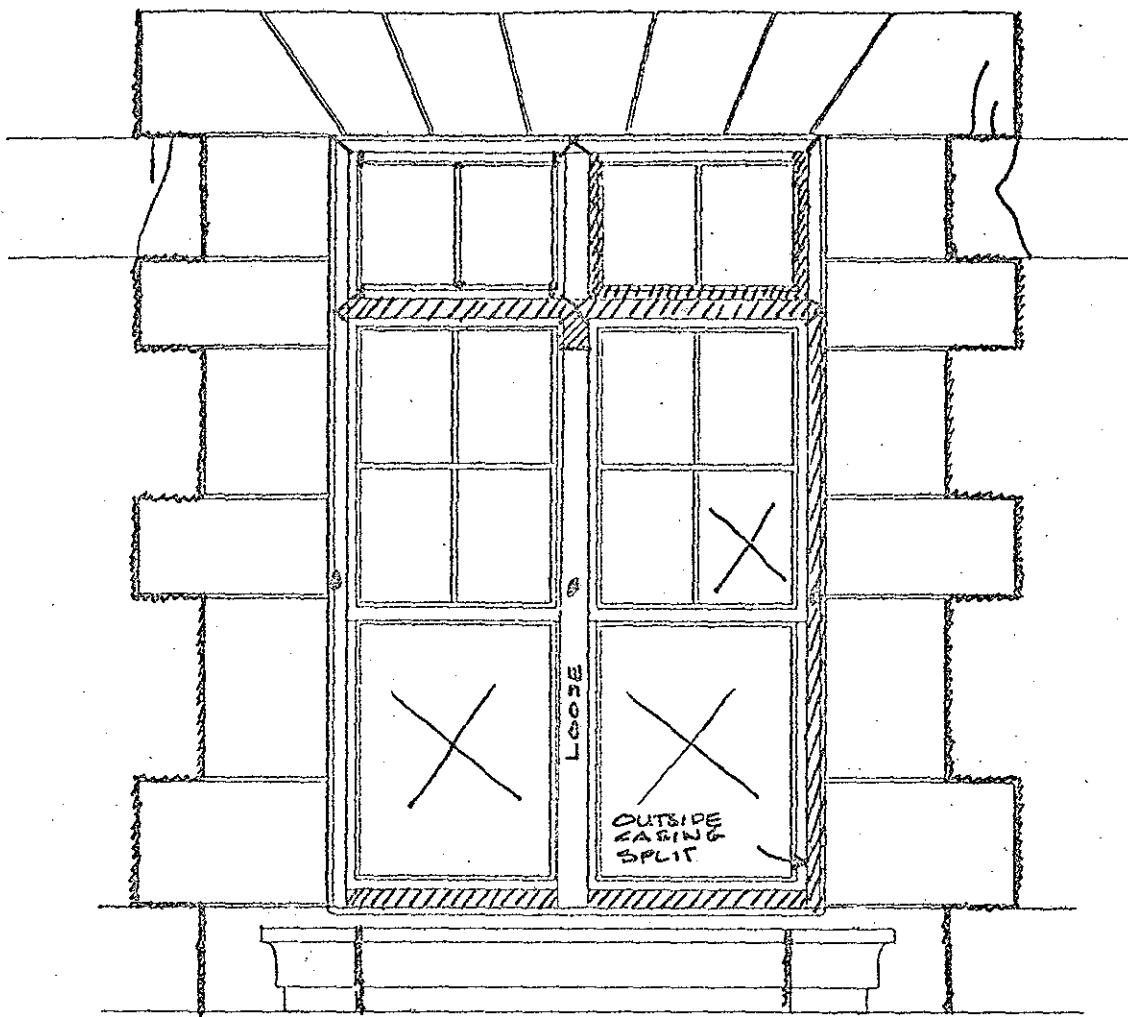
INTERIOR: TRANSOM FASCIA SPLIT

NO GRILL

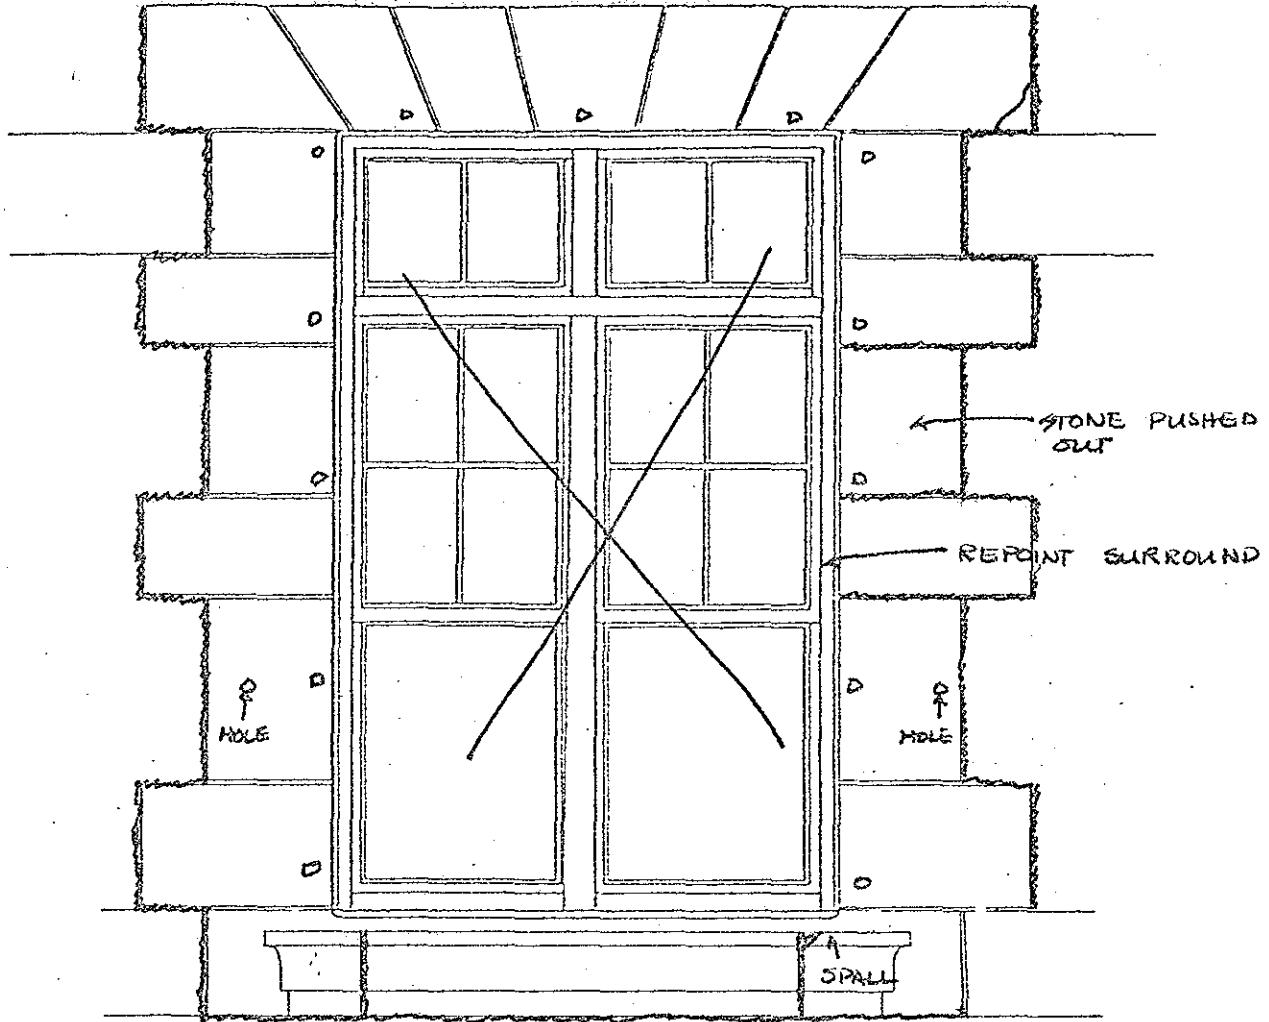
J SECOND FLOOR EXTERIOR ELEVATIONS	NUMBER 5203	CLASS 3
MECHANICAL AND ELECTRICAL REHABILITATION MAIN BUILDING ELLIS ISLAND Statue of Liberty National Monument, New York	BUILDING CONSERVATION TECHNOLOGY THE DECORATORS GROUP 19 West 44th Street, New York NY 10036

WINDOW HAS FALLEN OUT

GRILL REMOVED

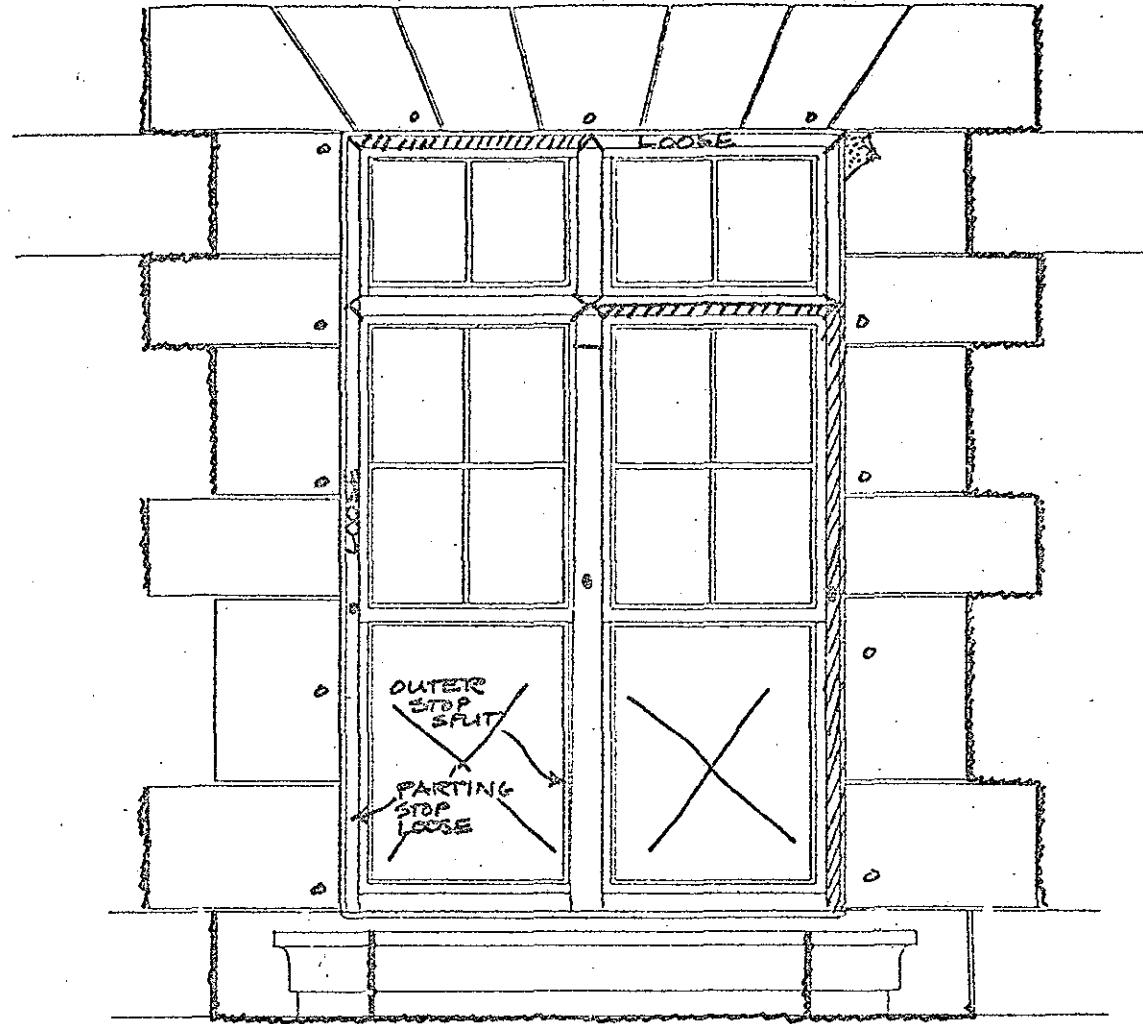
J. SECOND FLOOR EXTERIOR ELEVATIONS	NUMBER S 204	CLASS 2 wood
MECHANICAL AND ELECTRICAL REHABILITATION MAIN BUILDING ELLIS ISLAND Statue of Liberty National Monument, New York	BUILDING CONSERVATION TECHNOLOGY THE DEGENKOLB GROUP	2 stone

INTERIOR:

- SOFFIT OF HEAD SPLIT
- CEILING LOWERED TO TRANSOM BAR

GRILL REMOVED

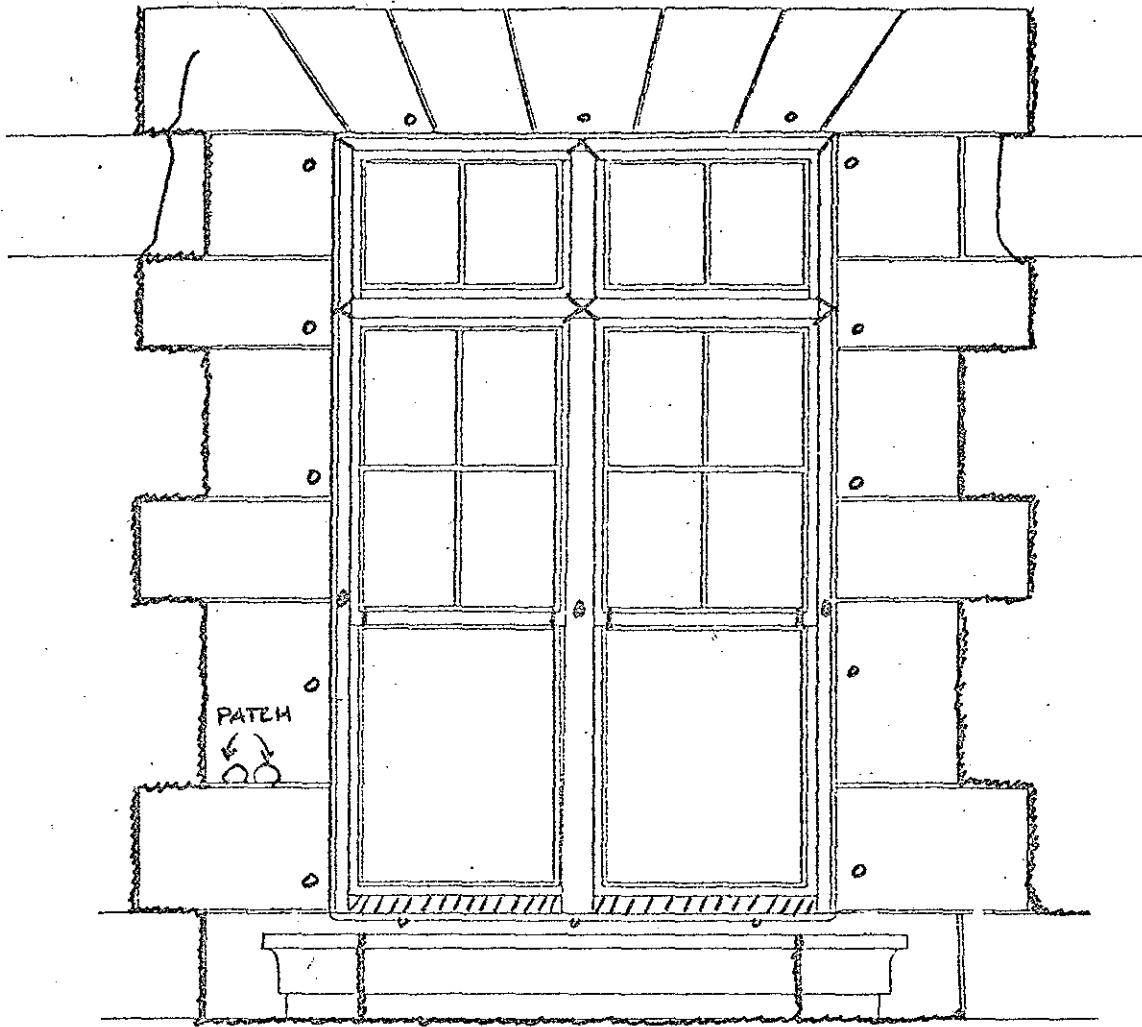
J SECOND FLOOR EXTERIOR ELEVATIONS	NUMBER 5205	CLASS 2
MECHANICAL AND ELECTRICAL REHABILITATION MAIN BUILDING ELLIS ISLAND Statue of Liberty National Monument, New York	BUILDING CONSERVATION TECHNOLOGY THE DEDERONKOFF GROUP 19 West 44th Street, New York NY 10036

INTERIOR:

- MLDGS LOOSE, JOINTS OPEN
- TRANSOM MECHANISM RUSTED

GRILL REMOVED.

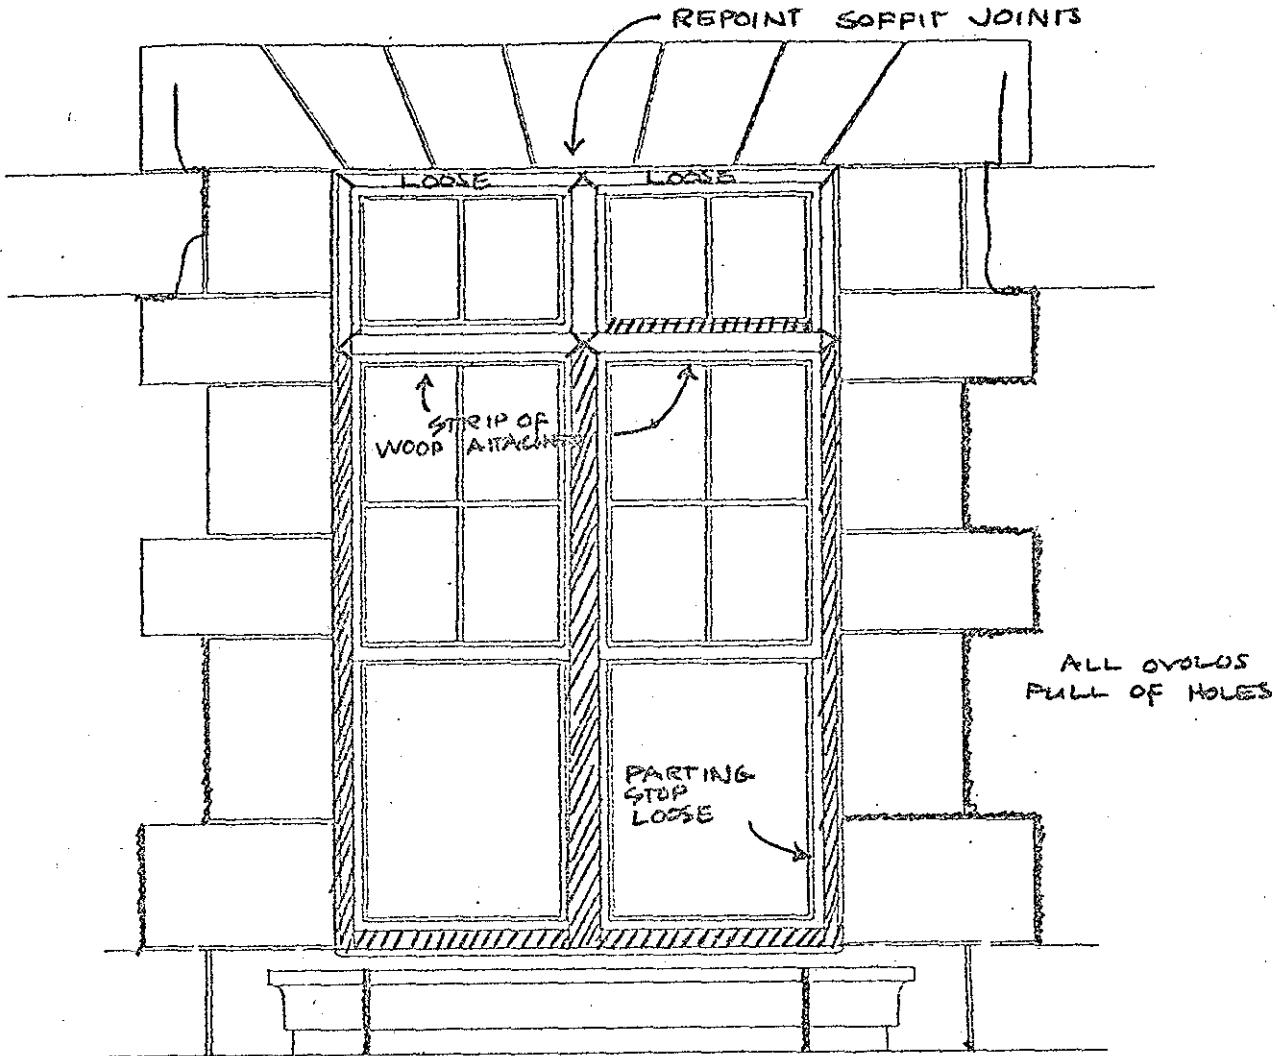
INTERIOR: • REPLACE HEAD

NO GRILL

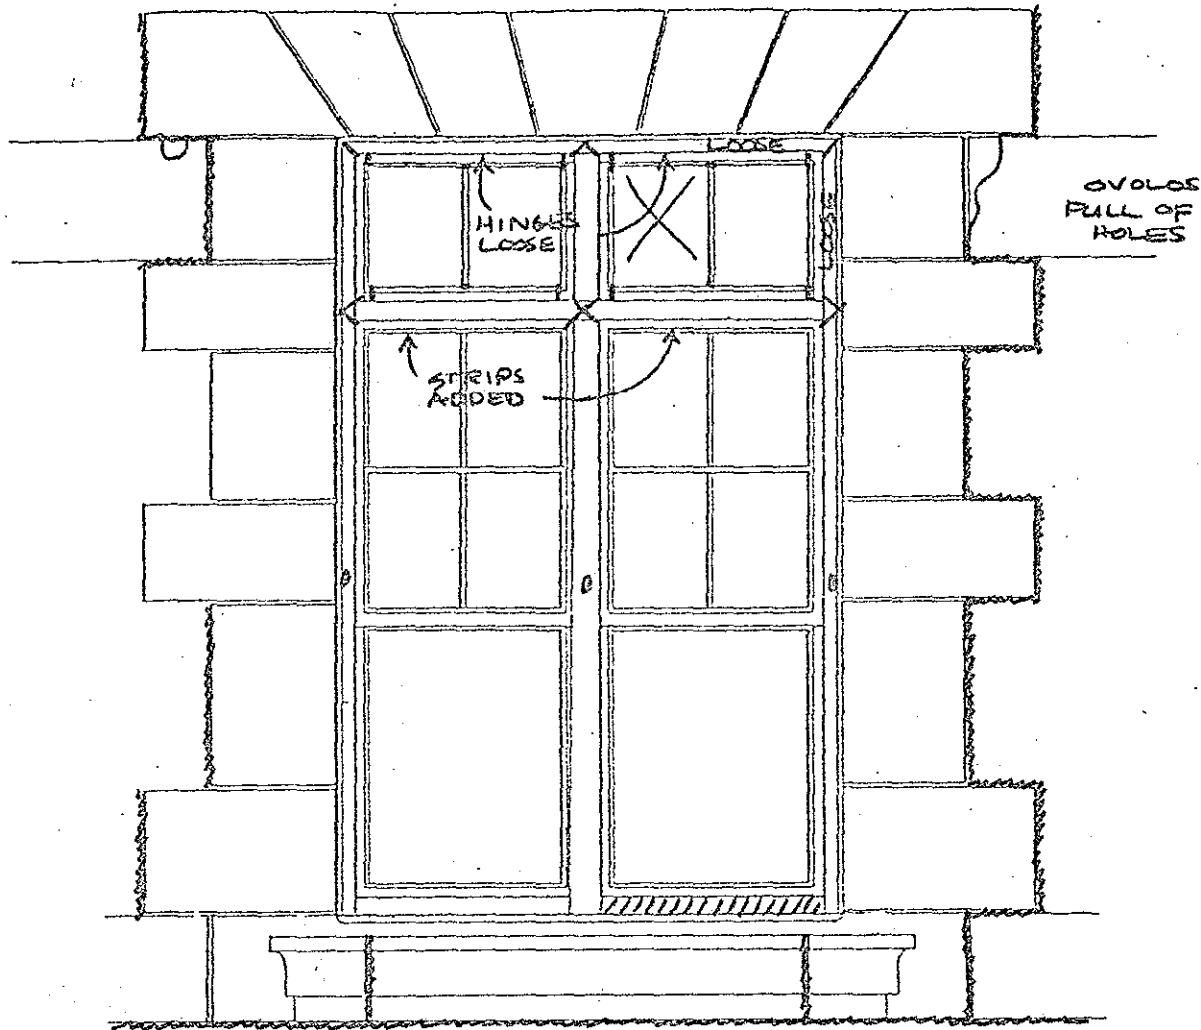
J SECOND FLOOR EXTERIOR ELEVATIONS	NUMBER 5212	CLASS 2
MECHANICAL AND ELECTRICAL REHABILITATION MAIN BUILDING ELLIS ISLAND Statue of Liberty National Monument, New York	BUILDING OBSERVATION PROGRAM THE DEDONOFF GROUP

INTERIOR : EAST JAMB FRAMING ROTTED, WINDOW
BEGINNING TO SAG IN FROM TOP.

NO GRILL

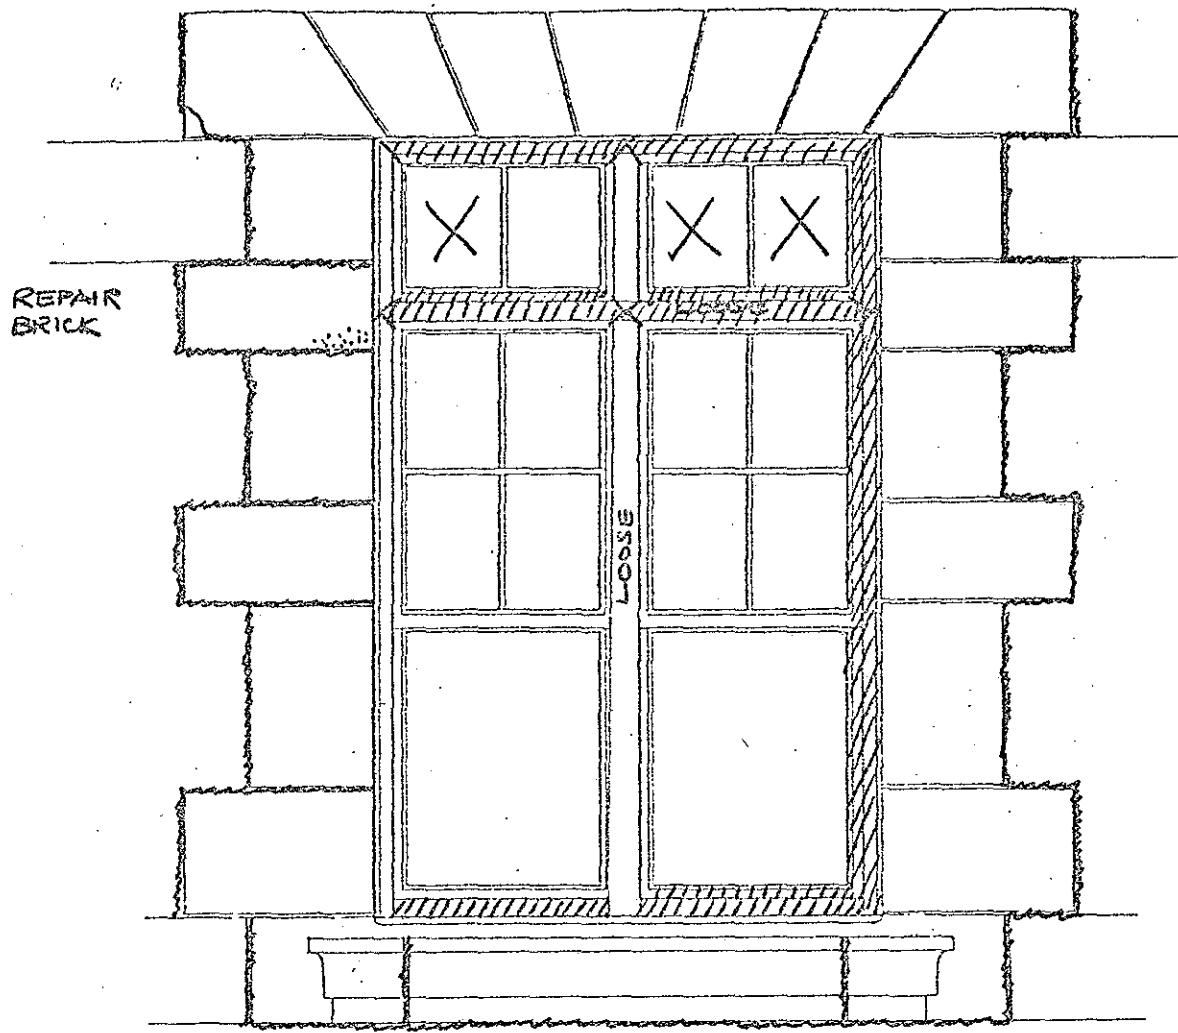
J. SECOND FLOOR EXTERIOR ELEVATIONS	NUMBER S 213	CLASS 73
MECHANICAL AND ELECTRICAL REHABILITATION MAIN BUILDING ELLIS ISLAND Statue of Liberty National Monument, New York	BUILDING CONSERVATION TECHNOLOGY THE DENGRAZI GROUP

INTERIOR:

- 2" GAP BETWEEN TRANSOM BAR & CENTER JAMB
- BOTH JAMBS & HEAD FRAMING ROTTED, WINDOW FALLING IN FROM TOP
- EAST STOOL ROTTED

NO GRILL

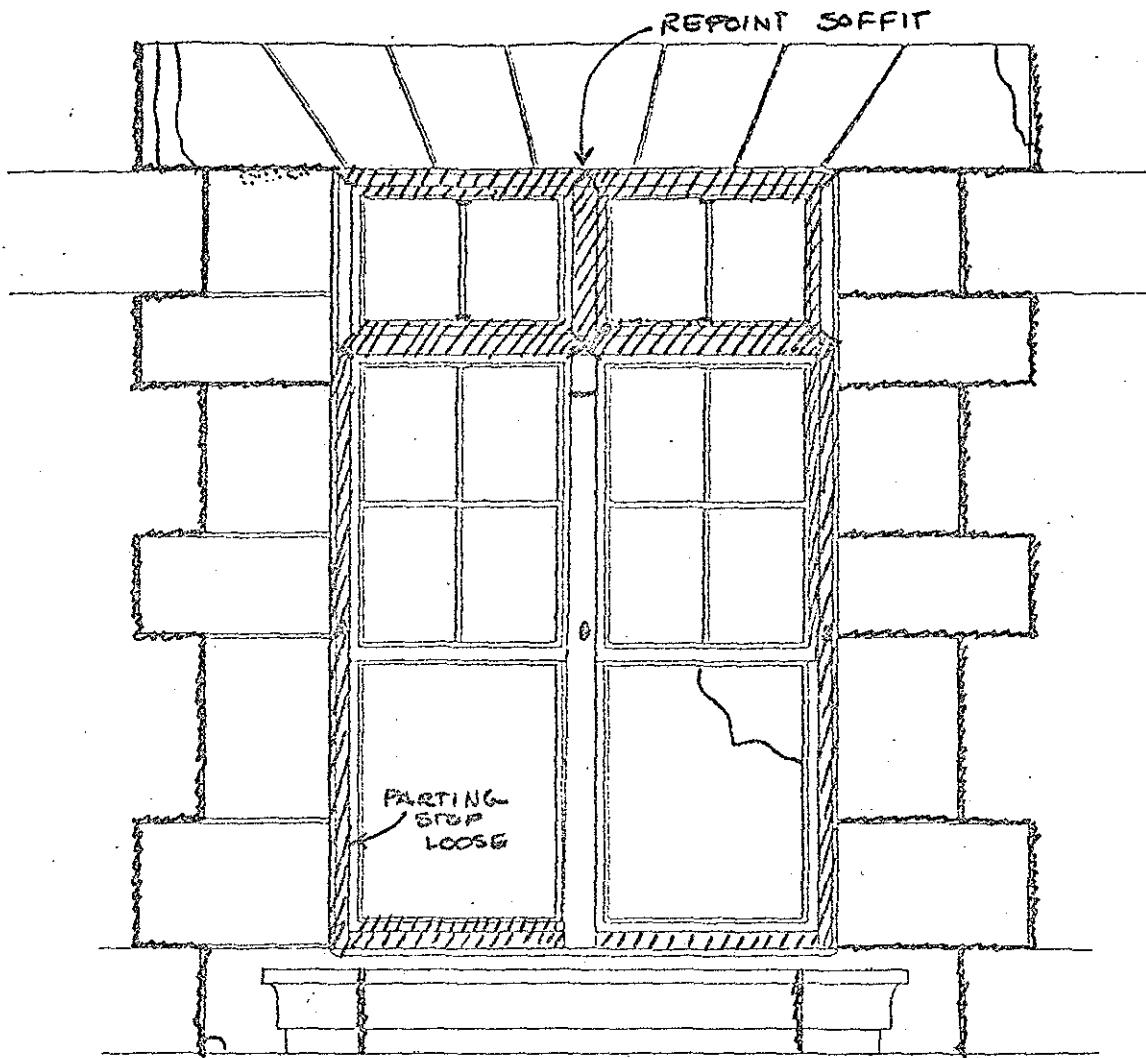
J. SECOND FLOOR EXTERIOR ELEVATIONS	NUMBER 5214	CLASS 3
MECHANICAL AND ELECTRICAL REHABILITATION MAIN BUILDING ELLIS ISLAND Statue of Liberty National Monument, New York	BUILDING CONSERVATION TECHNOLOGY THE BERKNER GROUP	19 West 46th Street, New York NY 10036

INTERIOR: - TRANSOM SOFFIT SPLIT
 * MLDGS AT HEAD LOOSE, WARPED
 * FRAME BEGINNING TO FALL IN

NO GRILL

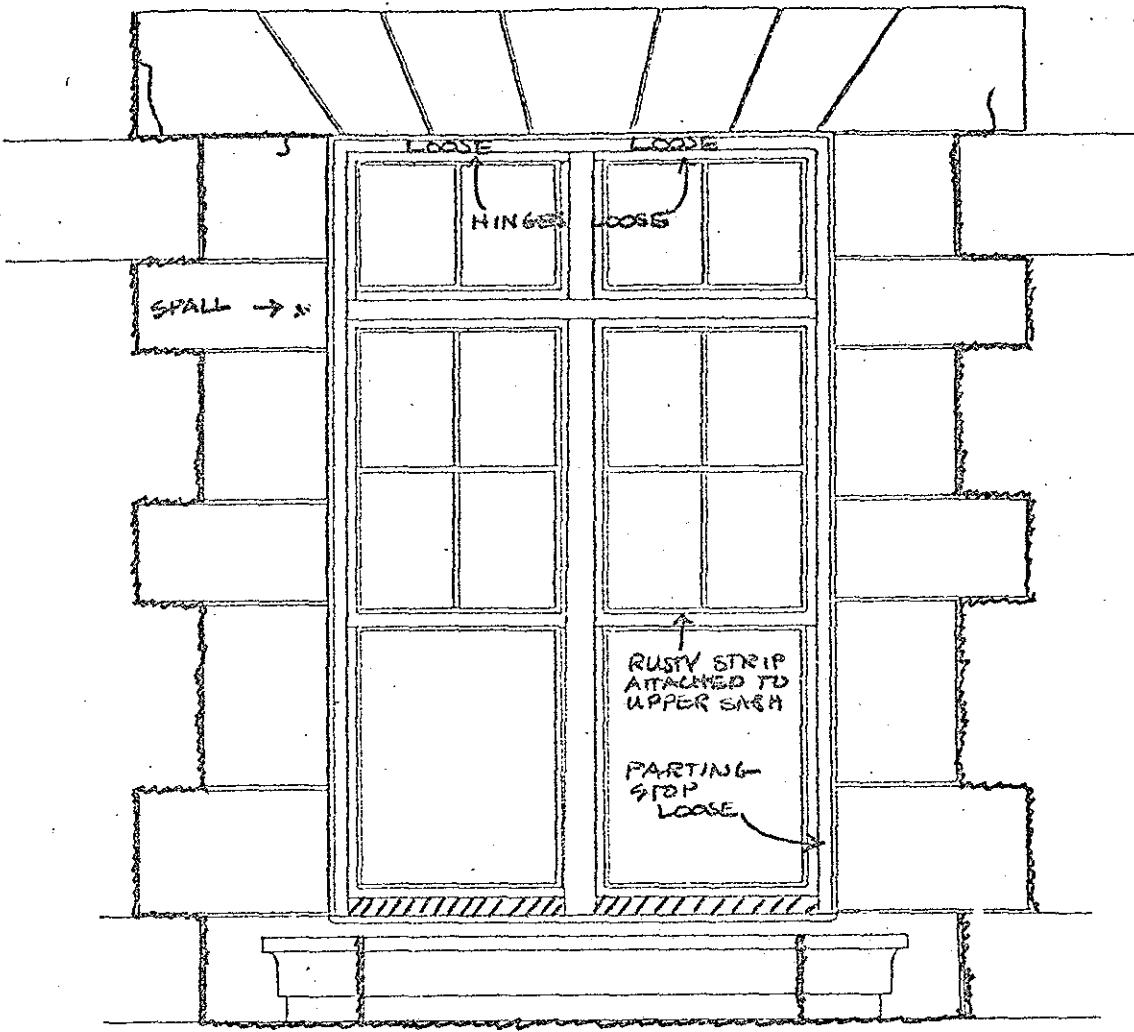
J SECOND FLOOR EXTERIOR ELEVATIONS	NUMBER S215	CLASS 2
MECHANICAL AND ELECTRICAL REHABILITATION MAIN BUILDING ELLIS ISLAND Statue of Liberty National Monument, New York	BUILDING CONSERVATION TECHNOLOGY THE DENGWERTZ GROUP 19 West 44th Street, New York NY 10036

FRAME BUILT ON TOP OF OVOLOS - IS NOW SPLIT - REMOVE

NO GRILL

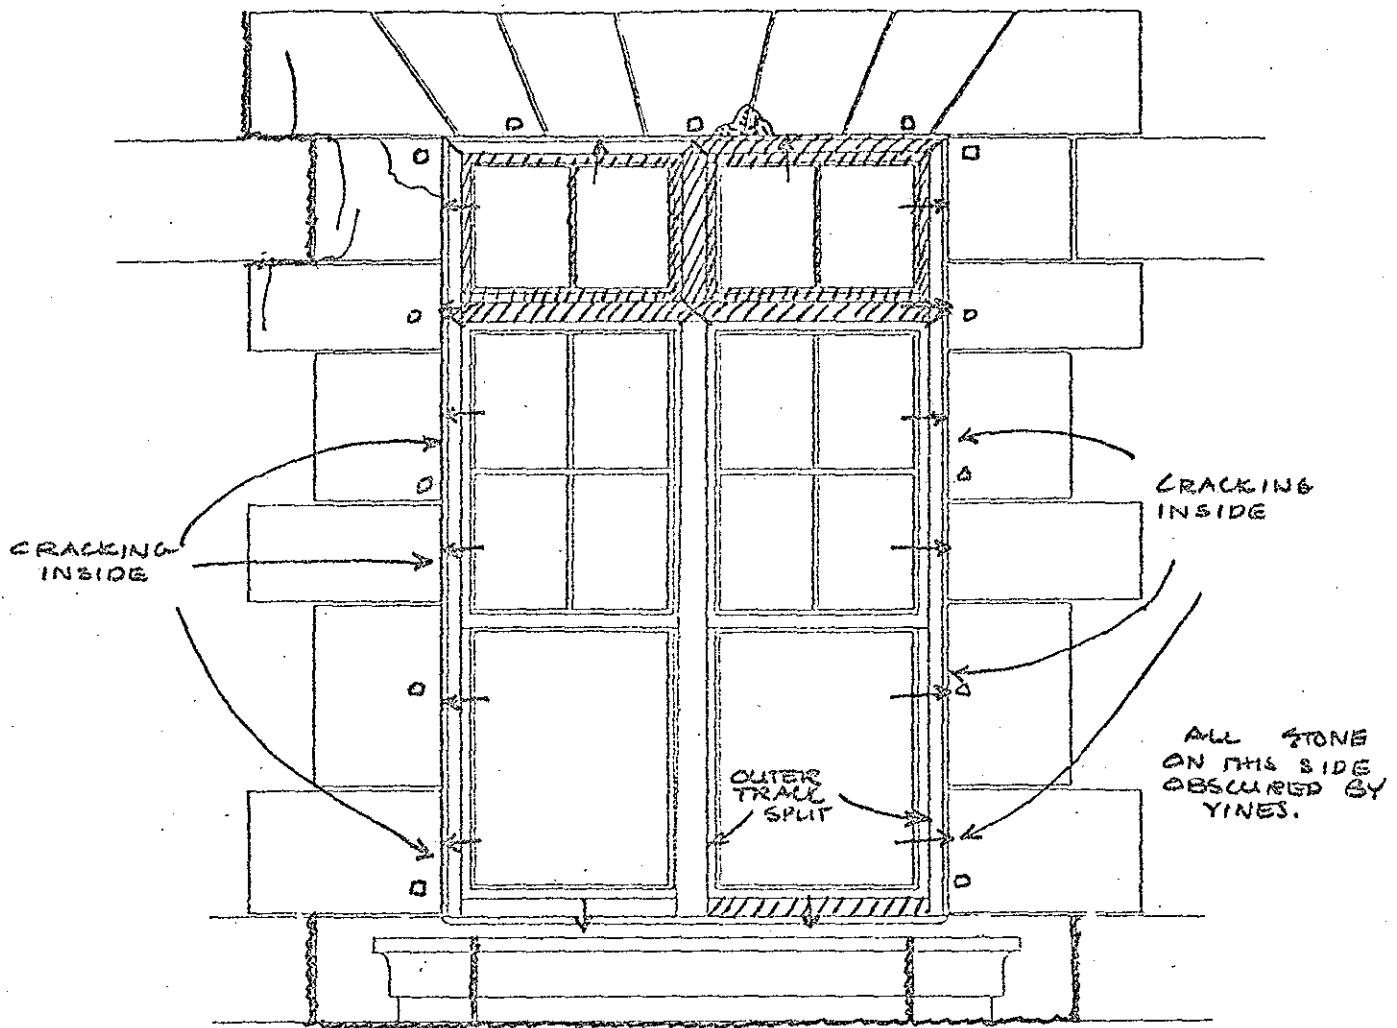
INTERIOR: HEAD, TRANSOM, SOUTH (RIGHT) JAMB ROTTED

GRILL

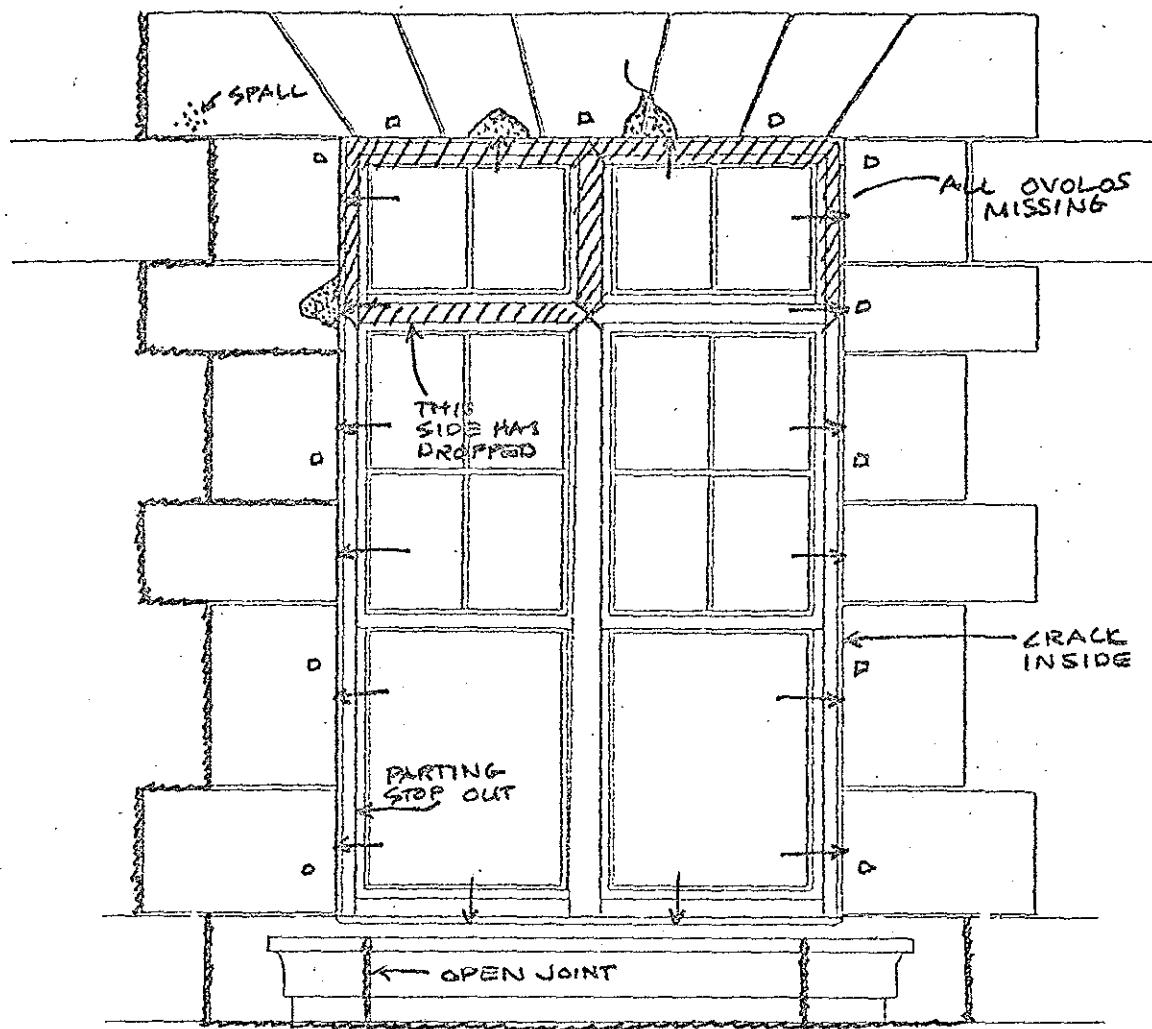
J SECOND FLOOR EXTERIOR ELEVATIONS	NUMBER W202	CLASS 3 wood
MECHANICAL AND ELECTRICAL REHABILITATION MAIN BUILDING ELLIS ISLAND Statue of Liberty National Monument, New York	WELDING OBSERVATION TECHNOLOGY THE DEGENARATZ GROUP 19 West 44th Street, New York NY 10036	2 stone

INTERIOR:

- HEAD MISSING
- STEEL LINTEL RUSTED
- BOTH JAMBS MISSING
- WINDOW ABOUT TO FALL IN

GRILL

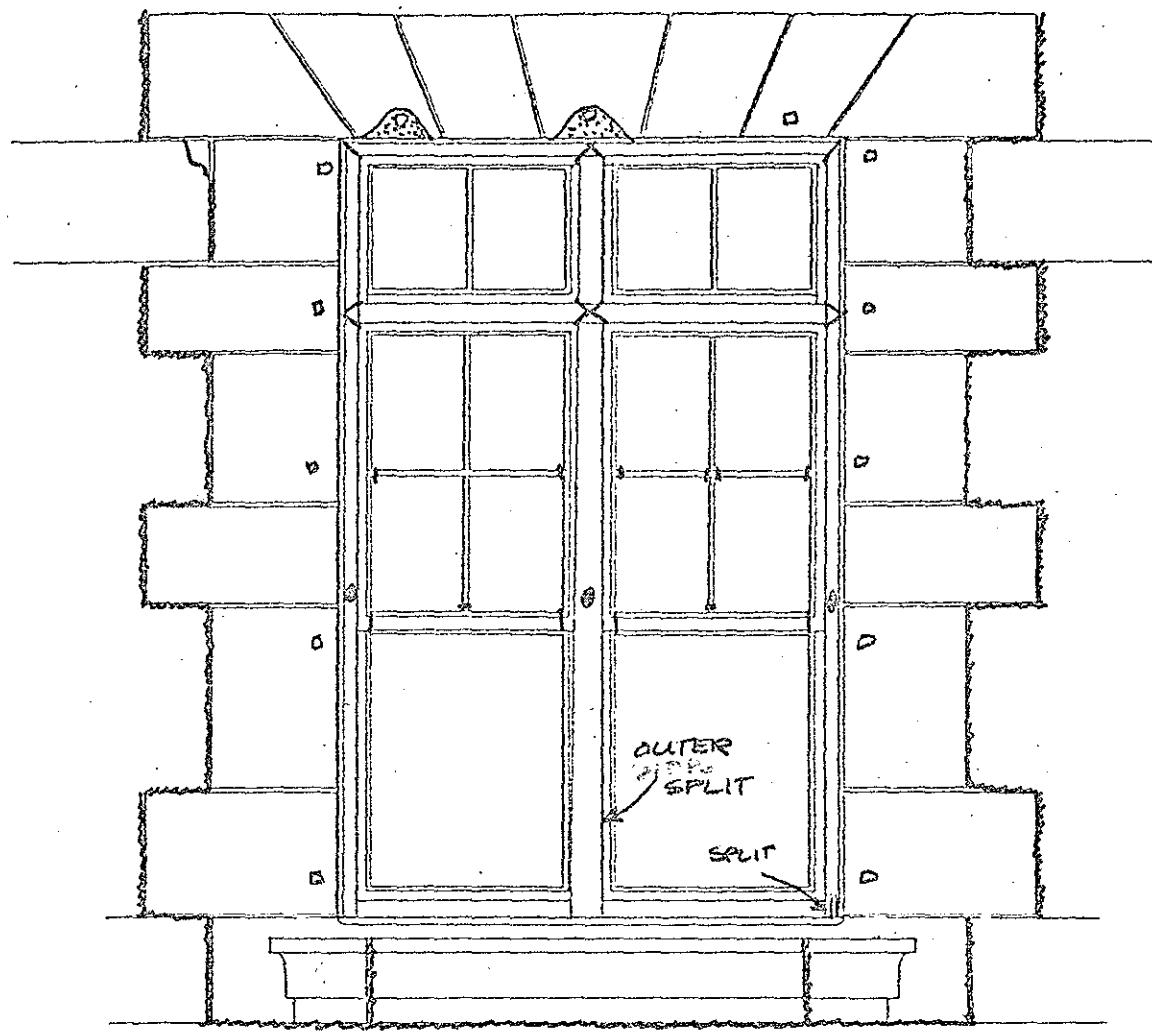
J SECOND FLOOR EXTERIOR ELEVATIONS	NUMBER W 203	CLASS 2
MECHANICAL AND ELECTRICAL REHABILITATION MAIN BUILDING ELLIS ISLAND Statue of Liberty National Monument, New York	BUILDING PRESERVATION TECHNOLOGY THE DEENGANZ GROUP 19 West 46th Street, New York NY 10036

INTERIOR:

- ALL MLDGS LOOSE
- TRANSOM MECHANISM RUSTY
- SOFFITS OF HEAD & TRANSOM & TRANSOM FASCIA SPLIT

GRILL

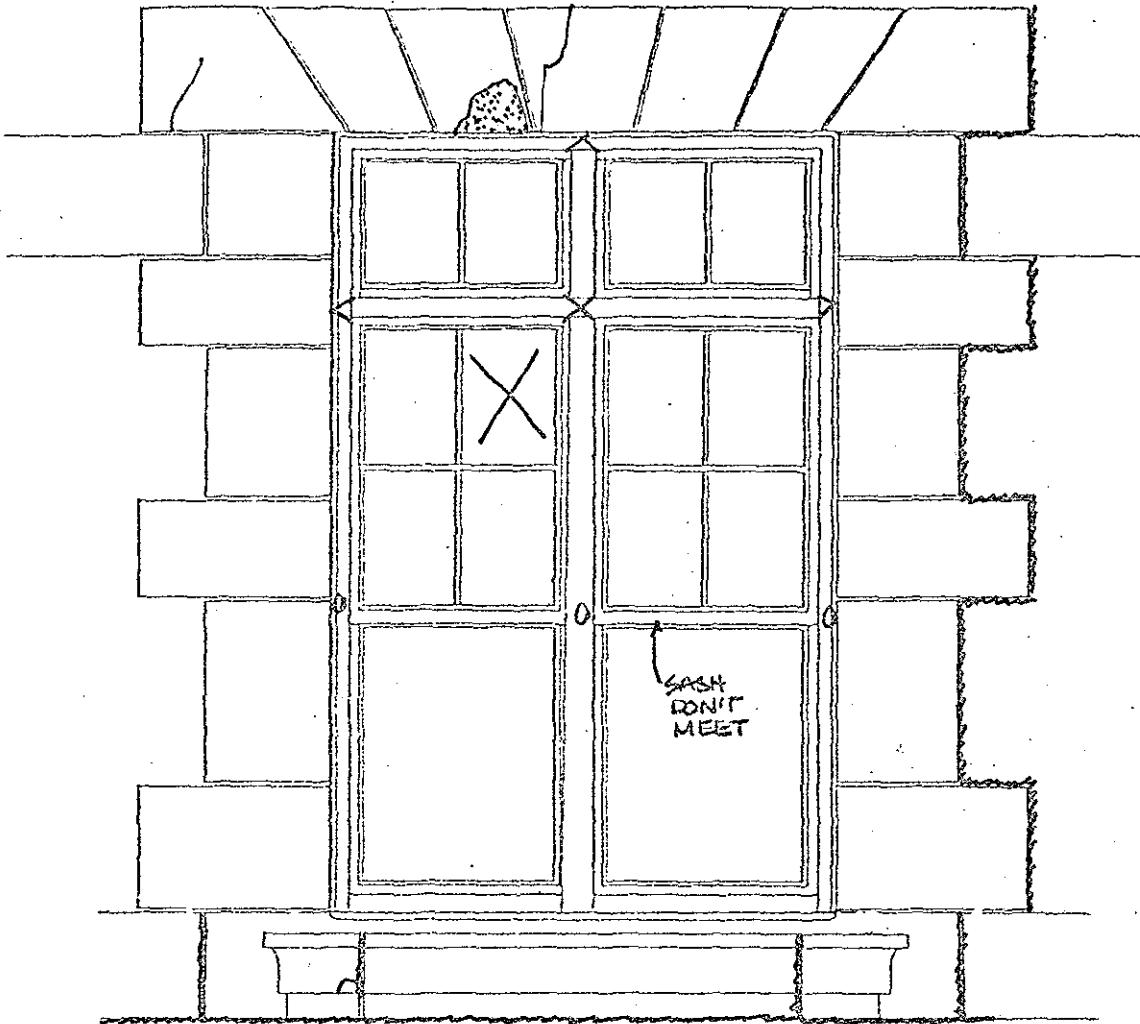
J. SECOND FLOOR EXTERIOR ELEVATIONS	NUMBER W204	CLASS 2
MECHANICAL AND ELECTRICAL REHABILITATION MAIN BUILDING ELLIS ISLAND Statue of Liberty National Monument, New York	BUILDING OBSERVATION TECHNOLOGY THE DIFERANTZ GROUP

INTERIOR:

- REPLACE SPLIT SPLINT ON NORTH (LEFT) WINDOW
- ALL MLDGS. WARPED, LOOSE
- SOFFIT OF HEAD WET
- SOFFIT OF TRANSOM SPLIT, POORLY REPAIRED
- TRANSOM MECHANISM RUSTY

GRILL

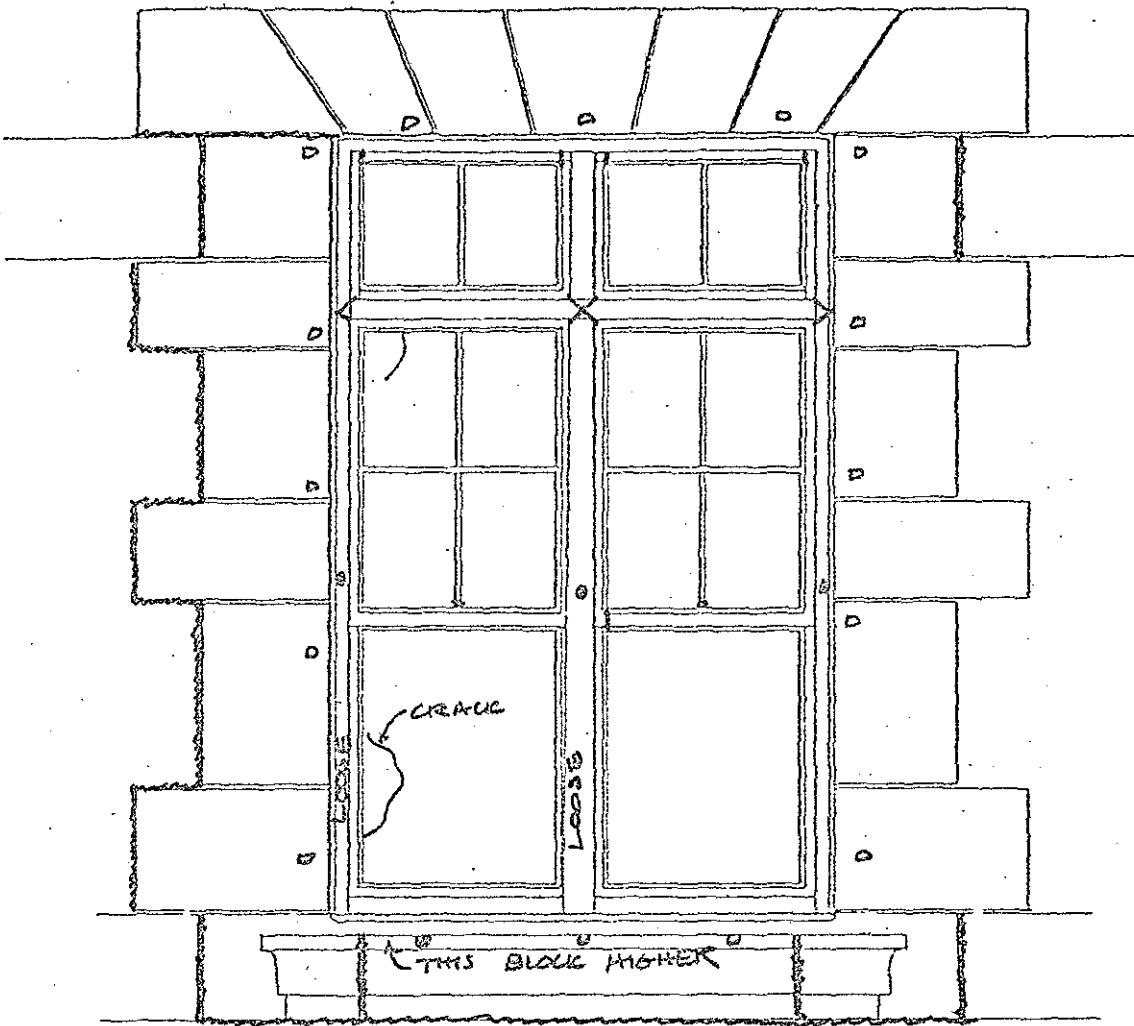
INTERIOR:

- ALL MLDGS FRAMING OPENINGS LOOSE, WARPED
- TRANSMOM MECHANISM RUSTED
