historic structures report

mechanical/electrical rehabilitation

main building

STATUE OF LIBERTY ELLIS ISLAND

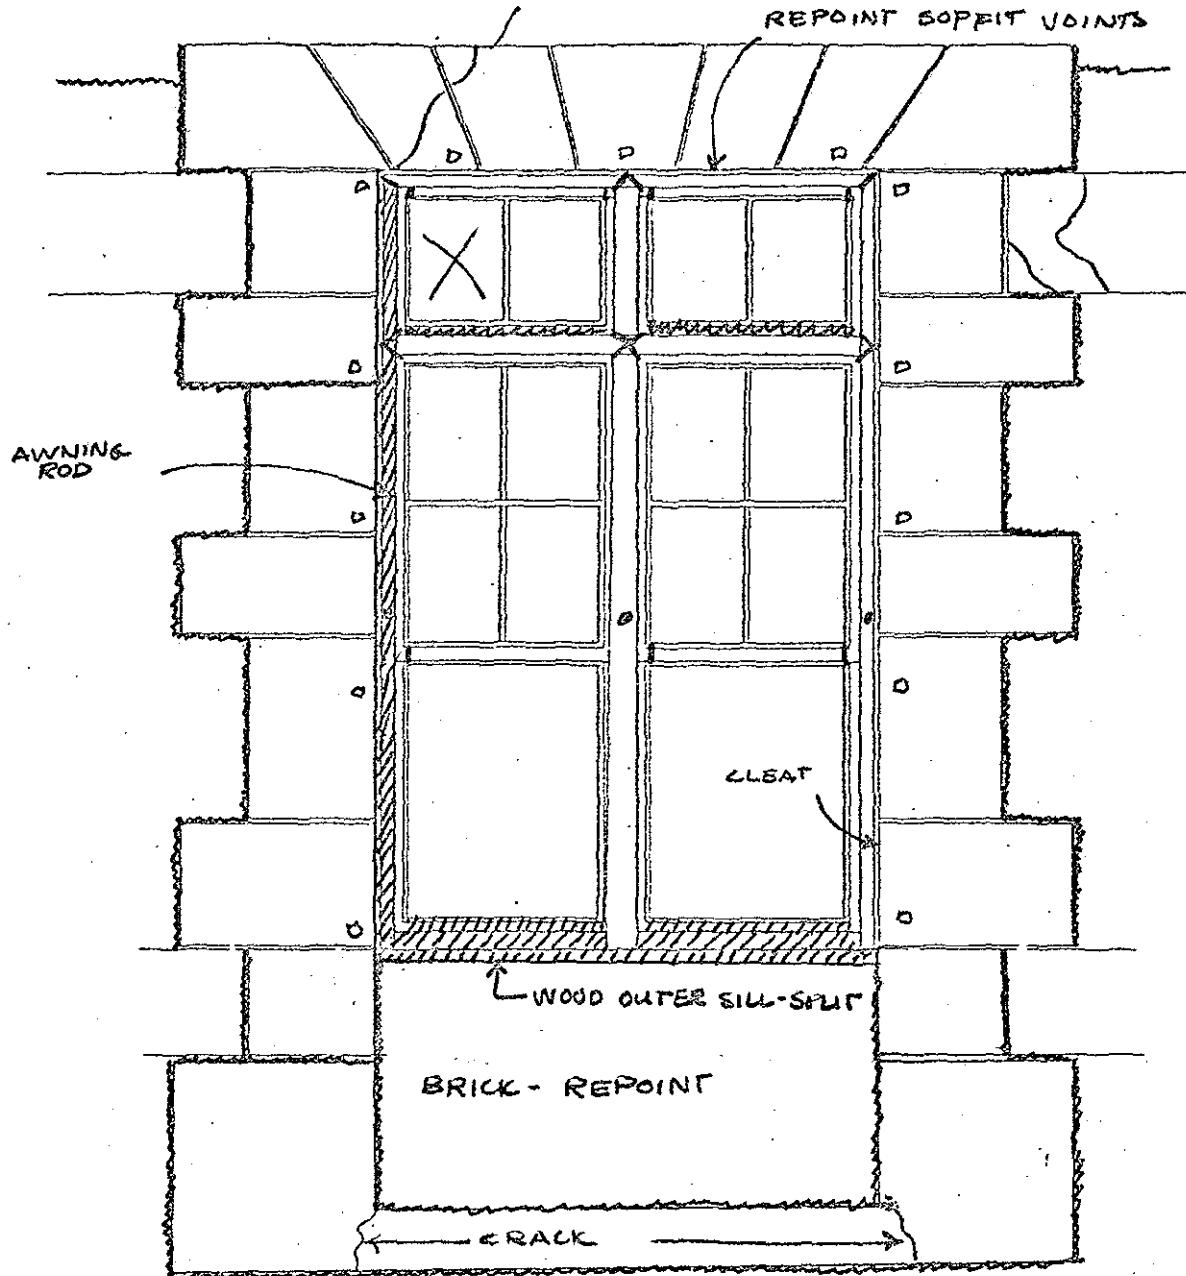
J SECOND FLOOR EXTERIOR ELEVATIONS	NUMBER W 206	CLASS 2
MECHANICAL AND ELECTRICAL REHABILITATION MAIN BUILDING ELLIS ISLAND Statue of Liberty National Monument, New York	BUILDING CONSERVATION TECHNOLOGY THE DIPENWALZ GROUP 19 West 44th Street, New York NY 10036

- TRANSMON SOFFIT (NORTH SIDE) & FASCIA SPLIT
- JOINTS AT HEAD OPEN
- WINDOWS STUCK SHUT
- REPLACE STOOL, SOUTH SIDE
- TRANSMON MECHANISM (RUSTED)

GRILL REMOVED

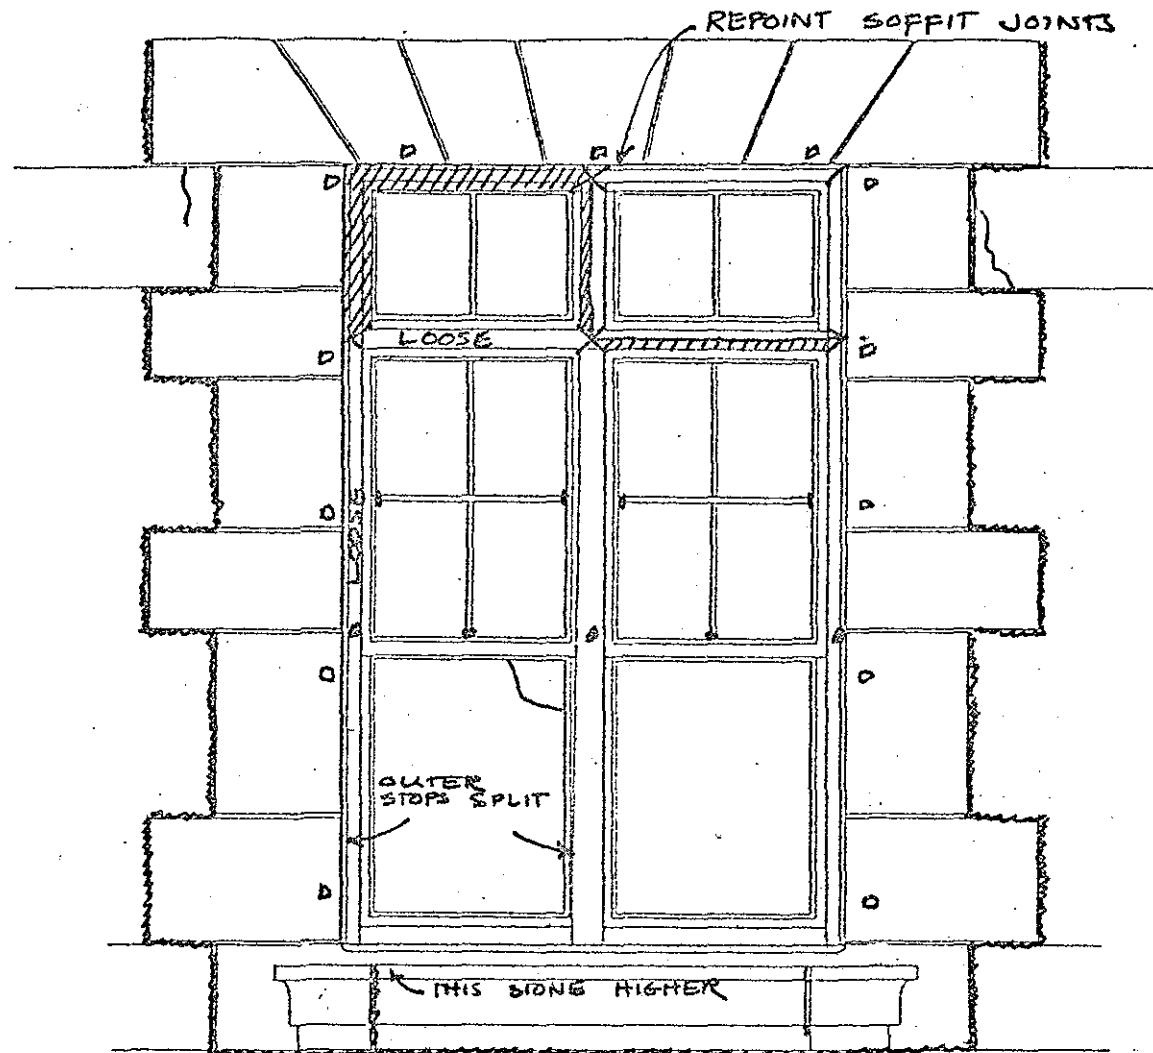
J SECOND FLOOR EXTERIOR ELEVATIONS	NUMBER W 207	CLASS 3
MECHANICAL AND ELECTRICAL REHABILITATION MAIN BUILDING ELLIS ISLAND Statue of Liberty National Monument, New York	BUILDING CONSERVATION TECHNOLOGY THE DERNANTZ GROUP

- REPLACE MISSING HEAD
- TRANSMON & JAMBS ROTTED, SPLIT
- SASH STUCK SHUT
- TRANSMON MECHANISM RUSTED

GRILL REMOVED

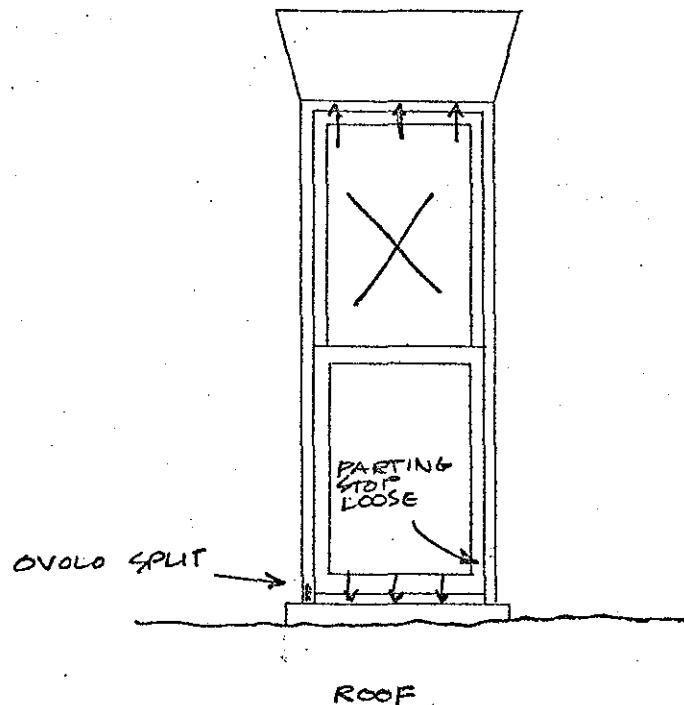
J SECOND FLOOR EXTERIOR ELEVATIONS	NUMBER W208	CLASS 3
MECHANICAL AND ELECTRICAL REHABILITATION MAIN BUILDING ELLIS ISLAND Statue of Liberty National Monument, New York	BUILDING CONSERVATION TECHNOLOGY THE DETERGENT GROUP

- INTERIOR:
- HEAD JOINTS OPEN
 - MLDGS FRAMING OPENINGS LOOSE
 - NORTH (LEFT) JAMB ROTTED
 - TRANSMON BOARDDED UP.
 - REPLACE NORTH (LEFT) STOOL.
 - COUNTERBALANCE BROKEN

GRILL REMOVED

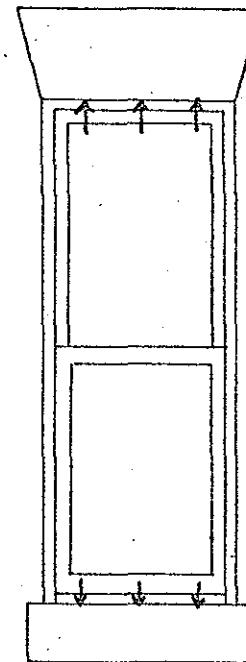
K TOKEN WINDOW (16)	NUMBER NET - 201	PLATE 1
MECHANICAL AND ELECTRICAL REHABILITATION MAIN BUILDING ELLIS ISLAND Statue of Liberty National Monument, New York	BUILDING CONSERVATION TECHNOLOGY THE EHRENKRANZ GROUP 19 West 44th Street, New York NY 10036	NET NO.

IRON BARS

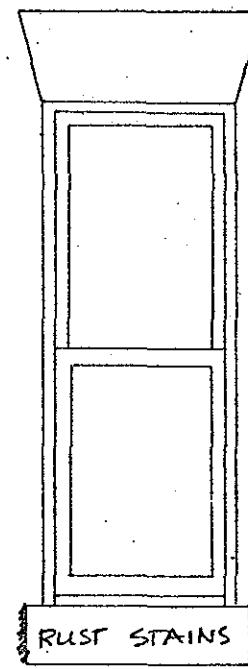
K TOWER WINDOW (16)	NUMBER NET-202	CLASS I
MECHANICAL AND ELECTRICAL REHABILITATION MAIN BUILDING ELLIS ISLAND Statue of Liberty National Monument, New York	BUILDING CONSERVATION TECHNOLOGY THE EHRENGRANTZ GROUP 19 West 44th Street, New York NY 10036

PARTING STOPS LOOSE

IRON BARS

REPAIR &
REPOINT BRICK

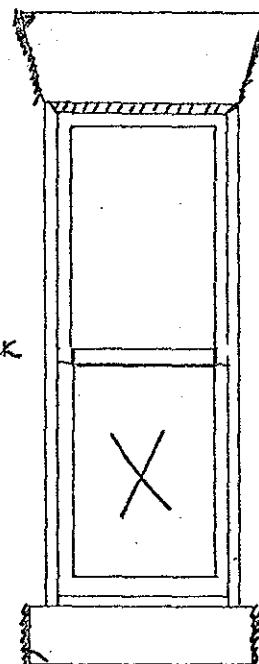
K TOWER WINDOW (16)	NUMBER NET - 203	CLASS I
MECHANICAL AND ELECTRICAL REHABILITATION MAIN BUILDING ELLIS ISLAND Statue of Liberty National Monument, New York	BUILDING CONSERVATION TECHNOLOGY THE EHRENKRANTZ GROUP 19 West 44th Street, New York NY 10036

NOT ACCESSIBLE

GRILL

REPAIR &
REPOINT BRICK

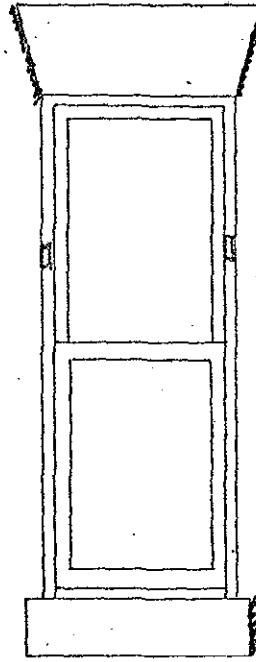
K TOWER WINDOW (16)	NUMBER NET-204	CLASS 2
MECHANICAL AND ELECTRICAL REHABILITATION MAIN BUILDING ELLIS ISLAND Statue of Liberty National Monument, New York	BUILDING CONSERVATION TECHNOLOGY THE EHRENKRANTZ GROUP 19 West 44th Street, New York NY 10036

- PARTING STOPS LOOSE
- BOTTOM RAIL WORN

GRILL

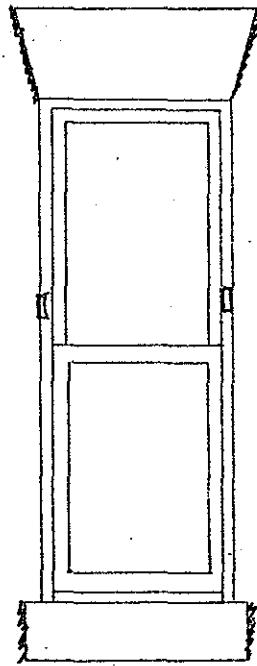
K TOWER WINDOW (16)	NUMBER SET-201	CLASS I
MECHANICAL AND ELECTRICAL REHABILITATION MAIN BUILDING ELLIS ISLAND Statue of Liberty National Monument, New York	BUILDING CONSERVATION TECHNOLOGY THE EBENKRAVITZ GROUP 19 West 44th Street, New York NY 10036

BOTTOM SASH WILL NOT OPEN - COULD NOT
INSPECT SILL OR SASH

GRILL

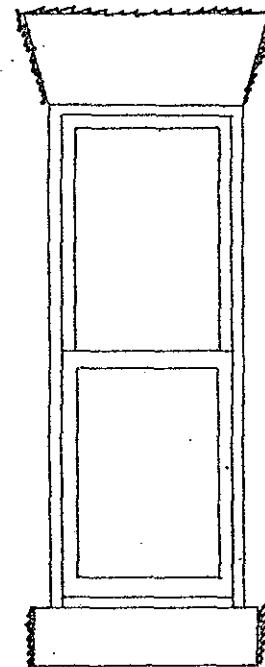
K TOP SASH WINDOW (16)	NUMBER SET-202	CLASS I
MECHANICAL AND ELECTRICAL REHABILITATION MAIN BUILDING ELLIS ISLAND Statue of Liberty National Monument, New York	BUILDING CONSERVATION TECHNOLOGY THE EHRENKRANTZ GROUP

WILL NOT OPEN - UNABLE TO INSPECT SILL

GRILL

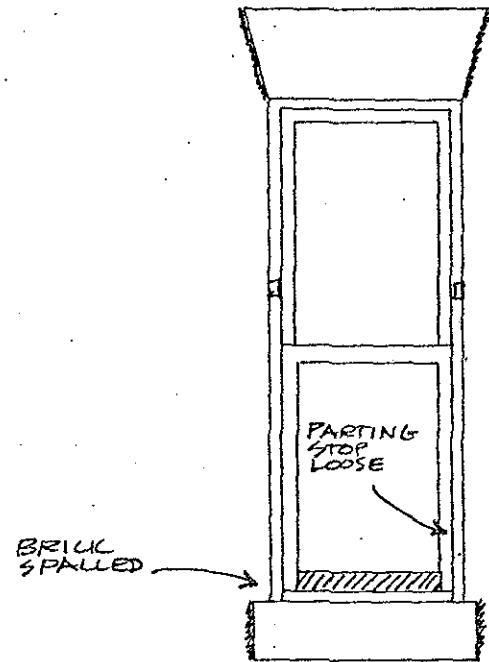
K TOWER WINDOW (16)	NUMBER SET- 204	CLASS 1
MECHANICAL AND ELECTRICAL REHABILITATION MAIN BUILDING ELLIS ISLAND Statue of Liberty National Monument, New York	BUILDING CONSERVATION TECHNOLOGY THE EIRENKRANTZ GROUP 19 West 44th Street, New York NY 10036

MOULDINGS PRAMING OPENINGS INSIDE HAVE SLIPPED
OR WERE POORLY INSTALLED.

IRON LINTEL PARTLY EXPOSED INSIDE - RUSTY

GRILL

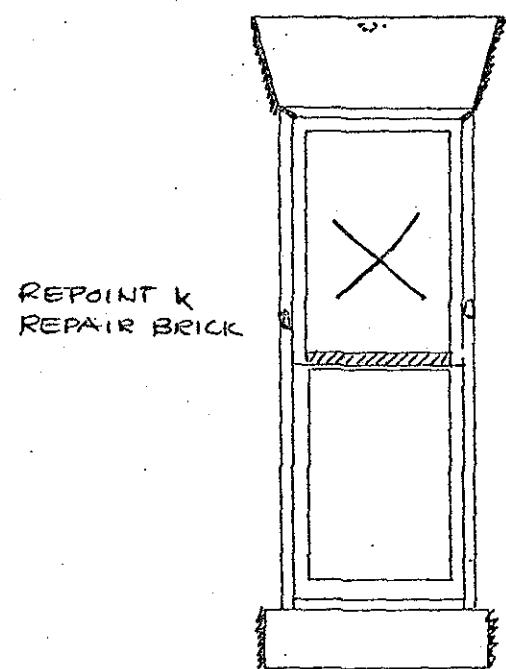
K TOWER WINDOW (16)	NUMBER SWT-201	CLASS 2
MECHANICAL AND ELECTRICAL REHABILITATION MAIN BUILDING ELLIS ISLAND Statue of Liberty National Monument, New York	BUILDING CONSERVATION TECHNOLOGY THE EHRENKRANTZ GROUP

GRILL - LOOSE AT BOTTOM

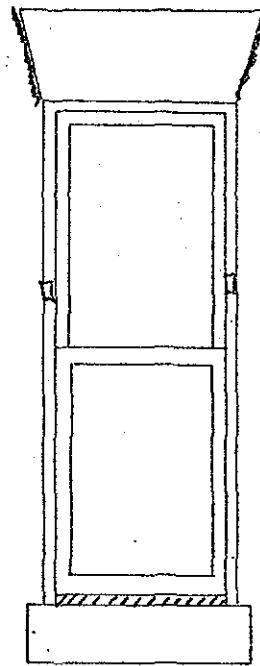
K TOWER WINDOW (16)	NUMBER SWT-202	CLASS 2
MECHANICAL AND ELECTRICAL REHABILITATION MAIN BUILDING ELLIS ISLAND Statue of Liberty National Monument, New York	BUILDING CONSERVATION TECHNOLOGY THE EHRENKRANZ GROUP	19 West 44th Street, New York NY 10036

GRILL

REPOINT &
REPAIR BRICK

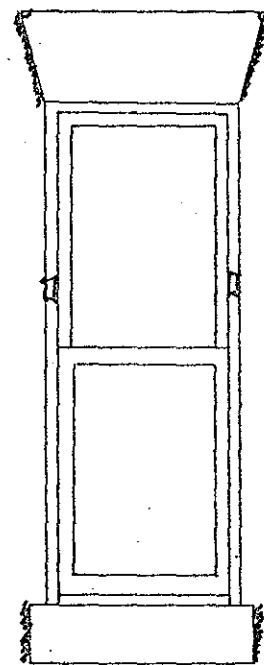
K TOWER WINDOW (16)	NUMBER SWT-203	CLASS 2
MECHANICAL AND ELECTRICAL REHABILITATION MAIN BUILDING ELLIS ISLAND Statue of Liberty National Monument, New York	BUILDING CONSERVATION TECHNOLOGY THE EISENKRANTZ GROUP

LEFT (W) PARTING STOP LOOSE

GRILL

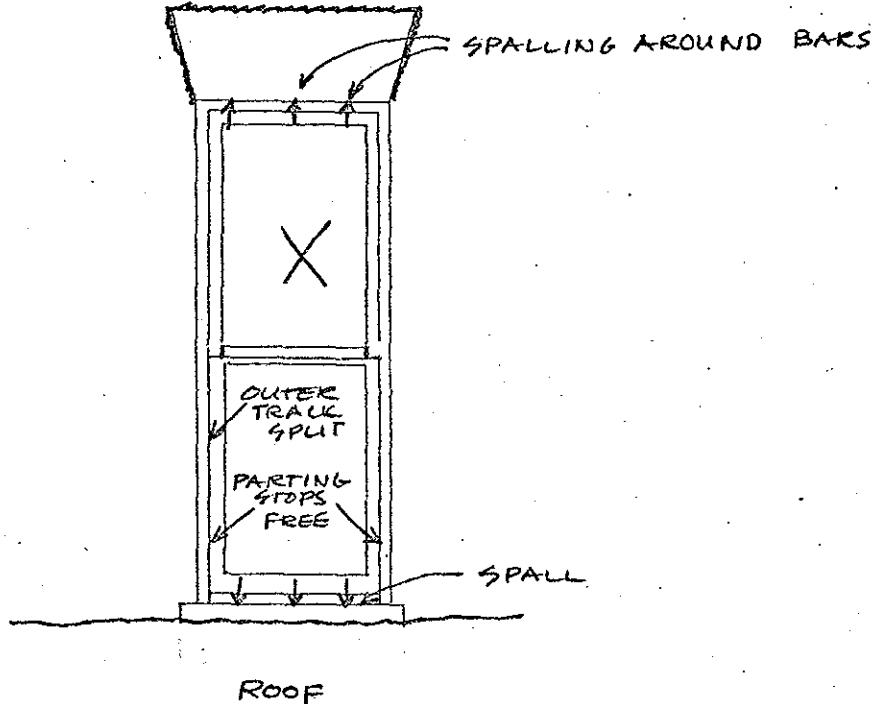
K TOEEL WINDOW (16)	NUMBER SWT-204	CLASS 1
MECHANICAL AND ELECTRICAL REHABILITATION MAIN BUILDING ELLIS ISLAND Statue of Liberty National Monument, New York	BUILDING CONSERVATION TECHNOLOGY THE EBENKRAZ GROUP

RIGHT (N) PARTING STOP OUT SLIGHTLY

GRILL

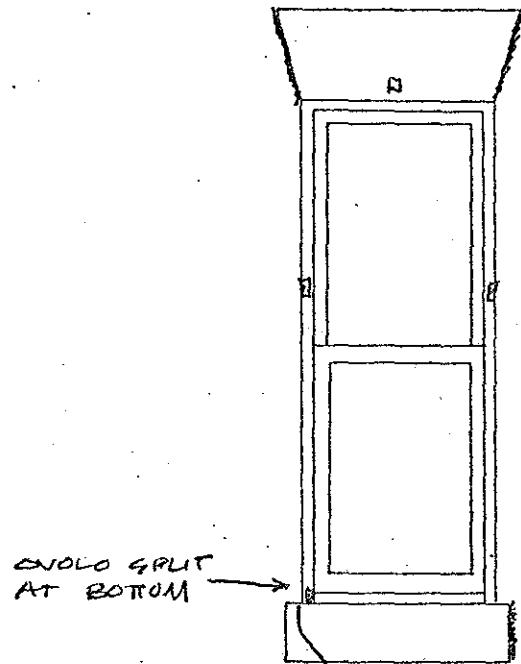
K TO SIDE WINDOW (16)	NUMBER NWT - 201	CLASS 2
MECHANICAL AND ELECTRICAL REHABILITATION MAIN BUILDING ELLIS ISLAND Statue of Liberty National Monument, New York	BUILDING CONSERVATION TECHNOLOGY THE EHRNRAYZ GROUP 19 West 44th Street, New York NY 10036

IRON BARS

REPLACE WORN STOOL

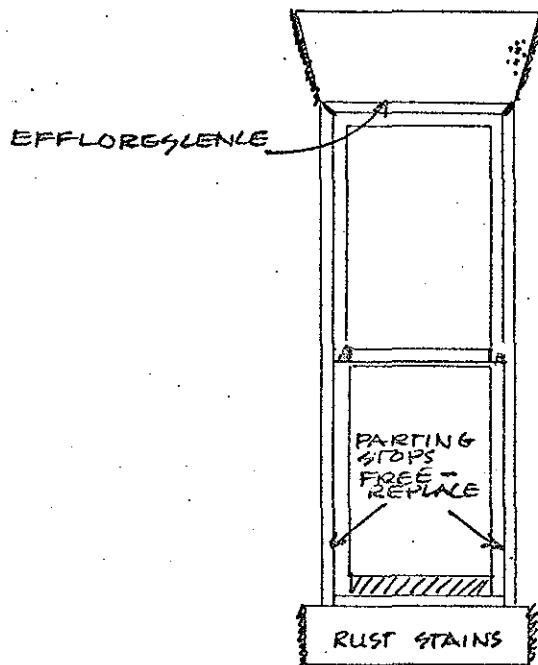
K TOKEE WINDOW (16)	NUMBER NWT - 202	GLASS 1
MECHANICAL AND ELECTRICAL REHABILITATION MAIN BUILDING ELLIS ISLAND Statue of Liberty National Monument, New York	BUILDING CONSERVATION TECHNOLOGY THE EHRENKRANZ GROUP 19 West 44th Street, New York NY 10036

PARTING STOPS SLIGHTLY LOOSE

GRILL

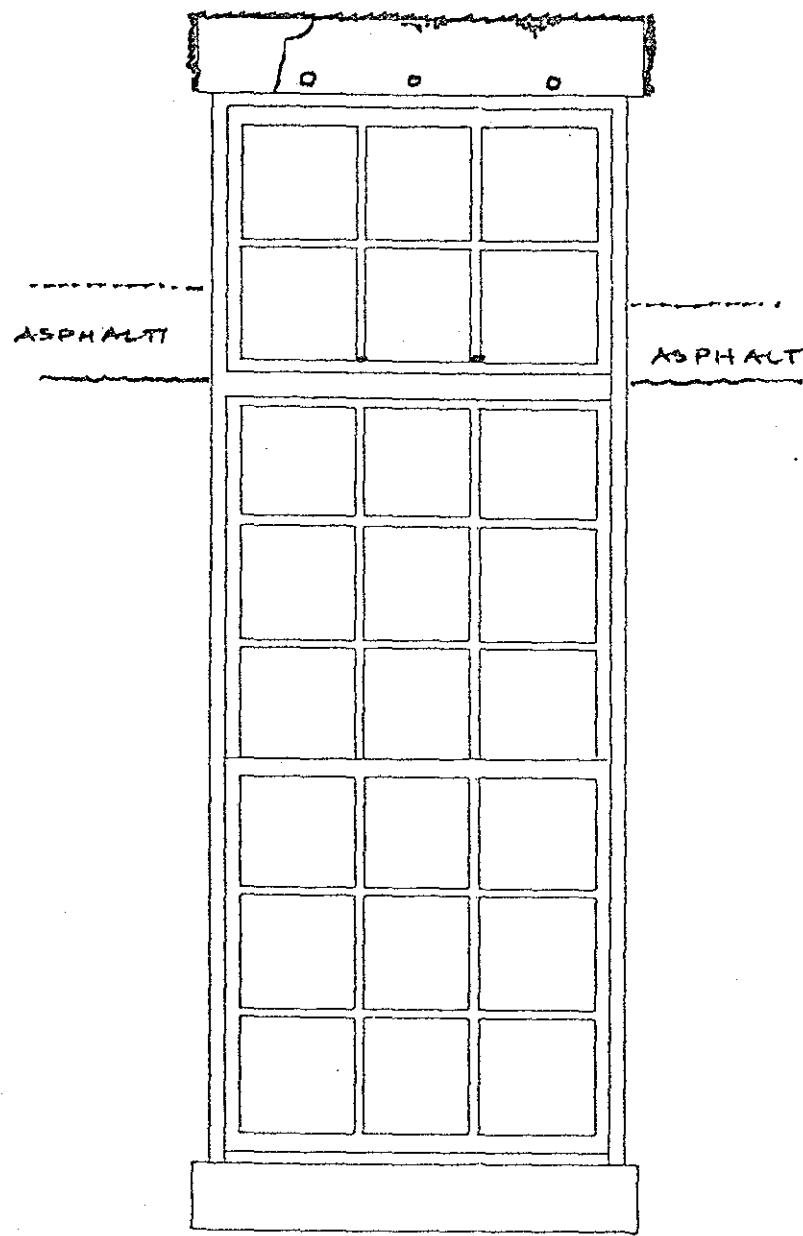
K TOWER WINDOW (16)	NUMBER NWT-204	CLASS I
MECHANICAL AND ELECTRICAL REHABILITATION MAIN BUILDING ELLIS ISLAND Statue of Liberty National Monument, New York	BUILDING CONSERVATION TECHNOLOGY THE FIRENKRANZ GROUP

SASH WILL NOT OPEN

GRILL

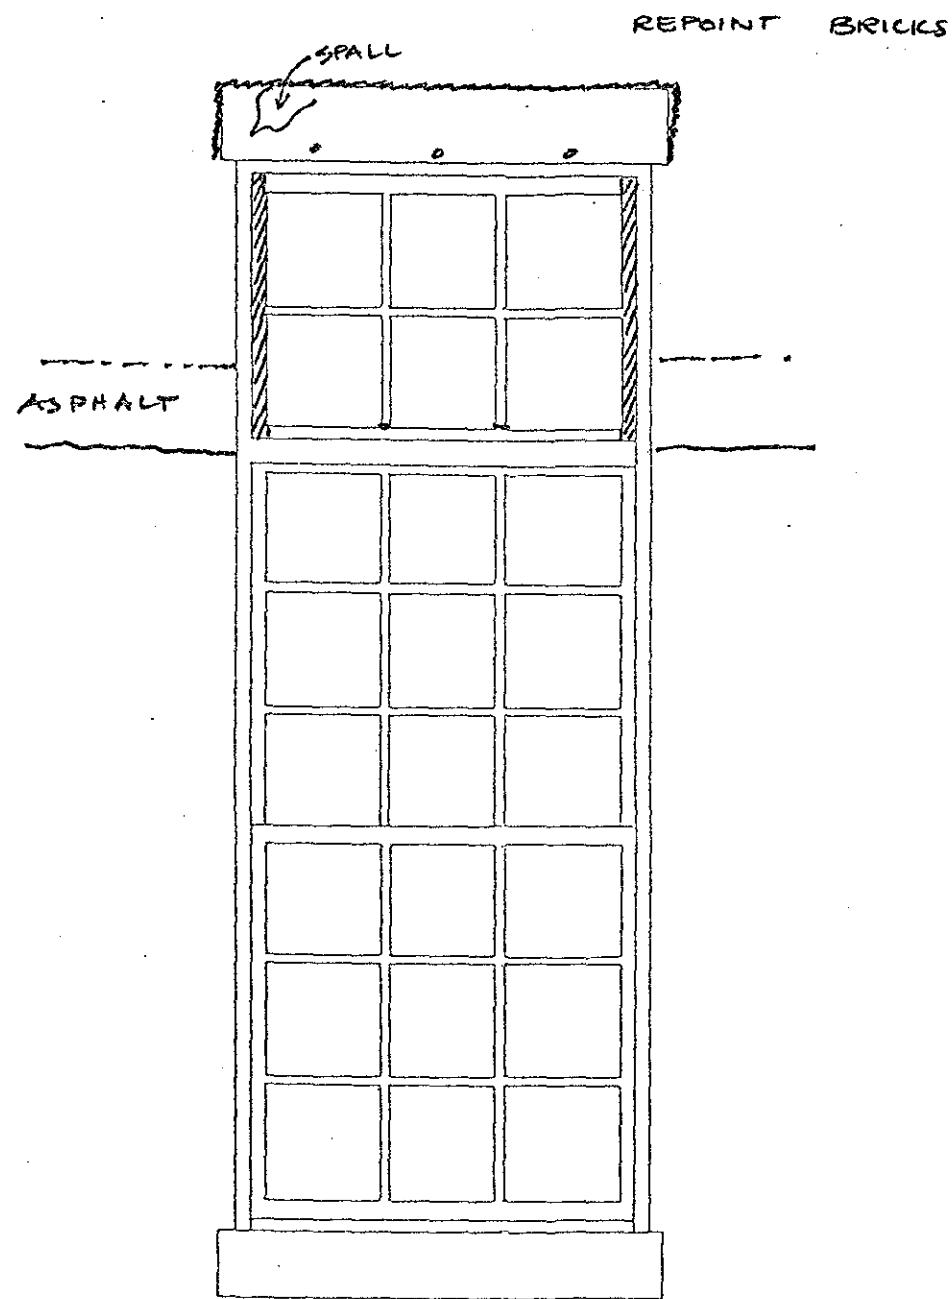
L2 2 nd FLOOR LIGHT COURTS	NUMBER NEL-201	CLASS I
MECHANICAL AND ELECTRICAL REHABILITATION MAIN BUILDING ELLIS ISLAND Statue of Liberty National Monument, New York	BUILDING CONSERVATION TECHNOLOGY THE DIBENKORN GROUP 19 West 44th Street, New York NY 10036

TRANSOM ONLY EXPOSED TO EXTERIOR

SCREENS OUTSIDE OF UPPER HALF, INSIDE OF LOWER
HALF - IN FAIR CONDITION

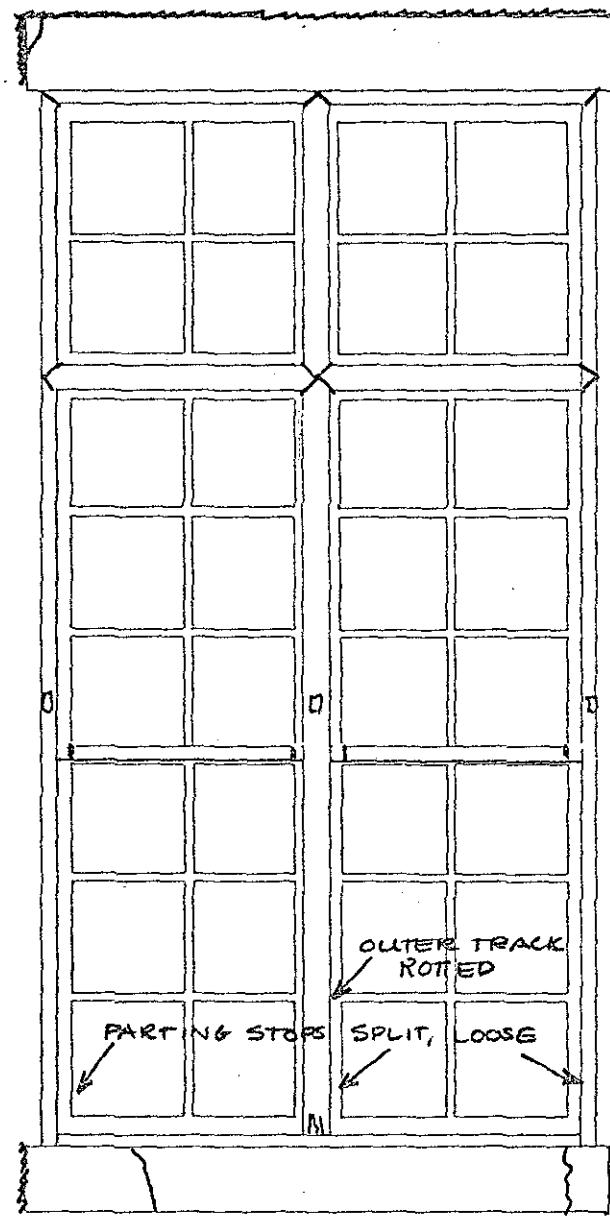
L2 2 nd FLOOR LIGHT COURTS	NUMBER NEL-202	CLASS 2
MECHANICAL AND ELECTRICAL REHABILITATION MAIN BUILDING ELLIS ISLAND Statue of Liberty National Monument, New York	BUILDING CONSERVATION TECHNOLOGY THE DECORATOR GROUP 19 West 46th Street, New York NY 10036

ONLY TRANSOM EXPOSED TO EXTERIOR

SCREENS ON OUTSIDE OF UPPER HALF, INSIDE OF
LOWER - FAIR CONDITION

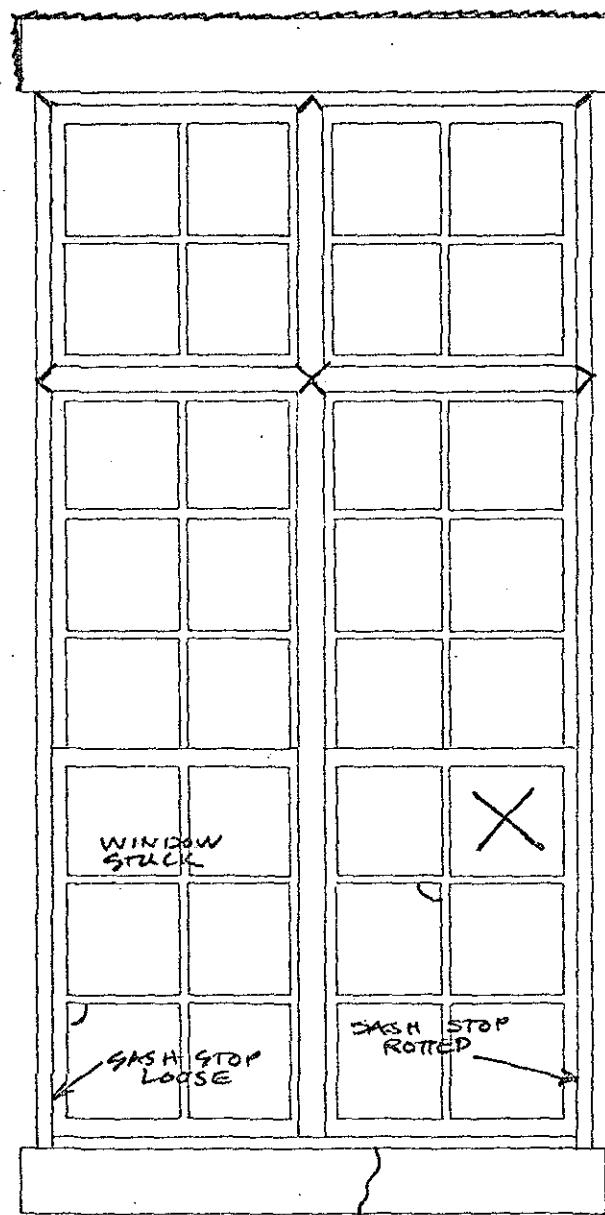
L1 2 nd FLOOR LIGHT COURTS	NUMBER NEL-203	CLASS 2
MECHANICAL AND ELECTRICAL REHABILITATION MAIN BUILDING ELLIS ISLAND Statue of Liberty National Monument, New York	BUILDING CONSERVATION TECHNOLOGY THE BRENNIGANTZ GROUP 19 West 44th Street, New York NY 10036	✓

GRILL - CORRODED AT BOTTOM

SCREENS OVER TOP & BOTTOM OF TRANSOM; MISSING FROM LOWER SASH

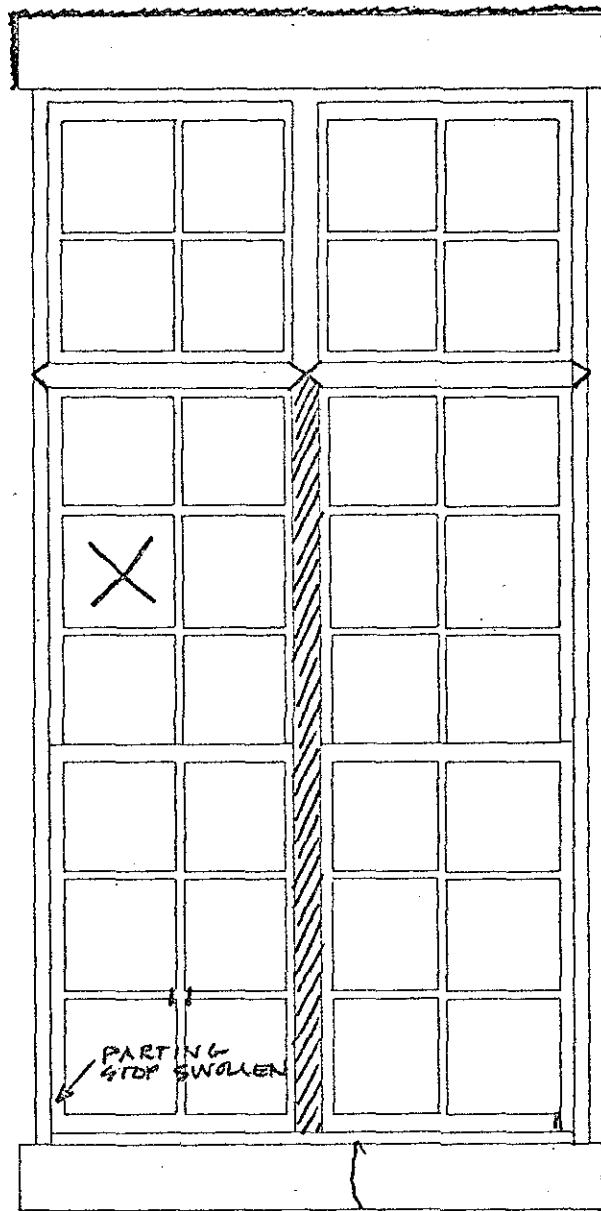
L1 2 nd FLOOR LIGHT COURTS	NUMBER NEL-204	CLASS I
MECHANICAL AND ELECTRICAL REHABILITATION MAIN BUILDING ELLIS ISLAND Statue of Liberty National Monument, New York	BUILDING CONSERVATION TECHNOLOGY THE EBENKRAITZ GROUP 19 West 44th Street, New York NY 10036

GRILL CORRODED AT BOTTOM

SCREENS OVER TRANSOM ONLY

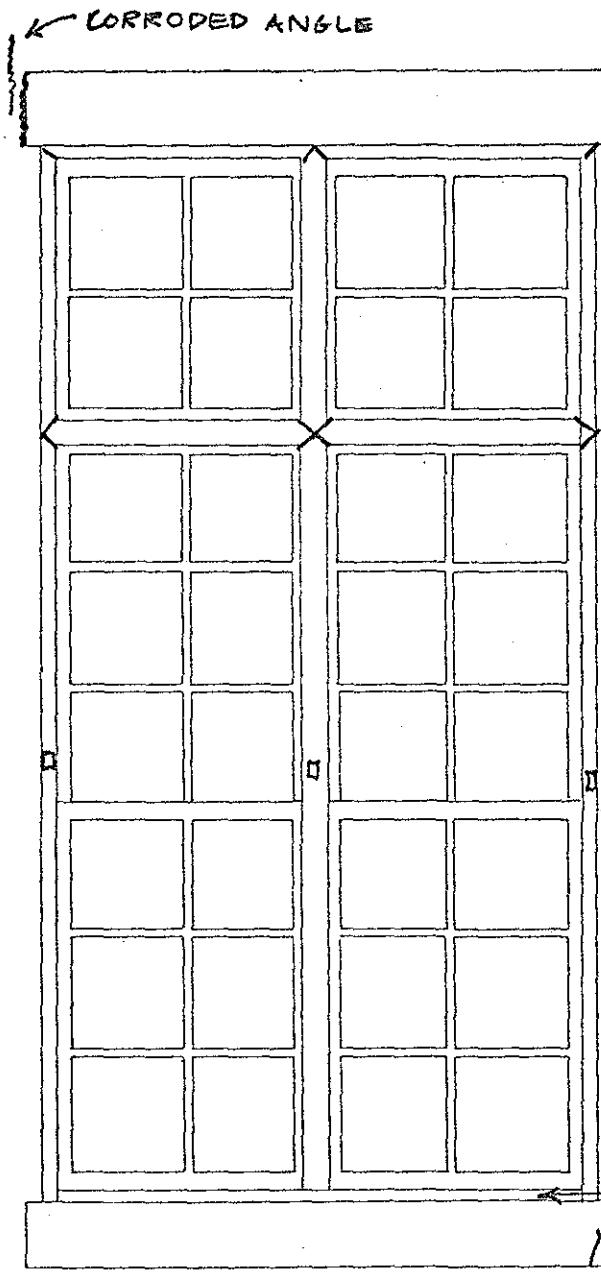
L4 2 nd FLOOR LIGHT COURTS	NUMBER SEL-208	CLASS 2
MECHANICAL AND ELECTRICAL REHABILITATION MAIN BUILDING ELLIS ISLAND Statue of Liberty National Monument, New York	BUILDING CONSERVATION TECHNOLOGY THE BRENKER GROUP 19 West 44th Street, New York NY 10036

INTERIOR + TRANSOM MECHANISM RUSTED

GRILL

SCREENS OVER TRANSOM WINDOWS; METAL TRACKS ON
LOWER SASH BUT NO SCREENS

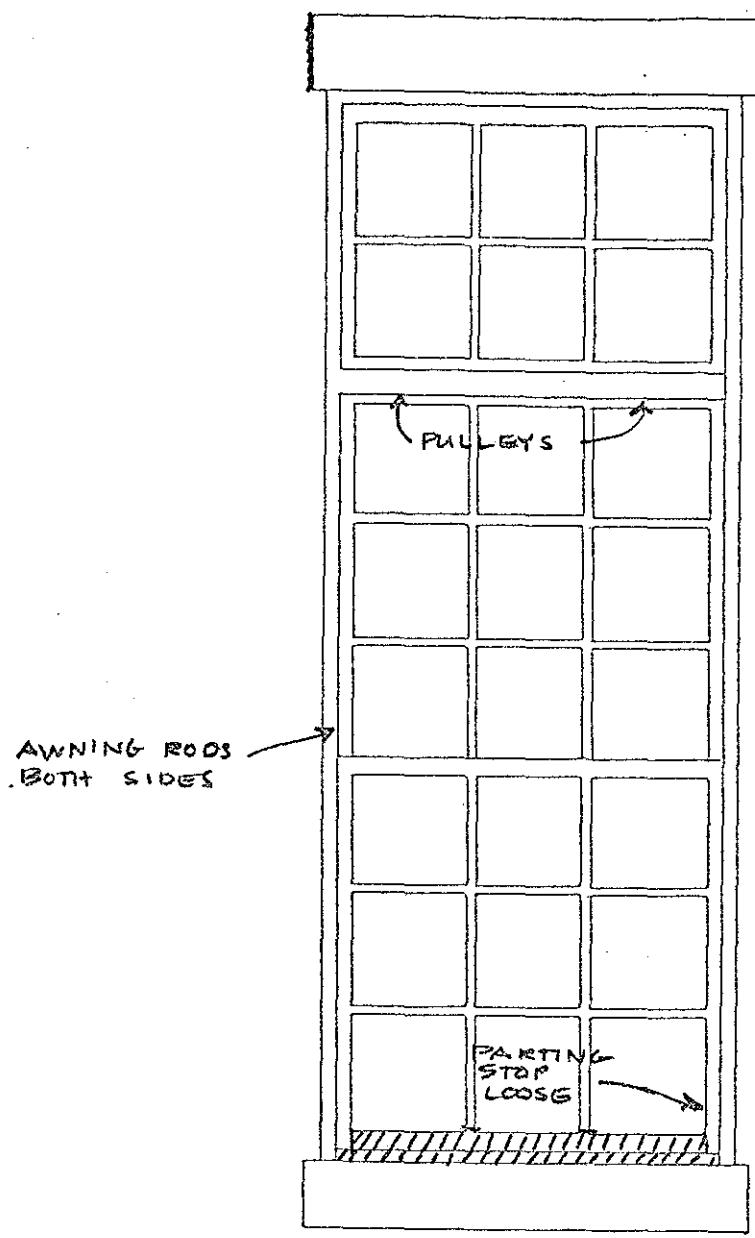
L1 2 nd FLOOR LIGHT COURTS	NUMBER SEL - 209	CLASS 1
MECHANICAL AND ELECTRICAL REHABILITATION MAIN BUILDING ELLIS ISLAND Statue of Liberty National Monument, New York	BUILDING CONSERVATION TECHNOLOGY THE EBERLE GRANTZ GROUP 19 West 44th Street, New York NY 10036

INTERIOR: - SOFFIT ON RIGHT (EAST) SIDE OF TRANSMON APPEARS DAMP, SASH STOP THERE SPLIT.

GRILL DIVIDING BAR CORRODED THRU AT BOTTOM

SCREENS ON TRANSMON WINDOWS; METAL TRACKS BUT NO SCREENS. ON LOWER SASH

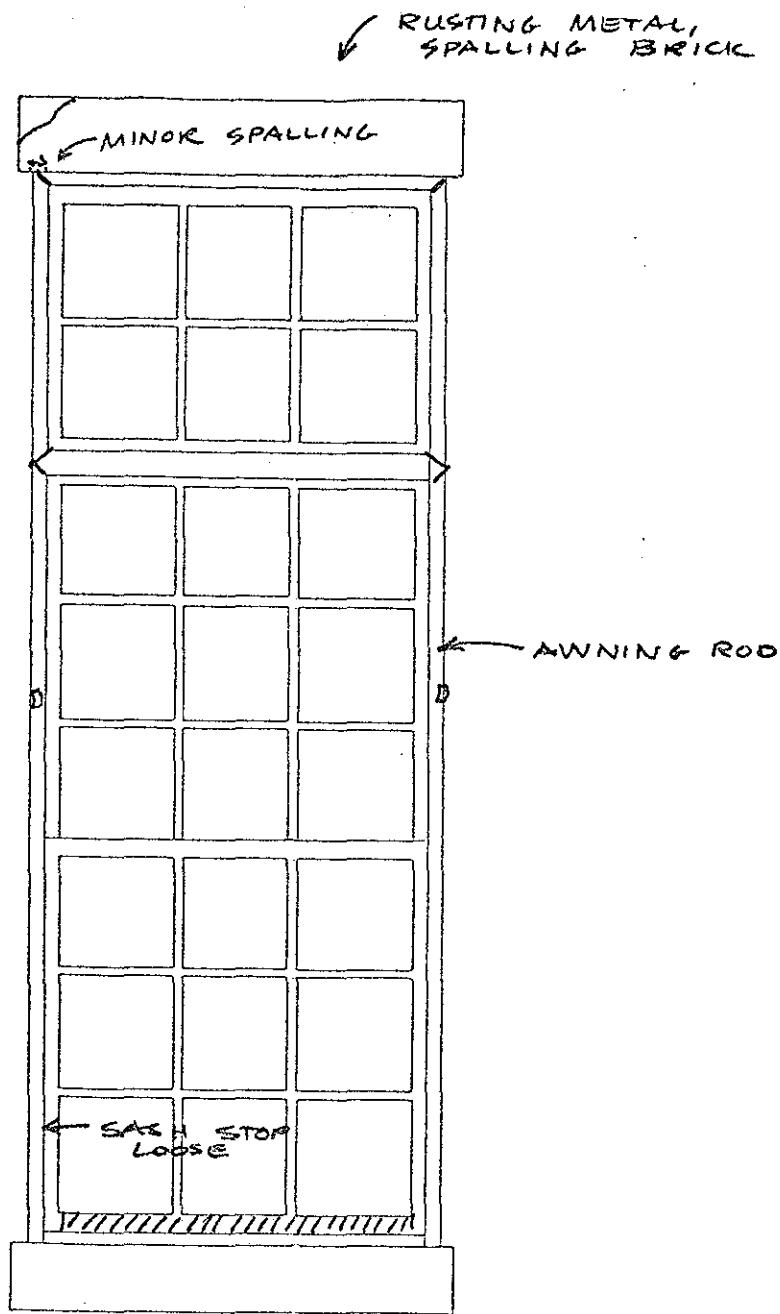
L2 2nd FLOOR LIGHT COURTS	NUMBER	CLASS
MECHANICAL AND ELECTRICAL REHABILITATION MAIN BUILDING ELLIS ISLAND Statue of Liberty National Monument, New York	SEL-210	2
	BUILDING CONSERVATION TECHNOLOGY THE DREGENGARTZ GROUP	
	19 West 44th Street, New York NY 10036

INTERIOR: INNER TRACK ON RIGHT (EAST) SIDE LOOSE,
GAP BETWEEN IT & JAMB MOULDING

GRILL

SCREENS OVER TRANSOMS IN GOOD CONDITION; METAL TRACKS
ON LOWER SASH BUT NO SCREENS

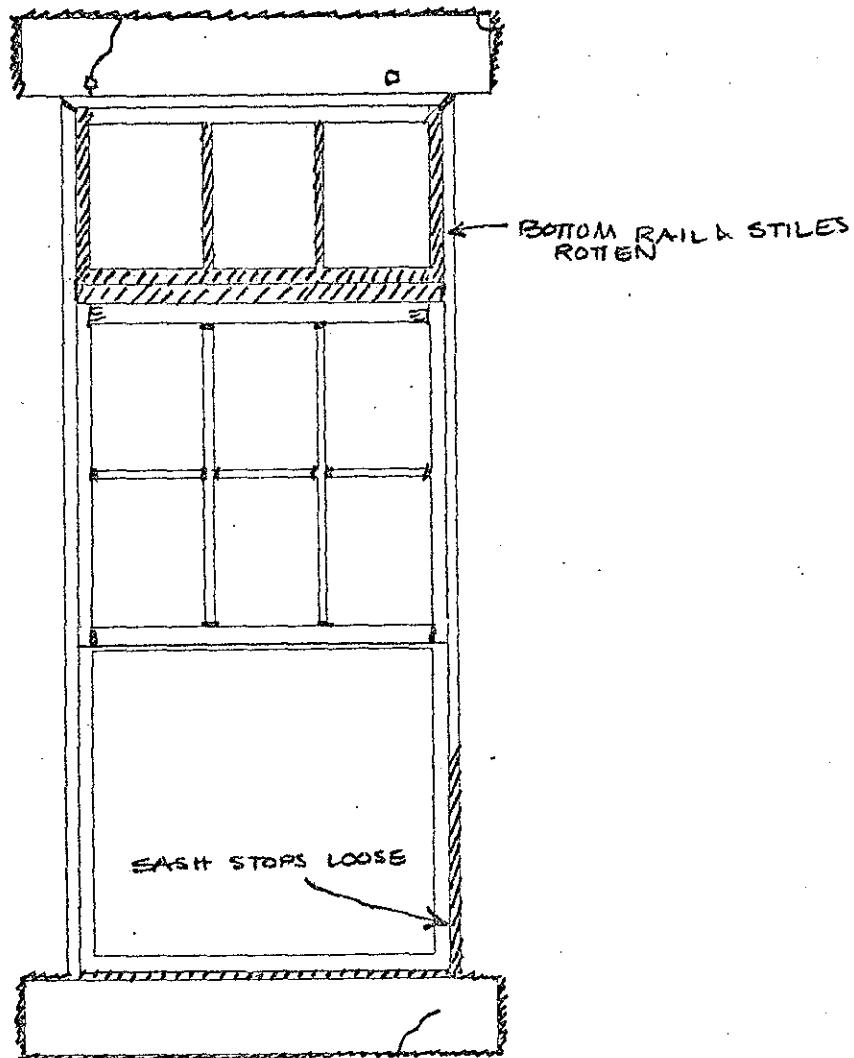
L2 2 nd FLOOR LIGHT COURTS	NUMBER SEL-211	CLASS 2
MECHANICAL AND ELECTRICAL REHABILITATION MAIN BUILDING ELLIS ISLAND Statue of Liberty National Monument, New York	BUILDING CONSERVATION TECHNOLOGY THE DRENNANZ GROUP

SASH WILL ONLY OPEN PART WAY - UNABLE TO GET OUT
ON SILL

GRILL

SCREENS ON TRANEOM IN FAIR CONDITION ; METAL
TRACK ON LOWER SASH.

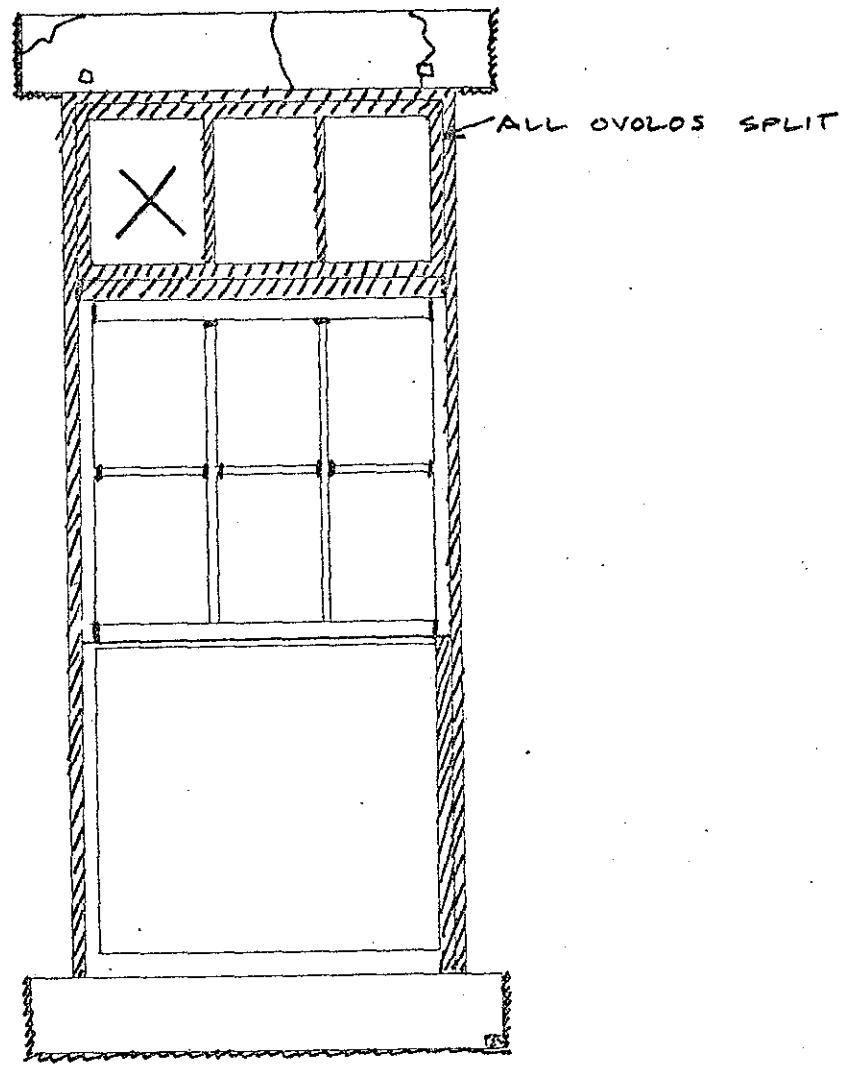
T1 THIRD FLOOR, LIGHT COURTS (29)	NUMBER SEL-301	CLASS 2
MECHANICAL AND ELECTRICAL REHABILITATION MAIN BUILDING ELLIS ISLAND Statue of Liberty National Monument, New York	BUILDING CONSERVATION TECHNOLOGY THE BRENNANZ GROUP 19 West 44th Street, New York NY 10036

GRILL

SCREEN OVER LOWER SASH - POOR CONDITION

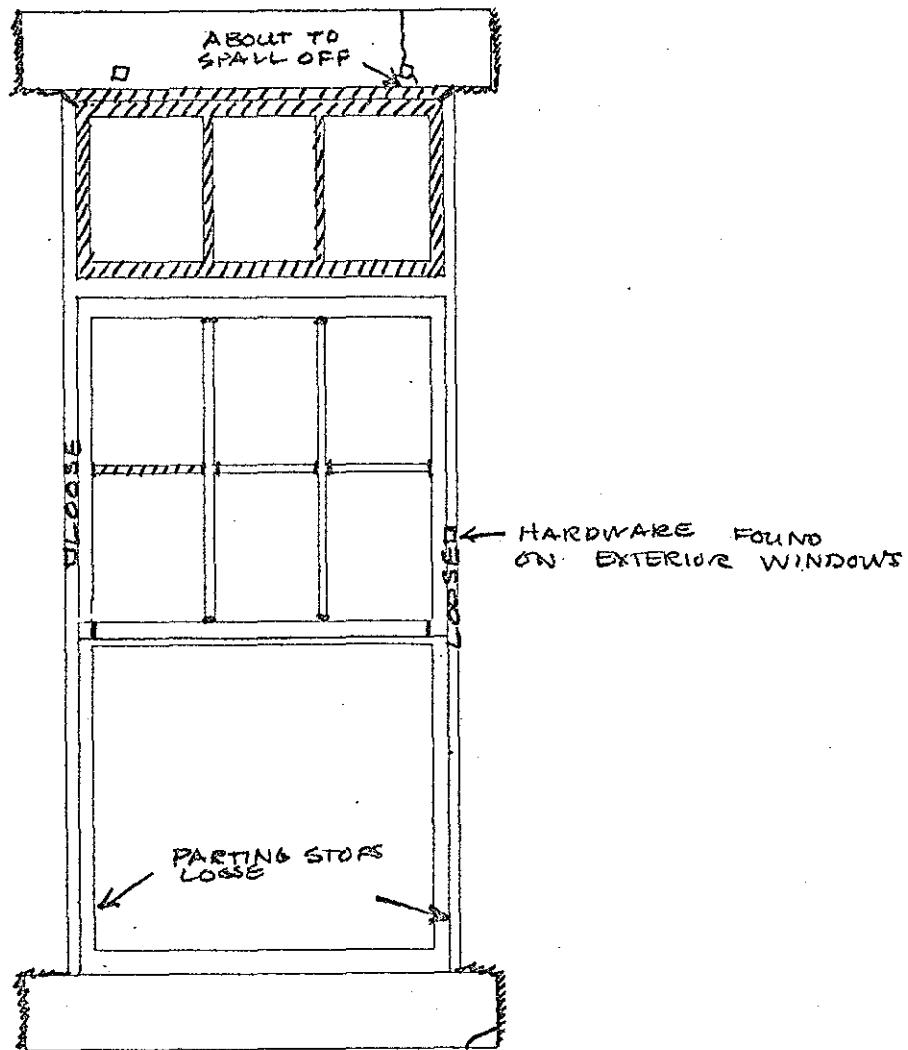
T1 THIRD FLOOR, LIGHT COURTS (20)	NUMBER SEL-302	CLASS 13
MECHANICAL AND ELECTRICAL REHABILITATION MAIN BUILDING ELLIS ISLAND Statue of Liberty National Monument, New York	BUILDING CONSERVATION TECHNOLOGY THE EICHENKRIZZ GROUP

- BOTTOM RAIL OF TRANSOM COMPLETELY ROTTEN
- MOULDINGS FRAMING TRANSOM OPENING ROTTED
- SASH TRACKS & STOPS ON RIGHT (WEST) JAMB ROTTED
- TRANSOM SOFFIT ROTTED

SCREEN ON LOWER SASH - POOR CONDITION

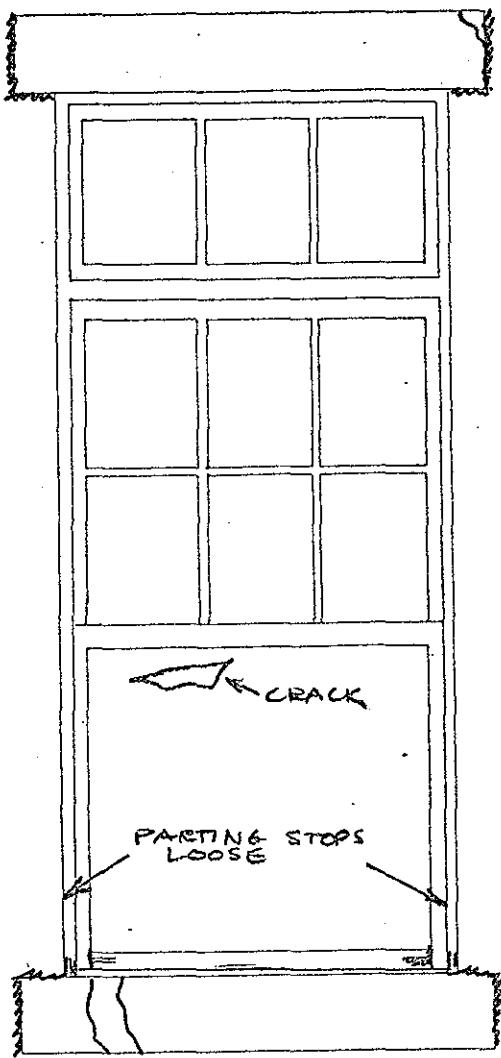
T1 THIRD FLOOR, LIGHT COURTS (29)	NUMBER SEL-303	CLASS 2
MECHANICAL AND ELECTRICAL REHABILITATION MAIN BUILDING ELLIS ISLAND Statue of Liberty National Monument, New York	BUILDING CONSERVATION TECHNOLOGY THE BIRENKRABZ GROUP

- INTERIOR:
- INNER TRACK ON BOTH SIDES? ROTTEN ON BOTTOM, FULL OF HOLES
 - WOOD BEHIND PARTING STOP ON RIGHT (WEST) JAMB ROTTEN

GRILL

SCREEN OVER LOWER SASH - POOR CONDITION

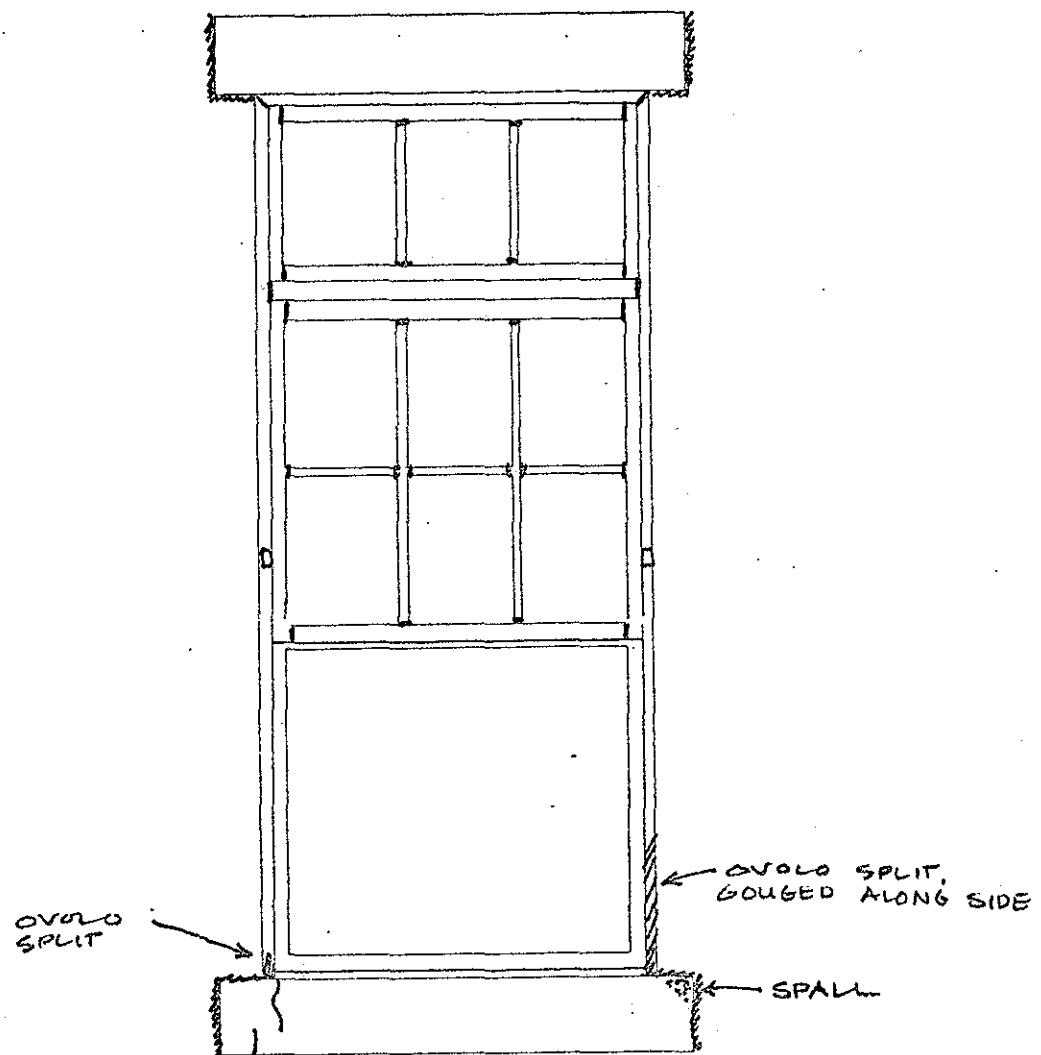
T1 THIRD FLOOR, LIGHT COURTS (29)	NUMBER SEL- 304	CLASS I
MECHANICAL AND ELECTRICAL REHABILITATION MAIN BUILDING ELLIS ISLAND Statue of Liberty National Monument, New York	BUILDING CONSERVATION TECHNOLOGY THE DIRENKRAUT GROUP 19 West 44th Street, New York NY 10036

GRILL SCREEN OVER LOWER SASH - POOR CONDITION

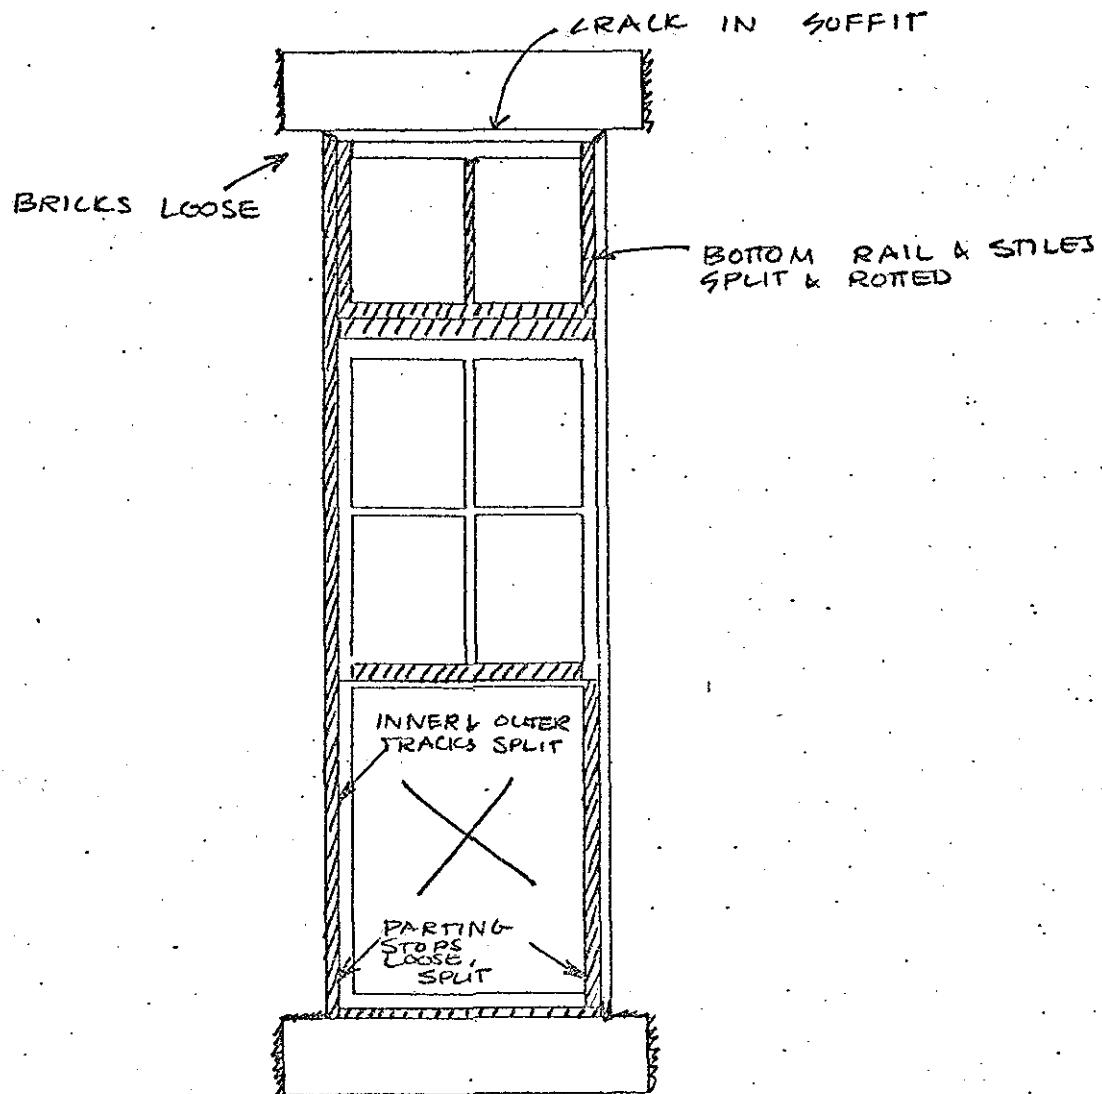
T1 THIRD FLOOR, LIGHT COURTS (29)	NUMBER SEL-305	CLASS I
MECHANICAL AND ELECTRICAL REHABILITATION MAIN BUILDING ELLIS ISLAND Statue of Liberty National Monument, New York	BUILDING CONSERVATION TECHNOLOGY THE DRENNKANTZ GROUP 19 West 44th Street, New York NY 10036	"

GRILL
SCREEN ON LOWER SASH - POOR CONDITION
