historic structures report

mechanical/electrical rehabilitation

main building

STATUE OF LIBERTY ELLIS ISLAND

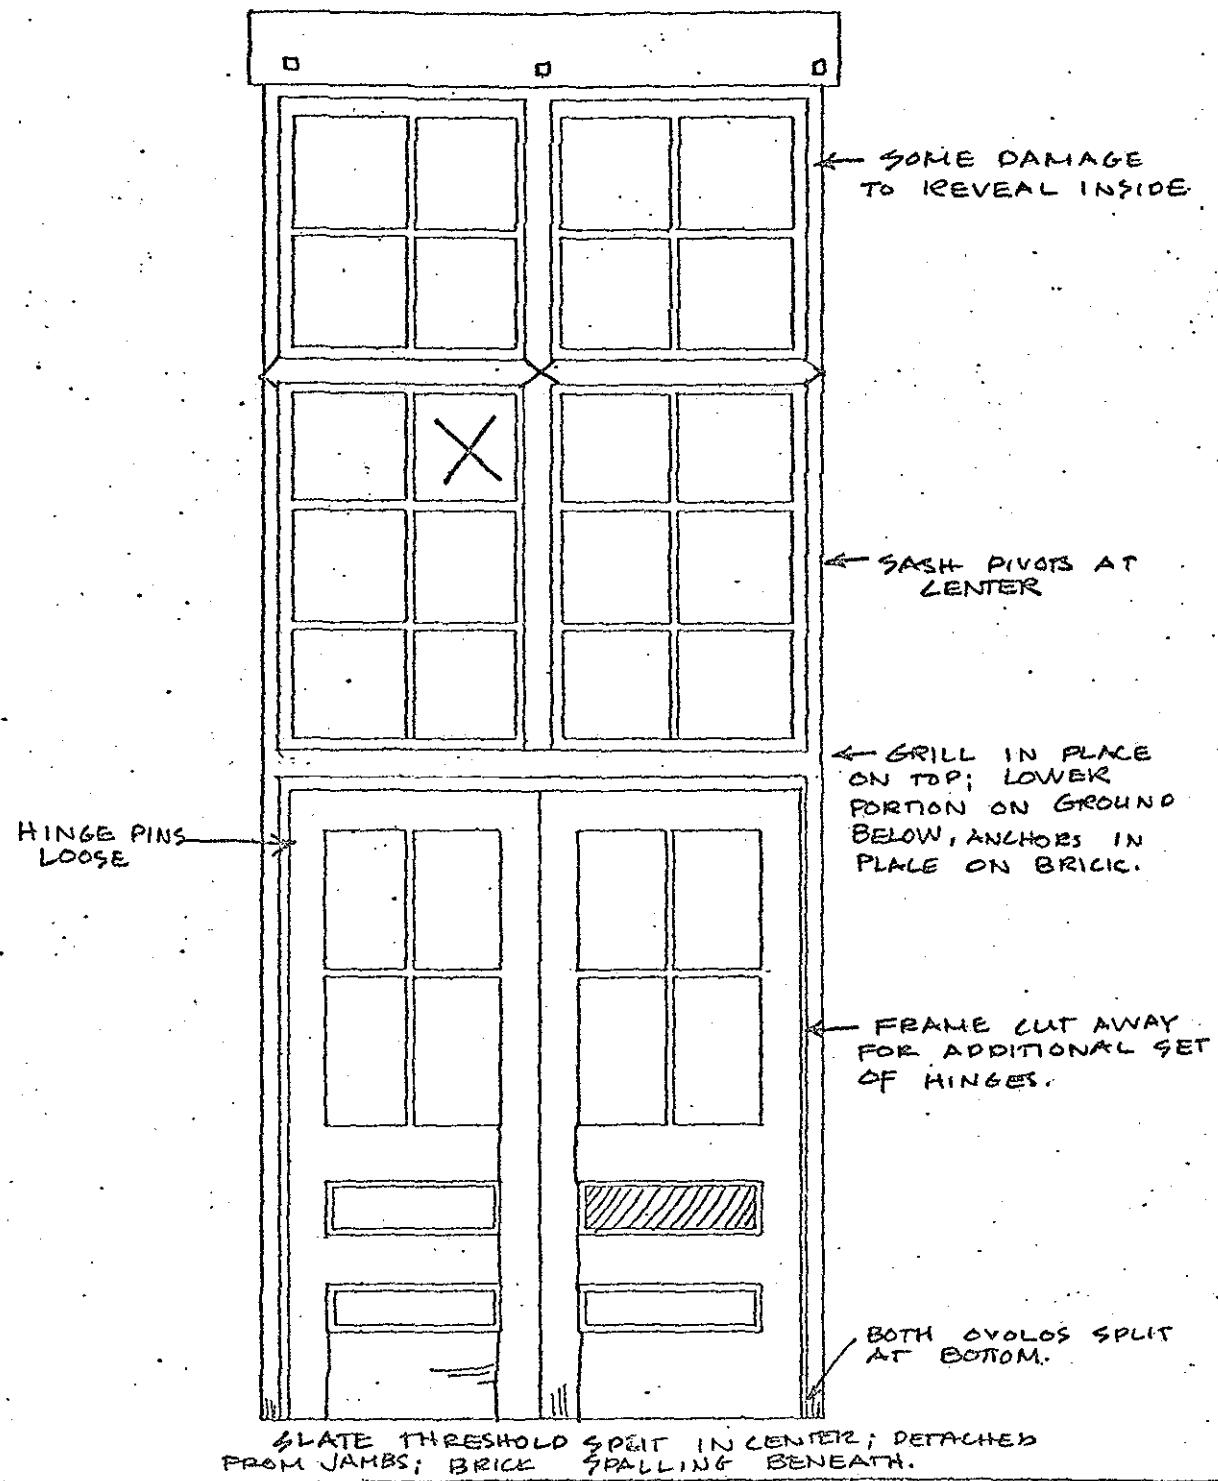
T2 THIRD FLOOR, LIGHT COURTS (2)	NUMBER SEL-307	CLASS 2
MECHANICAL AND ELECTRICAL REHABILITATION MAIN BUILDING ELLIS ISLAND Statue of Liberty National Monument, New York	BUILDING CONSERVATION TECHNOLOGY THE DRENNERATZ GROUP 19 West 44th Street, New York NY 10036

INTERIOR: MOULDINGS FRAMING OPENING LOOSE ON
RIGHT (EAST) SIDE.

GRILL.

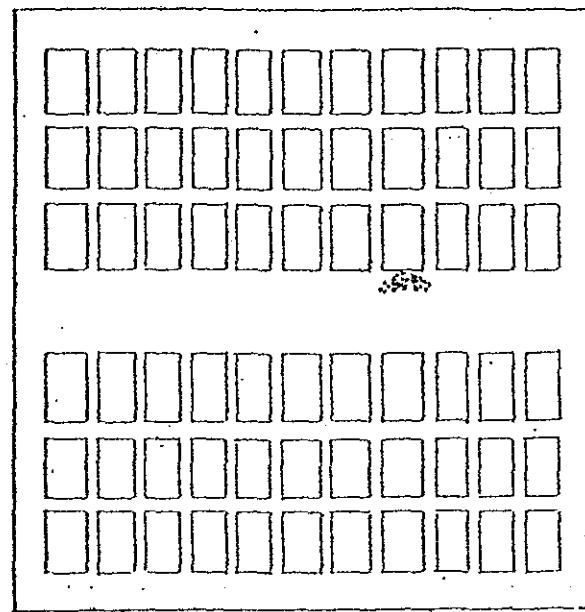
L1 2 nd FLOOR LIGHT COURTS (5)	NUMBER NWL-203	CLASS I
MECHANICAL AND ELECTRICAL REHABILITATION MAIN BUILDING ELLIS ISLAND Statue of Liberty National Monument, New York	BUILDING OBSERVATION TECHNOLOGY THE DERNERWITZ GROUP 19 West 44th Street, New York NY 10036

GOOD PAINT COVERING
NO SCREENS ON TRACICE
GRILL IN PLACE

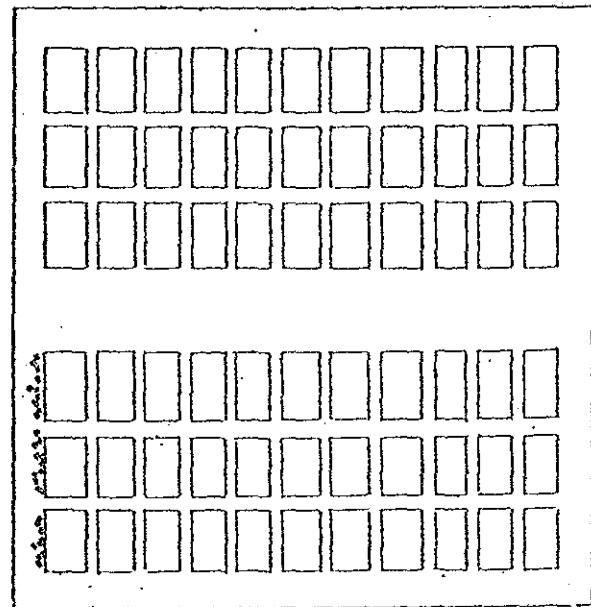
M4 SKYLIGHTS, TICKET OFFICE	NUMBER	CLASS
M4 SKYLIGHTS, TICKET OFFICE	M 201	2
MECHANICAL AND ELECTRICAL REHABILITATION MAIN BUILDING ELLIS ISLAND	BUILDING CONSERVATION TECHNOLOGY THE DEDMONTE GROUP	DWG NO.
Statue of Liberty National Monument, New York	19 West 44th Street, New York NY 10036

✓ STEEL CORRODED

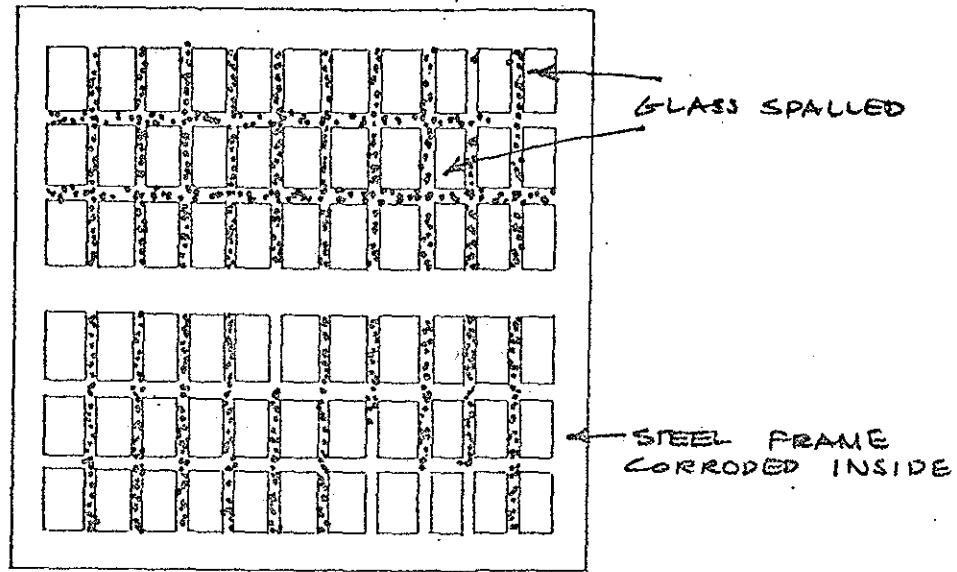
M3 SKYLIGHTS, TICKET OFFICE (4)	NUMBER M 203	CLASS 3.
MECHANICAL AND ELECTRICAL REHABILITATION MAIN BUILDING ELLIS ISLAND Statue of Liberty National Monument, New York	BUILDING CONSERVATION TECHNOLOGY THE DROKANZ GROUP 19 West 44th Street, New York NY 10036	DWG NO.

GLASS CHIPPED

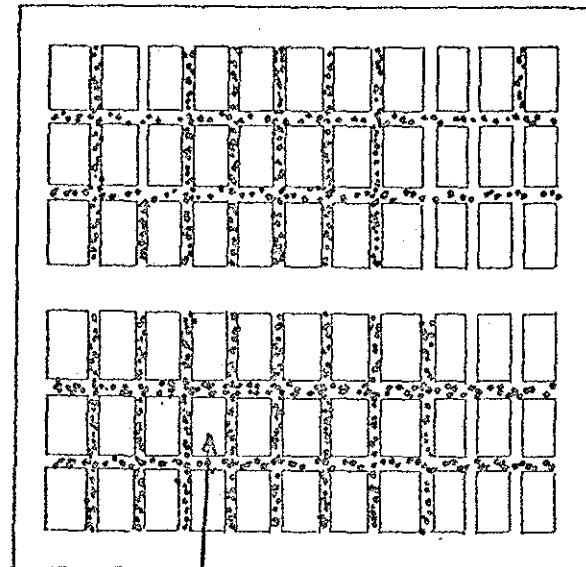
M3 SKYLIGHTS, TICKET OFFICE (4)	NUMBER M 204	CLASS 3
MECHANICAL AND ELECTRICAL REHABILITATION MAIN BUILDING ELLIS ISLAND Statue of Liberty National Monument, New York	BUILDING CONSERVATION TECHNOLOGY THE DREIKANTZ GROUP 19 West 44th Street, New York NY 10036	DWG. NO.

GLASS CHIPPED

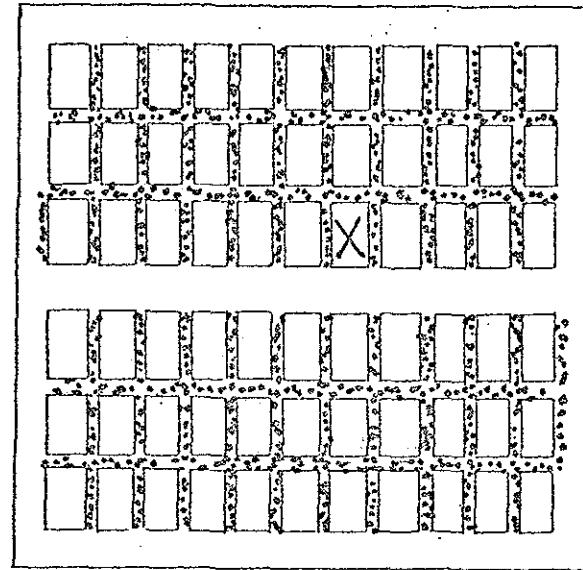
M3 SKYLIGHTS, TICKET OFFICE (4)	NUMBER M 205	CLASS 3.
MECHANICAL AND ELECTRICAL REHABILITATION MAIN BUILDING ELLIS ISLAND Statue of Liberty National Monument, New York	BUILDING CONSERVATION TECHNOLOGY THE BERNKANTZ GROUP 19 West 44th Street, New York NY 10036	DWG NO.

← STEEL FRAME
CORRODED INSIDE

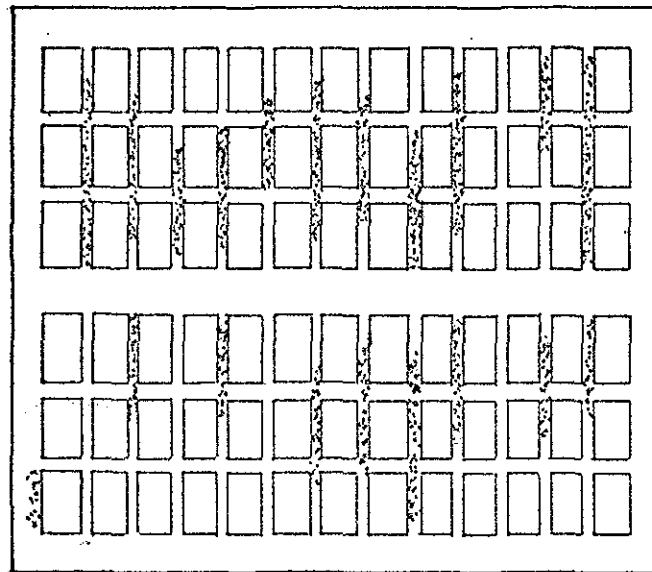
M3 SKYLIGHTS, TICKET OFFICE (4)	NUMBER M 206	CLASS 3
MECHANICAL AND ELECTRICAL REHABILITATION MAIN BUILDING ELLIS ISLAND Statue of Liberty National Monument, New York	BUILDING CONSERVATION TECHNOLOGY THE BERGERANTZ GROUP 19 West 44th Street, New York NY 10036	DWG NO.

CONCRETE SPALLED, STEEL BARS RUSTING

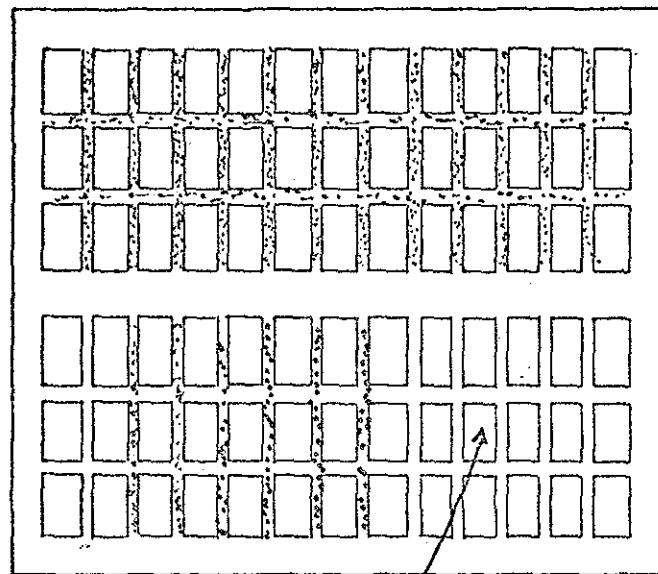
M1 SKYLIGHTS, TICKET OFFICE (4)	NUMBER M 207	CLASS 3
MECHANICAL AND ELECTRICAL REHABILITATION MAIN BUILDING ELLIS ISLAND Statue of Liberty National Monument, New York	BUILDING CONSERVATION TECHNOLOGY THE BIRCHMILL GROUP 19 West 44th Street, New York NY 10036

GLASS CHIPPED

ALL CONCRETE CRACKED & SPALLING
FRAME RUSTED

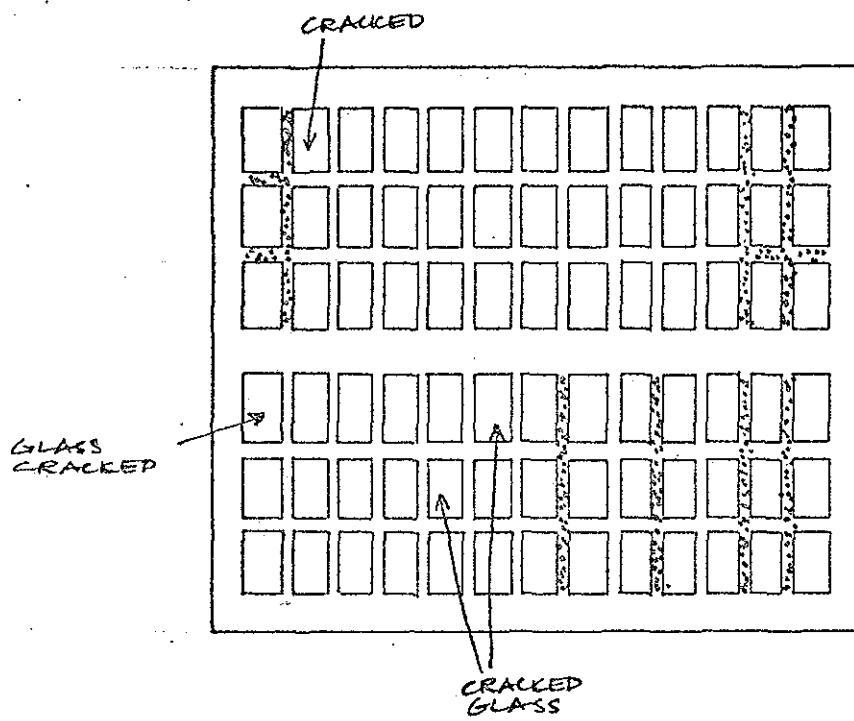
M1 SKYLIGHTS, TICKET OFFICE (4)	NUMBER M 208	CLASS 3
MECHANICAL AND ELECTRICAL REHABILITATION MAIN BUILDING ELLIS ISLAND Statue of Liberty National Monument, New York	BUILDING CONSERVATION TECHNOLOGY THE ENTHOV GROUP 19 West 44th Street, New York NY 10036

FRAME CORRODED

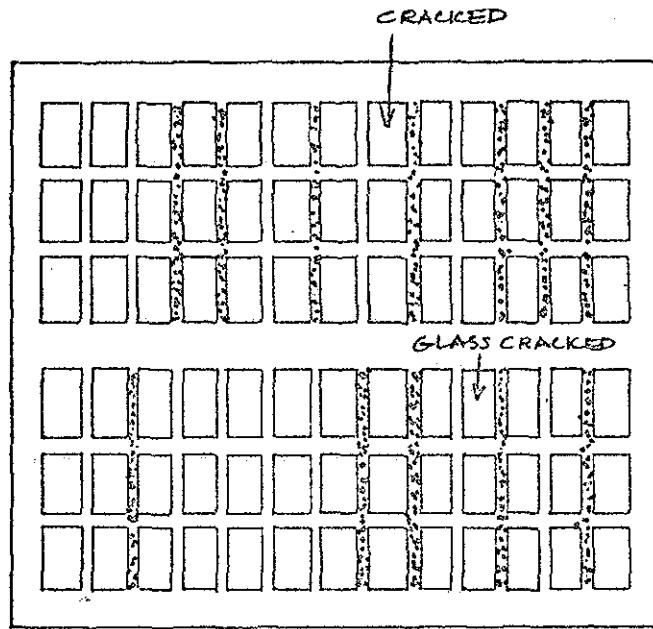
M2 SKYLIGHTS, TICKET OFFICE (A)	NUMBER N210	CLASS 3
MECHANICAL AND ELECTRICAL REHABILITATION MAIN BUILDING ELLIS ISLAND	BUILDING CONSERVATION TECHNOLOGY THE EDELMANZ GROUP	
Statue of Liberty National Monument, New York		19 West 44th Street, New York NY 10036

FRAME CORRODED

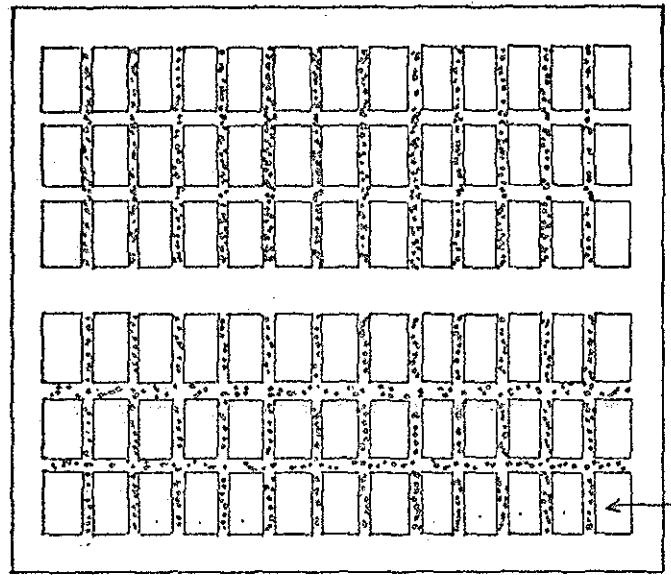
M1 SKYLIGHTS, TICKET OFFICE (4)	NUMBER M 211	CLASS 3
MECHANICAL AND ELECTRICAL REHABILITATION MAIN BUILDING ELLIS ISLAND Statue of Liberty National Monument, New York	BUILDING CONSULTATION TECHNOLOGY THE DRAZNER GROUP 19 West 44th Street, New York NY 10036

GLASS BROKEN
(COPPER LAYER)

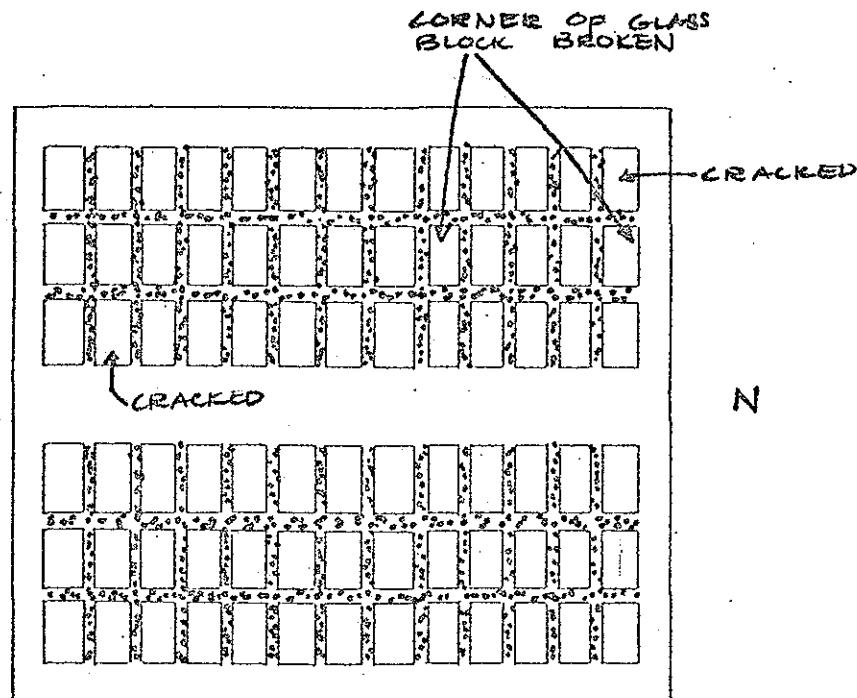
M2 SKYLIGHTS, TICKET OFFICE (4)	NUMBER M 213	CLASS B
MECHANICAL AND ELECTRICAL REHABILITATION MAIN BUILDING ELLIS ISLAND Statue of Liberty National Monument, New York	BUILDING CONSERVATION TECHNOLOGY THE DRAPE GROUP 19 West 44th Street, New York NY 10036	DWG NO.

REINFORCEMENT BARS EXPOSED & CORRODED

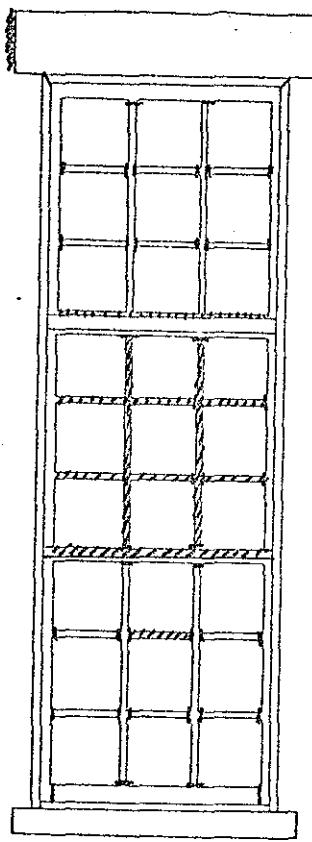
N EAST LIGHT COURTS (4)	NUMBER SEL-212	CLASS 2
MECHANICAL AND ELECTRICAL REHABILITATION MAIN BUILDING ELLIS ISLAND Statue of Liberty National Monument, New York	BUILDING CONSERVATION TECHNOLOGY THE EISENBERG GROUP 19 West 44th Street, New York NY 10036

- INTERIOR:
- TRIM WATER-DAMAGED
 - ONLY ABLE TO REACH LOWEST SASH - WILL NOT OPEN
 - MOLDINGS FRAMING TOP OPENINGS LOOSE, WARPED

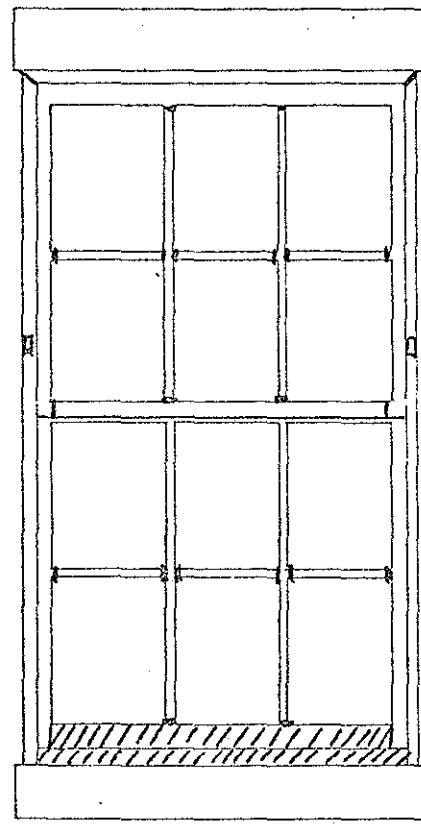
N EAST LIGHT COURTS (4)	NUMBER SEL-213	CLASS 2
MECHANICAL AND ELECTRICAL REHABILITATION MAIN BUILDING ELLIS ISLAND Statue of Liberty National Monument, New York	BUILDING CONSERVATION TECHNOLOGY THE BERNKANTZ GROUP	19 West 44th Street, New York NY 10036

- INTERIOR:
- REPLACE STOOL
 - MOULDING FRAMING OPENING LOOSE, WARPED ALONG HEAD
 - JAMB FRAMING EXPOSED, WET, ROTTED ON RIGHT (NORTH) SIDE

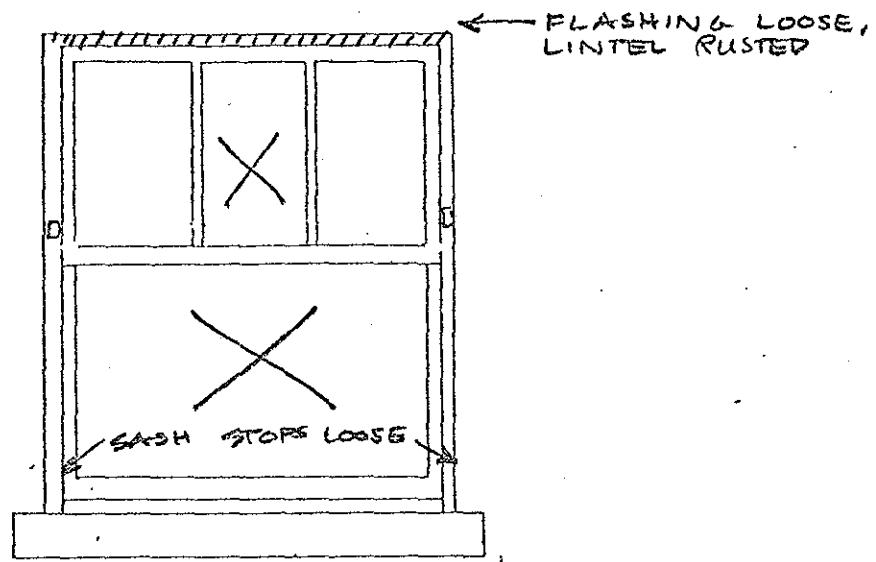
P EAST LIGHT COURTS (1)	NUMBER NEL-206	CLASS I
MECHANICAL AND ELECTRICAL REHABILITATION MAIN BUILDING ELLIS ISLAND Statue of Liberty National Monument, New York	BUILDING CONSERVATION TECHNOLOGY THE EBENKANTZ GROUP 19 West 44th Street, New York NY 10036

INTERIOR: WALL IS FALLING THROUGH HEAD
REPLACE ALL HEAD FRAMING & SASH
TRACKS

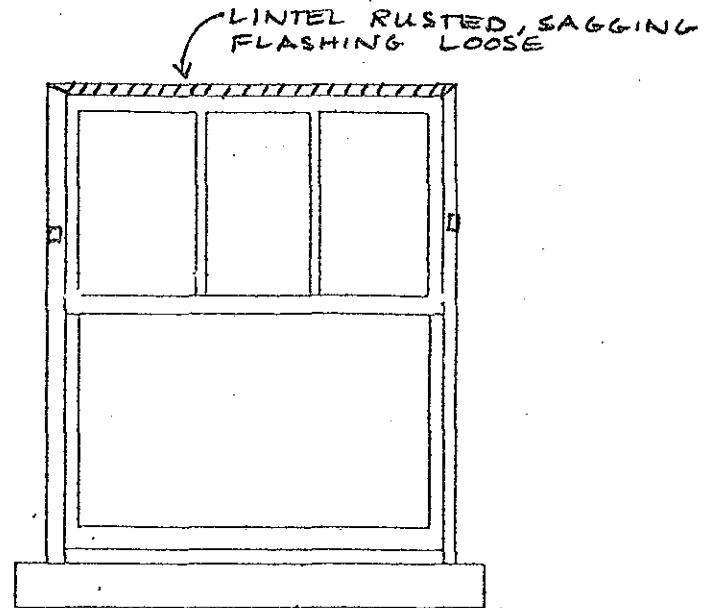
P EAST LIGHT COUNTS (1)	NUMBER NEL - 208	CLASS 2
MECHANICAL AND ELECTRICAL REHABILITATION MAIN BUILDING ELLIS ISLAND Statue of Liberty National Monument, New York	BUILDING CONSERVATION TECHNOLOGY THE PERROTANTZ GROUP 19 West 44th Street, New York NY 10036

INTERIOR: HEAD & JAMBS SPLIT & ROTTED - REPLACE

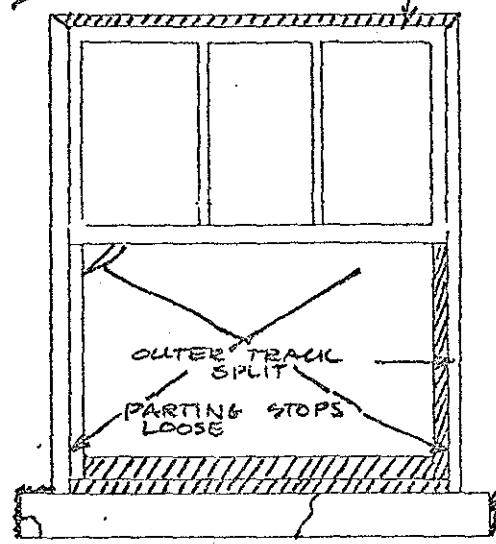
P EAST LIGHT COURTS (1)	NUMBER SEL-201	CLASS I
MECHANICAL AND ELECTRICAL REHABILITATION MAIN BUILDING ELLIS ISLAND Statue of Liberty National Monument, New York	BUILDING CONSERVATION TECHNOLOGY THE DESCENDANT GROUP 19 West 44th Street, New York NY 10036

LINTEL RUSTED,
FLASHING LOOSE →

OVOLIO & BLOCKING LOOSE,
HAVE PULLED OUT $3/8"$
ON THIS SIDE

INTERIOR: MOULDINGS FRAMING TOP SASH LOOSE
& WARPED. NO APPARENT ROT AT PRESENT.

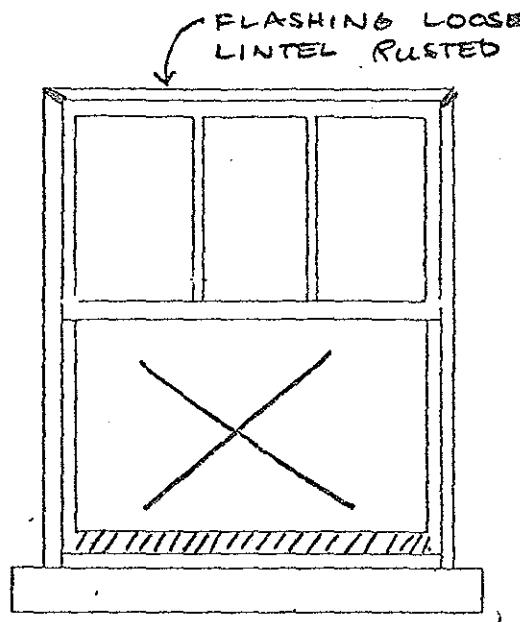
P EAST LIGHT OUTS (1)	NUMBER SEL-204	CLASS I
MECHANICAL AND ELECTRICAL REHABILITATION MAIN BUILDING ELLIS ISLAND Statue of Liberty National Monument, New York	BUILDING CONSERVATION TECHNOLOGY THE DIBBLENTZ GROUP

- INTERIOR:
- MOULDING FRAMING OPENING LOOSE ALONG HEAD
 - GAP BETWEEN INNER TRACKS & STOOL

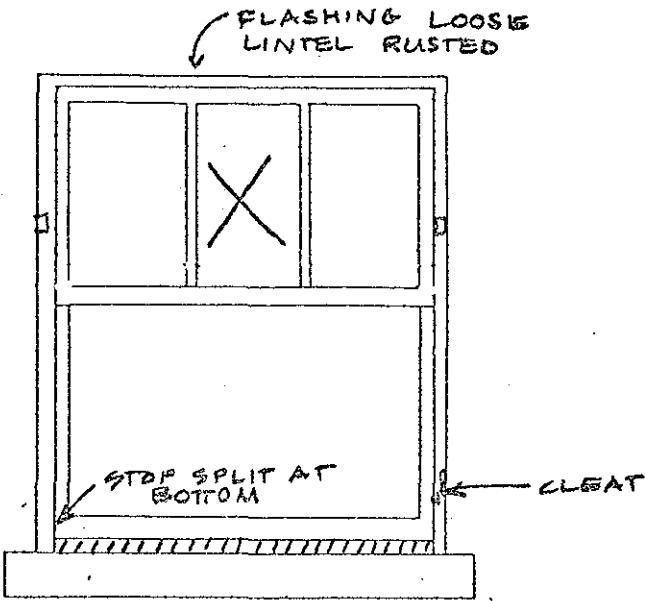
P EAST LIGHT COURTS	NUMBER SEL-205	CLASS 2
MECHANICAL AND ELECTRICAL REHABILITATION MAIN BUILDING ELLIS ISLAND Statue of Liberty National Monument, New York	BUILDING PRESERVATION TECHNOLOGY THE DERNERANTZ GROUP

- INTERIOR:
- SASH STOP ON HEAD WORN BY LOCK
ON TOP RAIL OF LOWER SASH
 - SCREW MISSING ON RIGHT (EAST) SIDE INNER TRACK
 - INNER TRACK ON LEFT (WEST) SPLIT - REPLACE
 - GAP BETWEEN INNER TRACKS & STOOLS, BOTH SIDES

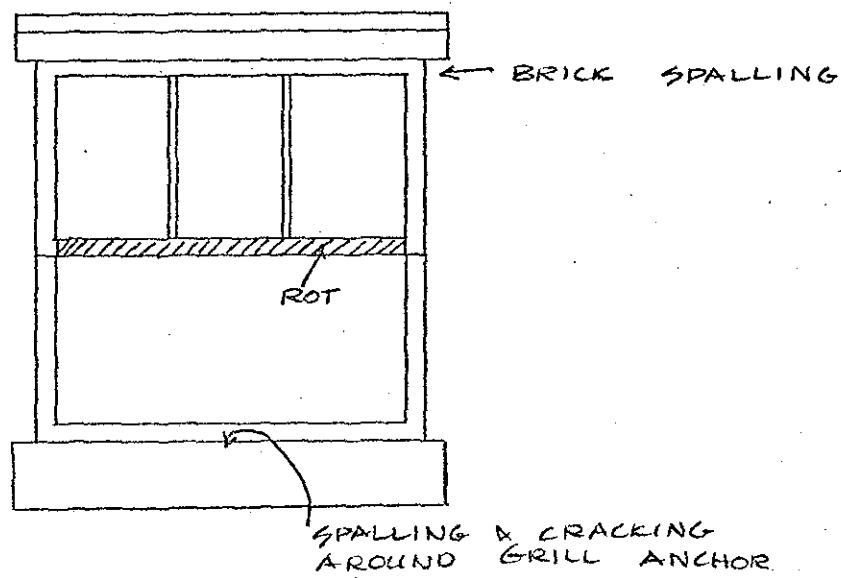
Q WEST LIGHT COUETS (1)	NUMBER SWL-208	CLASS I
MECHANICAL AND ELECTRICAL REHABILITATION MAIN BUILDING ELLIS ISLAND Statue of Liberty National Monument, New York	BUILDING CONSERVATION TECHNOLOGY THE BRENNKRAFT GROUP 19 West 44th Street, New York NY 10036

- INTERIOR:
 - SASH STUCK OPEN
 - BOARD NAILED ACROSS HEAD TO SUPPORT STAIR FRAMING
 - HEAD ROTTED

GRILL IN PLACE - LOOSE AT BOTTOM LEFT CORNER (HINGED ON RIGHT SIDE)

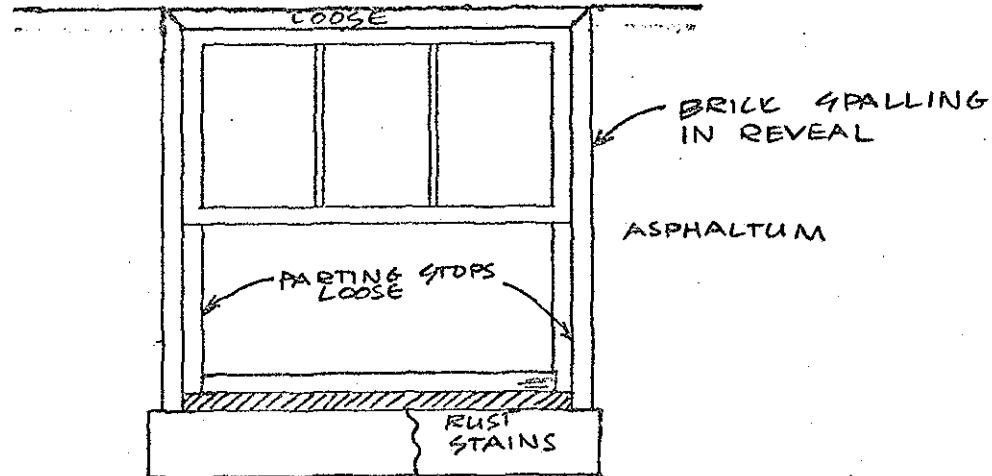
Q HEET LIGHT DUCTS (1)	NUMBER SWL-211	CLASS 2
MECHANICAL AND ELECTRICAL REHABILITATION MAIN BUILDING ELLIS ISLAND Statue of Liberty National Monument, New York	BUILDING CONSERVATION TECHNOLOGY THE EIRENGLANZ GROUP 19 West 44th Street, New York NY 10036

- INTERIOR:
- SOFFIT OF HEAD SPLIT BUT APPEARS O.K.
 - Lintel EXPOSED, RUSTY

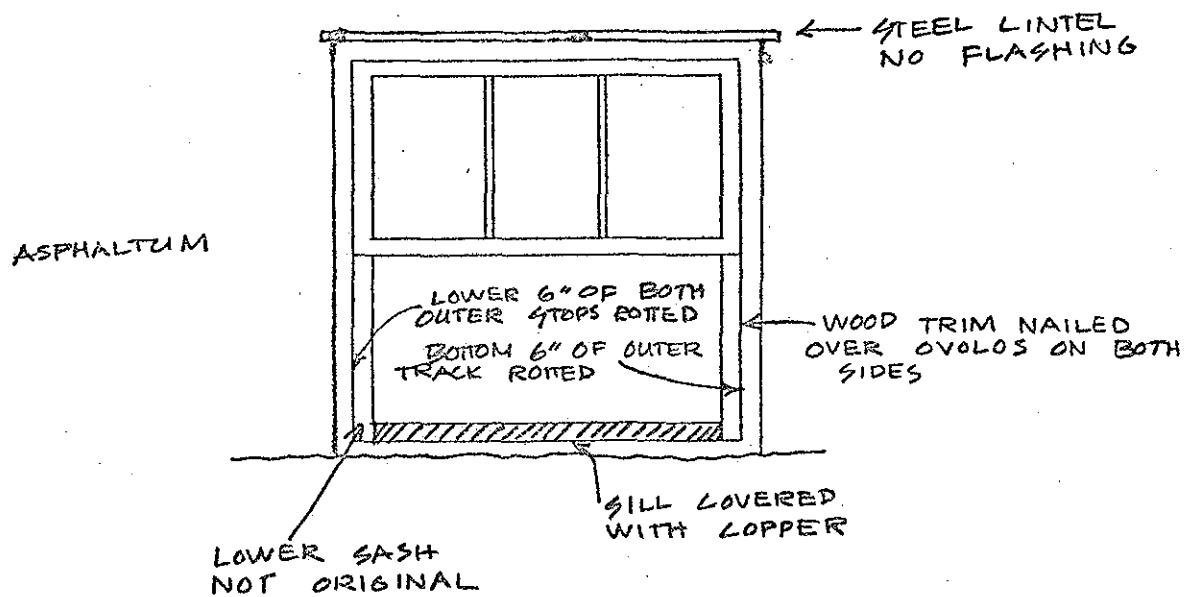
Q HFT LIGHT / QUBS: (1)	NUMBER SWL-212	CLASS 2
MECHANICAL AND ELECTRICAL REHABILITATION MAIN BUILDING ELLIS ISLAND Statue of Liberty National Monument, New York	BUILDING CONSERVATION TECHNOLOGY THE EIRENKRANTZ GROUP 19 West 44th Street, New York NY 10036

- INTERIOR:
- ALL INNER STOP MOULDINGS MISSING
 - LOWER 2/3 OF JAMB MOULDINGS & INNER TRACK MISSING ON LEFT (EAST) SIDE
 - JAMB FRAMING EXPOSED & ROTTING ON TOP OF BOTH SIDES
 - MARBLE STOOL & JAMB COVERS

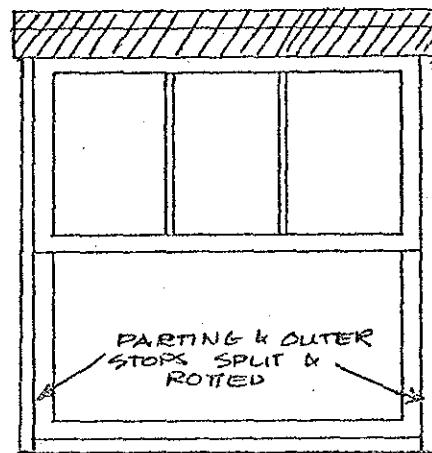
Q. 4 FEET LIGHT COURTS (1)	NUMBER NWL-202	CLASS I
MECHANICAL AND ELECTRICAL REHABILITATION MAIN BUILDING ELLIS ISLAND Statue of Liberty National Monument, New York	BUILDING CONSERVATION TECHNOLOGY THE EBENGRANTZ GROUP 19 West 44th Street, New York NY 10036

GRILL IN PLACE - VERY RUSTY

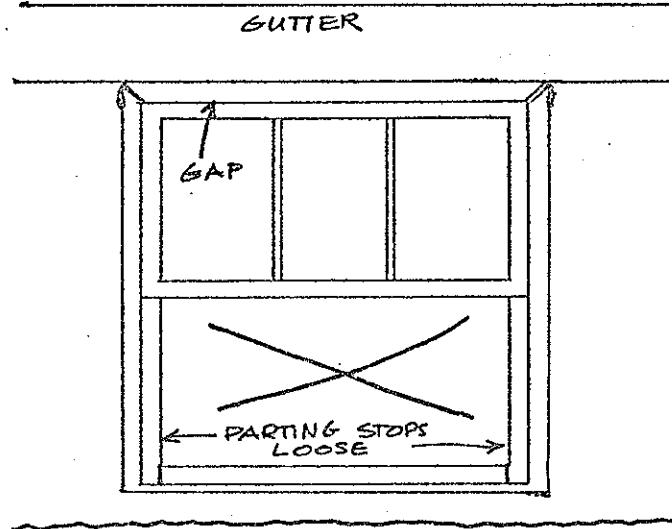
Q LEFT LIGHT COUETS (1)	NUMBER NWL-208	CLASS 2
MECHANICAL AND ELECTRICAL REHABILITATION MAIN BUILDING ELLIS ISLAND Statue of Liberty National Monument, New York	BUILDING CONSERVATION TECHNOLOGY THE EICHENKRANTZ GROUP

- JAMB FRAMING EXPOSED ON LEFT SIDE BUT APPEARS SOUND
- MARBLE STOOL & JAMB COVERS

GRILL IN PLACE - CORRODED.

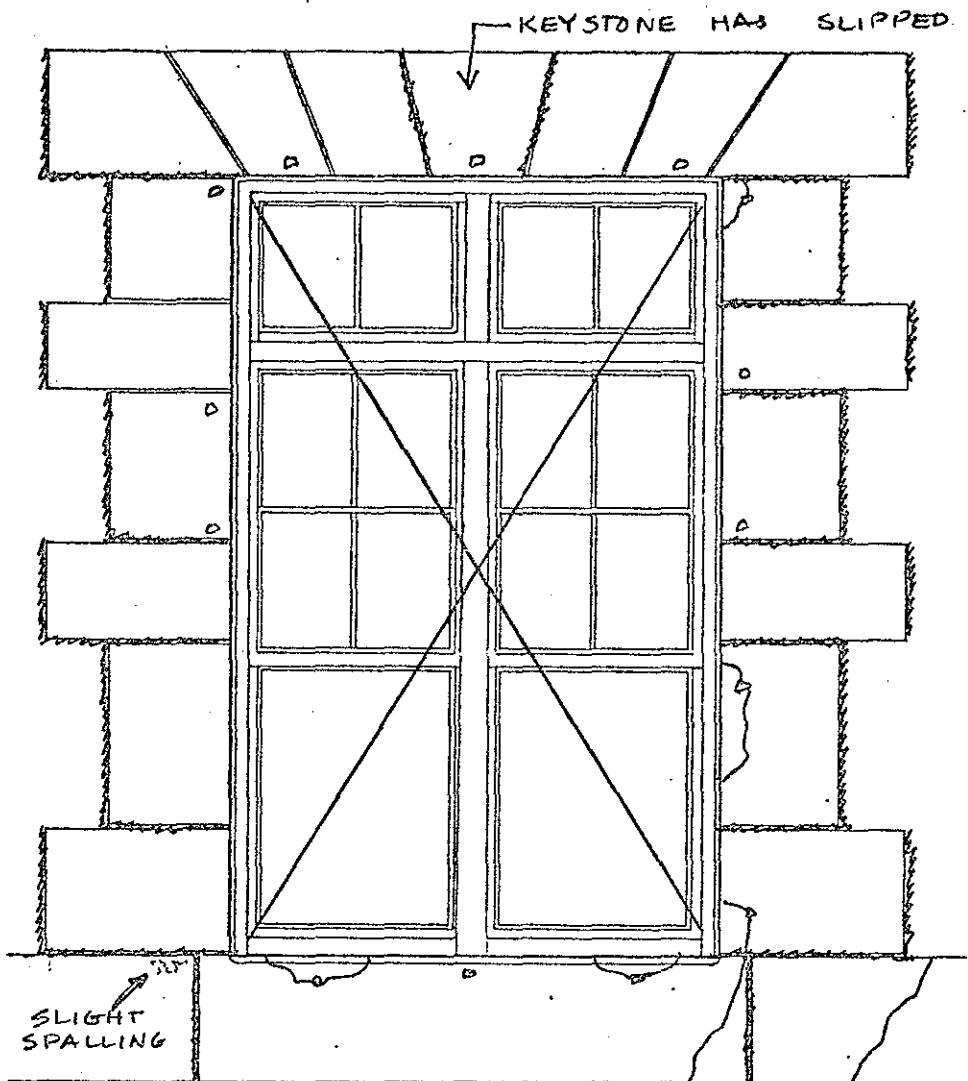
R WEST LIGHT COURTS (2)	NUMBER NWL-205	CLASS 2
MECHANICAL AND ELECTRICAL REHABILITATION MAIN BUILDING ELLIS ISLAND Statue of Liberty National Monument, New York	BUILDING CONSERVATION TECHNOLOGY THE EIRENKRAUTZ GROUP 19 West 44th Street, New York NY 10036

WINDOW HAS FALLEN IN

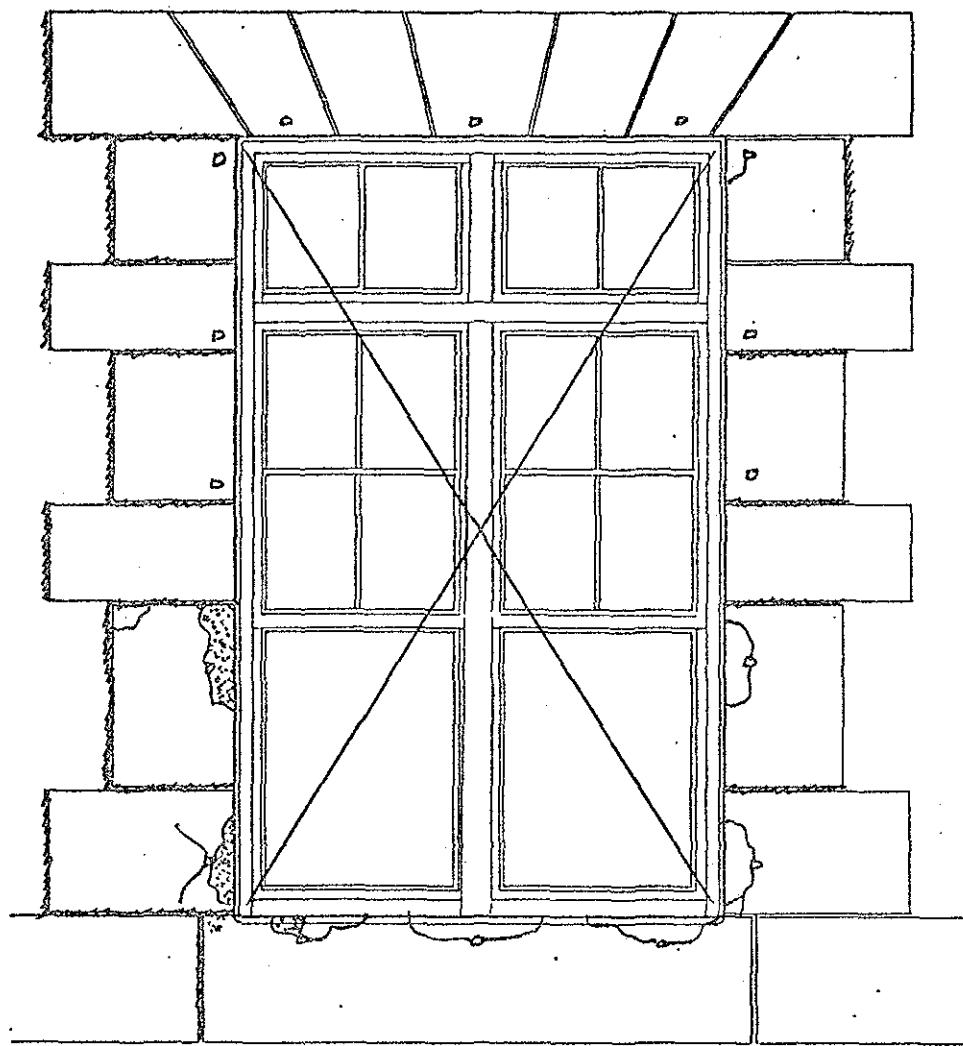
S. THIRD FLOOR, EXTERIOR ELEVATION (B)	NUMBER N 302	CLASS 3 wood
MECHANICAL AND ELECTRICAL REHABILITATION MAIN BUILDING ELLIS ISLAND Statue of Liberty National Monument, New York	BUILDING CONSERVATION TECHNOLOGY THE EBRENNANTZ GROUP	2 stone

WINDOW HAS FALLEN IN

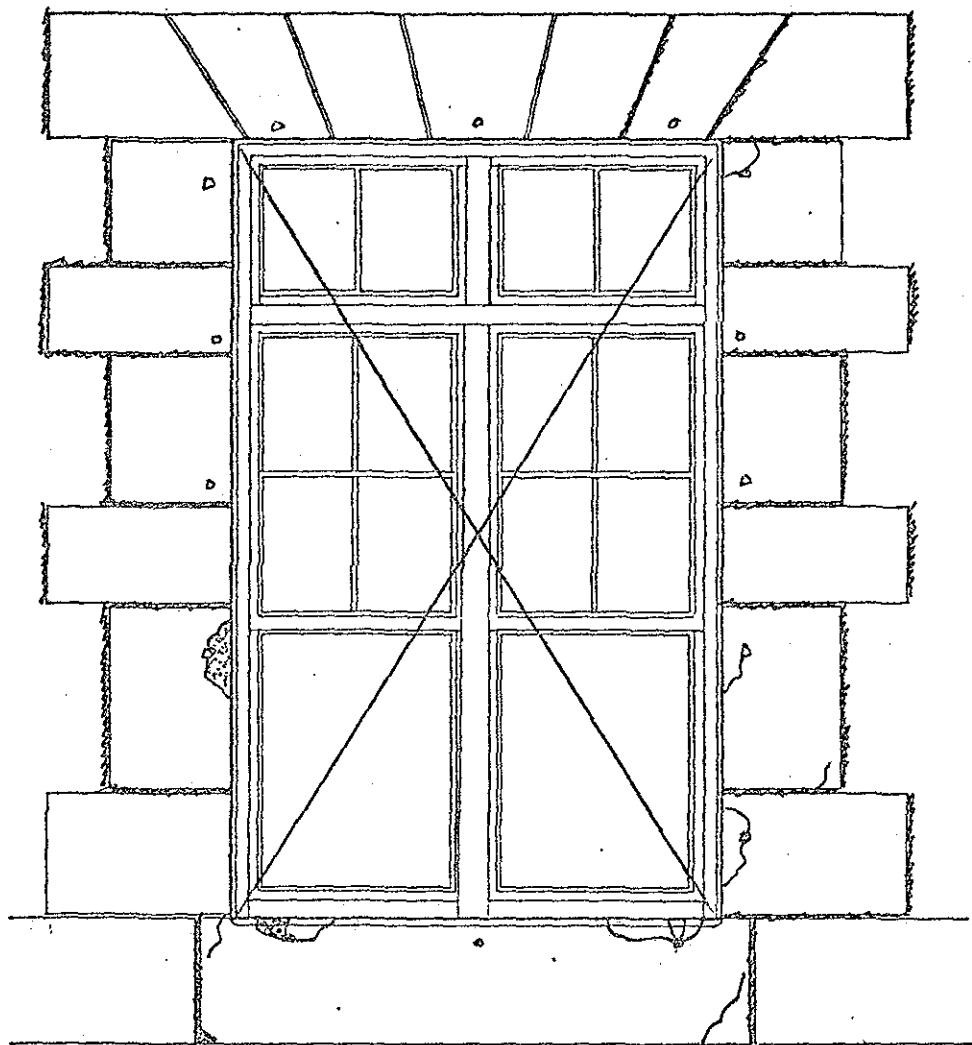
S. THIRD FLOOR, EXTERIOR ELEVATIONS (18)	NUMBER N 303	CLASS 3 wood
MECHANICAL AND ELECTRICAL REHABILITATION MAIN BUILDING ELLIS ISLAND Statue of Liberty National Monument, New York	BUILDING CONSERVATION TECHNOLOGY THE ENGENKRAUTZ GROUP 19 West 44th Street, New York NY 10036	2 stone

WINDOW HAS FALLEN IN

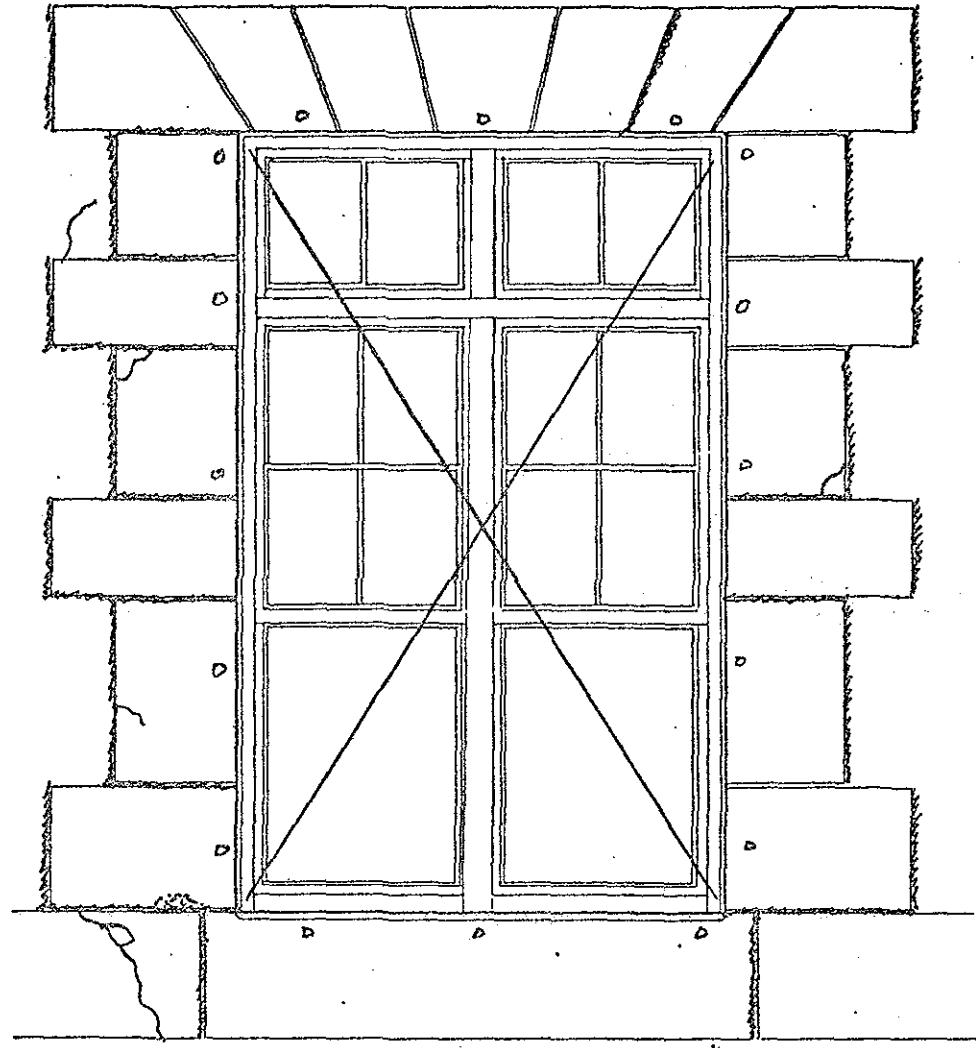
S. THIRD FLOOR, EXTERIOR ELEVATIONS (2B)	NUMBER N 305	CLASS 3
MECHANICAL AND ELECTRICAL REHABILITATION MAIN BUILDING ELLIS ISLAND Statue of Liberty National Monument, New York	BUILDING CONSERVATION TECHNOLOGY THE BIRENKRANTZ GROUP 19 West 46th Street, New York NY 10036

WINDOW HAS FALLEN IN

GRILL REMOVED

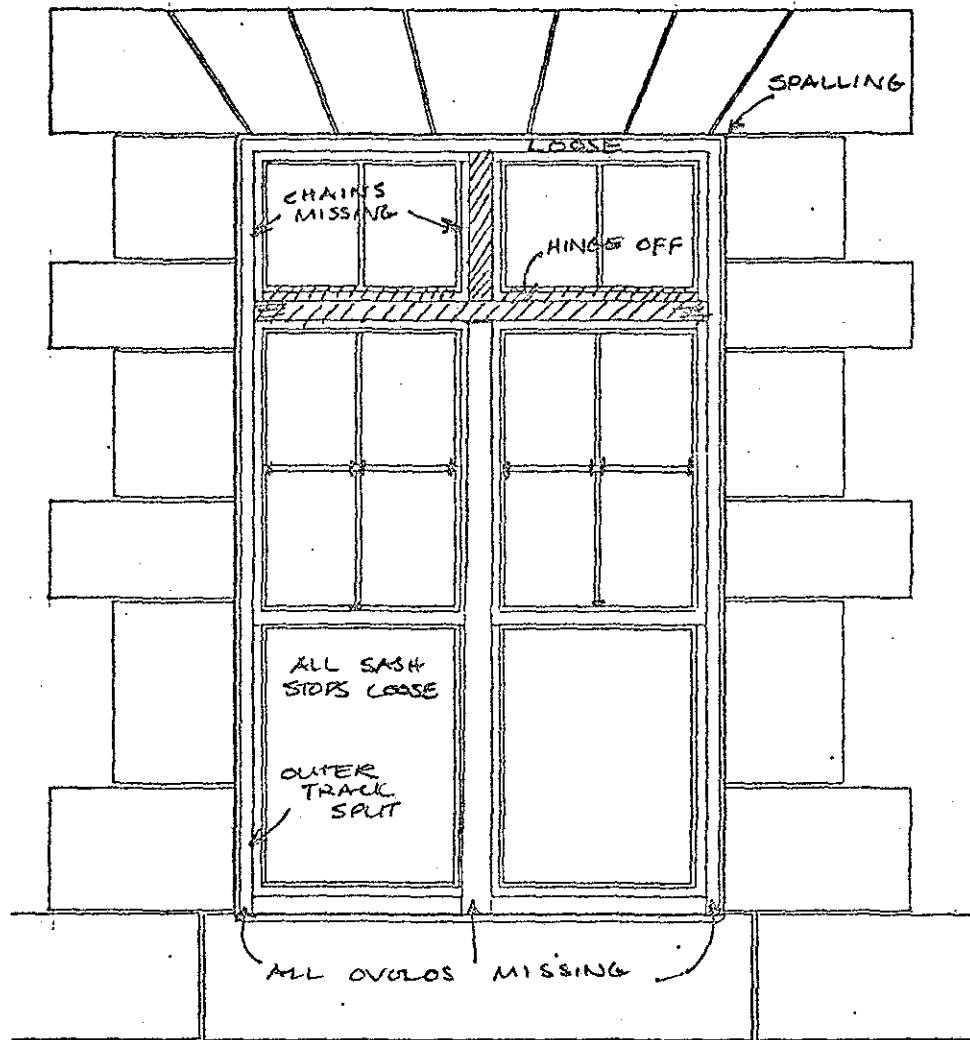
S. THIRD FLOOR, EXTERIOR ELEVATIONS (38)	NUMBER N 323	CLASS 2
MECHANICAL AND ELECTRICAL REHABILITATION MAIN BUILDING ELLIS ISLAND	BUILDING CONSERVATION TECHNOLOGY THE BURENGRANTZ GROUP	
Statue of Liberty National Monument, New York	19 West 44th Street, New York NY 10036

INTERIOR:

- ALL MLDGS FRAMING OPENINGS BUCKLED
- TRANSOM ROTTED

SCREENS REMOVED

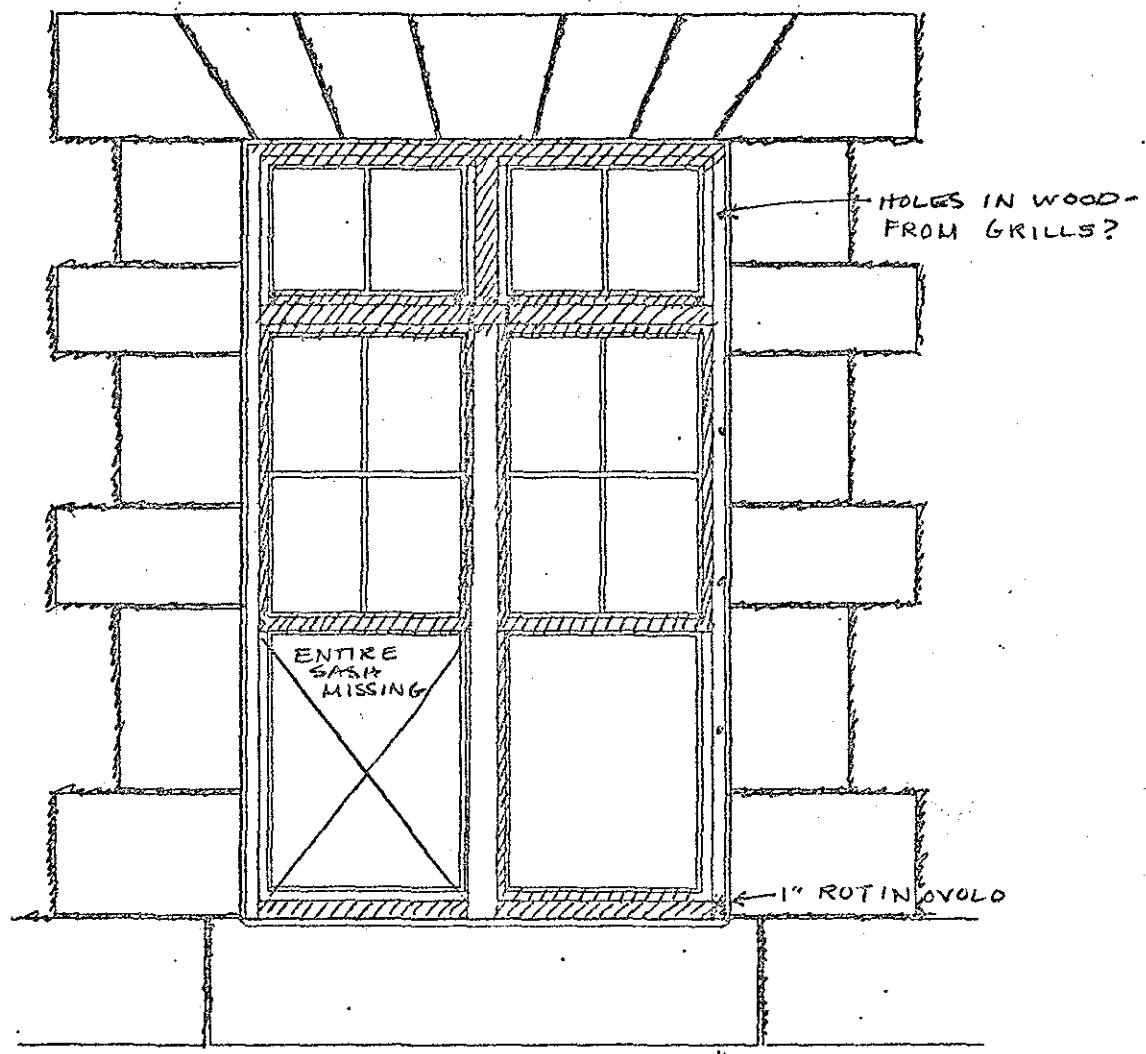
S. THIRD FLOOR, EXTERIOR ELEVATIONS (38)	NUMBER N 326	CLASS 3
MECHANICAL AND ELECTRICAL REHABILITATION MAIN BUILDING ELLIS ISLAND Statue of Liberty National Monument, New York	BUILDING CONSERVATION TECHNOLOGY THE EHRENKRANTZ GROUP 19 West 44th Street, New York NY 10036

INTERIOR:

- HEAD ROTTED
- ALL FRAMING MEMBERS ROTTED
- MLDGS FRAMING OPENINGS ROTTED
- TRANSMON ROTTED.

SCREEN ON RIGHT WINDOW ONLY - POOR CONDITION
GRILL REMOVED

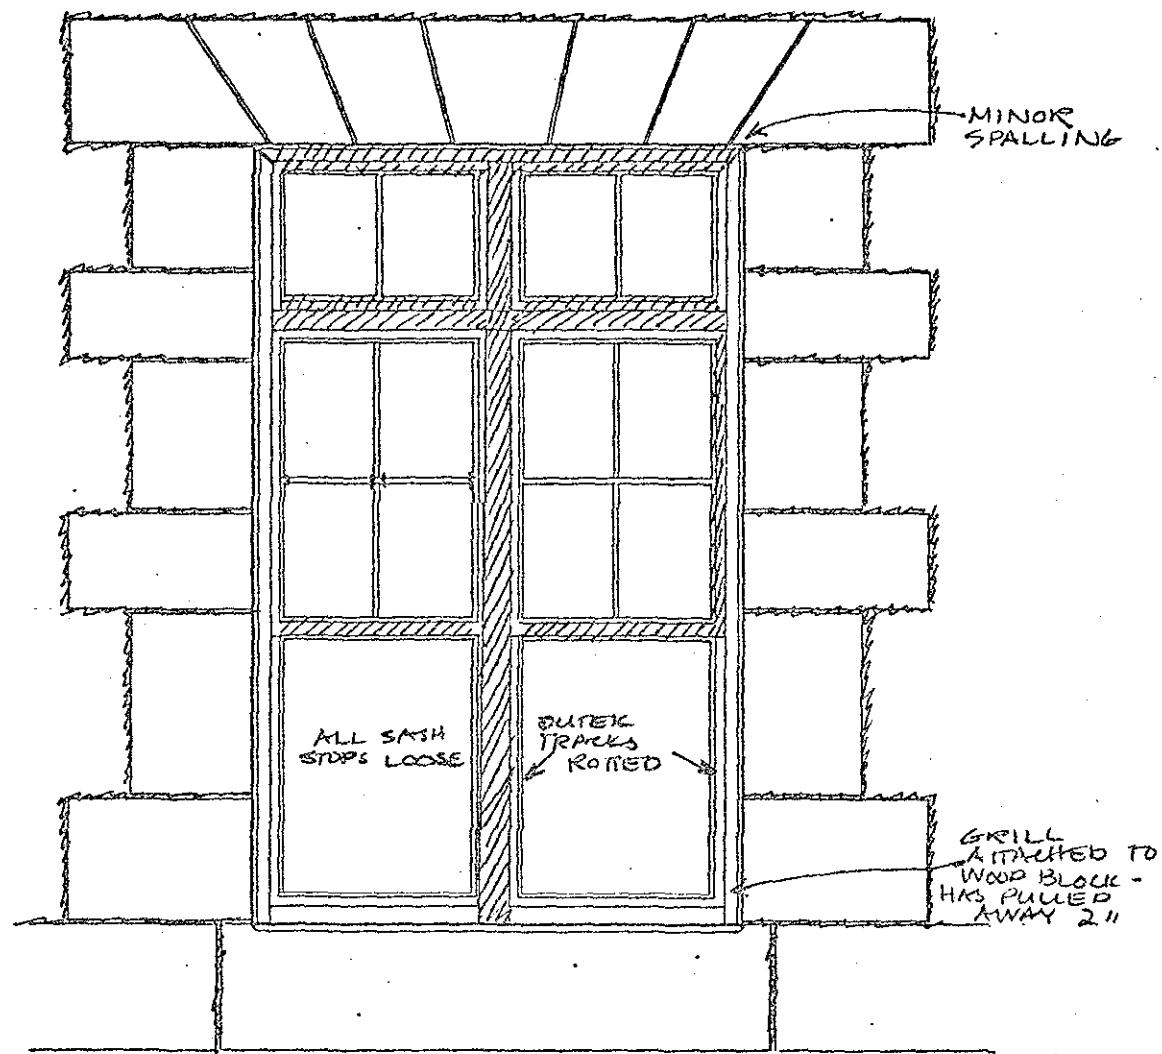
S, THIRD FLOOR, EXTERIOR ELEVATIONS (38)	NUMBER N327	CLASS 2
MECHANICAL AND ELECTRICAL REHABILITATION MAIN BUILDING ELLIS ISLAND Statue of Liberty National Monument, New York	BUILDING CONSERVATION TECHNOLOGY THE EBENKRAUTZ GROUP

GRILL IN PLACE - GOOD CONDITION

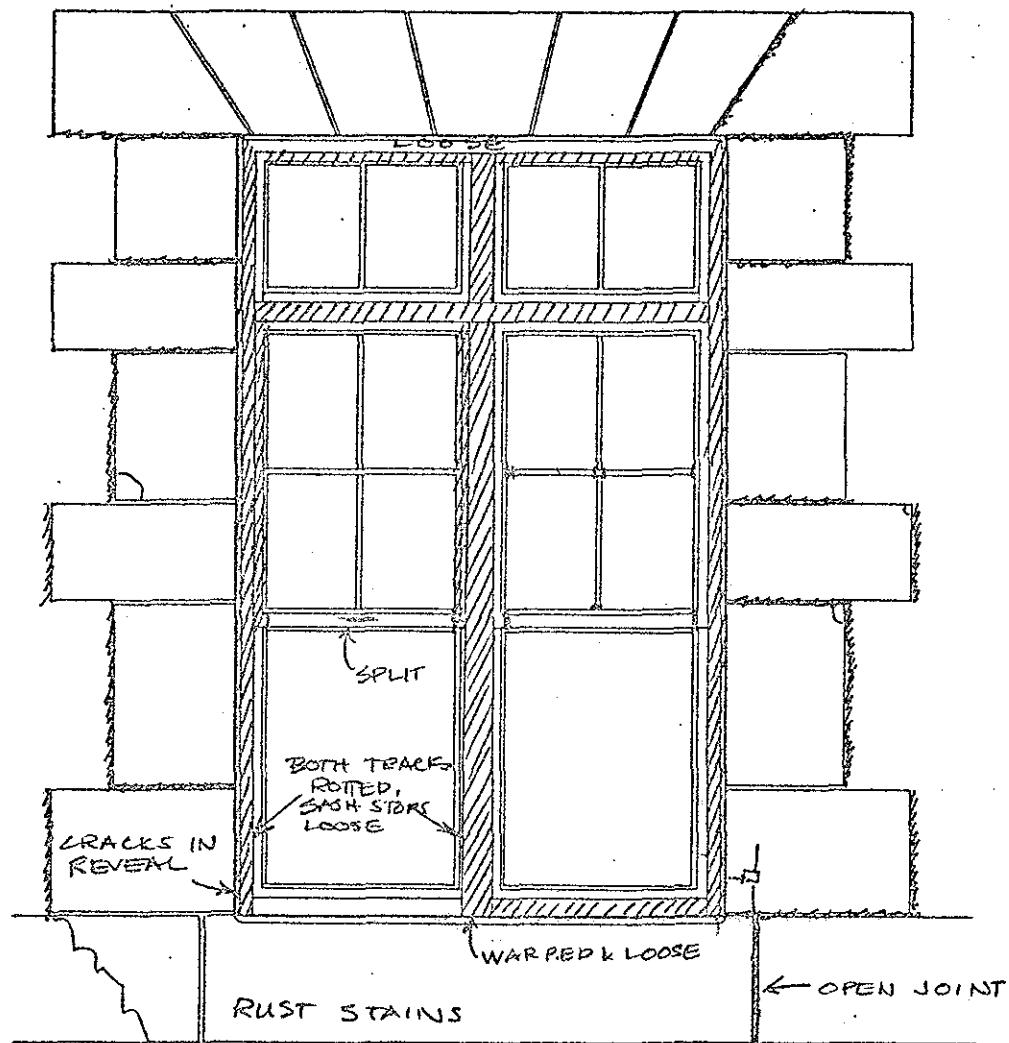
S. THIRD FLOOR, EXTERIOR ELEVATIONS (08)	NUMBER E 303	CLASS 3
MECHANICAL AND ELECTRICAL REHABILITATION MAIN BUILDING ELLIS ISLAND Statue of Liberty National Monument, New York	BUILDING CONSERVATION TECHNOLOGY THE EHRENKRANTZ GROUP 19 West 44th Street, New York NY 10036

SCREENS ON LOWER SASH - POOR CONDITION

INTERIOR: • REPLACE STOOLS ON BOTH WINDOWS
