historic structures report

mechanical/electrical rehabilitation

main building

STATUE OF LIBERTY ELLIS ISLAND

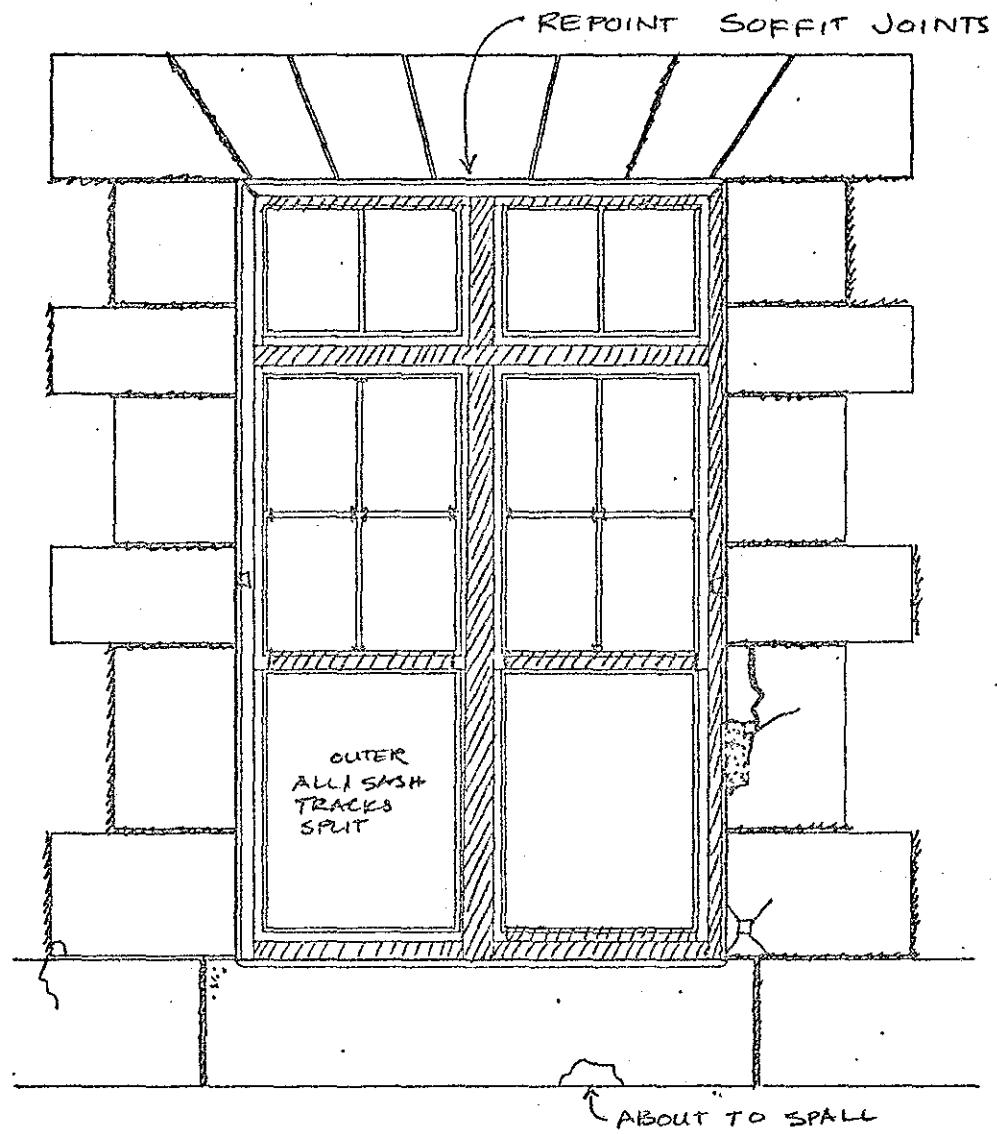
S THIRD FLOOR, EXTERIOR ELEVATIONS (obj)	NUMBER E 304	CLASS 2 wood
MECHANICAL AND ELECTRICAL REHABILITATION MAIN BUILDING ELLIS ISLAND Statue of Liberty National Monument, New York	BUILDING CONSERVATION TECHNOLOGY THE EBENGRANTZ GROUP 19 West 44th Street, New York NY 10036	2 stone

INTERIOR: HEAD WATER STAINED

SCREENS - ON LOWER SASH - POOR CONDITION

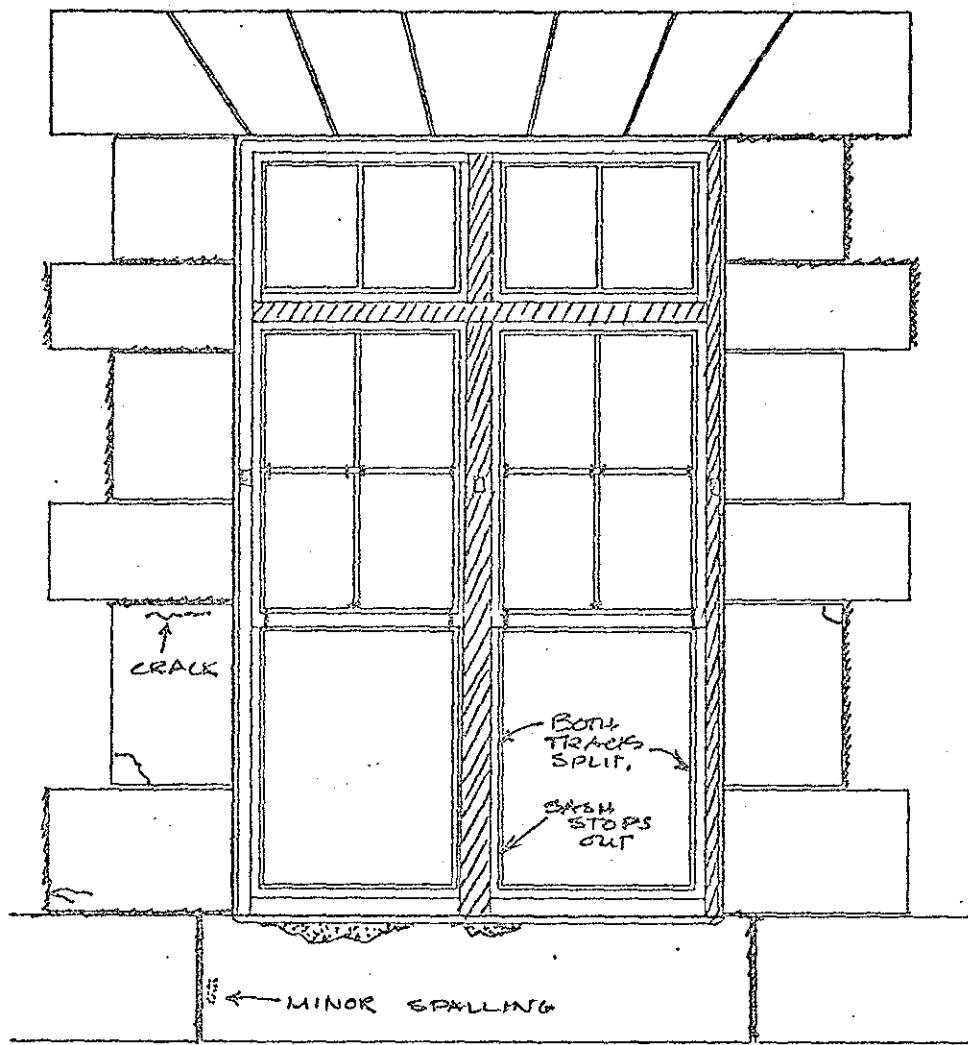
S. THIRD FLOOR, EXTERIOR ELEVATION(S) (9,10)	NUMBER E 306	CLASS 2 wood
MECHANICAL AND ELECTRICAL REHABILITATION MAIN BUILDING ELLIS ISLAND	BUILDING CONSERVATION TECHNOLOGY THE DRENNKRAFT GROUP	2 stone

GRILL
NO SCREENS

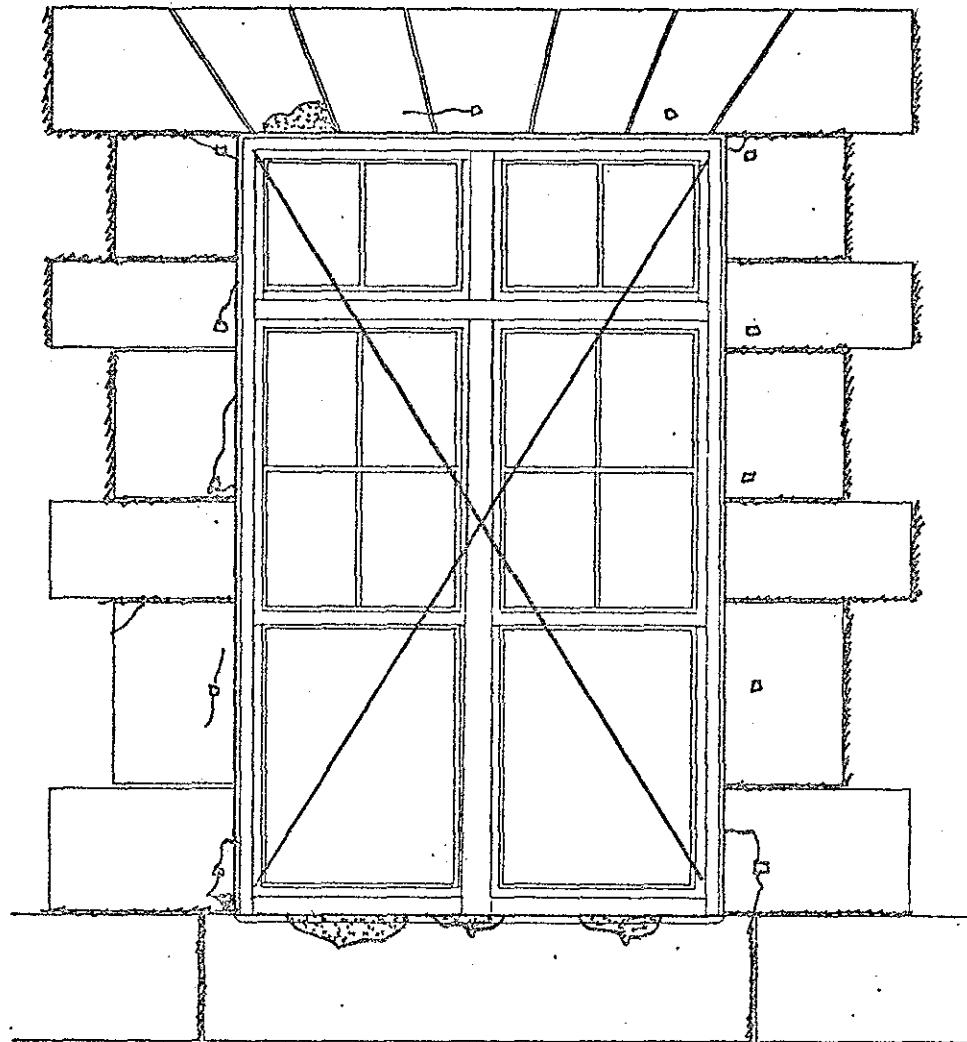
S. THIRD FLOOR, EXTERIOR ELEVATIONS (2,8)	NUMBER E 307	CLASS 3 wood
MECHANICAL AND ELECTRICAL REHABILITATION MAIN BUILDING ELLIS ISLAND Statue of Liberty National Monument, New York	BUILDING CONSERVATION TECHNOLOGY THE EBENKRANTZ GROUP 19 West 44th Street, New York NY 10036	2 stone

WINDOW HAS FALLEN IN

GRILL OFF

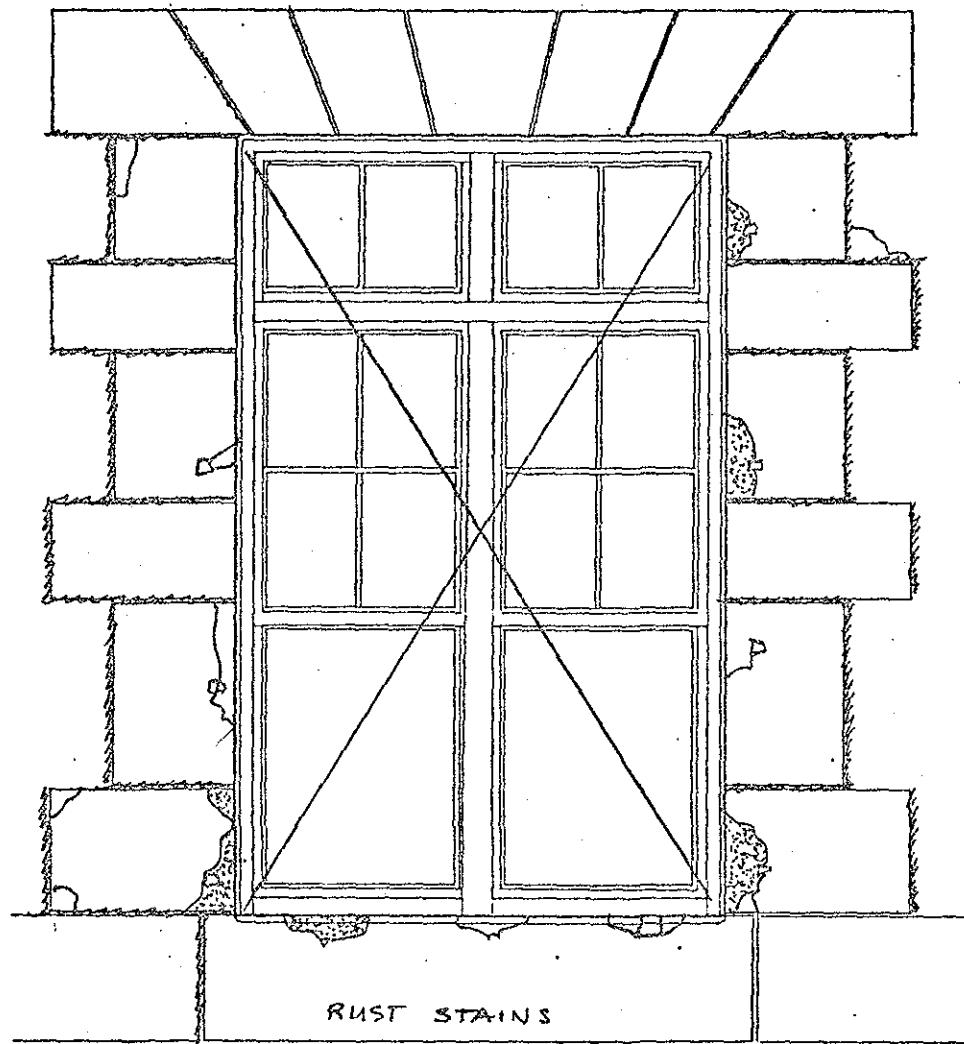
S. THIRD FLOOR, EXTERIOR ELEVATION(S) (18)	NUMBER E 308	CLASS 3
MECHANICAL AND ELECTRICAL REHABILITATION MAIN BUILDING ELLIS ISLAND Statue of Liberty National Monument, New York	BUILDING CONSERVATION TECHNOLOGY THE EBENENGRANTZ GROUP 19 West 46th Street, New York NY 10036	2 stone

WINDOW HAS FALLEN IN

GRILL IN PLACE

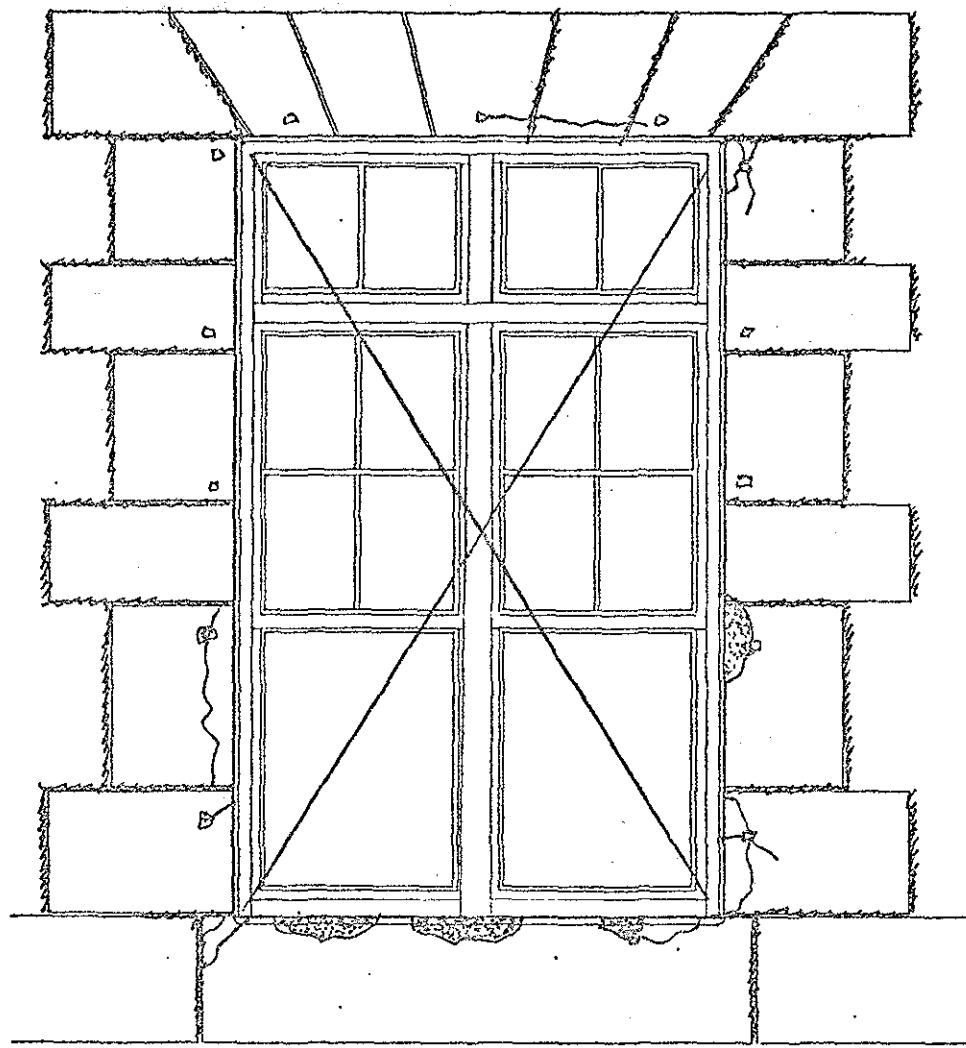
S. THIRD FLOOR, EXTERIOR ELEVATION (obj)	NUMBER E 309	CLASS 3 wood
MECHANICAL AND ELECTRICAL REHABILITATION MAIN BUILDING ELLIS ISLAND Statue of Liberty National Monument, New York	BUILDING CONSERVATION TECHNOLOGY THE EPENIGRANTZ GROUP 19 West 44th Street, New York NY 10036	2 stone

WINDOW HAS FALLEN IN

GRILL REMOVED

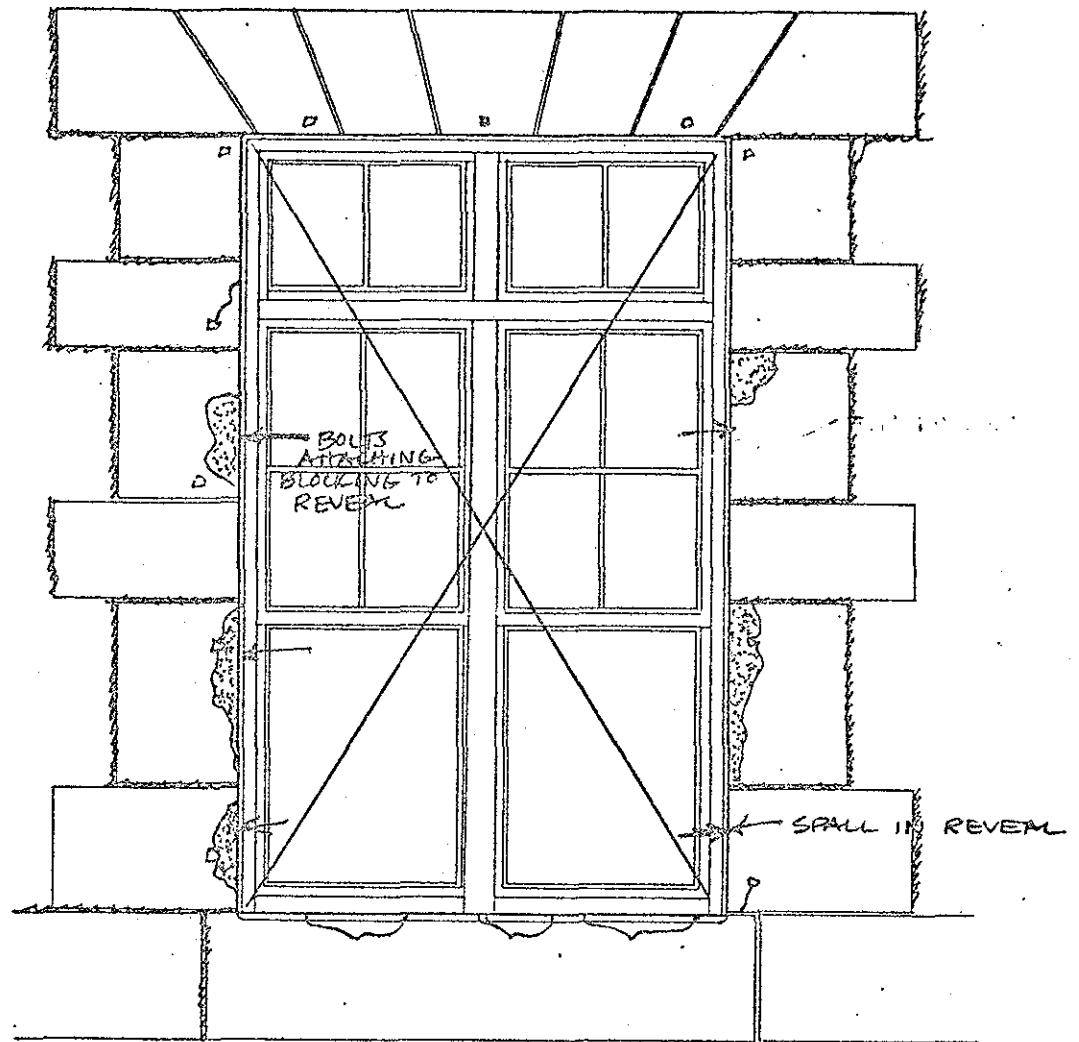
S. THIRD FLOOR, EXTERIOR ELEVATIONS (28)	NUMBER E 310	CLASS 3 wood
MECHANICAL AND ELECTRICAL REHABILITATION MAIN BUILDING ELLIS ISLAND Statue of Liberty National Monument, New York	BUILDING CONSERVATION TECHNOLOGY THE FIRENZE GROUP 19 West 44th Street, New York NY 10036	2 stone

WINDOW HAS FALLEN IN

GRILL REMOVED

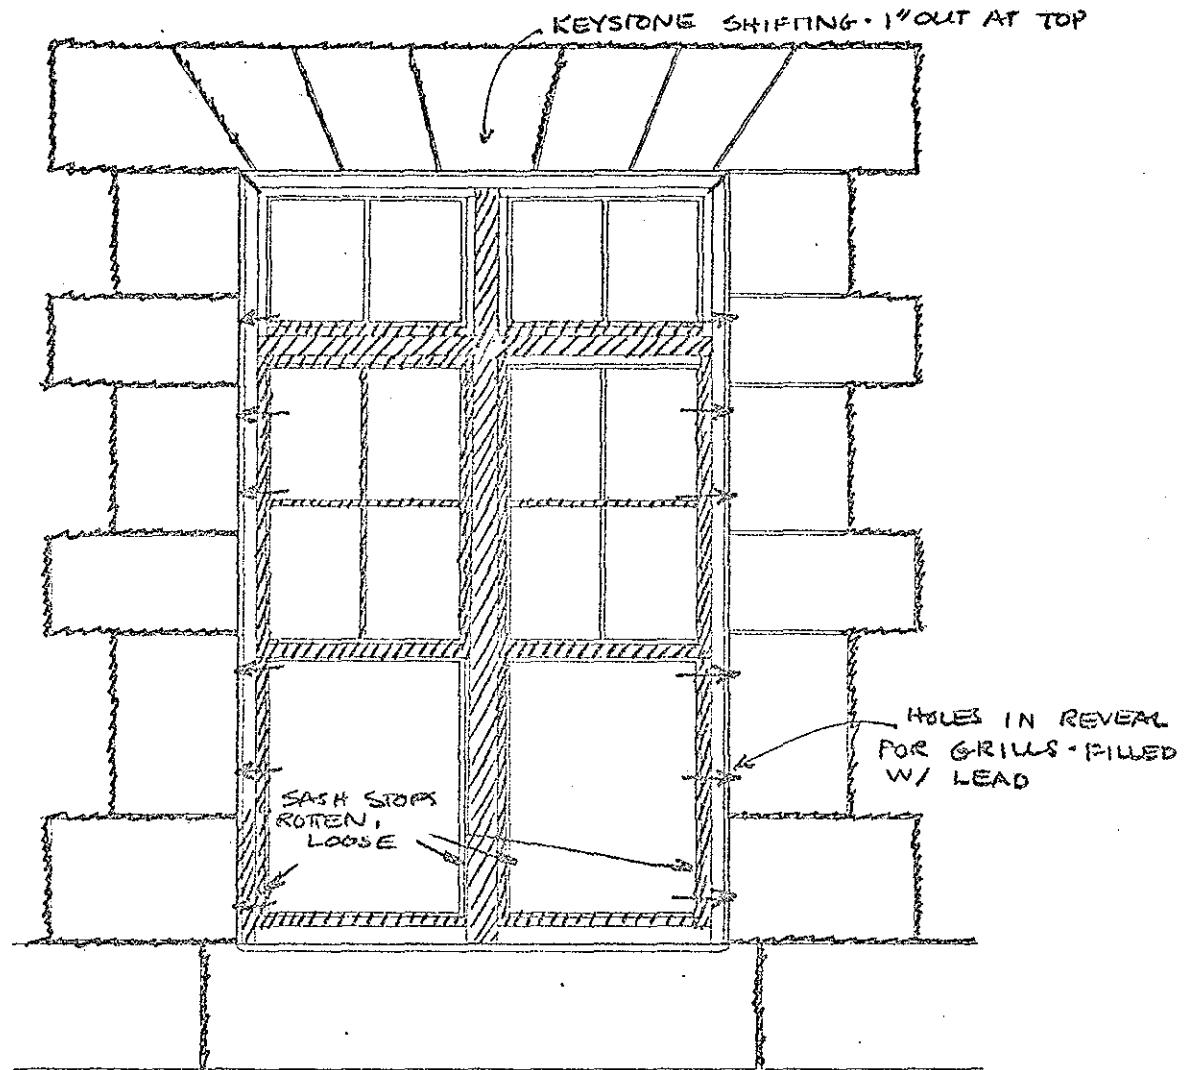
STORY 5, DOOR, EXTERIOR ELEVATIONS (48)	NUMBER S 301	CLASS 3
MECHANICAL AND ELECTRICAL REHABILITATION MAIN BUILDING ELLIS ISLAND Statue of Liberty National Monument, New York	BUILDING CONSERVATION TECHNOLOGY THE EBENKRANTZ GROUP 19 West 44th Street, New York NY 10036

SCREENS REMOVED
GRILL REMOVED

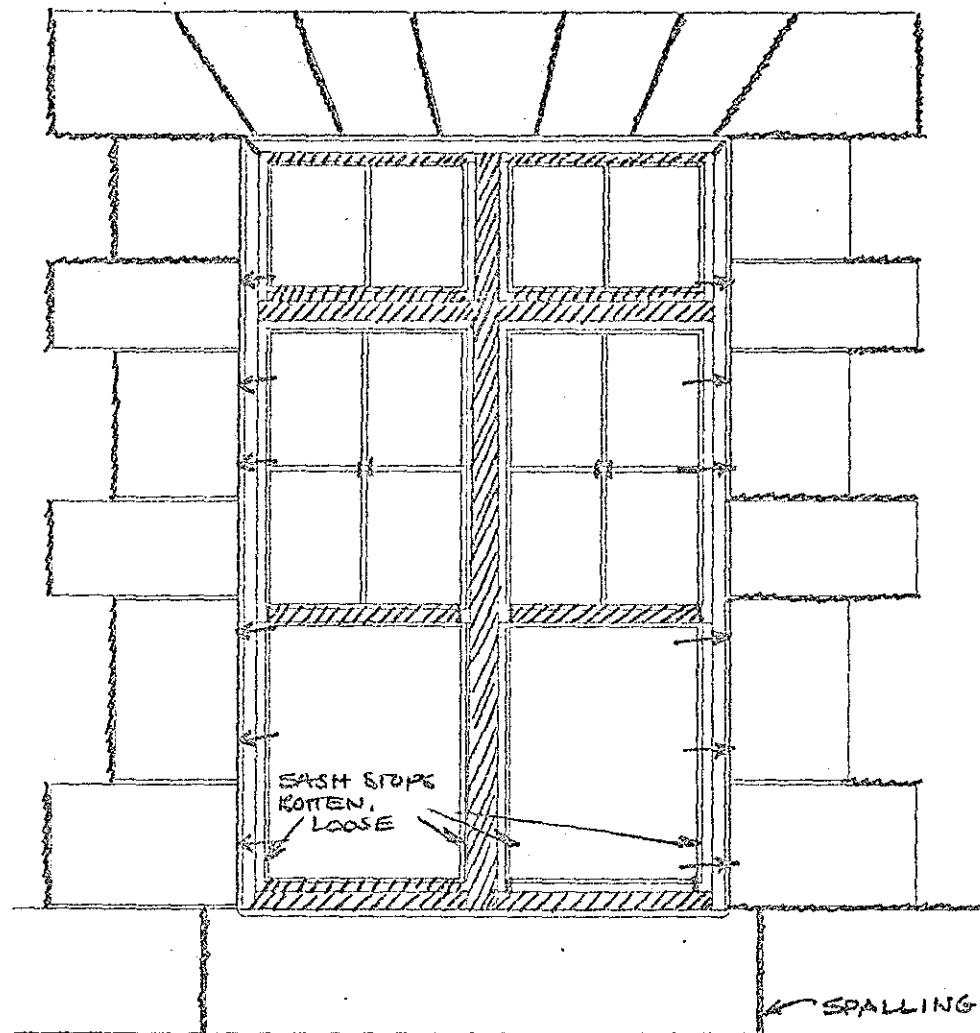
S THIRD FLOOR EXTERIOR ELEVATIONS	NUMBER 5302	CLASS 2
MECHANICAL AND ELECTRICAL REHABILITATION MAIN BUILDING ELLIS ISLAND Statue of Liberty National Monument, New York	BUILDING CONSERVATION TECHNOLOGY THE ESENTRANTZ GROUP

GRILL REMOVED
SCREENS REMOVED

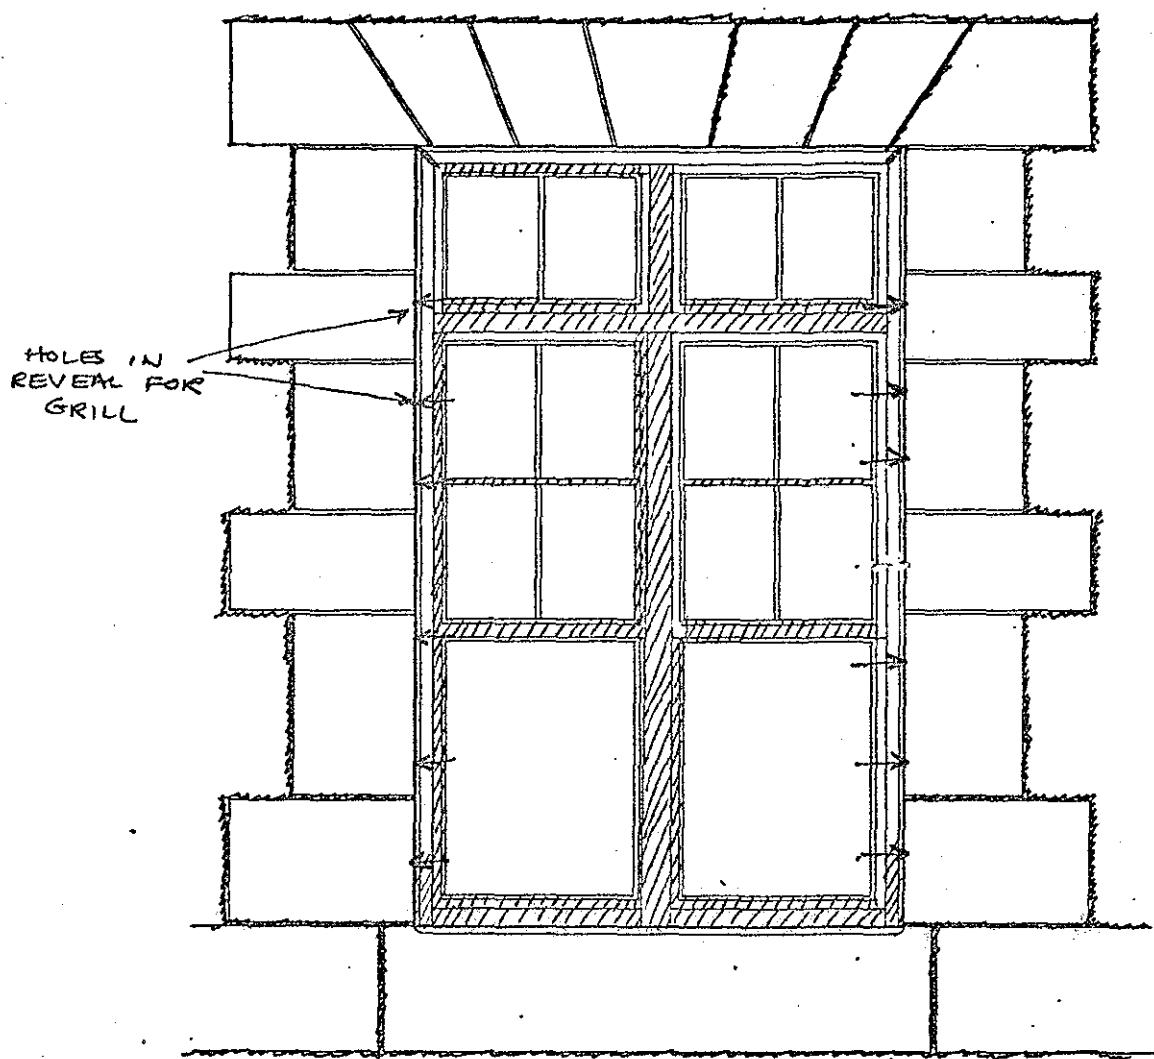
S. THIRD FLOOR, EXTERIOR ELEVATIONS (N.E.)	NUMBER S 303	CLASS 2
MECHANICAL AND ELECTRICAL REHABILITATION MAIN BUILDING ELLIS ISLAND Statue of Liberty National Monument, New York	BUILDING CONSERVATION TECHNOLOGY THE ENTHORNANZ GROUP 19 West 44th Street, New York NY 10036

ALL SASH GUIDES & STOPS ROTTEN, LOOSE, MISSING

GRILL REMOVED

METAL GUIDES PRESENT, BUT NO SCREENS

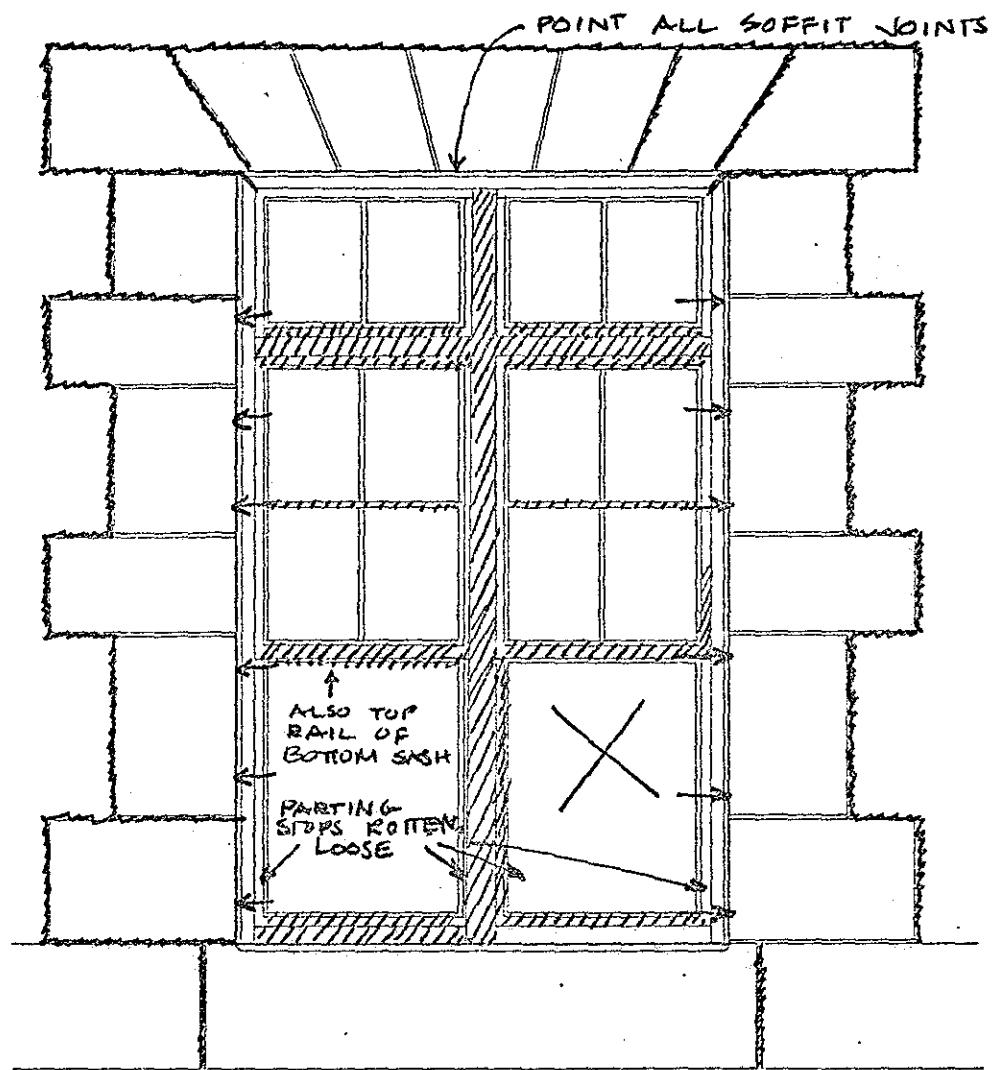
S THIS FLOOR, GROUND ELEVATION'S '301	NUMBER 5304	CLASS 2
MECHANICAL AND ELECTRICAL REHABILITATION MAIN BUILDING ELLIS ISLAND Statue of Liberty National Monument, New York	BUILDING CONSERVATION TECHNOLOGY THE BRENGARTZ GROUP

SCREENS REMOVED
GRILL REMOVED

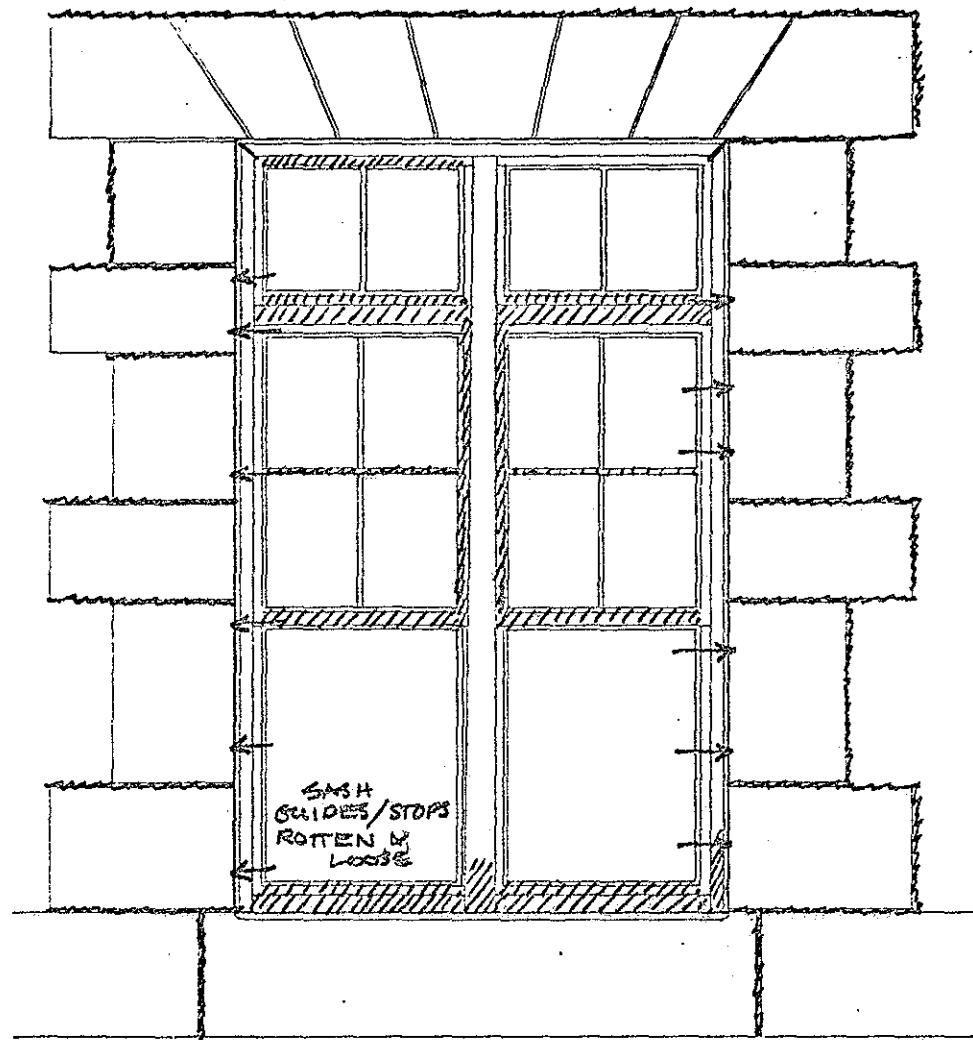
S THREE E. 300 ELEVATIONS (38)	NUMBER S 305	CLASS 2
MECHANICAL AND ELECTRICAL REHABILITATION MAIN BUILDING ELLIS ISLAND Statue of Liberty National Monument, New York	BUILDING CONSERVATION TECHNOLOGY THE EHRENGRANZ GROUP 19 West 44th Street, New York NY 10036

SCREENS REMOVED

GRILL REMOVED

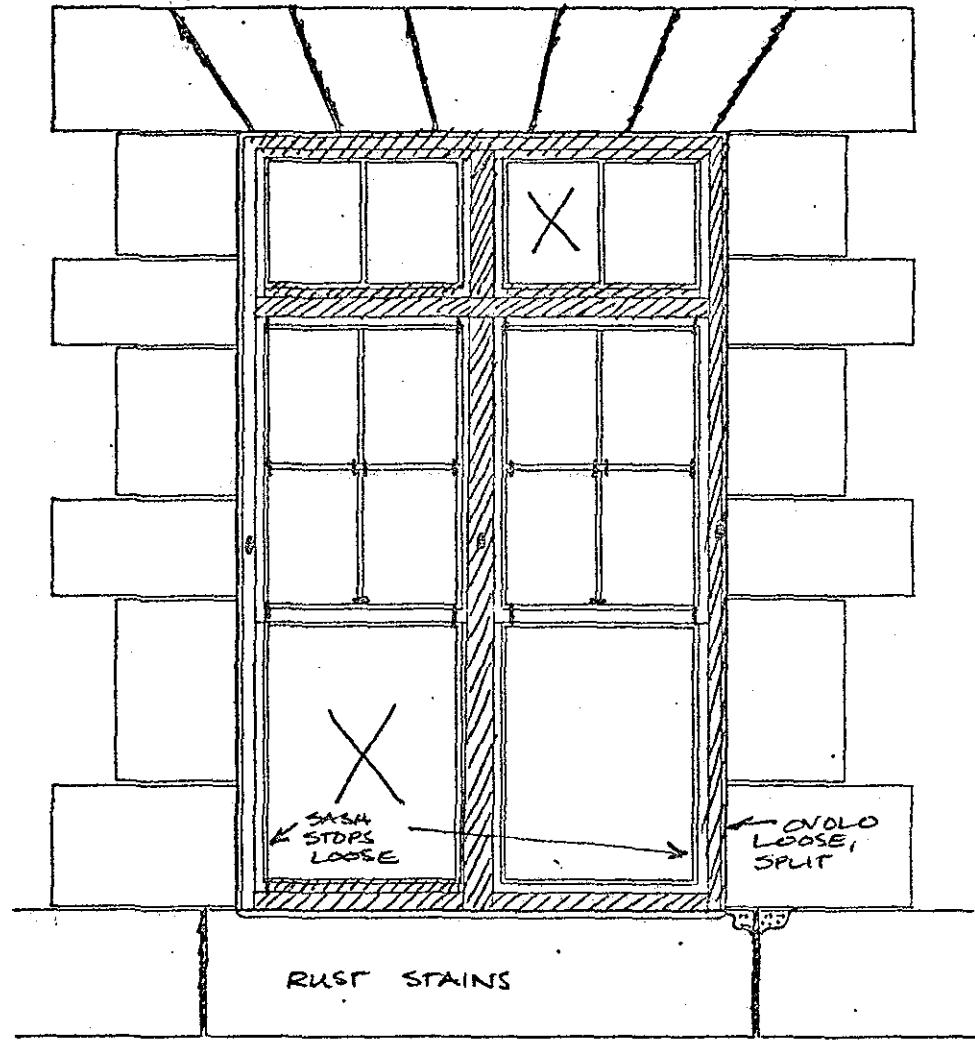
S, THIRD FLOOR, EXTERIOR ELEVATIONS (30)	NUMBER S 323	CLASS 3
MECHANICAL AND ELECTRICAL REHABILITATION MAIN BUILDING ELLIS ISLAND	BUILDING CONSERVATION TECHNOLOGY THE EBENGRANTZ GROUP

SCREENS OVER LOWER SASH - POOR CONDITION

- INTERIOR:
- ALL MOULDINGS LOOSE
 - REPLACE RIGHT (EAST) STOOL
 - REPLACE HEAD
 - REPLACE LEFT (W) JAMB

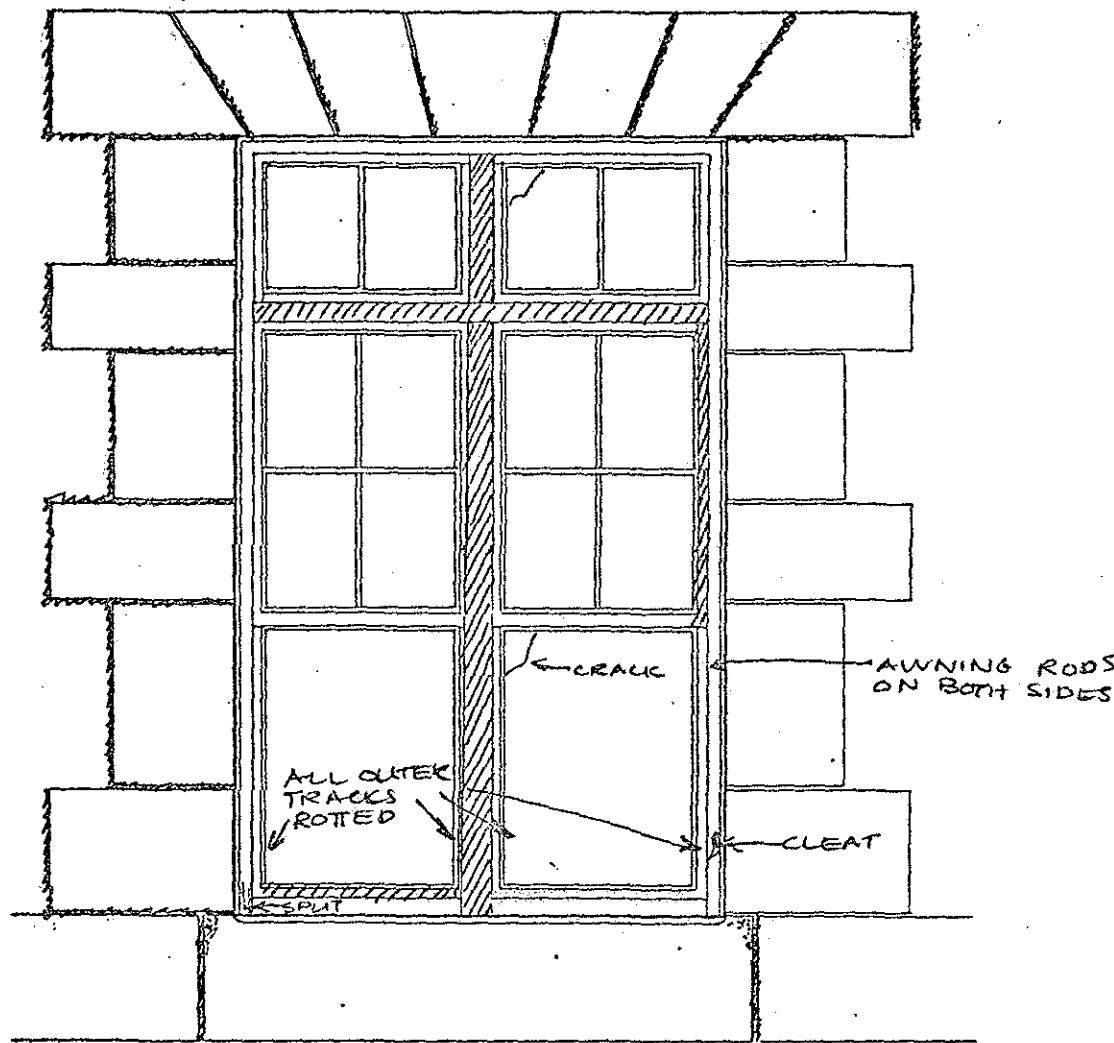
S, THIRD FLOOR, EXTERIOR ELEVATIONS (2,0)	NUMBER S 325	CLASS 2
MECHANICAL AND ELECTRICAL REHABILITATION MAIN BUILDING ELLIS ISLAND Statue of Liberty National Monument, New York	BUILDING CONSERVATION TECHNOLOGY THE BIRENKRANTZ GROUP

INTERIOR:

- SASH WEIGHTS BROKEN ON RIGHT (EAST) WINDOW
- MOULDINGS LOOSE

SCREEN OVER RIGHT (EAST) WINDOW - POOR CONDITION

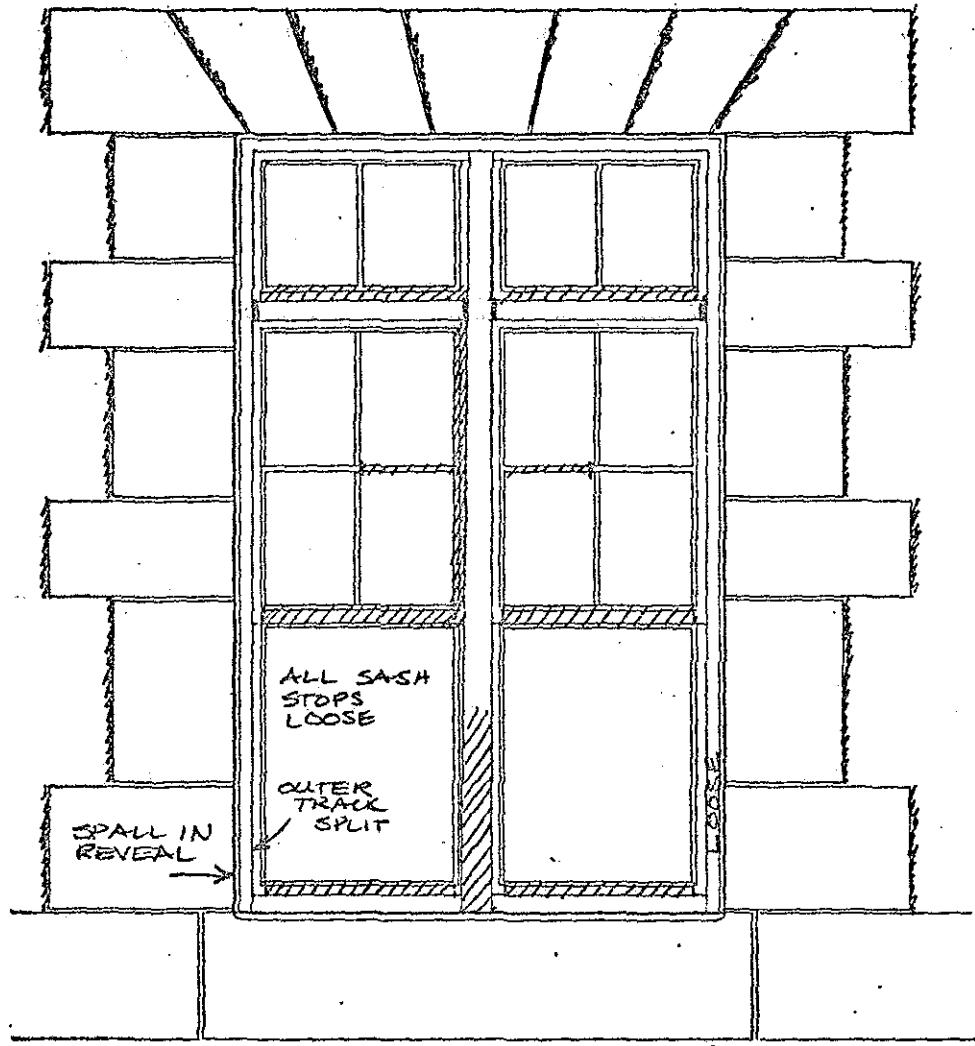
S. THIRD FLOOR, EXTERIOR ELEVATIONS (30)	NUMBER W 301	CLASS 2
MECHANICAL AND ELECTRICAL REHABILITATION MAIN BUILDING ELLIS ISLAND Statue of Liberty National Monument, New York	BUILDING CONSERVATION TECHNOLOGY THE DIBENKORN GROUP 19 West 44th Street, New York NY 10036

NO GRILL

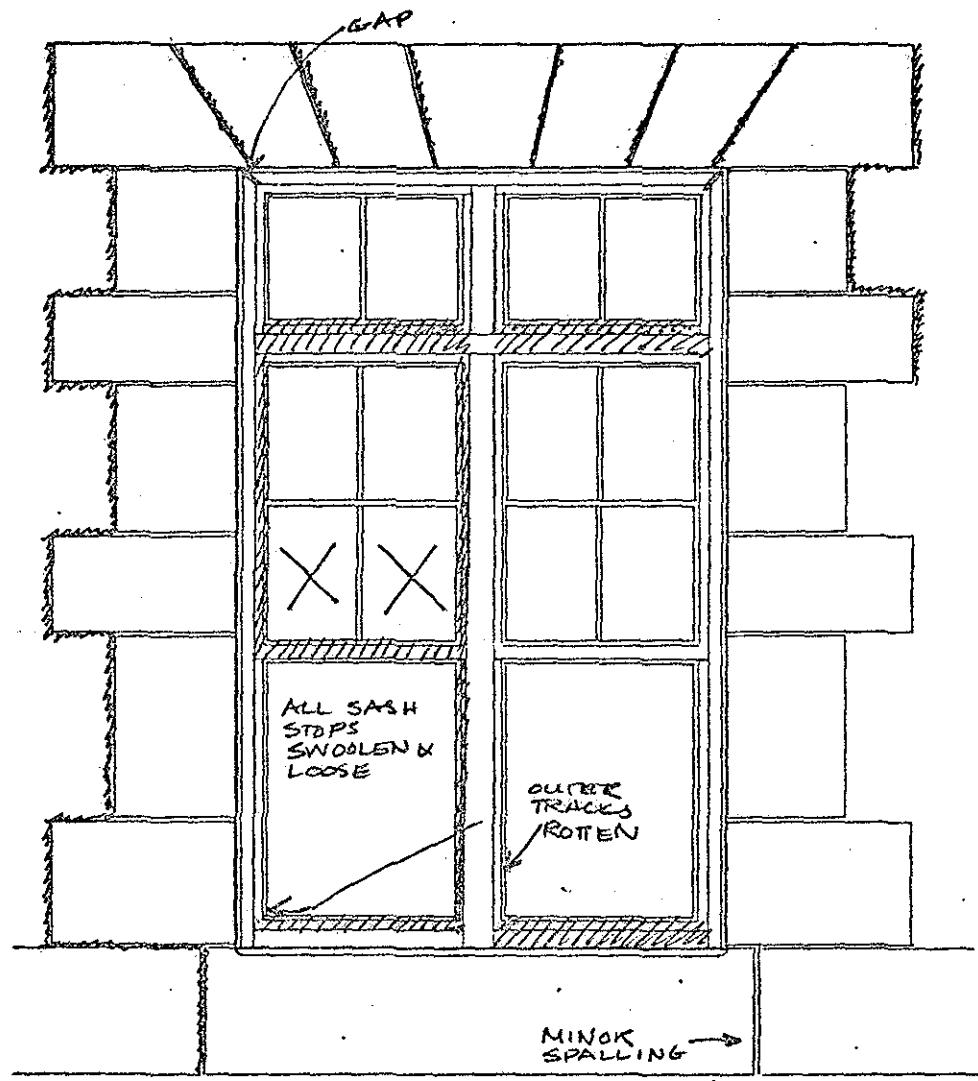
S. THIRD FLOOR, EXTERIOR ELEVATIONS (38)	NUMBER W 302	CLASS 2
MECHANICAL AND ELECTRICAL REHABILITATION MAIN BUILDING ELLIS ISLAND Statue of Liberty National Monument, New York	BUILDING CONSERVATION TECHNOLOGY THE EIRENKRAZT GROUP

INTERIOR: TRANSOM BUCKLED

NO GRILL

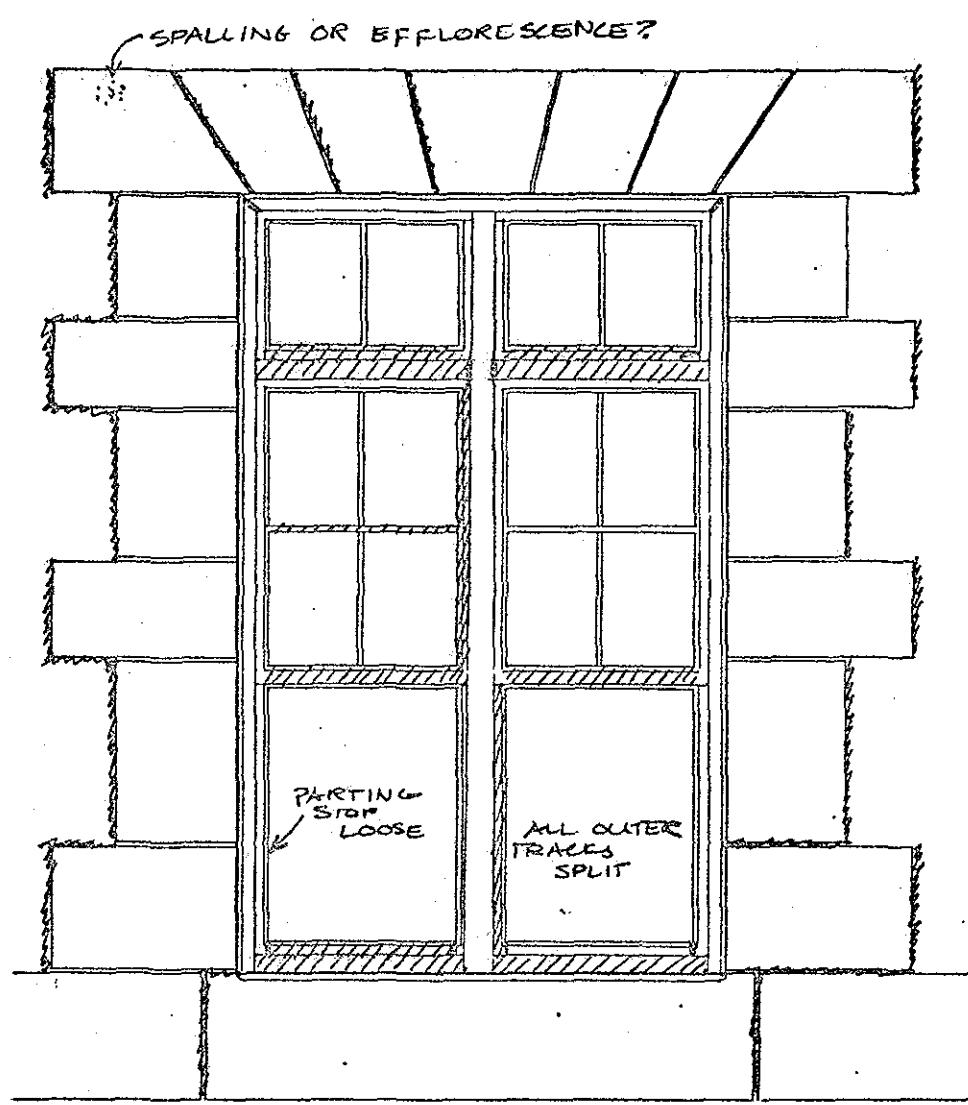
S. THIRD FLOOR, EXTERIOR ELEVATIONS (38)	NUMBER W 303	CLASS 3
MECHANICAL AND ELECTRICAL REHABILITATION MAIN BUILDING ELLIS ISLAND Statue of Liberty National Monument, New York	BUILDING CONSERVATION TECHNOLOGY THE EURENKRANTZ GROUP

INTERIOR: TRANSMON BUCKLED
SASH TRACK ROTTED, LEFT (NORTH) JAMB

SCREENS REMOVED

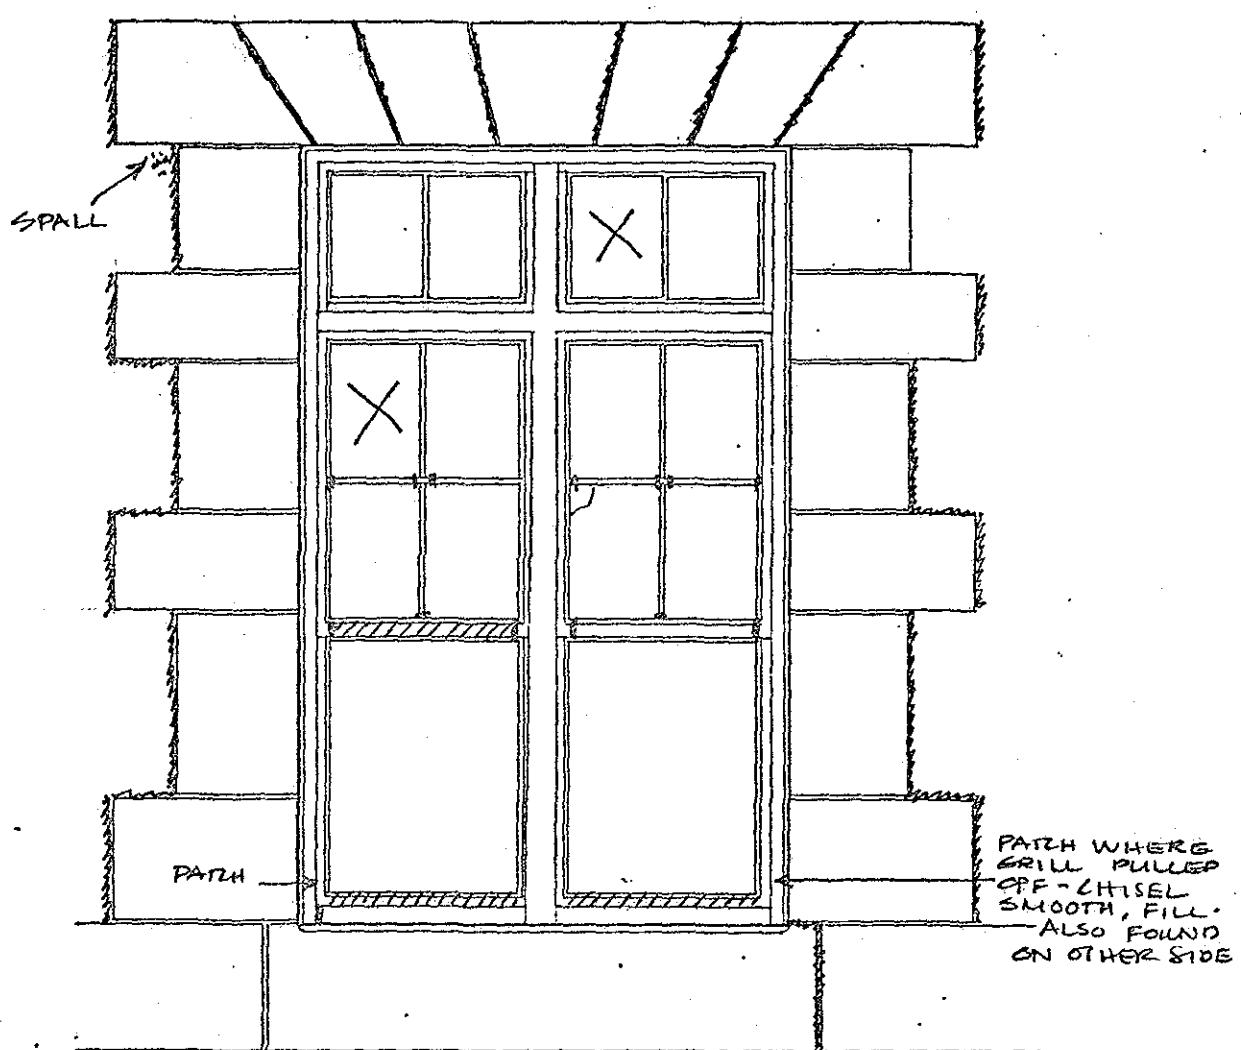
S. THIRD FLOOR, EXTERIOR ELEVATIONS (38)	NUMBER W 304	CLASS 3
MECHANICAL AND ELECTRICAL REHABILITATION MAIN BUILDING ELLIS ISLAND Statue of Liberty National Monument, New York	BUILDING CONSERVATION TECHNOLOGY THE EHRENKRANTZ GROUP

INTERIOR: HEAD & TRANSOM ROTTED

GRILL REMOVED

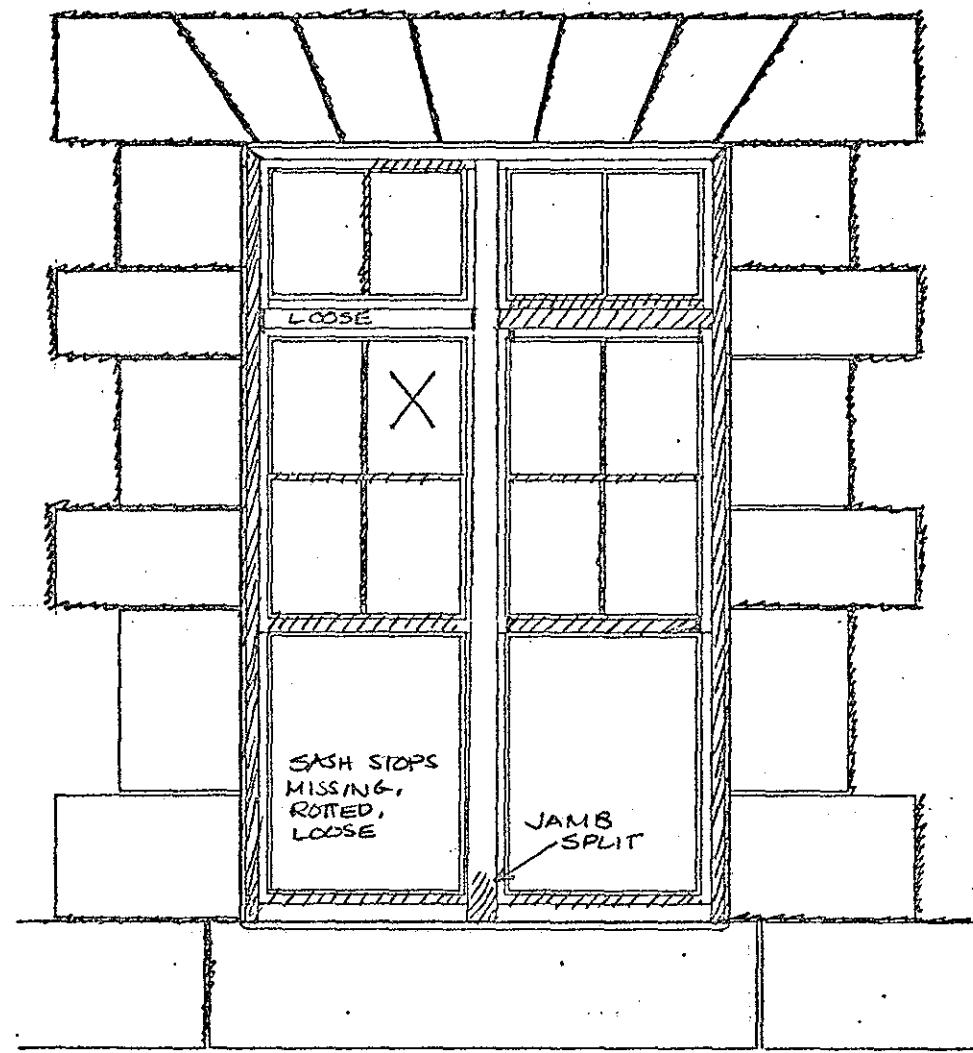
S. THIRD FLOOR, EXTERIOR ELEVATIONS (38)	NUMBER W 306	CLASS 2
MECHANICAL AND ELECTRICAL REHABILITATION MAIN BUILDING ELLIS ISLAND	BUILDING CONSERVATION TECHNOLOGY THE EINERGRANTZ GROUP

INTERIOR: GAPS IN HEAD & JAMB FRAMING

NO GRILL
SCREENS REMOVED

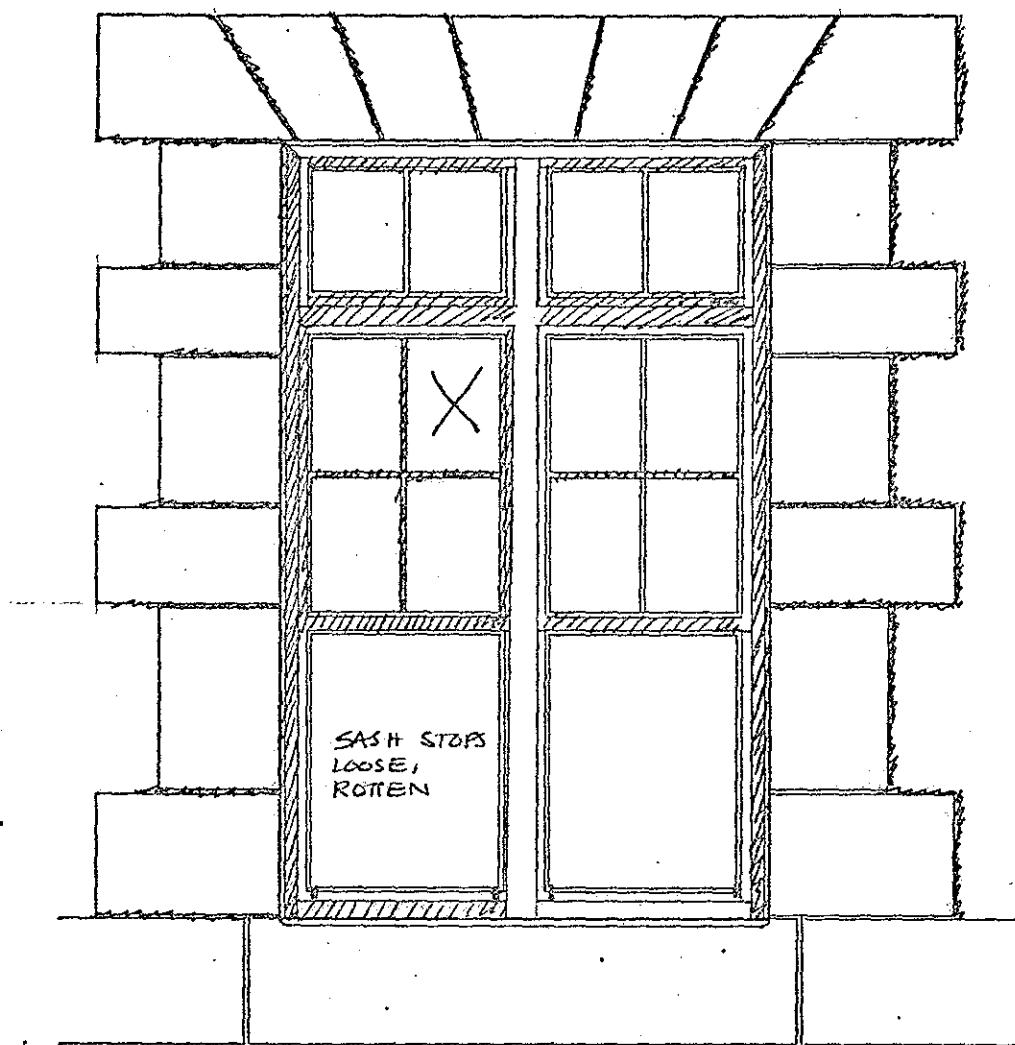
S. THIRD FLOOR, EXTERIOR ELEVATIONS (38)	NUMBER W 307	CLASS 3
MECHANICAL AND ELECTRICAL REHABILITATION MAIN BUILDING ELLIS ISLAND Statue of Liberty National Monument, New York	BUILDING CONSERVATION TECHNOLOGY THE ERENKRANTZ GROUP 19 West 44th Street, New York NY 10036

INTERIOR: ALL JAMBS ROTTEN

NO GRILL
SCREENS REMOVED.
