historic structures report

mechanical/electrical rehabilitation

main building

STATUE OF LIBERTY ELLIS ISLAND

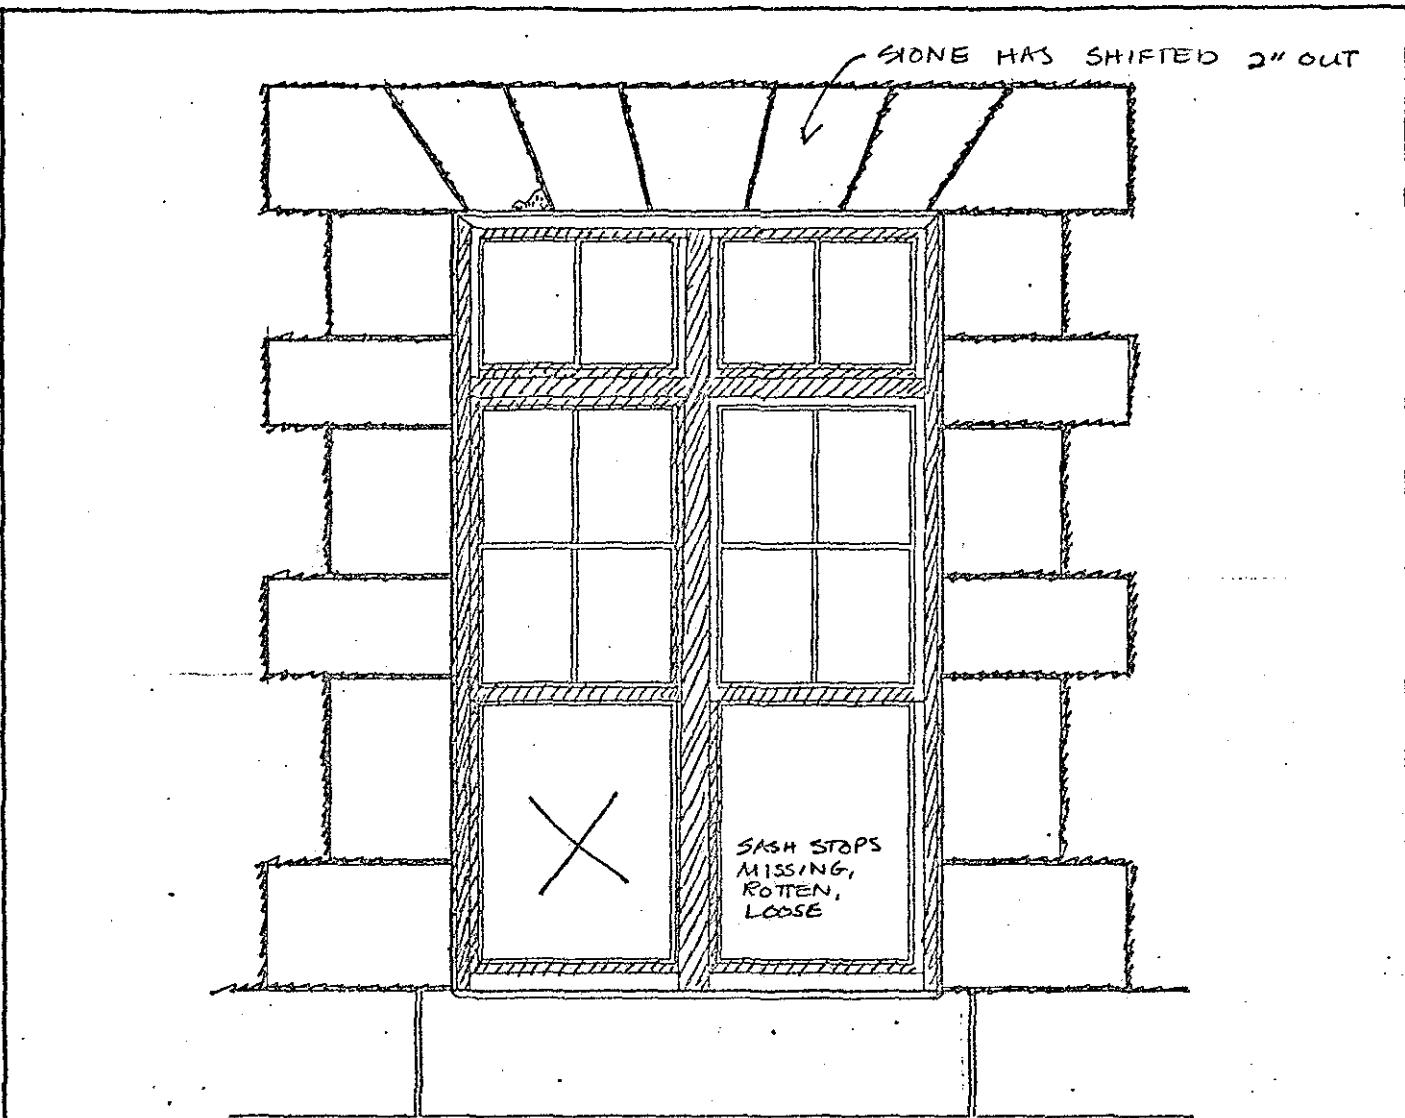
S. THIRD FLOOR, EXTERIOR ELEVATIONS (30)	NUMBER W 308	CLASS 3
MECHANICAL AND ELECTRICAL REHABILITATION MAIN BUILDING ELLIS ISLAND	BUILDING CONSERVATION TECHNOLOGY THE EHRENKRANTZ GROUP

INTERIOR: LARGE SPACES BETWEEN FRAME
MEMBERS AT HEAD, JAMB & SILL

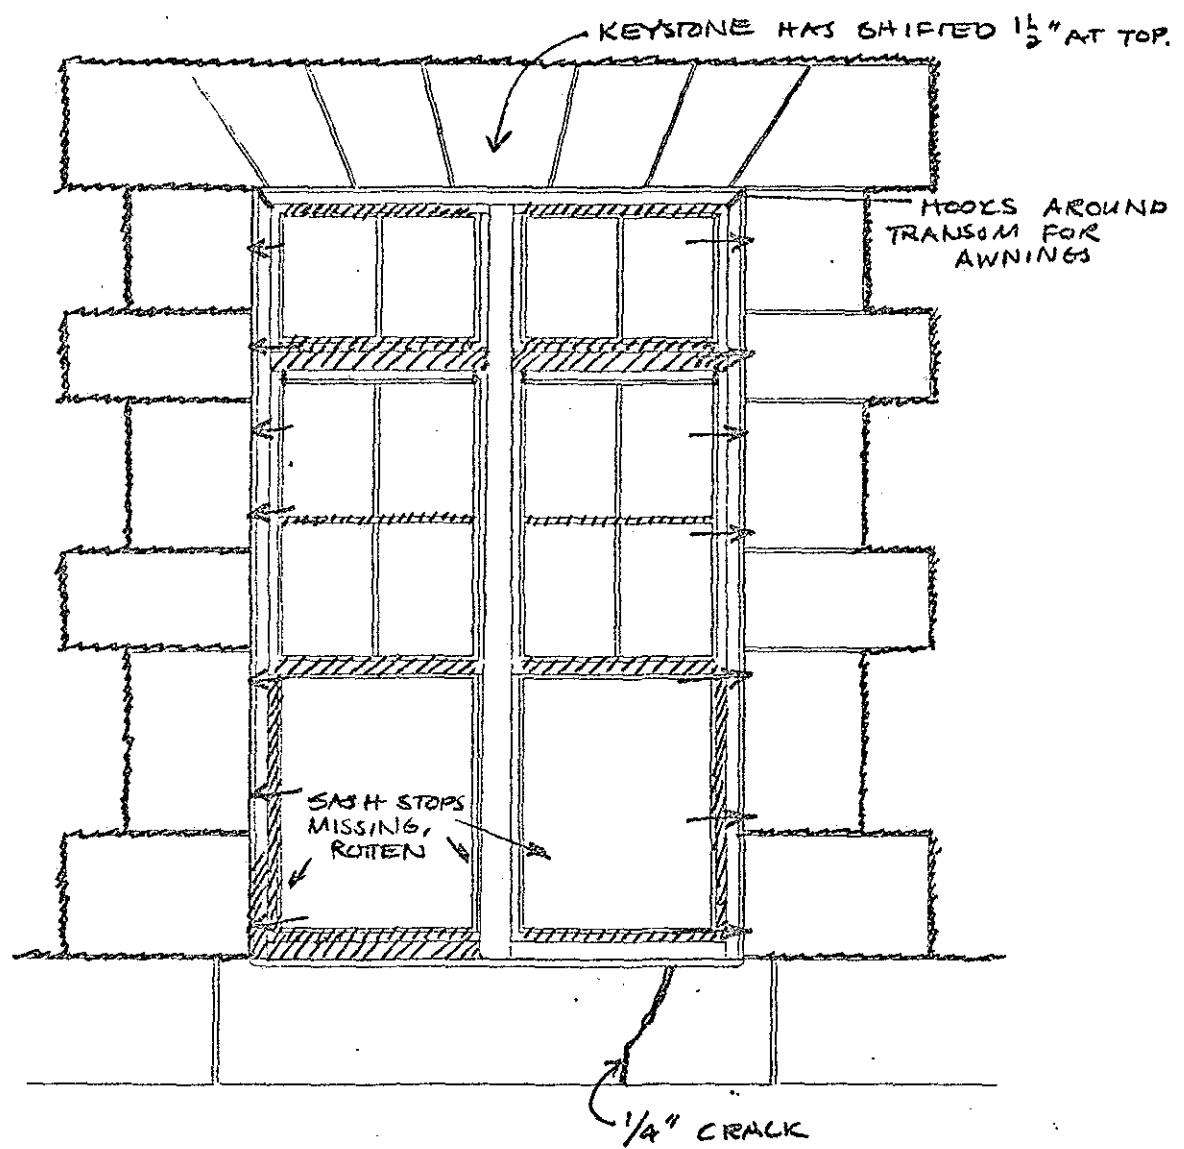
S. THIRD FLOOR FIREPLACE (38)	NUMBER W 309	CLASS 2 wood
MECHANICAL AND ELECTRICAL REHABILITATION MAIN BUILDING ELLIS ISLAND Statue of Liberty National Monument, New York	BUILDING CONSERVATION TECHNOLOGY THE EBENGRANTZ GROUP	2 stone

SCREENS REMOVED
GRILL REMOVED

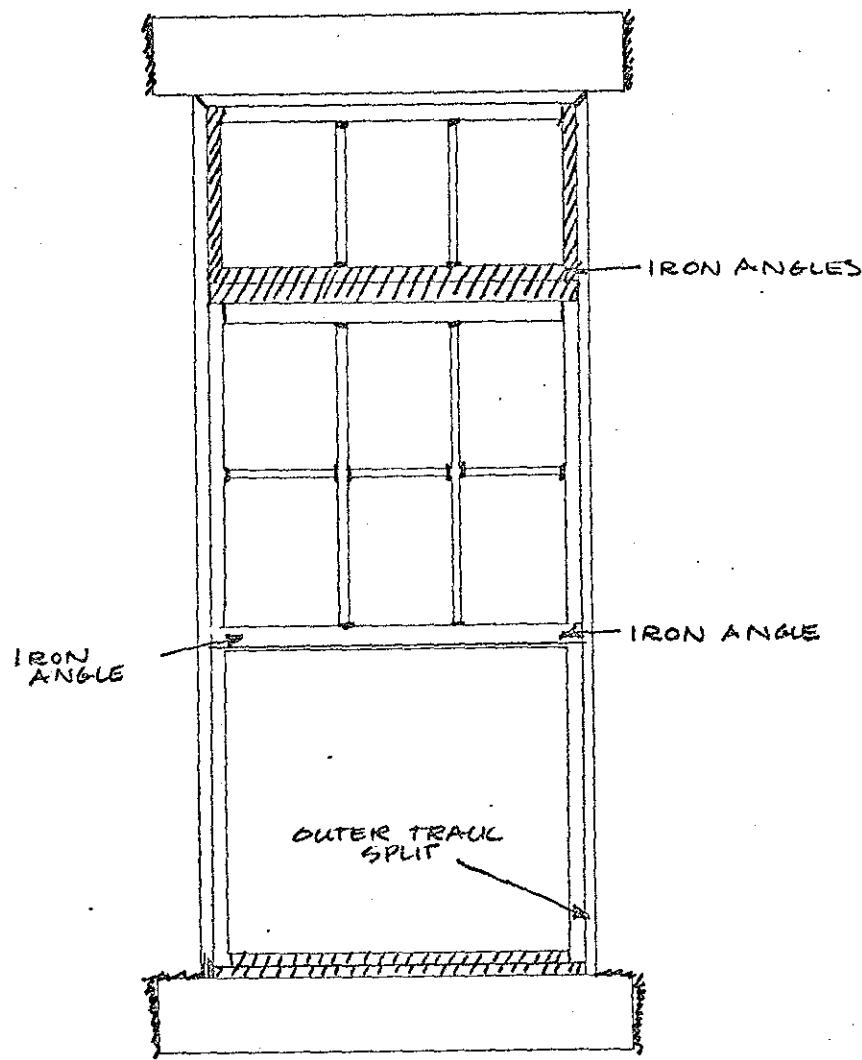
T1 THIRD FLOOR, LIGHT COURTS (29)	NUMBER NEL - 305	CLASS 2
MECHANICAL AND ELECTRICAL REHABILITATION MAIN BUILDING ELLIS ISLAND Statue of Liberty National Monument, New York	BUILDING CONSERVATION TECHNOLOGY THE EIRENKRANZ GROUP 19 West 44th Street, New York NY 10036

INTERIOR:

- STOOL SPLIT
- MOULDING ON RIGHT (WEST) SIDE OF OPENING LOOSE
- BOTTOM RAIL, STILES, FASCIA & MOULDINGS OF TRANSOM & SASH SPLIT, ROTTED

GRILL - HAS HOLE CUT IN IT

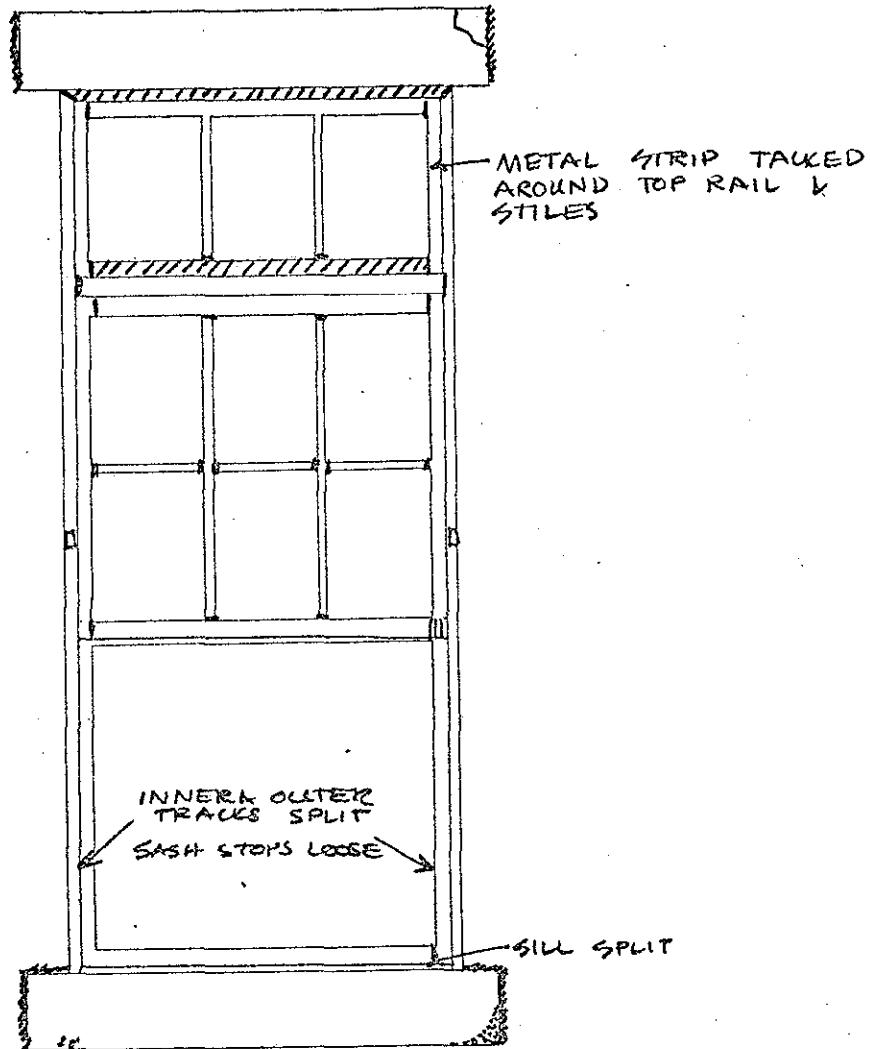
T1 THIRD FLOOR, LIGHT COURTS (29)	NUMBER NEL-306	CLASS 2
MECHANICAL AND ELECTRICAL REHABILITATION MAIN BUILDING ELLIS ISLAND Statue of Liberty National Monument, New York	BUILDING CONSERVATION TECHNOLOGY THE EIRENKRAZ GROUP 19 West 44th Street, New York NY 10036

GRILL
SCREEN ON LOWER SASH - POOR CONDITION

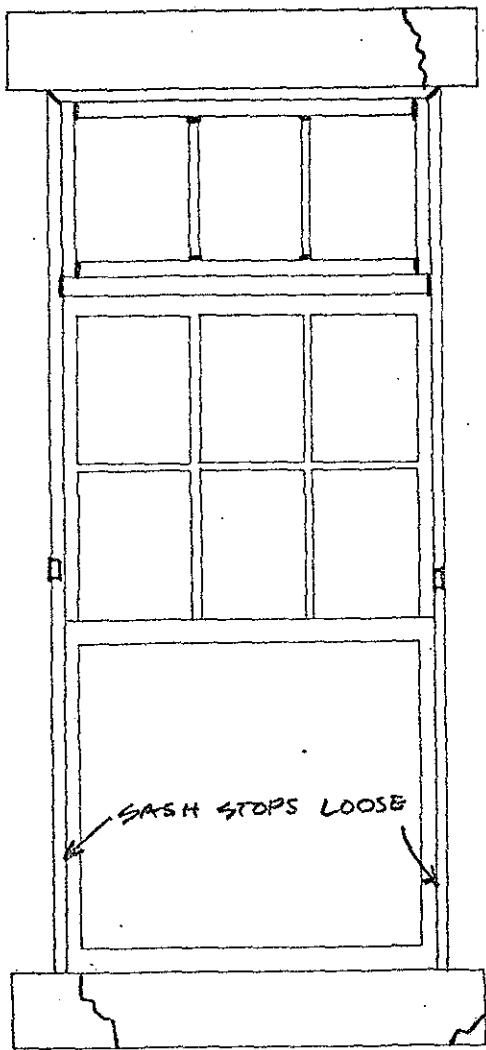
T1 THIRD FLOOR, LIGHT COURTS (29)	NUMBER NEL-307	CLASS I
MECHANICAL AND ELECTRICAL REHABILITATION MAIN BUILDING ELLIS ISLAND Statue of Liberty National Monument, New York	BUILDING CONSERVATION TECHNOLOGY THE EHRENKRANZ GROUP 19 West 44th Street, New York NY 10036

SCREENS OVER LOWER SASH - POOR CONDITION

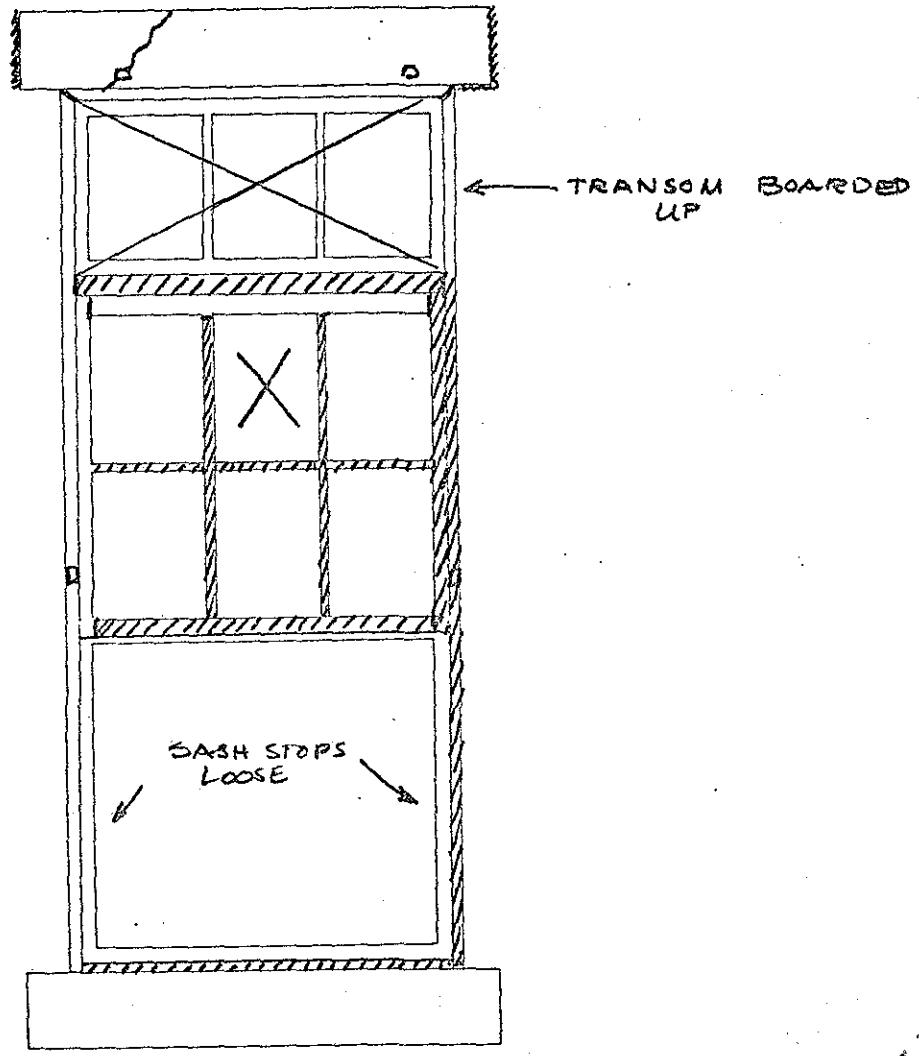
T1 THIRD FLOOR, LIGHT COURTS (29)	NUMBER NEL-309	CLASS 3
MECHANICAL AND ELECTRICAL REHABILITATION MAIN BUILDING ELLIS ISLAND Statue of Liberty National Monument, New York	BUILDING CONSERVATION TECHNOLOGY THE DIRENFRANZ GROUP 19 West 44th Street, New York NY 10036

RUSTED SHUT - COULD NOT EXAMINE OUTSIDE

GRILL
SCREENS OVER LOWER SASH - POOR CONDITION

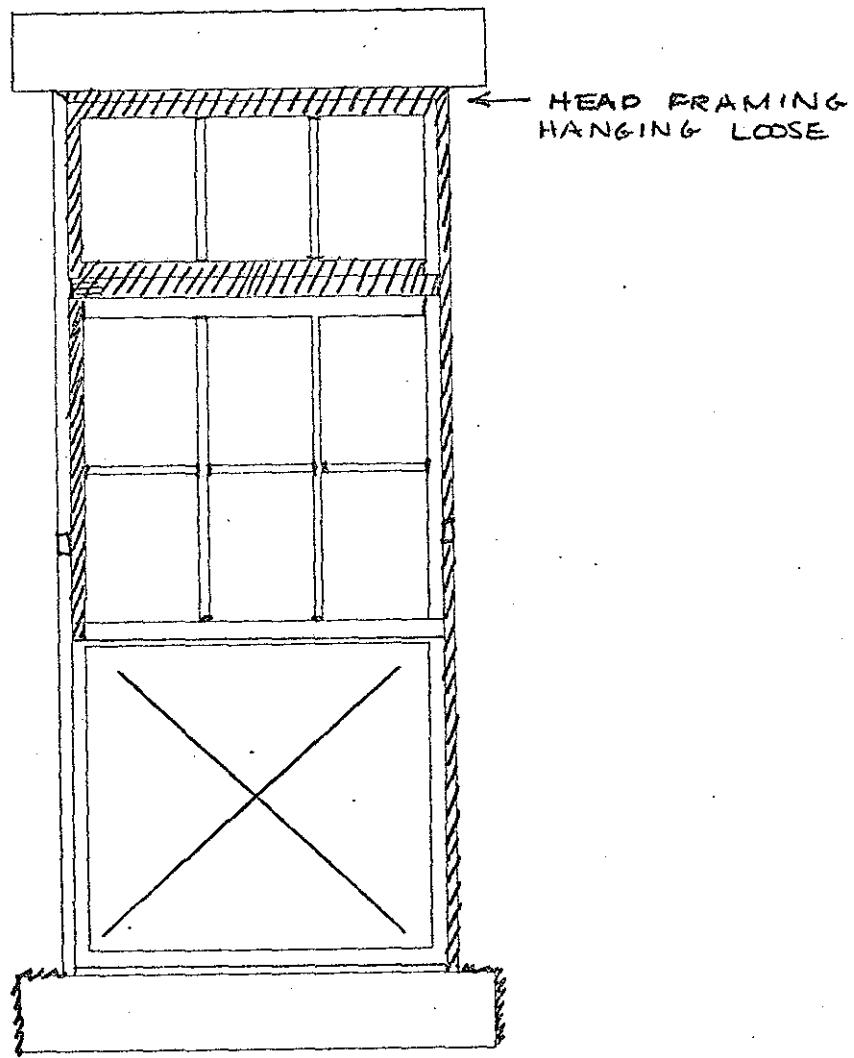
T1 THIRD FLOOR, LIGHT COURTS (29)	NUMBER NEL- 310	CLASS 3
MECHANICAL AND ELECTRICAL REHABILITATION MAIN BUILDING ELLIS ISLAND Statue of Liberty National Monument, New York	BUILDING CONSERVATION TECHNOLOGY THE DIRENKRATZ GROUP

INTERIOR:

- MOULDINGS FRAMING OPENINGS LOOSE
- LOWER SASH BOARDED UP - UNABLE TO SEE SILL OR OUTER FRAME

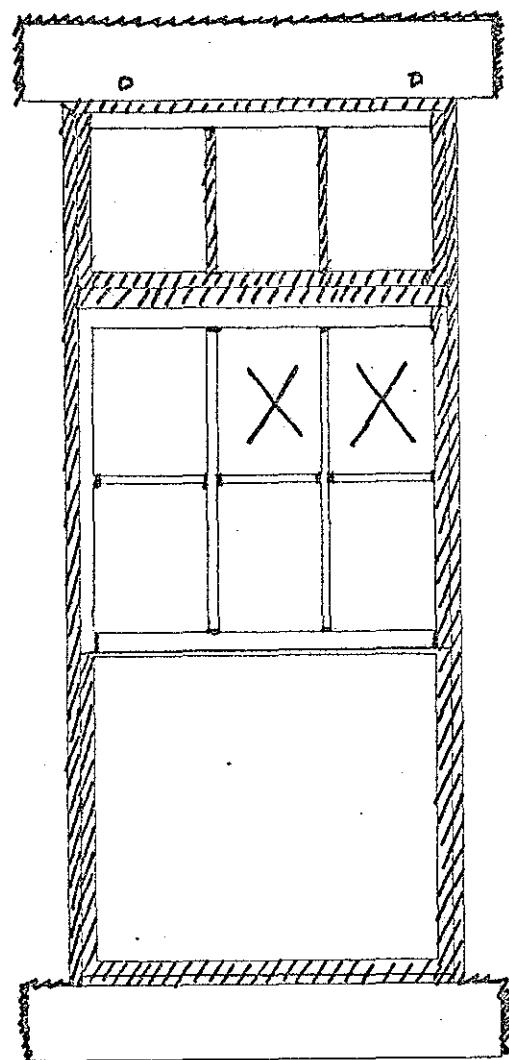
T1 THIRD FLOOR, LIGHT COURTS (29)	NUMBER NEL-311	CLASS 3
MECHANICAL AND ELECTRICAL REHABILITATION MAIN BUILDING ELLIS ISLAND Statue of Liberty National Monument, New York	BUILDING CONSERVATION TECHNOLOGY THE EBRENNKRAUT GROUP

INTERIOR: MARBLE STOOL SPLIT

GRILL REMOVED

METAL TRACKS BUT NO SCREEN'S

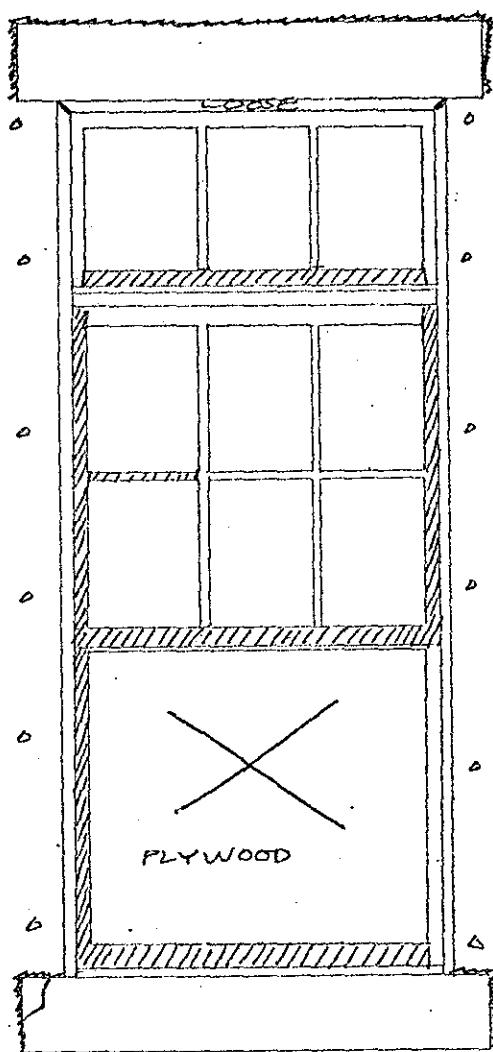
T1 THIRD FLOOR, LIGHT COURTS (S)	NUMBER SWL 301	CLASSES 2
MECHANICAL AND ELECTRICAL REHABILITATION MAIN BUILDING ELLIS ISLAND Statue of Liberty National Monument, New York	BUILDING CONSERVATION TECHNOLOGY THE EICHENBERG GROUP 19 West 44th Street, New York NY 10036

INTERIOR:

- FRAMING EXPOSED BUT APPEARS O.K.
- SASH NAILED SHUT

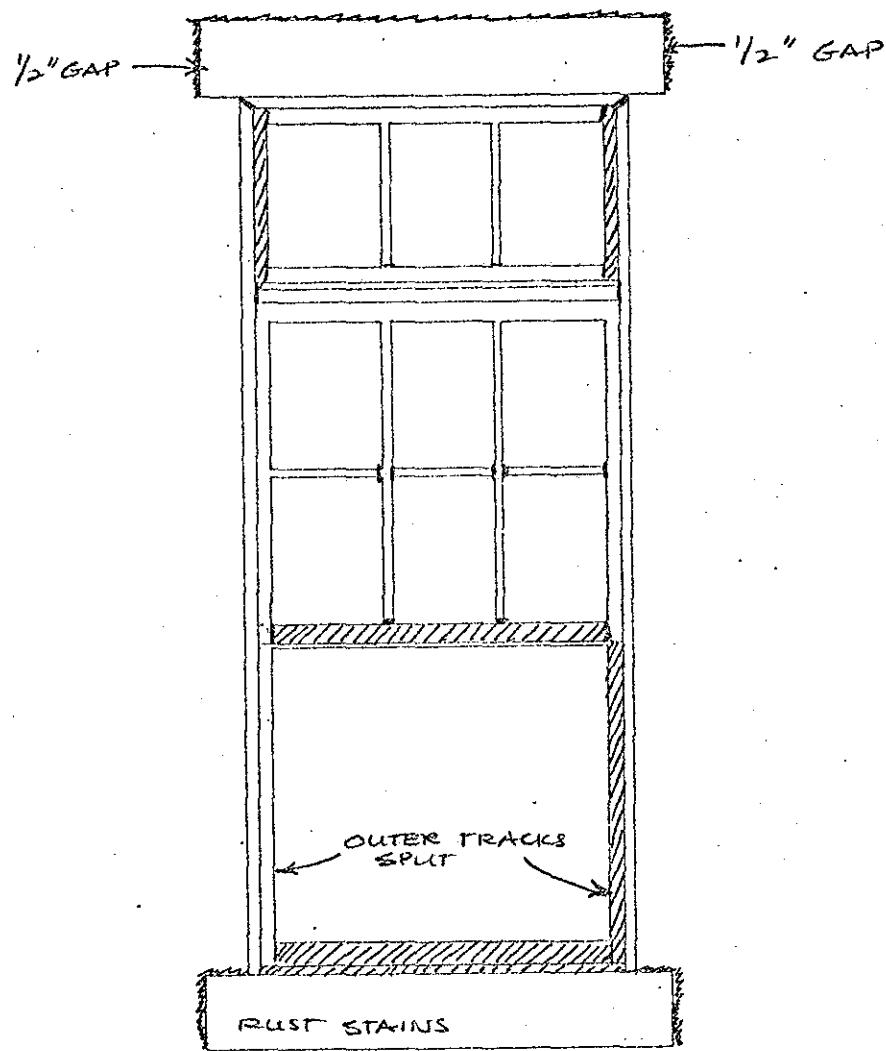
INTERIOR: ALL TRACKS SPLIT
 ALL PARTING STOPS LOOSE

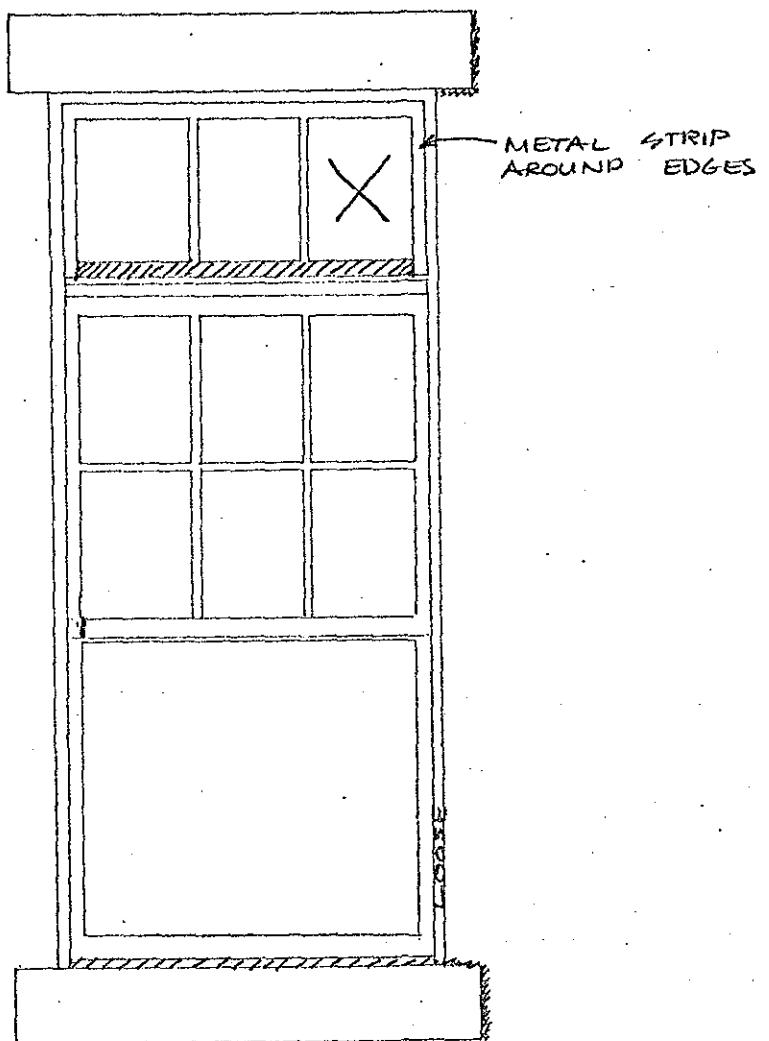
INTERIOR: JAMB FRAMING EXPOSED ON WEST SIDE;
SOME SMALL BLOCKING PIECES APPEAR ROTTED.
SASH STOPS LOOSE

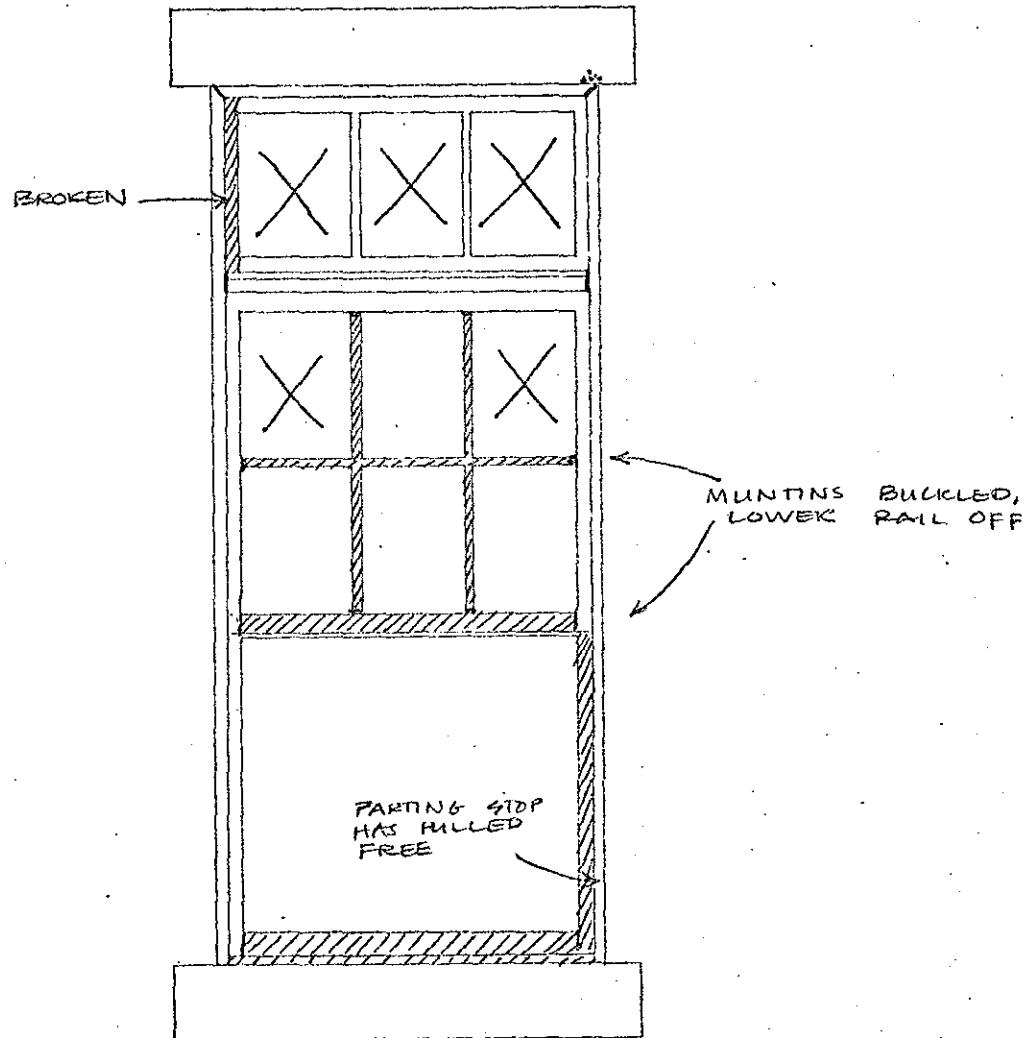
INACCESSIBLE

GRILL
SCREEN OVER TRANSOM

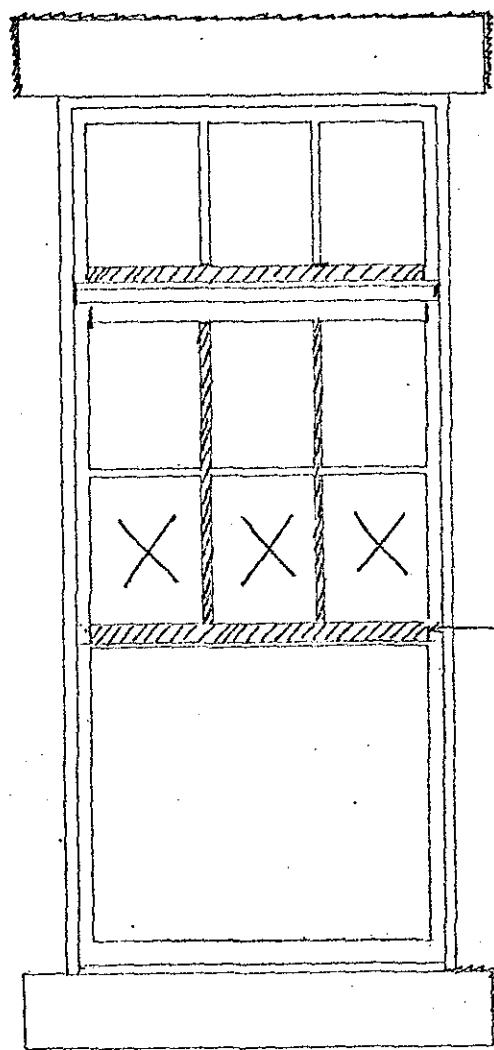
INTERIOR: ALL INNER STOP MOULDINGS VERY LOOSE

GRILL REMOVED

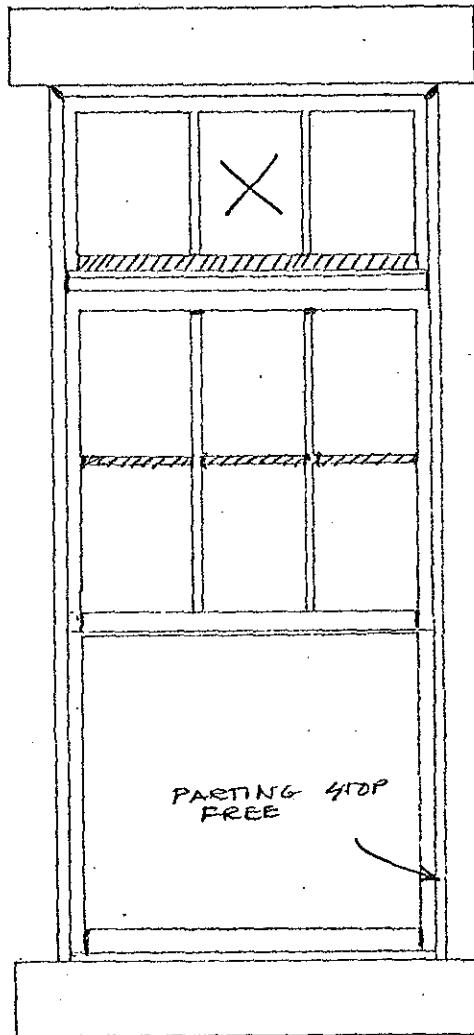
- INNER STOPS WARPED
- MARBLE STOOL & JAMB COVERS
- NOT ACCESSIBLE

GRILL IN PLACE - ANCHORED TO FRAME

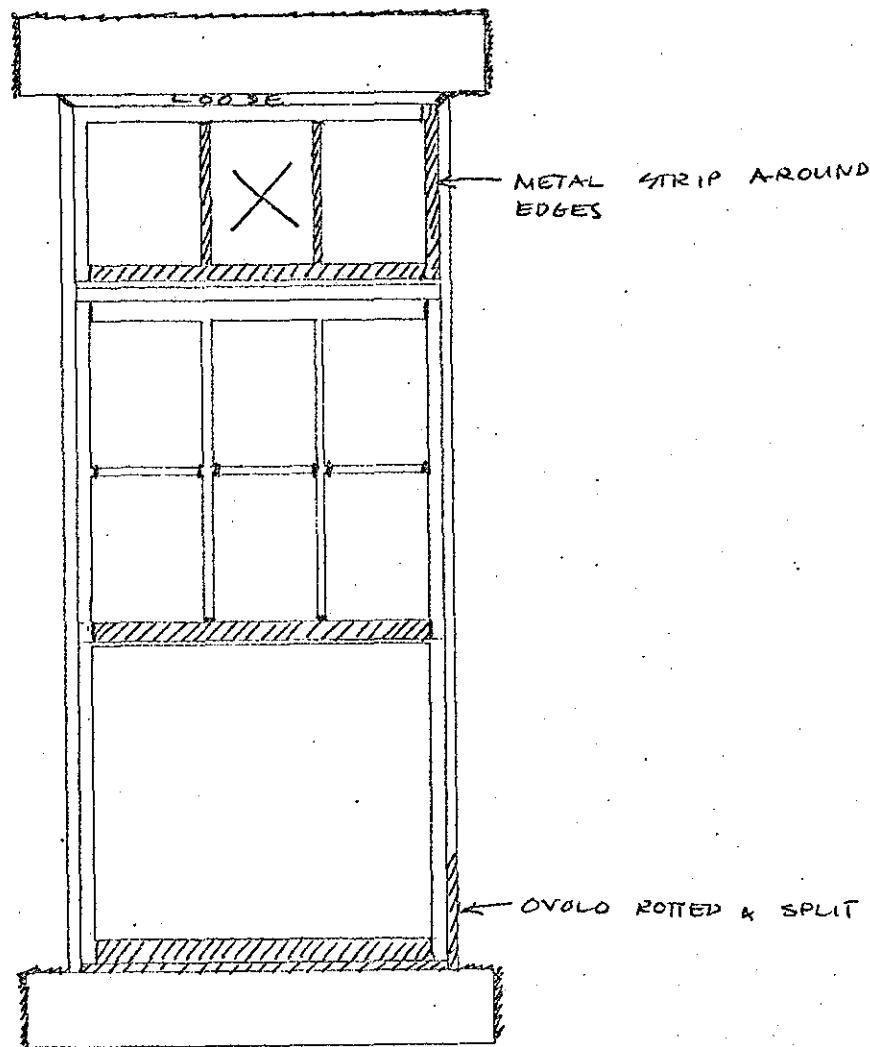
INTERIOR: MARBLE STOOL & JAMB COVERS

GRILL REMOVED

METAL TRACERS BUT NO SCREENS

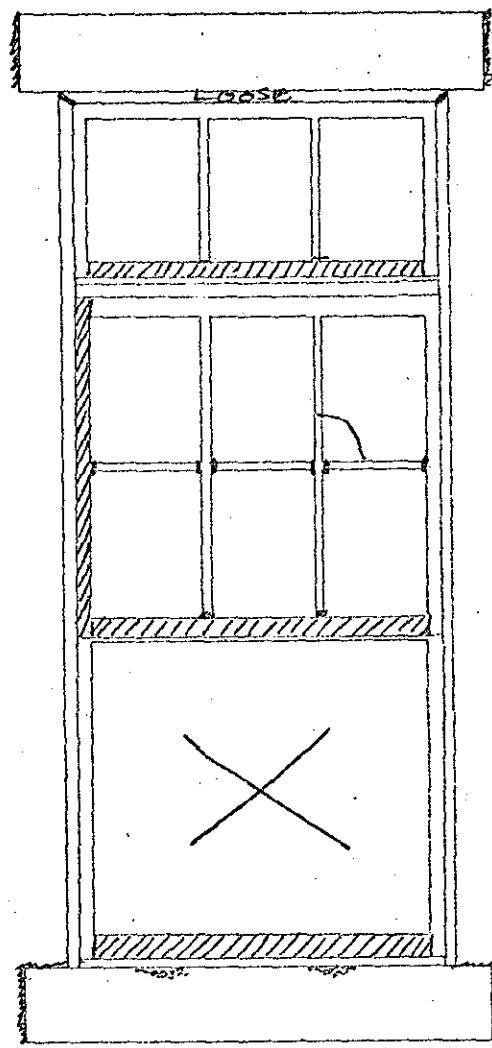
- INTERIOR:
- SASH NAILED SHUT
 - ALL INSIDE STOP MOULDINGS MISSING
 - MARBLE STOOL & JAMB COVERS
 - ALL FRAMING LOOSE & ROTTED

GRILL REMOVED.

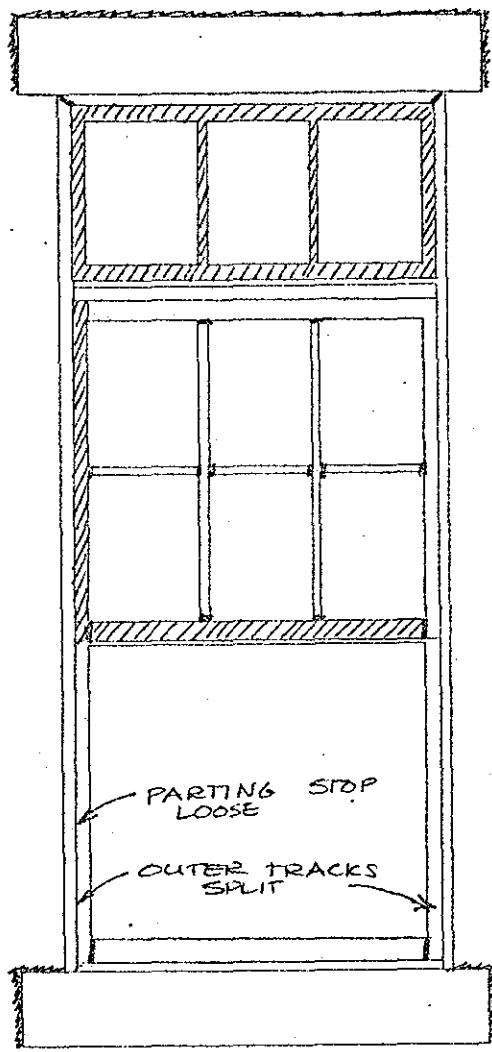
- MARBLE STOOL & JAMB COVERS
- GLASS LEFT (SOUTH) CORNER DAMAGED
- JAMB FRAMING EXPOSED BUT APPEARS TO BE O.K.

GRILL REMOVED

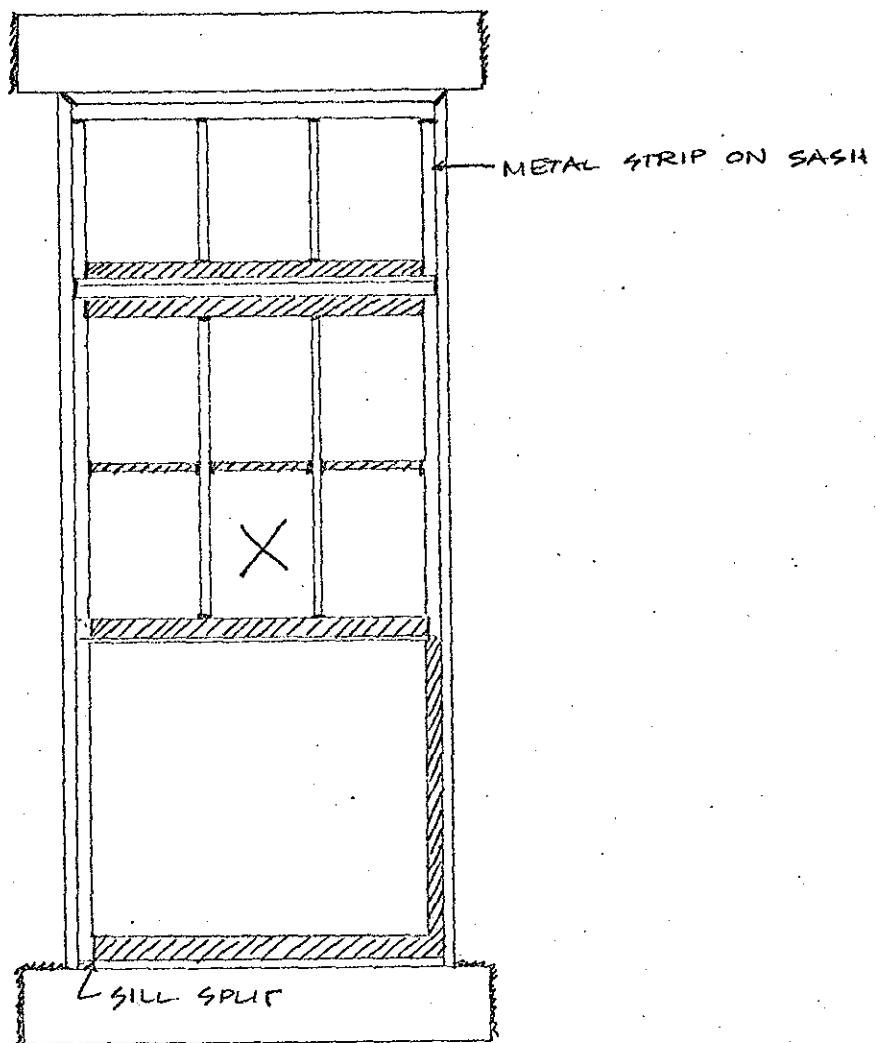
GRILL REMOVED

SCREEN ON LOWER SASH - POOR CONDITION

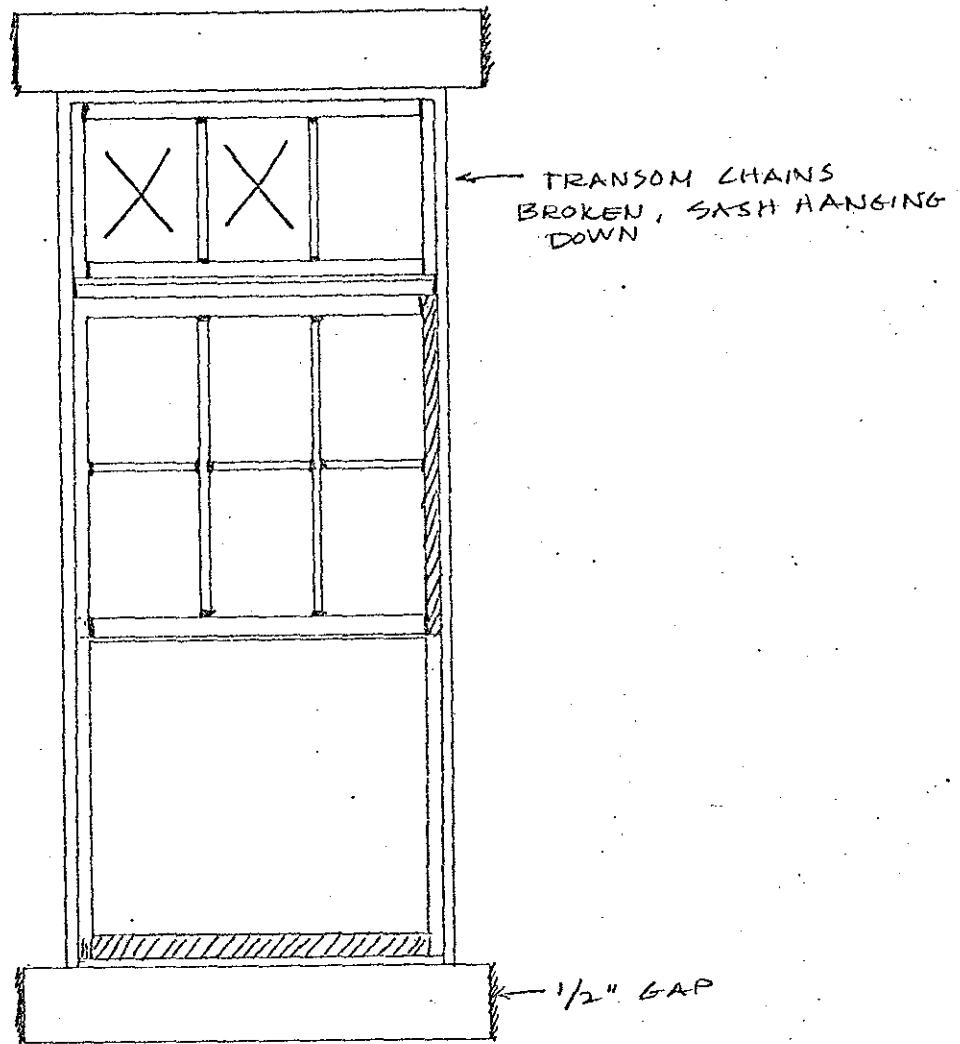
INTERIOR: MARBLE STOOL & JAMB COVERS
 • INNER & OUTER TRACKS SPLIT
 • PARTING STOPS LOOSE

GRILL REMOVED

SCREEN OVER LOWER SASH - POOR CONDITION

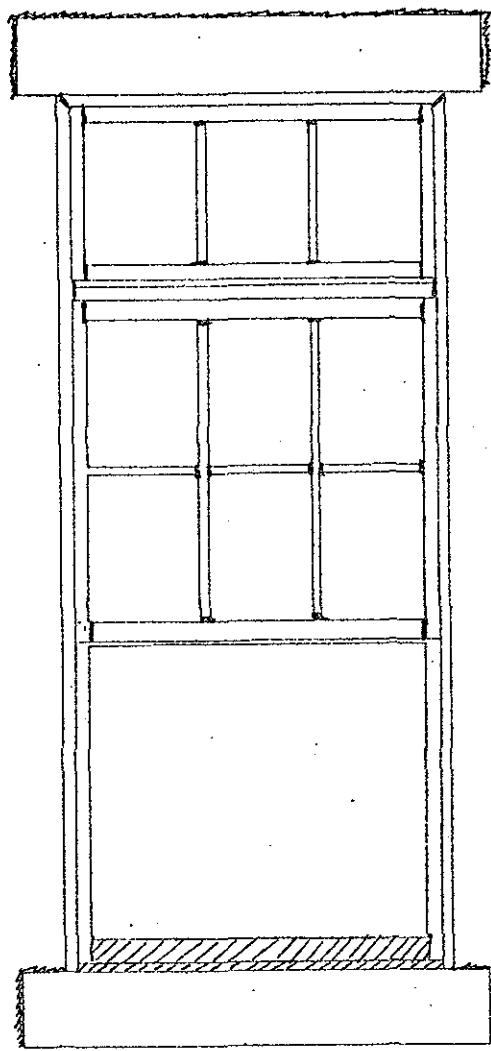
INTERIOR: MARBLE STOOL & JAMB COVERS

GRILL REMOVED

METAL TRACKS BUT NO SCREENS

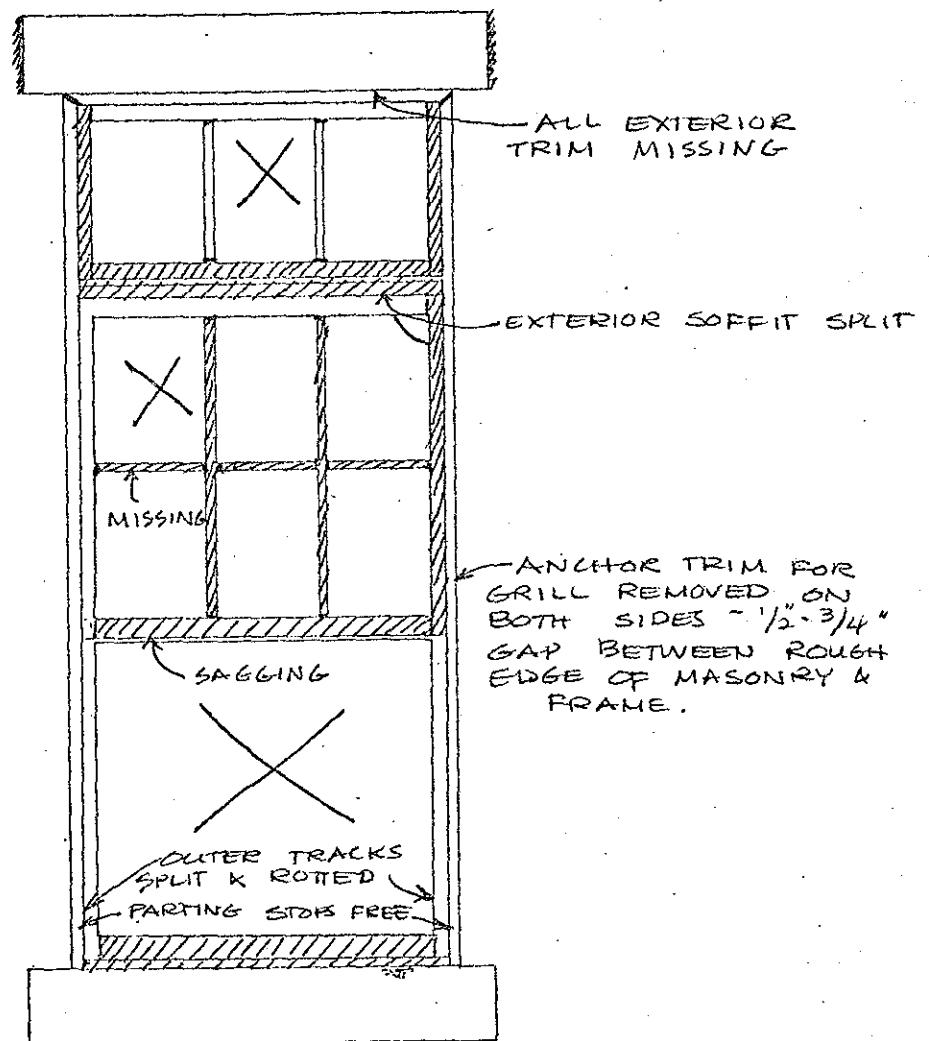
- INNER STOP MOULDINGS LOOSE
- PARTING STOPS LOOSE
- MARBLE STOOL & JAMB COVERS

GRILL REMOVED
METAL TRACKS BUT NO SCREENS

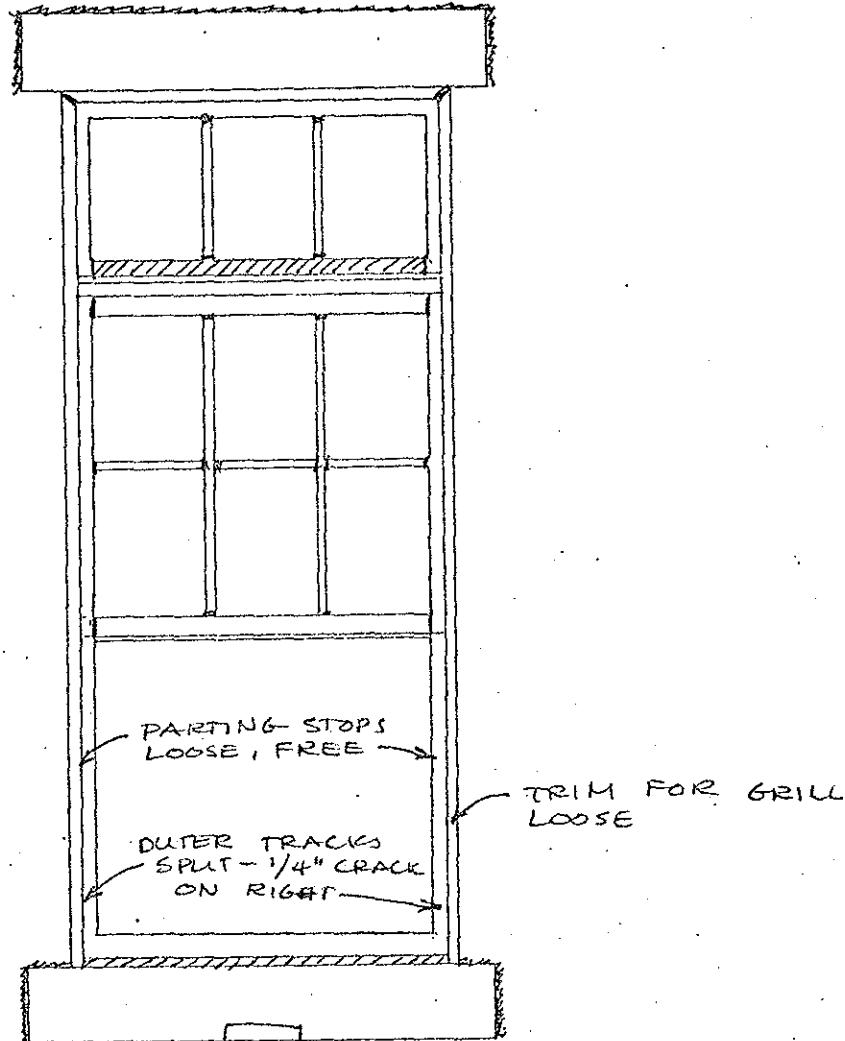
- ALL FRAMING EXPOSED INSIDE
- MARBLE STOOLS & JAMB COVERS

METAL TRACKS BUT NO SCREENS

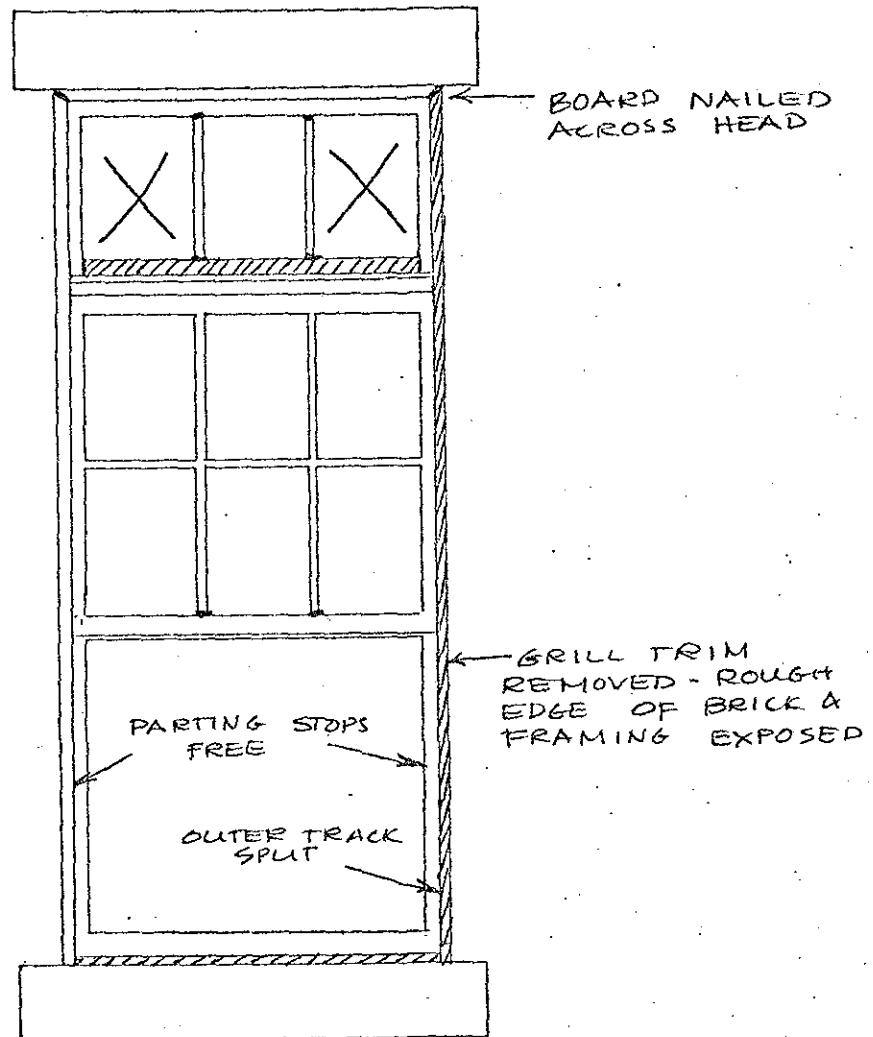
- MARBLE STOOL & JAMB COVERS
- FRAMING EXPOSED BUT APPEARS SOUND
- SASH COUNTERBALANCE BROKEN

GRILL REMOVED

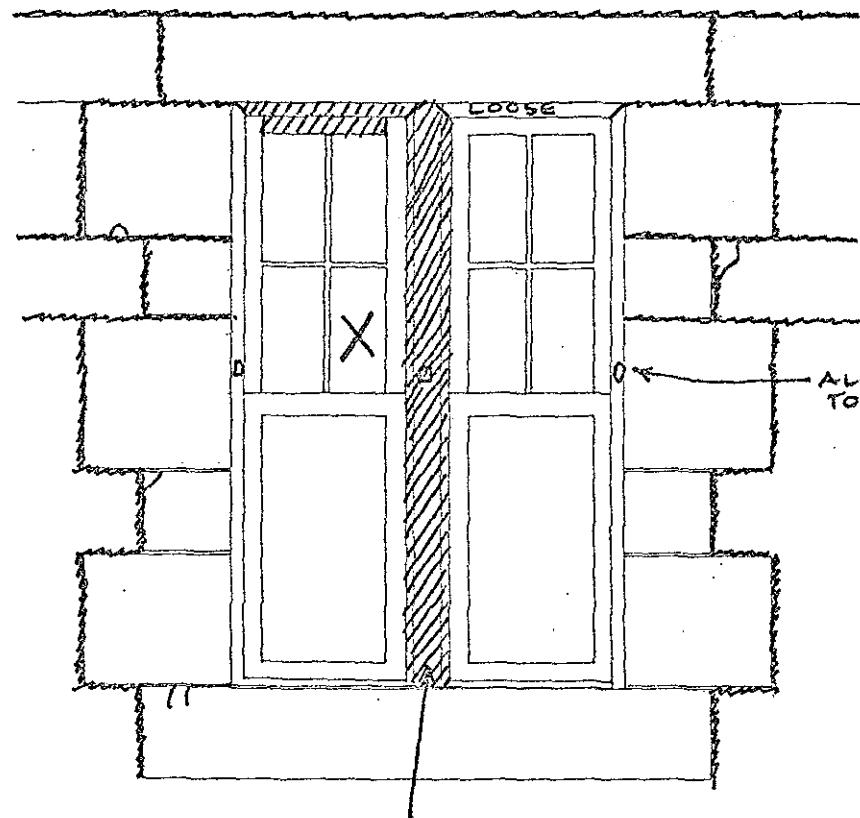
INTERIOR: • REPLACE STOPS ALONG INNER SILL -
LOOSE & CRACKED

GRILL REMOVED

METAL TRACKS BUT NO SCREENS

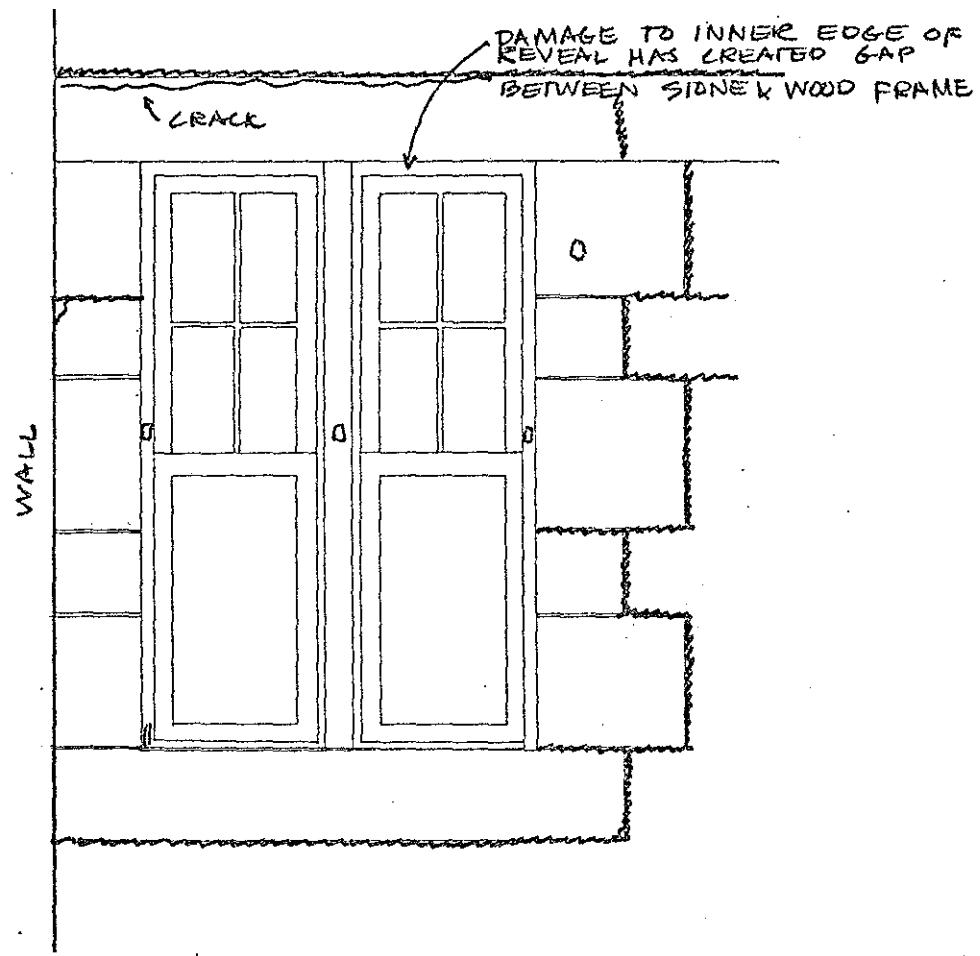
SCREEN OVER LOWER SASH - POOR CONDITION.
