historic structures report

mechanical/electrical rehabilitation

main building

STATUE OF LIBERTY ELLIS ISLAND

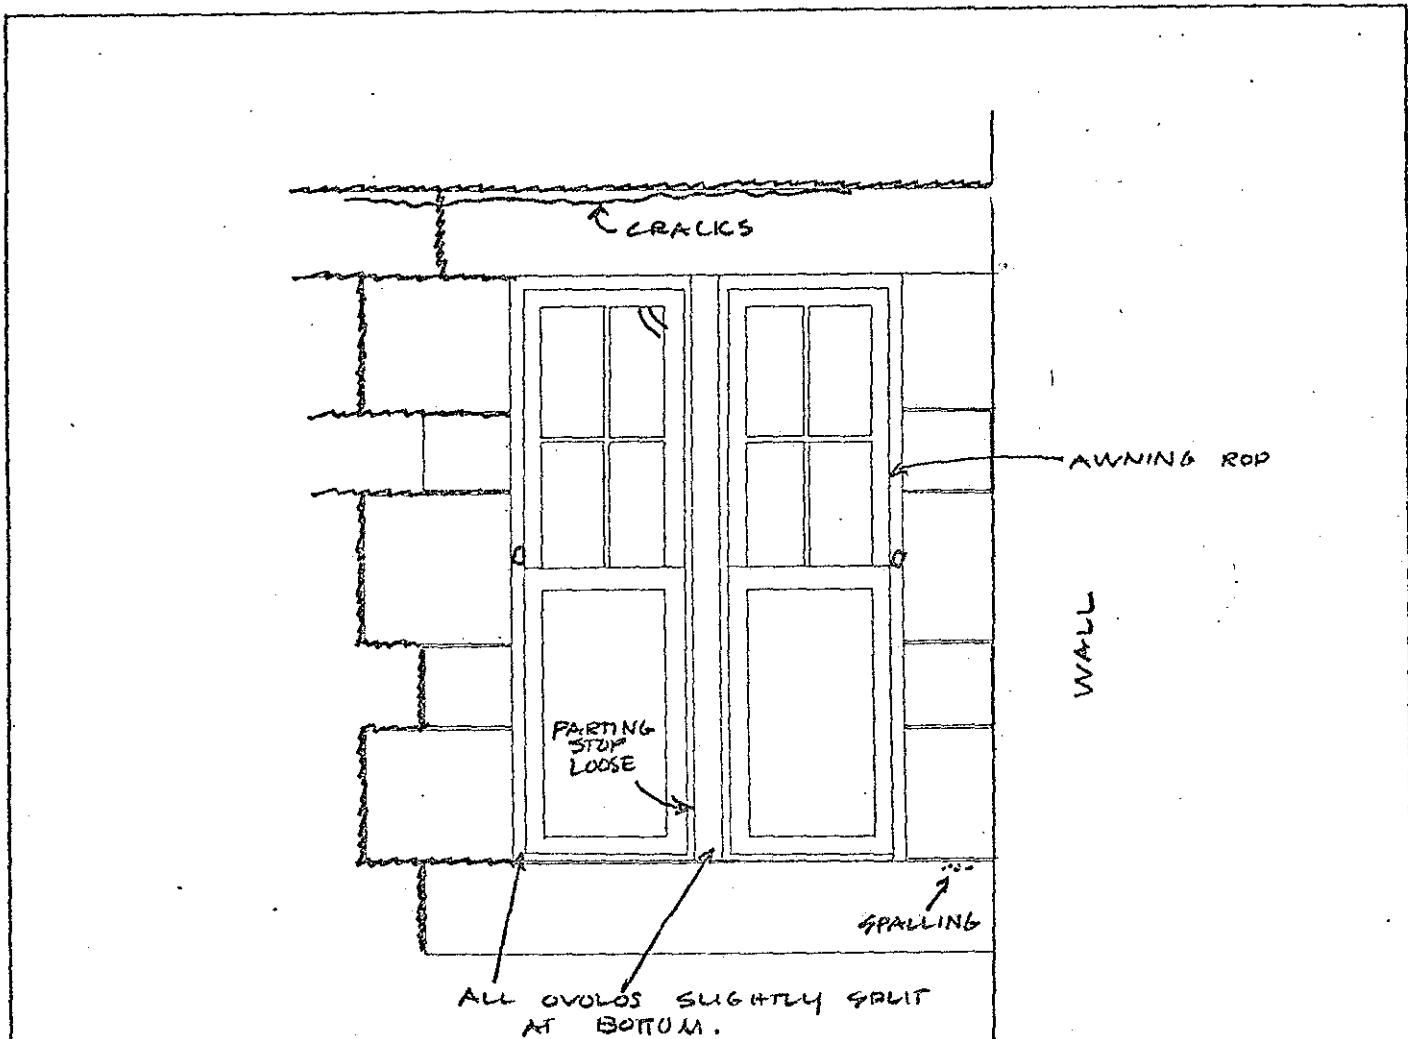
SCREENS OVER LOWER SASH - FAIR CONDITION

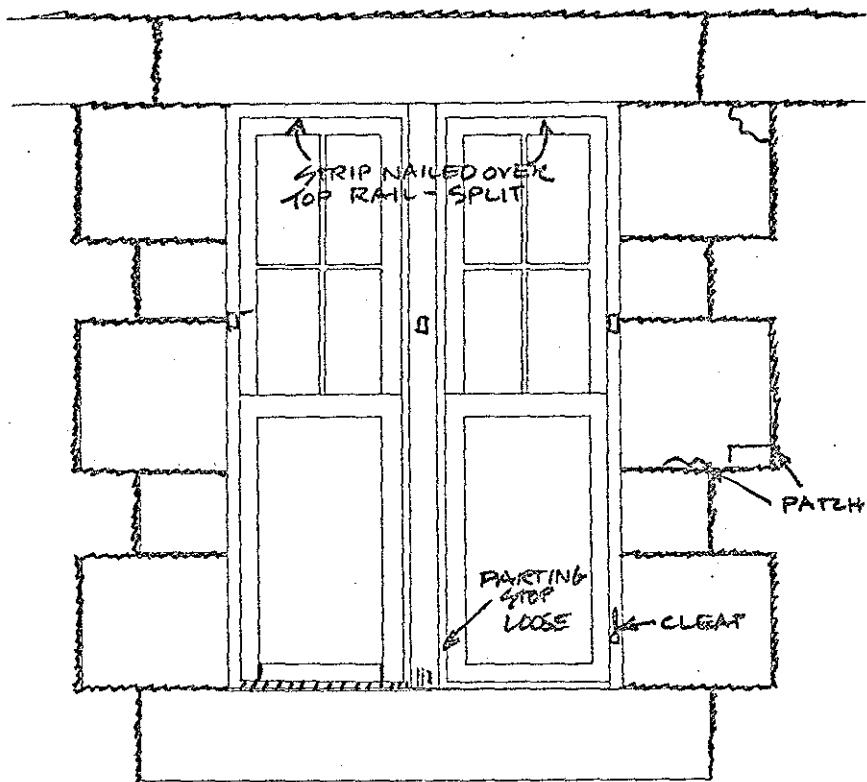
SCREENS ON LOWER SASH - POOR CONDITION

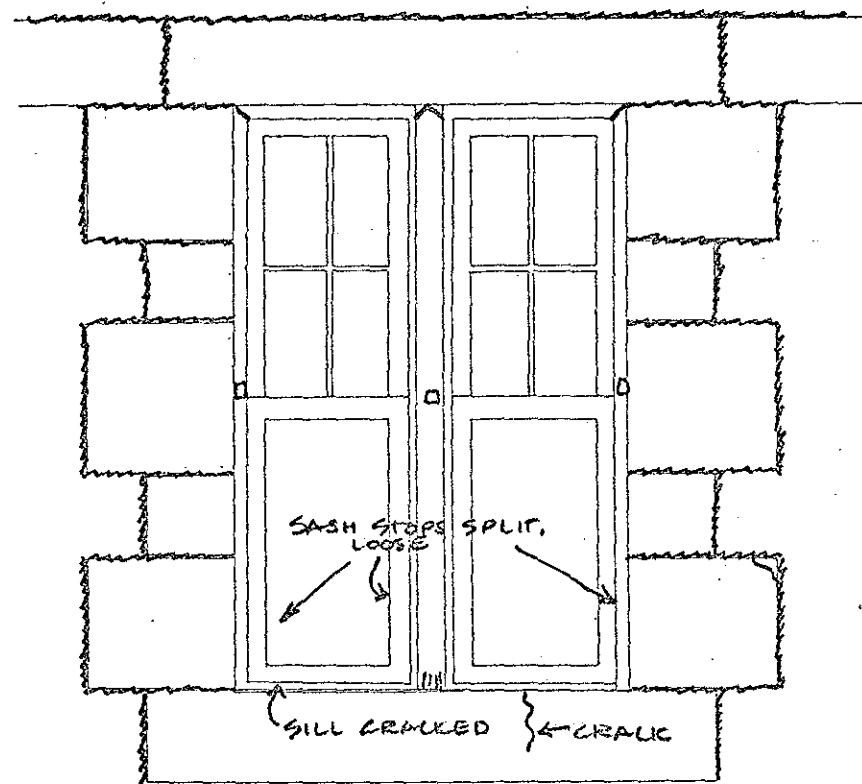
SCREENS ON LOWER SASH - POOR CONDITION

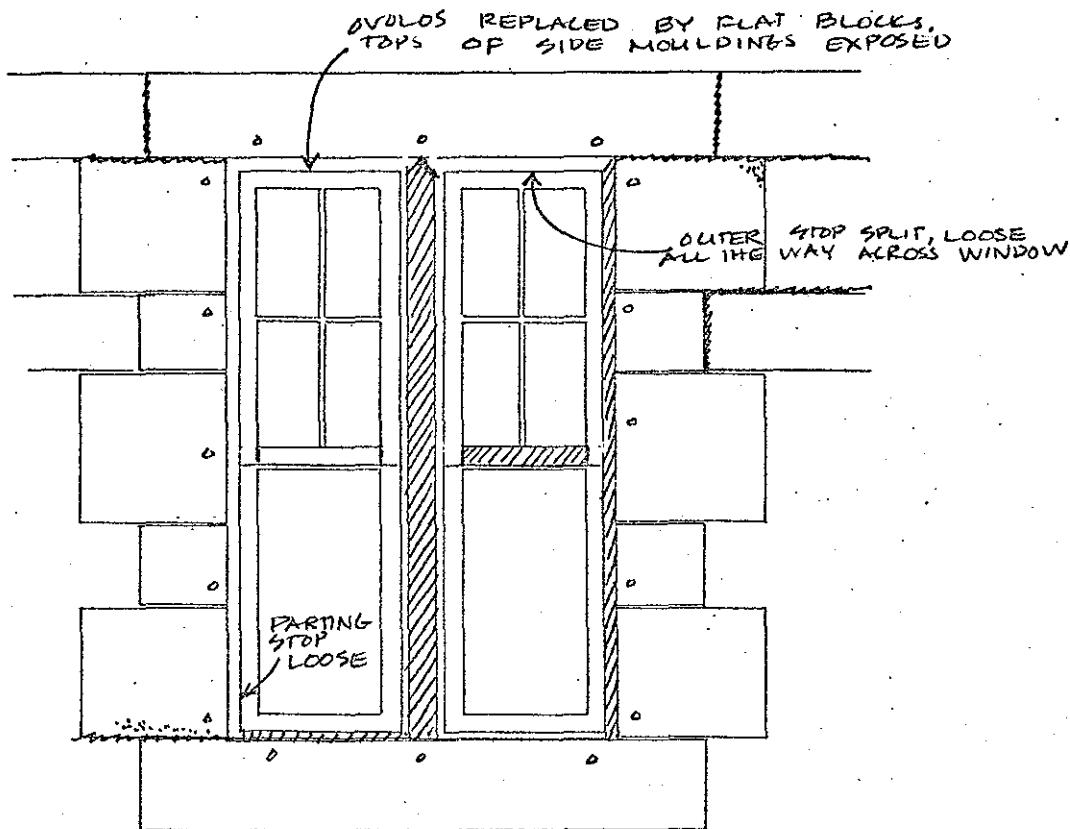
SCREEN ON LOWER SASH - POOR CONDITION

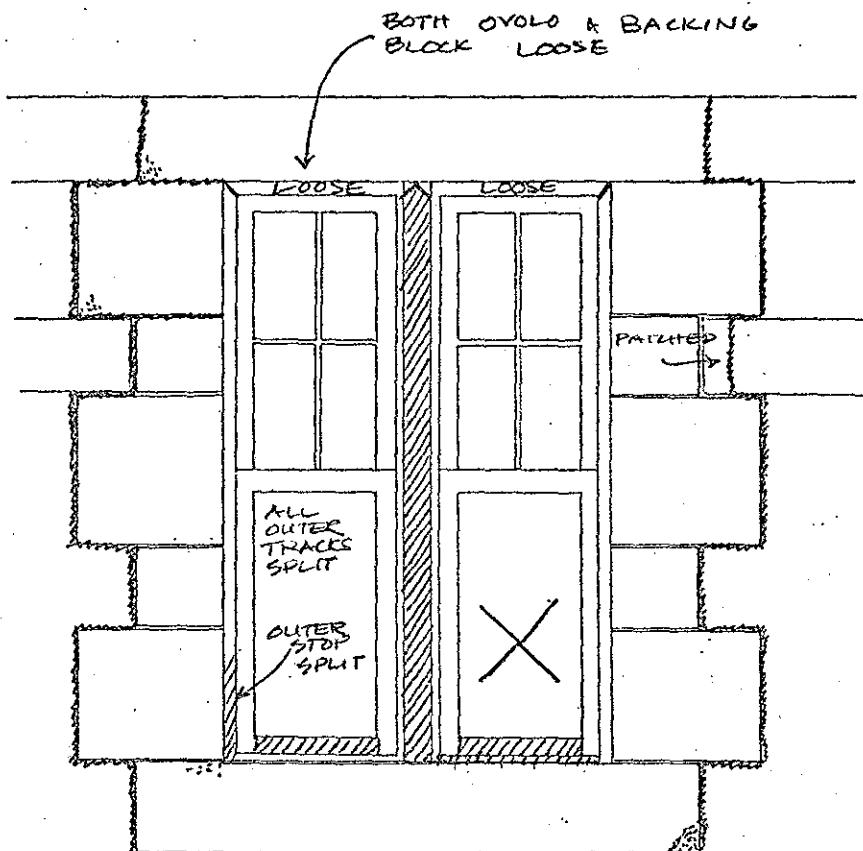
GRILL REMOVED, SLEEVES IN PLACE

SCREENS ON LOWER SASH - POOR CONDITION.

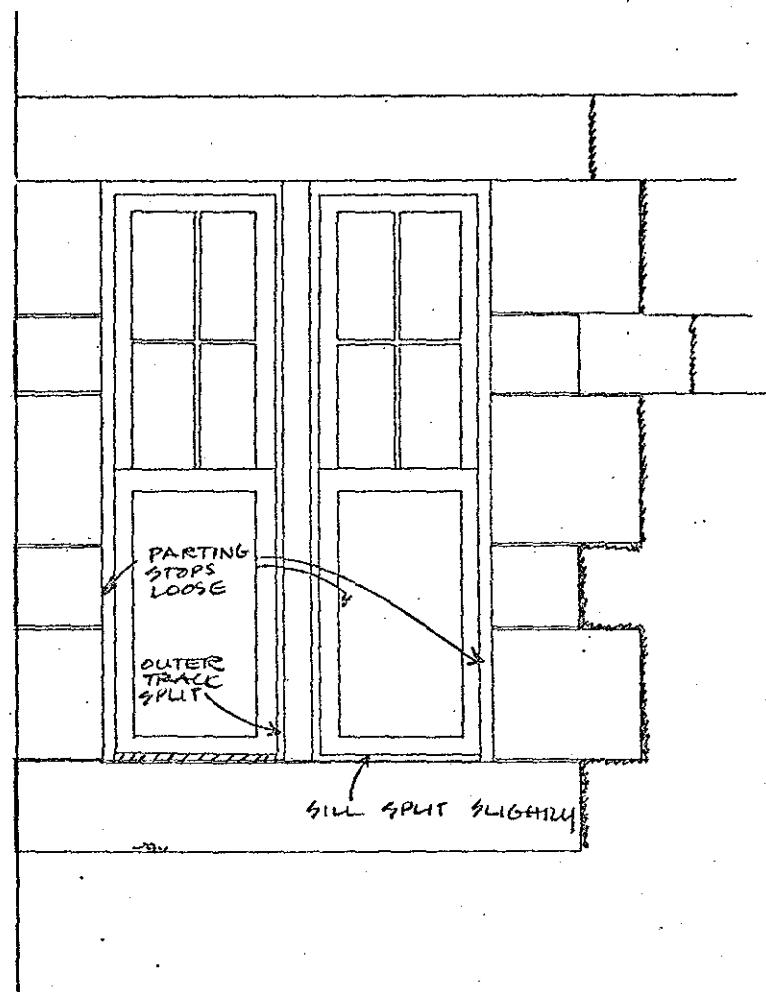
- INTERIOR:
- ALL SASH STOPS MISSING OR HANGING FREE
 - MOULDINGS FRAMING OPENING LOOSE ON DIVIDING BAR
 - LEFT (WEST) SASH STUCK OPEN

GRILL REMOVED

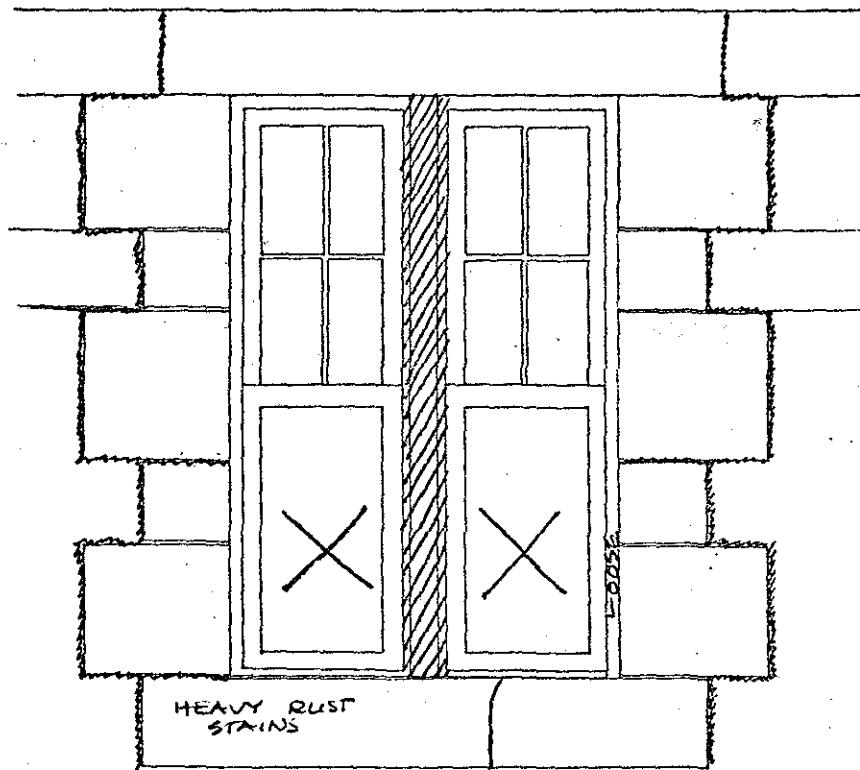
LEFT SASH WON'T OPEN

SCREENS ON LOWER SASH - FAIR CONDITION

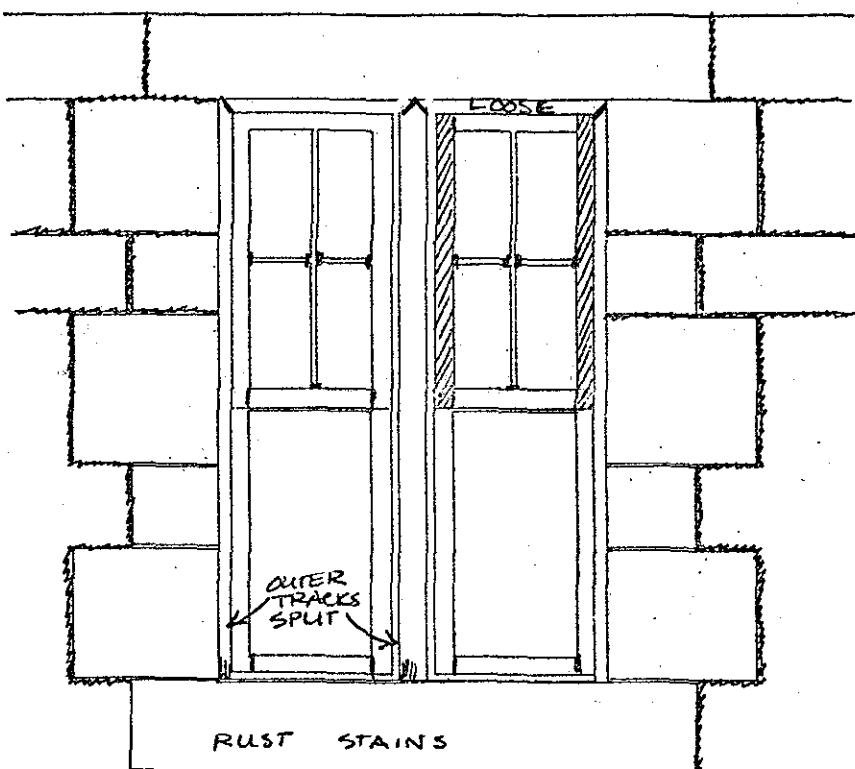
- INTERIOR:
- GAPS BETWEEN INNER STOPS & TRACKS
ON LEFT (EAST) JAMB & CENTER BAR (1/2"
WIDE)
 - ALL PARTING STOPS LOOSE

SCREENS ON LOWER SASH - POOR CONDITION

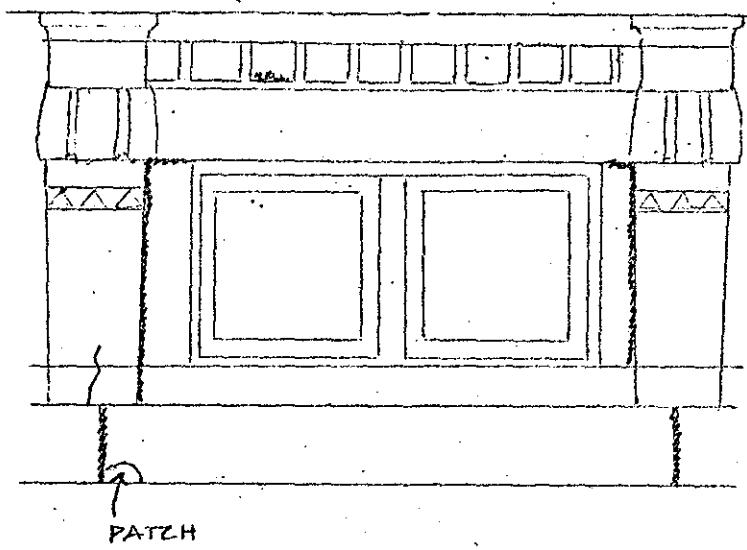
INTERIOR: • RIGHT (WEST) WINDOW, INNER TRACKS SPLIT
• ALL PARTING STOPS LOOSE

GRILL
METAL TRACKS, NO SCREENS

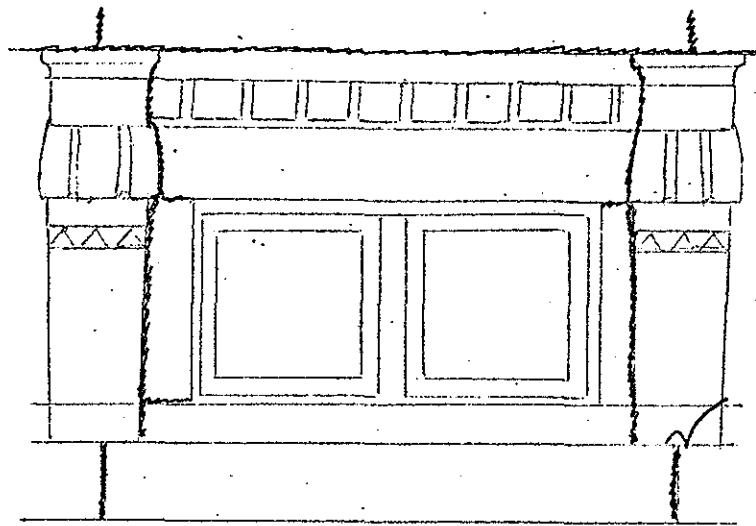
- SASH & SURROUND APPEARS TO BE IN GOOD CONDITION
- LINTEL EXPOSED & RUSTED

BLOCKED BY WING

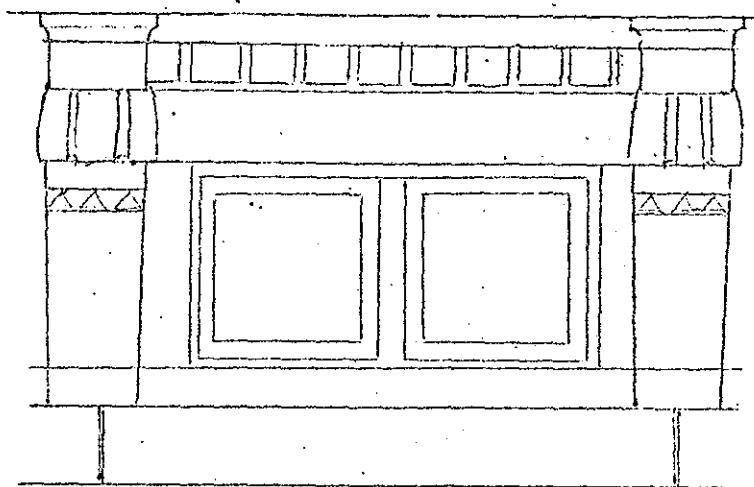
INTERIOR: LINTEL EXPOSED X RUSTY

BLOCKED BY WING

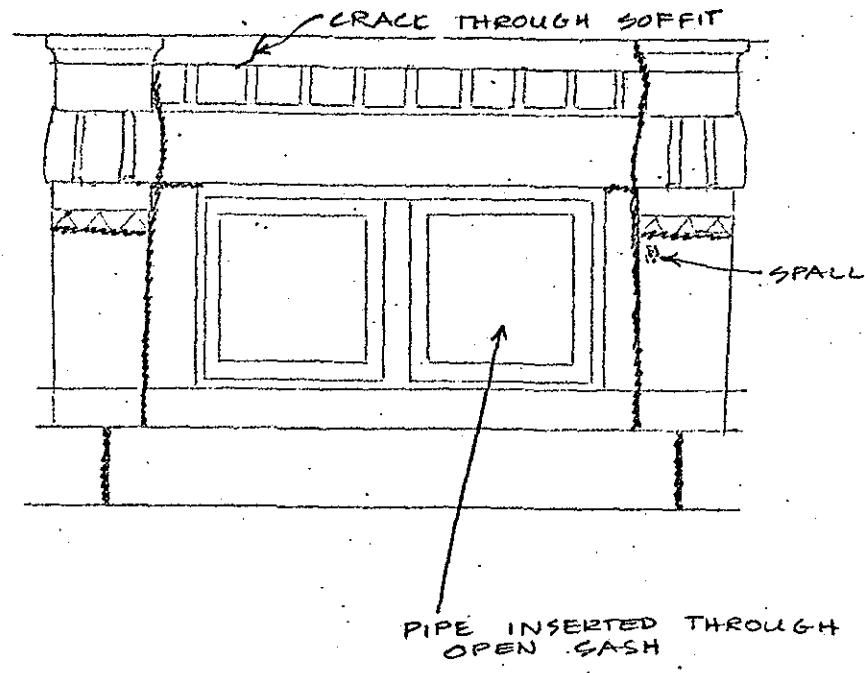
INTERIOR TRIM APPEARS O.K.

GRILL-HOLE CUT THROUGH RIGHT (EAST) SIDE

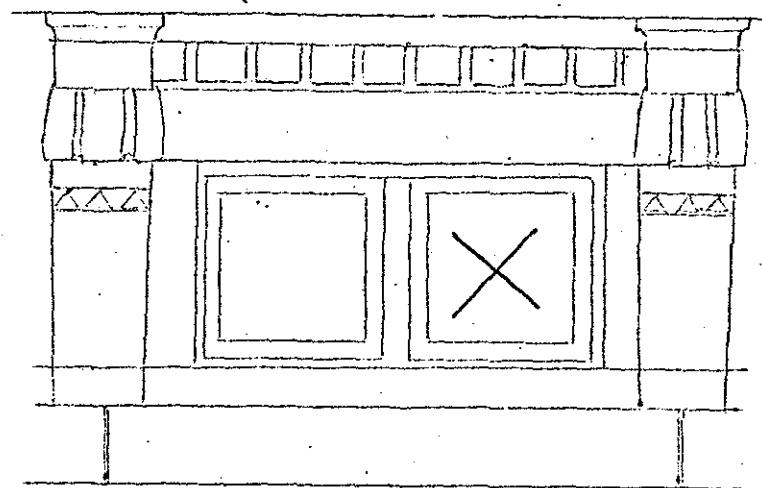
V THIRD FLOOR, TOWER (12)	NUMBER SWT-303	CLASS I
MECHANICAL AND ELECTRICAL REHABILITATION MAIN BUILDING ELLIS ISLAND Statue of Liberty National Monument, New York	BUILDING CONSERVATION TECHNOLOGY THE BRINKMANN GROUP 19 West 45th Street, New York NY 10036

GRILL

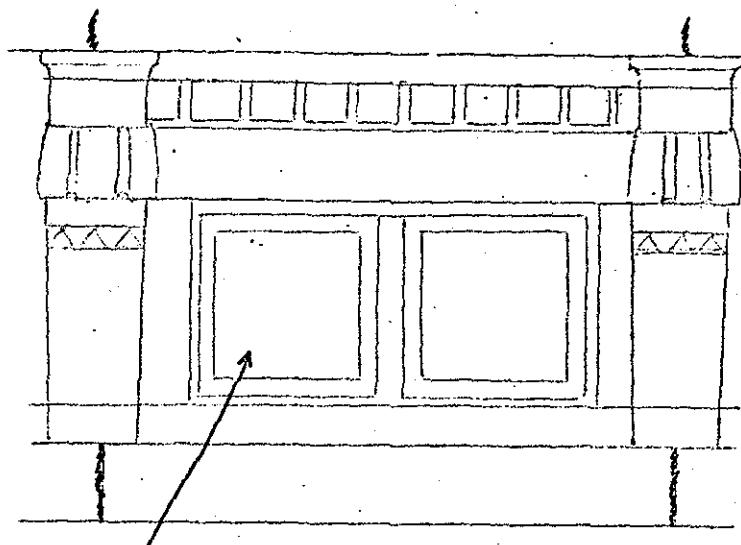
V THIRD FLOOR, TOWER (W)	NUMBER NWT- 301	CLASS
MECHANICAL AND ELECTRICAL REHABILITATION MAIN BUILDING ELLIS ISLAND Statue of Liberty National Monument, New York	BUILDING CONSERVATION TECHNOLOGY THE BRENNAN GROUP 19 West 46th Street, New York NY 10036

- LINTEL RUSTY
- FRAMING APPEARS TO BE IN GOOD CONDITION

BLOCKED BY WING

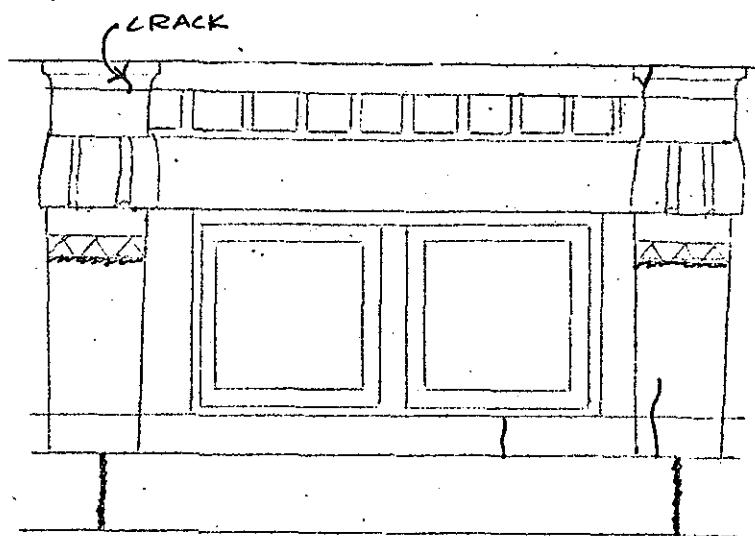
V FLOOR, TOWER (N)	NUMBER NWT-302	CLASS I
MECHANICAL AND ELECTRICAL REHABILITATION MAIN BUILDING ELLIS ISLAND Statue of Liberty National Monument, New York	BUILDING CONSTRUCTION TECHNOLOGY THE INGENIERIE GROUP 19 West 44th Street, New York NY 10036

PIPE INSERTED THRU
WINDOW - SASH OPEN

- LINTEL & NORTH SIDE OF JAMB EXPOSED
- INNER STOP MOULDINGS LOOSE

GRILL - HOLE CUT IN MIDDLE OF GRILL

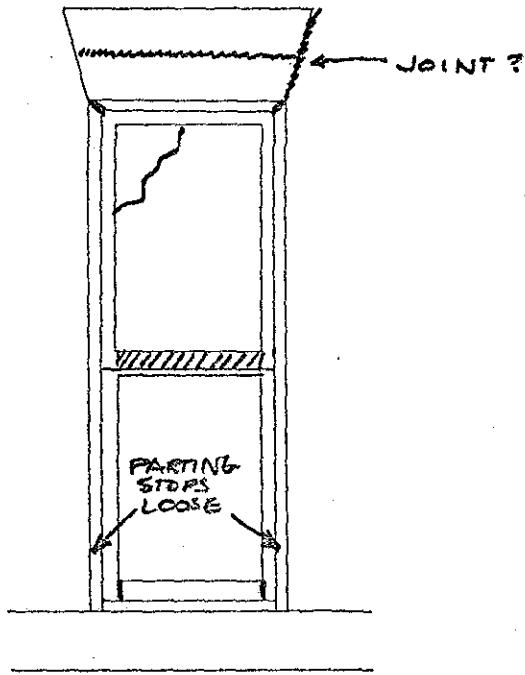
V FAIRD FLOOR, TOWER (S)	NUMBER NWT-303	CLASS
MECHANICAL AND ELECTRICAL REHABILITATION MAIN BUILDING ELLIS ISLAND Statue of Liberty National Monument, New York	BUILDING CONSERVATION TECHNOLOGY THE FINEBERG GROUP 19 West 44th Street, New York NY 10036

INTERIOR: TRIM APPEARS TO BE IN GOOD CONDITION

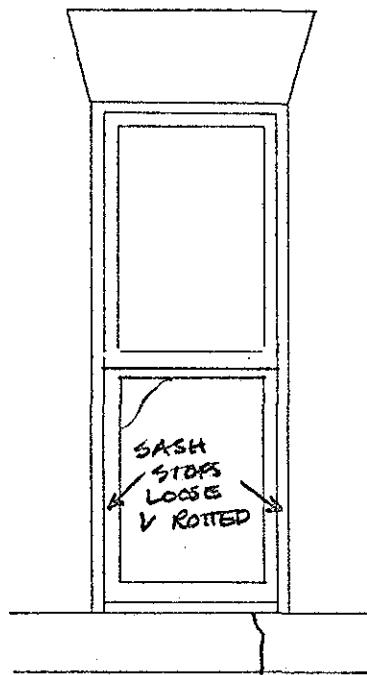
W BATHROOM NEXT TO TOWER, THIRD FLOOR (4)	NUMBER N 322	CLASS 2
MECHANICAL AND ELECTRICAL REHABILITATION MAIN BUILDING ELLIS ISLAND Statue of Liberty National Monument, New York	BUILDING CONSERVATION TECHNOLOGY THE EINENKRANTZ GROUP 19 West 44th Street, New York NY 10036	DWG NO.

SCREEN OVER LOWER SASH - GOOD CONDITION

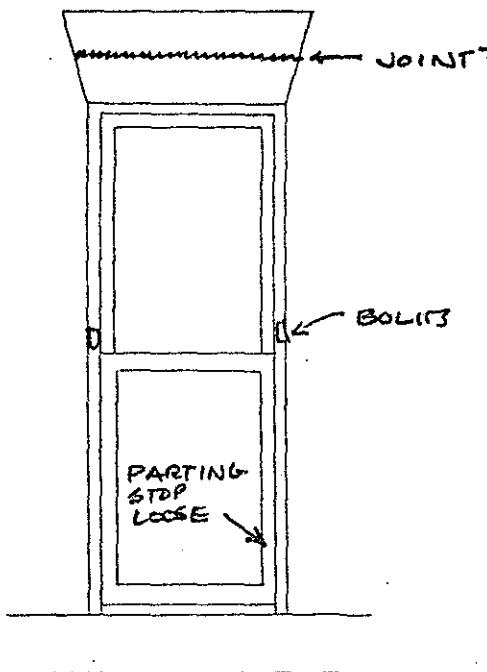
W BATHROOM NEXT TO TOWER, THIRD FLOOR (4)	NUMBER S 306	CLASS I
MECHANICAL AND ELECTRICAL REHABILITATION MAIN BUILDING ELLIS ISLAND Statue of Liberty National Monument, New York	BUILDING CONSERVATION TECHNOLOGY THE BRENKERTZ GROUP 19 West 44th Street, New York NY 10036	DWG NO.

METAL TRACKS BUT NO SCREEN

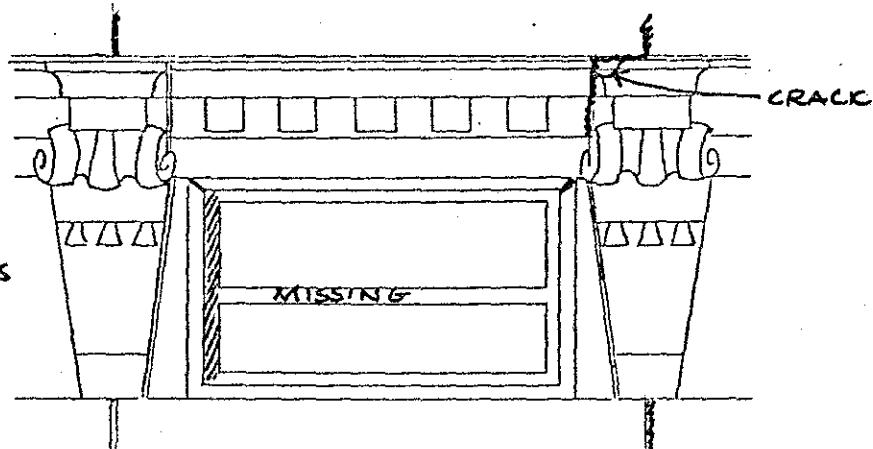
W BATHROOM NEXT TO OVER THIRD FLOOR (4)	NUMBER S 322	CLASS I
MECHANICAL AND ELECTRICAL REHABILITATION MAIN BUILDING ELLIS ISLAND Statue of Liberty National Monument, New York	BUILDING CONSERVATION TECHNOLOGY THE BRENNERKANTZ GROUP 19 West 44th Street, New York NY 10036	DWG NO.

WINDOW OPERATES SMOOTHLY

SCREEN OVER LOWER SASH - POOR CONDITION

REPOINT
BRICK
BOTH SIDES

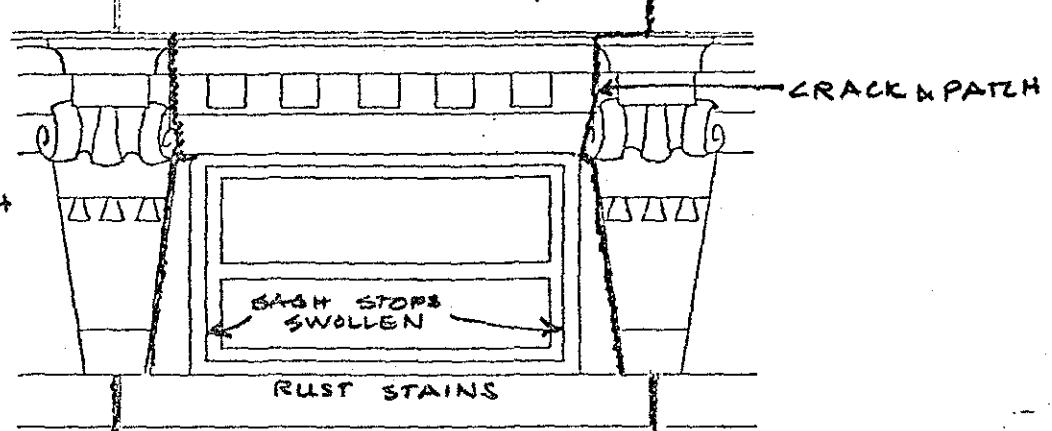
X THIRD FLOOR	NUMBER N 307	CLASS I
MECHANICAL AND ELECTRICAL REHABILITATION MAIN BUILDING ELLIS ISLAND Status of Liberty National Monument, New York	BUILDING CONSERVATION TECHNOLOGY THE PERGRINUS GROUP 29 West 44th Street, New York NY 10036

INTERIOR: MLDG ON RIGHT (WEST) JAMB SPLIT

GRILL
NO SCREENS

REPOINT
BRICK, BOTH
SIDES

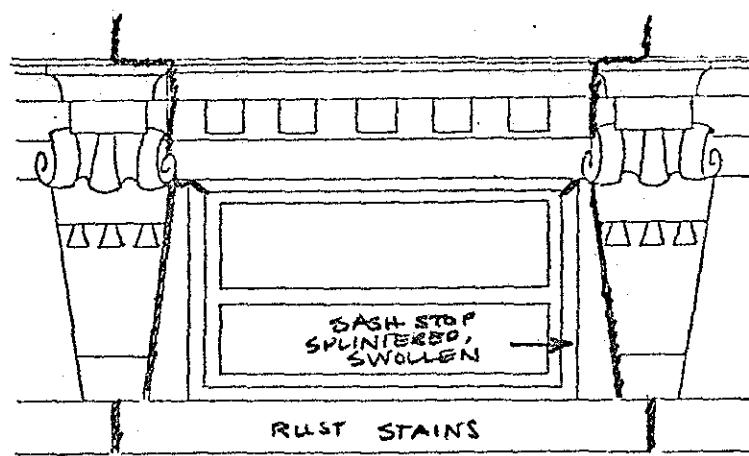
X THIRD FLOOR	NUMBER N 308	CLASS 2
MECHANICAL AND ELECTRICAL REHABILITATION MAIN BUILDING ELLIS ISLAND Statue of Liberty National Monument, New York	BUILDING CONSERVATION TECHNOLOGY DE DODDANTZ GROUP 19 West 44th Street, New York NY 10036

- INTERIOR:
- WINDOW WON'T OPEN
 - MLDGS FRAMING OPENING LOOSE
 - MLDG AT BOTTOM OF SILL ROTTED

GRILL
NO SCREENS

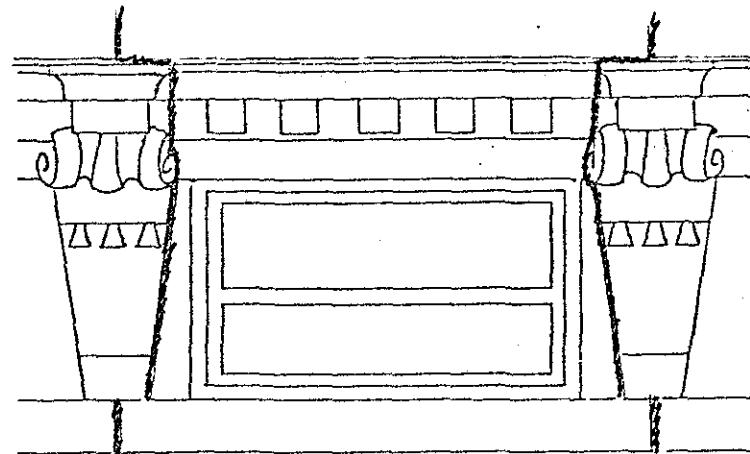
X THIRD FLOOR	NUMBER N 309	CLASS I
MECHANICAL AND ELECTRICAL REHABILITATION MAIN BUILDING ELLIS ISLAND Statue of Liberty National Monument, New York	BUILDING CONSERVATION TECHNOLOGY THE BRENNANZ GROUP 19 West 44th Street, New York NY 10036

- LINTEL EXPOSED & RUSTY
- OUTER EDGE OF BOTH SIDE RAILS CUT AWAY 4" FROM BOTTOM
- WILL NOT CLOSE COMPLETELY

2 SCREENS; LOWER ONE HAS FALLEN OFF

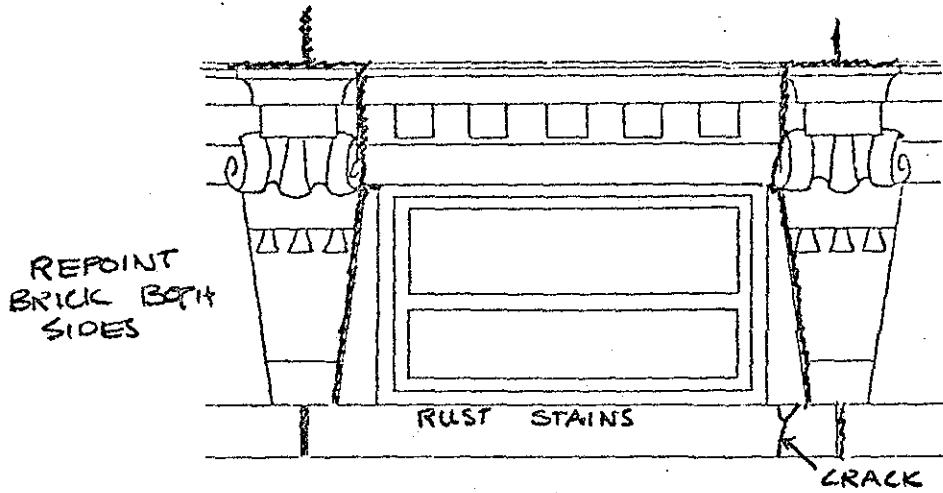
X THIRD FLOOR	NUMBER	CLASS
MECHANICAL AND ELECTRICAL REHABILITATION MAIN BUILDING ELLIS ISLAND Statue of Liberty National Monument, New York	N 310 BUILDING CONSERVATION TECHNOLOGY THE BREKANTZ GROUP 19 West 44th Street, New York NY 10036

- LINTEL EXPOSED & RUSTY
- WINDOW WILL NOT OPEN
- ALL MLDGS FRAMING OPENING LOOSE
- CENTER BALE MISSING

2 SCREENS, FAIR CONDITION

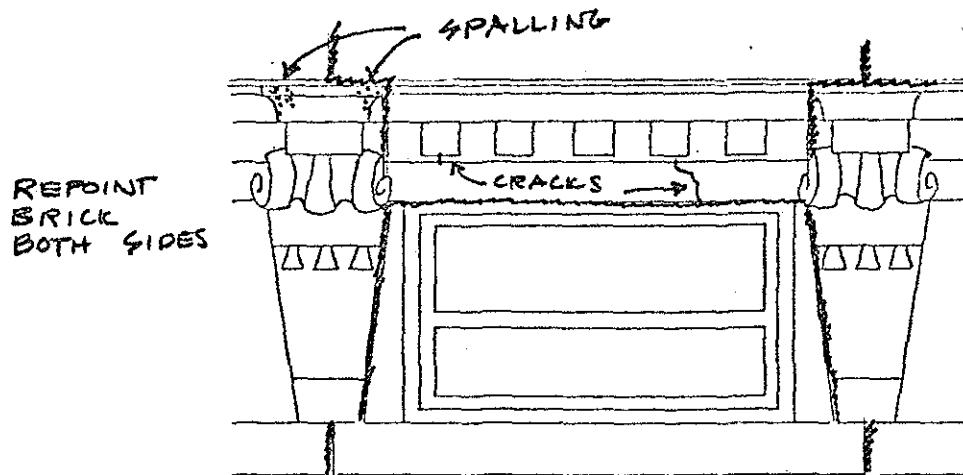
X THIRD FLOOR	NUMBER N 311	CLASS I
MECHANICAL AND ELECTRICAL REHABILITATION MAIN BUILDING ELLIS ISLAND	BUILDING CONSERVATION TECHNOLOGY THE ENERGYZERS GROUP	
Statue of Liberty National Monument, New York	19 West 44th Street, New York NY 10036

- LINTEL EXPOSED & RUSTY
- MOLDS AT BOTTOM OF SILL LOOSE
- WILL NOT CLOSE TIGHT

GRILL - RUSTY

2 SCREENS - FAIR CONDITION

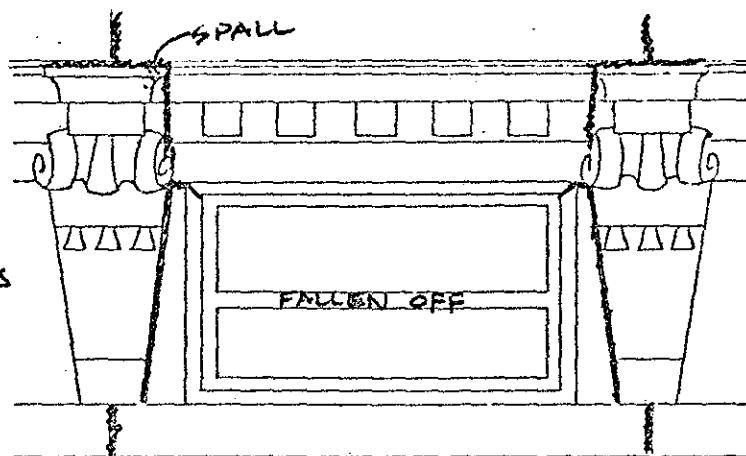
X THIRD FLOOR	NUMBER N 312	CLASS 2
MECHANICAL AND ELECTRICAL REHABILITATION MAIN BUILDING ELLIS ISLAND Statue of Liberty National Monument, New York	BUILDING CONSERVATION TECHNOLOGY THE PRESERVANT GROUP

- INTERIOR:
- LINTEL EXPOSED & RUSTY
 - WILL NOT CLOSE - HEAD SAGGING?
 - REPLACE LOWER SASH STOP ON JAMBS & SILL

REPOINT
BRICK
BOTH SIDES

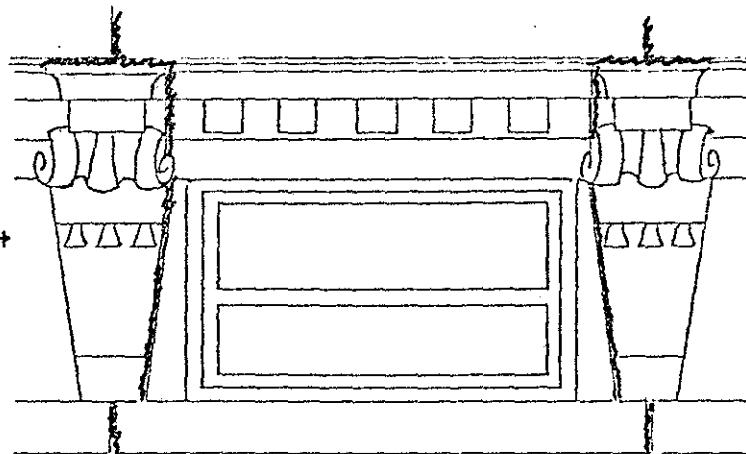
X THIRD FLOOR	NUMBER N 313	CLASS 1
MECHANICAL AND ELECTRICAL REHABILITATION MAIN BUILDING ELLIS ISLAND Statue of Liberty National Monument, New York	BUILDING CONSERVATION TECHNOLOGY THE EFCORANTZ GROUP

- LINTEL EXPOSED & RUSTY
- WILL NOT CLOSE

2 SCREENS - FAIR CONDITION

REPOINT
BRICK BOTH
SIDES

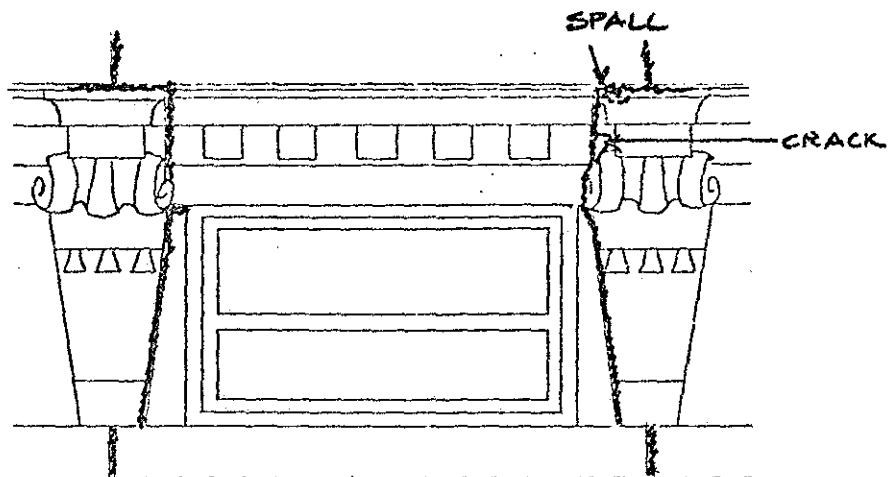
X THIRD FLOOR	NUMBER N 314	CLASS 2
MECHANICAL AND ELECTRICAL REHABILITATION MAIN BUILDING ELLIS ISLAND Statue of Liberty National Monument, New York	BUILDING CONSERVATION TECHNOLOGY THE DETERANTZ GROUP

- INTERIOR:
- LINTEL EXPOSED & RUSTY
 - ALL MLDGS FRAMING SURROUND
ARE LOOSE
 - 1" ROT ON BOTTOM OF LEFT (EAST)
JAMB - REPLACE
 - * WON'T CLOSE COMPLETELY

2 SCREENS - POOR CONDITION

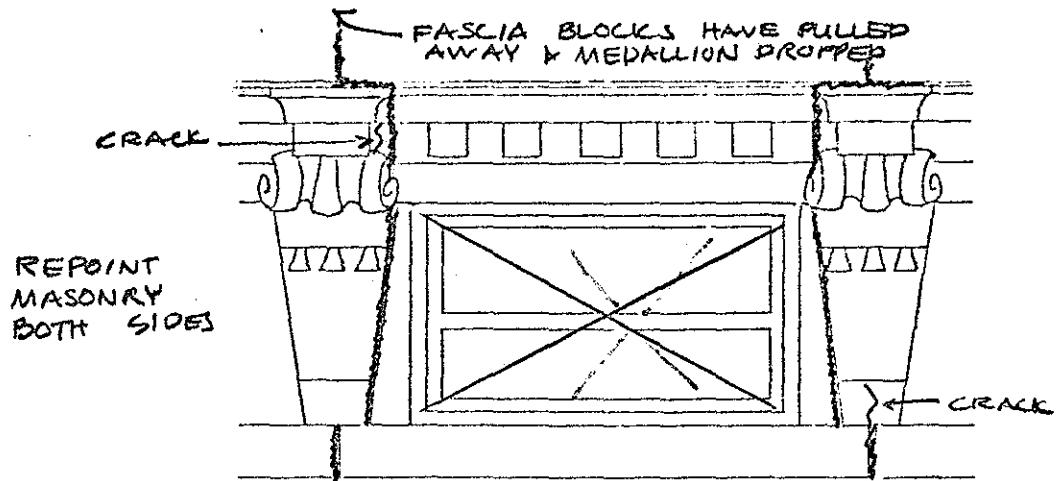
X THIRD FLOOR	NUMBER	CLASS
MECHANICAL AND ELECTRICAL REHABILITATION MAIN BUILDING ELLIS ISLAND Statue of Liberty National Monument, New York	N 315	2
	BUILDING CONSERVATION TECHNOLOGY THE HERCULEAN GROUP

- Lintel exposed & rusty
- 1/2" rot across bottom of sill - replace
- Mdg's at top of surround loose

GRILL
2 SCREENS - OFF TRACKS

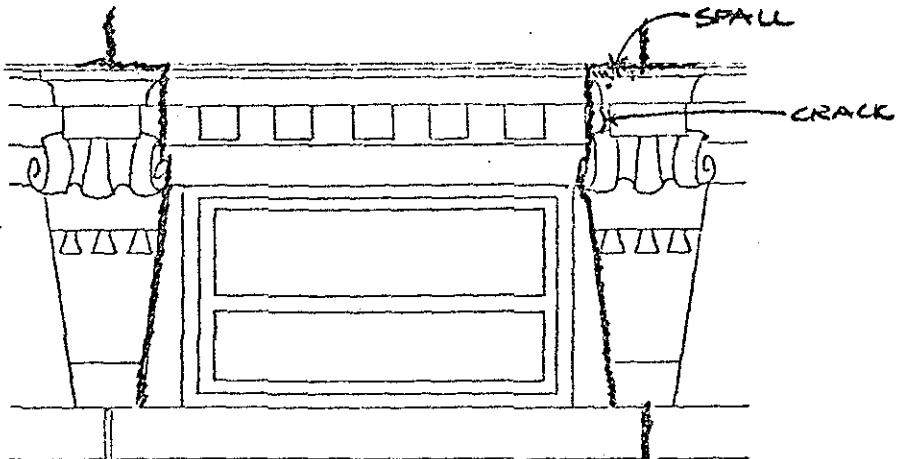
X THIRD FLOOR	NUMBER N 316	CLASS 3
MECHANICAL AND ELECTRICAL REHABILITATION MAIN BUILDING ELLIS ISLAND Statue of Liberty National Monument, New York	BUILDING CONSERVATION TECHNOLOGY THE PERINANT GROUP 19 West 44th Street, New York NY 10036

BOARDDED UP

GRILL
SCREENS MISSING

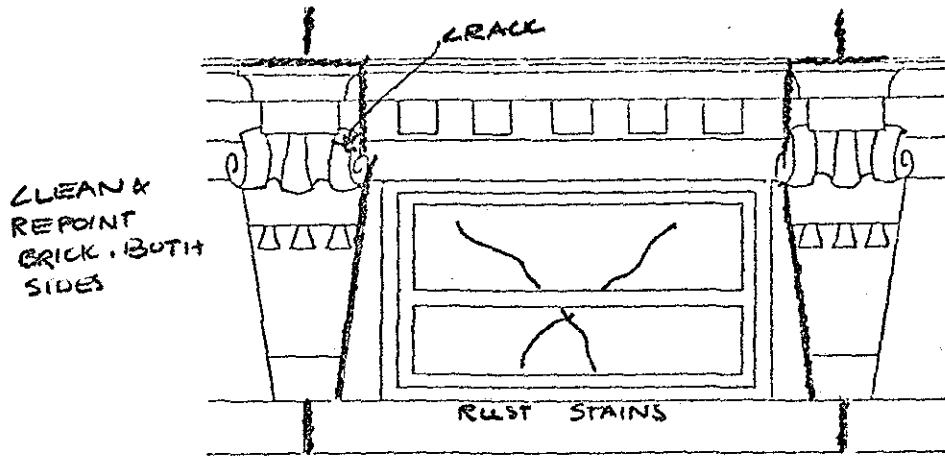
X THIRD FLOOR	NUMBER	CLASS
MECHANICAL AND ELECTRICAL REHABILITATION MAIN BUILDING ELLIS ISLAND	N 317	I
Statue of Liberty National Monument, New York	WILLING CONSERVATION TECHNOLOGY THE IMMIGRANT GROUP	19 West 44th Street, New York NY 10036

SPALL

CRACK

INTERIOR =
- LINTEL EXPOSED & RUSTY
- WINDOW WILL NOT OPEN

GRILL
& SCREENS - FAIR CONDITION

REPOINT
BRICK, BOTIT
SIDES

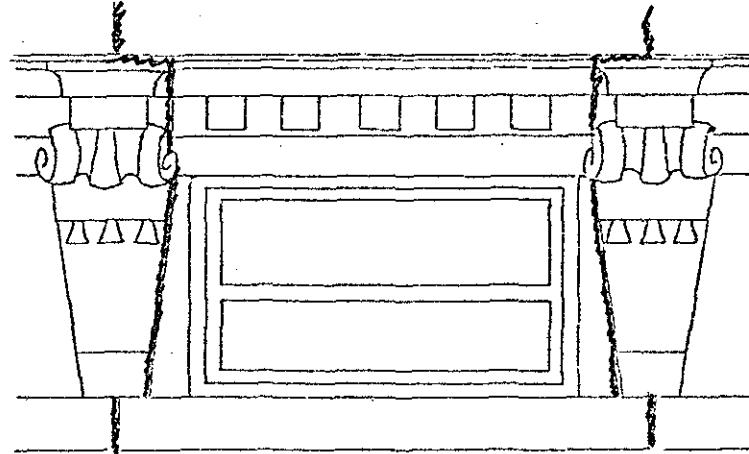
X THIRD FLOOR	NUMBER N 318	CLASS
MECHANICAL AND ELECTRICAL REHABILITATION MAIN BUILDING ELLIS ISLAND Statue of Liberty National Monument, New York	BUILDING CONSERVATION TECHNOLOGY THE DIFENBARNET GROUP 19 West 44th Street, New York NY 10036

- MLDGS FRAMING OPENING LOOSE
- LINTEL EXPOSED & RUSTY

2 SCREENS - POOR CONDITION

REPOINT
BRICK, BOTH
SIDES

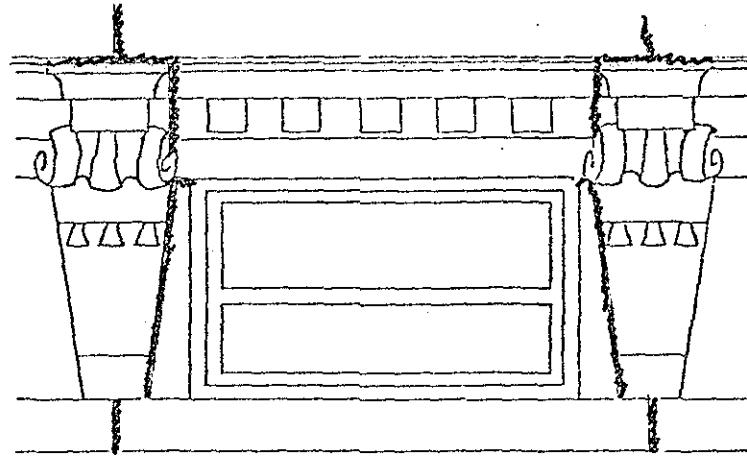
X THIRD FLOOR	NUMBER N 319	CLASS I
MECHANICAL AND ELECTRICAL REHABILITATION MAIN BUILDING ELLIS ISLAND Statue of Liberty National Monument, New York	BUILDING CONSERVATION TECHNOLOGY THE EPSTEINFRANZ GROUP 19 West 44th Street, New York NY 10036

- INTERIOR:
- LINTEL EXPOSED & RUSTY
 - MUDG FRAMING OPENING HAS SAGGED
ON HEAD

GRILL
NO SCREENS

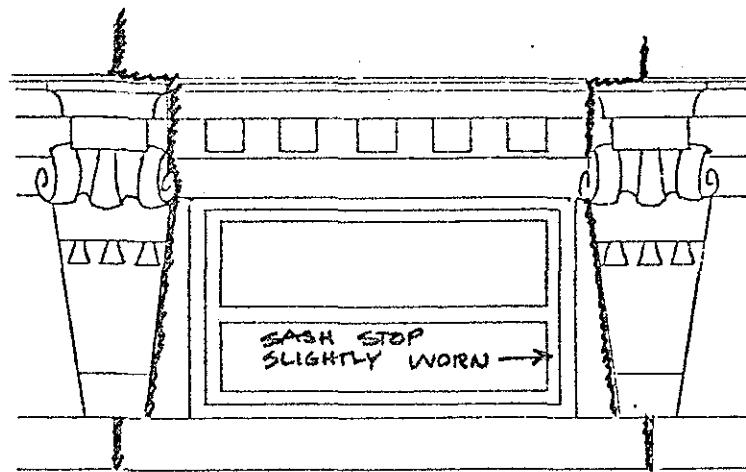
X THIRD FLOOR	NUMBER N 320	CLASS I
MECHANICAL AND ELECTRICAL REHABILITATION MAIN BUILDING ELLIS ISLAND	BUILDING CONSERVATION TECHNOLOGY THE DREYFANZ GROUP	
Statue of Liberty National Monument, New York	19 West 44th Street, New York NY 10036

INTERIOR: TOP & EDGE OF LINTEL

NO SCREENS

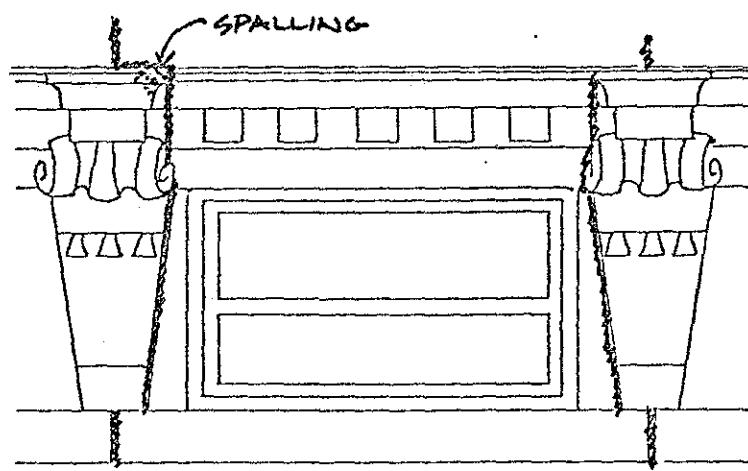
X THIRD FLOOR	NUMBER N 321	CLASS I
MECHANICAL AND ELECTRICAL REHABILITATION MAIN BUILDING ELLIS ISLAND Statue of Liberty National Monument, New York	BUILDING CONSERVATION TECHNOLOGY THE DEDICANT GROUP

INTERIOR: WON'T CLOSE COMPLETELY

GRILL
NO SCREENS

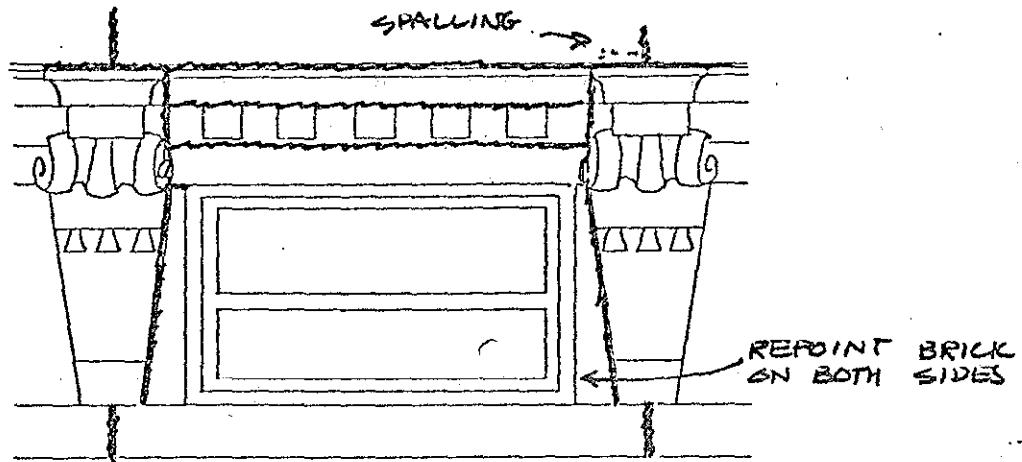
X THIRD FLOOR	NUMBER S 307	CLASS ?
MECHANICAL AND ELECTRICAL REHABILITATION MAIN BUILDING ELLIS ISLAND Statue of Liberty National Monument, New York	BUILDING CONSERVATION TECHNOLOGY THE BREKANTZ GROUP

INACCESSIBLE FROM INTERIOR

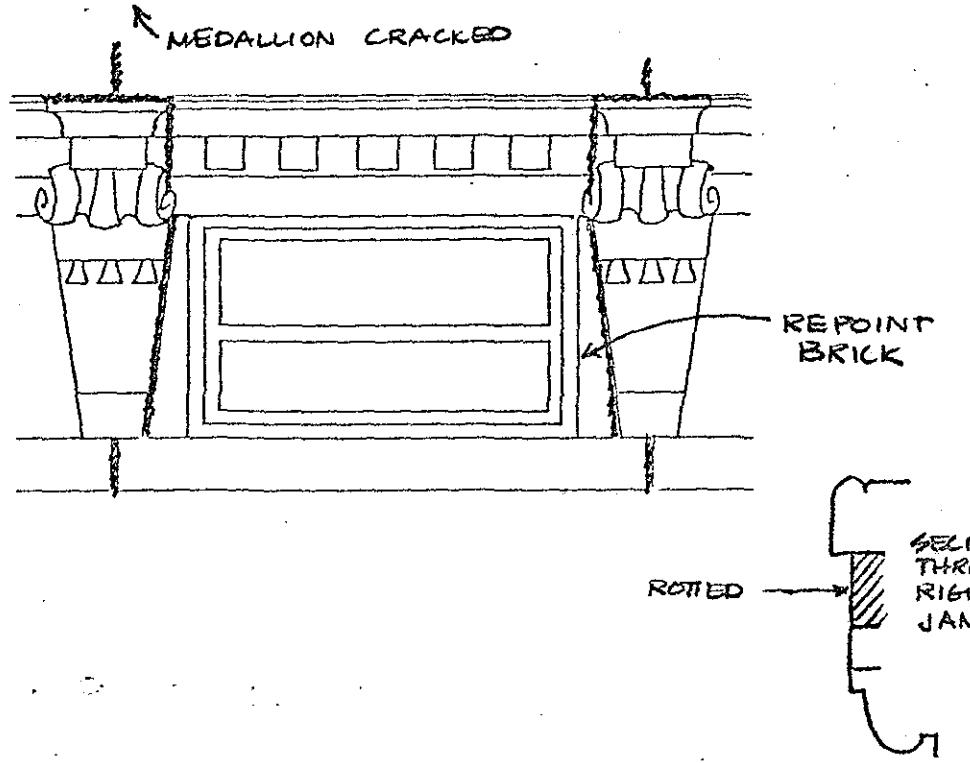
X THIRD FLOOR	NUMBER 5308	CLASS I
MECHANICAL AND ELECTRICAL REHABILITATION MAIN BUILDING ELLIS ISLAND Statue of Liberty National Monument, New York	BUILDING CONSERVATION TECHNOLOGY THE DIFENBARN GROUP 19 West 44th Street, New York NY 10036

- MLOGS FRAMING SURROUND NOT ORIGINAL
- TOP & EDGE OF STEEL UNTIL EXPOSED
- DOES NOT CLOSE TIGHT

2 SCREENS - FAIR CONDITION

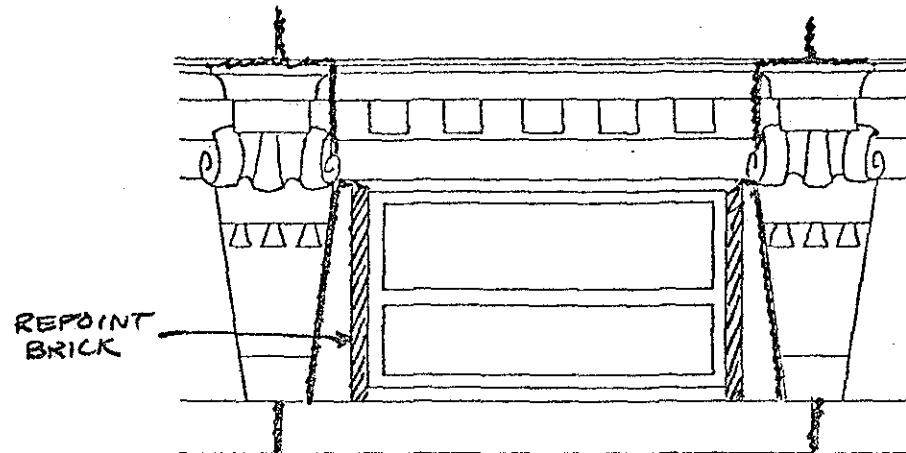
X THIRD FLOOR	NUMBER 5309	CLASS 2
MECHANICAL AND ELECTRICAL REHABILITATION MAIN BUILDING ELLIS ISLAND Statue of Liberty National Monument, New York	BUILDING CONSERVATION TECHNOLOGY THE ENERGRANZ GROUP

- INTERIOR:
- MLDGS FRAMING SURROUND NOT ORIGINAL
 - STEEL LINTEL EXPOSED & RUSTY
 - MLDG FRAMING OPENING & SILL FASCIA LOOSE IN LOWER LEFT (WEST) CORNER,
 - RIGHT RAIL SLIGHTLY WORN

NO SCREENS -

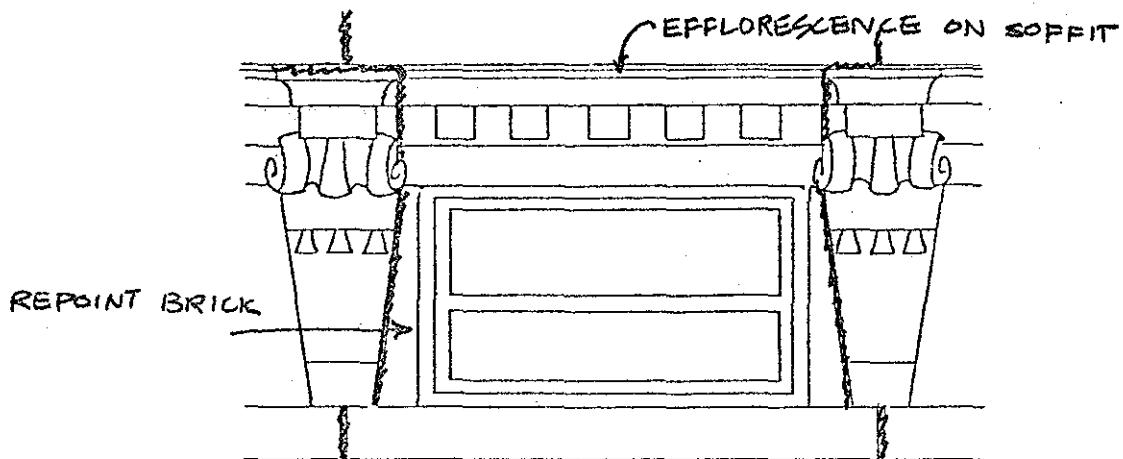
X THIRD FLOOR	NUMBER 5310	CLASS 2
MECHANICAL AND ELECTRICAL REHABILITATION MAIN BUILDING ELLIS ISLAND Statue of Liberty National Monument, New York	BUILDING CONSERVATION TECHNOLOGY THE BRECHER GROUP	19 West 44th Street, New York NY 10036

- LINTEL EXPOSED & RUSTY
- SILL ROTTEN
- LEFT JAMB ROTTED
- HEAD DAMP

2 SCREENS - POOR CONDITION

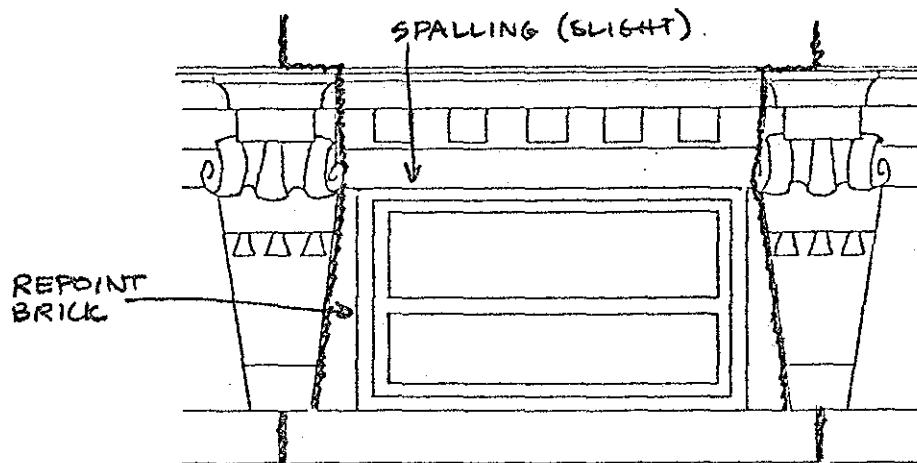
X THIRD FLOOR	NUMBER 5311	CLASS 2
MECHANICAL AND ELECTRICAL REHABILITATION MAIN BUILDING ELLIS ISLAND Statue of Liberty National Monument, New York	BUILDING PRESERVATION TECHNOLOGY THE DREGENAZZI GROUP	19 West 44th Street, New York NY 10036

- INTERIOR:
- LINTEL EXPOSED & RUSTY ON TOP
 - WILL NOT OPEN
 - MLOG AT BOTTOM OF SILL & FASCA BEING IT ARE ROTTED
 - MLOGS FRAMING SURROUND NOT ORIGINAL
 - CROSS BAR MISSING

2. SCREENS - POOR CONDITION

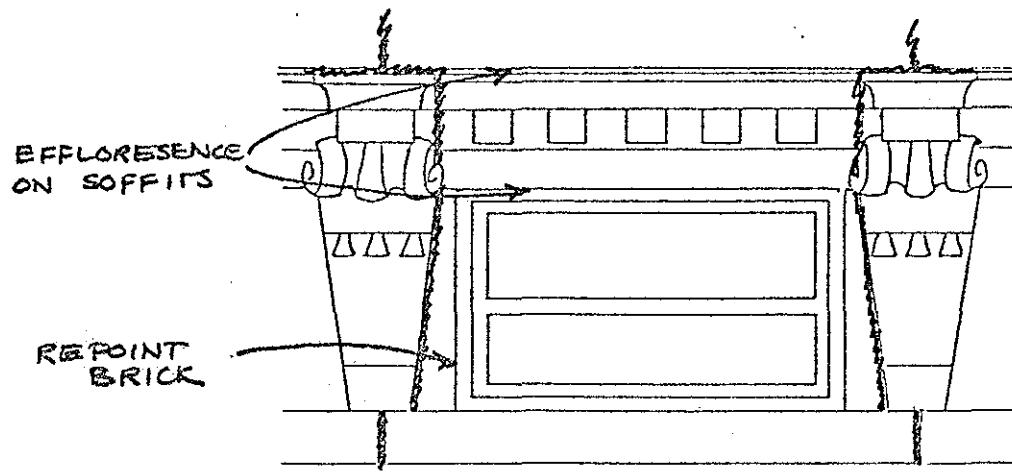
X THIRD FLOOR	NUMBER 5312	CLASS 2
MECHANICAL AND ELECTRICAL REHABILITATION MAIN BUILDING ELLIS ISLAND Statue of Liberty National Monument, New York	BUILDING CONSERVATION TECHNOLOGY THE DEDMANZ GROUP

- OUTER EDGE OF LINTEL EXPOSED & RUSTED
- WINDOW WILL NOT OPEN (CAN'T INSPECT SILL)
- SILL FASCIA SPLIT, BOWED UP IN CENTER - ALSO MLOG BELOW IT - REPLACE

2 SCREENS - POOR CONDITION
