historic structures report

mechanical/electrical rehabilitation

main building

STATUE OF LIBERTY ELLIS ISLAND

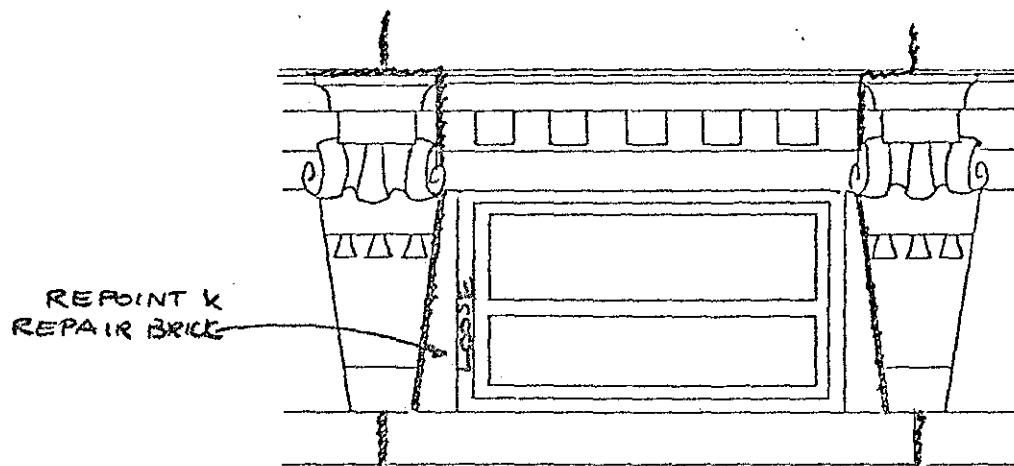
X THIRD FLOOR	NUMBER 5313	CLASS 2
MECHANICAL AND ELECTRICAL REHABILITATION MAIN BUILDING ELLIS ISLAND Statue of Liberty National Monument, New York	BUILDING CONSERVATION TECHNOLOGY THE DEPERANIE GROUP 19 West 44th Street, New York NY 10036

- LINTEL EXPOSED ON TOP & EDGE
- ALL JOINTS OPEN - WOOD APPEARS TO HAVE WET & DRIED
- WORKS WELL
- UNABLE TO SEE HEAD OR OUTER EDGE OF SILL

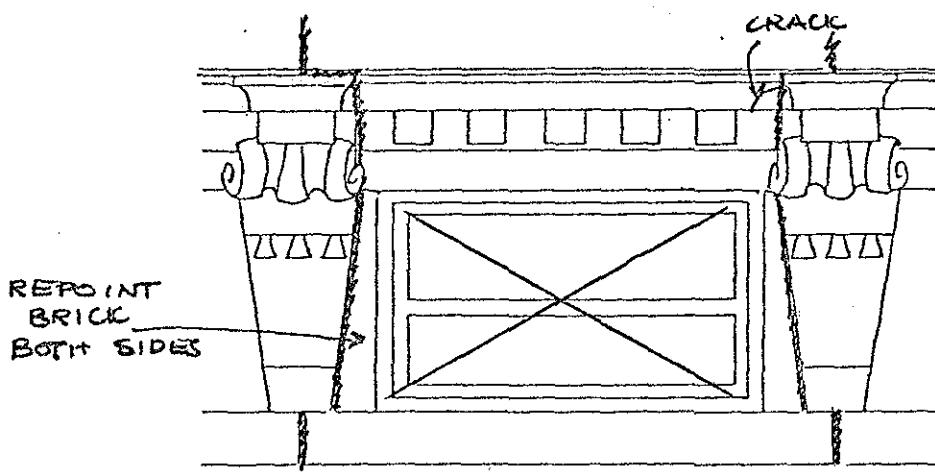
X THIRD FLOOR	NUMBER S 314	CLASS 1/2
MECHANICAL AND ELECTRICAL REHABILITATION MAIN BUILDING ELLIS ISLAND Statue of Liberty National Monument, New York	BUILDING CONSERVATION TECHNOLOGY THE BREWSTER GROUP

- LINTEL EXPOSED & RUSTY
- ALL JOINTS OPEN (AS MUCH AS $\frac{1}{4}$ "") -
APPEAR TO HAVE WET & DRIED
- FASCIA & MLDGS OF SILL LOOSE

GRILL
LOWER SCREEN ONLY

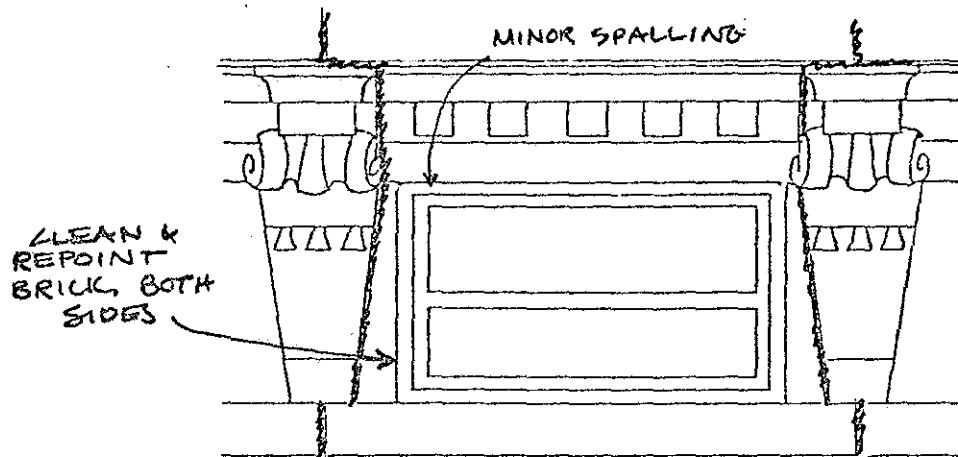
X THIRD FLOOR	NUMBER 5315	CLASS 3
MECHANICAL AND ELECTRICAL REHABILITATION MAIN BUILDING ELLIS ISLAND Statue of Liberty National Monument, New York	BUILDING CONSERVATION TECHNOLOGY THE DIVERSANT GROUP 19 West 44th Street, New York NY 10036

WINDOW BLOCKED WITH PLYWOOD; MUCH OF
FRAME, INCL IRON CENTER BAR APPEARS
TO BE IN PLACE. GLASS BROKEN.

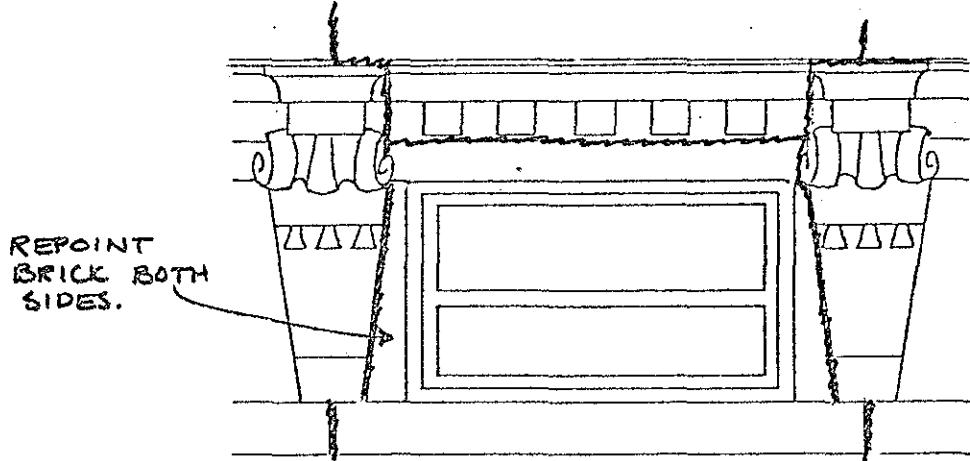
X THIRD FLOOR	NUMBER 5316	CLASS 1,2
MECHANICAL AND ELECTRICAL REHABILITATION MAIN BUILDING ELLIS ISLAND Statue of Liberty National Monument, New York	BUILDING CONSERVATION TECHNOLOGY THE DEDDARAZZ GROUP

- LINTEL EXPOSED & RUSTY
- ALL JOINTS OPEN

SCREEN ON UPPER HALF ONLY

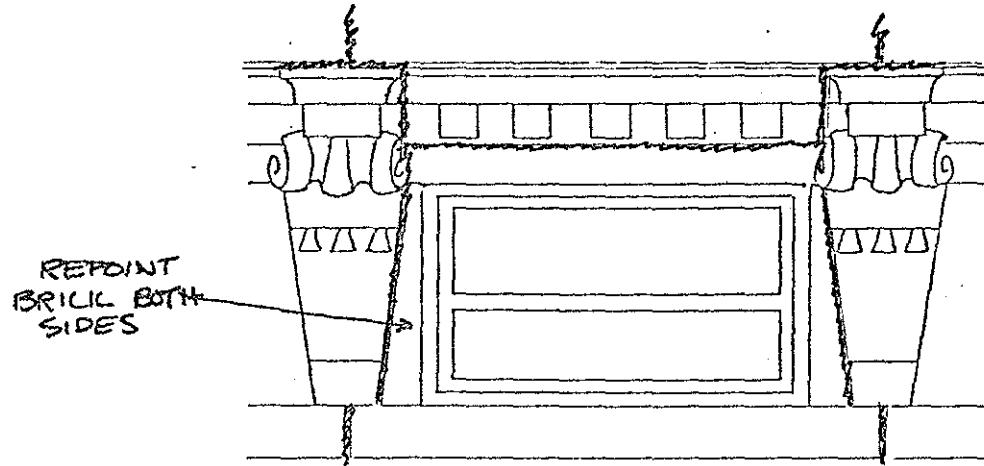
X THIRD FLOOR	NUMBER 5317	CLASS 1 2
MECHANICAL AND ELECTRICAL REHABILITATION MAIN BUILDING ELLIS ISLAND Statue of Liberty National Monument, New York	BUILDING CONSERVATION TECHNOLOGY THE BREWSTER GROUP 19 West 44th Street, New York NY 10036

- LINTEL EXPOSED & RUSTY
- MLDG FRAMING SURROUND LOSSE
& SPLINTERED IN LOWER LEFT (WEST) CORNER.

2 SCREENS - FAIR CONDITION

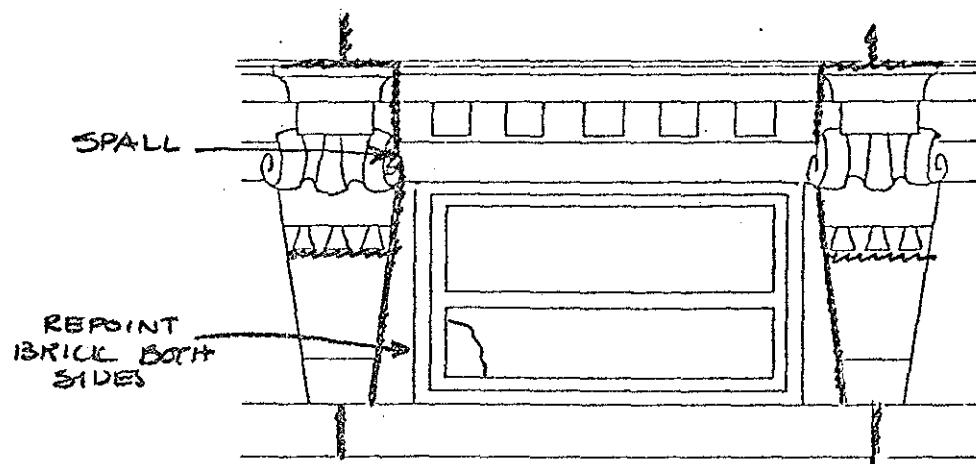
X THIRD FLOOR	NUMBER S 318	CLASS I
MECHANICAL AND ELECTRICAL REHABILITATION MAIN BUILDING ELLIS ISLAND Statue of Liberty National Monument, New York	BUILDING CONSERVATION TECHNOLOGY THE DPERFRANZ GROUP

- IRON LINTEL EXPOSED & RUSTED
- WON'T SHUT COMPLETELY

2 SCREENS - UPPER HAS FALLEN OFF

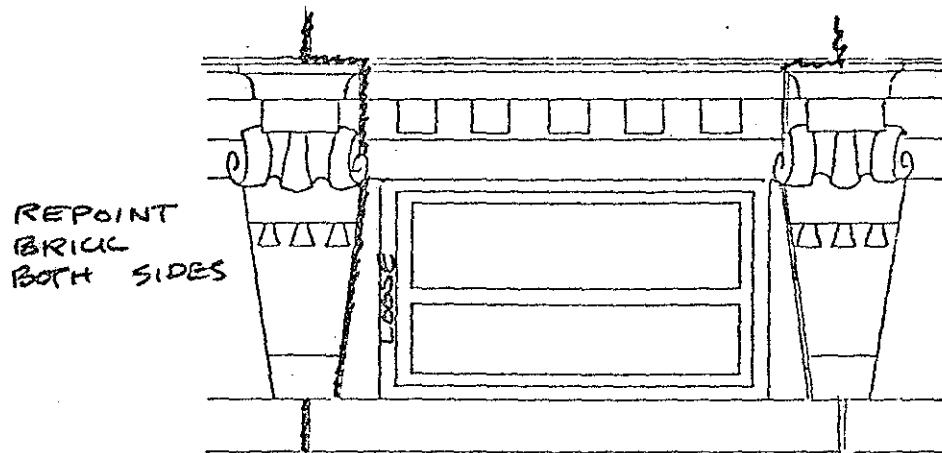
X THIRD FLOOR	NUMBER	CLASS
MCHANICAL AND ELECTRICAL REHABILITATION MAIN BUILDING ELLIS ISLAND Statue of Liberty National Monument, New York	S 319 BUILDING CONSERVATION TECHNOLOGY THE EPERANTZ GROUP	1

- WINDOW WON'T OPEN
- LINTEL EXPOSED & RUSTY

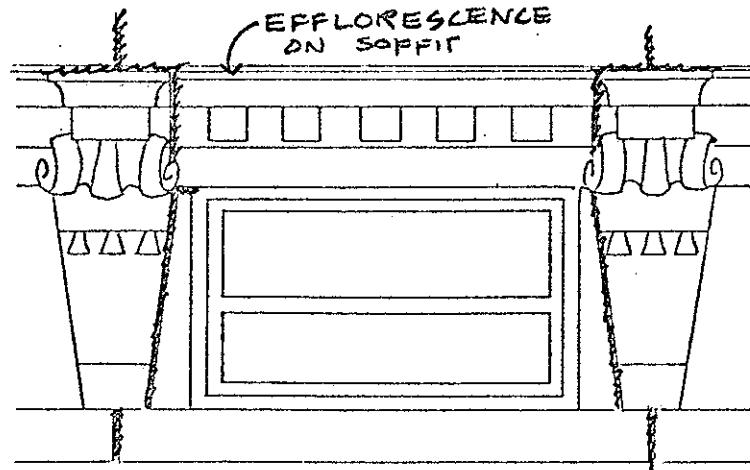
X THIRD FLOOR	NUMBER 5 320	CLASS I
MECHANICAL AND ELECTRICAL REHABILITATION MAIN BUILDING ELLIS ISLAND Statue of Liberty National Monument, New York	BUILDING CONSERVATION TECHNOLOGY THE DETERGENT GROUP 19 West 44th Street, New York NY 10036

WINDOW WILL NOT OPEN

2 SCREENS - GOOD CONDITION

REPOINT
BRICK
BOTH SIDES

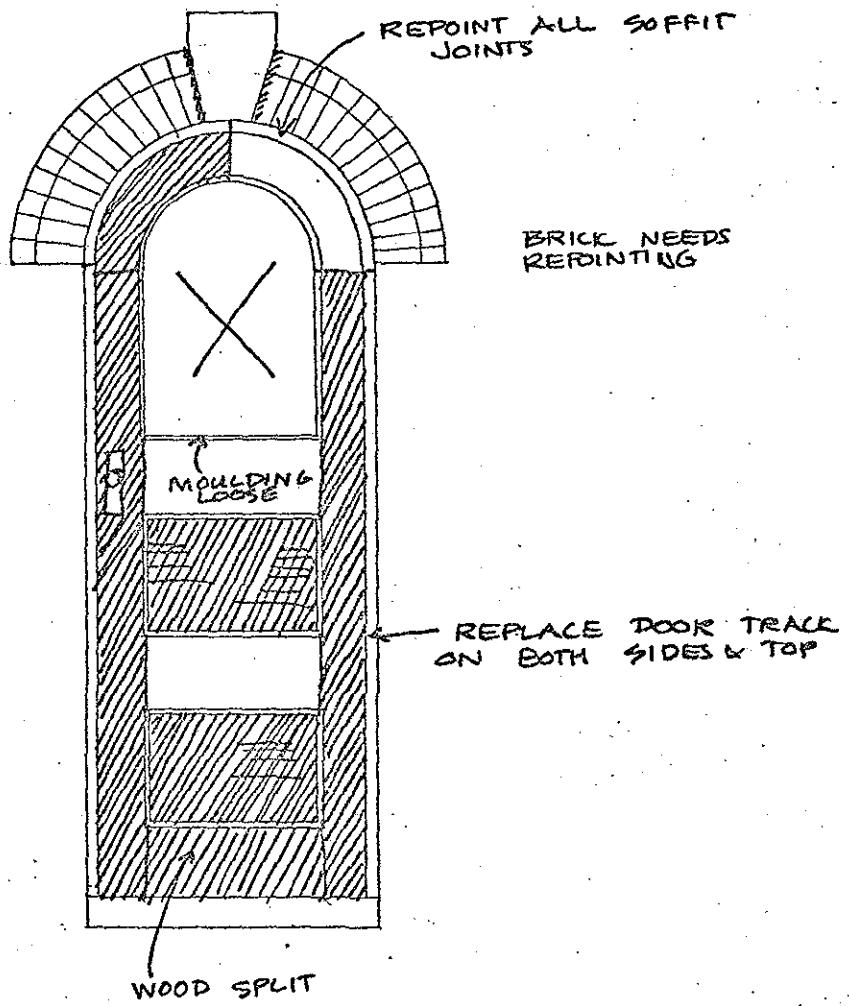
Y TOWER ROOF DOOR (4)	SCALE NET - 402	DATE 3
MECHANICAL AND ELECTRICAL REHABILITATION MAIN BUILDING ELLIS ISLAND Statue of Liberty National Monument, New York	BUILDING CONSERVATION TECHNOLOGY THE EIRENKRANTZ GROUP 19 West 44th Street, New York NY 10036	DWG NO.

DOOR TAKEN OFF HINGES, STORED INSIDE TOWER

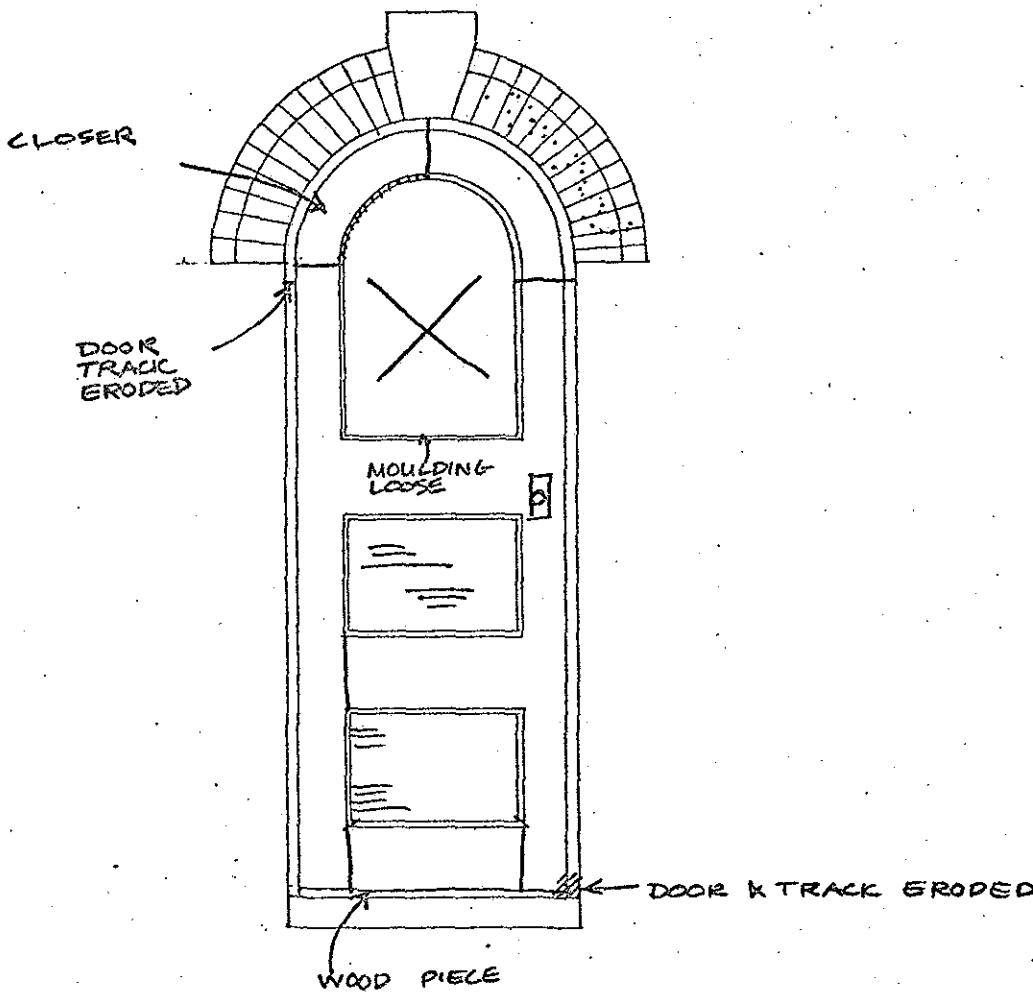
Y TOWER ROOF DOOR (4)	SCALE SET - 404	DATE 2
MECHANICAL AND ELECTRICAL REHABILITATION MAIN BUILDING ELLIS ISLAND Statue of Liberty National Monument, New York	BUILDING CONSERVATION TECHNOLOGY THE EHNERKRAUTZ GROUP	DWG NO.
	19 West 44th Street, New York NY 10036

DOOR WILL NOT SHUT TIGHT - WOOD PIECE AT
BOTTOM CATCHES ON SILL.

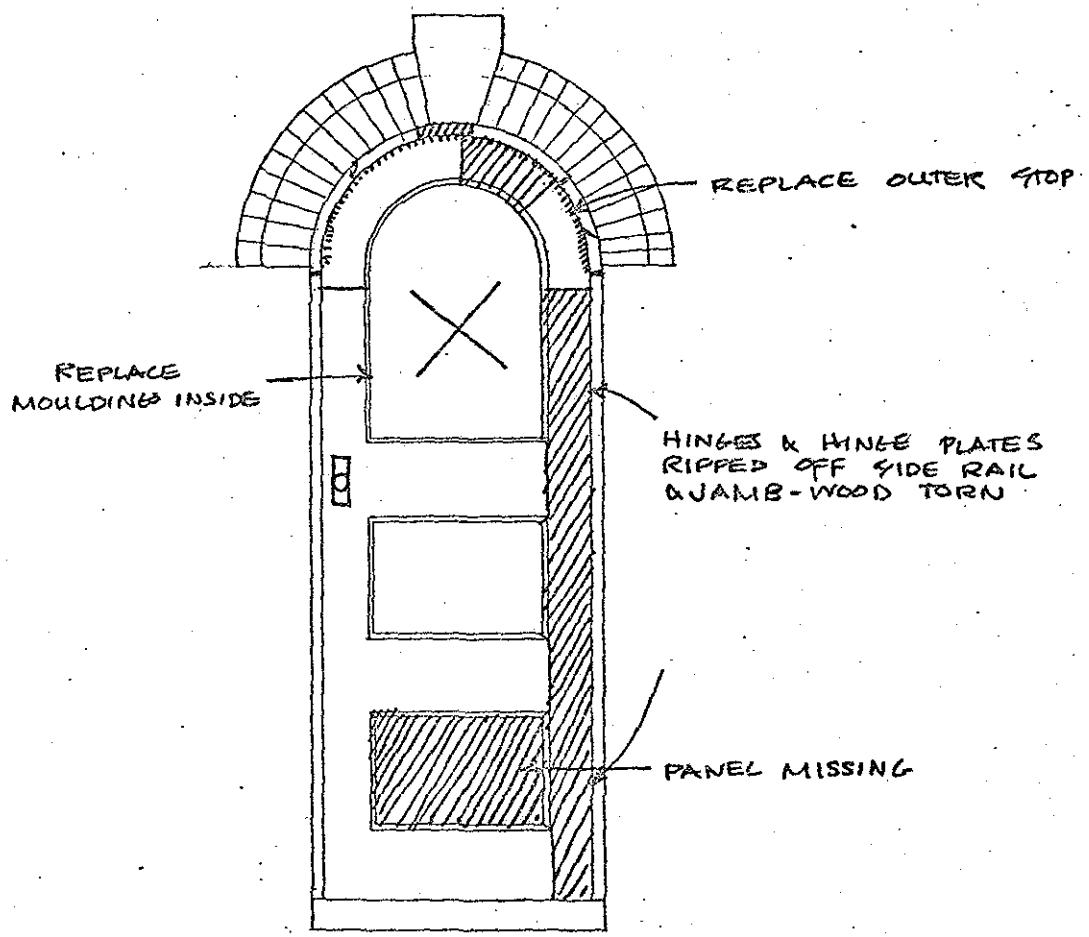
Y TOWER ROOF DOOR (4)	SWT-404	2
MECHANICAL AND ELECTRICAL REHABILITATION MAIN BUILDING ELLIS ISLAND Statue of Liberty National Monument, New York	BUILDING CONSERVATION TECHNOLOGY THE EBENKRAUTZ GROUP 19 West 44th Street, New York NY 10036

DOOR HAS BEEN REMOVED, STORED INSIDE
REPLACE ALL INNER STOP

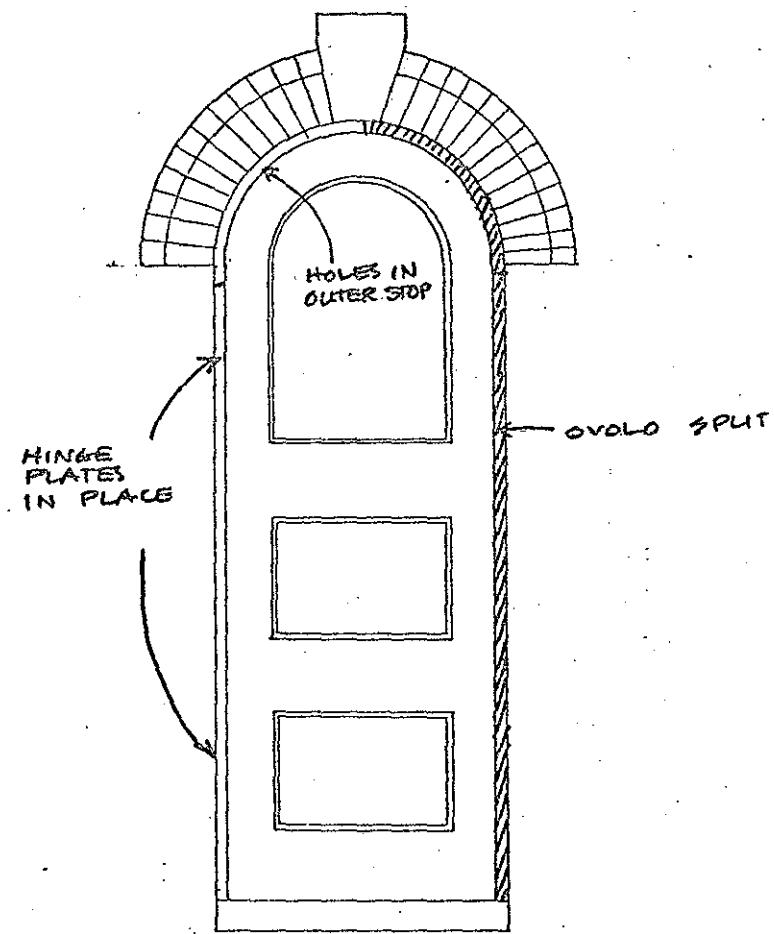
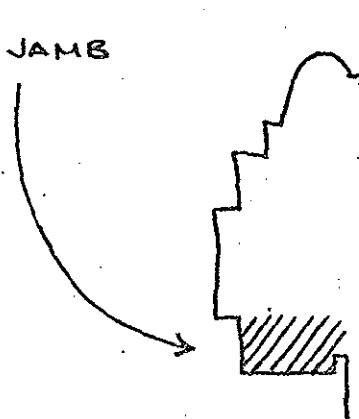
Y TOWER ROOF DOOR (4)	SCALE NWT - 40%	DATE 3
MECHANICAL AND ELECTRICAL REHABILITATION MAIN BUILDING ELLIS ISLAND Statue of Liberty National Monument, New York	BUILDING CONSERVATION TECHNOLOGY THE EBENSTEIN GROUP 19 West 44th Street, New York NY 10036	DWG NO.

DOOR MISSING

REPLACE ALL INNER JAMB
