Coastal Hazards & Sea-Level Rise Asset Vulnerability Assessment for Cape Lookout National Seashore

Updated Summary of Results

NPS 623 187597, February 2023

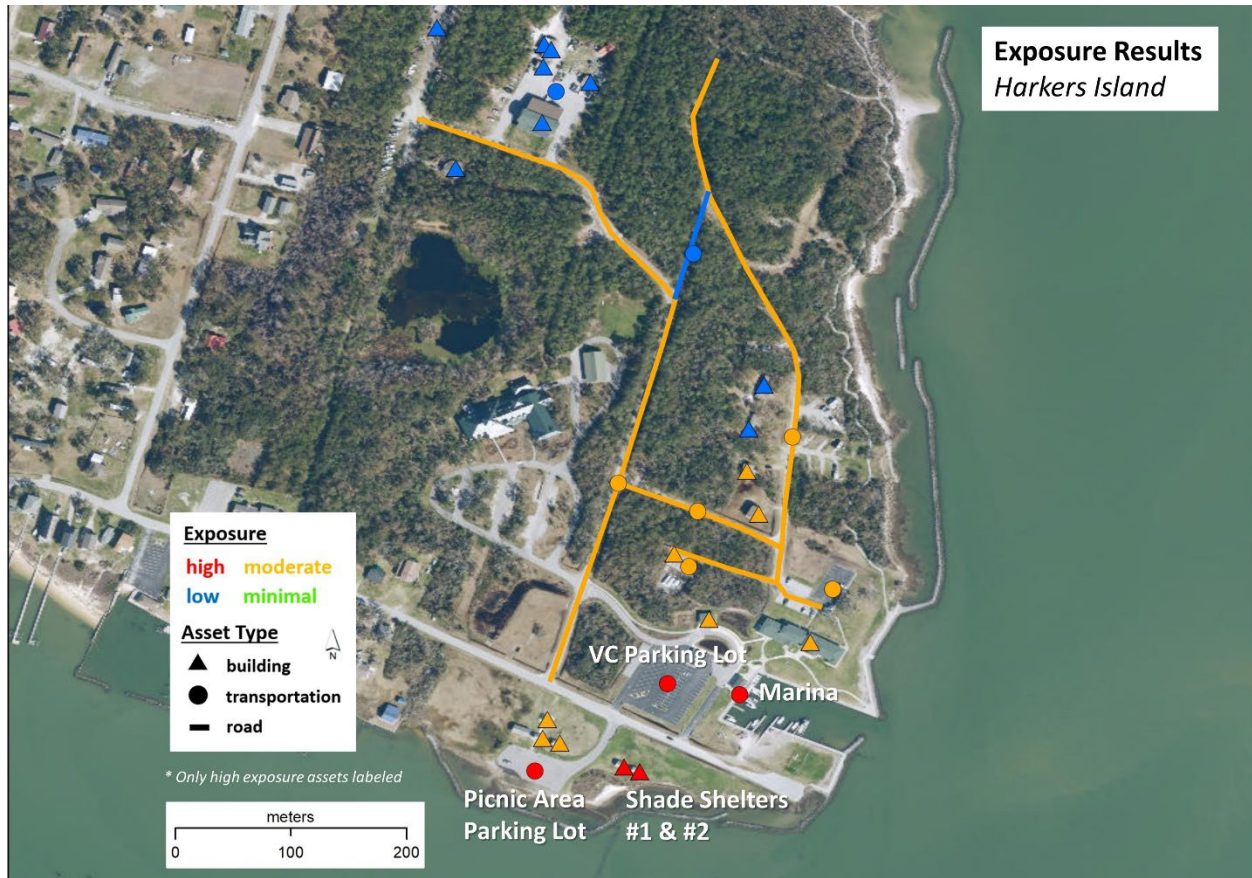
Figure 1. Exposure results for the Harkers Island area of CALO. Only high exposure assets are labeled. Background is ESRI streaming imagery.

Most assets analyzed at CALO have either high (69%) or moderate (25%) exposure to the evaluated coastal hazards (Table 2, and Figures 1-5). Few assets (6%) have low exposure, most of which are in the maintenance area of Harkers Island. These results are primarily a factor of the park's high exposure to coastal flooding, as indicated by the widespread Federal Emergency Management Agency (FEMA) AE zone (1% annual chance flood) and modeled category 3 surge extent. In addition, over 80% of assets have been flooded by previous storms.

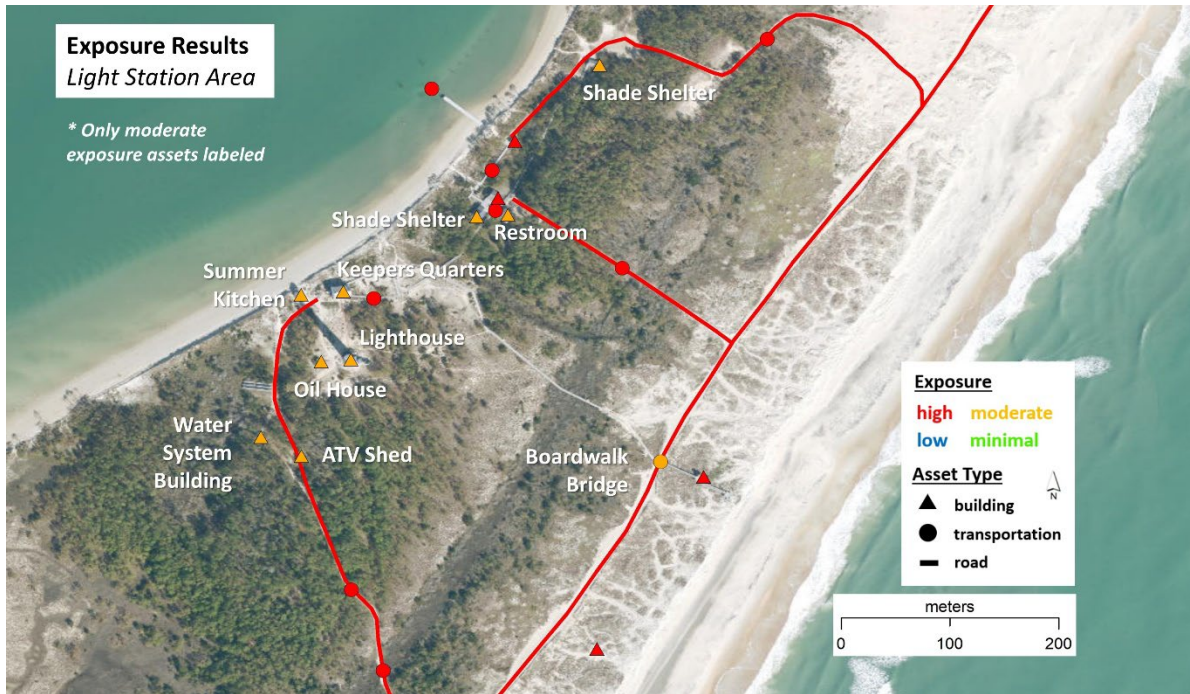
Figure 2. Exposure results for the Light Station area of CALO. Only moderate exposure assets are labeled. Background is ESRI streaming imagery.

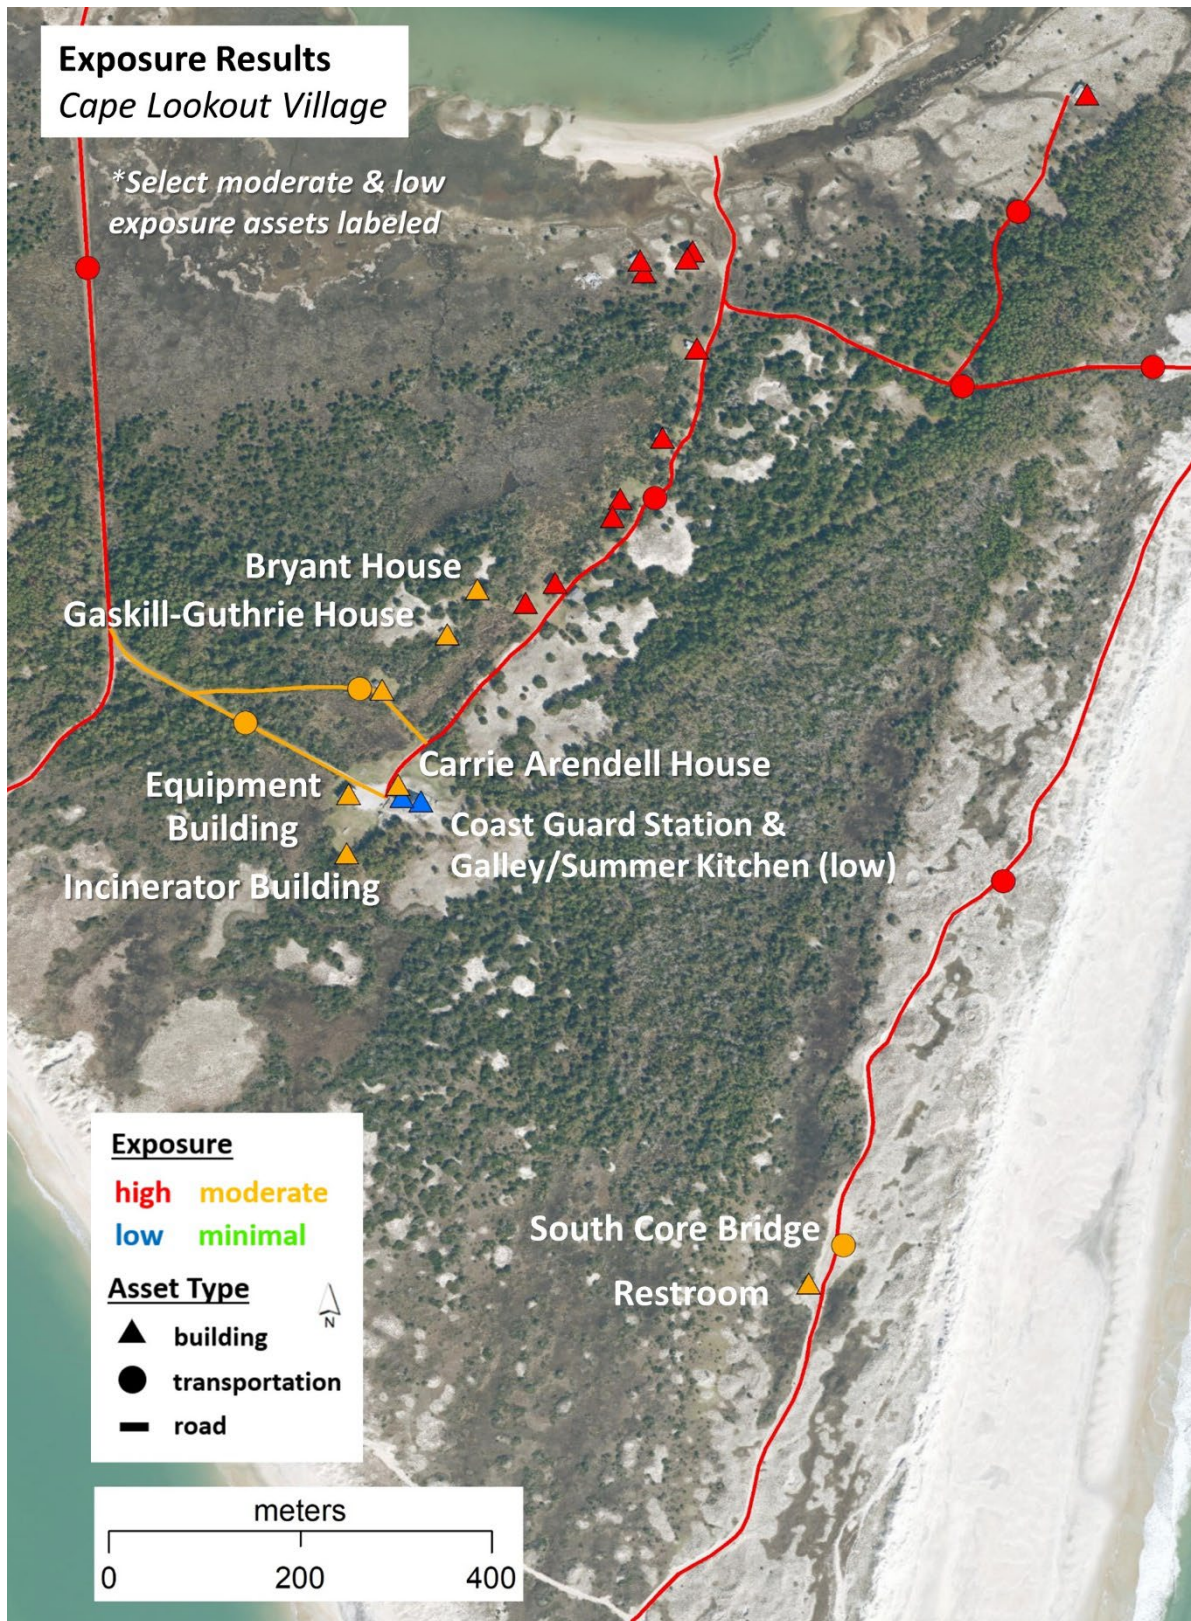
Figure 5. Exposure results for the Cape Lookout Village area of CALO. Select moderate and low exposure assets are labeled. Background is ESRI streaming imagery.

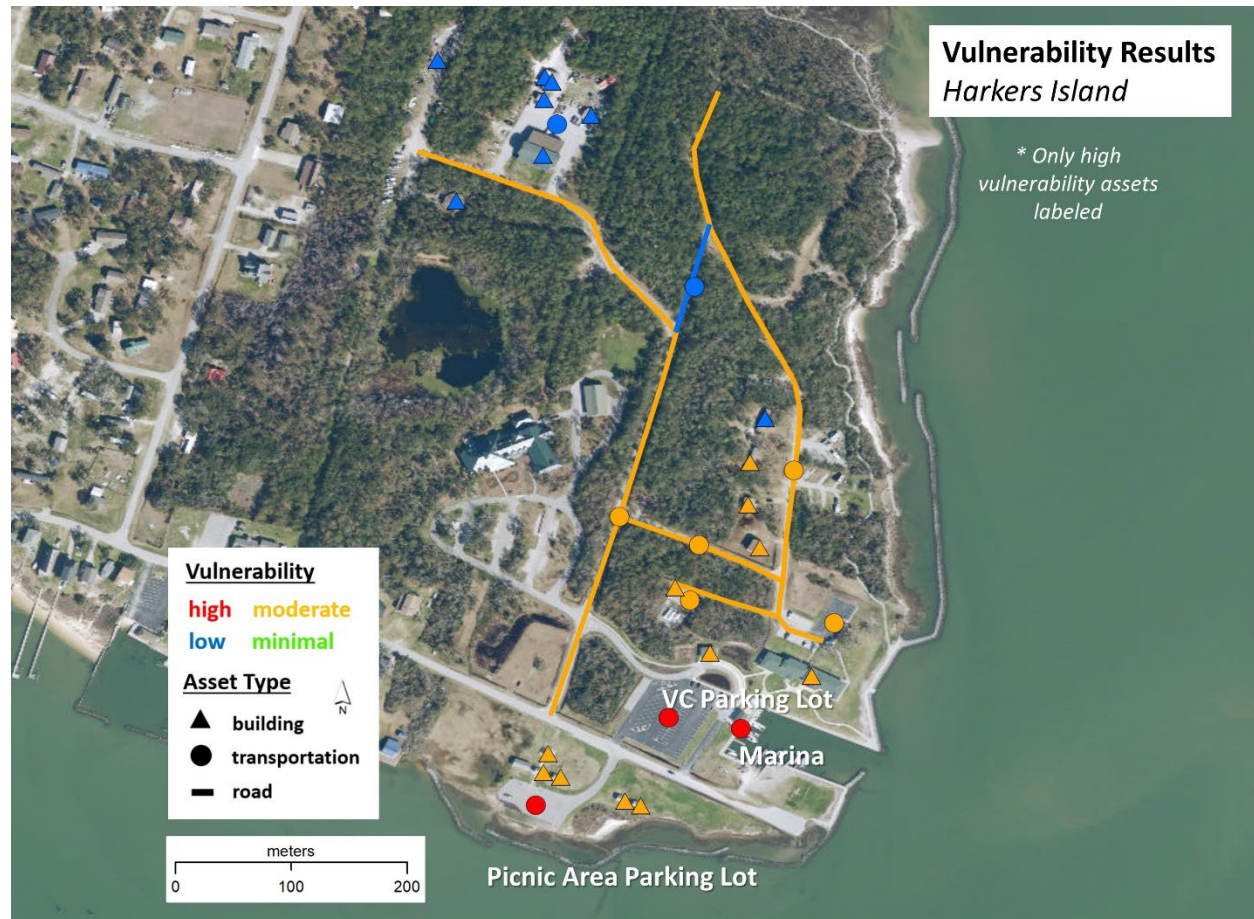
Figure 6. Vulnerability results for the Harkers Island area of CALO. Only high vulnerability assets are labeled. Background is ESRI streaming imagery.

Nearly three-quarters (73%) of assets analyzed at CALO have high vulnerability to the evaluated coastal hazards, 20% have moderate vulnerability, and only 7% have low vulnerability (Table 4, and Figures 6-11). No assets have minimal vulnerability. Eighty-seven assets (38 buildings and 49 transportation) have both high exposure and high sensitivity; most of these are historic buildings in Cape Lookout and Portsmouth villages and sand-road segments along North Core and South Core

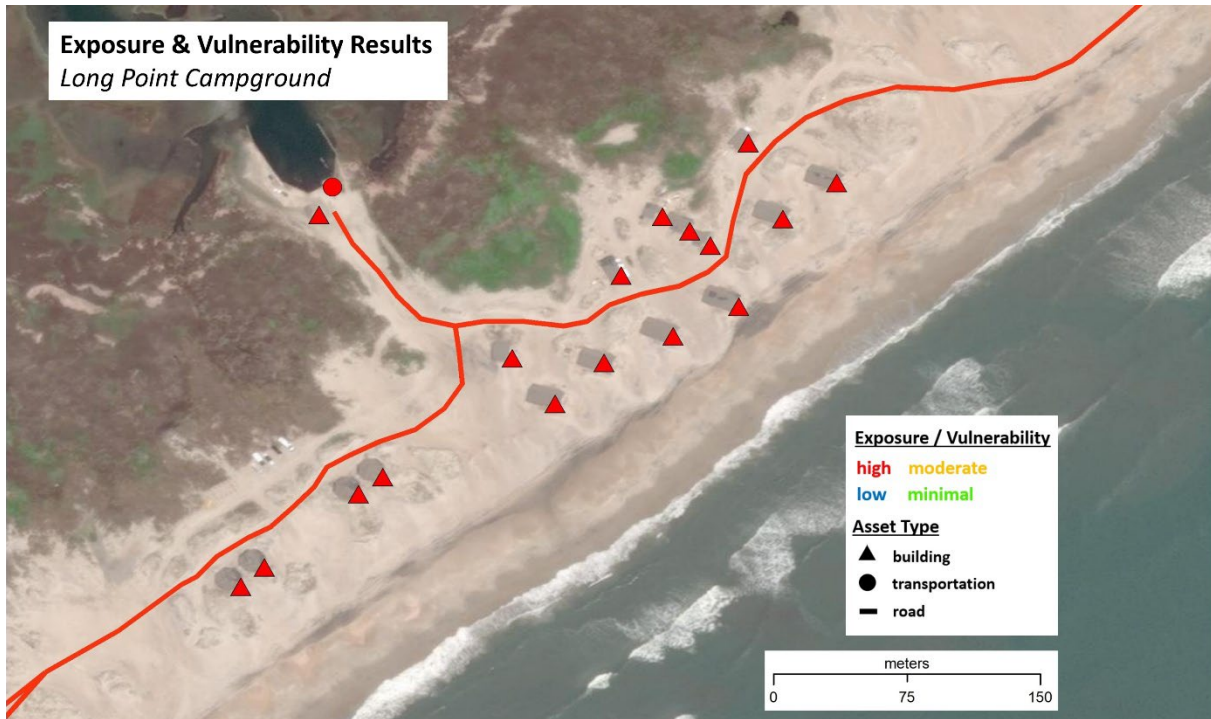
Figure 9. Exposure and vulnerability results for the Long Point Campground area of CALO. Background is ESRI streaming imagery.

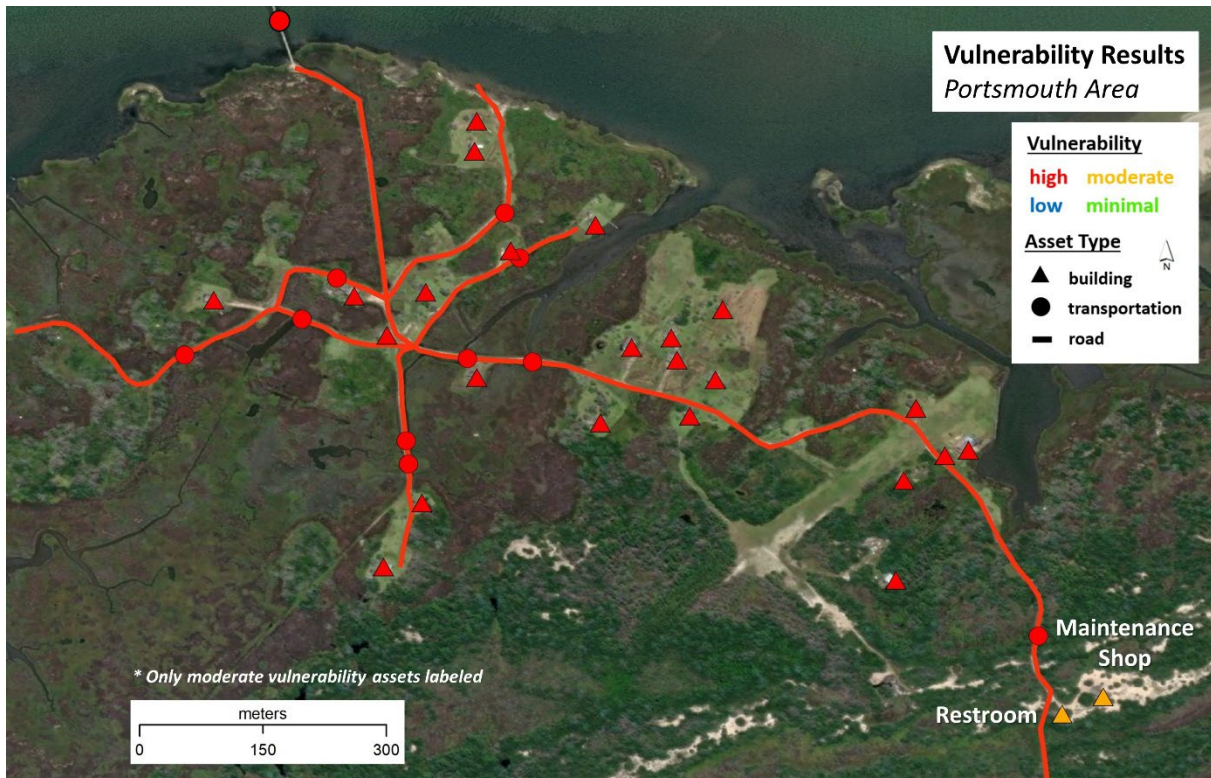
Figure 10. Vulnerability results for the Portsmouth area of CALO. Only moderate vulnerability assets are labeled. Background is ESRI streaming imagery.
