# Dry Tortugas National Park Garden Key Cultural Landscape Report

# Cultural Landscape Report

June 2011

National Park Service

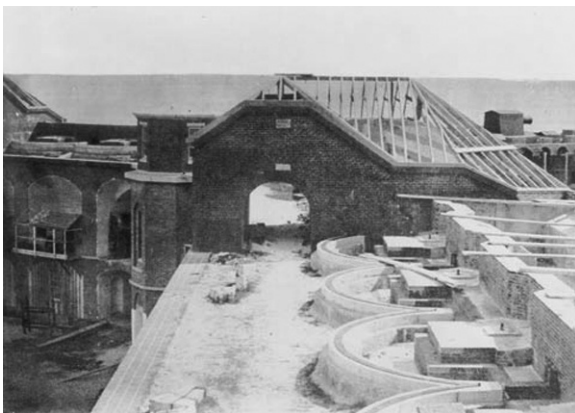
Figure 9. Terreplein under construction, 1863. (DRTO 300646)

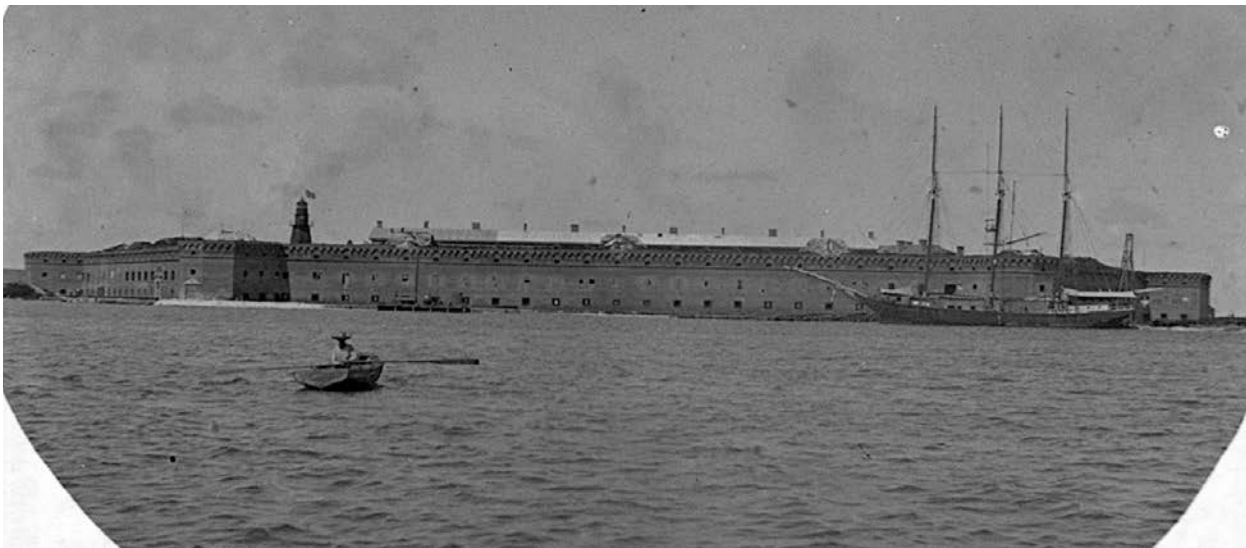
**Figure 12.** Fort Jefferson with wrought-iron lighthouse, C. 1898 (John Meigs Photograph Collection, Dry Tortugas National Park, DRTO 3805)

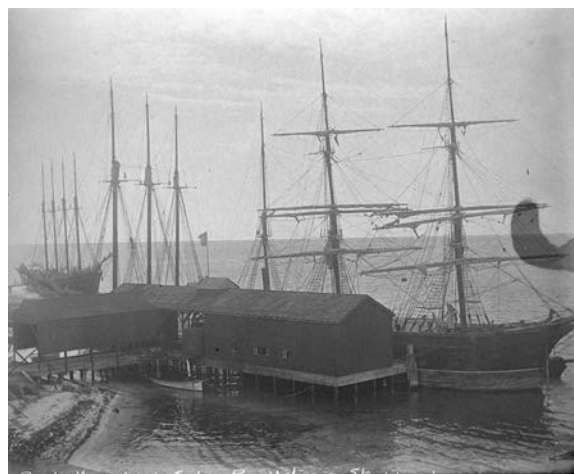
**Figure 13.** Dock, 1898. (John Meigs Photograph Collection, Dry Tortugas National Park, DRTO 3805)

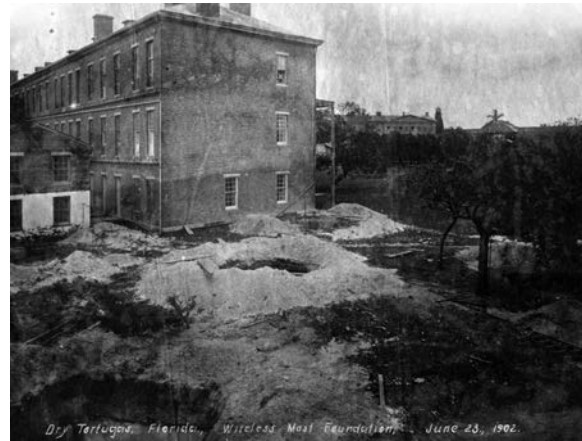
**Figure 17.** Wireless mast foundation, 1902. (Monroe County Library)

17.	Wireless mast foundation, 1902. (National Archives) (Monroe County Library). . . . .	24
18.	Damage to south coal depot, 1911. (T.W. Vaughn 353, USGS Photographic Library). . . . .	25

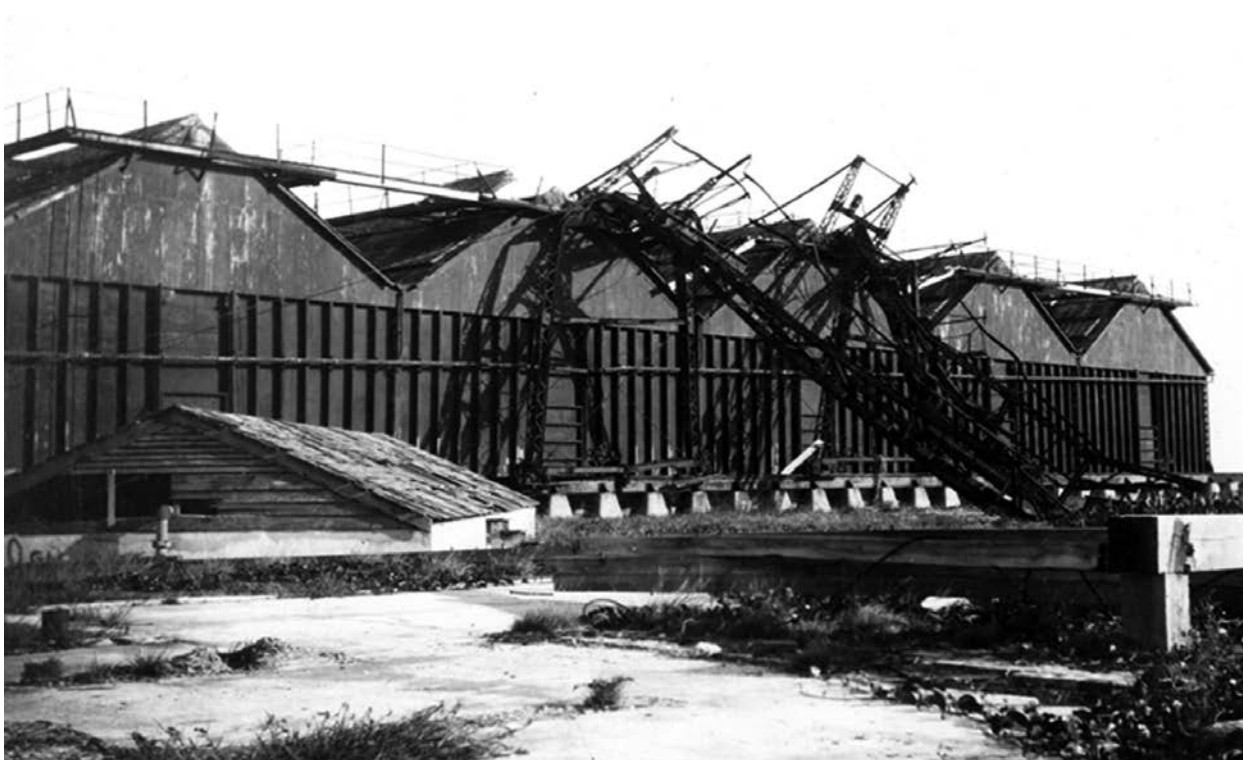
**Figure 18.** Damage to south coal depot, 1911. (USGS Photographic Library vtw00353)

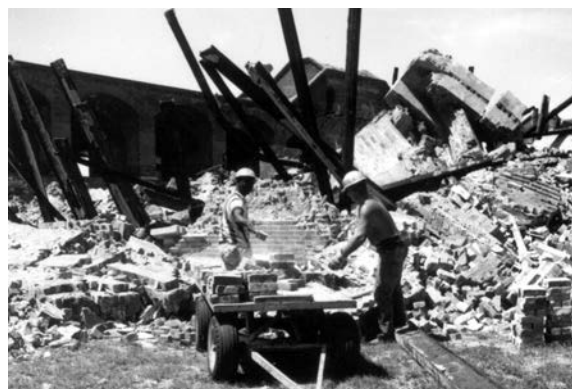
Figure 23. Enlisted men's quarters during demolition, 1962. (DRTO 300792)

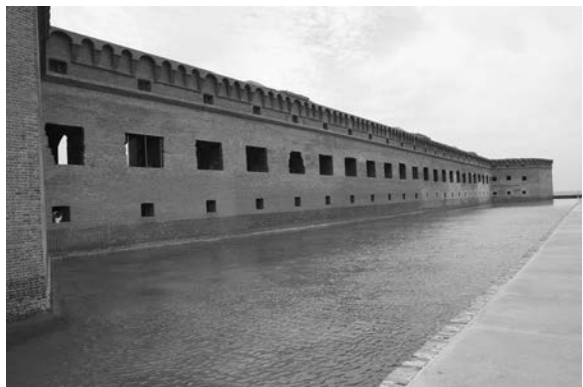
**Figure 26.** Front 4 wall repair, June 2009. (SERO image)

The park and the Florida State Historic Preservation Office entered into a Memorandum of Agreement in 2003 to guide the fort's stabilization. Phase I stabilization of the fort walls included carefully removing the existing brick surrounding the embrasures on the lower level in order to gain access to the original iron elements and was 90% complete in 2006. In 2007, the park began Phase II of this project to repair the exterior scarp wall in the following areas: the north and east faces of Bastion 3, Front 4, the west and northwest faces of Bastion 4; Bastion 5, Front 6, and the northeast and east faces of Bastion 6, with a projected completion date of June 2011.

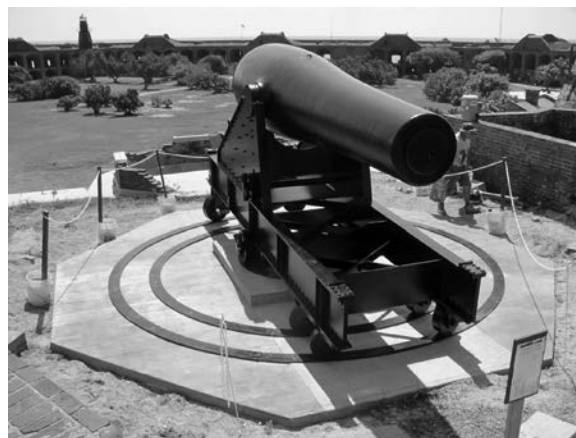
**Figure 27.** Conserved Rodman cannon mounted on reproduction iron carriage and gun platform, 2011. (NPS image)

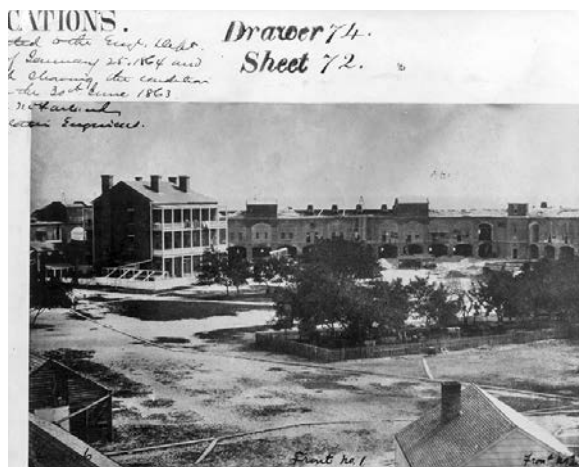
Figure 29. First block of the officers' quarters, 1863. (EVER 7396)

Workmen completed a 69-foot section of the three-story officers' quarters with piazzas during Fiscal Year 1850 (see Figure 29). Three detached brick kitchens were constructed in the rear yards. By 1854, Lieutenant Wright discovered that the Hudson River bricks used in construction were rapidly deteriorating. During Fiscal Year 1855, workmen repainted the structure and replaced the decayed bricks.<sup>63</sup>

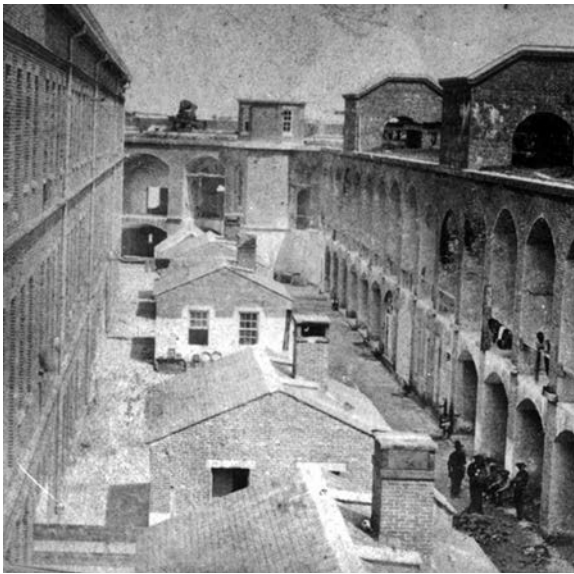
**Figure 32.** Detached kitchens behind enlisted men's quarters, 1870s. (DRTO 300654)

Civil War-era images also show wooden staircases to the second tier casemates in place on the parade. Many casemates on the second tier were enclosed for housing, which also gave a vastly different appearance to the interior of the fort. Wooden barriers were also used on open casemates on the second tier on the parade side (see Figures 32 and 42).

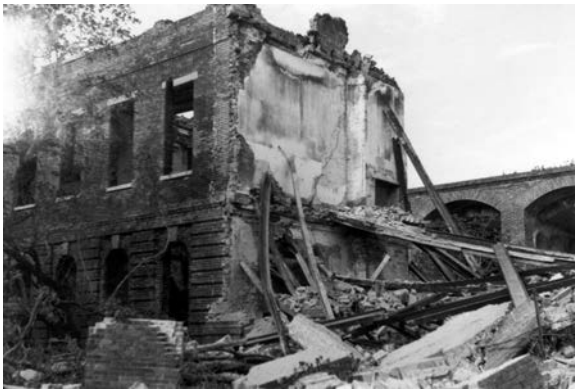
**Figure 40.** Enlisted men's quarters demolition, 1962. (DRTO 300673)

In April 1962, the ruins of both quarters buildings were demolished to the foundations, leaving the footprint of the structures. The plan was to use the rubble from the demolition to rehabilitate the counterscarp wall. A general cleanup of the rubble within the foundation areas had been

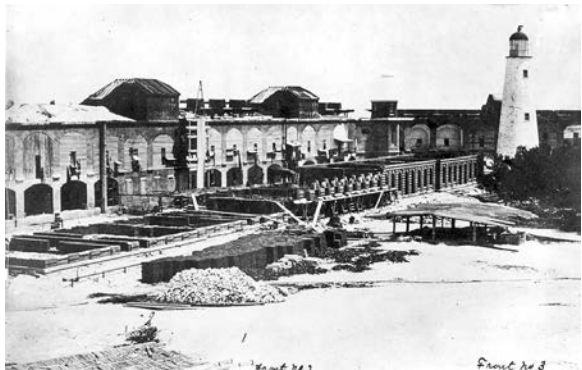
**Figure 42.** Original lighthouse, 1867. (EVER 7404)

Photographs from the 1860s show the original frame lightkeeper's residence enclosed by a picket fence (see Figures 42, 100). Hurricanes in 1873 and 1875 damaged the 1825 lighthouse, rendering the lantern almost useless, and damaged the keeper's quarters. The erection of a new wrought iron light

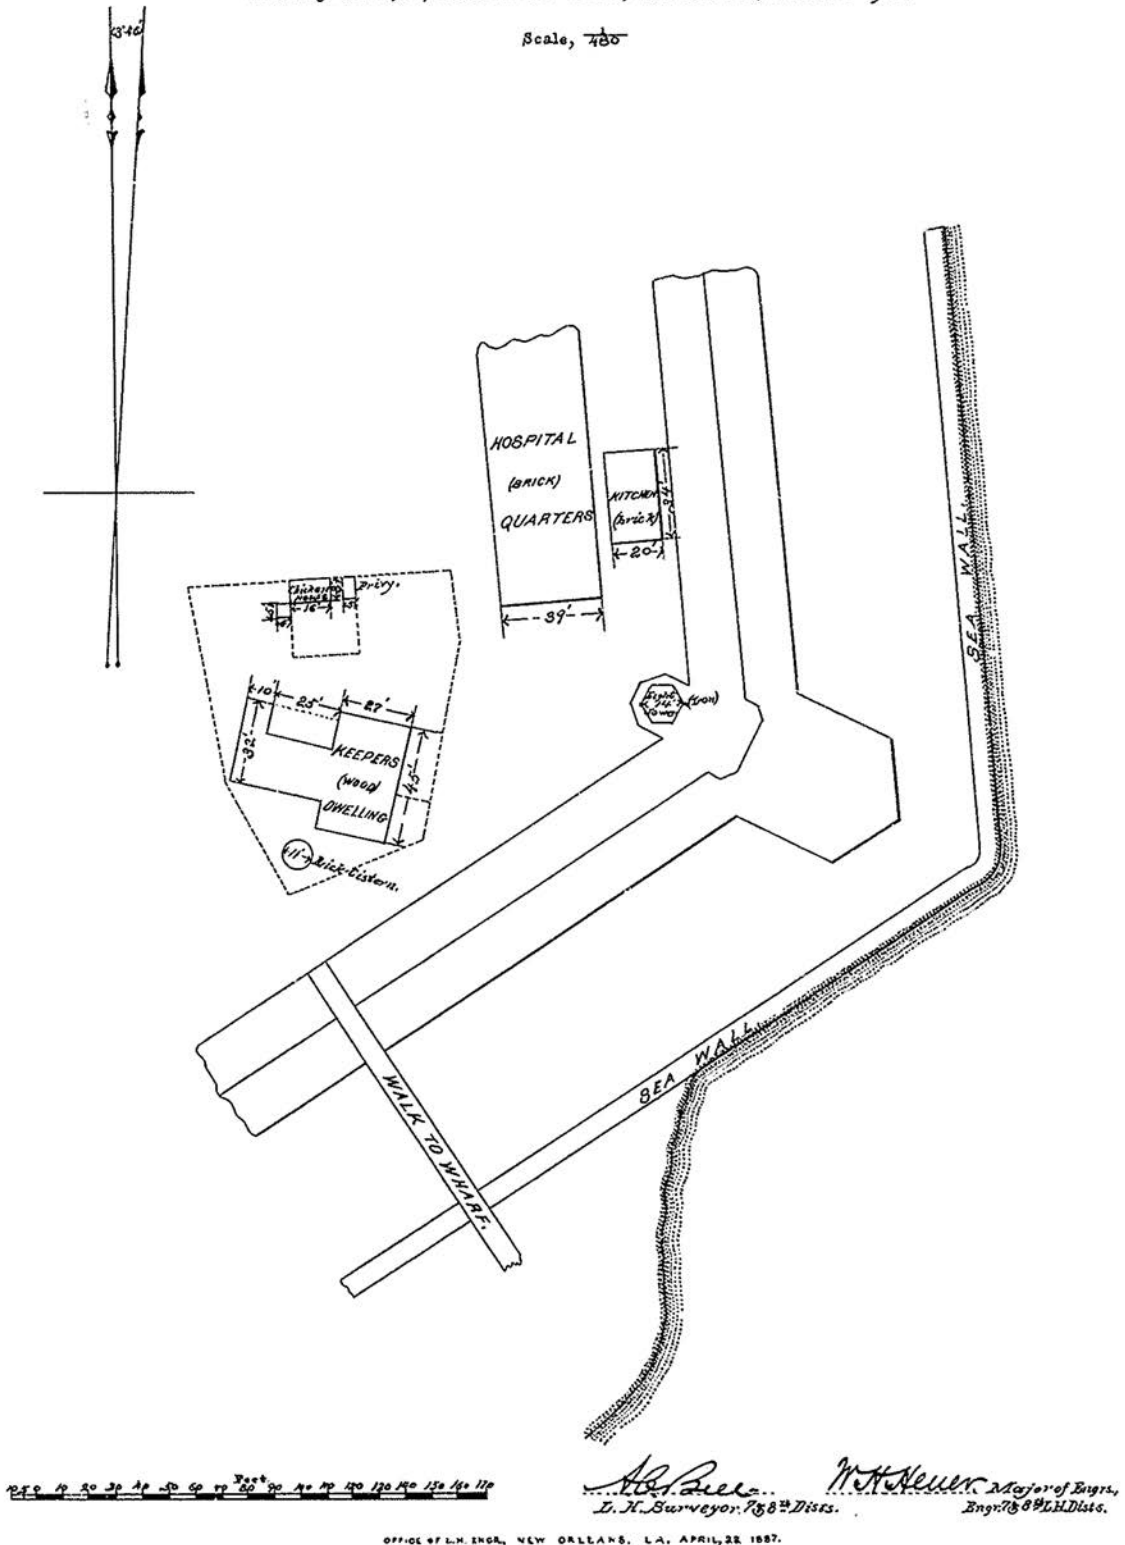
Figure 43. Light keeper complex, 1887. (Denver Service Center etic 364/25901)

Buildings Surveyed, March 6<sup>th</sup> 1887 by A. C. BELL, L. K. Surveyor.

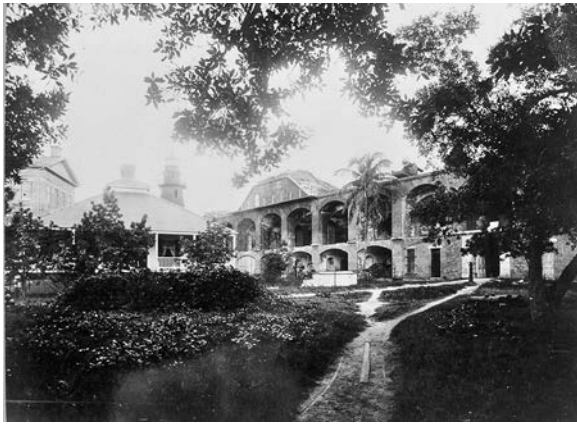
**Figure 44.** 1876 iron light tower and complex, 1898. (EVER 7349)

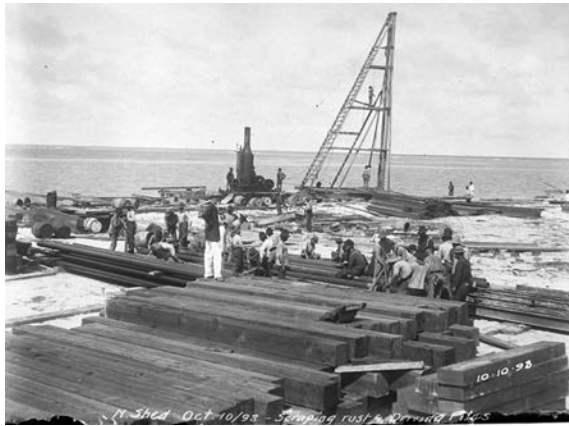
Figure 51. Construction of north coal depot, 1898. (John Meigs Photograph Collection, Dry Tortugas National Park, DRTO 3805)

At that time, the Navy began dredging the harbor channels and constructing a coal depot, which was completed in 1904. Twin coal sheds and piers were built to the north and south of the fort. At the southeastern corner of the fort, a condensing plant converted salt water to fresh water at the rate of 60,000 gallons per day. Plans from 1903 show the layout of the coal depot, including the distilling plant. In 1910, a hurricane wrecked the coal conveyors, and they were never repaired.

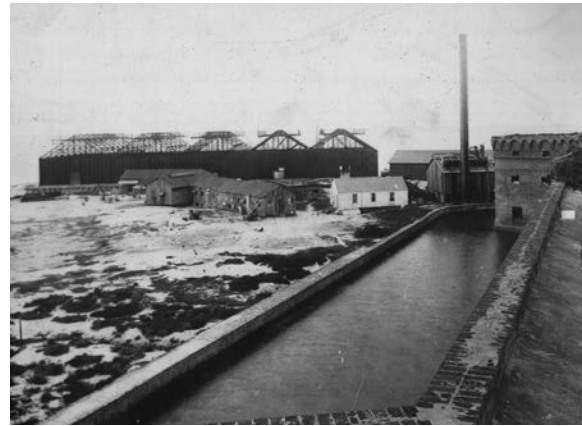
Figure 53. South coal depot, (DRTO 300639)

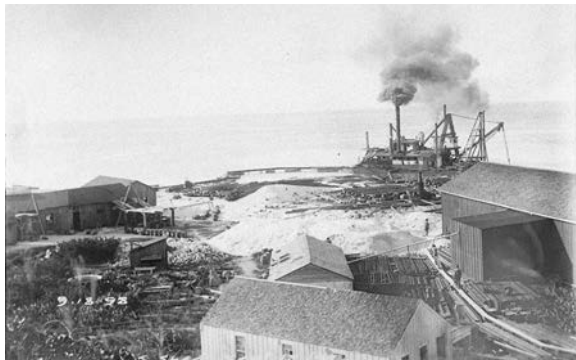
Figure 52. Construction of south coal depot, 1898. (John Meigs Photograph Collection, Dry Tortugas National Park, DRTO 3805)

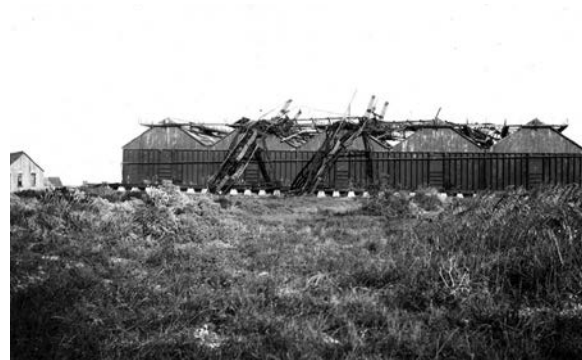
Figure 54. Damage to south coal shed, 1911. (USGS Photographic Library vtw00352)

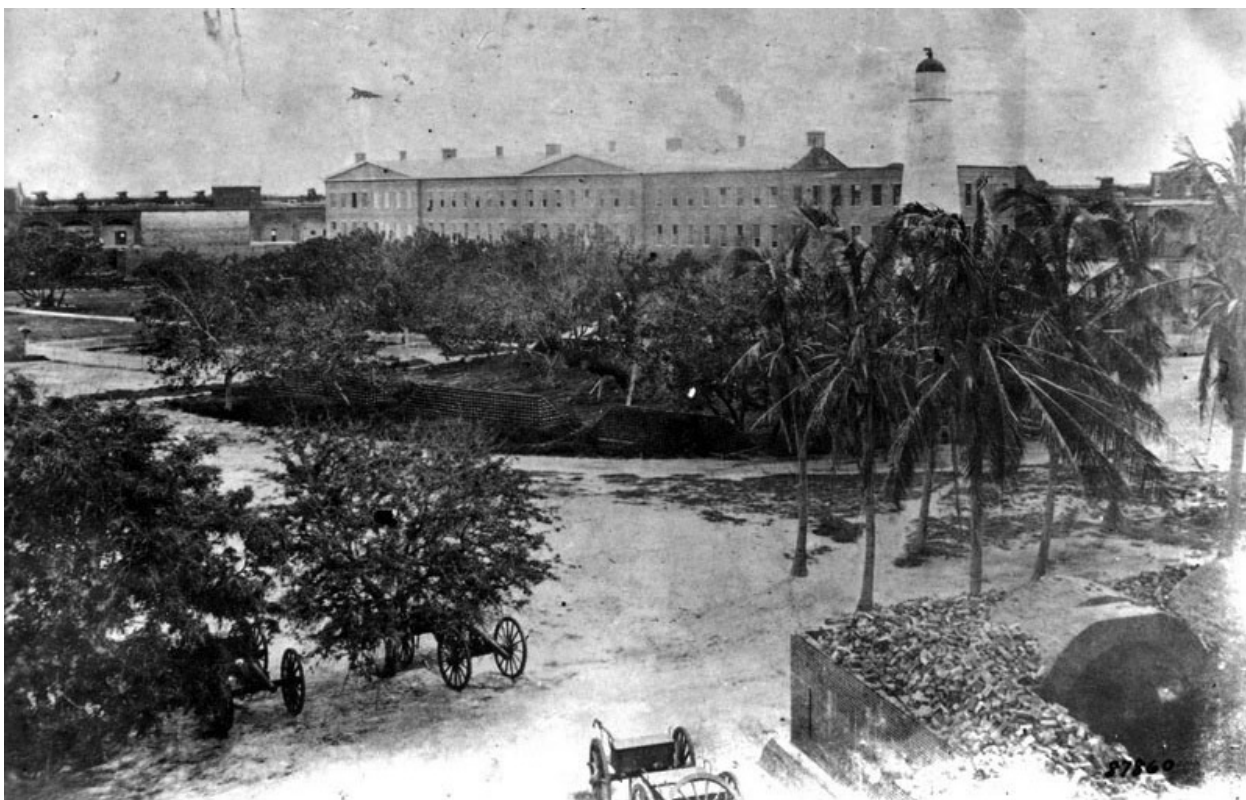
**Figure 59.** Parade with buttonwood grove, coconut palms, and enclosed garden. (National Archives 87860)

- G Plant additional buttonwoods that were present during the period of significance (see Figure 59).
- H Preserve the hot shot furnace.
- I Interpret the lightkeeper's complex and light tower.

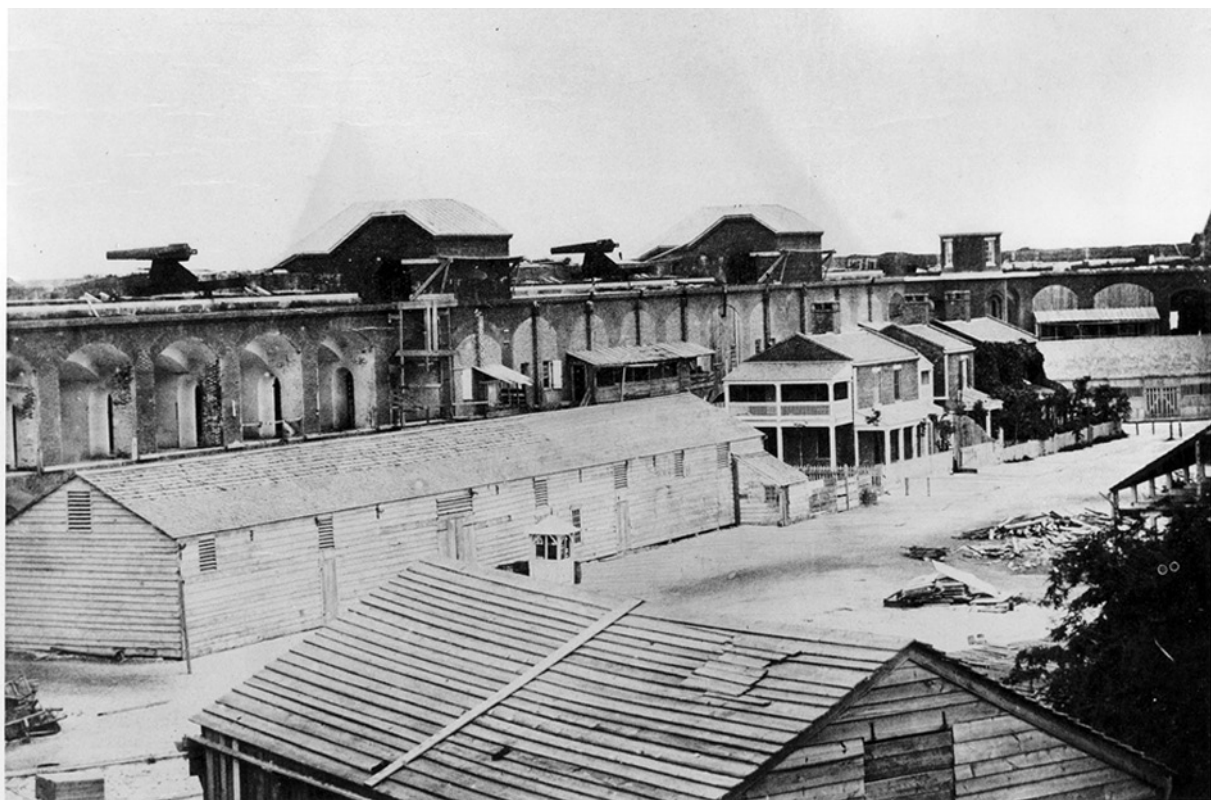
Figure 61. Engineer officers' quarters with vines, 1867. (EVER 7392)

Historic photographs of the parade from the 1860s show a fenced area cultivated as a garden near the center of the parade ground to the west of the main pathway, where livestock was sometimes enclosed. A grove of buttonwoods can be seen on either side of the main pathway. Coconut palms were planted near the sally port and small magazine. Secondary pathways branched off to other structures. Paling fences enclosed three detached kitchens used as engineer officers' quarters (see Figure 61).

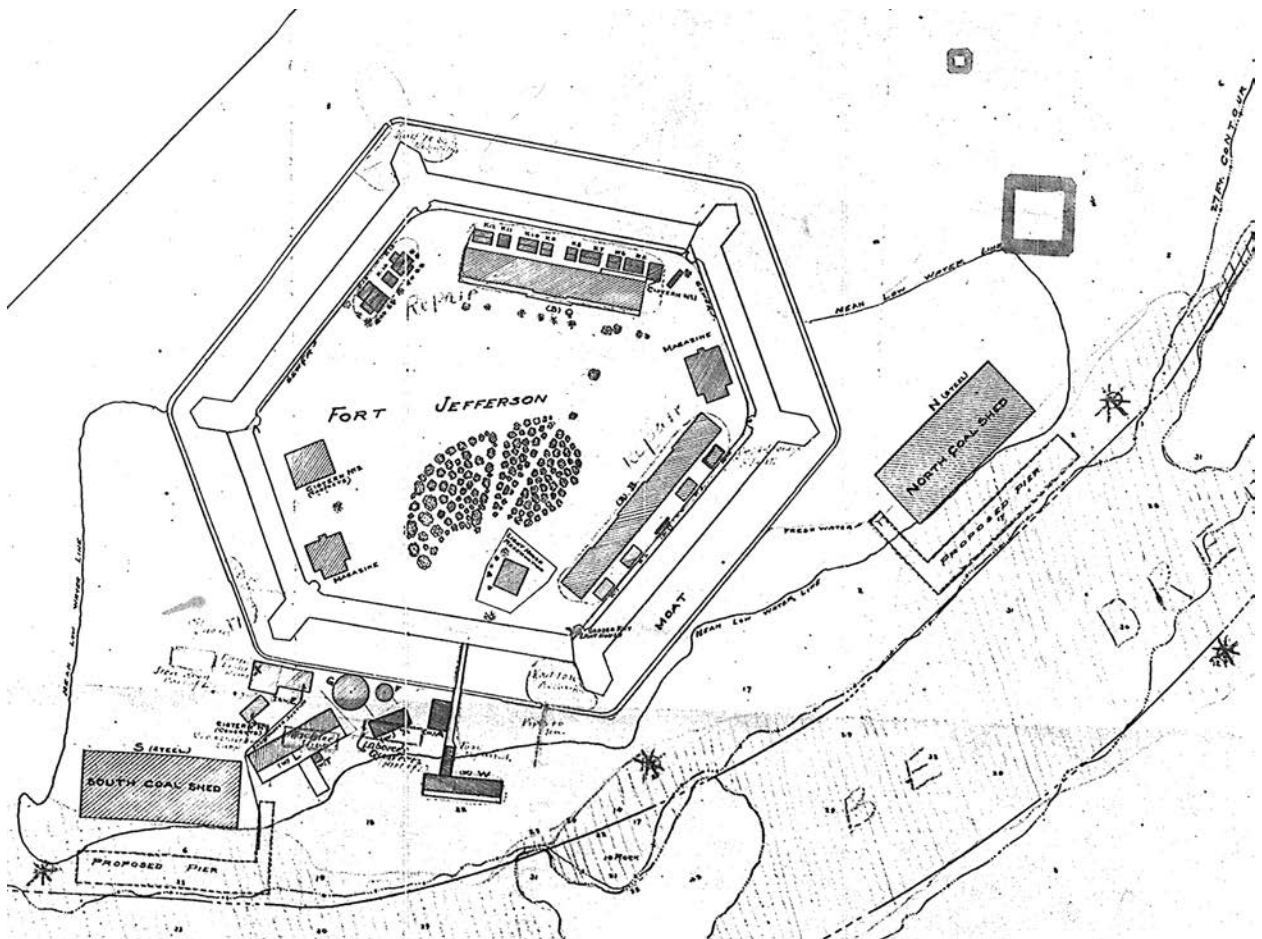
Figure 68. 1901 plan showing parade vegetation. (Denver Service Center etic 364/60904)

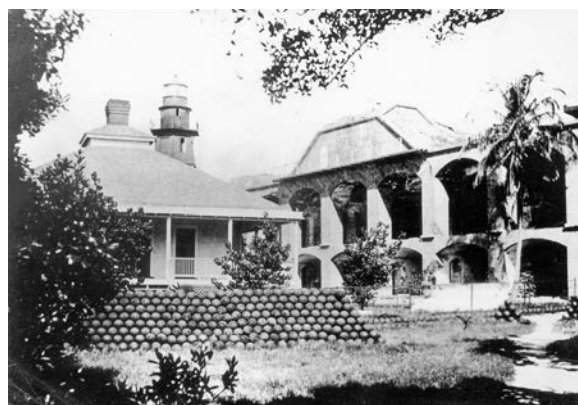
Figure 85. Front of lightkeeper's complex, 1898 (note new keeper's quarters). (DRTO 300834)

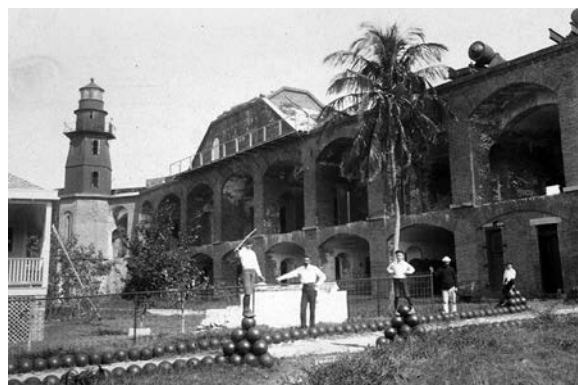
Figure 86. Lightkeeper's complex, 1910s. (National Archives RG 90)

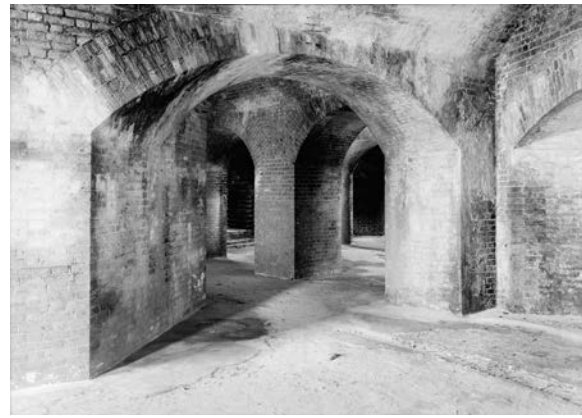
**Figure 88.** Typical arch construction, 1934. (HABS 053147)

First-tier, iron-framed embrasures (gun ports) are evenly spaced along all six fronts. As a result of subsidence, second tier embrasures were never completed. At the beginning of the Civil War, gaping holes between the vaulted piers were closed by masons, who built walls of only a single brick in thickness with embrasure-sized windows to simulate a completed tier of guns. Much of this temporary work did not last past the end of the war. Small rectangular recesses of embrasure dimensions, to give the impression of another row of gun ports, rest on a corbelled band above the second tier embrasure openings. A contiguous

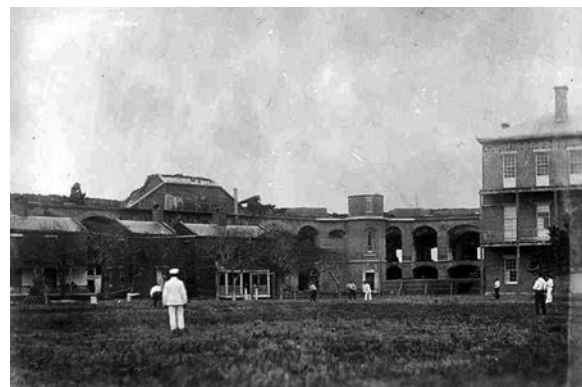
**Figure 89.** Stair tower with turret, wooden galleries, and cannon, 1901. (DRTO 301203)

season. The work included reinforcement of the traverse magazines, addition of wooden galleries, and infilling the terreplein with sand to form a parapet, which allowed six 15-inch Rodmans and four 300-pounder Parrotts to be mounted.

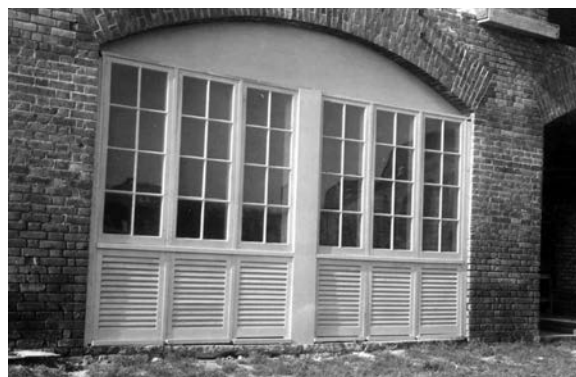
Figure 90. Casemate enclosure, 1945. (DRTO 300906)

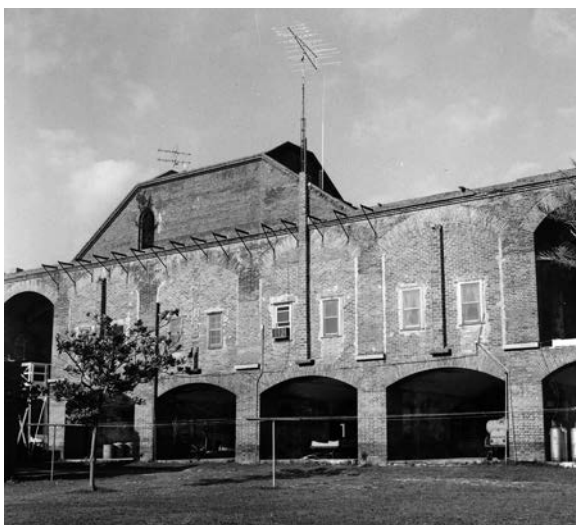
**Figure 92.** Quarters #3 in upper tier casemates Front 3, maintenance units in bottom, 1970. (Alexander Physical Status Report 80)

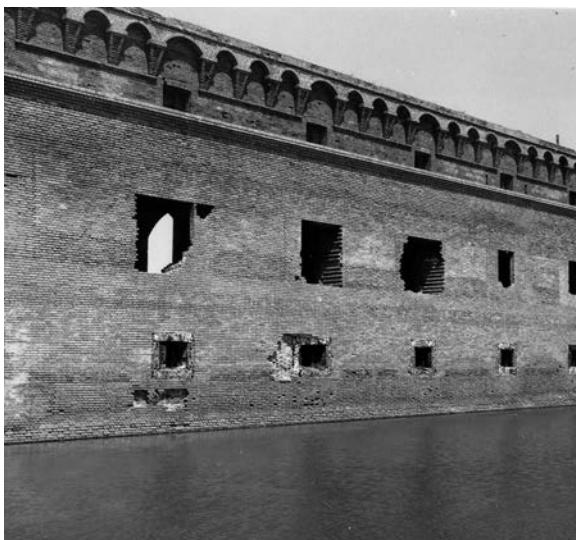
**Figure 93.** Loss of face brick due to iron exfoliation, 1970. (Alexander Physical Status Report 27)

The fort contains a large quantity of wrought iron. The constantly humid salt atmosphere has caused severe exfoliation of the iron, with resultant expansion which the masonry cannot contain. Deterioration is progressive and continuing.

A 1986 report stated the problem—continued exfoliation of the iron components forced the masonry of the scarp to break apart. As the mortar holding the face brick together weathered away and cracked, the brick, forced out of position by the embedded iron, broke and fell into the moat. In some instances, one brick at a time fell, and at

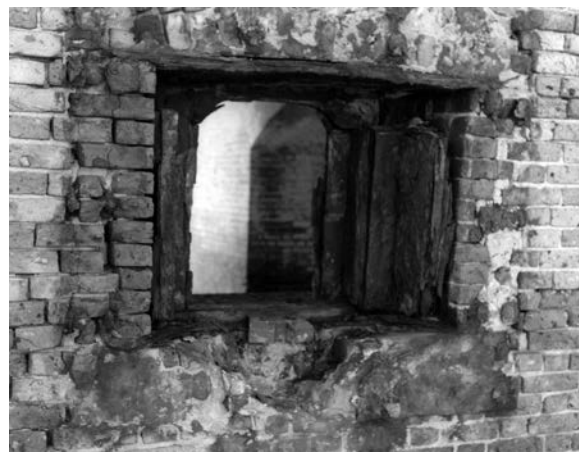
**Figure 94.** Typical lower tier embrasure showing exfoliation, 1970. (Alexander Physical Status Report 20)

Gun embrasures in the lower tier are critical areas. Here exfoliation of the iron frames set into the scarp ... has set up pressures which burst the interior bonding of the masonry and cause the wall around the embrasures to bulge dangerously out of line. ... The condition is a fairly recent development, widespread and serious, and it is worsening. Moreover, it is a public safety hazard and seriously endangers the stability of the scarp.

The loss or detachment of face brick around the gunports has exposed the core of the scarp wall to weathering. The quality of this core material is decidedly inferior in comparison to the face brick and is thus significantly less weather resistant. The structural integrity of the fort thus is severely threatened as this core material helps to bear the load of the casemate vaults. Should structural failure of the arches occur, the ongoing collapse of the entire fort would be accelerated and extremely difficult to arrest.

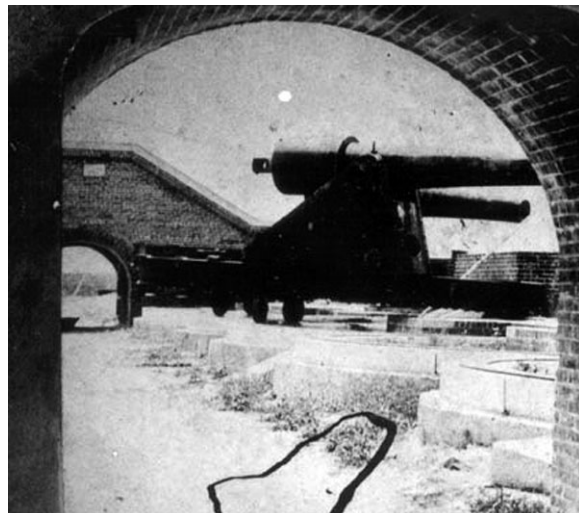
**Figure 95.** Parrott rifled cannon on terreplein, 1870. (DRTO 300652)

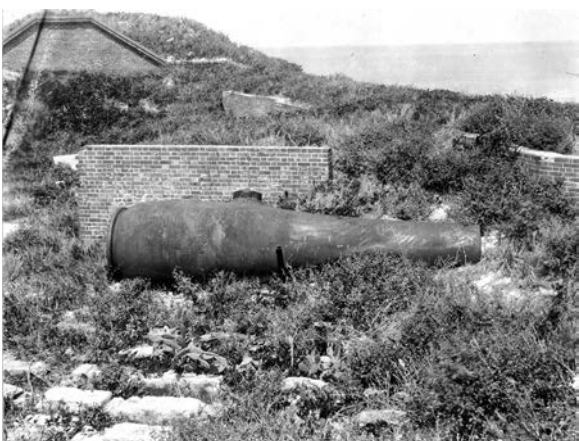
**Figure 96.** Displaced cannon on the terreplein, 1913. (USGS Photographic Library drb00117)

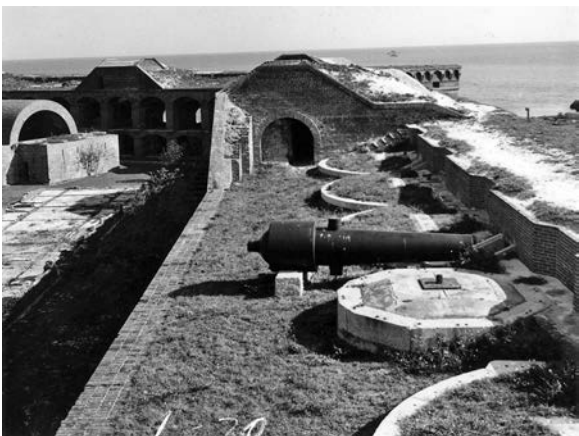
**Figure 97.** Parrott gun, Front 6, 1970. (Alexander Physical Status Report 72)

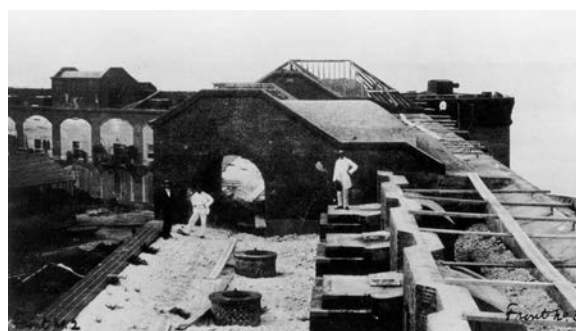
**Figure 98.** Water collection system on the terreplein, 1863. (DRTO 300685)

Assistant Chief Engineer Preece's inspection of the fort in 1937 revealed that a thin layer of slate, instead of lead sheathing, was used on the terreplein to induce increased percolation to the cisterns below. However, it also offered less protection to the top side of the brick arches. He saw considerable leaching of the lime in the mortar throughout the entire ceiling of the second tier, which he feared might eventually lead to the failure of some of the arches. Water collected through the terreplein catchment system fed down through six-inch iron leader pipes embedded in the pillars on each side of the casemates of the upper and lower tiers. He found the leaders to the cisterns clogged, which if not repaired would cause water caught on the terreplein to escape through the faces of the walls.

A 1970 physical status report stated that the six-inch iron pipes of the terreplein catchment system were badly corroded causing structural failure of the columns within which they were embedded. By this time, the casemate cisterns were no longer being used due to the intrusion of sea water through settlement cracks in some of the cisterns.

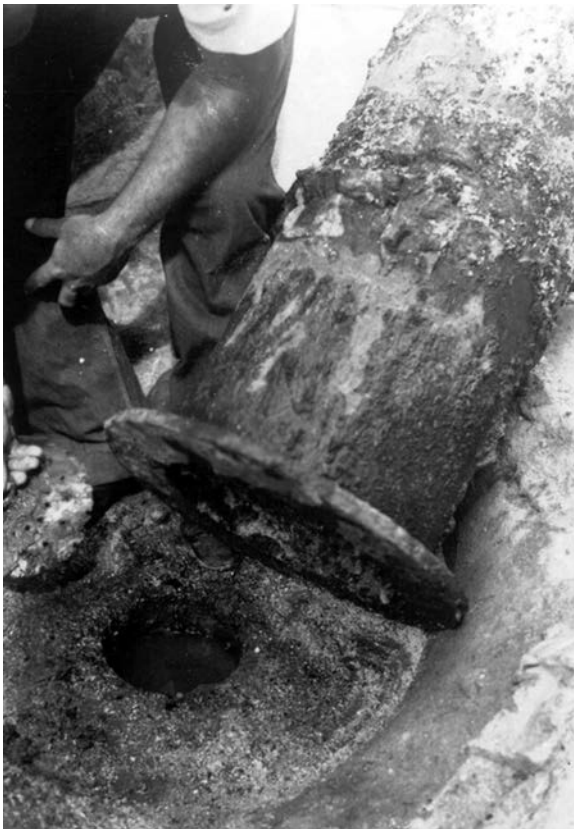
Figure 99. Cistern pipe, Bastion 1, 1938. (DRTO 300954)

In 1940, the park determined that leaders over the southwest face failed and installed new four-inch vitrified tile pipe between each arch. Holes six feet square were dug to reach the leader pipe openings between arches at the bottom of the parapet wall. The catchment area was refilled, tamped, and graded around the riser pipe. One layer of salvaged brick was laid over this surface, over which a coat of heated asphalt was applied. According to Acting Superintendent James Felton, this was the most extensive ERA job undertaken at Fort Jefferson, which moved, cleaned, and re-laid approximately 100,000 bricks. All materials were handled by hand and hoisted from the parade ground to the terreplein using a hand-powered winch. After completion of the repairs, less than one-quarter-inch of rainfall produced a stream in the leader pipes dropping to the cisterns.<sup>48</sup>

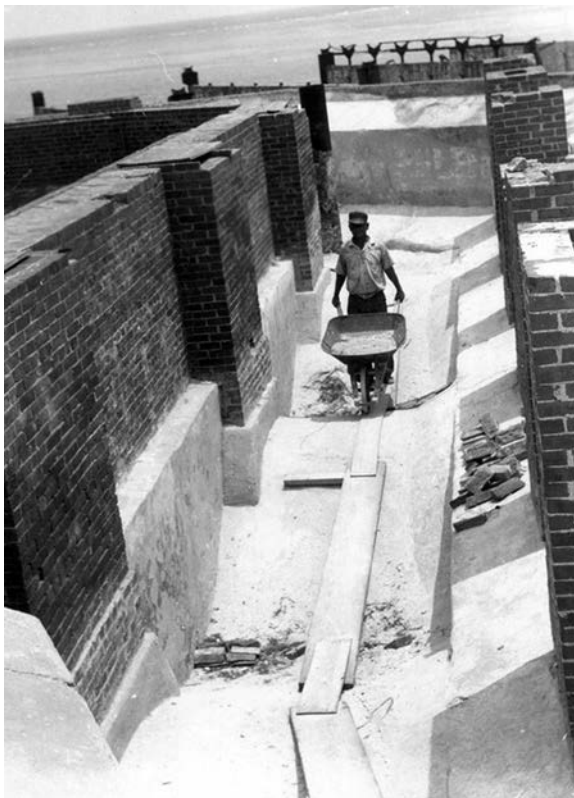
Figure 100. Removing sand, 1938. (DRTO 300950)

During a 1938 inspection, resident landscape architect Puderer reported that sand on the terreplein directly opposite the chapel/office cistern had been removed and that the exposed area was ready to be treated with a waterproofing

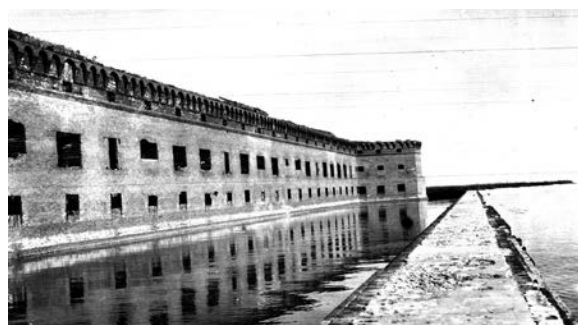
Figure 102. Counterscarp, 1915. (USGS Photographic Library sew01374)

The purpose of the counterscarp or seawall was twofold. One was to form one side of a ditch, in which “a depth of water too great for fording is obtained, and by preventing boats from reaching the scarp, thus strengthening the work against assault.” Secondly, the wall protected the scarp foundation against wave action. By the first week of April 1849, the foundation for 100 feet of counterscarp had been laid, and the wall brickwork

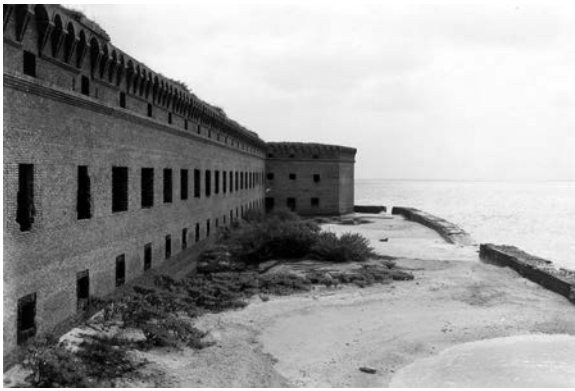
Figure 103. Moat filled with sand, Front 4, 1937. (EVER 7175)

Acting Superintendent Puderer found three bad breaks in the northwest counterscarp in 1937, allowing sand and coral to fill the moat. Approximately 250 feet of wall needed to be repaired. When Assistant Chief Engineer Preece

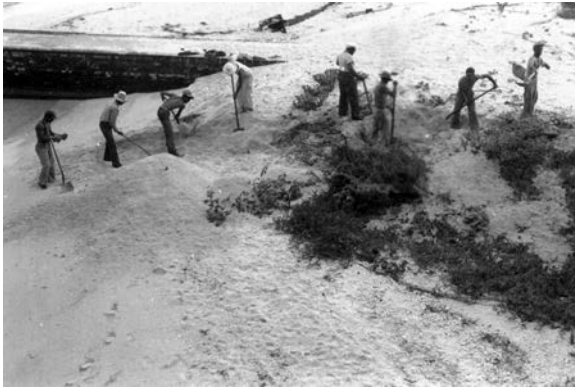
Figure 104. Sand removal, 1938. (DRT0 300947)

inspected the fort he reported that a channel forming under the wall caused the collapse of certain sections of the counterscarp. He did not recommend repairing the wall, stating that removal of the sand from the moat would create a constant maintenance problem. As of 1940, no job had been submitted to repair bricks in the counterscarp or to replace the brick coping.<sup>53</sup>

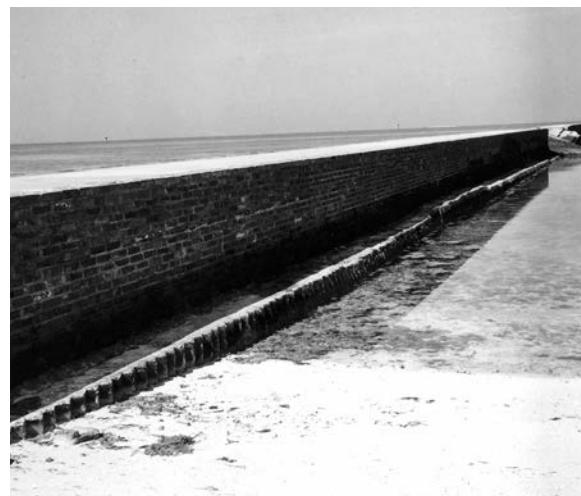
Figure 105. Counterscarp wall repair opposite Front 4 showing section in back washed out by Hurricane Betsy, 1970. (Alexander Physical Status Report 7)

Hurricane Betsy breached the counterscarp at the east end of Front 4 (historic 6) in 1956. A project to rehabilitate the counterscarp wall was finally funded in 1962. The Project Construction Program Proposal described 620 lineal feet of wall that had fallen into the sea, allowing wave action directly against the fort wall. Salvage brick, rubble, masonry, or rock for fill was obtained from the demolition of the officers' and enlisted men's quarters. By June 1963, repairs to 378 lineal feet had been completed to within one brick height of the original wall elevation, leaving areas that

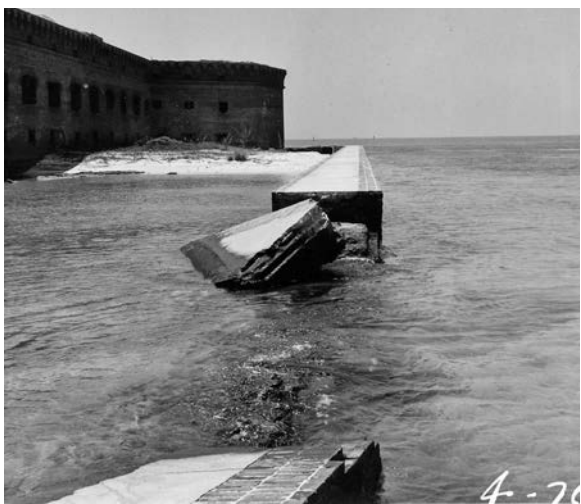
**Figure 106.** Close-up of section washed out by Hurricane Betsy, 1970. (Alexander Physical Status Report 9)

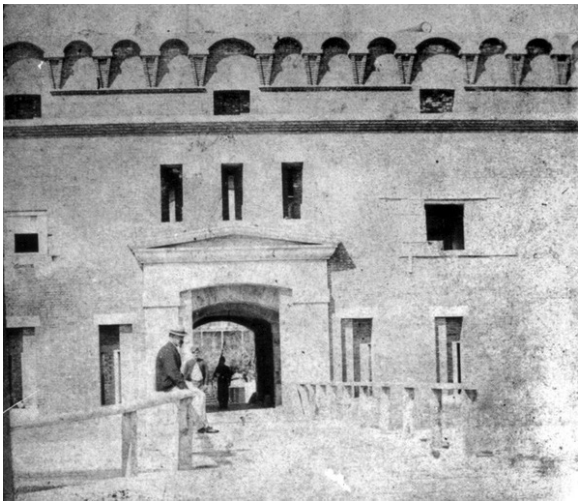
Figure 108. Sally port, 1870s. (DRTO 300692)

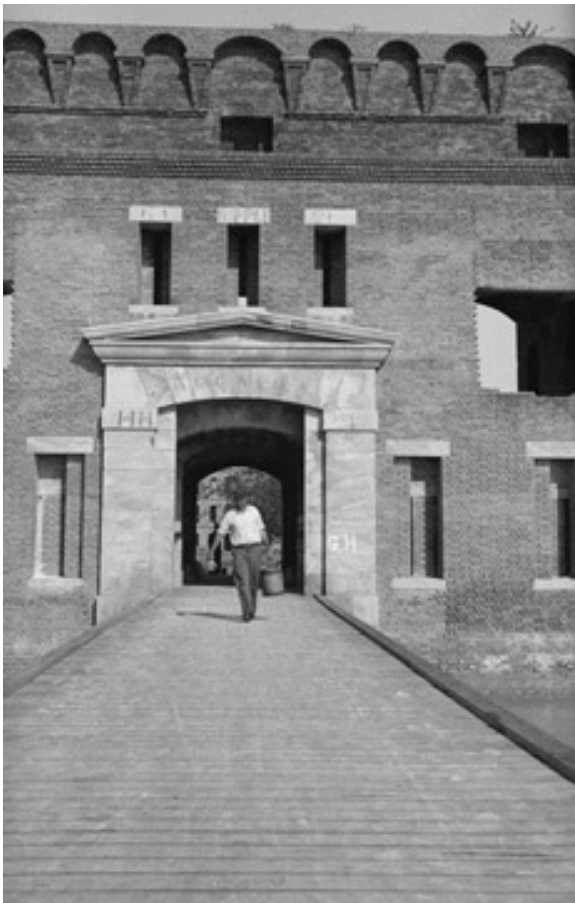
Figure 112. Sally port, 1934. (HABS 053108)

The rehabilitation of the sally port occurred from 1999 to 2000. In 1999, the Architectural Conservation Projects Program of the Intermountain Support Office disassembled the parade ground elevation of the sally port's granite surround and then reassembled the surround without the iron gudgeons, which were causing severe displacement of the upper stones in the surround. In 2000, preservation crewmembers, an exhibit specialist, and a masonry specialist repointed the stones disassembled during the rehabilitation of the sally port during 1999. Repointing replicated historic pointing in appearance, color, profile, and texture as found in the exterior elevation of the sally port surround, and as documented during the removal of the granite stones from the parade ground elevation of the sally port's granite surround. Hinge gudgeons were produced to match in appearance those removed; the original became part of the park's museum collection and are stored at the South Florida Collections Management Center (SFCMC)

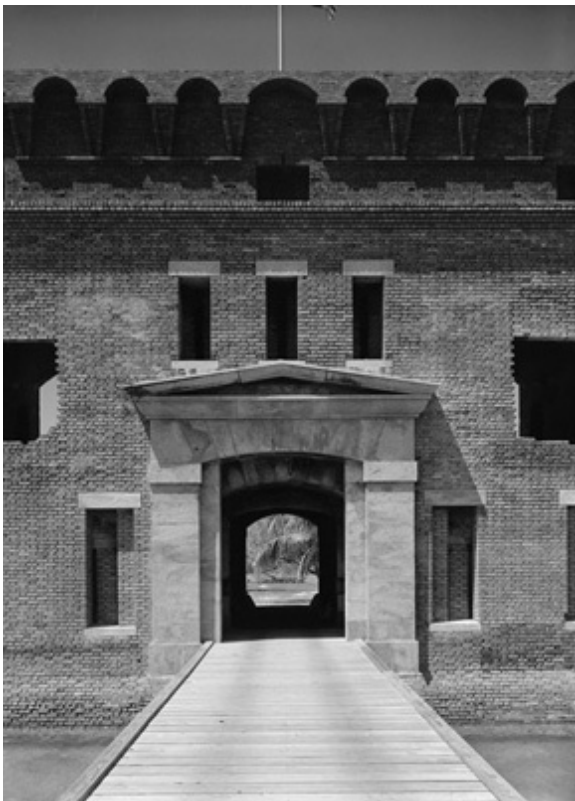
Figure 113. Sally port, 1962. (HABS 053131)

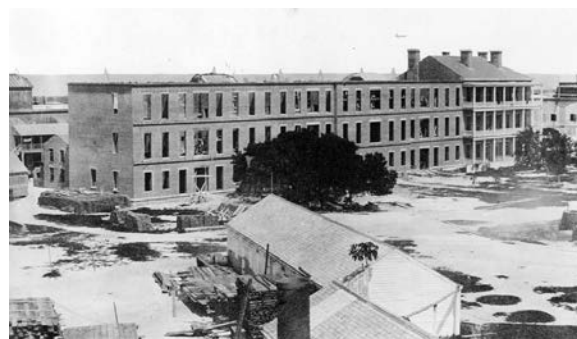
**Figure 115.** Officers' quarters, 1865. (DRTO 300682)

An expansion of the officers' quarters occurred in the 1860s. By 1865, the entire block with detached kitchens had been completed to its full three-story height and was waiting to be floored and roofed. Difficulties in securing a final plan delayed the roofing of both the officers' quarters and enlisted men's quarters until 1866 when iron beams and the roof were completed to a height of thirty-three feet. The replacement of the rear third story wall damaged in the 1865 hurricane also occurred in 1866, as well as the completion of the detached kitchens. The structure was roofed with galvanized iron in 1867, leaving only the halls and piazzas to be completed. The hurricane of 1873 damaged the roof of the first section, allowing water in, which flooded the rooms below. Repairs were completed in 1874. After the Army withdrew the garrison, the windows were covered with wooden shutters in 1876.

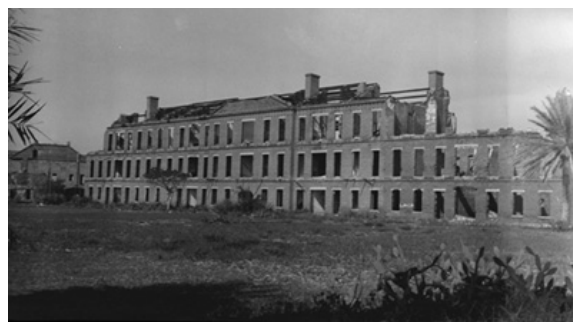
Figure 117. Officers' quarters, 1934. (HABS 053121)

In 1916, it was noted that the original section was in a dilapidated condition, although the slate roof generally was in good condition, the balconies were unsafe, and the roofs of the detached kitchens leaked. Following a period of general decline at Fort Jefferson, the officers' quarters burned in 1927.<sup>66</sup>

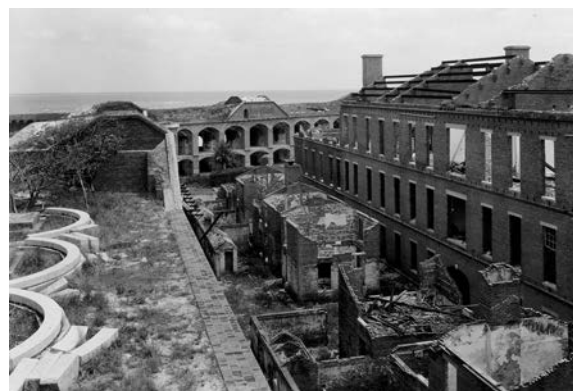
Figure 118. Officers' quarters showing detached kitchens, 1937. (EVER 7188)

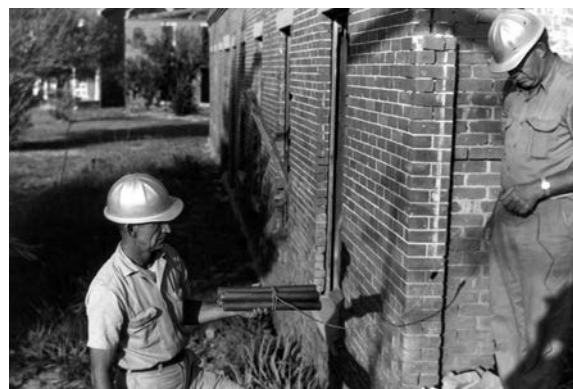
Figure 119. Demolition of officers' quarters, 1962. (DRTO 300765)

The demolition of the building to the foundation occurred in 1962, in spite of the fact that NPS policy called for the approval by the director of a historic structure report (HSR), which had not been prepared, before such an action could proceed. The justification for the demolition was that the walls, roofs, and floors had completely fallen or cracked to the point that the building was considered dangerous. Given that dynamite was necessary to facilitate the demolition, it is unclear exactly how serious or immediate the danger was

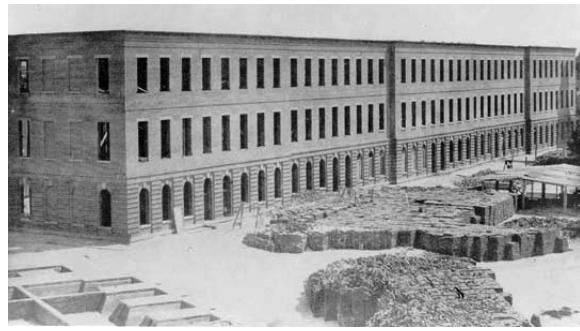
**Figure 120.** Enlisted men's quarters under construction, 1864. (DRTO 300894)

Work on the foundation of the enlisted men's quarters began in 1862 after the fort was garrisoned in 1861. By June 30, 1863, the foundation was complete, the water table laid, and three wall sections raised to the level of the lower window sills. Walls were ready for roofing, and four detached kitchens were completed by 1865. Captain McFarland ordered a temporary roof placed over two sections of the enlisted men's quarters in 1864 while waiting on the Engineer Department to make a final decision about the treatment of the roof. He suggested using iron beams and galvanized iron sheathing for the roof covering. Although Chief Engineer Richard Delafield approved McFarland's idea to substitute iron roofs for wooden ones on the parade buildings, the enlisted men's quarters' roof construction was delayed. Between 1866 and 1870, the enlisted men's quarters and officers' quarters neared completion, with the exception of interior finish in some sections. Roofing for part of the officers' quarters and all of the enlisted men's quarters was galvanized iron (see Figure 156).
