# Dry Tortugas National Park Garden Key Cultural Landscape Report

# Cultural Landscape Report

June 2011

National Park Service

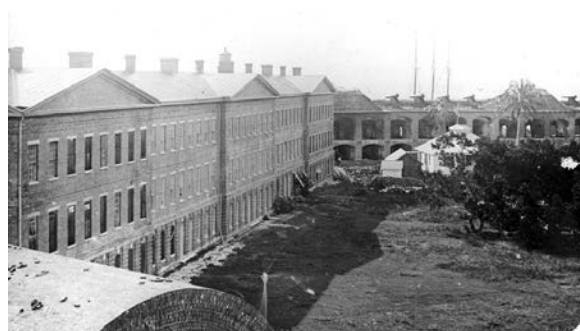
**Figure 121.** Enlisted men's quarters, 1898 (EVER 7317)

By 1889, the condition of the enlisted men's quarters had deteriorated. In 1895, Surgeon R. D. Murray reported that most of the rooms were too damp to be used by the quarantine station. Between 1901 and 1906, \$30,000 was spent on the repair and improvement of both the enlisted men's quarters and officers' quarters. On October 17, 1910, a devastating hurricane tore off the galvanized roof of the enlisted men's quarters, and the building burned in 1912 when a fire spread from the lightkeeper's house. In 1914, 35,000 bricks were salvaged from the detached kitchens and transported to the U. S. Naval Station at Key West, where they were used to erect a boiler.<sup>71</sup>

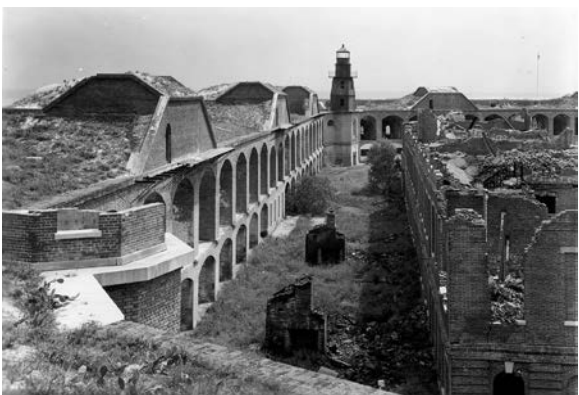
Figure 122. Enlisted men's quarters, 1937. (EVER 7175)

The 1938 Master Plan called for the building to be preserved as a ruin. It appears from historic images that by 1937 not much was left of the four detached kitchens and in 1938, much of the brick rubble was cleaned up, with only a few walls standing. In 1962, the NPS demolished the enlisted men's quarters to the foundation, along with the officers' quarters. The justification for the demolition was that the walls, roofs, and floors had completely fallen or cracked to the point that the building was considered dangerous. In 1965, it was reported that most of the rubble had been removed from the foundation area.<sup>72</sup>

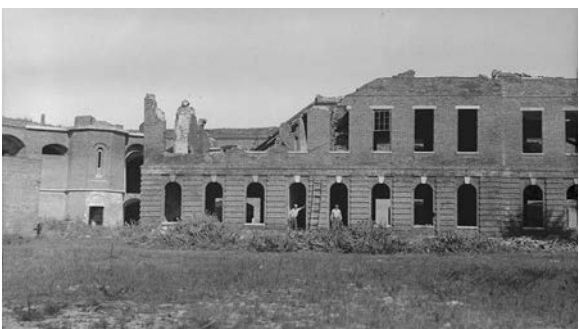
Figure 123. Enlisted men's quarters, 1934. (HABS image 053118)

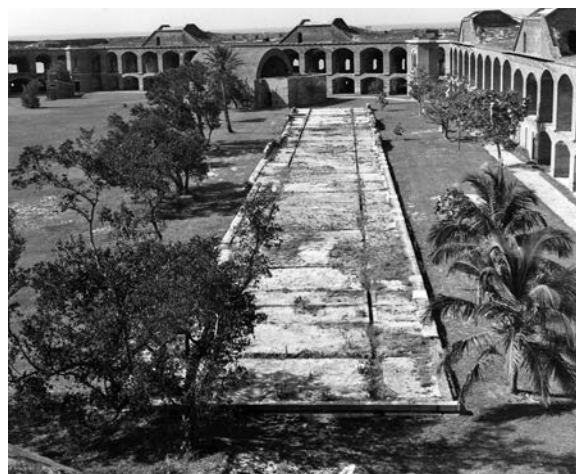
Figure 124. Enlisted men's quarters, 1970. (Alexander Physical Status Report 91)

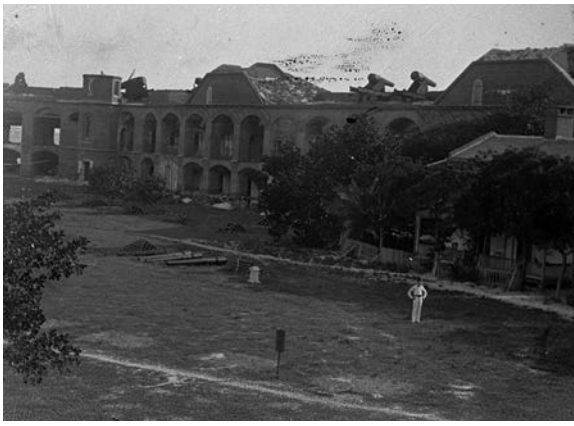
**Figure 125.** Engineer officers' quarters, c.1898 (John Meigs Photograph Collection, Dry Tortugas National Park, DRTO 3805)

Engineer Morton had two kitchens constructed as engineer officers' quarters on Front 5 (present-day 3) during his tenure from April 1861 to March 1862. Superintending Engineer McFarland built a third kitchen to serve as quarters for Lieutenant Holgate, then assistant in charge, on Front 5 (present-day 3) during 1864. These are the buildings referred to by Dr. Joseph B. Holder as "vine-clad and cozy." (see Figure 61) Previously, Superintending Engineer Woodbury had a kitchen built on Front 6 (present-day 4) during his tenure from 1856-1860 for the caretaker and his family.

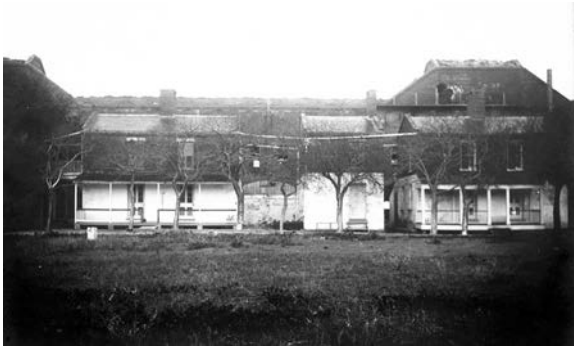
**Figure 126.** Engineer officers' quarters, 1909. (Monroe County Library)

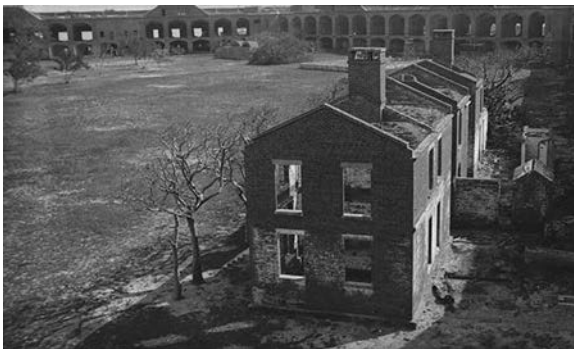
**Figure 127.** Engineer officers' quarters, 1934. (HABS 053117)

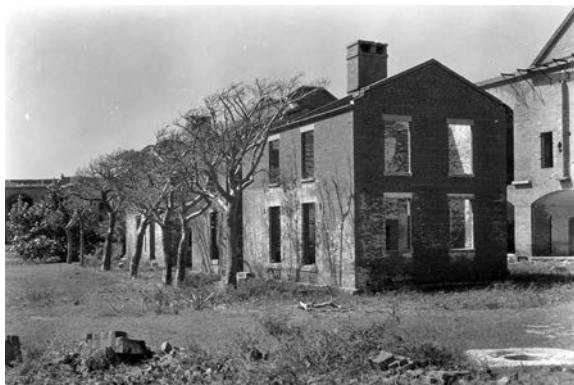
**Figure 128.** Engineer officers' quarters, 1937. (EVER 3136)

How the structures became brick shells by 1937 with no roofs, windows, doors, porches, or interior

floors, with many of the walls toppled, is unknown. Acting Superintendent Puderer reported many cracks in the standing walls and that the interior of one appeared to have been burned. However, in December 1938, plans were approved to rehabilitate two of the structures (8A and 8B) to serve as the superintendent's quarters using a connecting wooden hyphen. The plans placed a laundry and storehouse in one of the former detached outhouses behind the quarters.

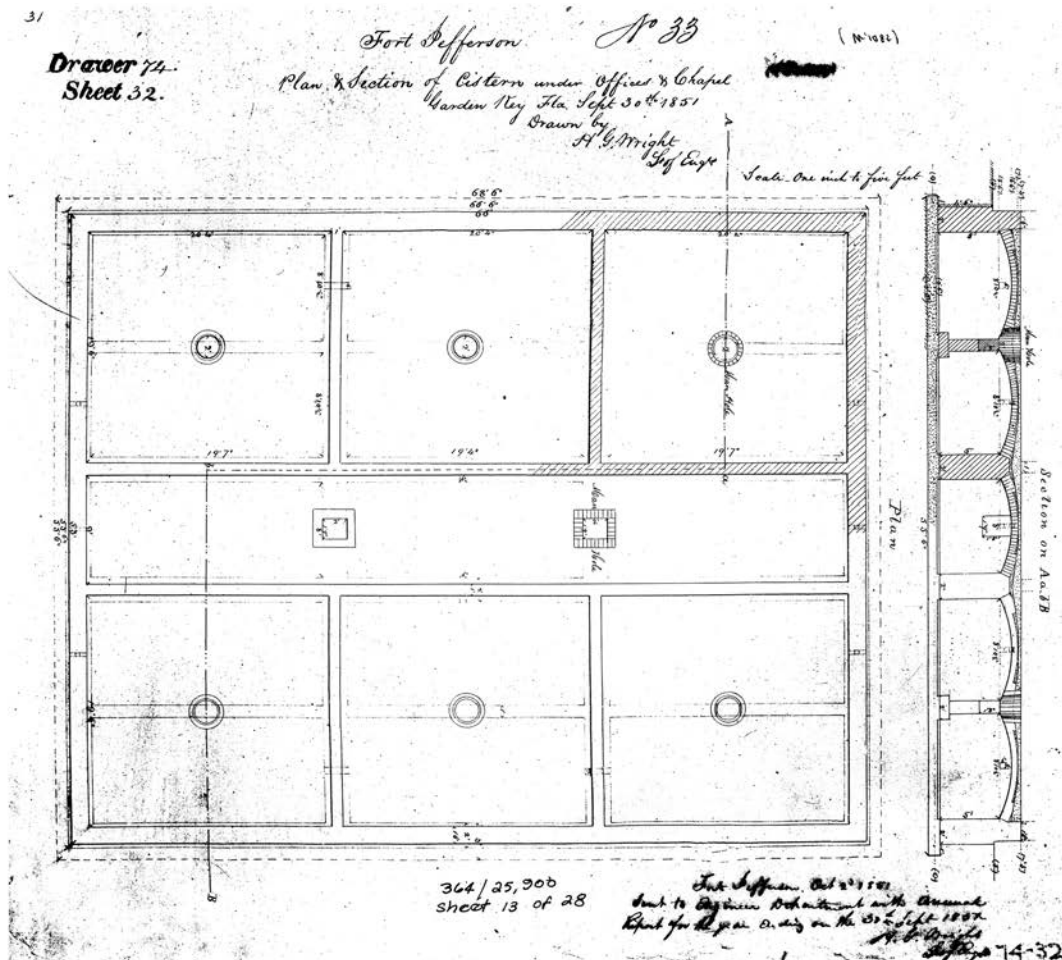
Figure 131. Plan of Chapel/office cistern, 1851. (Denver Service Center etic 364/25900)

were in a state of decay. He believed concrete cisterns were needed to meet the need for fresh water. The Engineer Department decided to construct a cistern on the site of a proposed chapel/office, with the cistern also serving as the building’s foundation. The structure was to be 66 ft. x 53 ft., with exterior walls of brick and interior walls of concrete. By May 13, 1852, the cistern was complete and full of water (see Figure 34). It was reported in 1876 that the building had been raised to the level of the first floor, with the part below arranged as a cistern. In 1895, 500 feet of galvanized pipe was removed from the chapel/office cistern and relocated to the cistern associated with the officers’ quarters. The superstructure of the chapel/office was never completed.<sup>79</sup>

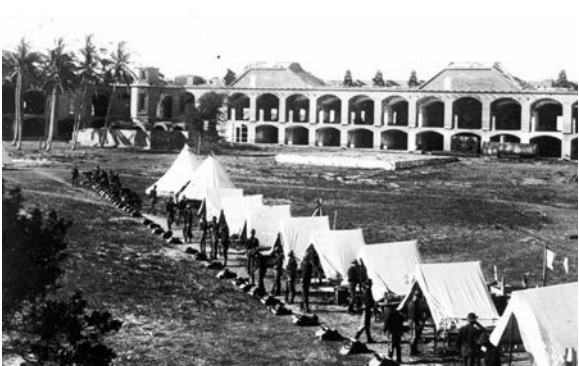
Figure 132. Chapel/office cistern, 1898. (EVER 7345)

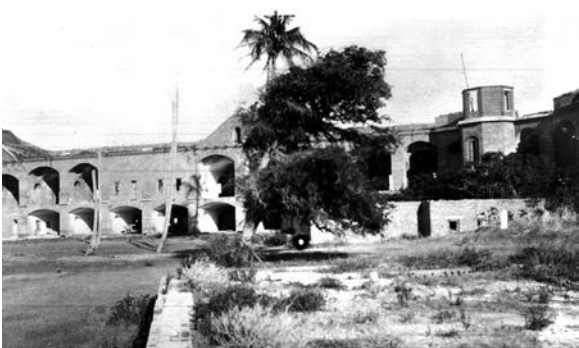
Figure 133. Chapel/office cistern, 1913. (USGS Photographic Library sew01385)

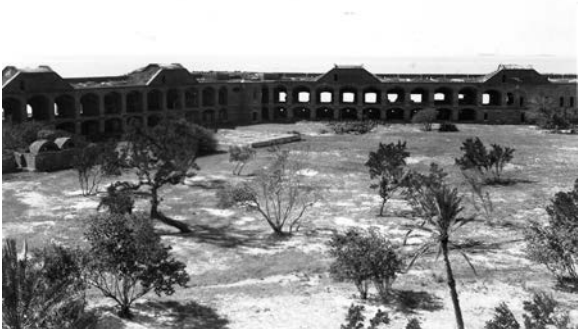
Figure 134. Chapel/office cistern, 1937. (DRTO 301080)

construction of a concrete deck covering the top of the cistern occurred in 1938. In order to prevent leaks into the cistern, the interior walls, originally covered with a cement plaster, were waterproofed by replastering with Embeco-treated cement plaster. Waterproofing of the floor areas with the same product also occurred but with the addition of aggregate in the mix.

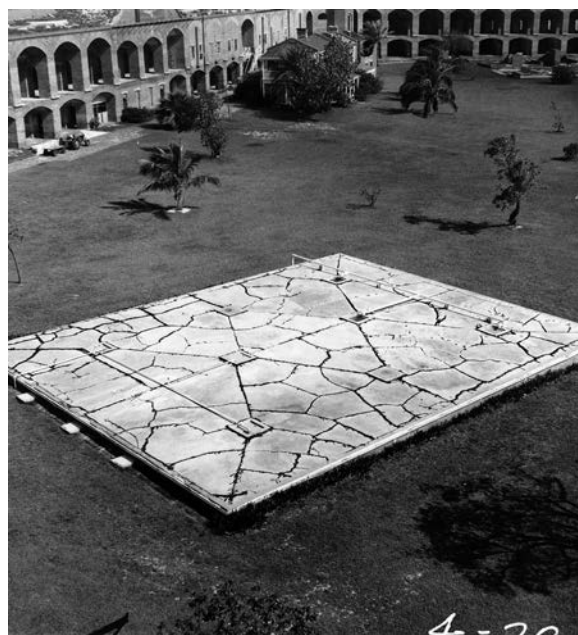
Figure 135. Chapel/office cistern, 1970. (Alexander Physical Status Report 94)

in the cracks with a small form and filling this with concrete. After the desired thickness of Embeco had been applied, a ½-inch coat of cement stucco prevented the stored water from coming in contact with the Embeco. The treatment covered the exterior walls with cement stucco and recovered the top with a three-inch slab of reinforced concrete. Openings, cut through the division walls, allowed water to flow towards the outlet pipes. The project also included new reinforced concrete manhole covers.<sup>80</sup>

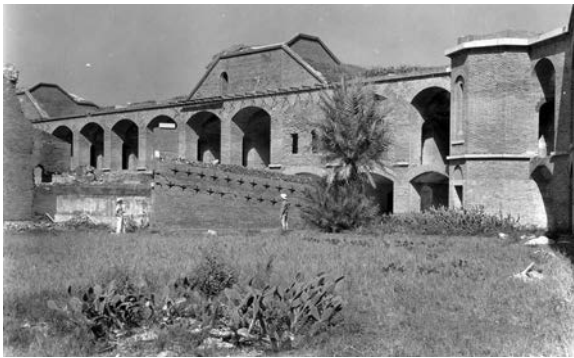
Figure 136. Officers' quarters, cistern, and hot shot furnace, 1937. (EVER 7183)

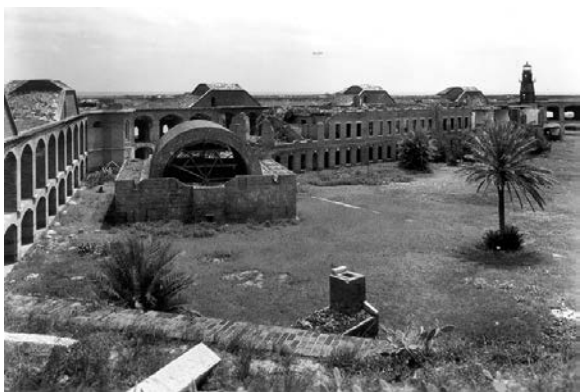
**Figure 138.** Large powder magazine, 1937. (EVER 7122) repointing and sealing to prevent the mortar from leaching out.<sup>84</sup>

Workers completed the foundation in 1864. By 1866, the walls had been raised thirteen and one-half feet and the principal arch had been turned. On an 1876 inspection, the magazine remained unfinished. A 1970 physical status report stated that the arch was in good condition but needed

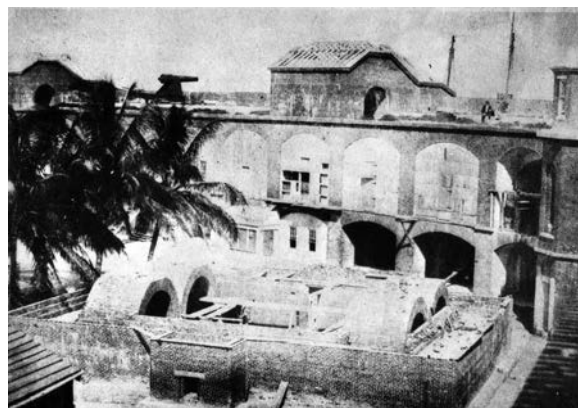
**Figure 139.** Small powder magazine, 1867. (HABS 053155/EVER 7390)

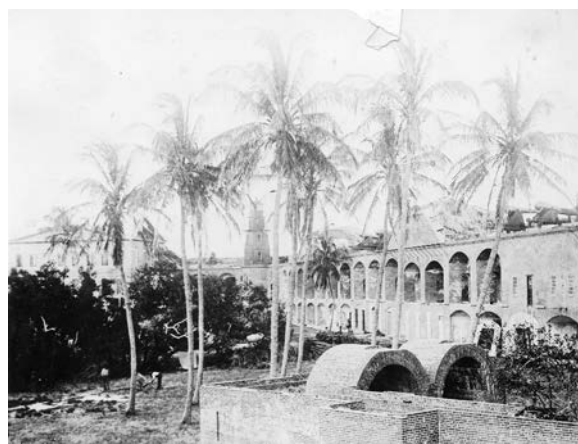
**Figure 140.** Small powder magazine, 1898. (DRTO 300891B)

Invasive vegetation was removed from the small powder magazine in 2000. The HSR-Amendment noted that vegetation had been cleared from the structure, which appeared to be in fair to good condition, but that a horizontal separation was observed in the middle of the perimeter wall. Biological growth and efflorescence was present at the interior arches. A new floor in the entrance area, laid with contemporary brick pavers, was not in keeping with the character of the original masonry.<sup>89</sup>

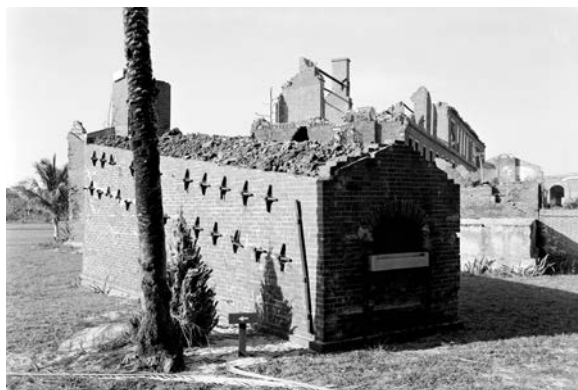
Figure 142. Hot shot furnace, 1934. (HABS 053154)

The construction of two concrete cisterns occurred in 1854. One was located outside the fort, between the temporary enlisted men's quarters and kitchen. The second cistern was sited at the officers' quarters, adjacent to one of the rear kitchens just west of the shot furnace (see Figure 142). Repairs to the cisterns occurred from 1895 to 1897. The exterior cistern's water is described in 1910 as "sweet," and both are described in 1916.

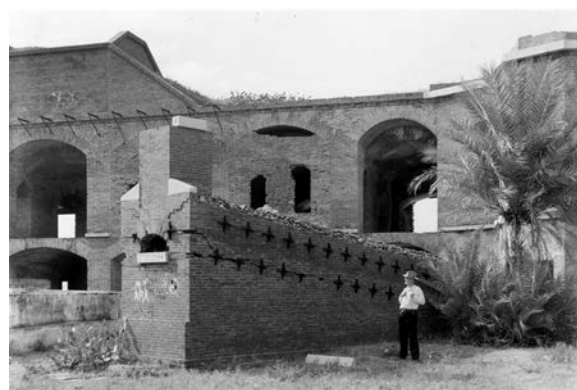
Figure 143. Hot shot furnace, 1937. (EVER 7138)

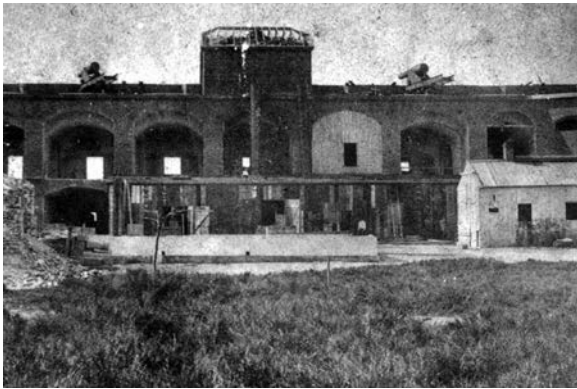
Figure 144. Blacksmith shop, 1870. (DRTO 300658)

In order to house the troops that arrived at Fort Jefferson in 1861, the Quartermaster Department took over the lime and lumber sheds as temporary quarters for the two companies. Another was constructed on the parade east of and parallel to Front 5 (present-day 3). It was completed in August 1861 (see Figure 63). At this time, the stables were being used as a temporary hospital. The removal of three frame buildings from the parade—blacksmith shop, paint shop, and bakehouse—occurred in 1870. )

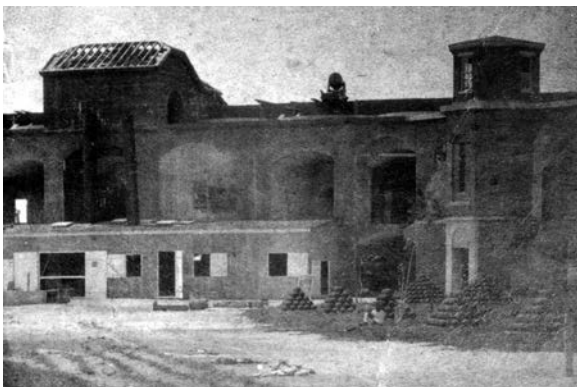
Figure 145. Blacksmith shop, undated.

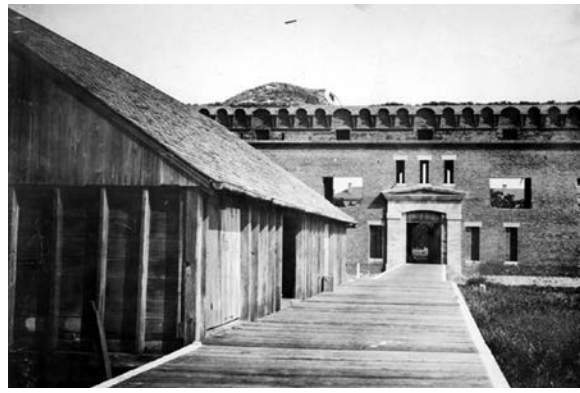
Figure 146. Frame building on wharf, 1908. (USGS Photographic Library vtw00292)

frame structures on the parade associated with the fort construction had been removed, and the frame buildings outside the fort were in a dilapidated condition. Although it was reported in 1887 that only one of the temporary frame structures, a shed, remained outside the fort and was “so dilapidated that it might collapse at any minute,” an 1895 report stated that “the frame structure formerly used by the Engineers as a carpenter’s shop” had been fitted with gutters to supply the cistern on the southeast spit. Included in the destruction of the 1910 hurricane were “sheds on entrance of wharf” and the blacksmith shop.

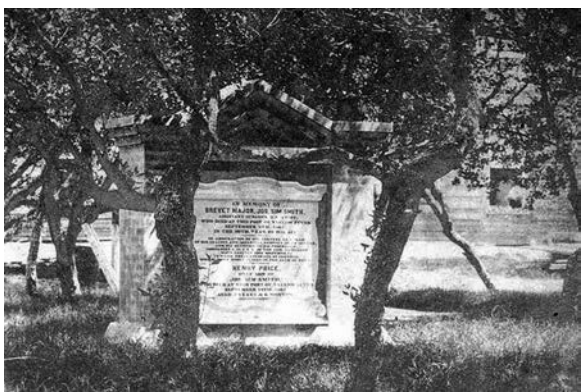
Figure 147. Major Smith Monument, 1870. (DRTO 301156)

A 9 ft. x 3 ft. x 8 ft. classical marker was constructed in 1870 of brick and stuccoed white with pilasters on each end and a pedimented central section. The marker can be seen in historic photographs surrounded by a concrete edging that also enclosed nearby buttonwood trees. Concrete coping surrounded the monument and continued out further into the parade ground.

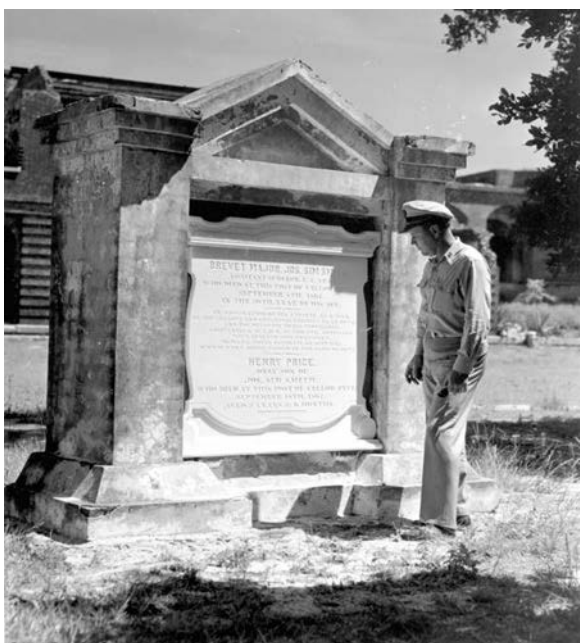
Figure 148. Major Smith Monument, 1940s. (017902 GPR)

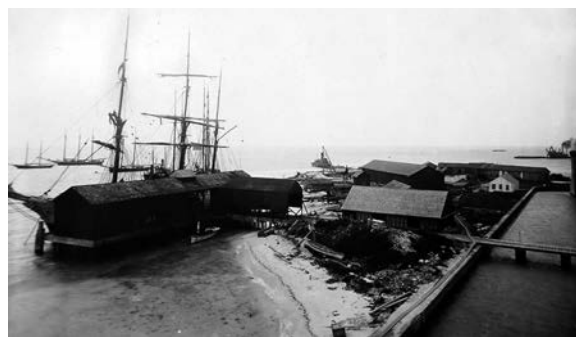
Figure 149. Wharf, 1898. (John Meigs Photograph Collection, Dry Tortugas National Park, DRTO 3805)

The construction of a simple pier head measuring 34 ft. x 28 ft. along Front 3 (present-day 1) occurred in 1849. Extensive wharves were not needed early in the construction process due to the depth of water close to shore. An additional wharf, built in 1855 opposite Front 2 (present-day 6), accommodated the larger quantity of building materials expected on site. Plans show a landing bridge over the moat going into the fort. An 1861 map shows three wharves, with a note that the 1855 wharf was of little use (see Figure 30). The embrasure opening, through which materials had been offloaded directly from the 1855 wharf into the fort, had been filled in as construction

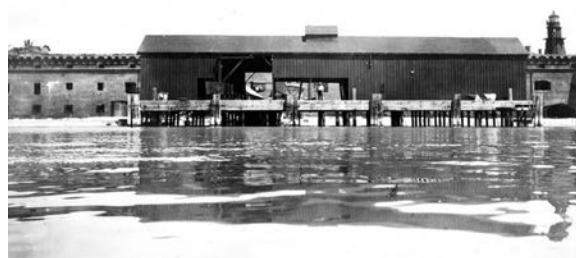
Figure 150. Wharf, 1909. (USGS Photographic Library vtw00305)

It was reported in 1876 that the wharves were in “tolerable condition.” The principal wharf was opposite the sally port and the other near the southern extremity of the key. An 1877 inspection described the smaller wharf as “somewhat decayed and broken.” By 1883, the principal wharf was also rotten, and by 1886, it was so decayed that it could not be used for landing heavy stores.

U.S. Marine Hospital Service finally constructed a new wharf in 1892. During Fiscal Year 1894, a coal shed was constructed beside the wharf gangway. Modifications were needed to give the new wharf more mooring space, and these occurred in Fiscal Year 1895. Quarantine personnel repaired the wharf bridge in 1898. The Navy spent \$2,000 on wharf repairs between 1898 and 1906. An inspector reported in 1910 that the deck was in good condition but that many of the diagonal ties beneath the deck were broken or corroded.<sup>94</sup>

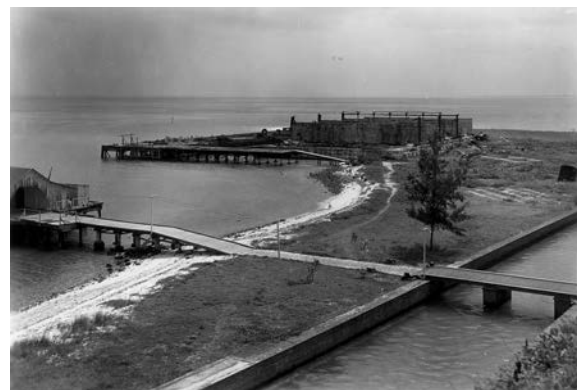
Figure 152. Wharf, 1937. (EVER 7157)

condition. The wooden deck was rotting, the iron piling supporting the deck was rusted, and six of the pilings in the front row were broken off at the water line. The only toilets at Fort Jefferson were the two on the main dock. Resident landscape architect Puderer reported in 1938 that a new dock was needed.<sup>95</sup>

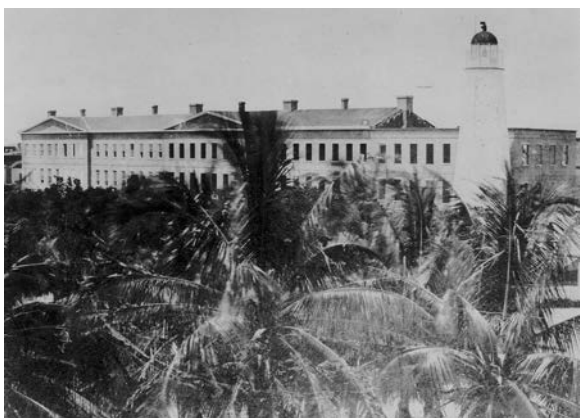
Figure 155. Original lighthouse, 1867. (DRTO 300889)

Photographs from the 1860s show the original frame lightkeeper's residence enclosed by a picket fence (see Figures 42, 100). Hurricanes in 1873 and 1875 damaged the 1825 lighthouse, rendering the lantern almost useless, and damaged the keeper's quarters. The erection of a new wrought iron light

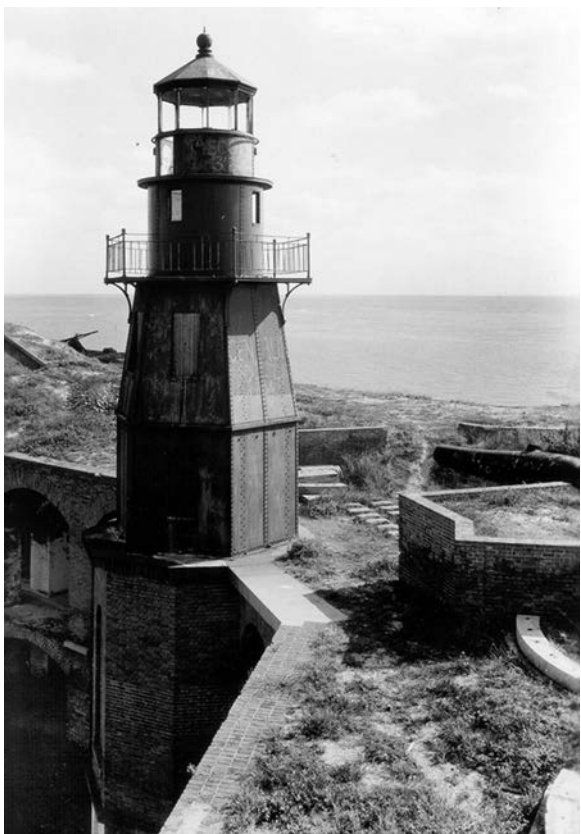
**Figure 159.** Light tower, 1937. (Harpers Ferry Center 000626)

site. The Lighthouse Service agreed to furnish a lens for the light when the repairs were complete.<sup>102</sup>

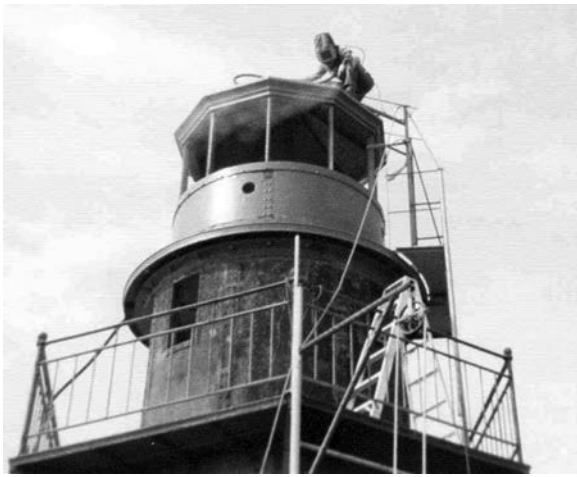
**Figure 160.** Light tower restoration, 1976. (DRTO 301708)

The report outlined three possible treatments for the light tower—minimal repairs, complete reconstruction using modern methods of welding and high strength bolts, or an intermediary level of rehabilitation. The park supported an intermediary level of rehabilitation that would permit some visitor access.<sup>103</sup>

of the wood window sash and many areas of rust on the metal body. Replacement of windows with historically accurate shutters occurred in 2009.<sup>104</sup>

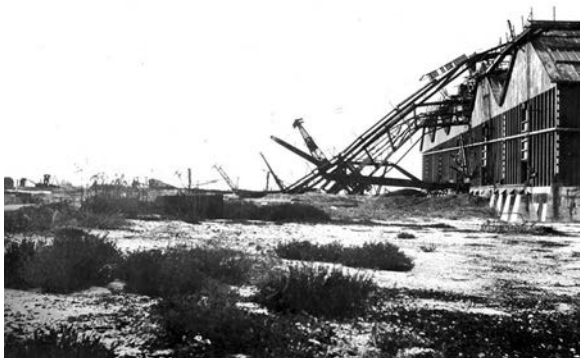
Figure 163. North depot hurricane damage, 1911. (USGS Photographic Library vtww00357)

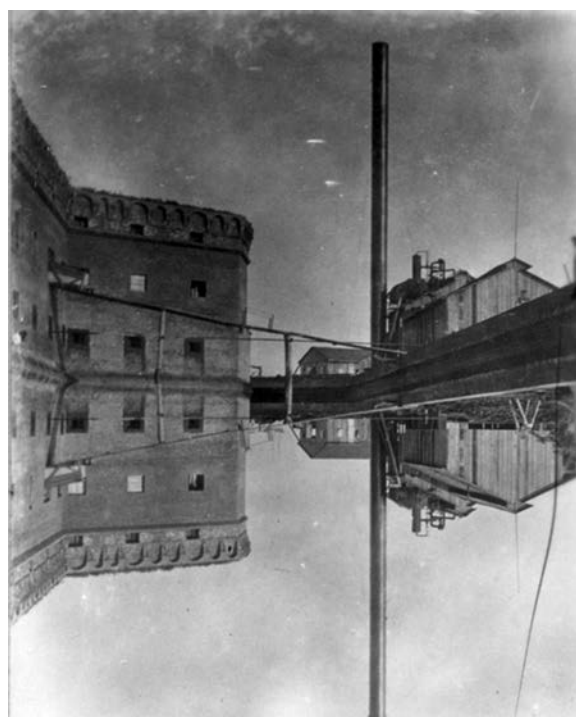
Figure 164. Distillation plant, 1907. (DRTO 300633)

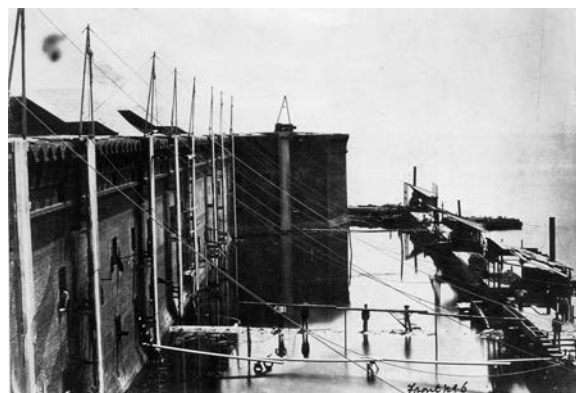
Figure 166. Hoisting sand to the terreplein, c. 1864. (DRTO 300651)

During modernization of the fort’s armament from 1871 to 1873, plans called for large amount of sand to be used to infill the bastions on the terreplein. All parapets having a thickness of 25 feet and under were to be constructed of sand, eliminating all masonry construction behind them. By 1872, 9,500 cubic yards had been hoisted as fill for six 15-inch salient angle platforms. Construction of the coaling stations around 1900 provided fill for Garden Key.<sup>114</sup>

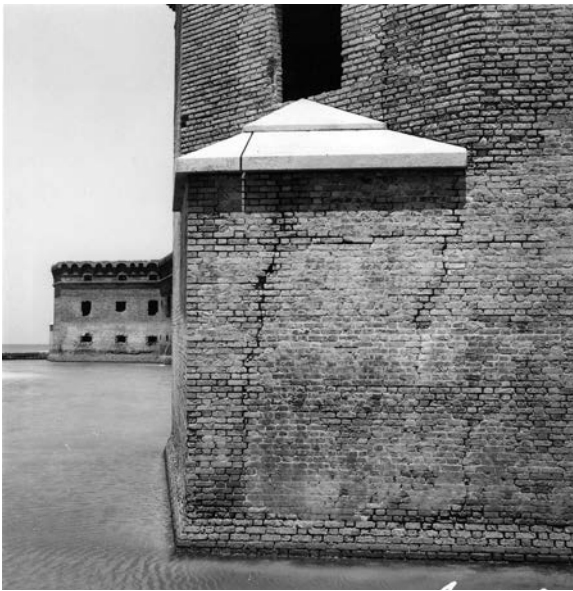
**Figure 167.** Vertical cracks at Bastion 1, 1970. (Alexander Physical Status Report 15)

Foundation settlement, which had exceeded 1.5' in some areas by 1862, is a continuing threat to stabilization of the ruin.

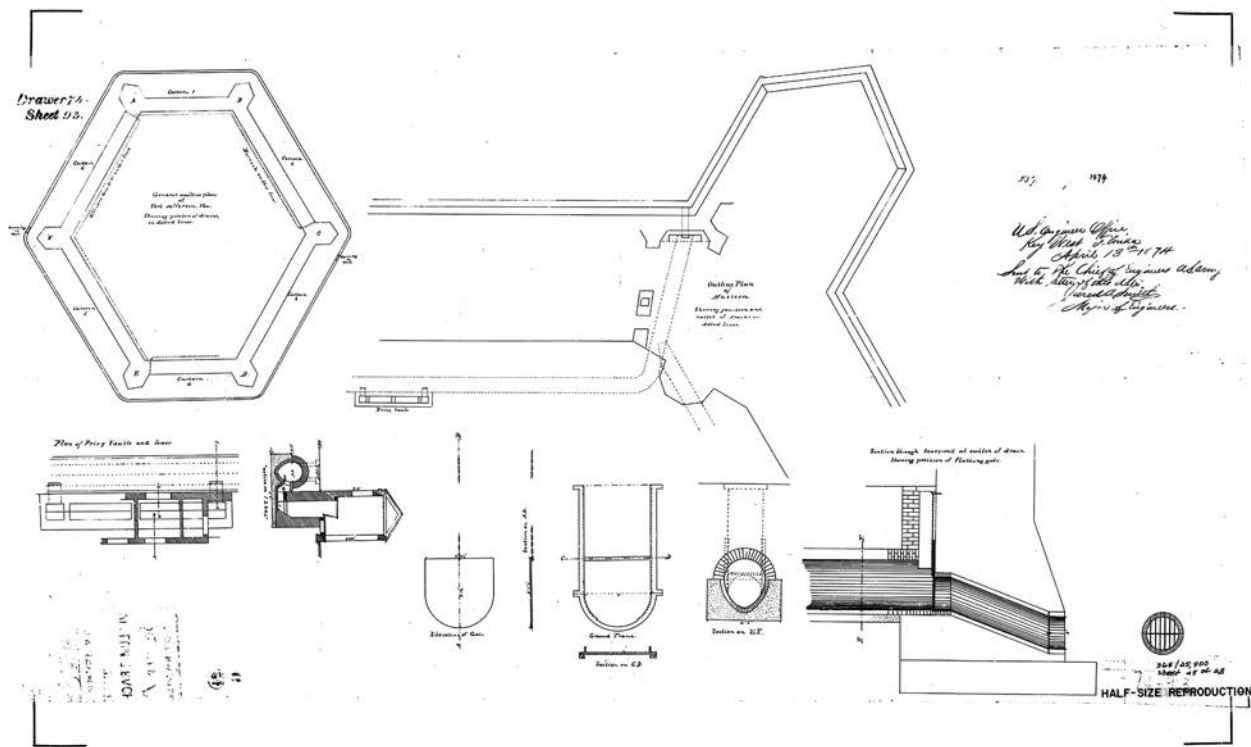
Figure 169. Plan of drains, 1874. (Denver Service Center etic 364/25900 sheet 25)

No money was available for repair work at Fort Jefferson until 1885. At this time, \$50 was allotted for clearing out the sewers. Superintending Engineer Rossell reminded Chief of Engineers Newton that the moat was filling up with sand. On an 1890 inspection of the quarantine station, Surgeon Walter Wyman reported that both sluiceways were clogged with sand and that the moat filled with stagnant water. He asked the

Engineer Department for assistance, noting that sewer gases would soon be unbearable. In 1898, both sluiceways were narrowed to about half their original width, and each was fitted with a gate that never worked properly. The eastern gate was closed in 1898.

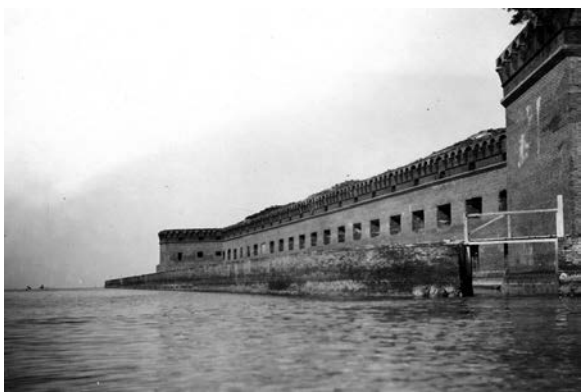
**Figure 170.** Front 4 showing sluice gate, 1910. (USGS Photographic Library vtw00323)

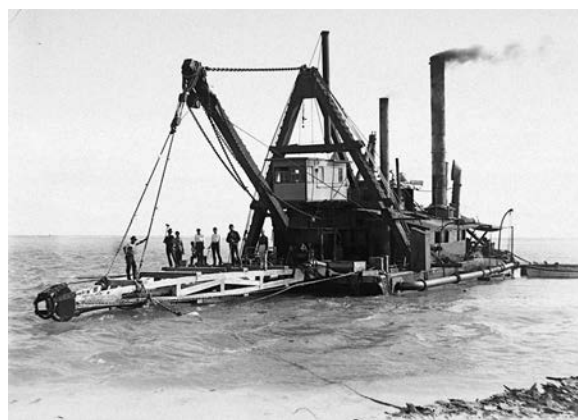
**Figure 171.** Dredging the harbor, 1898. (John Meigs Photograph Collection, Dry Tortugas National Park, DRTO 3805)

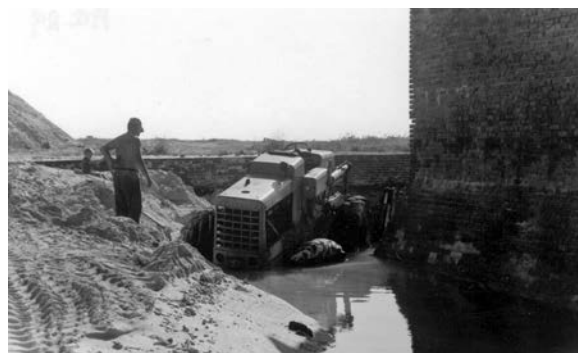
**Figure 172.** Moat dredging, 1965. (DRTO 300923)

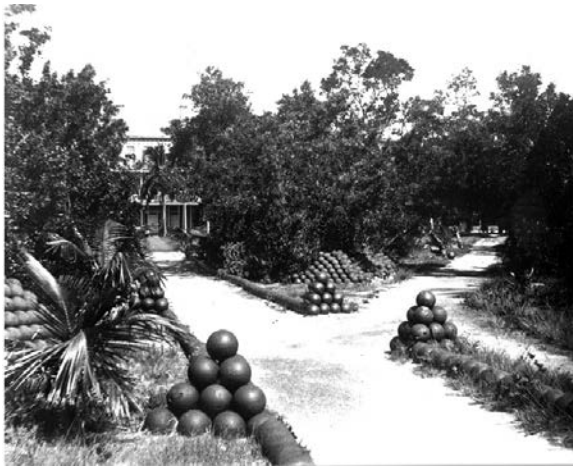
**Figure 173.** Parade walkways showing split, c. 1898 (DRTO 300518)

(Present-day 1). A main central pathway running northwest to southeast connected the sally port with the officers' quarters. Secondary pathways branched off the main pathway, which was described as "a well-kept, hard-cemented walk." Ordnance was stacked at intervals along the pathways, in accordance with military protocols and to facilitate counting the inventory of cannonballs. Dr. Joseph B. Holder stated in 1867 that "a neat walk leads to the officers' quarters through an arching group of mangroves, flanked by long rows of ordnance material." Paths within the lightkeeper's complex linked various parts of the landscape.

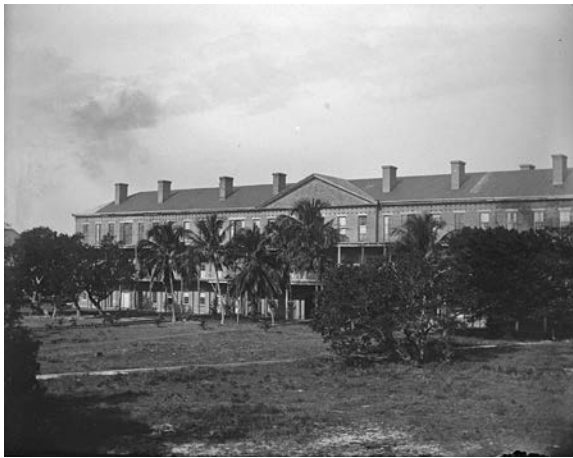
**Figure 174.** Parade walkways showing three paths, c. 1898. (DRTO 300898)

The construction of a new parade walkway from the sally port to the officers' quarters in 1896 may have been the impetus for adding cannonballs, as historic images from 1898 first show the ordnance-lined path. Cannonballs continue to show up in

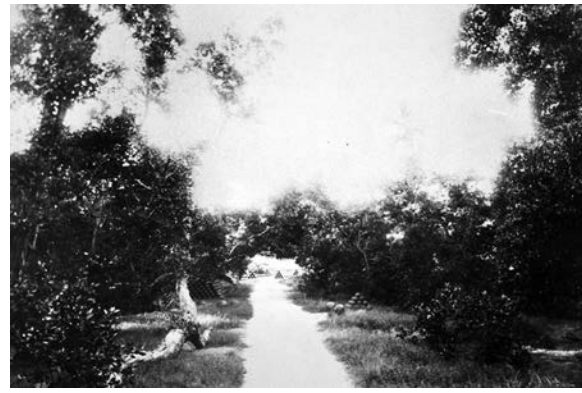
**Figure 175.** Secondary parade walkway, c. 1898. (John Meigs Photograph Collection, Dry Tortugas National Park, DRTO 3805)

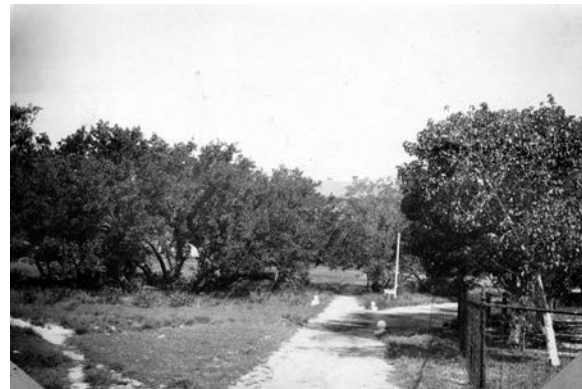
**Figure 176.** Parade walkway without ordnance, 1909. (USGS Photographic Library vtW00301)

historic images of the walkway through 1901. After an ordnance sale in 1900, all the ordnance, except for the ten big guns, had been sold or taken to Fort Taylor in Key West. Images after 1901 no longer show ordnance lining the main pathway. In 1943, Superintendent Budlong reported that vegetation had been removed in order to uncover traces of the old walk in front of the officers' quarters.<sup>128</sup>

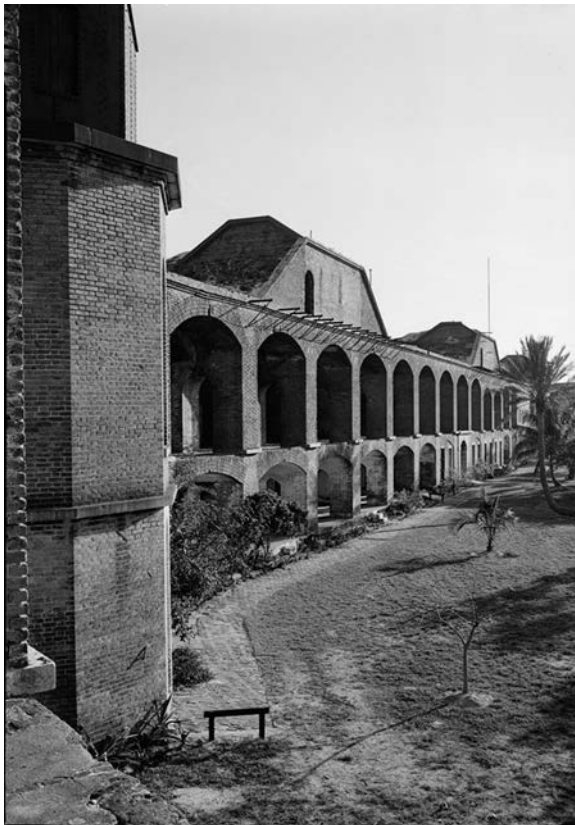
Figure 178. Image of walkway from Bastion 1 to 6, 1962. (HABS 053134)

trails placed and constructed as described in the PCP [Project Construction Proposal] would be of use and benefit for the protection, management, and interpretation of Fort Jefferson National Monument.” His proposal called for a 3-foot walk from the sally port across the parade to the residence and a 5-foot walk adjacent to the inner wall from Bastion 6 to Bastion 4 (historic C to A) with turnarounds for a small supply vehicle.

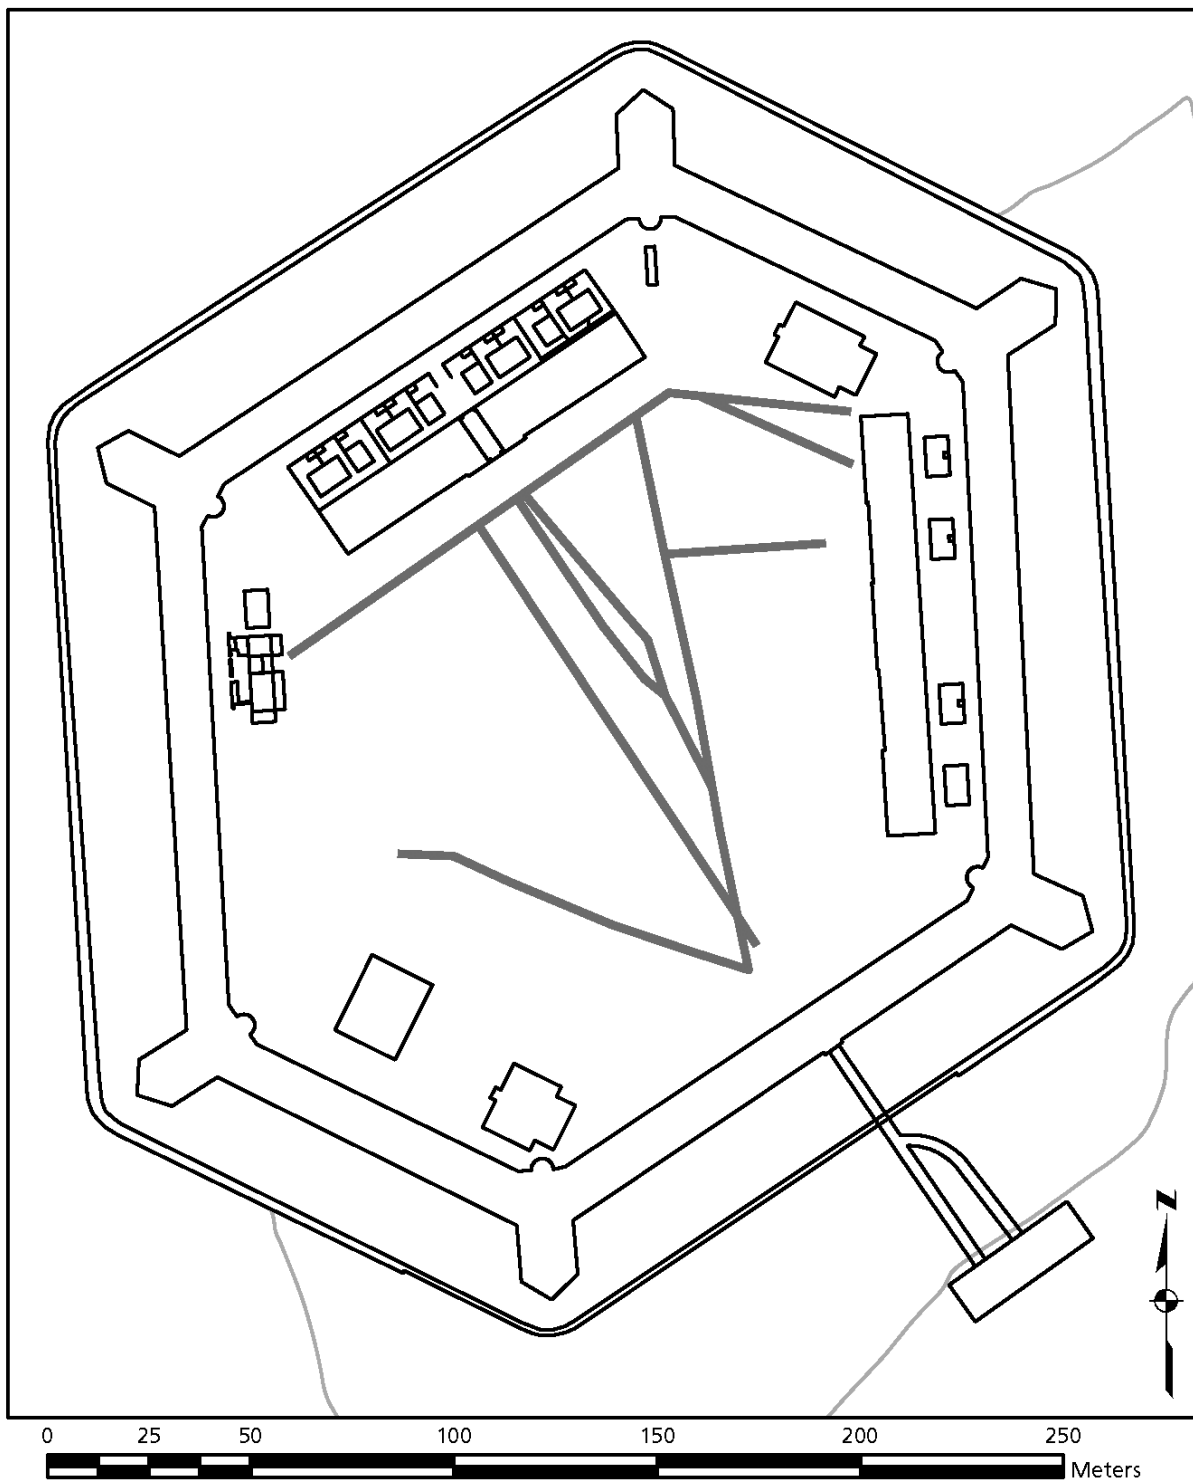
Figure 179. Map of historic pathways as detected by GPR, 2006. (Courtesy GPR survey)

three 10 ft. x 40 ft. turnarounds for maintenance equipment. The walkway, constructed with brick salvaged from the demolition of the officers' and enlisted men's quarters buildings, was laid in a herringbone pattern in a layer of beach sand. The completion report stated that the historic walks between the sally port and the officers' quarters were not reconstructed as planned due to personnel and time problems. The report also stated that due to a difference in elevation of the floor level of the first tier casemates and the parade, a portion of the walk between Bastions 4 and 5 (historic A and B) had to be built up using brick rubble and sand. Crews from the 482<sup>nd</sup> Civil Engineering Squadron replaced the perimeter walkway inside the fort in 1977.<sup>129</sup>

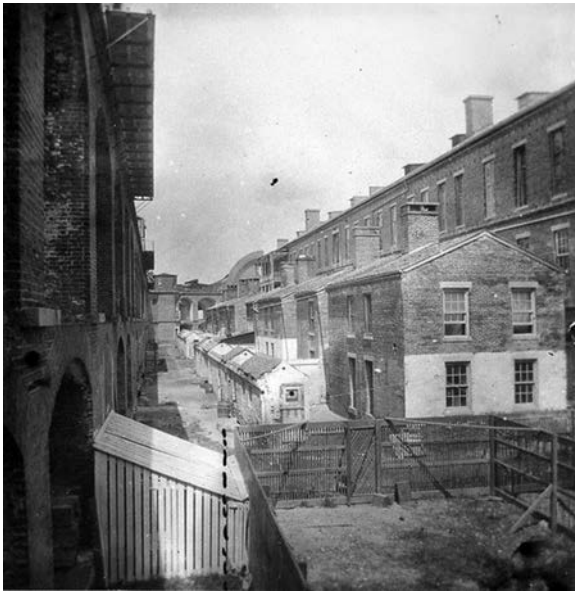
**Figure 184.** Paling fencing in the work yard of the officers' quarters, c. 1870s.

According to Engineer Department reports, the 1870 hurricane destroyed parade fencing.<sup>136</sup>

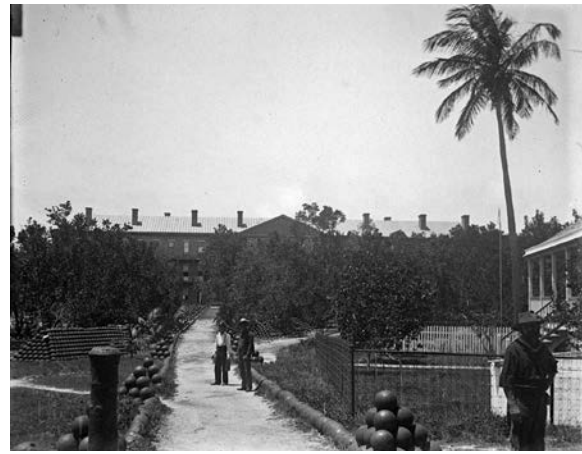
**Figure 185.** Paling and wire fencing enclosing the lightkeeper's complex, c.1899. (John Meigs Photograph Collection, Dry Tortugas National Park, DRT0 3805)

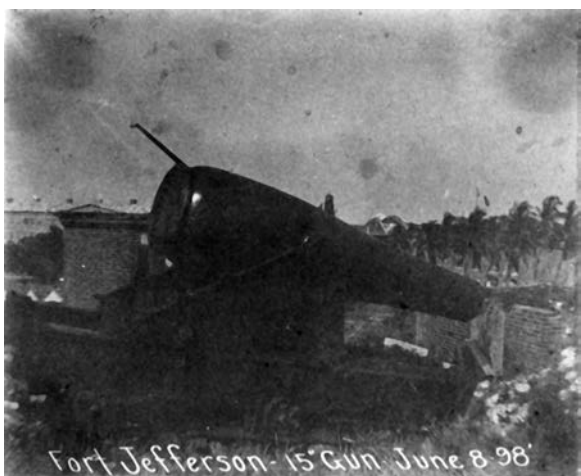
**Figure 186.** Rodman cannon, 1898. (National Archives)

The Rodman cannon were not installed at Fort Jefferson until 1872. Installation was in response to saber rattling from the British over an attempt by the U.S. Government to compel Great Britain to pay a huge sum for prolonging the Civil War by failing to exercise due diligence in enforcement of her neutrality. This increase in international

Six 15-inch guns were to be mounted on center-pintle carriages, one at each bastion. The carriages were to be mounted on timber platforms laid on a concrete foundation. Problems with the wooden timbers and with the traverse wheels delayed the mounting of the guns until 1873. The mounting of four 10-inch Parrotts also occurred during the 1872-73 construction season. They arrived at the fort in 1865 but were not mounted until 1872. Three Parrotts were mounted on front-pintle carriages and one was mounted on a center-pintle carriage. Along Fronts 1, 5, and 6, they replaced smaller guns, whose granite platforms were upgraded to accommodate the larger guns.

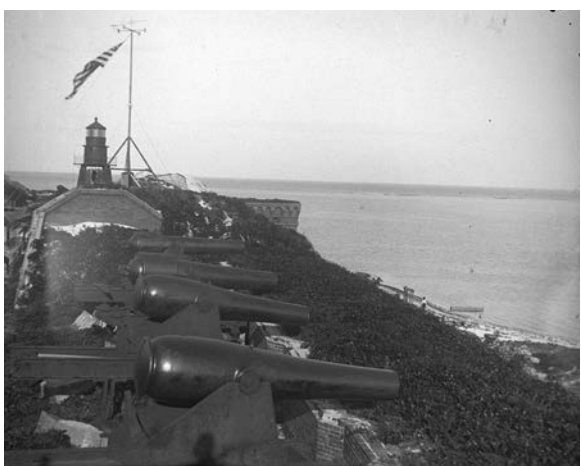
**Figure 187.** Parrotts on Front 1, c. 1900. (John Meigs Photograph Collection, Dry Tortugas National Park, DRTO 3805)

The sale included the six 15-inch Rodman and four 10-inch Parrott guns, but when the NPS took over the site in 1935 the large guns were still located on the terreplein. Park records indicate a concern about the condition of the cannon dating to the late 1950s, without any attempt at professional conservation.

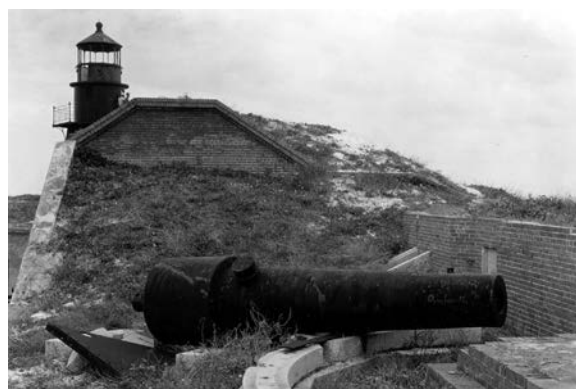
**Figure 188.** Parrott on Front 1, 1937. (EVER 7176)

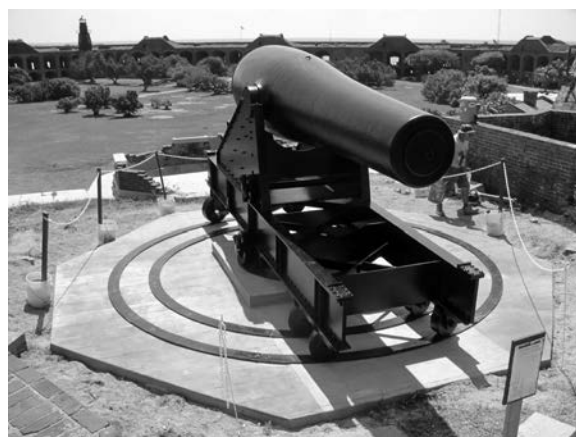
**Figure 189.** Rodman on reproduction carriage, 2011. (NPS image)

A renewed interest in conservation resulted in a collection condition survey in 2004. Phase I of a project to conserve the cannon began in 2007, 134 years after the garrison left Fort Jefferson. The first cannon to be treated was the Rodman at Bastion A (present-day 4). Phase II of this project concluded in February 2009, treating the Rodman guns at Bastions D and E (present-day 1 and 2), and Phase III saw the Rodman on Bastion F (present-day 3) and a Parrott on Front 4 conserved in February 2010. The Rodman on Bastion F (present-day 3) was successfully mounted on a full reproduction carriage in November 2010. It is anticipated that all the cannon will be conserved by late 2012. In addition, in 2009-2010 a contractor was developing an alternative mounting plan for the cannons that will not be mounted on full carriages. The goal of the alternative mounting system will be to ensure the guns preservation, facilitate routine

**Cannon.** All 10 big guns mounted at Fort Jefferson in 1873 remain on the terreplein. There are six 15-inch Rodman cannon, one at each bastion and four 10-inch Parrotts on Fronts 5, 6, and 1. All will eventually be conserved, with one Rodman mounted on a full reproduction carriage and others mounted on some kind of alternative carriage. Conservation of the cannon is currently ongoing, and over half of the collection has received treatment, including the remounting on a full reproduction carriage of the Rodman on Bastion 3 (see Figure 189) and the mounting on an alternative carriage on Bastion 4. The Rodman on Bastion 6 and two Parrotts on Front 1 are set into concrete. Most of the guns are incorrectly oriented, aiming at the fort's walls; several are mounted upside down or sideways.

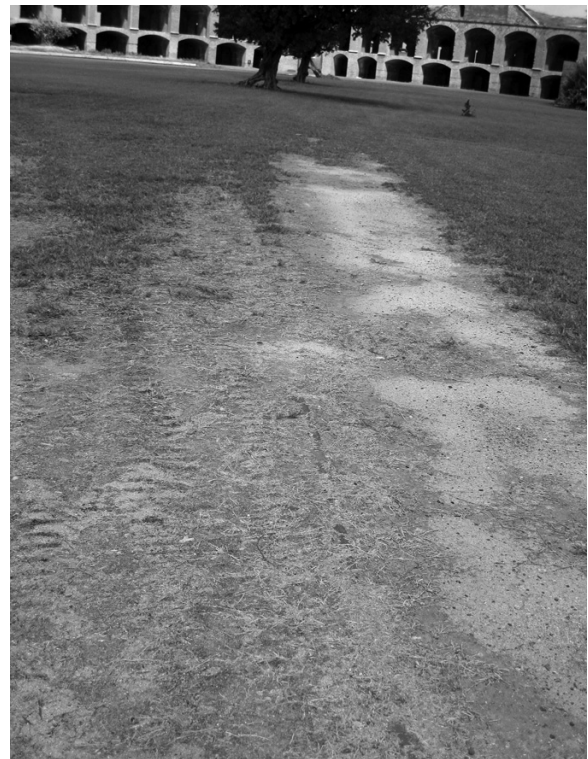
**Figure 197.** Remnant pathway showing brick edging, 2010. (SERO image 1530)

large magazine, small magazine, and cistern. Two of the most prominent buildings historically, the officers' quarters and the enlisted men's quarters, burned and survive only as ruins. Historic paths, described as hard-packed surfaces, are now sandy paths with some of the later brick edging exposed where it was previously covered with sand. The spatial delineation remains visible in some areas, but existing pathways do not necessarily conform to the historic circulation system documented in the ground penetrating radar survey and seen in historic photographs.

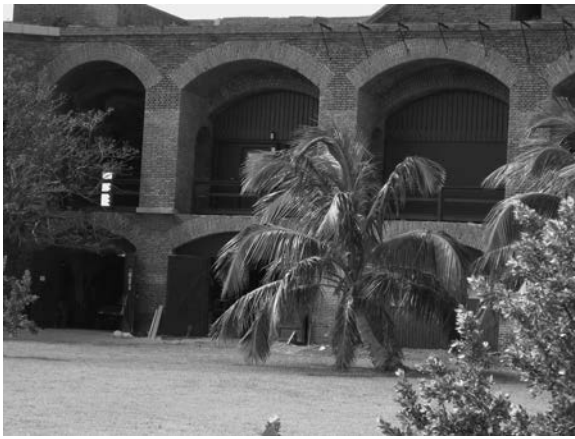
**Figure 198.** Casemates below used for maintenance, above used for housing, 2010. (SERO image 1535)

Casemates and what were historically the guard rooms adjacent to the sally port are being adaptively used as a small visitor center and park headquarters. Several casemates along Fronts 1, 2, and 3 and the engineer officers' quarters have been adapted to contain staff housing. Maintenance facilities and utilities are located within casemates concentrated along Fronts 2 and 3.

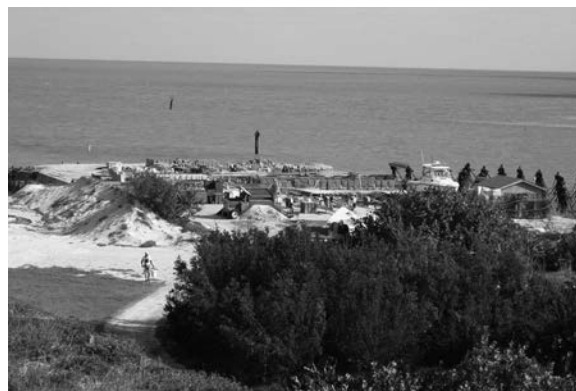
**Figure 204.** North coaling dock, 2010. (SERO image 1589)

The north coaling dock is cordoned off to the public and used as a staging ground for ongoing stabilization efforts. Fuel tanks for the generators are located underground near the south coaling docks. Fuel tanks for the boats and maintenance equipment are located in an aboveground, wood structure on the south coaling dock. A landing pad for helicopters occupies the remainder of the dock. Additional storage, workspace, and a brick and
