# Dry Tortugas National Park Garden Key Cultural Landscape Report

# Cultural Landscape Report

June 2011

National Park Service

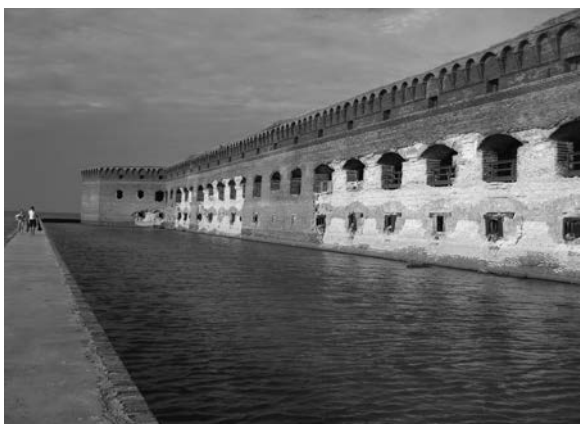
This Third-System brick fort was designed as a hexagonal structure with 2,000 brick arches and vaults, partitioned into 303 casemates, some of which have been converted to staff housing/ administration/maintenance use. The fortification has a bastion at each corner with a staircase to provide access to the open terreplein. Two stories of brick casemates rest on a foundation of vaulted cisterns. The embrasures in the first tier of casemates were originally framed with iron to support the Totten shutters, which were designed to close over the embrasure to protect the fort and soldiers from fire. The second tier embrasures were never completed, due to subsidence, leaving much larger, square openings than those on the first tier.

**Figure 215.** Fort Jefferson, 2010. (SERO image 1508)

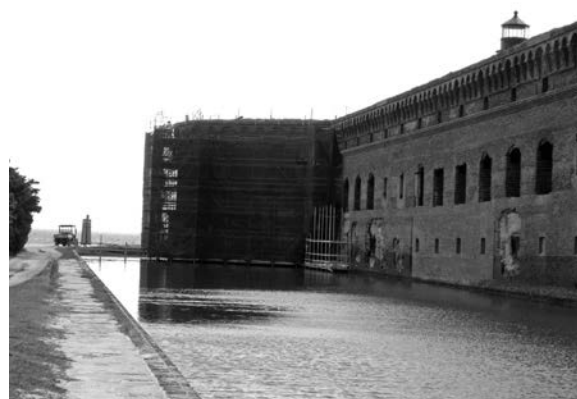
In 2007, the park began Phase II stabilization to repair the exterior scarp wall in the following areas: the north and east faces of Bastion 3, Front 4, the west and northwest faces of Bastion 4; Bastion 5, Front 6, and the northeast and east faces of Bastion 6. The work included the selective demolition of masonry to remove the corroded iron Totten shutters, armor blocks, and lintels; the installation of new non-corrosive glass fiber reinforced concrete armor blocks and lintel facsimiles; and the associated reconstruction and repointing of the masonry on the scarp wall. Additionally, the

**Figure 216.** Phase II stabilization, 2010. (SERO image 1514)

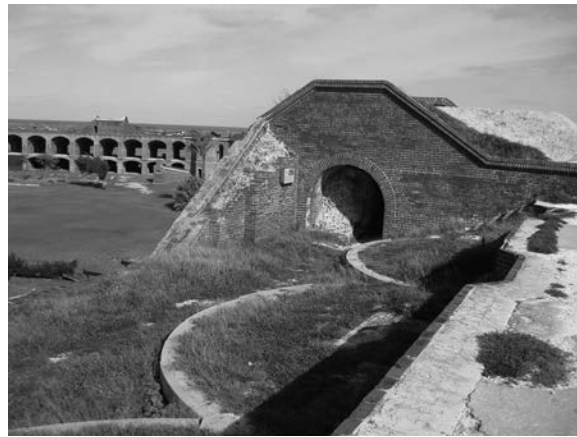
Today a portion of the self-guided tour includes walks on four fronts of the terreplein (1, 4, 5, and 6). Traverse magazines, placed symmetrically along all six fronts, are a prominent feature. The masonry of many of the magazines shows signs of deterioration such as loose and missing brick and deteriorated mortar joints. One traverse magazine is open to the public along Front 6. Brick steps have been constructed from the parapet to give visitors access to the magazine entrance below.

**Figure 218.** Traverse magazine and gun mounts on Front 6, 2010. (SERO image1576)

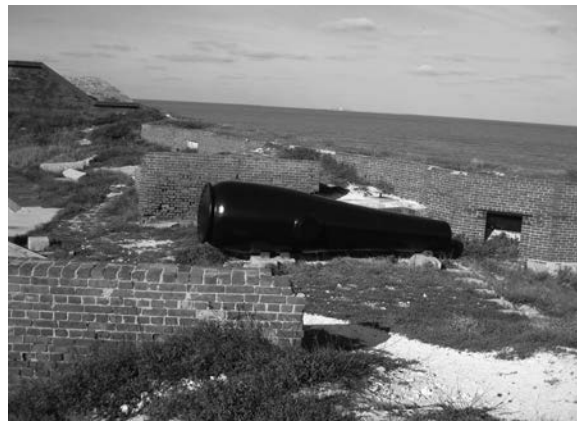
Six 15-inch Rodmans at each bastion and four 10-inch Parrotts along Fronts 1, 5, and 6 have been raised off the ground, most onto temporary mounts that utilize displaced granite blocks from the gun emplacement. The Rodman at Bastion 6 and Parrots on Fronts 1 and 6 were set into concrete in historically inaccurate positions prior to 1963. Good examples of gun emplacements not obscured by vegetation are found along Fronts 1 and 6, which is also the location of a radio antenna and satellite dishes within full view of the visitor. Along other fronts, vegetation covers some of the gun mounts. The disrupted gun mounts on either

**Figure 219.** Rodman cannon on temporary mounts, 2010. (SERO image 1551)

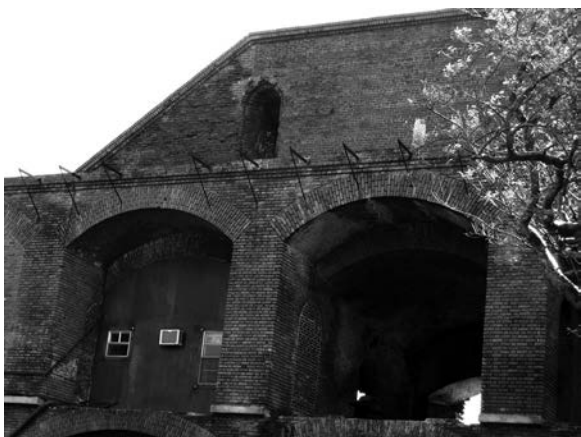
side of each bastion are actually part of the historic setting since their displacement dates to 1872-73. However, there are other places where individual pieces of granite could be replaced. On the parade face, the walkway braces of the galleries are also visible features of the cultural landscape. These are remnants of the galleries

Figure 221. Walkway braces, 2010. (SERO image 1533)

constructed when the traverse magazines were modified in 1873 for entry from the rear.

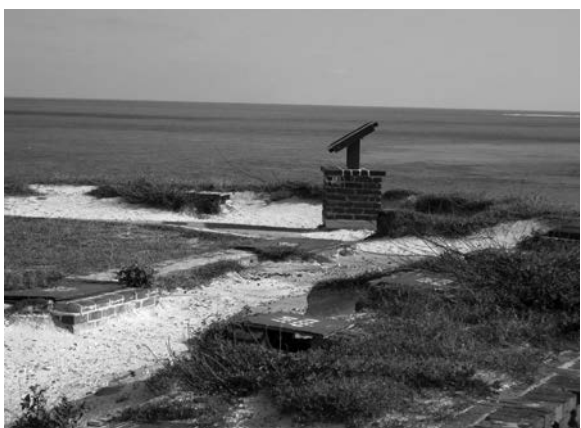
Figure 222. Plywood covers, 2010. (SERO image 1561)

The original terreplein filtered rainwater into the foundation cisterns through leader pipes, most of which are covered with round iron lids. Plywood covers chimney-smoke holes to keep water out of the fort. A waterproofing material has been used on portions of the terreplein to prevent leaks into the casemates below. The membrane currently installed has not been entirely effective as water infiltration below the treatment is evident, and portions of the membrane can be seen on the terreplein at Bastion 2 and Bastion 3. Along Front 3, a modern roof covers a portion of the housing area.<sup>2</sup>

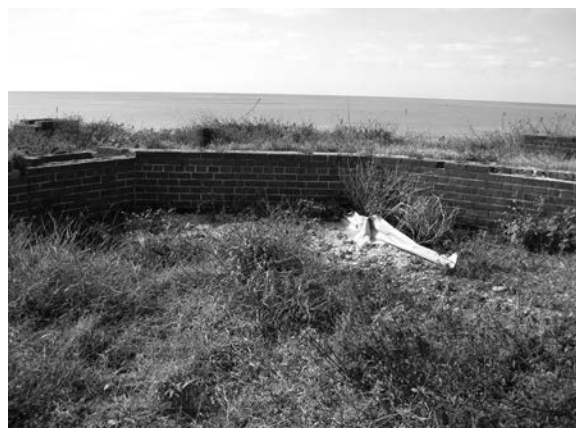
Figure 223. Waterproofing membrane, 2010. (SERO image 1640)

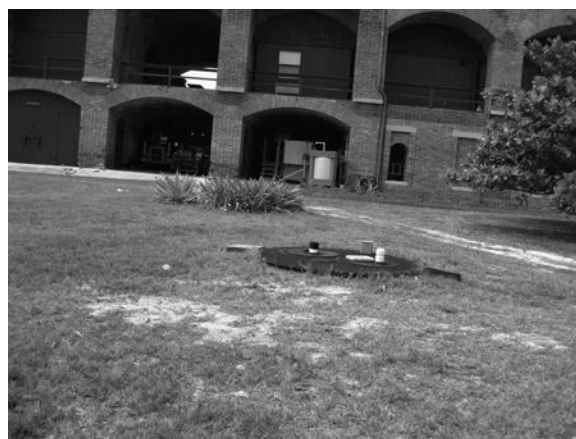
Figure 224. Maintenance area with modular housing units above, 2010. (SERO image 1537)

water plant, and a recycling facility occupy most of the casemates along Fronts 2 and 3, while other designated casemates provide housing for park residents and temporary staff and contractors working at the site. New modular housing units have been constructed on Front 3 in the second tier casemates.

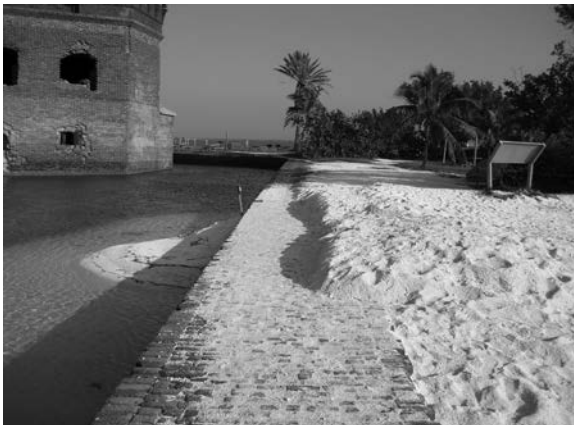
**Figure 225.** Sand covering counterscarp, Front 2, 2010. (SERO image 1506)

In 2008, cracks in the counterscarp along Front 3 became more pronounced after storms early in the year, followed by a major collapse in the spring. In 2010, sand covered the counterscarp walk along a portion of Fronts 1, 2, and 6. Near the end of Front 2, at the transition from brick to concrete, masonry was deteriorated, missing, or damaged with severe loss of mortar. Along Front 3, a collapsed section is marked with an orange cone. Along Front 6, the walkway is deteriorated along its length. Along Front 1, an existing repair near Bastion 6 using wood and concrete stands out in a section that only used brick historically.

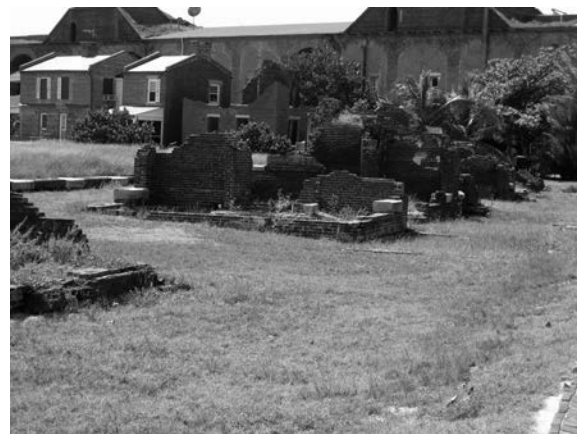
**Figure 228.** Officers' quarters detached kitchens, 2010. (SERO image 1474)

The outhouses and detached kitchens behind the officers' quarters are low ruins similar to those of the adjacent barracks. The kitchens are connected to the main building by the ruins of later brick walls. Some central chimneys are evident in the kitchens.

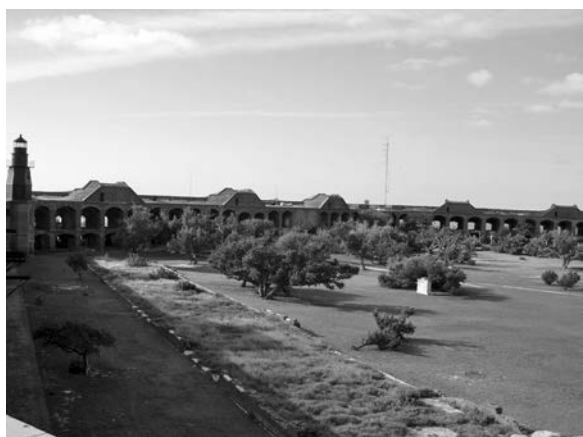
**Figure 229.** Enlisted men's quarters, 2010. (SERO image 1560)

The enlisted men's quarters span the length of Front 6 and remain as a brick and concrete foundation with granite blocks defining the building's perimeter. The foundation is two feet high in places with portions rising to three feet. Exotic grasses grow in the interior of the ruins. By the 1930s, very little remained of the four detached kitchens in the rear of the building, which were demolished in the 1960s, although a few brick piles can be seen in images from this period.

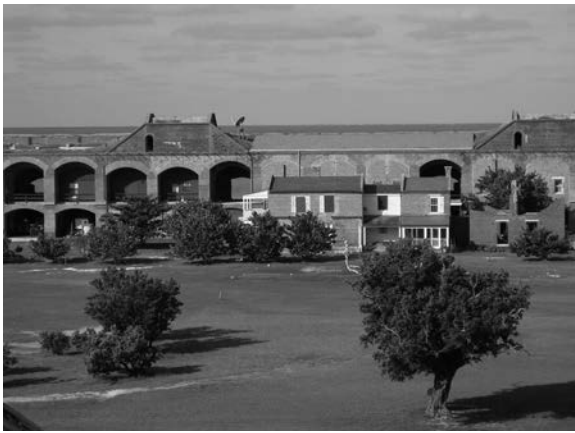
**Figure 230.** Engineer officers' quarters, 2010. (SERO image 1571)

elevation. The porch was near collapse, but the park was able to temporarily stabilize the structure with a forklift. Further investigation showed that the porch was tied into the brick work with iron thru bolts that had rusted away so that the porch was being supported by two pilasters and six posts set on concrete bases. As this was perceived to be a design flaw, a stabilization effort would not have been productive or cost effective. The forklift was removed and the porch collapsed to the ground. The park salvaged the 1930s copper gutter and the slate shingles.<sup>4</sup>

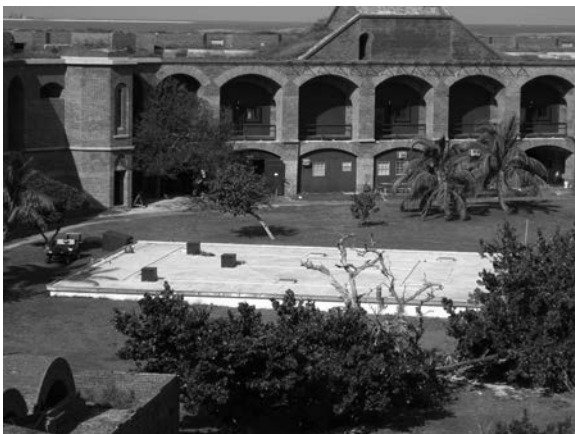
**Figure 231.** Cistern, 2010. (SERO image 1622)

A 90,000-gallon concrete cistern, rising two feet from the ground, is located along Front 2 at the southwest end of the parade. A metal and asphalt covering has eight water intake openings and three non-potable wooden water valve boxes. Delamination and cracking appear on the most recent parge coat. The cistern occupies the location designated for the chapel, whose superstructure was never completed. This area is designated “off-limits” to the public.<sup>5</sup>

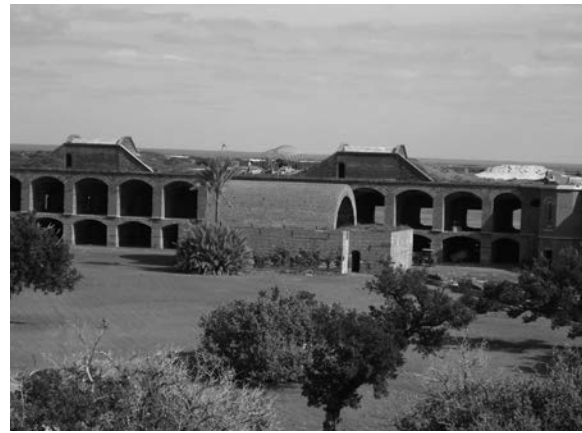
**Figure 232.** Large magazine, 2010. (SERO image 1625)

The large magazine is oriented east to west along Front 5. A 30-foot-high, barrel-vaulted magazine is surrounded by a rectangular brick enclosure

with an arched entry door on the north elevation and vertical ventilation slits in the walls. Because construction was never complete, the building is open-ended and exposed to the elements. The impact of “target practice” from the Spanish-American War occupation of the fort is still visible on the south façade, and a date palm grows nearby. No vegetation grows in the interior, except a few weeds and mold, although vegetation grows on the roof. There are three modern, wooden benches with decorative iron located in the entry of the magazine for visitor comfort.

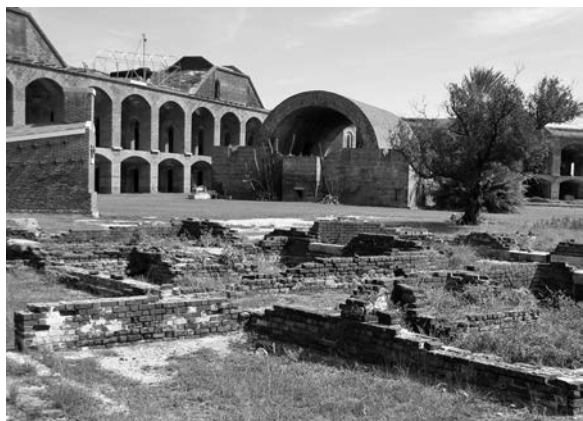
The hot shot furnace is a rectangular brick building with a slate roof opposite Bastion 4. A brick chimney rises to 16 ½ feet at the southern end. The west façade has a floor-level opening where coal was inserted. Two sets of reinforcements run horizontally through the furnace for support. Metal runners are visible through the length of the building with an arched opening at the north end to extract the shot. The building was recently rehabilitated and is interpreted by a wayside exhibit.

**Figure 234.** Hot shot furnace, officers' quarters, and large magazine, 2010. (SERO image 1659)

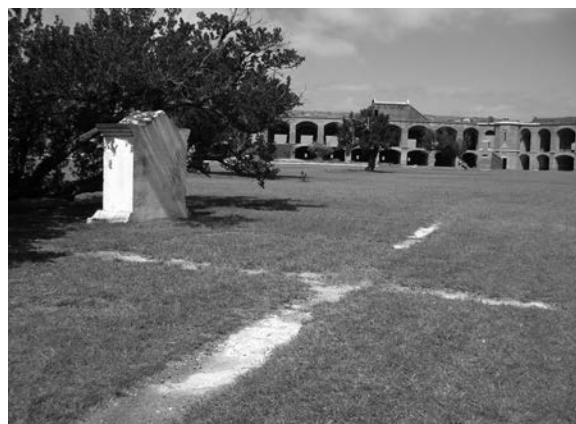
**Figure 235.** Major Smith Monument with concrete coping, 2010. (SERO image 1527)

The Major Smith Monument is in fair condition but has spalling and weathering on the corners and foundation. The marble inscription is in good condition. The monument has a broken pediment, and an old buttonwood has grown up around it, blocking the inscription from view. Sections of the poured-concrete foundation surrounding the Major Smith monument are partially exposed on the surface. It is faintly visible with sand and pebbles forming a grid beneath overgrown Bermuda grass. Ground-penetrating radar conducted in 2006 revealed the foundation remains more clearly. In historic photographs from the 1930s, they appear to be an edging or coping around the monument that extended out into the parade, similar to a cemetery plot edging.<sup>6</sup>

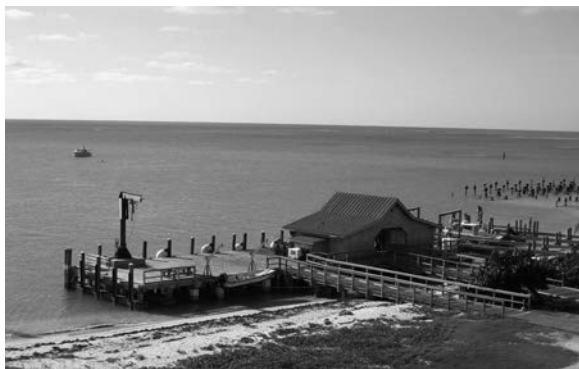
Figure 236. Dock, 2010. (SERO image 1598)

house with men’s and women’s changing rooms and a small interpretive room with information on park history, fishing, coral reefs, weather, and park regulations. Another section is a loading dock, used by the ferry concessionaires. A view of the fort from the dock is framed by seagrapes and a coconut palm. NPS vessels are docked in four finger piers adjacent to the main boat dock. 2010 plans call for the extension of the main dock, replacement of wood siding on the dock house with Hardiboard panels with battens, and the addition of two finger piers.

The main boat dock is located on the southeastern shore of Garden Key. One section contains a dock

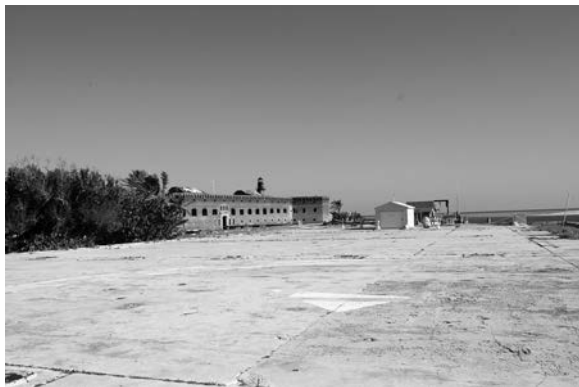
Figure 237. South coaling dock, 2008. (SERO image 0028)

The south coaling dock is a rectangular concrete foundation on the southwestern shore of Garden Key. A helicopter pad and modern fuel storage tank enclosure occupy a portion of the foundation. A wayside exhibit interprets the later history of Fort Jefferson and the coaling dock. Old bricks have been dumped in the coaling station ruins.

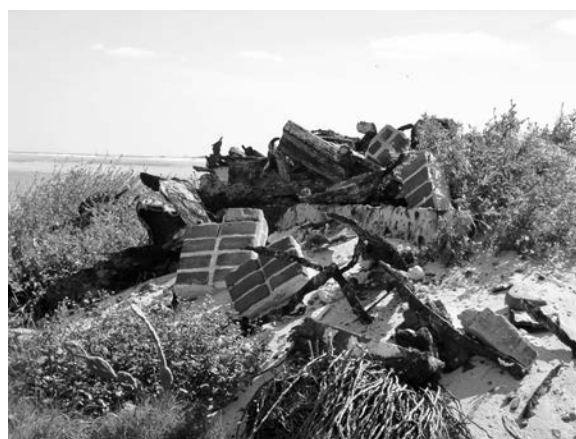
**Figure 241.** Architectural debris pile, 2010. (SERO image 1652)

The eastern portion of the island (Front 6) contains an overgrown dump site of architectural debris from the demolition of the quarters buildings and random material dislocated after hurricanes. It is overgrown with typical strand vegetation. The sand pile between Bastion 5 and the north coaling dock was removed in 2009 when the moat and boat slips were dredged. The spoil was put by the north coaling dock, as well as along the shoreline east of the brick rubble pile. Since the dredging, the sand has started to fill in the moat again by Bastion 5 and Bastion 1. Aside from these two man-made features, the landscape outside of the fort is flat.

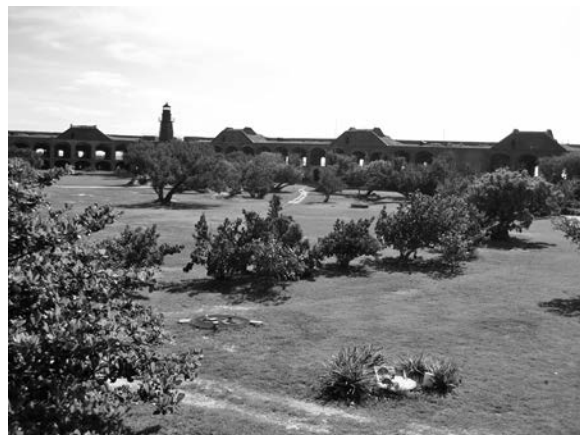
Figure 245. Interior pathways, 2010. (SERO image 1649)

The interior circulation followed formal walkways with stacked ordnance across the parade ground. Today some of these patterns are visible as sandy paths, several with an interrupted line of brick edging visible aboveground. No cannonballs remain from the military period. In 2003, SEAC excavated a portion of the path from the officers' quarters to the engineer officers' quarters and determined that it was lined with brick and parged.

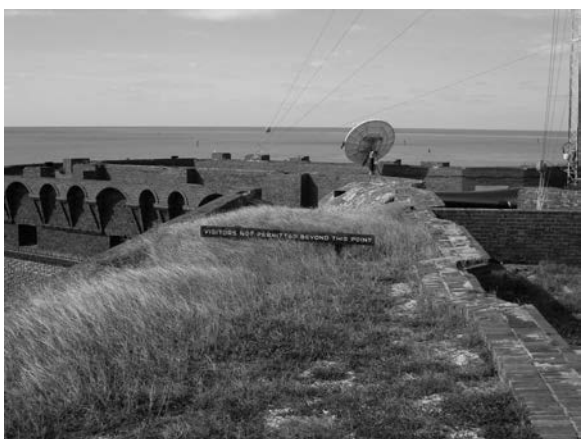
**Figure 247.** Communications equipment at Bastion 1, 2010. (SERO image 1629)

Views approaching and inside Fort Jefferson are diminished by communications equipment and a radio antenna along Front 1. Plastic chairs outside of staff quarters in the second tier casemates also degrade the viewshed on approach to Fort Jefferson.

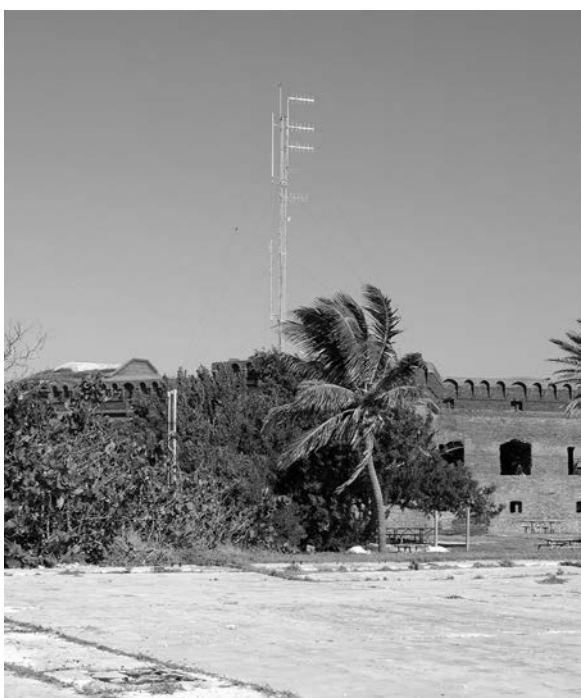
**Figure 248.** Radio antenna at Bastion 1, 2008. (SERO image 0029)

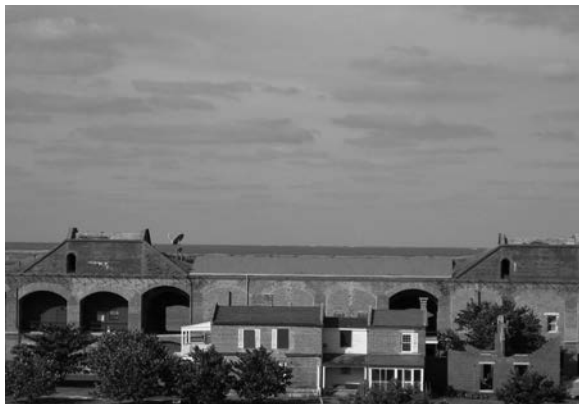
**Figure 252.** Views of asphalt roof and satellite dish, 2010. (SERO image 1572)

historic character. Portions of the waterproofing membrane can be seen at Bastion 2.

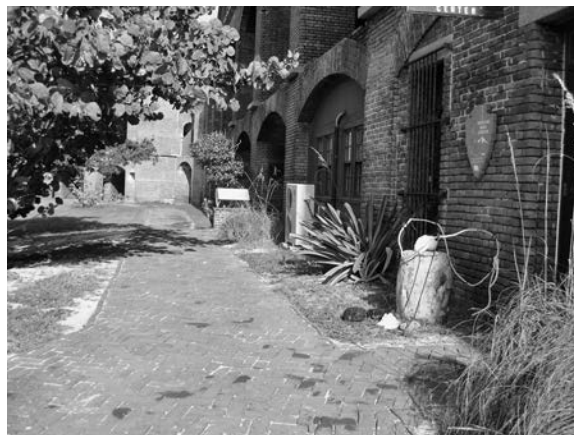
**Figure 253.** AC compressor on tour route, 2010. (SERO image 1493)

Views inside the parade ground are diminished by an air-conditioning compressor visible along the self-guided tour route near the sally port and by effluent mounds near Bastion 3. Signage on Bush Key is also visible through an embrasure opening. A vegetative screen, planted in the 1980s, helps to block the view of the housing/maintenance units along Fronts 2 and 3 from visitors on the parade ground, but these units are visible from the second tier and terreplein.

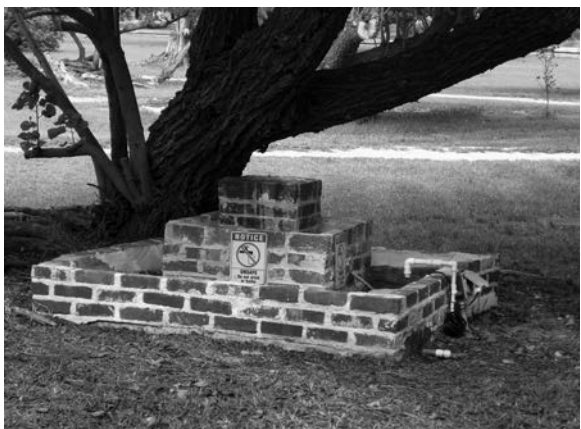
**Figure 255.** Tropical Audubon fountain, 2010. (SERO image 1468)

**Fountain.** The Tropical Audubon Society fountain is a modern feature added to the parade ground in the 1970s. The square, brick fountain has three tiers with concrete lining and evidence of numerous repairs. The electrical service is exposed on the east face. The fountain is surrounded entirely by buttonwoods, and one seaside mahoe is growing into its base. The fountain does not date to the period of significance and is a modern intrusion on the landscape. However, it may be politically insensitive to remove it in spite of the cultural and natural resource impacts, as birding is a primary activity of visitors. The masonry is repointed as needed, and the Tropical Audubon Society supplies the pump.<sup>11</sup>

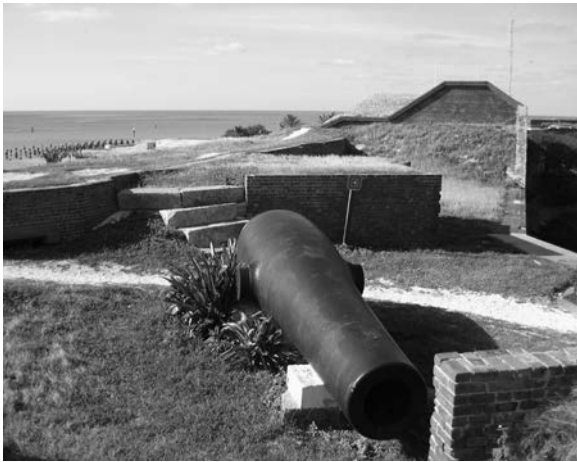
Figure 260. Cannon aiming in wrong direction, 2010. (SERO image 1595)

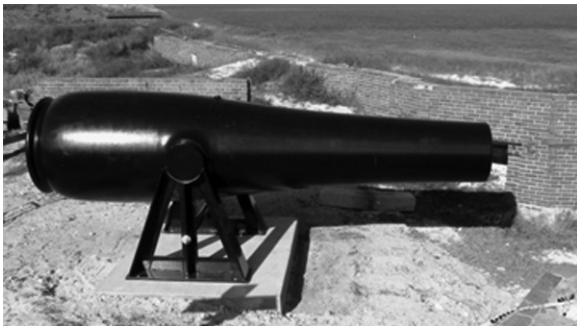
Figure 261. Cannon on alternative mount, 2012. (NPS image)

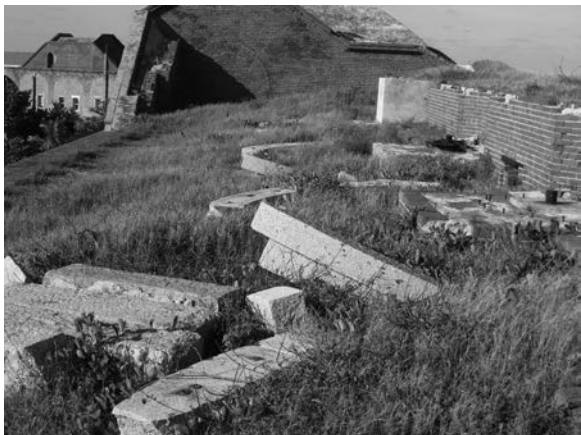
Figure 262. Disrupted granite pieces, Front 4, 2010. (SERO image 1544)

Many of the gun mounts without cannon are disrupted, with sections of granite scattered on the ground. The historic displacement of the traverse circles for the smaller guns on either side of each bastion occurred to facilitate installation of the 15-inch Rodmans. In addition, pintle blocks were replaced on the gun platforms when the 10-inch Parrotts were mounted on the fronts. Those replaced pintle blocks are still present on Fronts 1, 6 and 5. On Front 5, the pintle block is used to support the Parrott gun. In addition to the intentional, historic displacement of these elements, there are several gun platforms where single granite block has been moved, and it is still possible to determine where they belong.

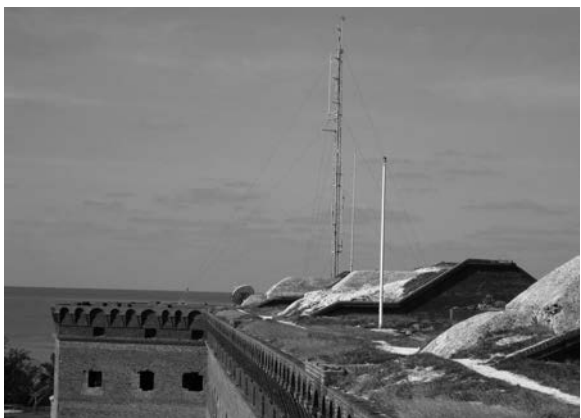
Figure 263. Telecommunications equipment along Front 1, 2010. (SERO image 1606)

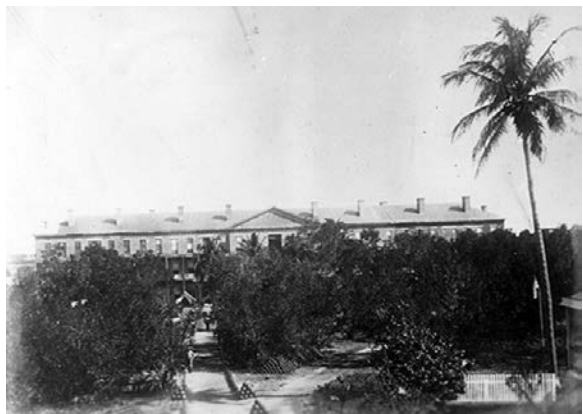
Figure 274. Pathways, 1901. (DRTO 301209)

The circulation across the parade ground of Fort Jefferson developed during fort construction. In 1854, the fort walls and counterscarp remained incomplete and areas within the walls were filled with excavated sand to create a level parade. The arrangement of temporary frame buildings and accompanying workspace likely kept circulation informal. As buildings were completed, circulation was formalized, and pathways, described as “hard as cement and white as snow,” connected the perimeter buildings. Cannonballs were stacked at

intervals along the main pathway connecting the sally port and the officers’ quarters, as well as along portions of other secondary pathways. It is not certain when cannonballs were added to line the main pathway, but it may have been in 1896 when the walk was rebuilt. On the fort’s exterior, the counterscarp was a favorite walking route.

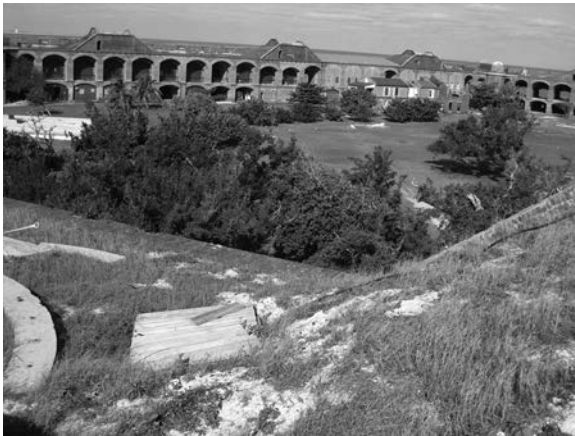
**Figure 276.** Wooden palette holding black cables, 2010. (SERO image 1619)

- Remove defunct satellite dish mounts on the terreplein.
- Cover exposed portions of the waterproofing membrane.
- Remove wooden palette holding black cables from communications tower in place on Front 1; replace with something more permanent that does not detract from the terreplein.

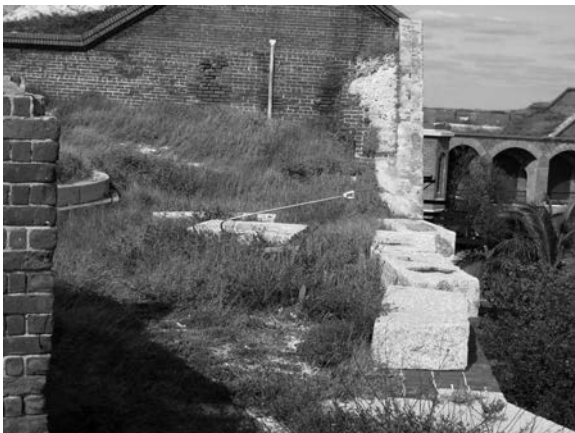
**Figure 277.** Old communication platform, 2010. (SERO image 1637)

- Remove old communication platform along Front 1 if it is no longer being used.
- Keep storage yard of north coaling dock free of debris.
- Remove abandoned Cuban refugee boats. This does not include the buried boats that are considered archeological resources.

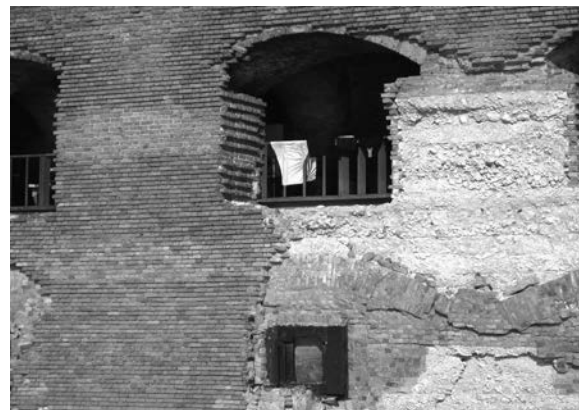
**Figure 278.** Laundry seen from the counterscarp walk, 2010. (SERO image 1510)

- Move AC condenser located near the perimeter path to a casemate.
- Conceal utility lines in underground trench using existing utility corridors.
- Use results of soundscape study to reduce the noise, vibration, and visual impact of generators housed in casemates along Front 2.

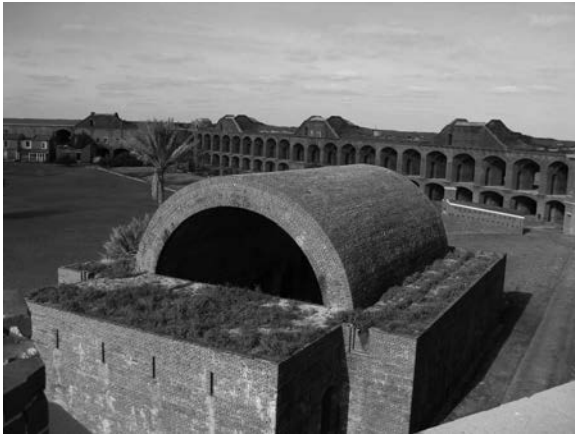
Figure 279. Vegetation on roof of large parade magazine, 2010. (SERO image 1559)

- Remove woody vegetation growing inside the structure and on the roof as needed.

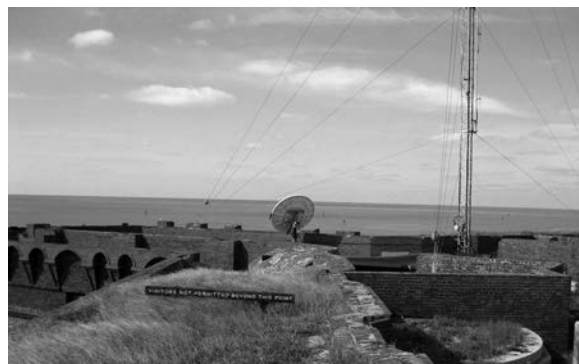
Figure 281. Communications equipment, 2010. (SERO image 1628)

Communications equipment installed at Bastion 1 is an adverse visual impact and diminishes integrity of setting.

- Investigate moving the equipment to another location. If it cannot be moved, seek new technologies to minimize the footprint and visual intrusion of the tower, dishes, and cabling.
- Ensure that communications equipment is at the lowest level without reducing satellite coverage.

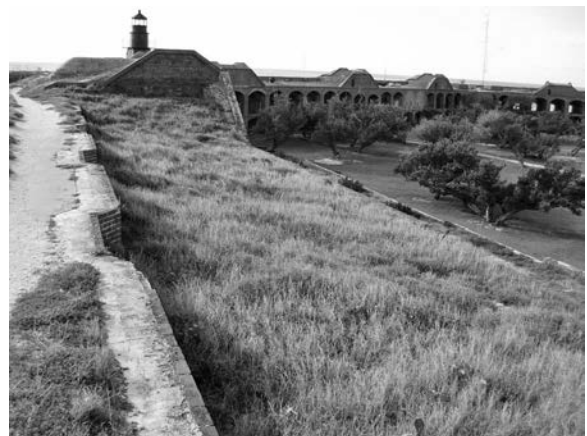
**Figure 282.** Vegetation covering traverse circles, 2010. (SERO image 1565)

In some areas, vegetation has completely covered the traverse circles. Many of the shot cellars are filled with sand and/or blocked by vegetation.

- Remove vegetation if it is covering the traverse circles.
- Remove spider lilies growing around cannon at Bastion 6. These could be replanted with other spider lilies along the perimeter walk on the parade ground or used to screen a lift station.
- Remove vegetation and/or sand from the shot

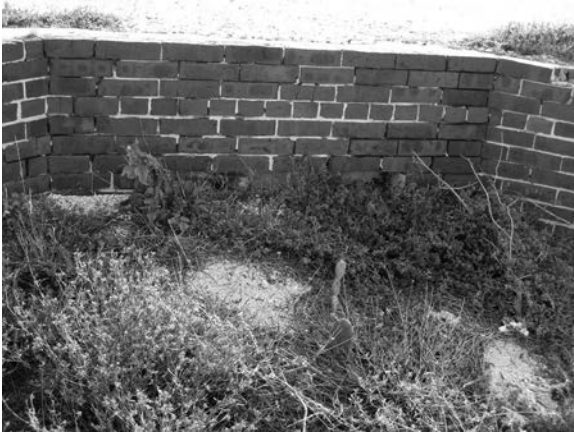
**Figure 283.** Shot cellar covered with sand and vegetation, 2010. (SERO image 1562)

cellars. Begin with those on the guided tour.

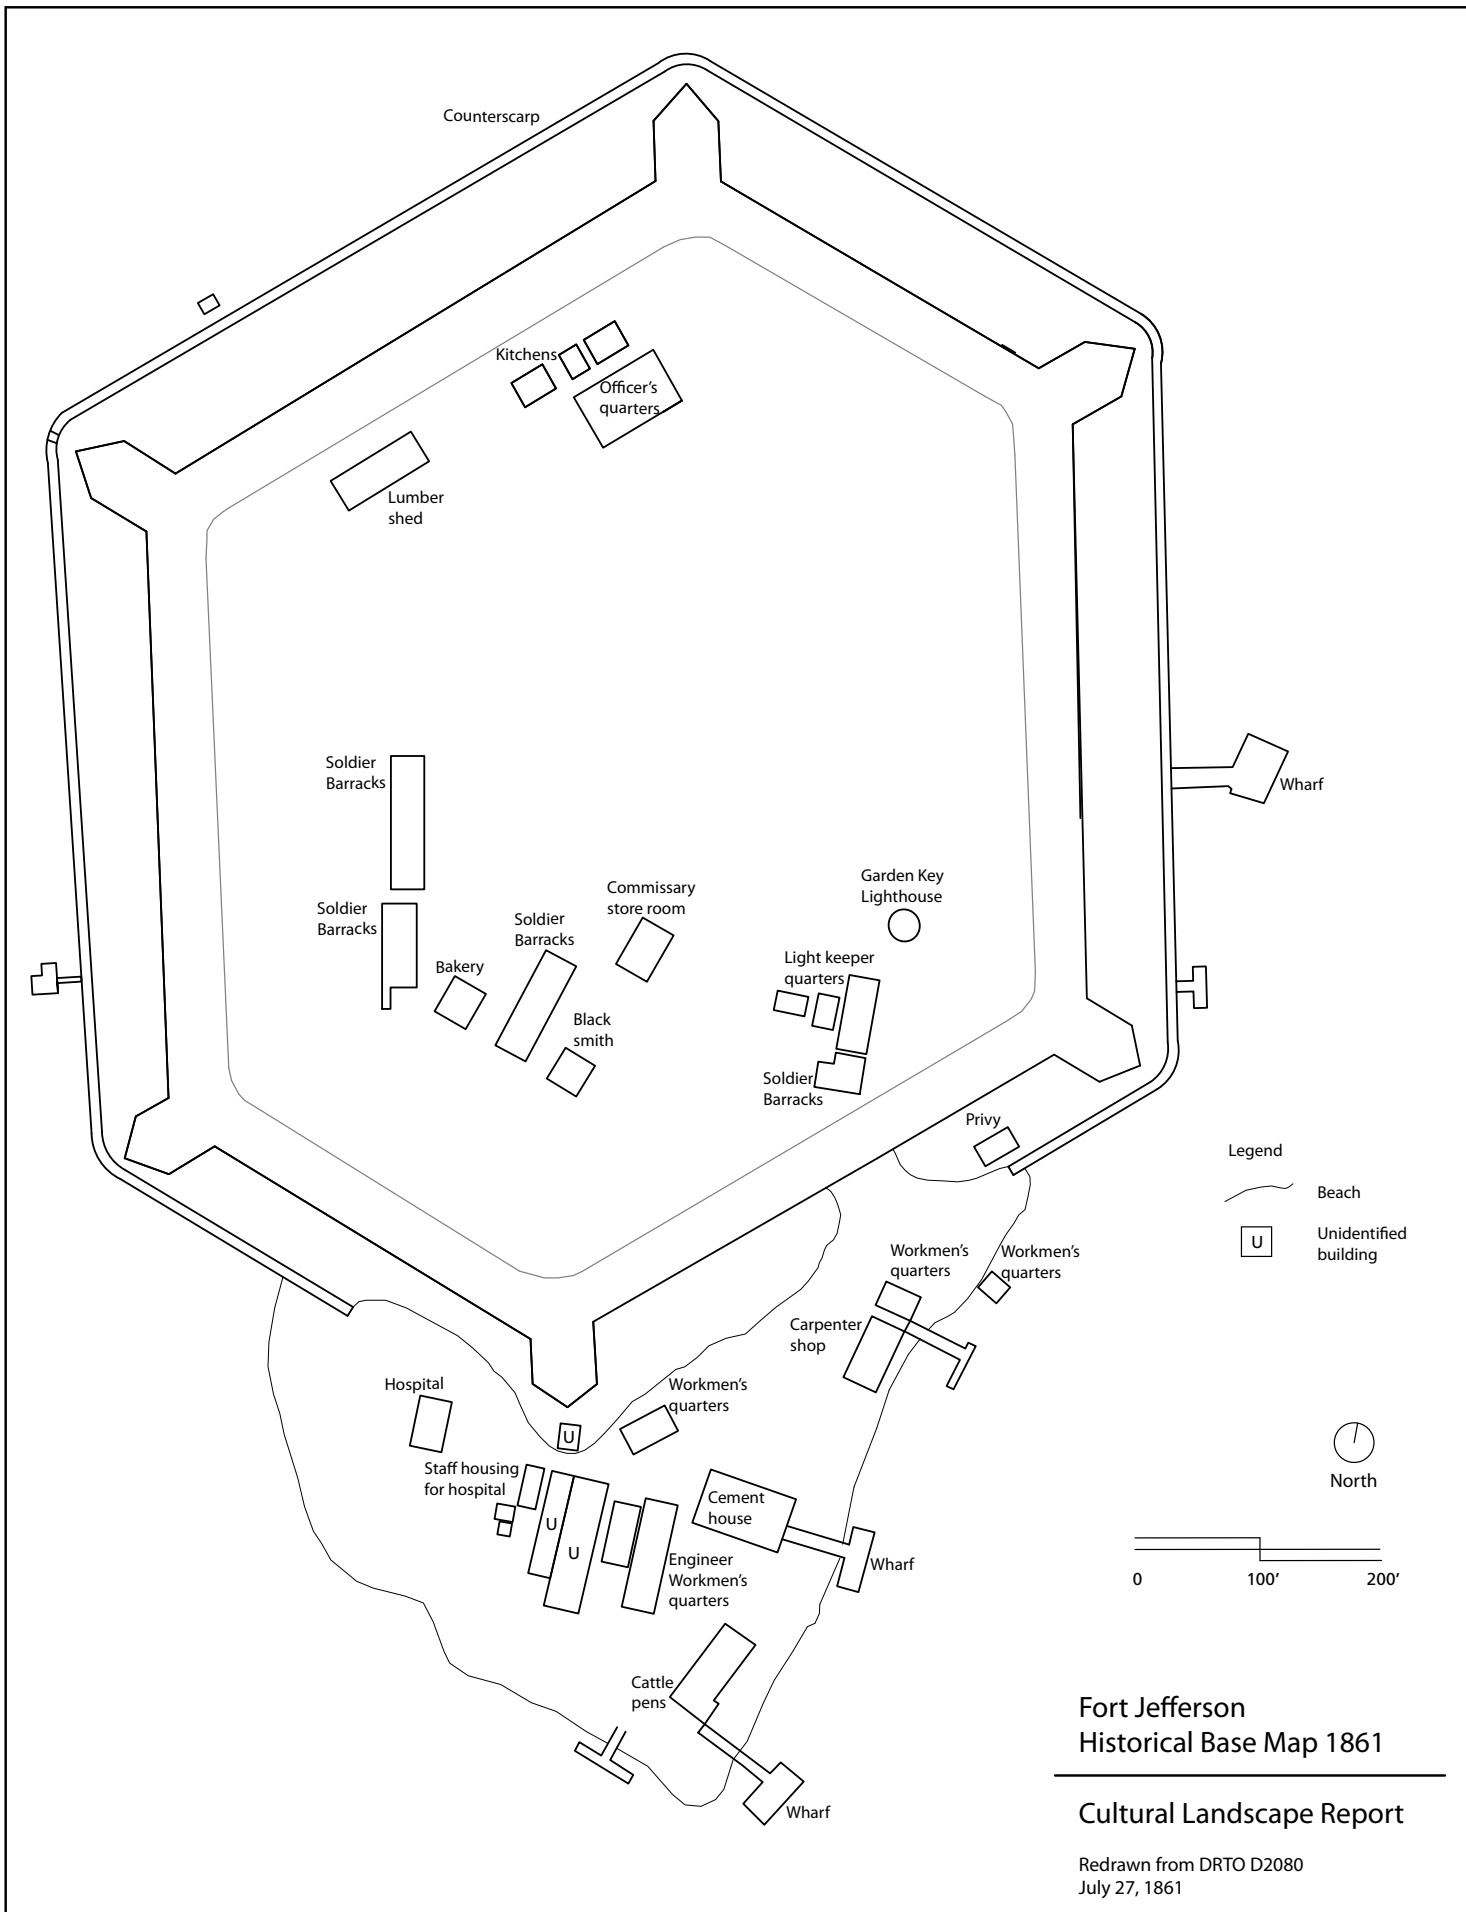
**Fort Jefferson  
Historical Base Map 1861**

Redrawn from DRTO D2080  
July 27, 1861

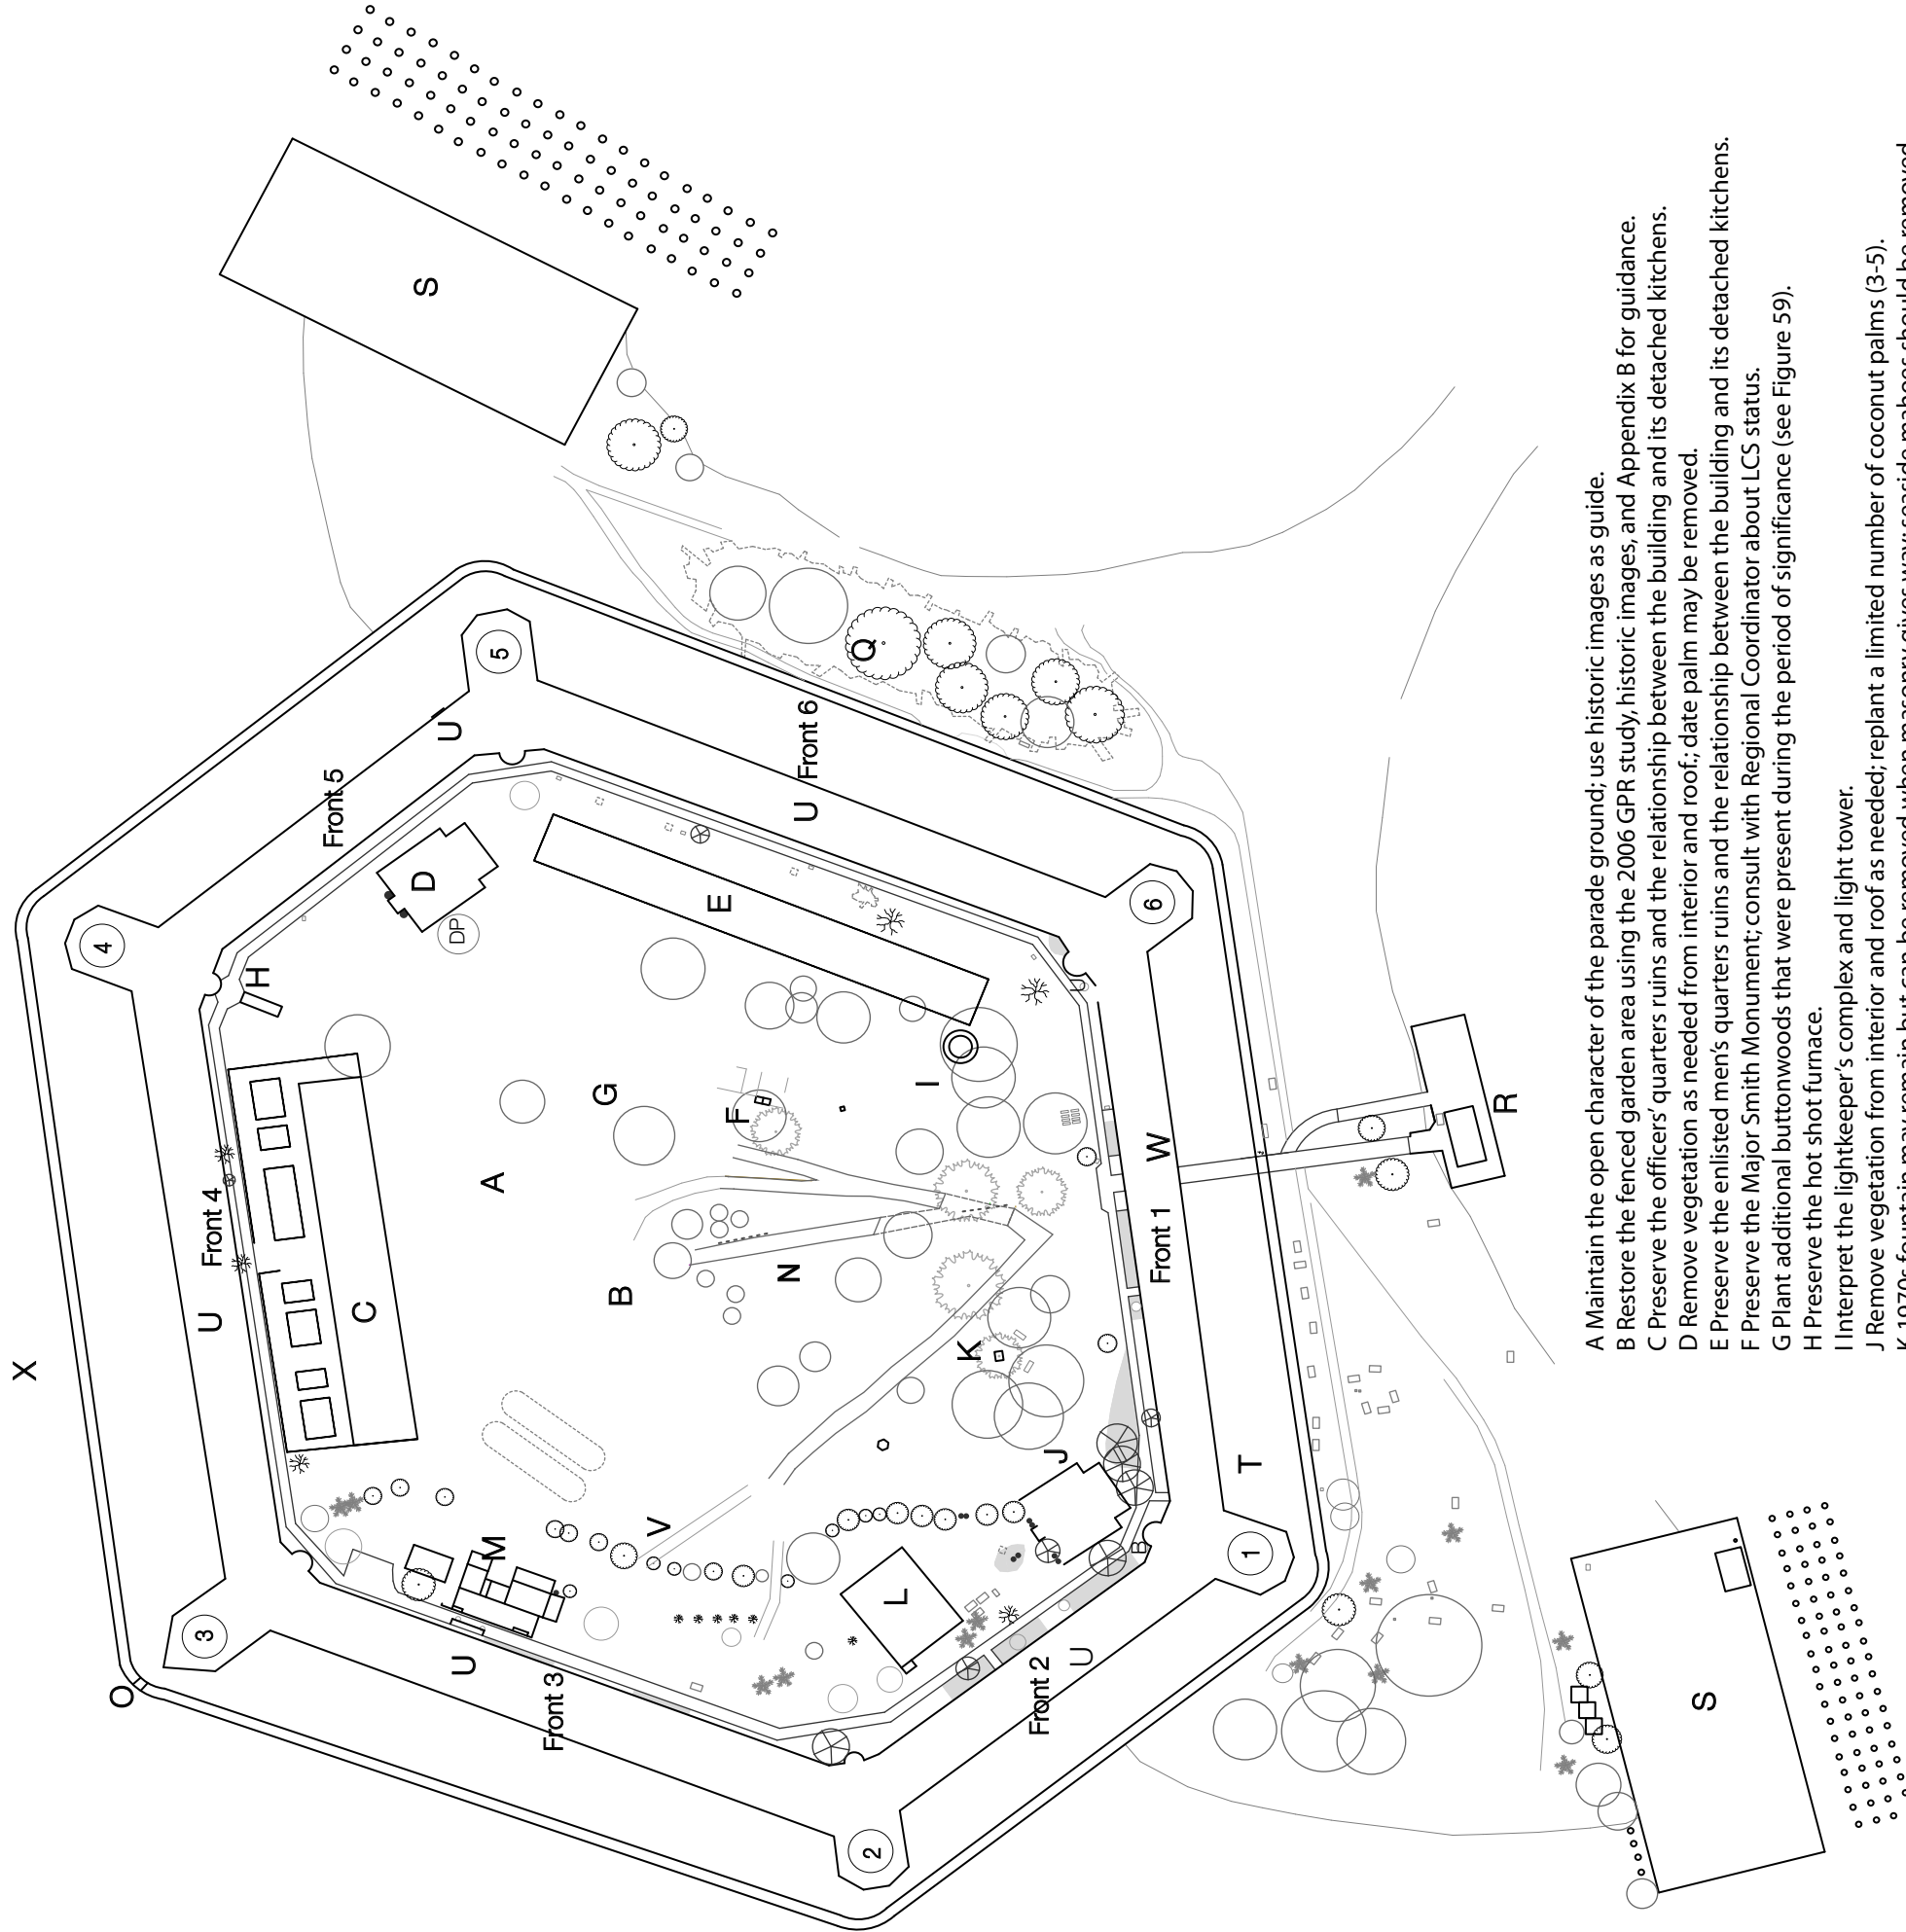
- A Maintain the open character of the parade ground; use historic images as guide.
- B Restore the fenced garden area using the 2006 GPR study, historic images, and Appendix B for guidance.

- C Preserve the officers' quarters ruins and the relationship between the building and its detached kitchens.
- D Remove vegetation as needed from interior and roof; date palm may be removed.
