Coastal Hazards & Sea-Level Rise Asset Vulnerability Assessment for Fort Monroe National Monument

Summary of Results

NPS 250/187656, February 2023

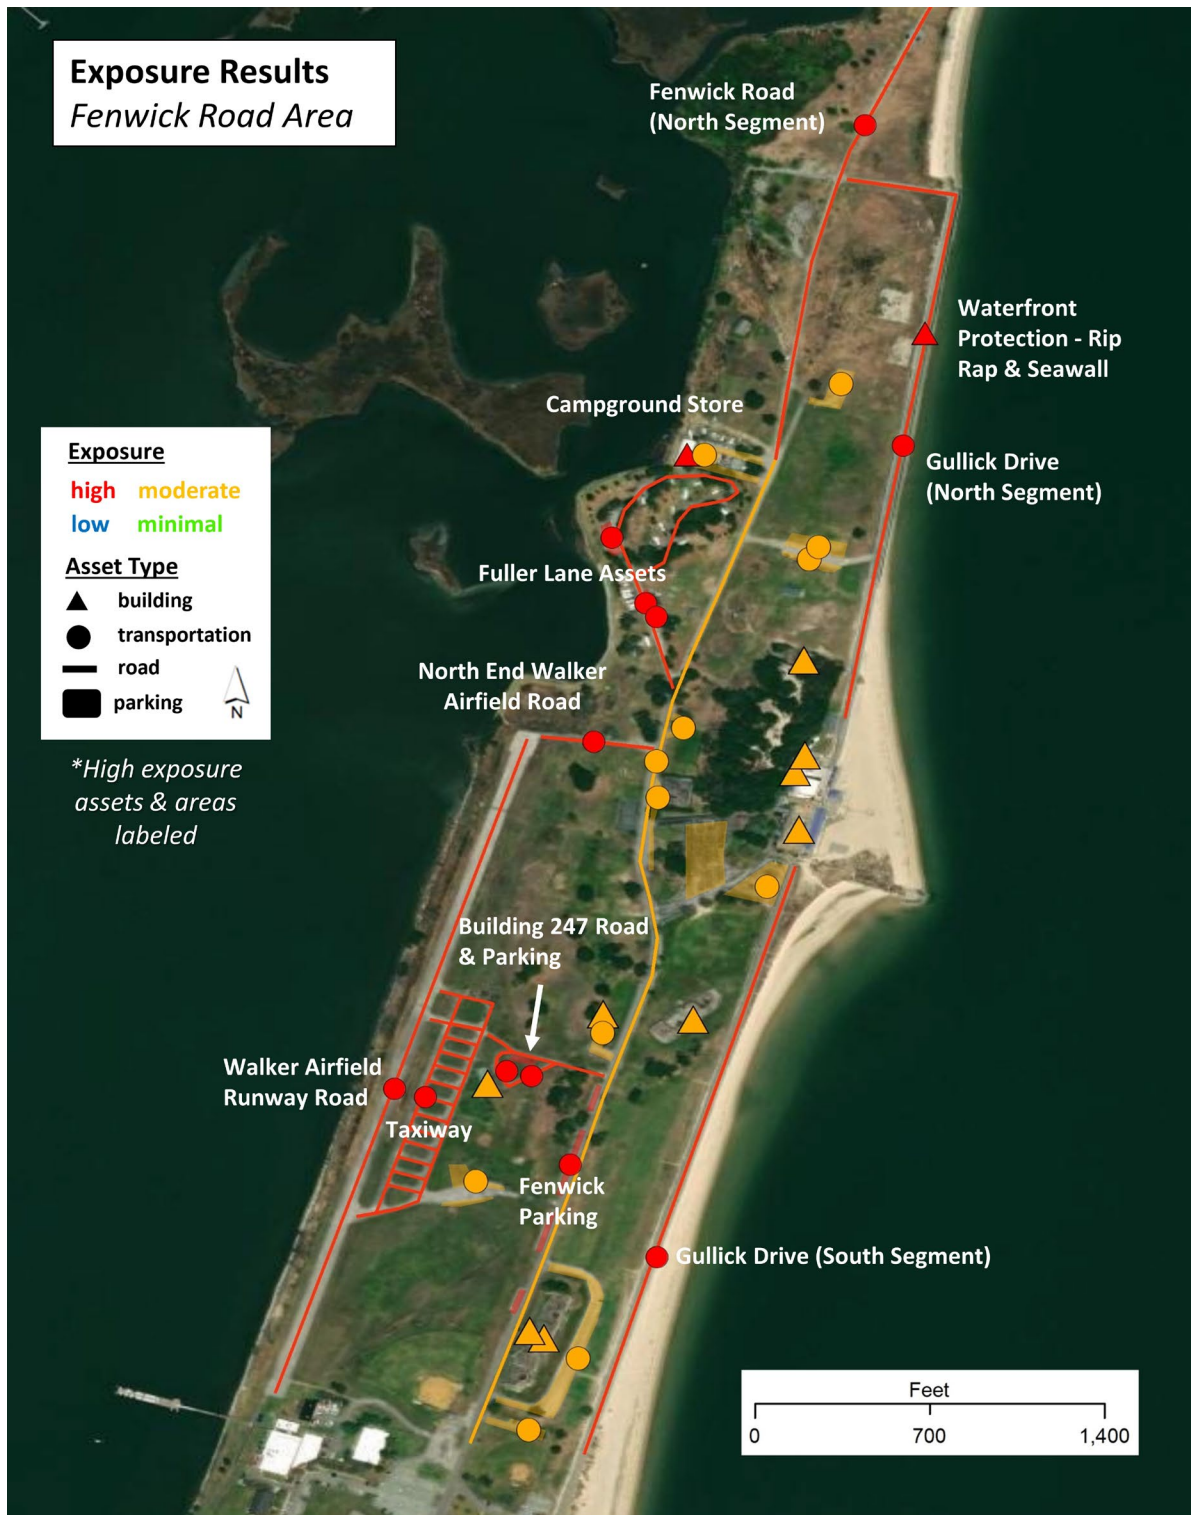
Figure 2. FOMR exposure results for the Fenwick Road area. Only high exposure assets and areas are labeled. Background map is ESRI streaming imagery.

All assets analyzed at FOMR have high (34%) or moderate (66%) exposure to the evaluated coastal hazards (Table 2, and Figure 1-2). These results are a factor of the park’s high exposure to coastal flooding, as indicated by the widespread Federal Emergency Management Agency (FEMA) AE zone (1% annual chance flood) and the modeled category 3 storm surge inundation extent across the park. In addition, all assets have been flooded by past coastal storms (primarily Hurricane Isabel). Four assets are within all evaluated exposure zones, including the Waterfront Protection – Rip Rap & Seawall, Fuller Lane, Fuller Lane Dump Station Parking, and Walker Airfield Runway Road. No assets have low or minimal exposure.

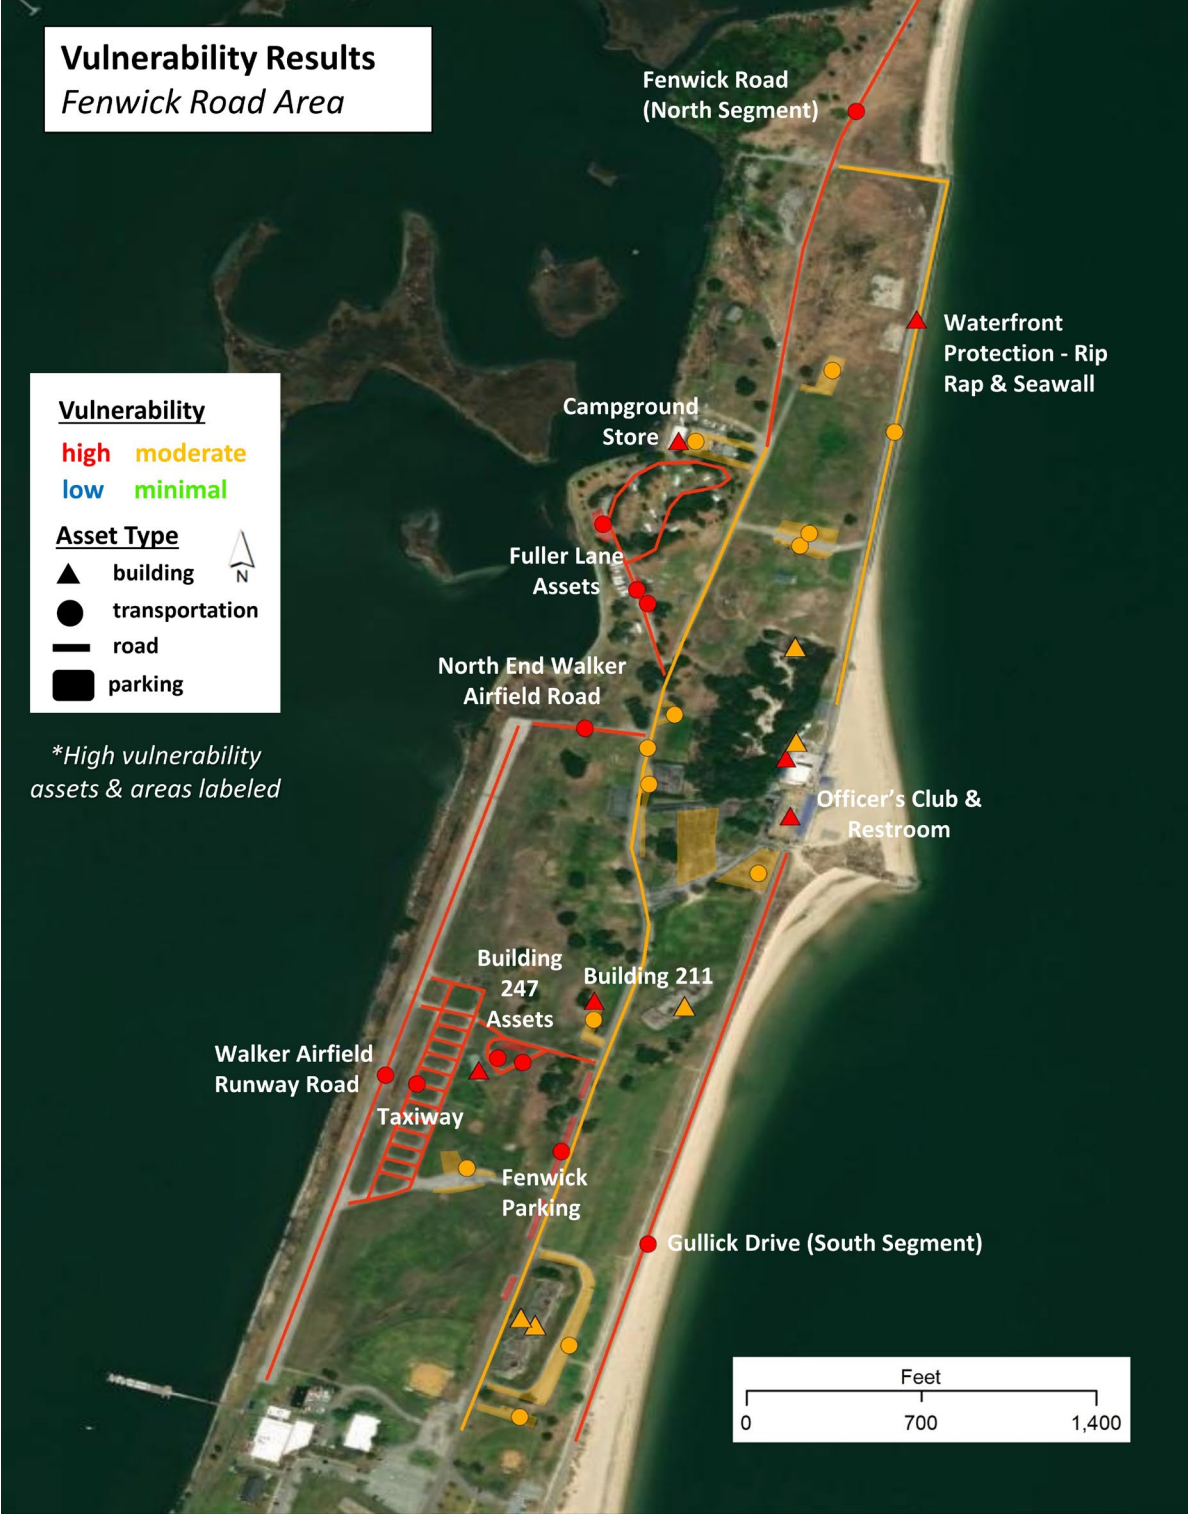
Figure 4. FOMR vulnerability results for the Fenwick Road. Only high vulnerability assets and areas are labeled. Background is ESRI streaming imagery.

The majority (61%) of assets analyzed at FOMR have moderate vulnerability to the evaluated coastal hazards; all other assets (39%) have high vulnerability (Table 4, and Figures 3-4). No assets have low or minimal vulnerability. Two high vulnerability assets, Gullick Drive - South Section and Waterfront Protection - Rip Rap & Seawall, also have a high asset priority index ($API \geq 70$, as reported in FMSS). The Original Fort Headquarters - Building 1 has moderate vulnerability and the highest possible API (100).
