Development Concept Plan
Environmental Assessment

Sunrise

MOUNT RAINIER

**Decision Notice
Finding of No Significant Impact
Development Concept Plan
Sunrise
Mount Rainier National Park
Washington**

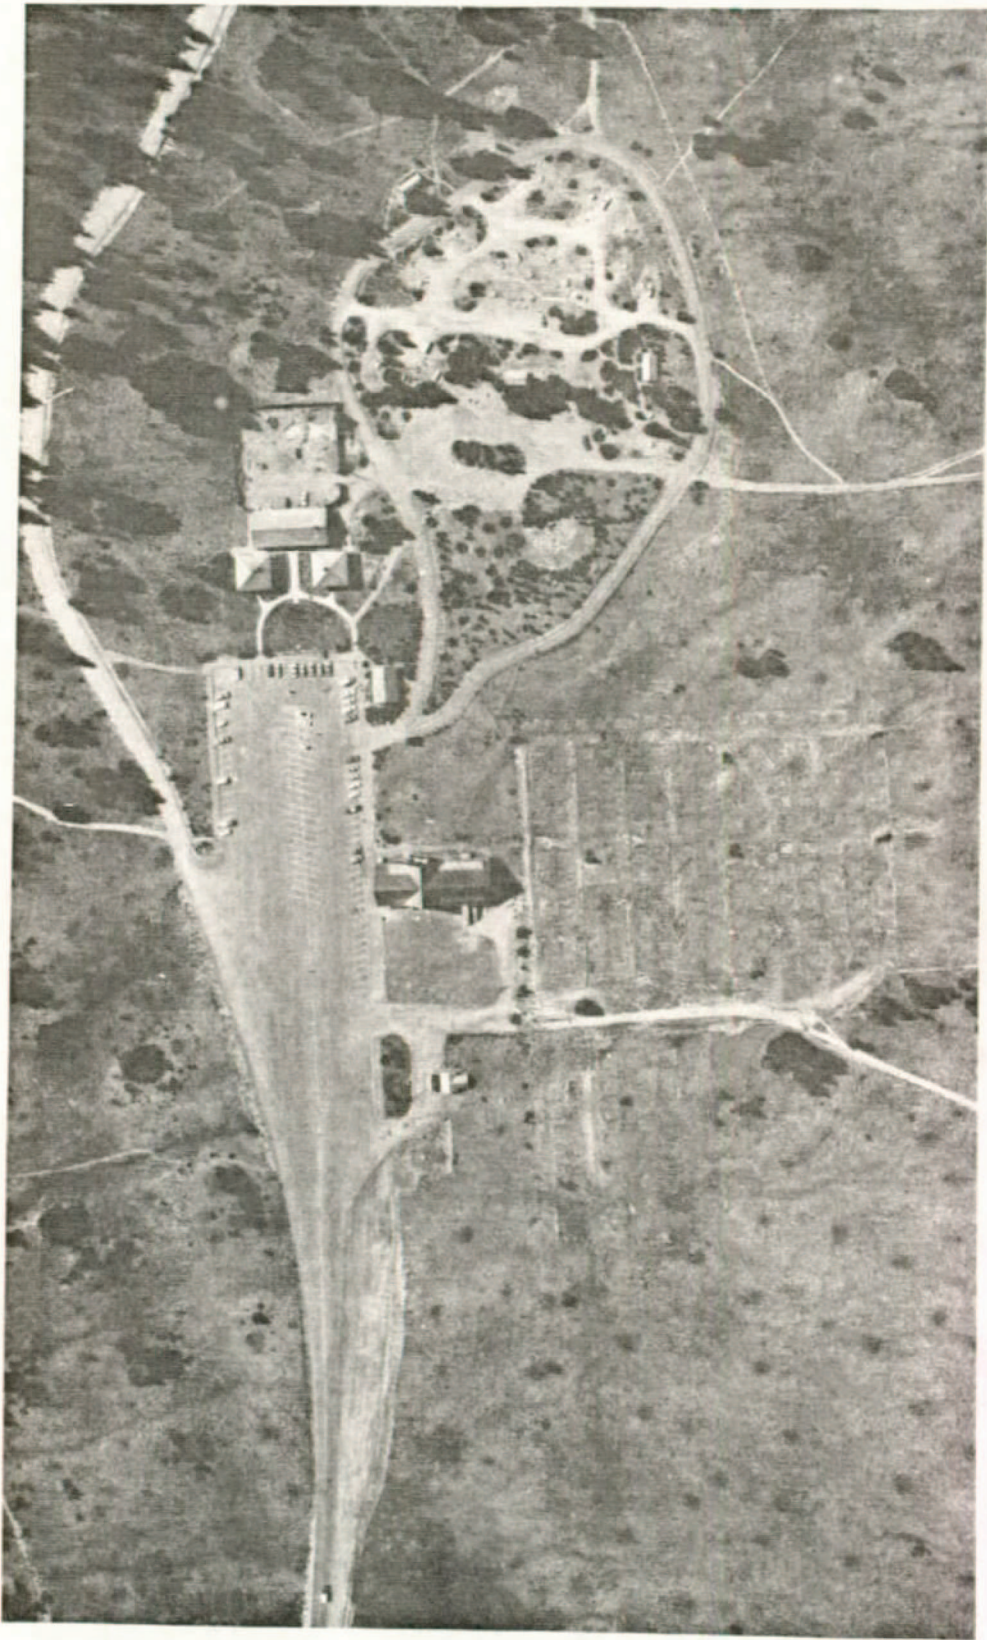
AERIAL PHOTO OF SUNRISE, 1971

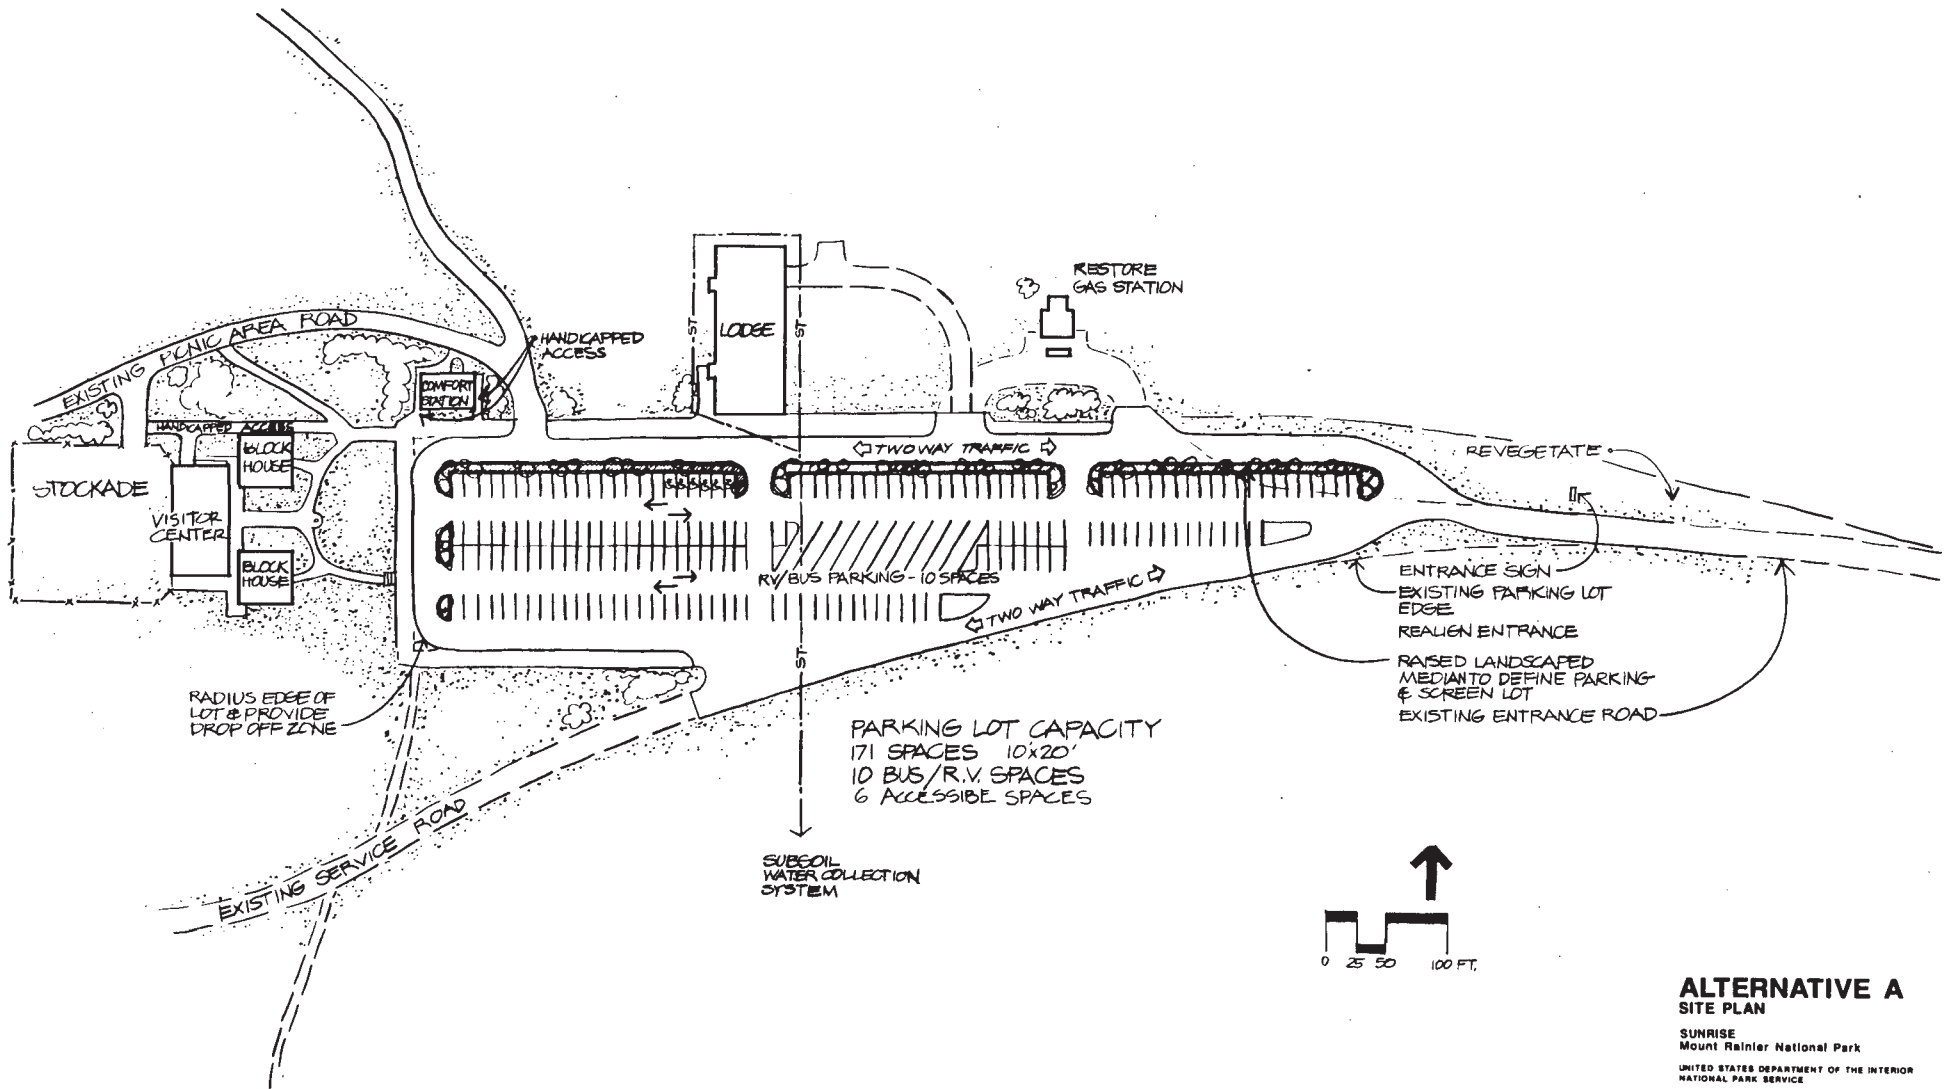
PARKING LOT CAPACITY
 171 SPACES 10x20'
 10 BUS/R.V. SPACES
 6 ACCESSIBLE SPACES

The lodge would remain at the existing size of 16,466 square feet total in two stories and a basement. The footprint would remain at 6,800 square feet (0.16 acre).

A subsoil water collection pipe and distribution system would be constructed to eliminate spring flooding in the basement and subsequent settling of the building foundation. This would entail excavating around the building foundation and through the parking area to lay drainage piping. Water would be drained south of the parking area through a 100-foot-long perforated pipe. Construction would involve excavating a 10-foot-wide area within a 40-foot construction zone around the building to lay drainage pipes a minimum of 7 feet deep, building a new spread footing foundation and structural piers, and leveling the building. The fuel oil tank, located 100 feet east of the lodge, would be excavated and replaced, requiring about a 200-square-foot excavation area.
