**GEOLOGIC HAZARD
and FLOODPLAIN MANAGEMENT**

**Mount Rainier General Management Plan
August 1997**

**Jon L. Riedel
National Park Service Geologist**

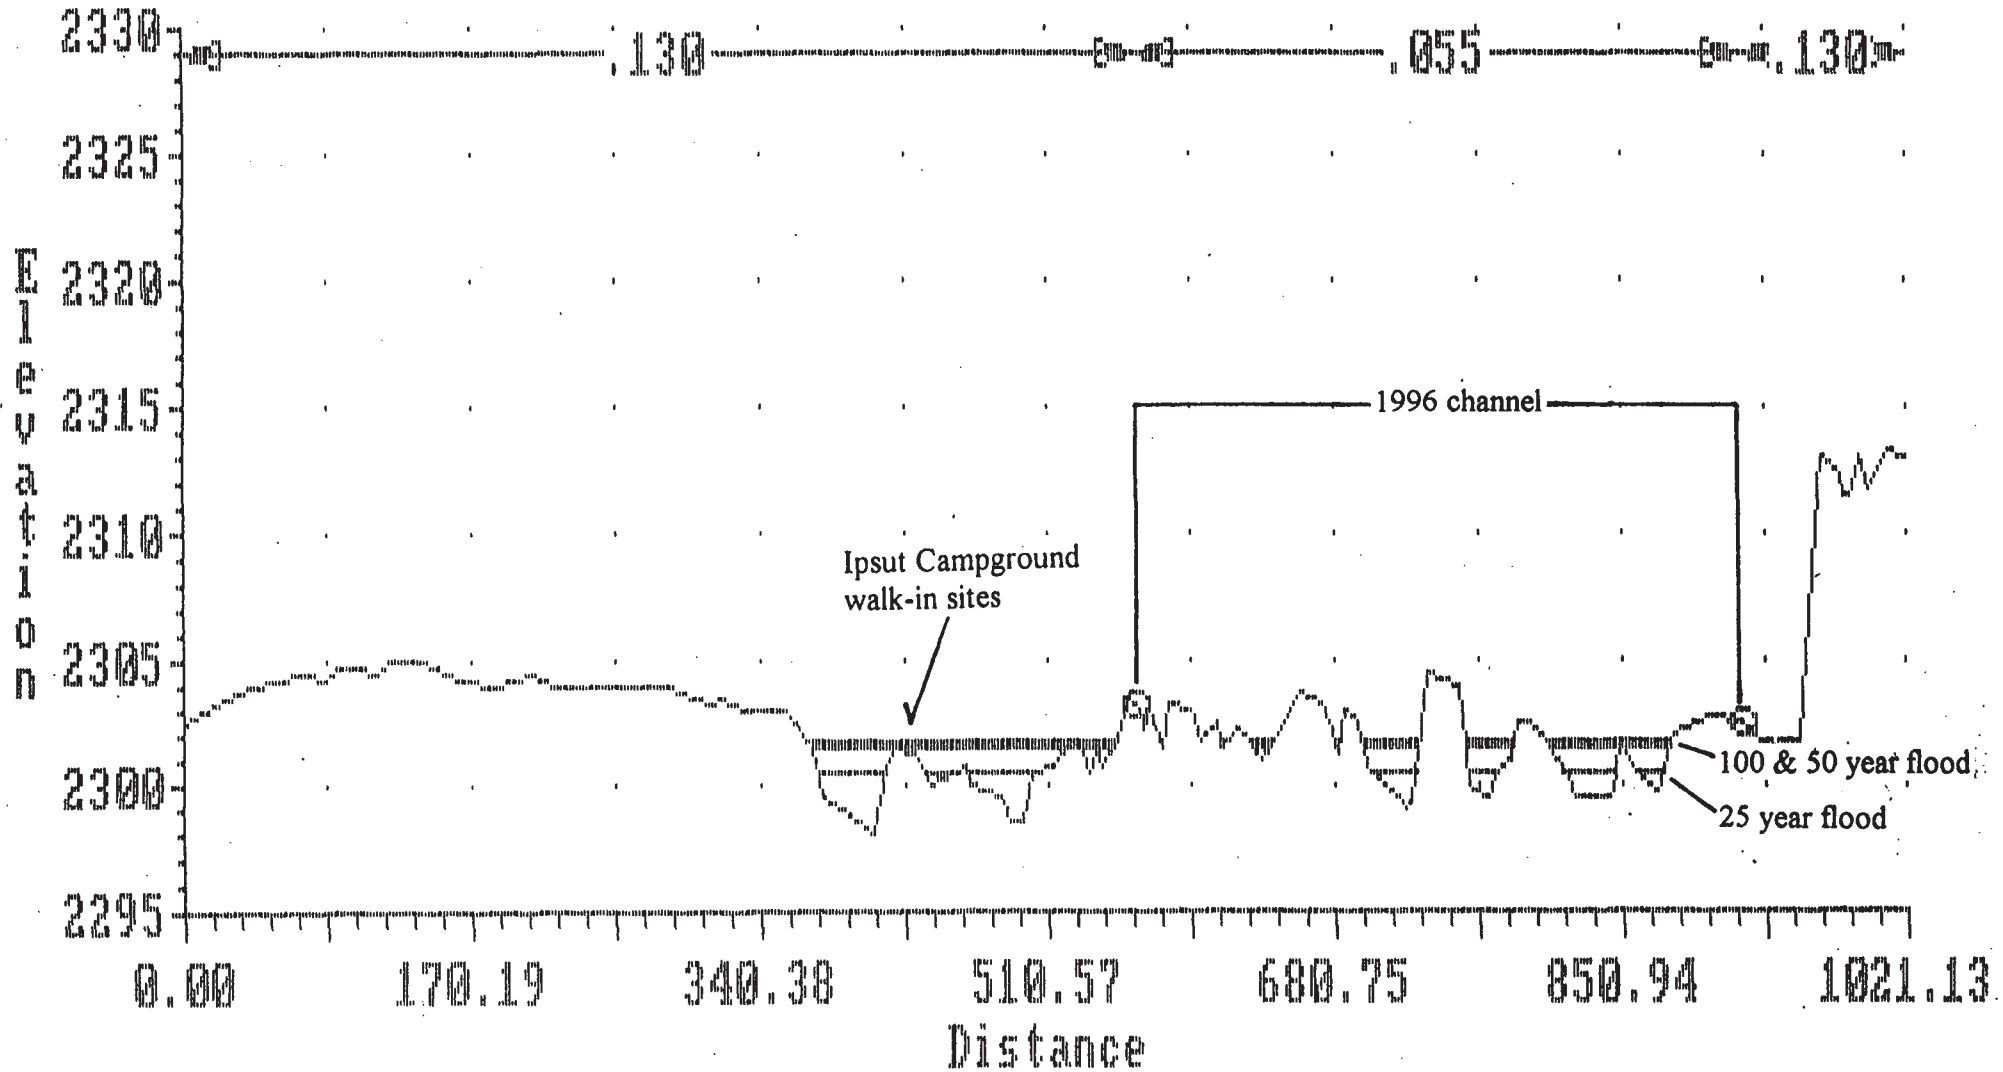
CARRON IPSUT
Cross-section 2.000

Figure 11. Floodplain cross section at Ipsut Campground from floodplain model HEC2. Cross section #2, see Figure12 for location. View looking downstream.

Surveyed cross sections shown in Figures 10 and 11 illustrate that parts of the campground, walk in sites and entrance road occupy very low parts of the floodplain. The majority of the campground rests on a low terrace, 5-6 ft (1.5-1.8m) above the modern channel. The walk in sites are isolated by swift water in a side-channel during even smaller flood events. High flood hazard occurs at discharges of 1,000 cfs or greater.

Hydraulic model output indicates that most of the camp is outside the existing 100 year floodplain (Figures 10 and 11). However, the unstable nature of braided channels and the fact that parts of the campground are at lower elevations than the active channel suggest that the 100 year floodplain boundaries from the model may not be accurate for very long. Therefore, the 100 year floodplain boundary lines are conservatively drawn to include the low-elevation flood channels on the southwest end of the valley (Figure 12). This places the campground within the 100 year floodplain.

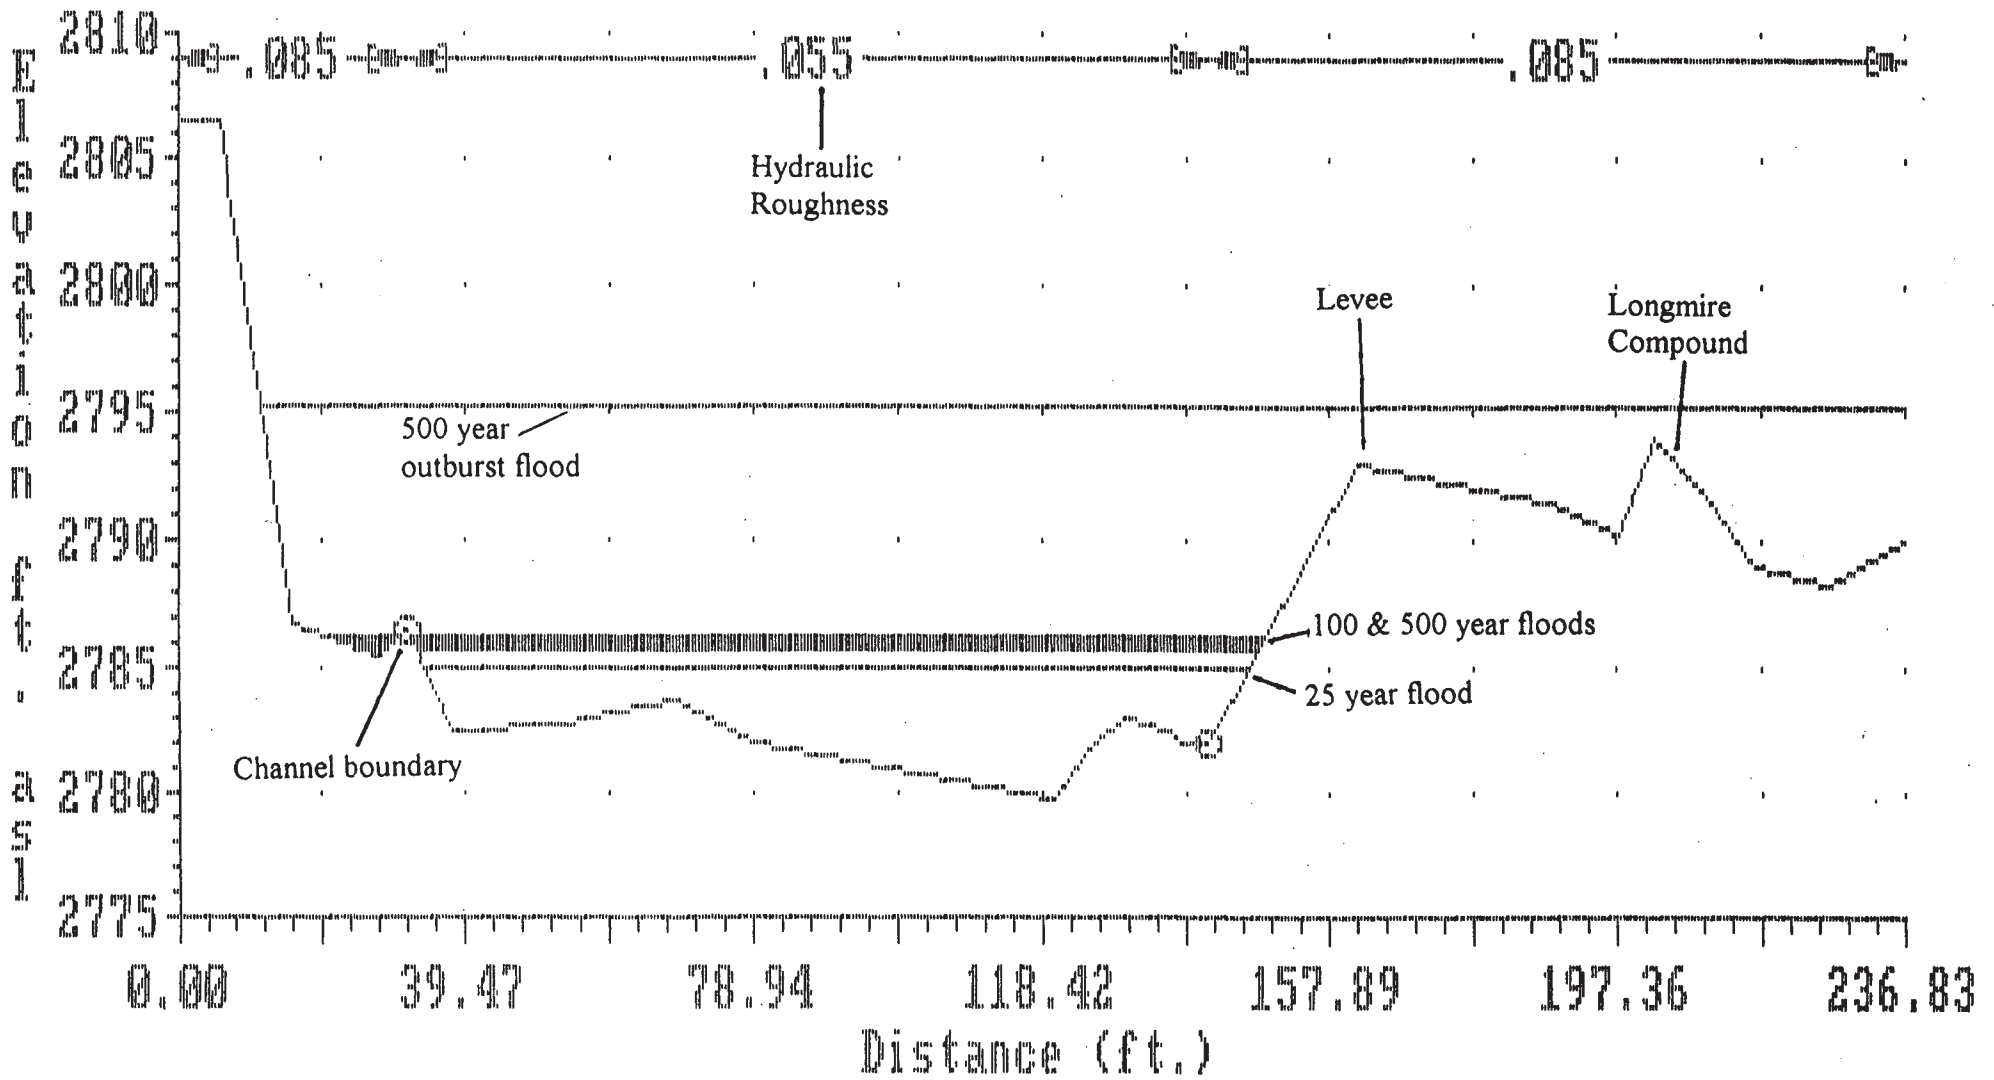
NISQUALLY RIVER AT LONGMIRE
 Cross-section 3.000

Figure 18. Floodplain cross section at Longmire from floodplain model HEC2. View looking downstream.

Direct comparison between the Nelson (1986) and this study is not possible because each used different survey grids. At the bridge, where cross sections from both studies were located, results were nearly identical between the two studies for water dominated 100 and 500 year floods. Figure 18 is a view looking downstream at cross section three from the 1994 hydraulic

model. It shows that 100 and 500 year precipitation flood flows are contained within the channel. The boundaries of the 100 year flood flow is shown on Figure 19.

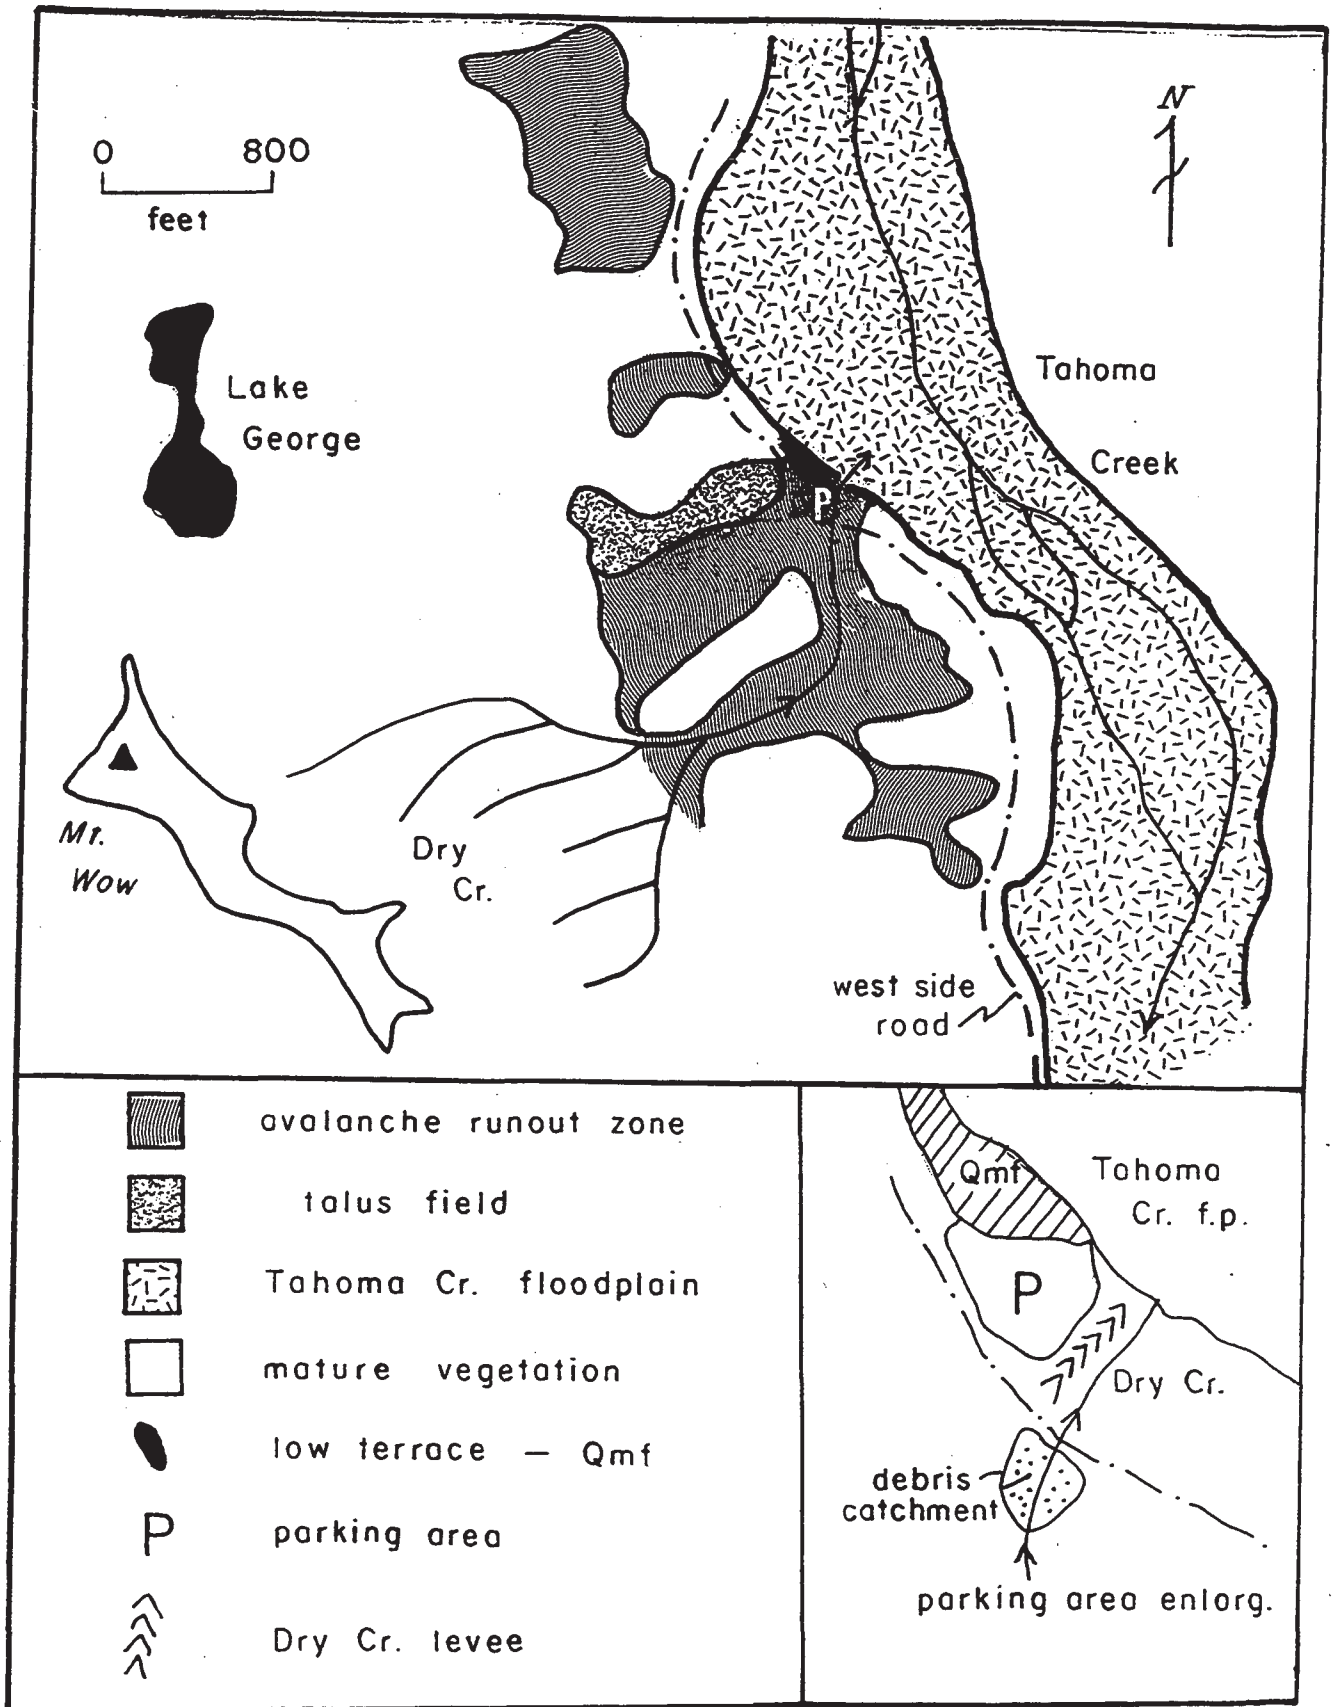
Figure 21. Geologic hazard map for the lower eastern slopes of Mt. Wow, including proposed pit toilet location and parking area along Tahoma Creek. Qmf denotes deposits from the Round Pass Mudflow (2,800 years before present) and Tahoma lahar (< 450 years before present).

The unstable bedrock on the slopes of Mt. Wow is geologic hazard. These slopes have sent several mass movements into the Tahoma Creek Valley (Scott and others, 1992). The road crosses a small talus field and rock fall hazard east of Lake Allen, and a larger talus field- rock fall and snow avalanche area between Dry Creek and the former picnic area. The current parking area at the end of the road is in a hazard zone from snow avalanches and rock fall, and should be considered for relocation (Figure 21). The old picnic area and campground are presently closed and should remain closed because of their proximity to the Tahoma Creek Floodplain and outburst flood/debris flow activity on Tahoma Creek.
