Coastal Hazards & Sea-Level Rise Asset Vulnerability Assessment for Saint Croix Island International Historic Site

Summary of Results

NPS 443/188060, April 2023

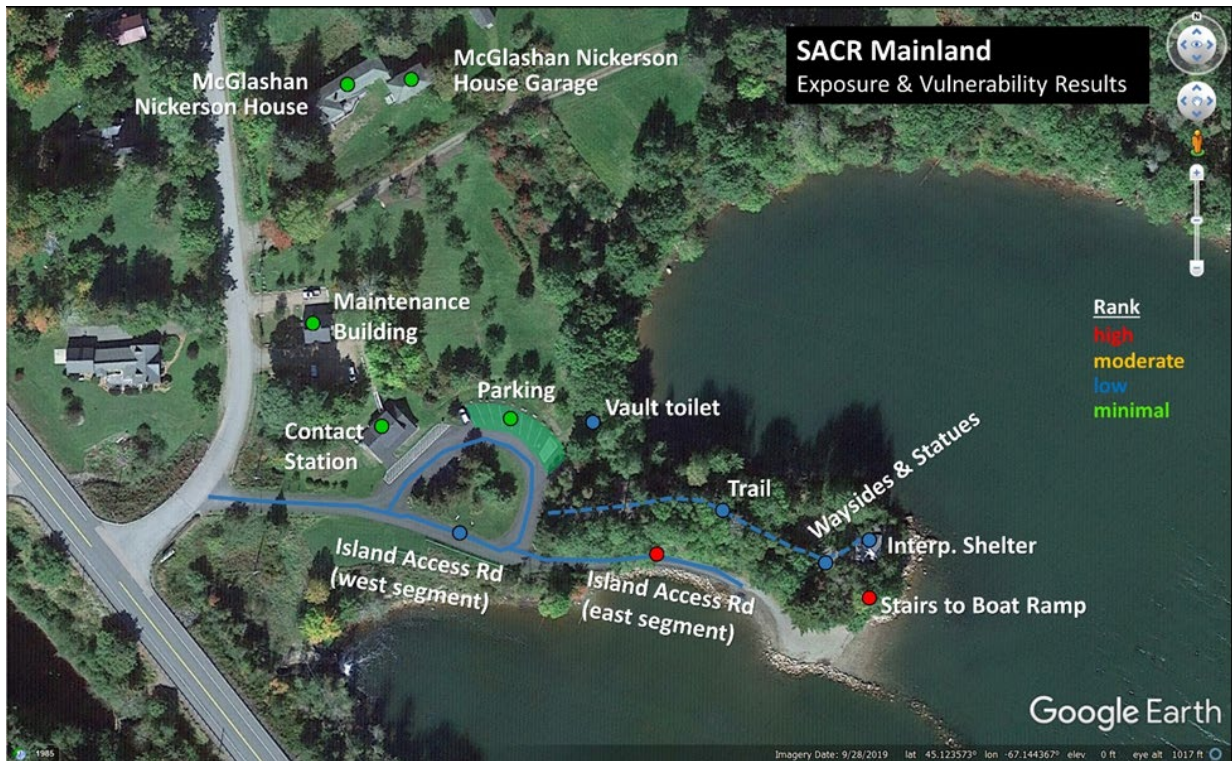
Figure 1. SACR exposure and vulnerability results summary for the mainland area. Background is Google Earth streaming imagery.

The vulnerability results at SACR are identical to the exposure results, which means that the vulnerability of these assets is primarily controlled by exposure (Table 4, and Figures 1-2). Four assets have high vulnerability to the evaluated coastal hazards and SLR: St. Croix Island Maintained Grounds (Stairs to Beach), St. Croix Boat House, Red Beach Maintained Grounds (Stairs to Boat Ramp), and St. Croix Island Access Road (East Segment to Boat Access). The St. Croix Boat House and St. Croix Island Maintained Grounds (Stairs to Beach) have both high exposure and high sensitivity. Most assets at SACR have low (40%) or minimal (33%) vulnerability to the evaluated coastal hazards.

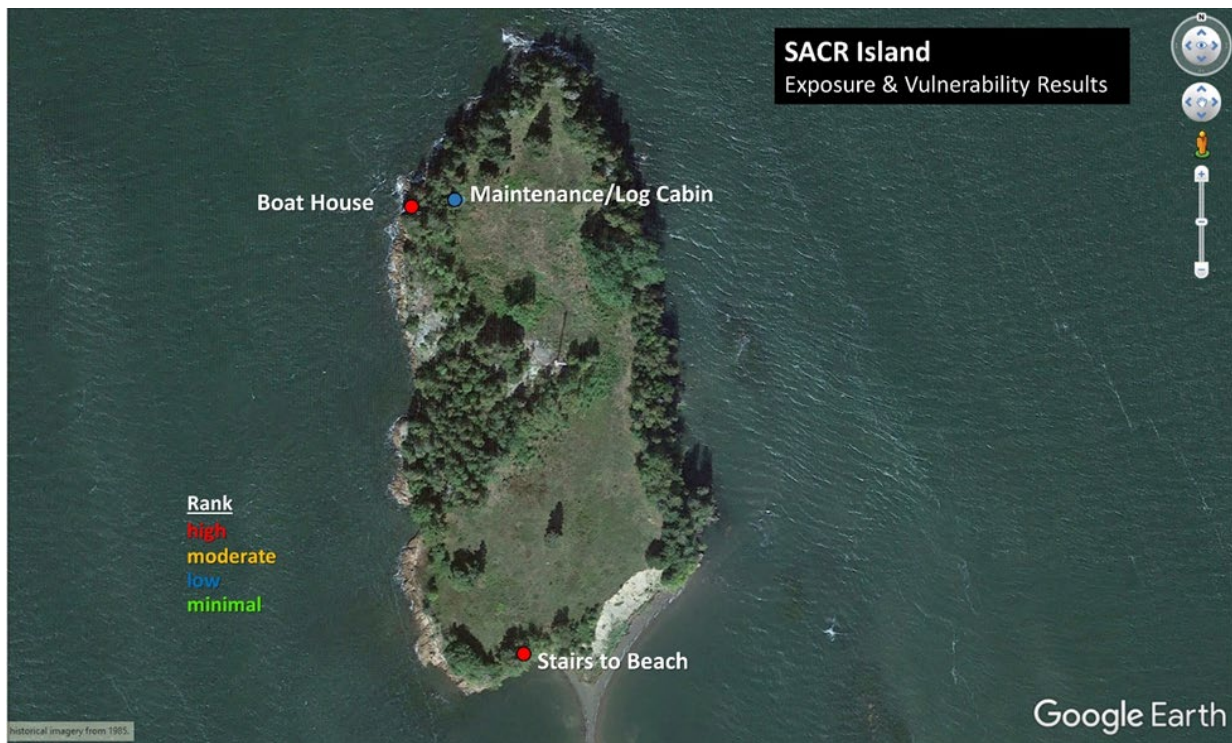
Figure 2. SACR exposure and vulnerability results summary for Saint Croix Island. Background is Google Earth streaming imagery.
