# The Road Inventory of Shenandoah National Park

## Road Inventory Program

Prepared By:  
Federal Highway Administration  
Eastern Federal Lands Highway Division  
December 1999

# Shenandoah National Park in Virginia

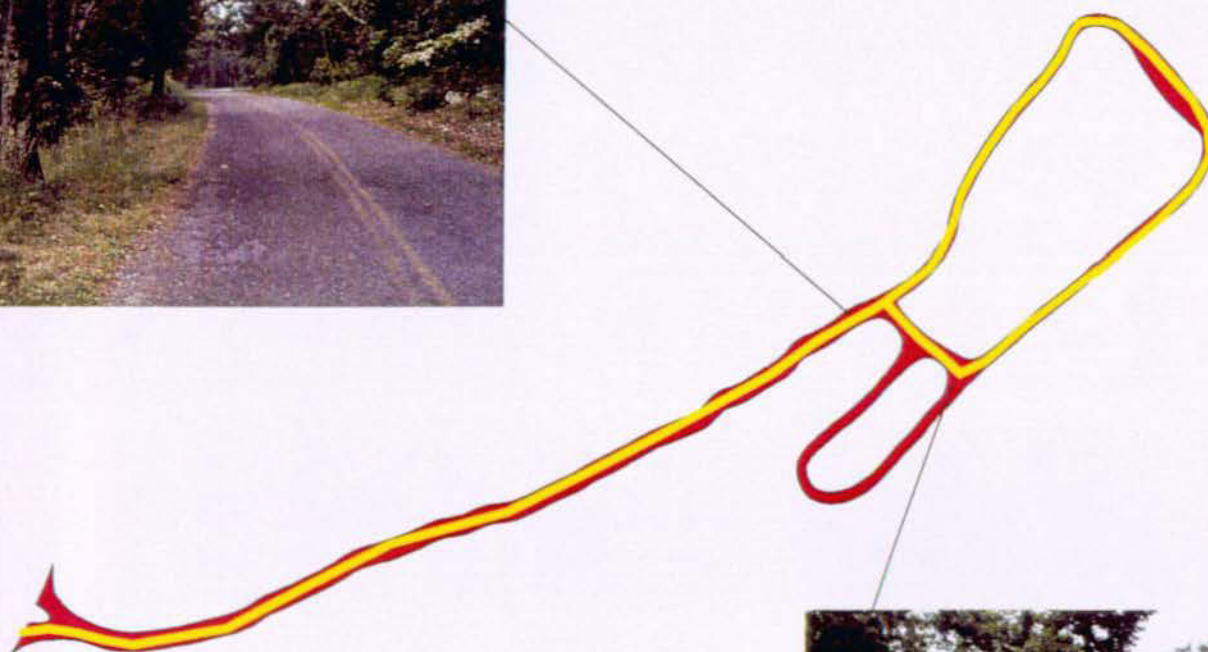
Route	Area (sq ft)	Lane Miles	Sample Section (mi)	Width (ft)	SCR	RI	PCR	Condition
78	41214	0.7	.44		71	NA	NA	FAIR
