The Road Inventory of Yosemite National Park

Road Inventory Program

Prepared By:
Federal Highway Administration
Eastern Federal Lands Highway Division
December 1999

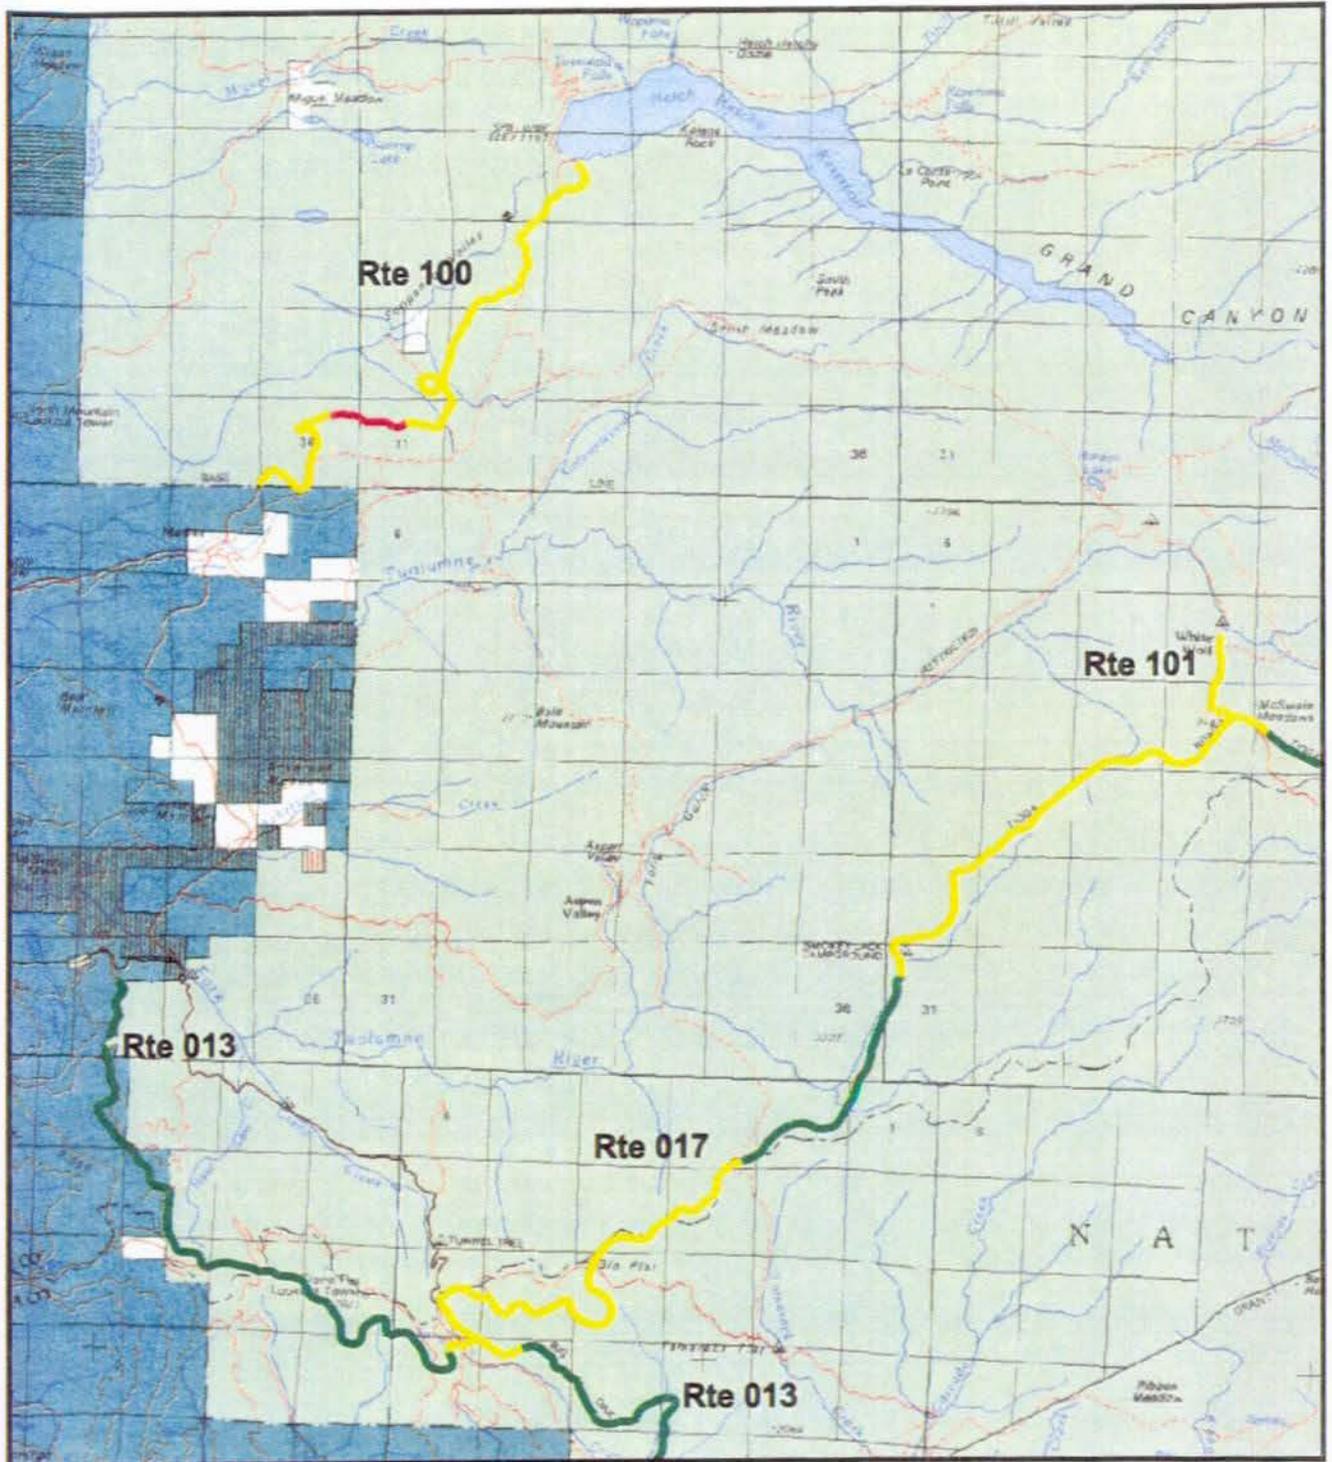
YOSEMITE NATIONAL PARK ROUTE CONDITION KEY MAP 1 PCR/DCR - Mile by Mile

PCR Excellent	Good	Fair	Poor	DCR Poor

* If the PCR rating is not available for a section, the SCR rating will be displayed

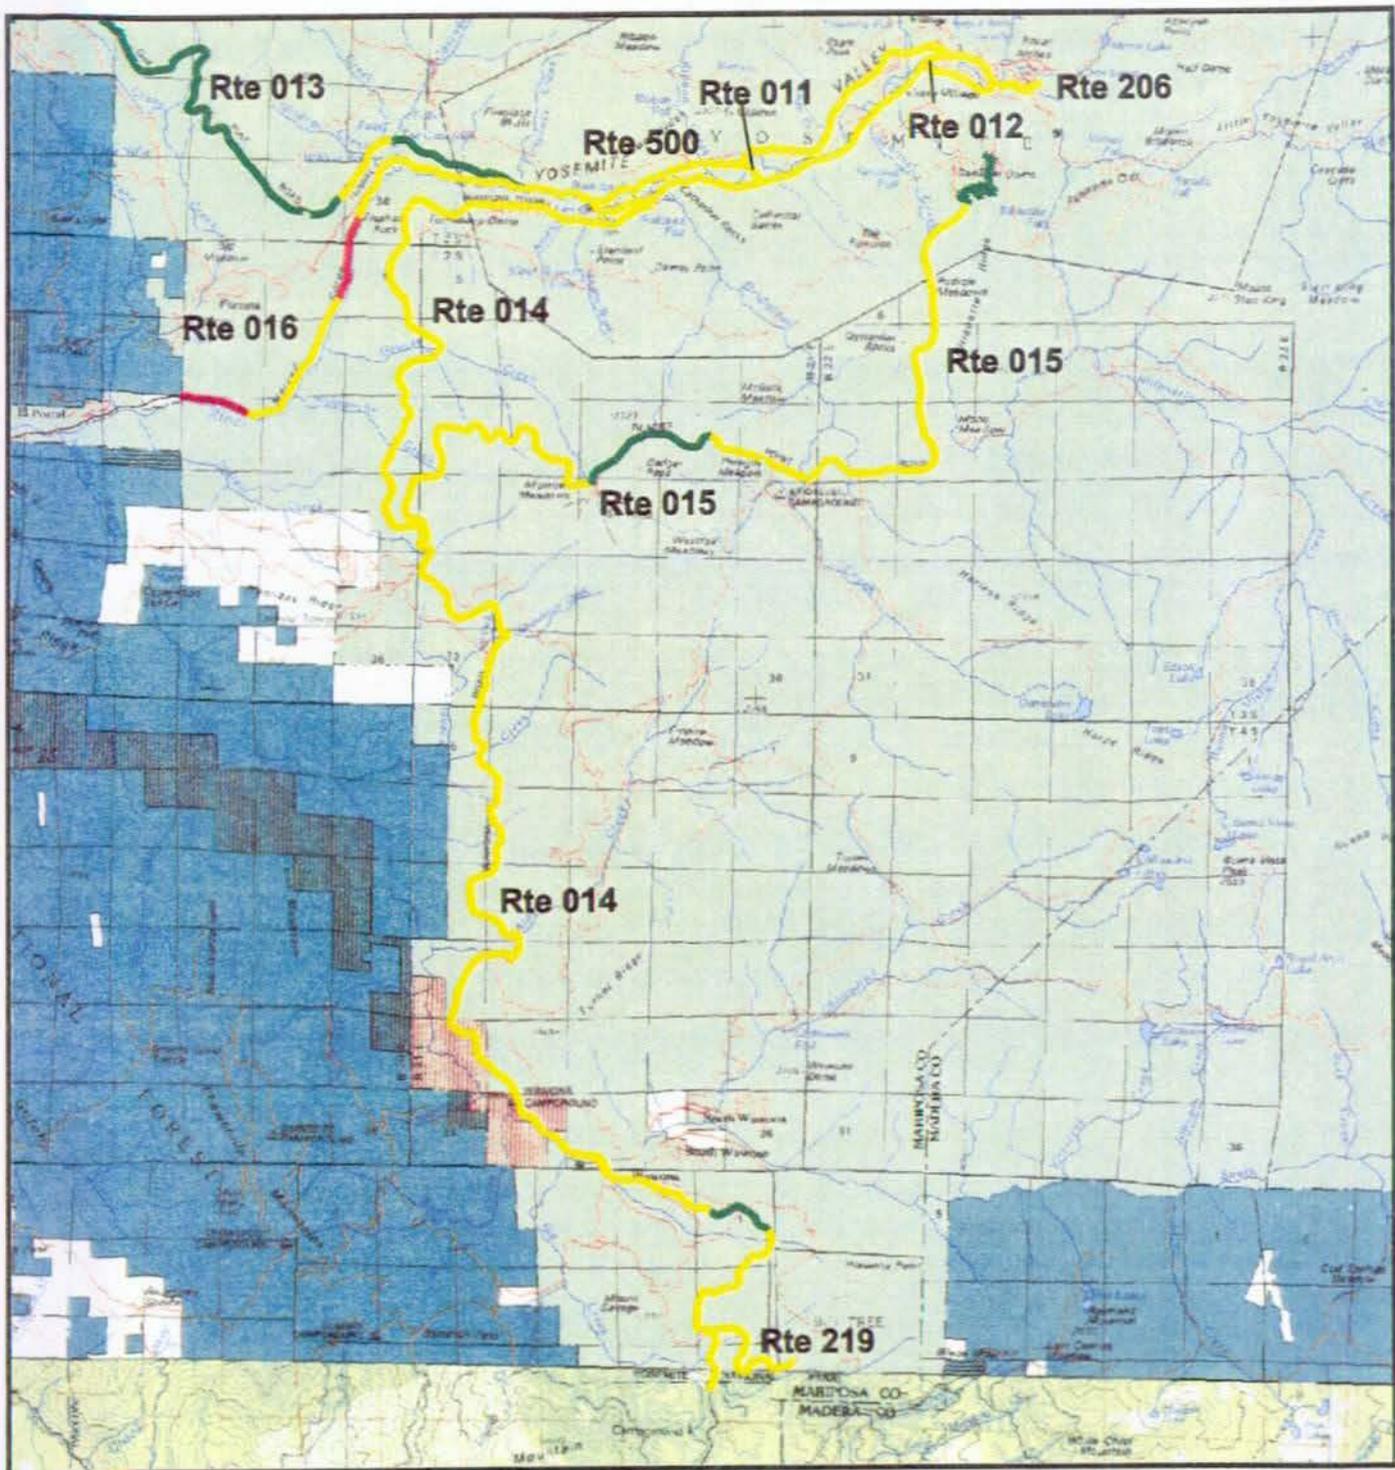
YOSEMITE NATIONAL PARK ROUTE CONDITION KEY MAP 3 PCR/DCR - Mile by Mile

PCR Excellent
 Good
 Fair
 Poor
 DCR Poor

* If the PCR rating is not available for a section, the SCR rating will be displayed

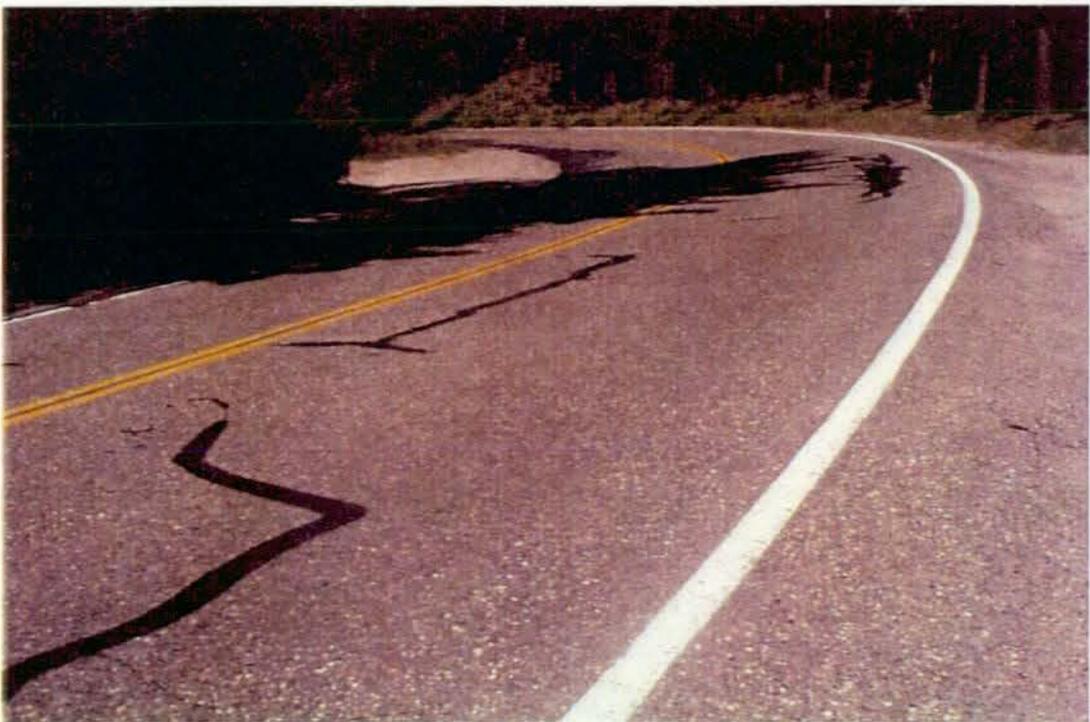
Photo #3450 - MP 17.80 - Typical Pavement Section, with sealed cracks.

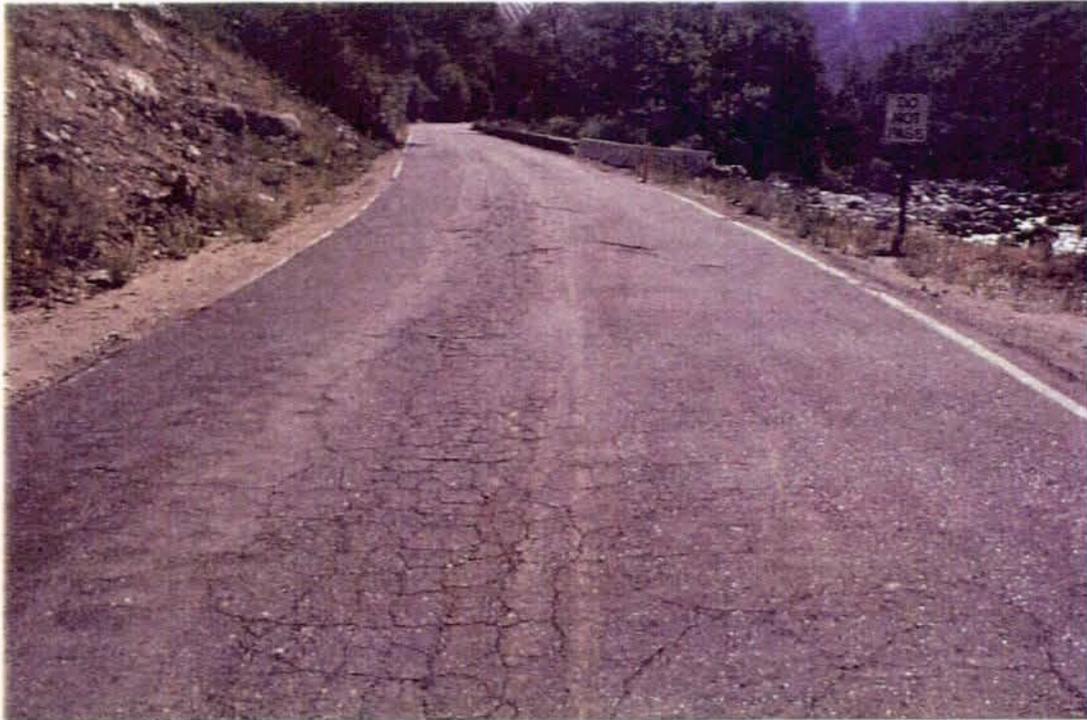
PARK NUMBER: 8800
ROUTE NUMBER: 016
DATE: 09/99

Photo #3439 - MP 0.00 - Begin at Park Boundary. Note alligator cracking.

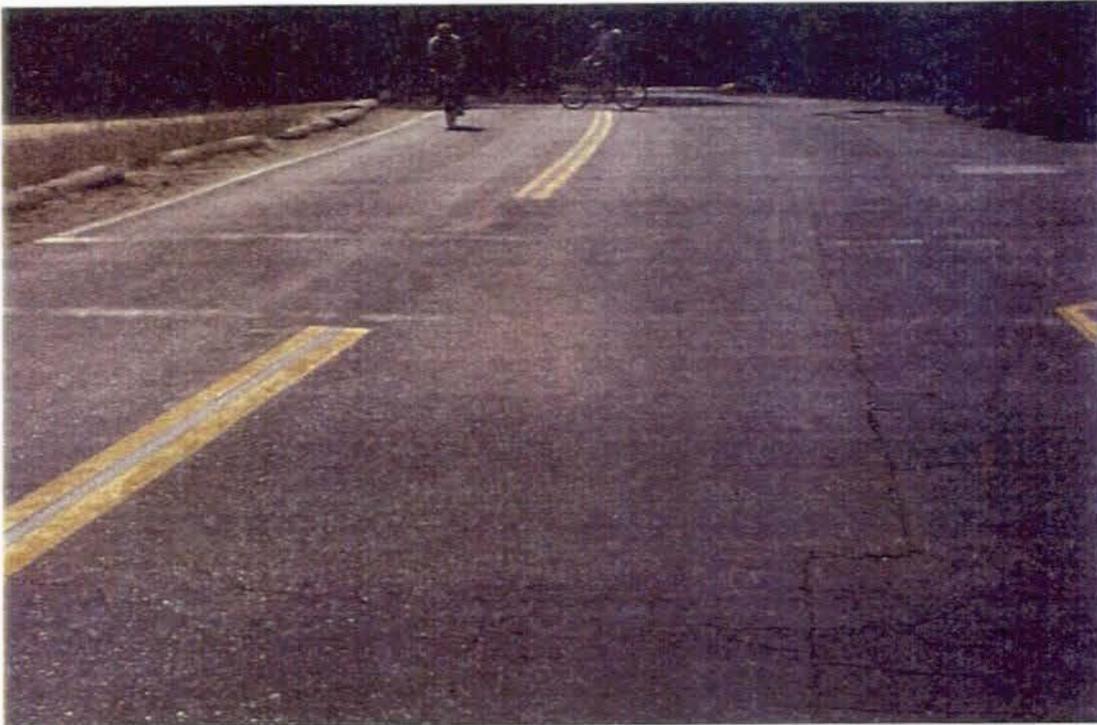
PARK NUMBER: 8800
ROUTE NUMBER: 213
DATE: 09/99

Photo #3463 - MP 0.00 - Begin at Rte 500. Note right side block cracking.

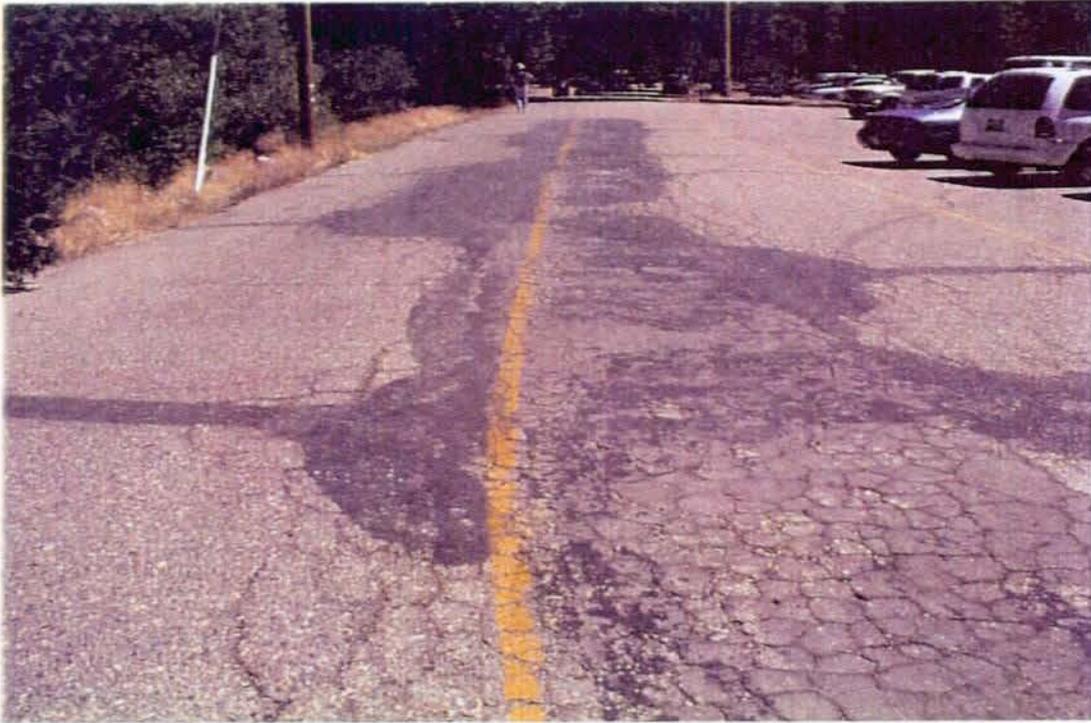
PARK NUMBER: 8800
ROUTE NUMBER: 220
DATE: 09/99

Photo #3442 - MP 0.00 - Begin at Rte 014. Heavy alligator cracking.

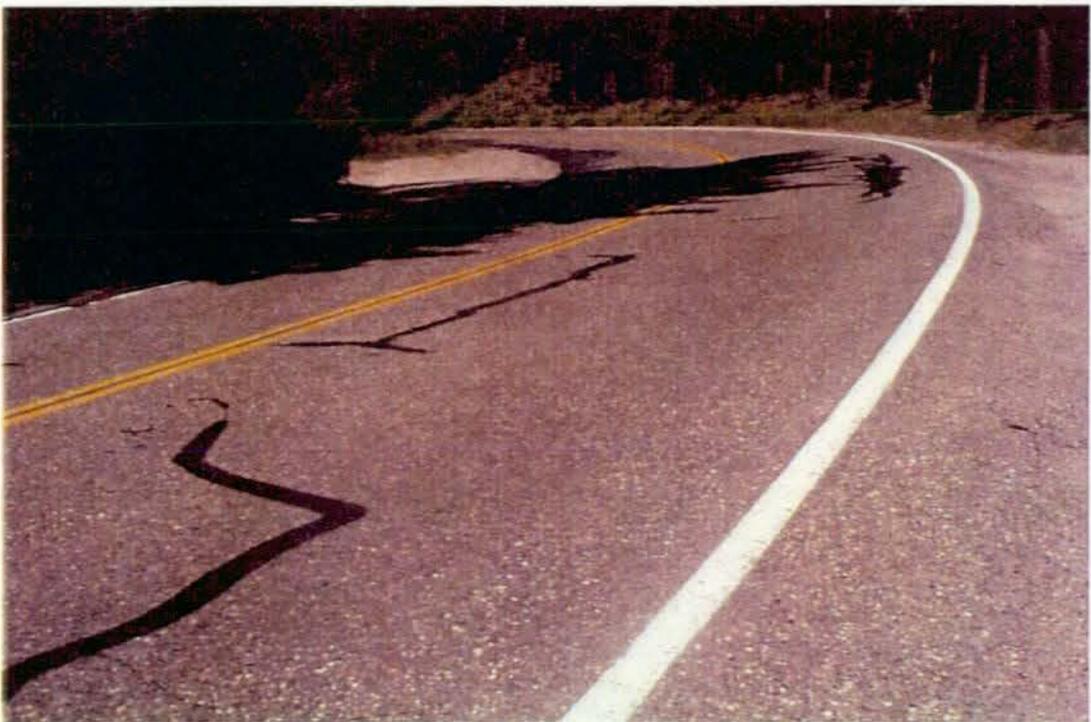
Photo #3450 - MP 17.80 - Typical Pavement Section, with sealed cracks.

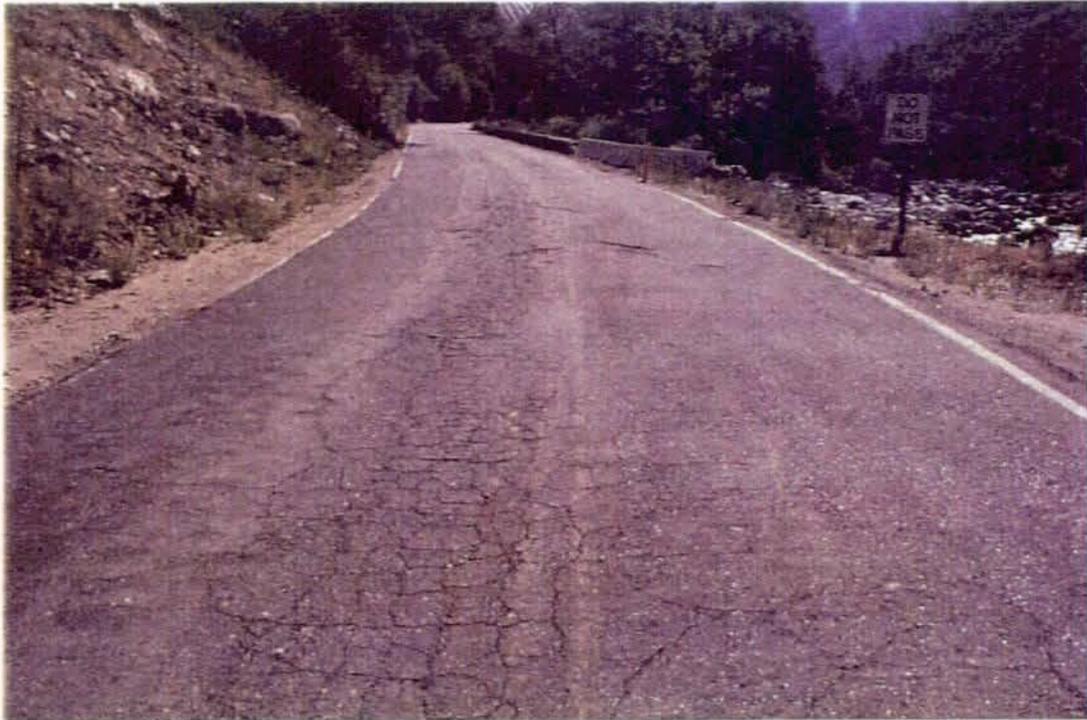
PARK NUMBER: 8800
ROUTE NUMBER: 016
DATE: 09/99

Photo #3439 - MP 0.00 - Begin at Park Boundary. Note alligator cracking.

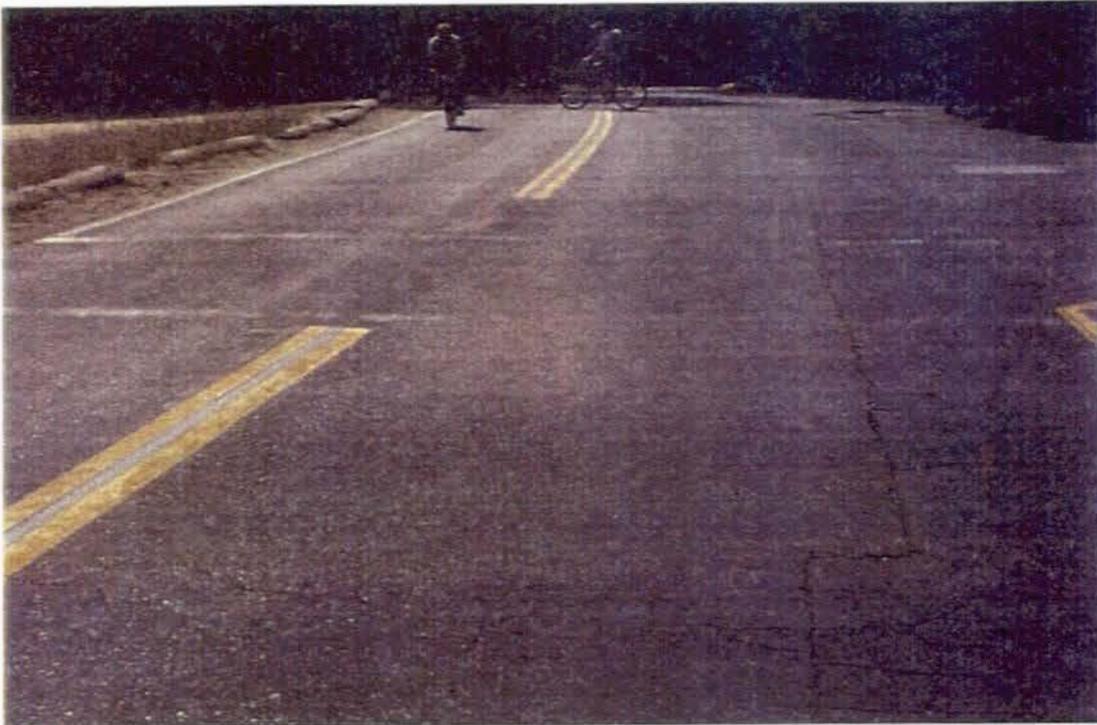
PARK NUMBER: 8800
ROUTE NUMBER: 213
DATE: 09/99

Photo #3463 - MP 0.00 - Begin at Rte 500. Note right side block cracking.

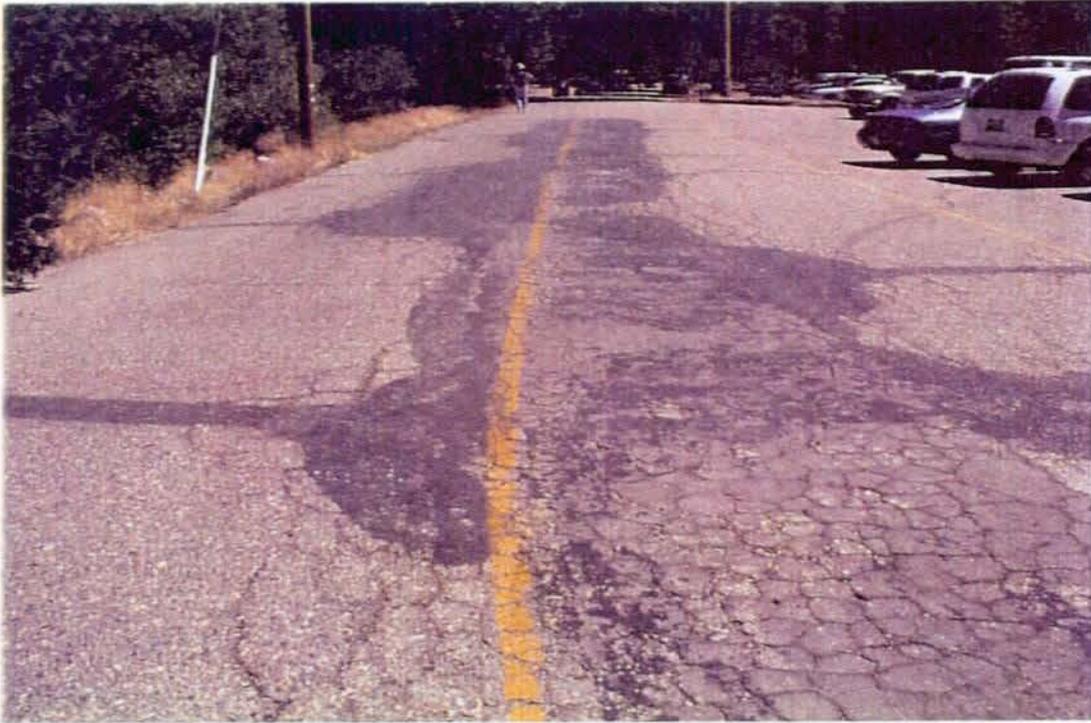
PARK NUMBER: 8800
ROUTE NUMBER: 220
DATE: 09/99

Photo #3442 - MP 0.00 - Begin at Rte 014. Heavy alligator cracking.
