The Road Inventory for Cape Hatteras National Seashore

Road Inventory Program

Prepared By:
Federal Highway Administration
Eastern Federal Lands Highway Division
August 1999

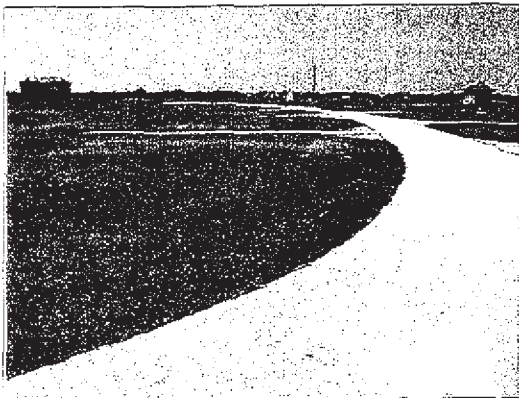
Route 234P

Route	Area (sq ft)	Lane Miles	Sample Section (mi)	Width (ft)	SCR	RI	PCR	Condition
234P	170,345	2.93	NA	NA	NA	NA	NA	GOOD

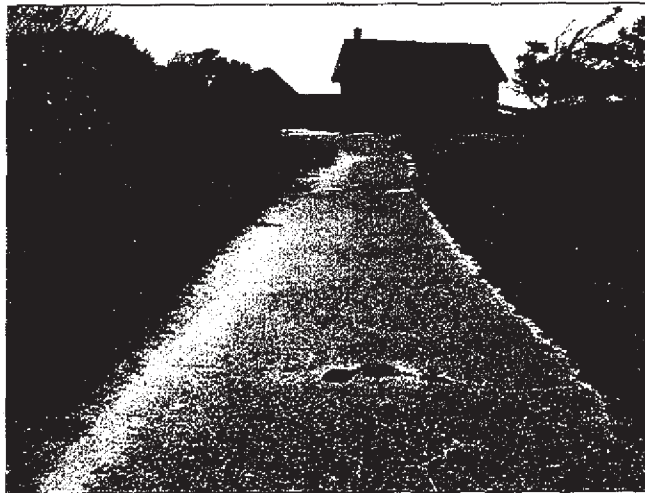
Route 404P

Route	Area (sq ft)	Lane Miles	Sample Section (mi)	Width (ft)	SCR	RI	PCR	Condition
404P	16,800	0.28	NA	NA	NA	NA	NA	FAIR

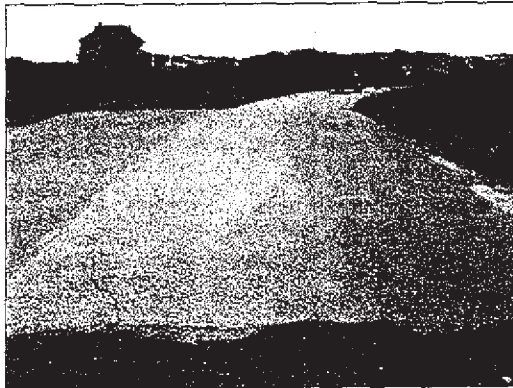
Route 411P

Route	Area (sq ft)	Lane Miles	Sample Section (mi)	Width (ft)	SCR	RI	PCR	Condition
411P	8,170	0.14	NA	NA	NA	NA	NA	GOOD

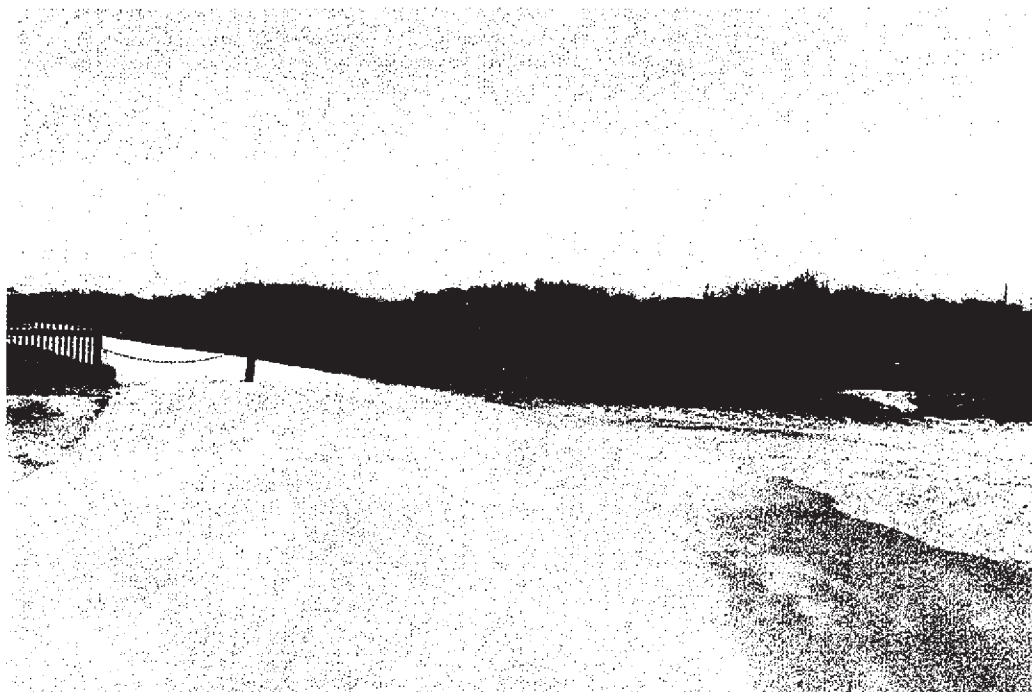
Photo #20 - MP 1.01 - End at closed campground and road to beach.

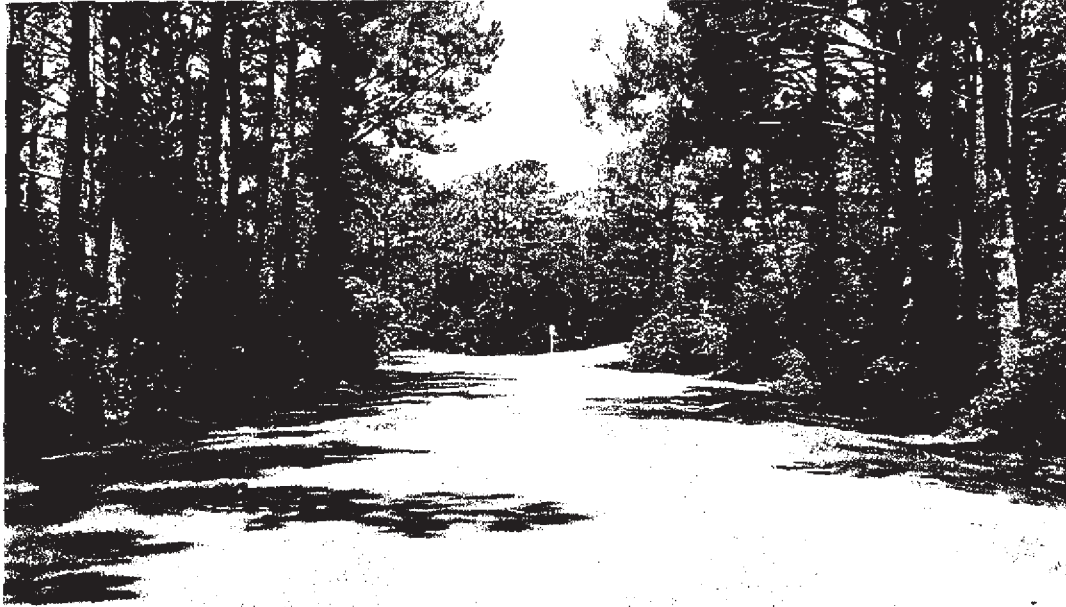
Photo #5 - MP 0.00 - Beginning of route—typical pavement section.
